MEDFIELD STATE HOSPITAL

CAPITAL ASSESSMENT REPORT

RE-USE, REPAIRS & MAINTENANCE RECOMMENDATIONS

September 2014

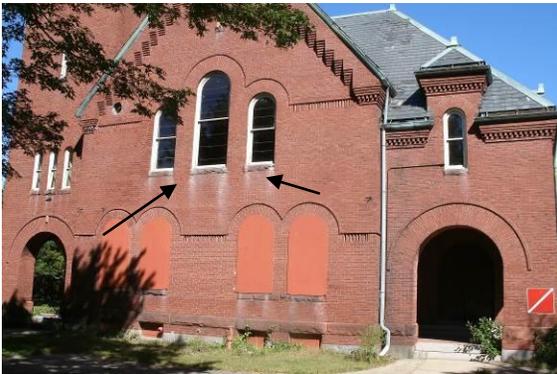
Typical façade Note efflorescence stains

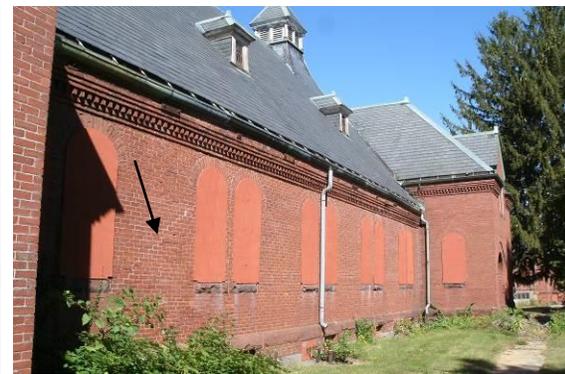
Typical façade Note cracks

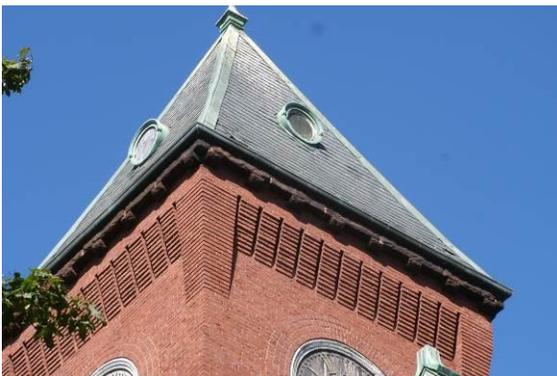
Decorative brick and stone tower corbels

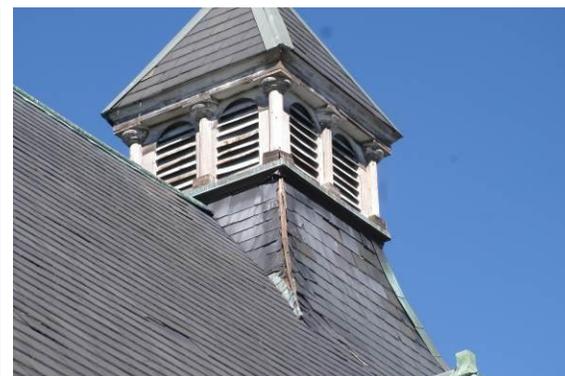
Deteriorated slate at cupola

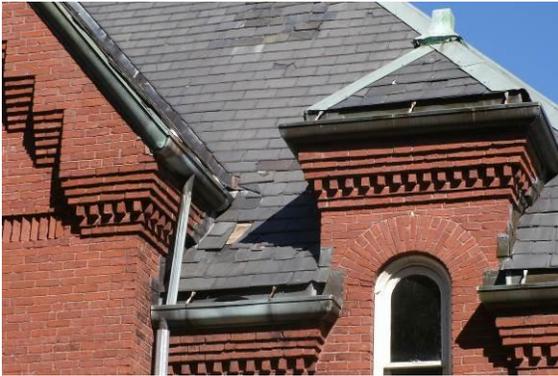
Deteriorated & missing slate

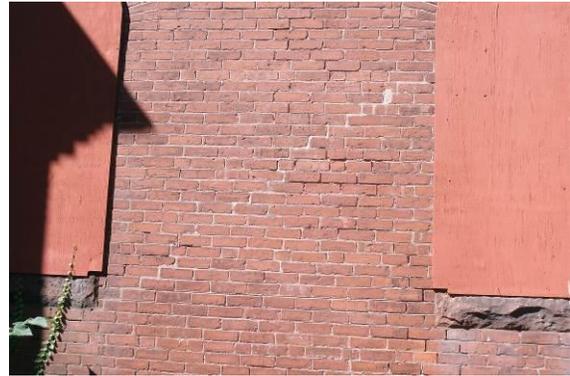
Step crack and eroded mortar joints

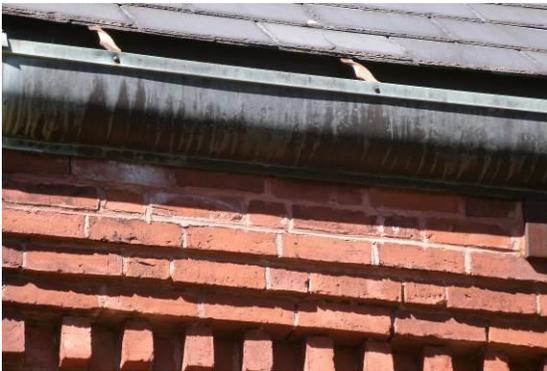
Close up of gutter showing past repairs

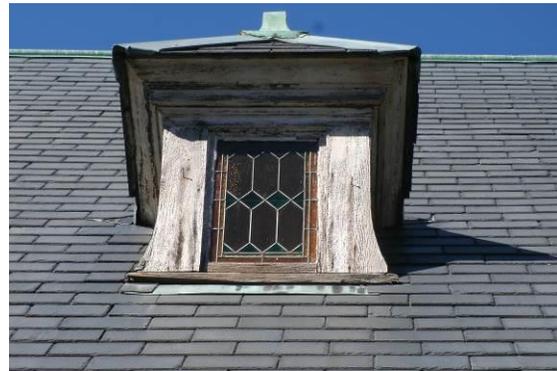
Deteriorated dormer

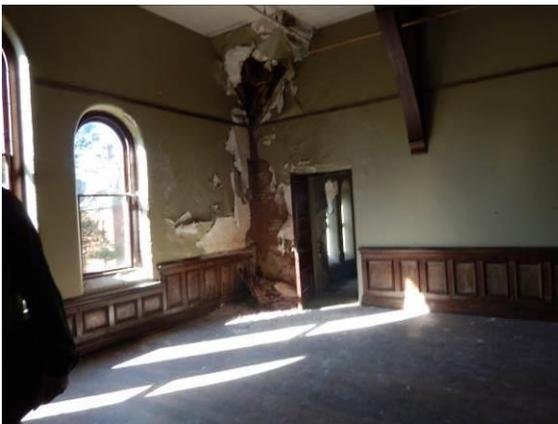
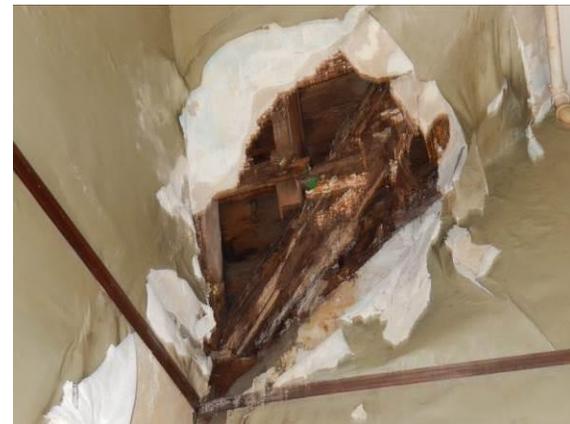
There is another roof leak at the mezzanine level at the southwest corner that has caused wood rot to the roof truss system and damaged the wall and floor finishes.

View of water damaged roof framing and walls in mezzanine at south west corner.

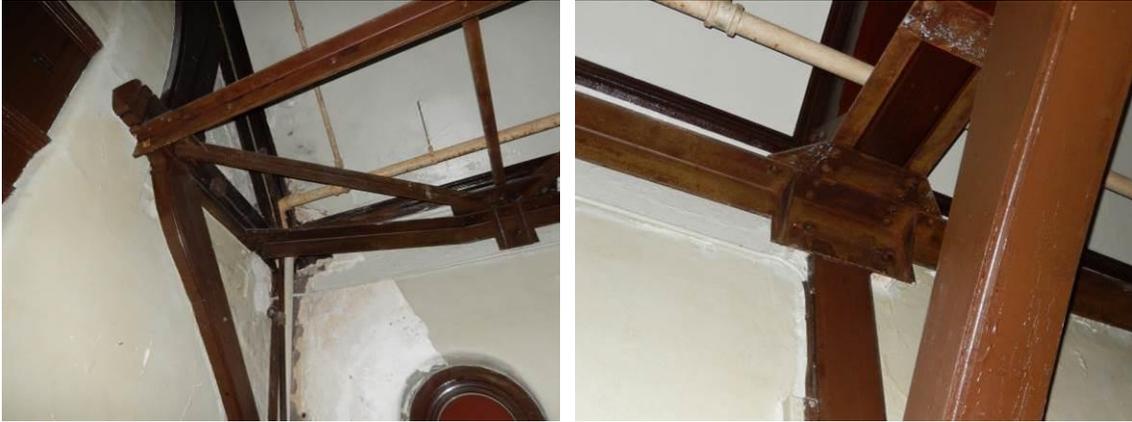
The interior of the building is in fair condition. There is a roof leak in the Hall along the west elevation that has compromised the wood and post construction steel truss framing system.

View of water damaged roof truss system at west wall of Hall.

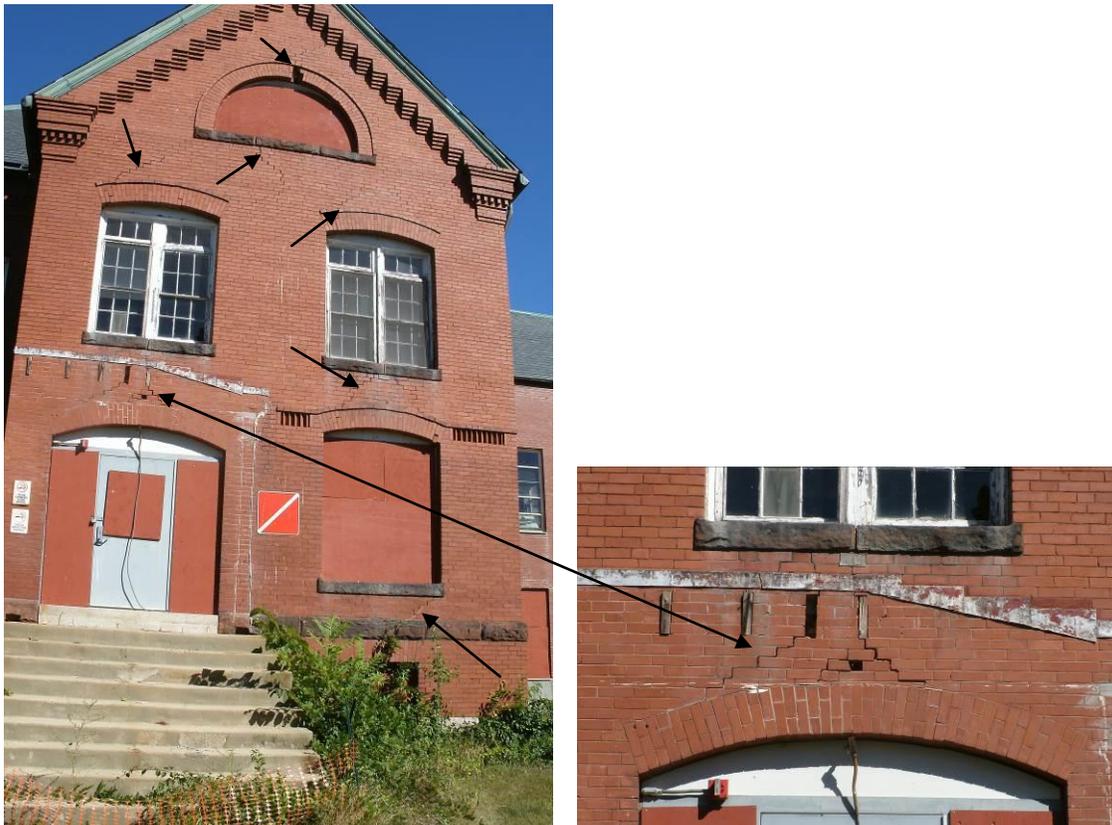
Front elevation showing deteriorated masonry arches and other cracks

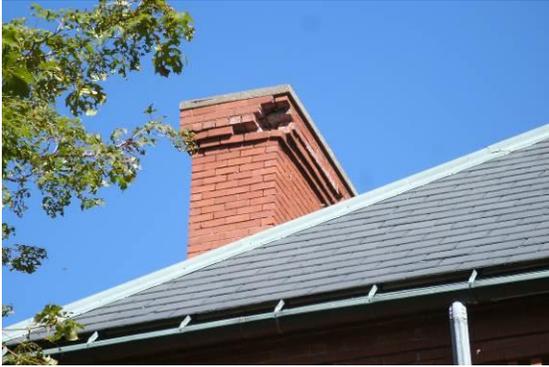
Condition of chimney

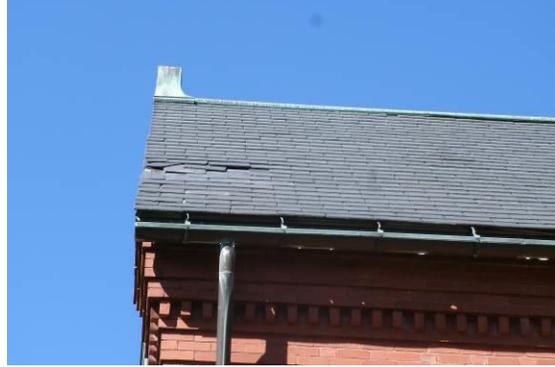
Condition of slate roofing

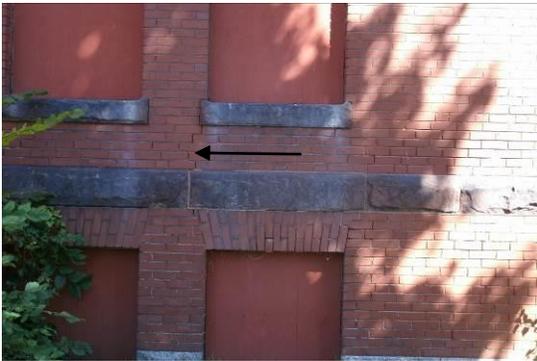
Step cracks extending between window openings

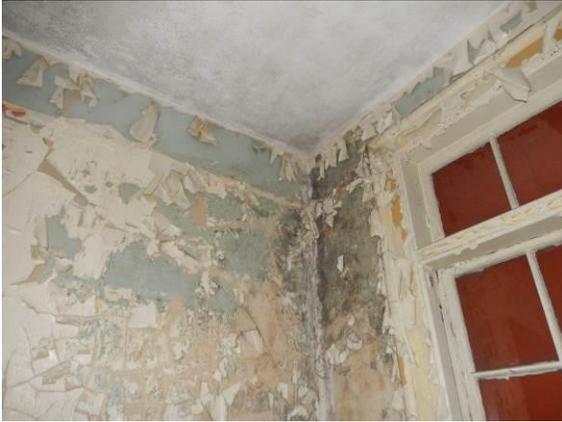
View of mold on walls.

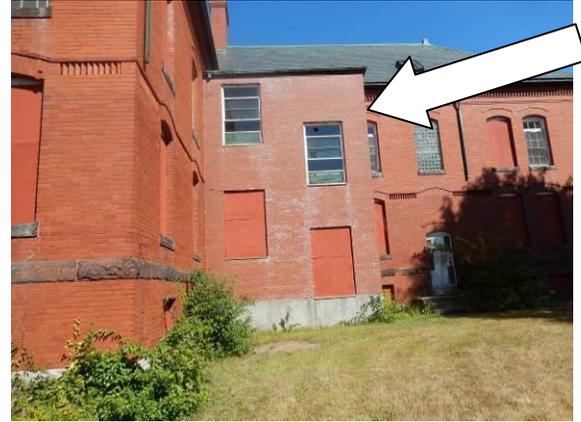
View of water saturated stairwell. Note efflorescence on exterior walls.

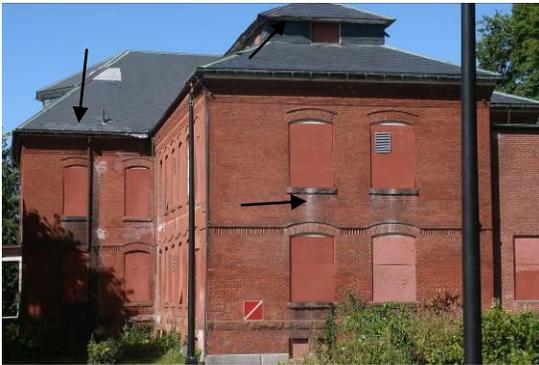
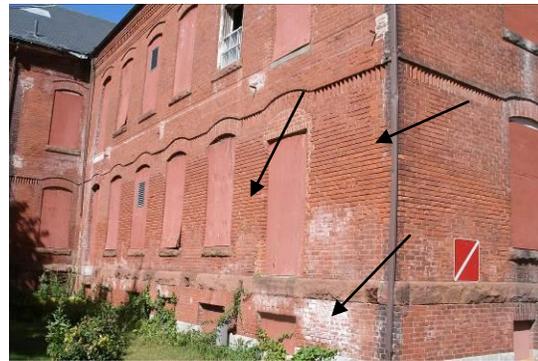
Deteriorated slate, efflorescence, and eroded mortar joints

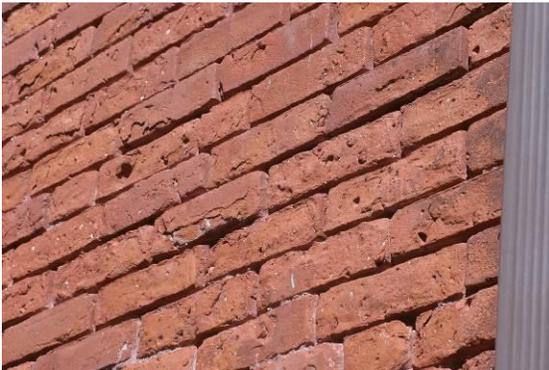
Eroded mortar joints

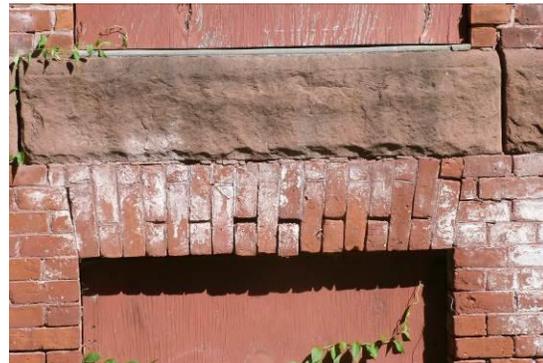
Efflorescence and displaced brick

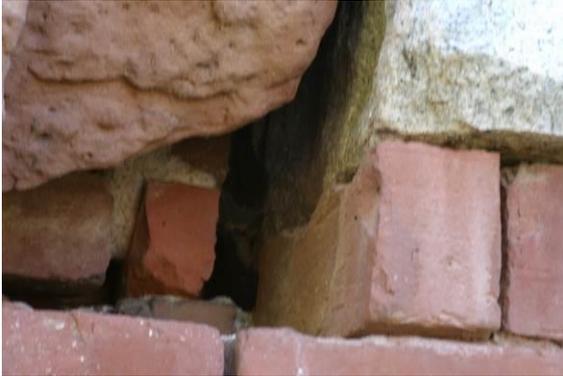
Interior wall voids

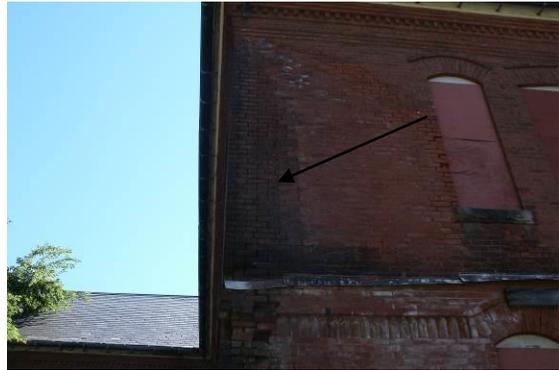
Mortar washed away due to missing down leader

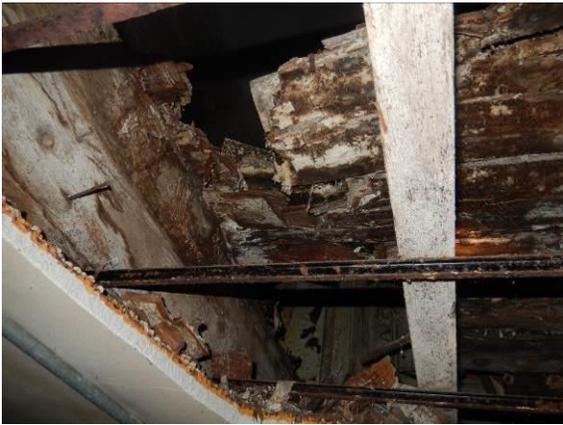
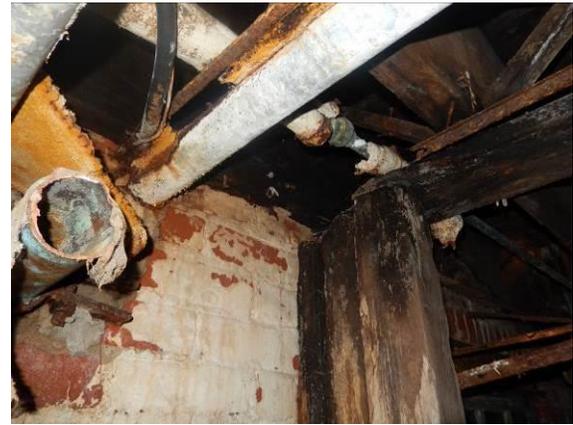
View of water damaged floor joists and flooring from basement looking up to 1st floor.

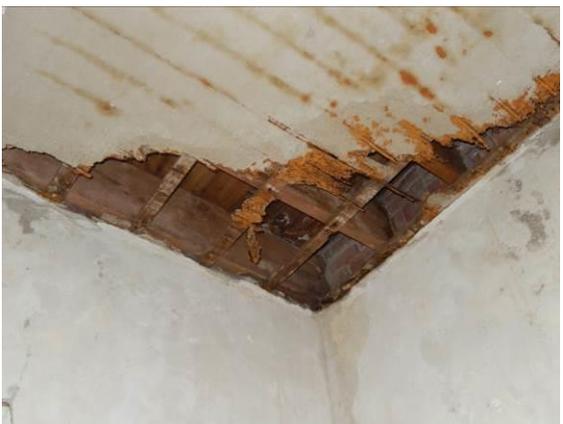
View of water damage at 1st floor ceiling.

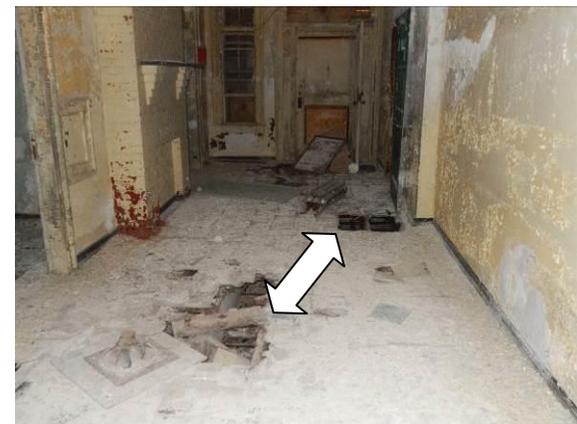
View of water wood rot at floor joists.

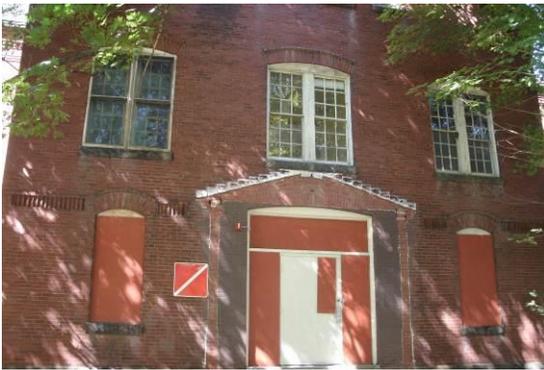
Entrance porch removed

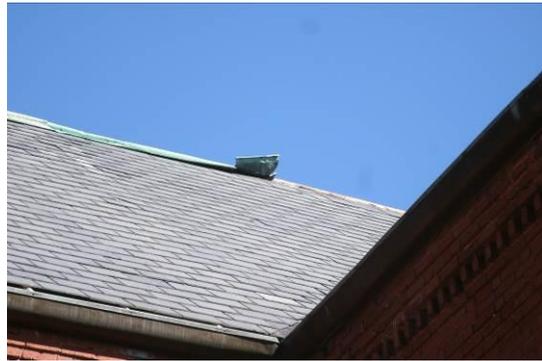
Deteriorated copper or slate roof

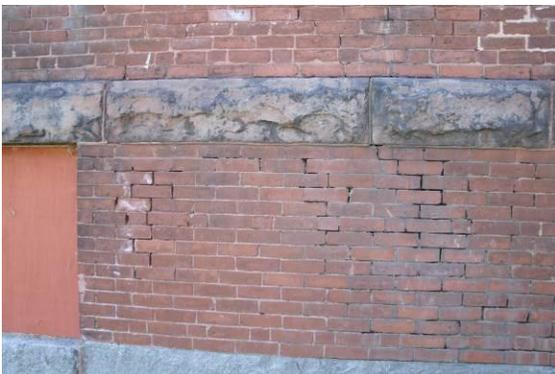
Eroded mortar

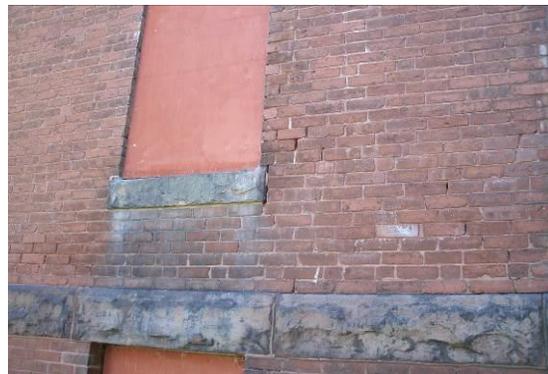
Deteriorated masonry

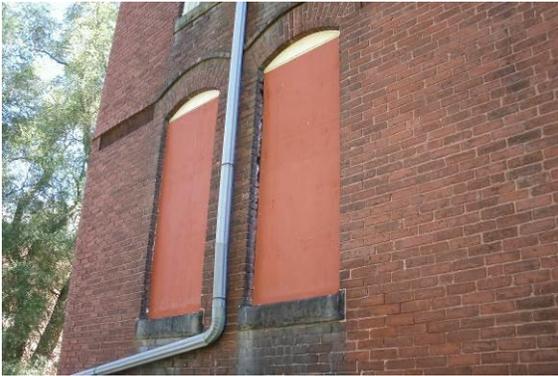
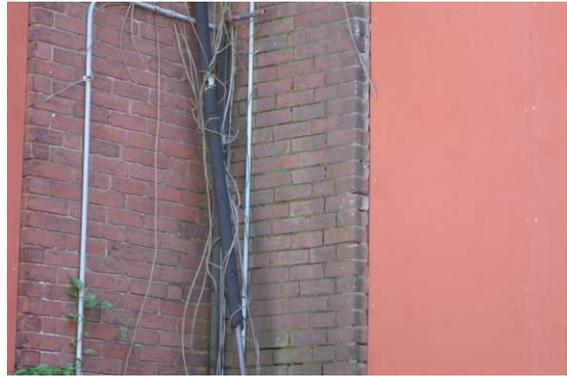
Conditions around windows

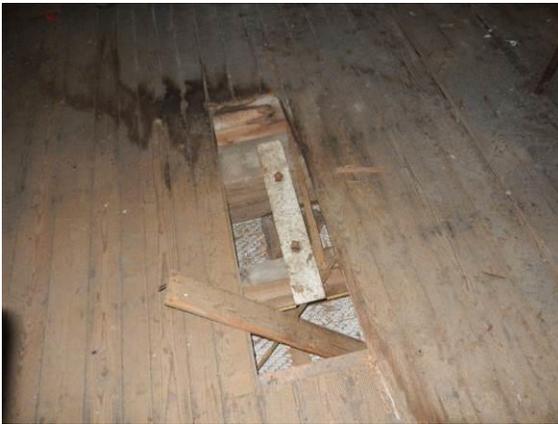
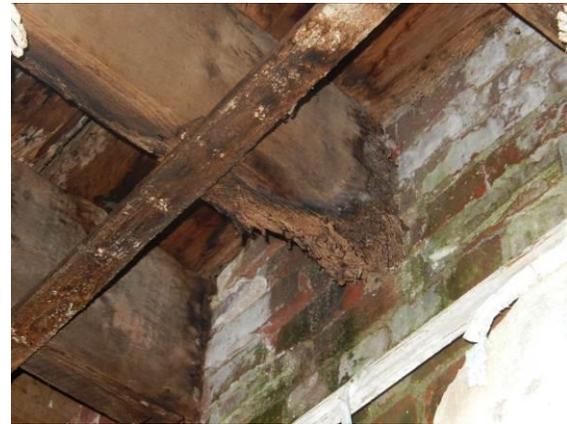
View of wood rot at floor boards in attic and joists in basement.

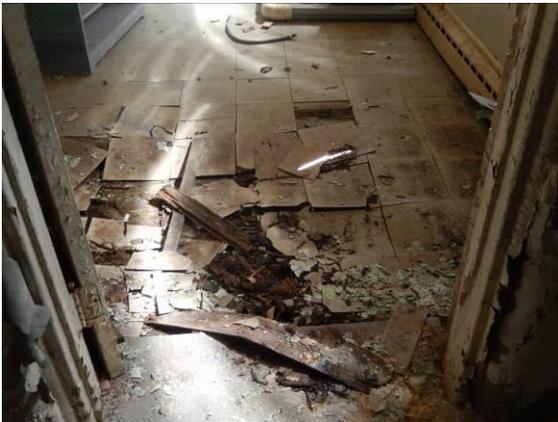
View of wood rot at floor boards in porch.
