TOWN OF MEDFIELD

Municipal Facilities

Evaluation and Capital Plan

October 6, 2017

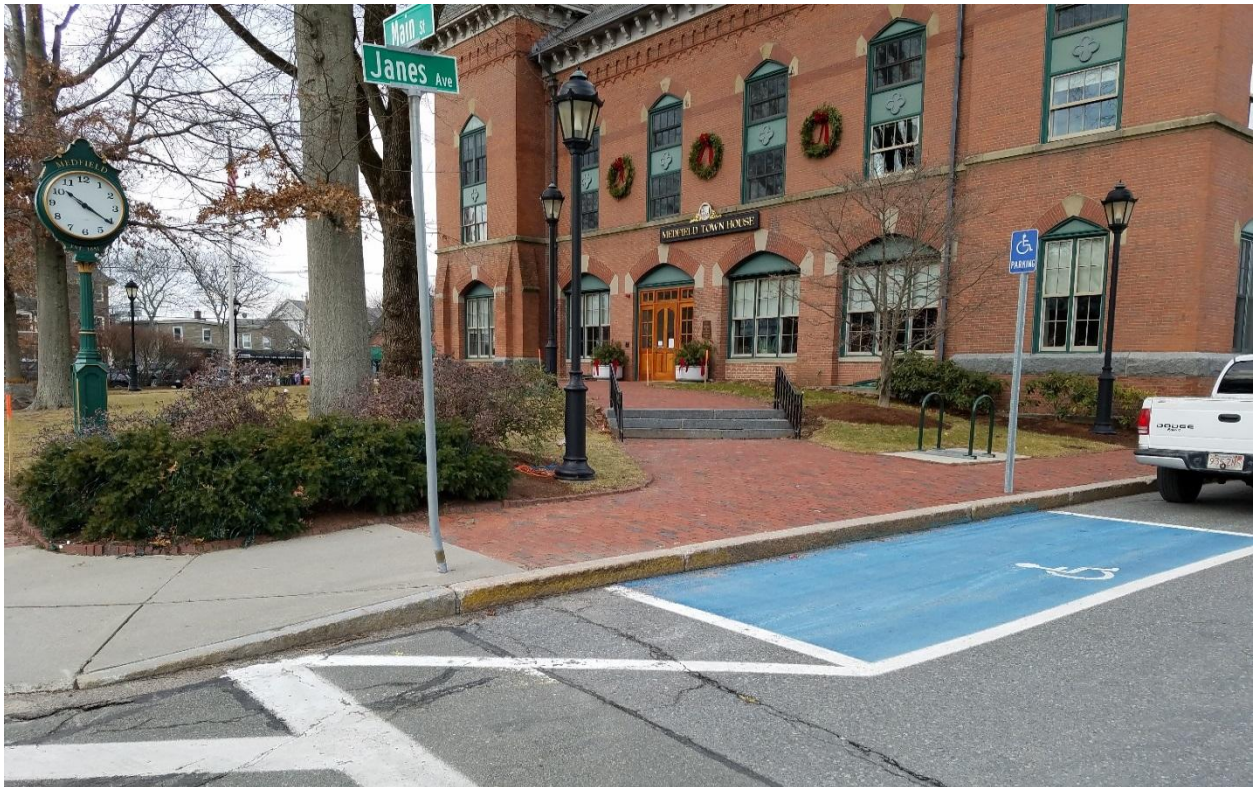
SHOWING ACCESSIBLE PARKING SPACE ALONG JANES AVE. (EAST)

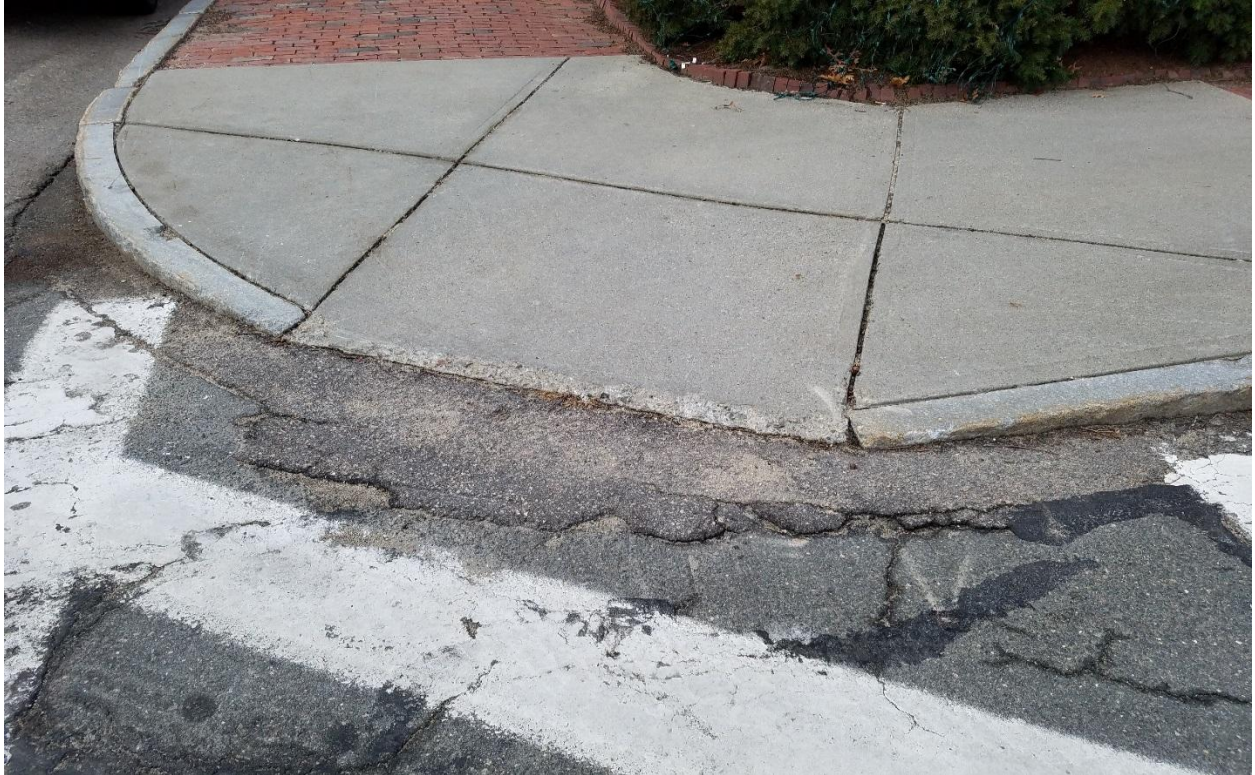
SHOWING POOR CONDITION OF CURB CUT AND PAVING AT JANES AVE CROSSWALK

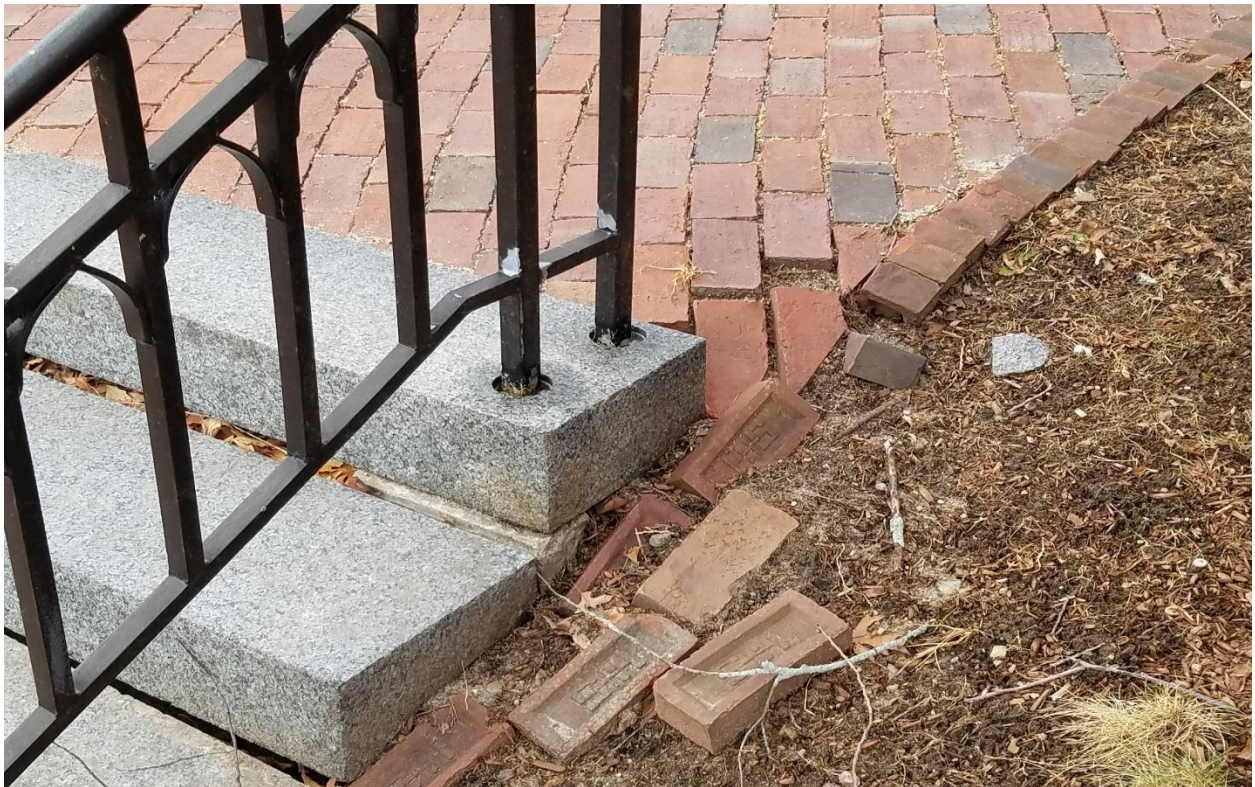
POOR CONDITION OF GRANITE STEPS AT FRONT ENTRANCE WALKWAY SHOWING GAPS IN GRANITE AND LOOSE BRICKS

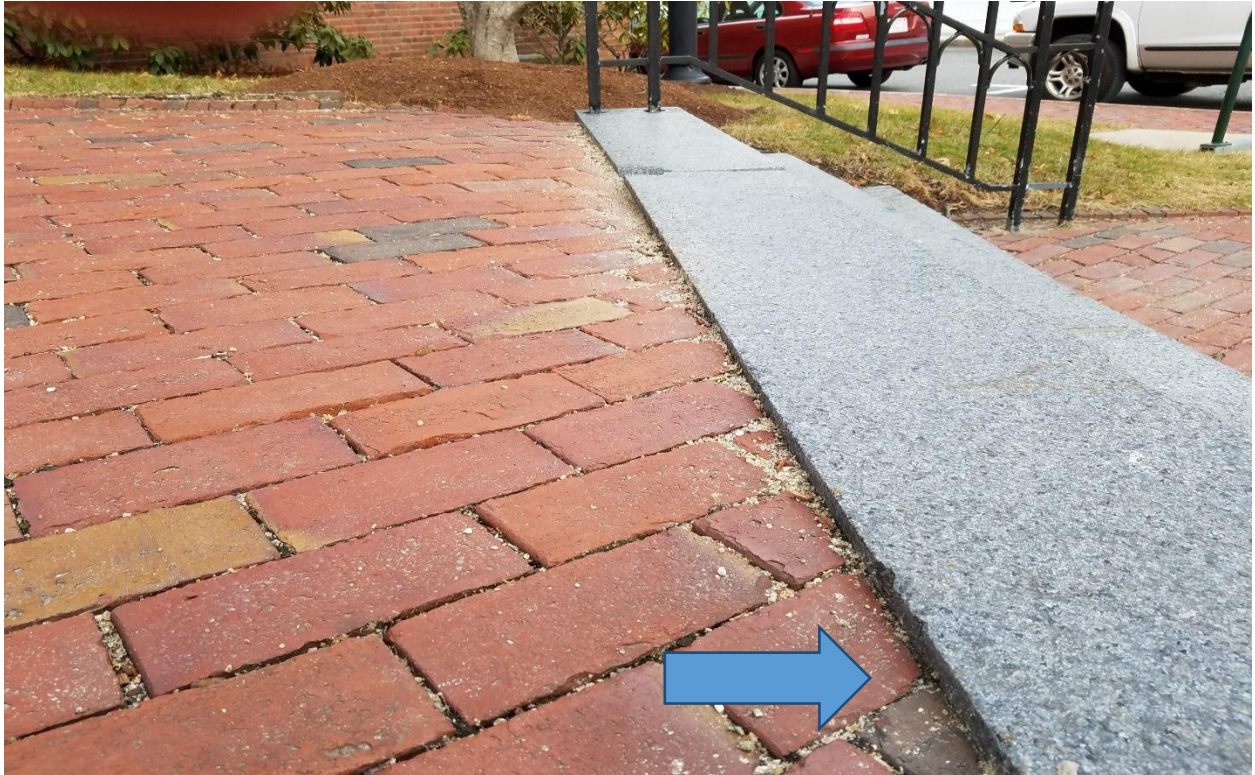
SHOWING LIP AT GRANITE TOP TREAD AND BRICK SETTLEMENT

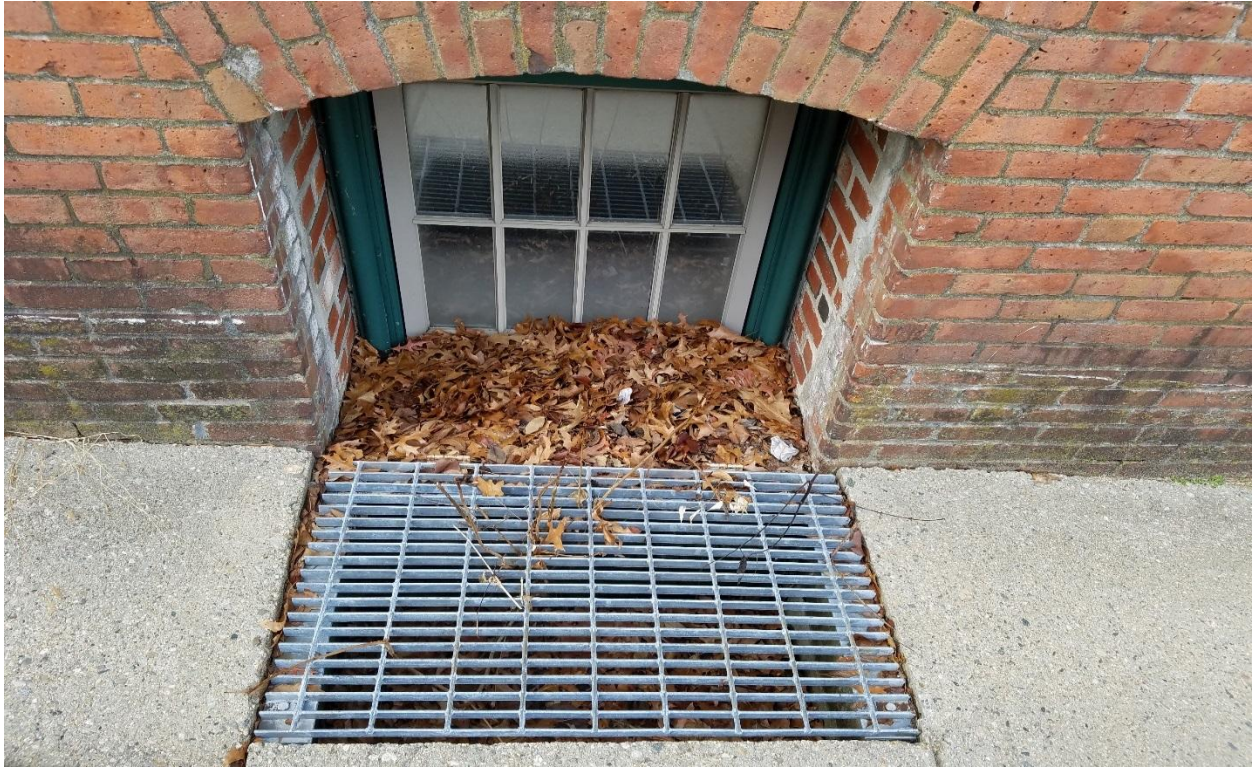
AREA WELL ALONG JANES AVE FILLED WITH LEAVES

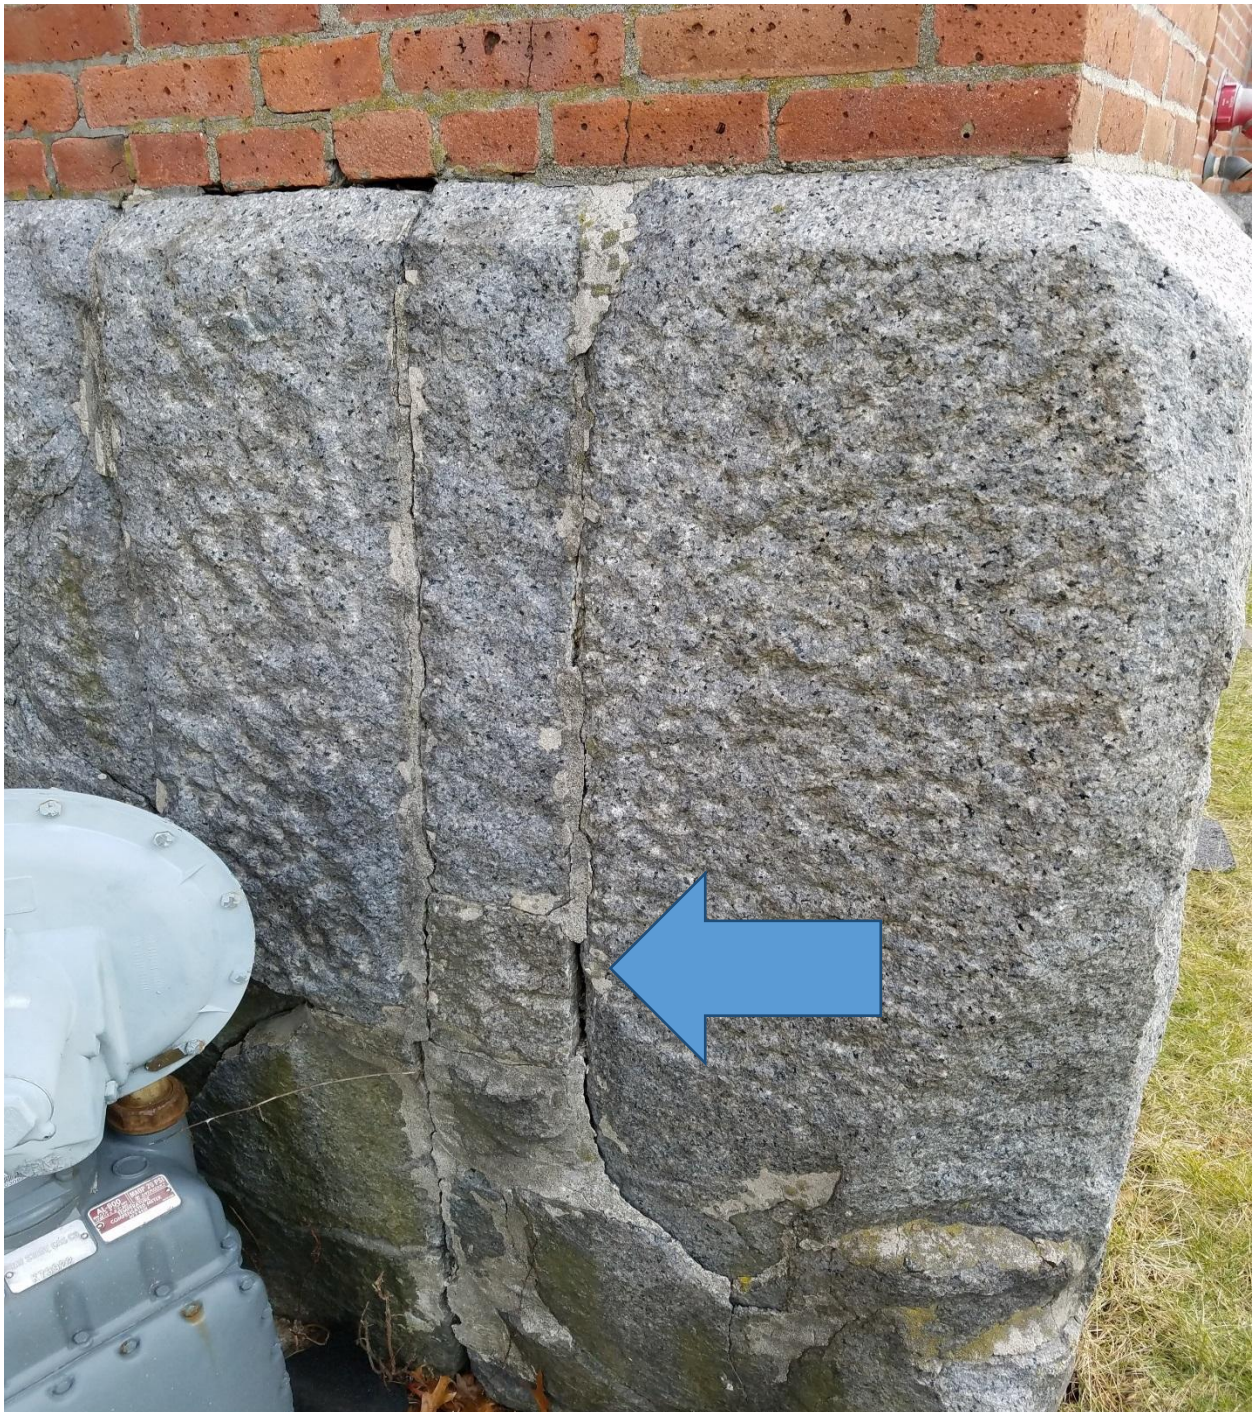
TYPICAL CRACKS IN GRANITE FOUNDATION CAP STONES

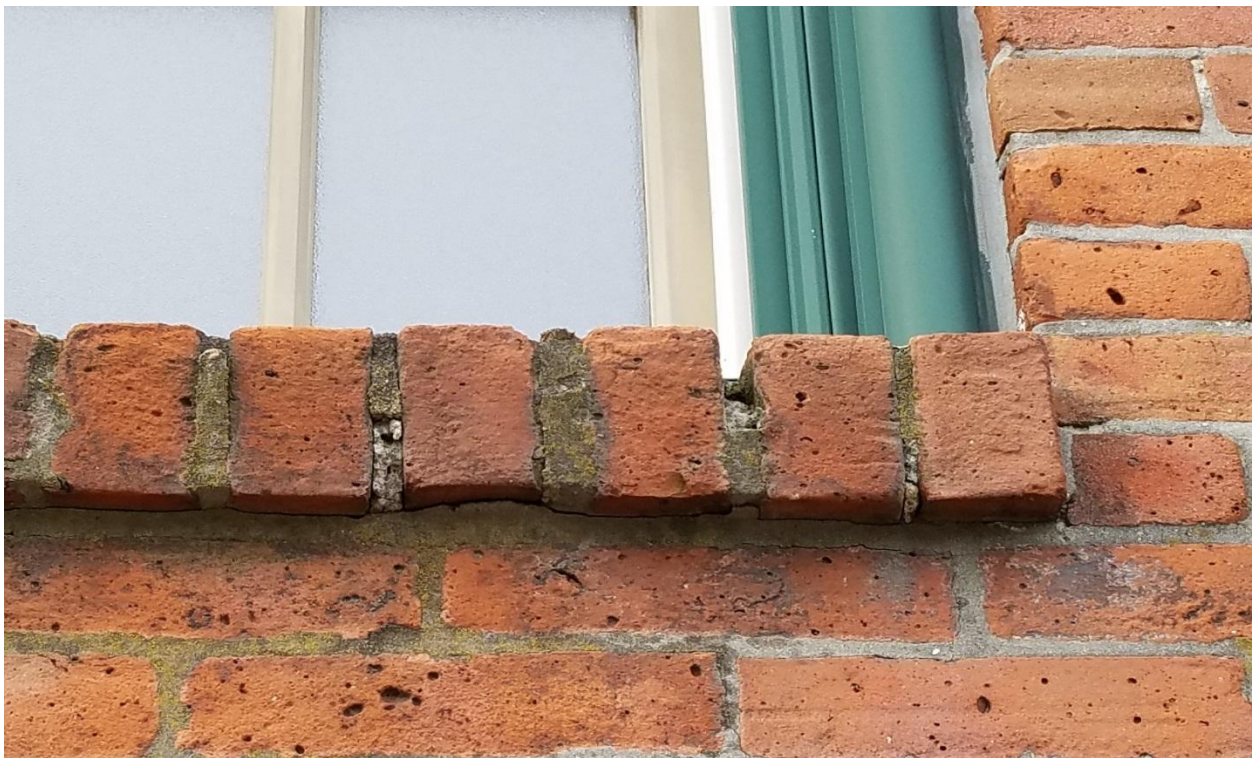
TYPICAL EXAMAPLE OF DETERIORATED ROXLOC BRICK SILLS

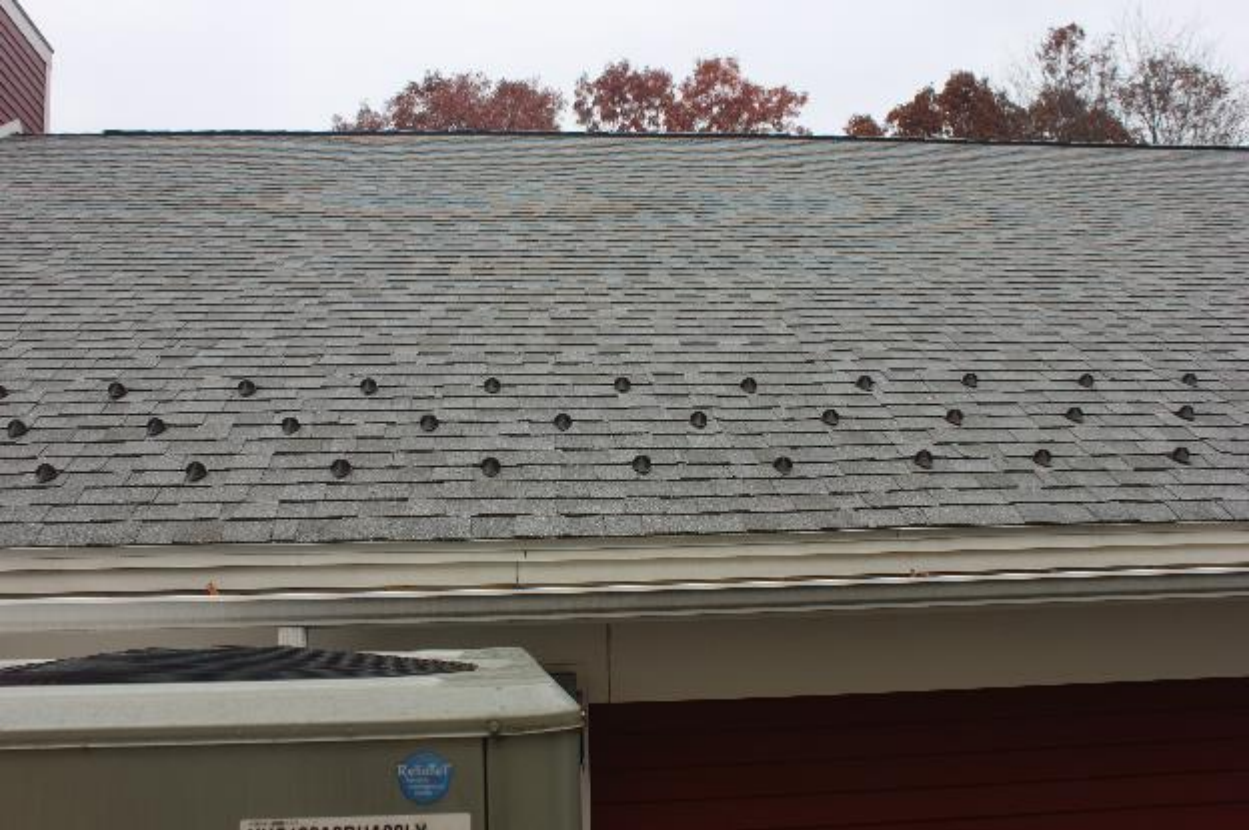
Roof with snow guards

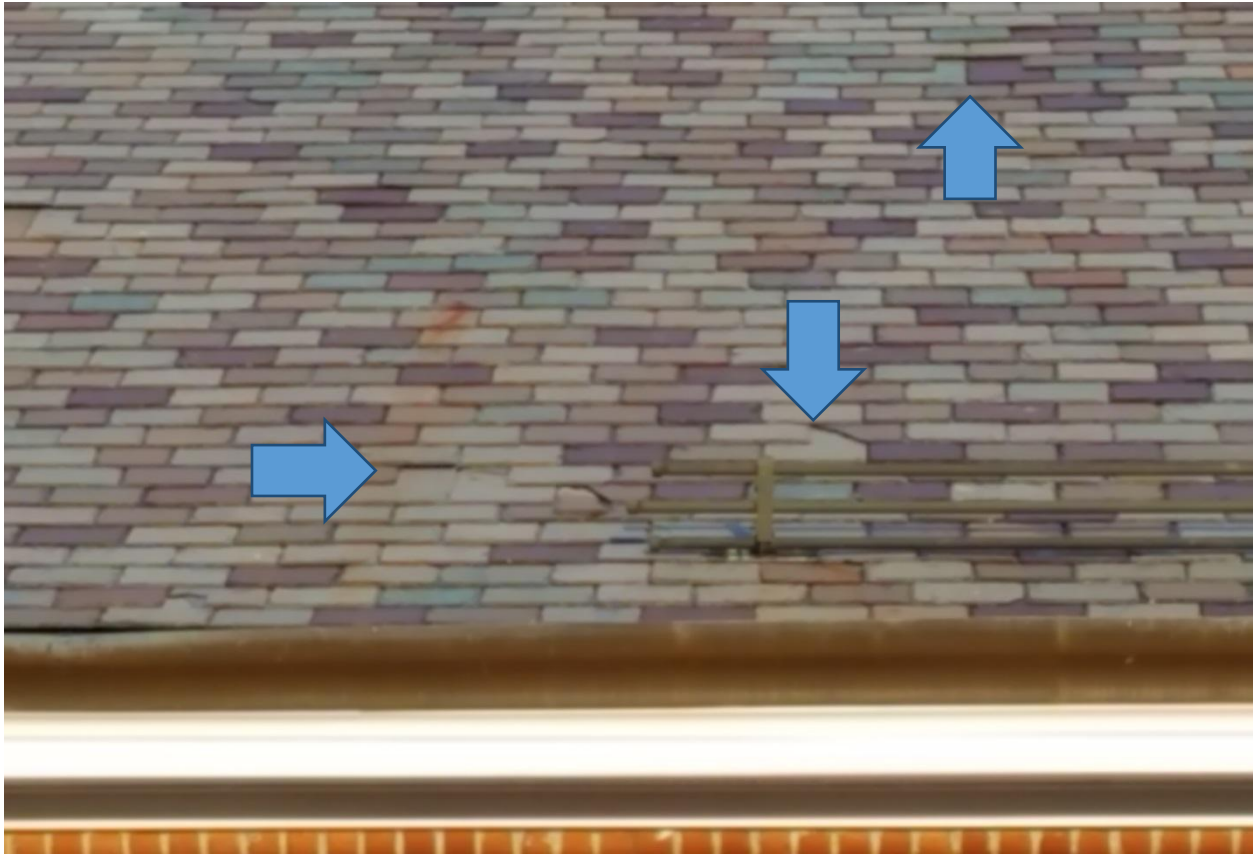
WEST-FACING SLATE ROOF SHOWING MISSING SLATES

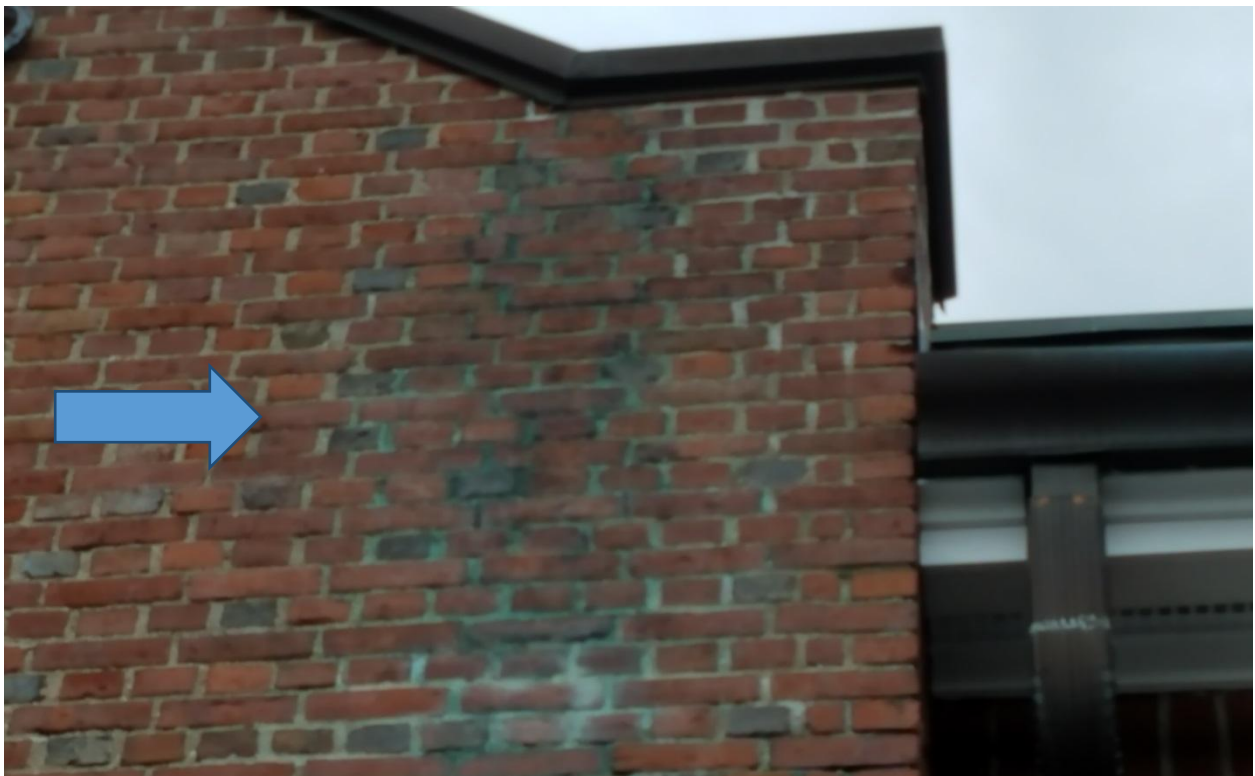
POSSIBLE LEAK AT PARAPET COPING CAUSING INFILTRATION INTO WALL & EFFLORESCENCE

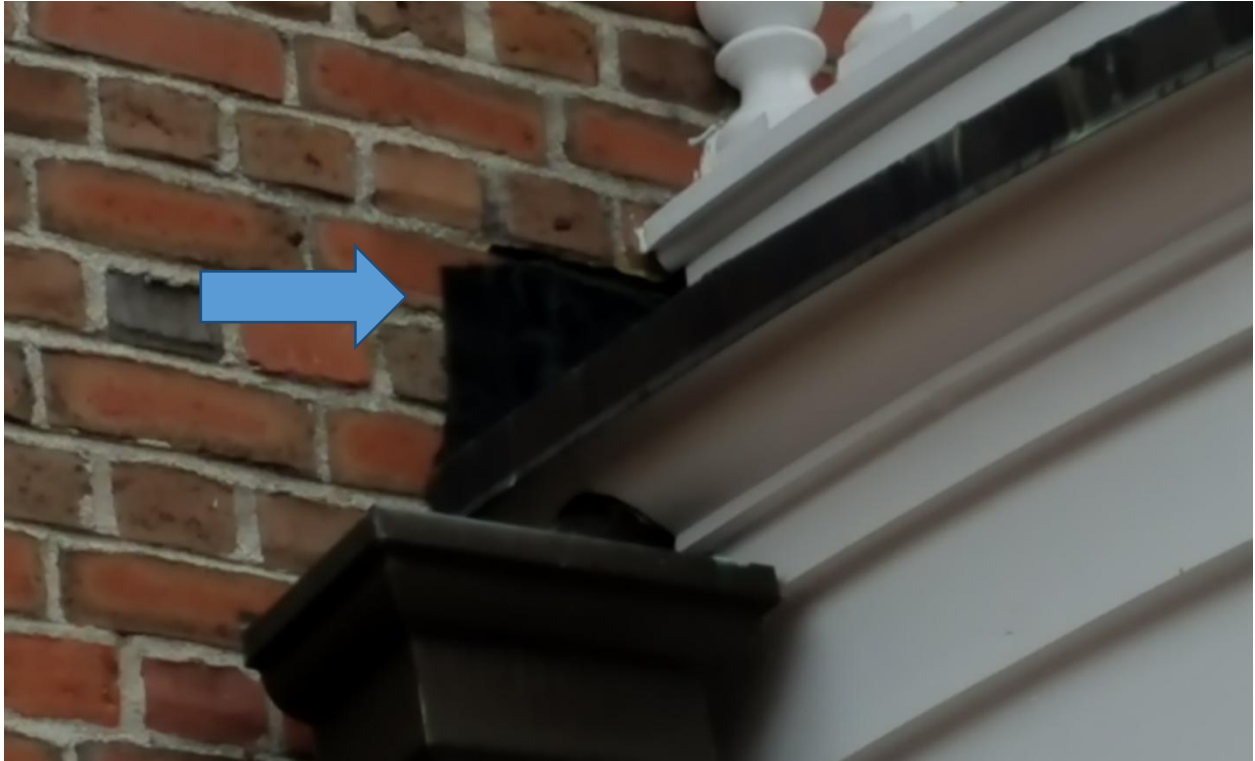
MEMBRANE ROOF AT EAST ENTRY NOT PROPERLY TERMINATED (ARROW)

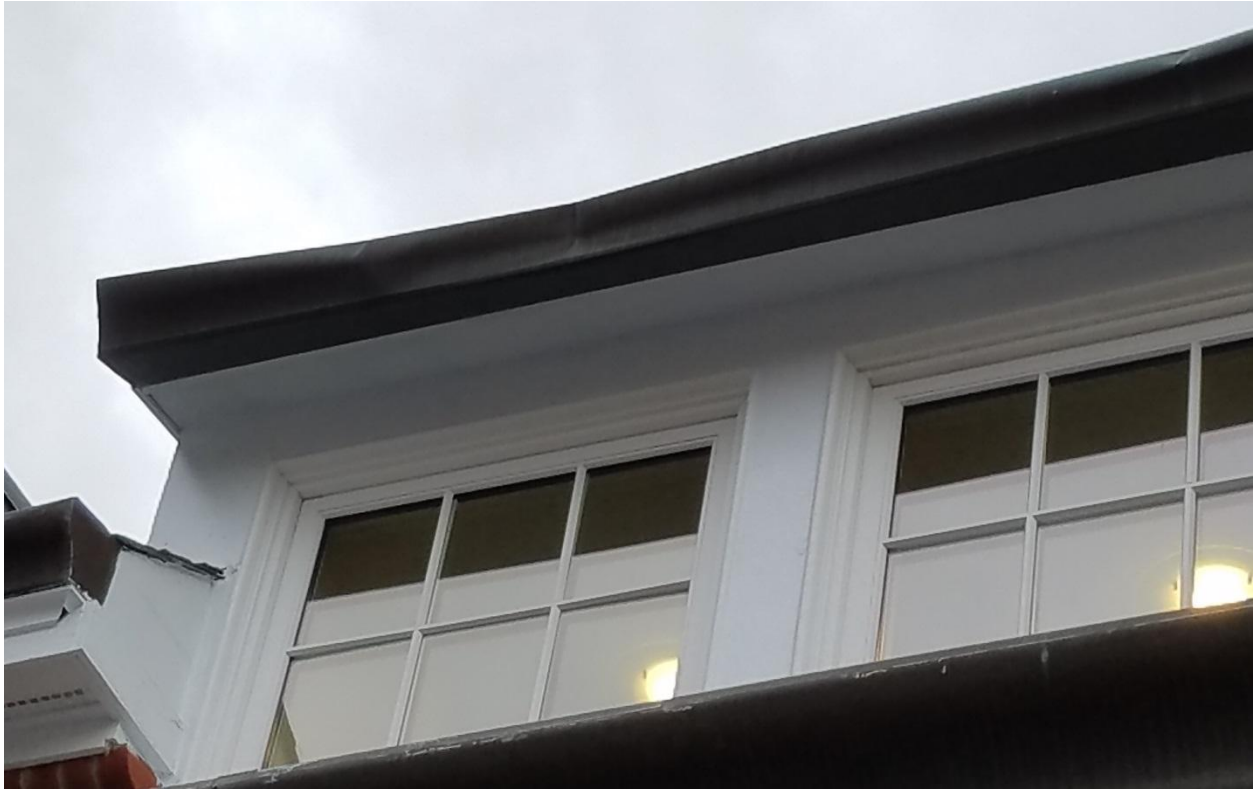
EXAMPLE OF DAMAGED GUTTERS (WEST ELEVATION)

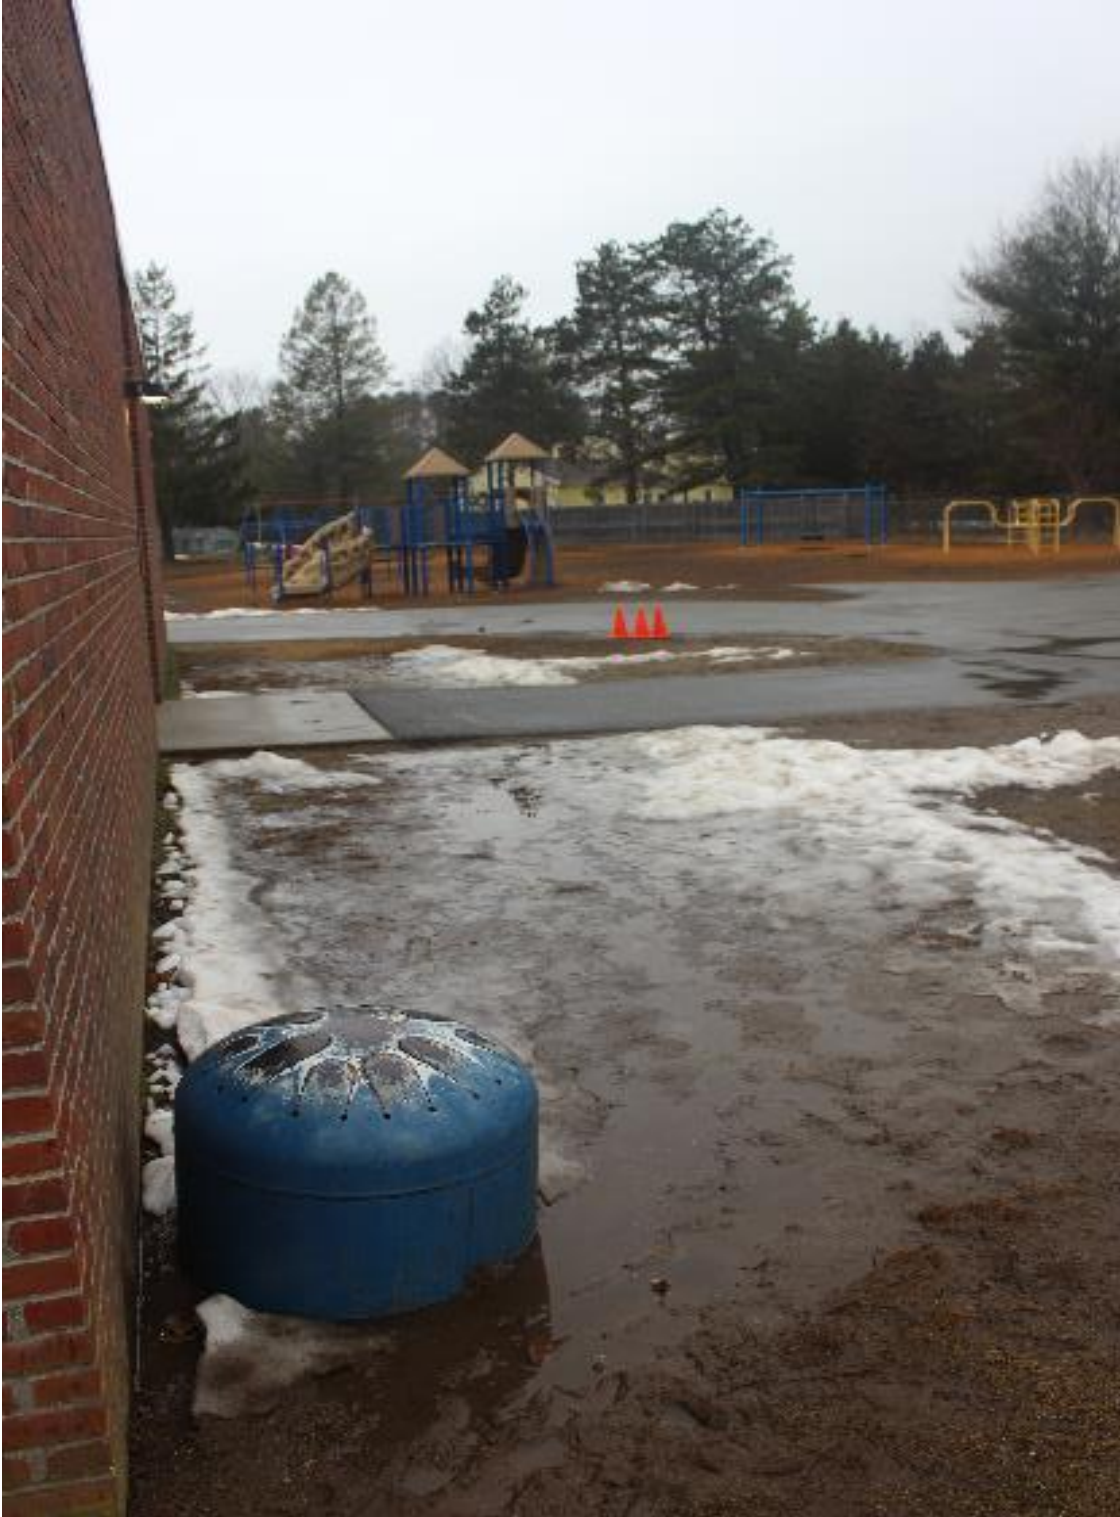
Main Recess door. Note traffic wear and north facing area does not permit grass/vegetation to grow.
Install an impervious landscape material.

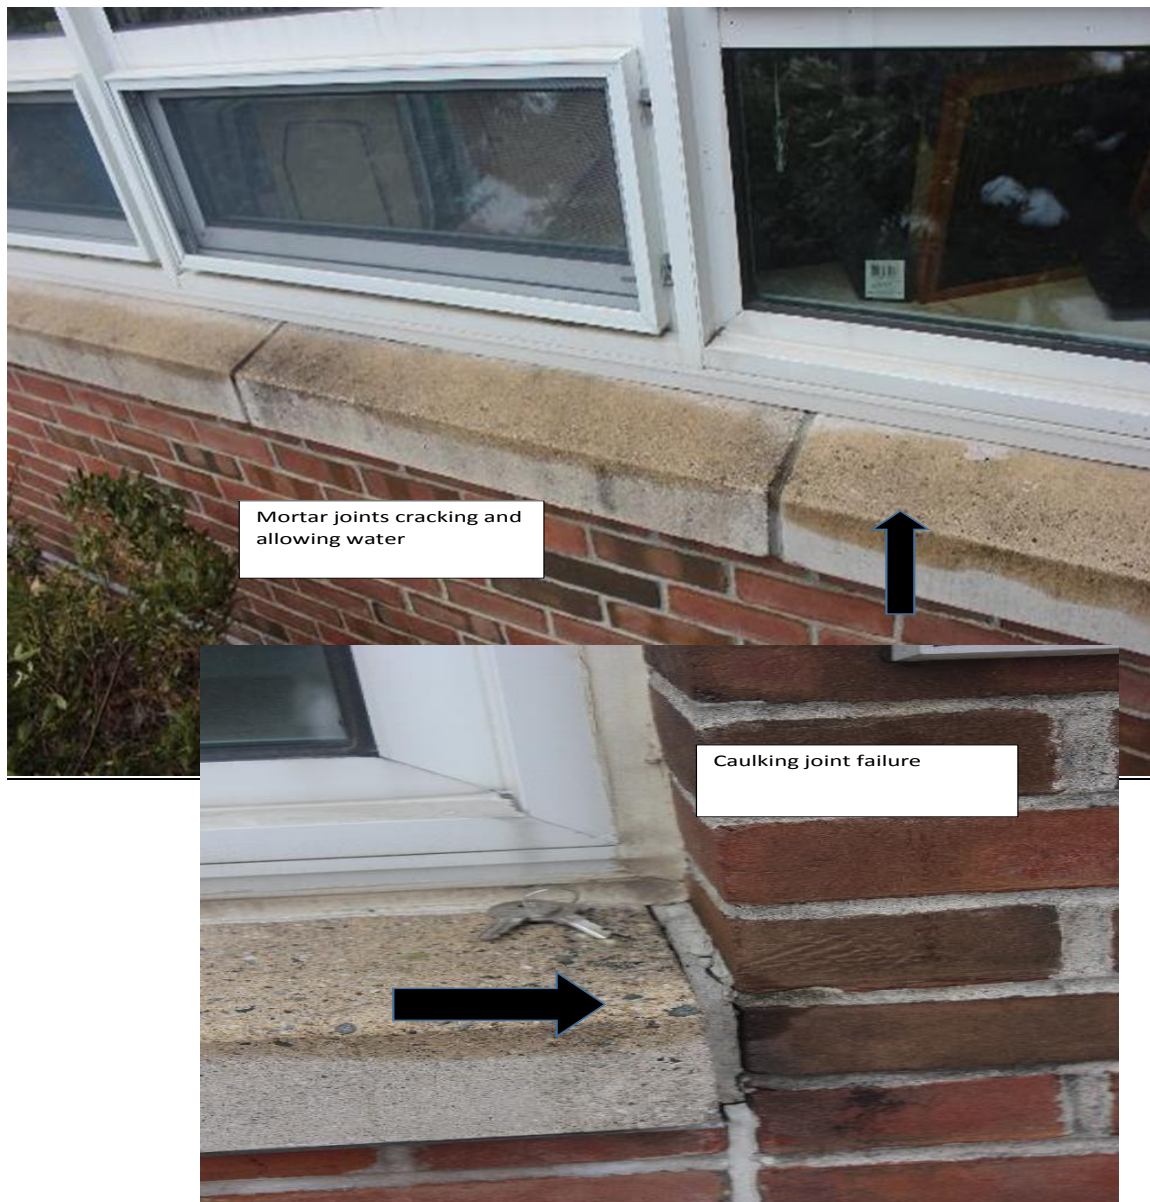
Water penetration at
flashing

Spot repointing and flashing repairs \$10,000 every five years

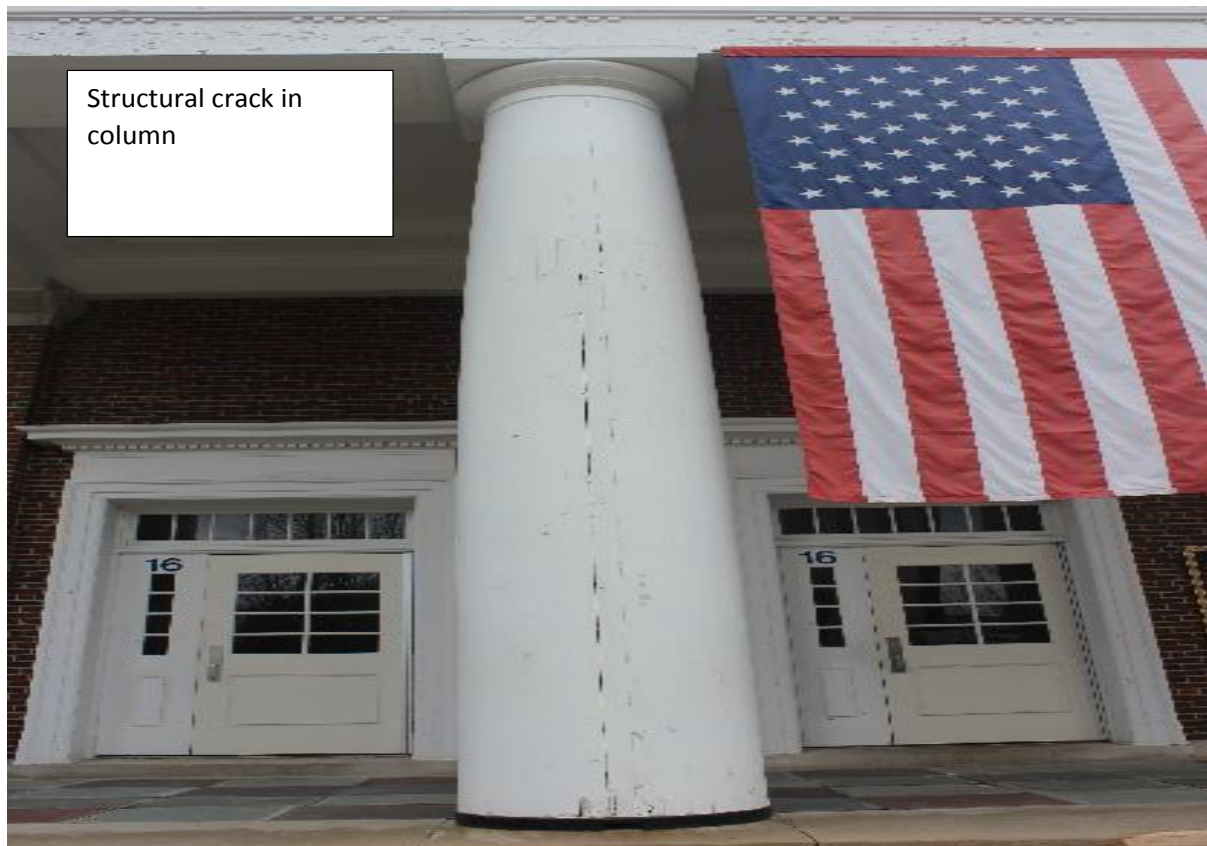
Structural crack in column

Repair structural columns, bases, and stair/handrails of the Dale Street portico

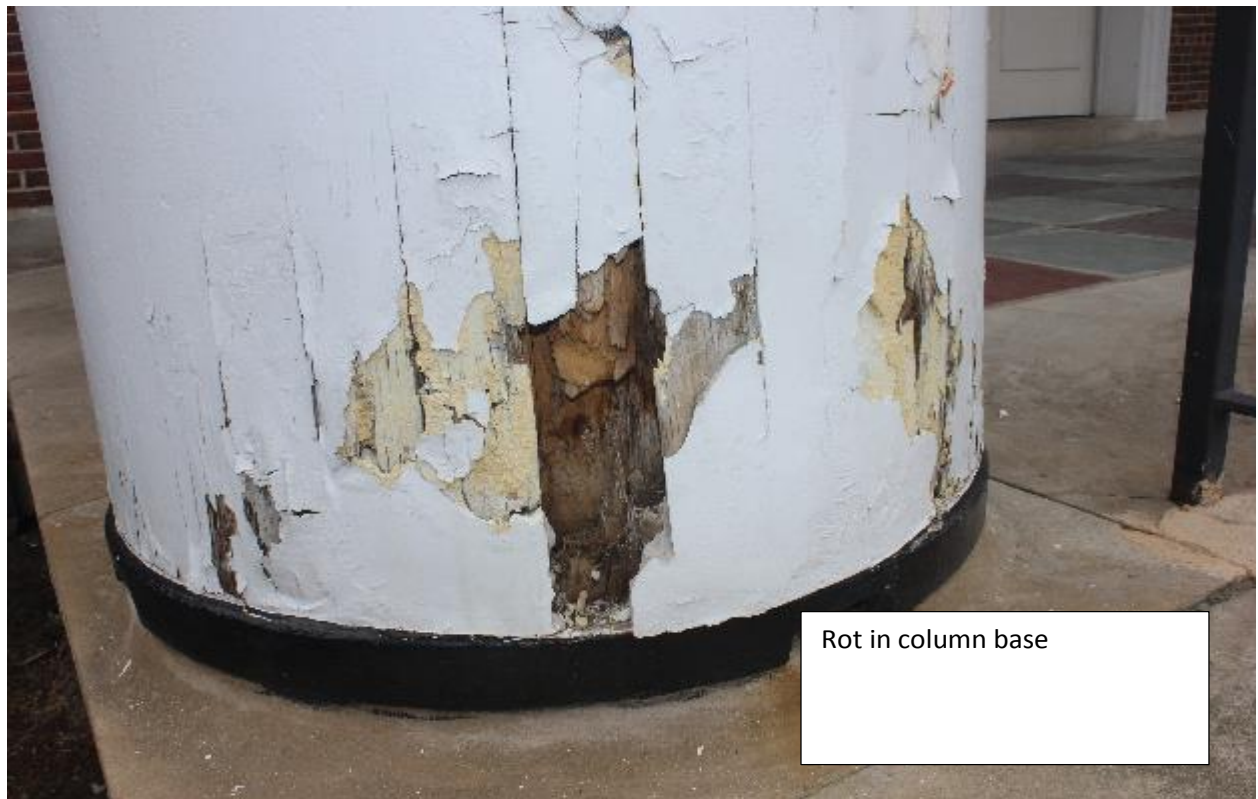
Rot in column base

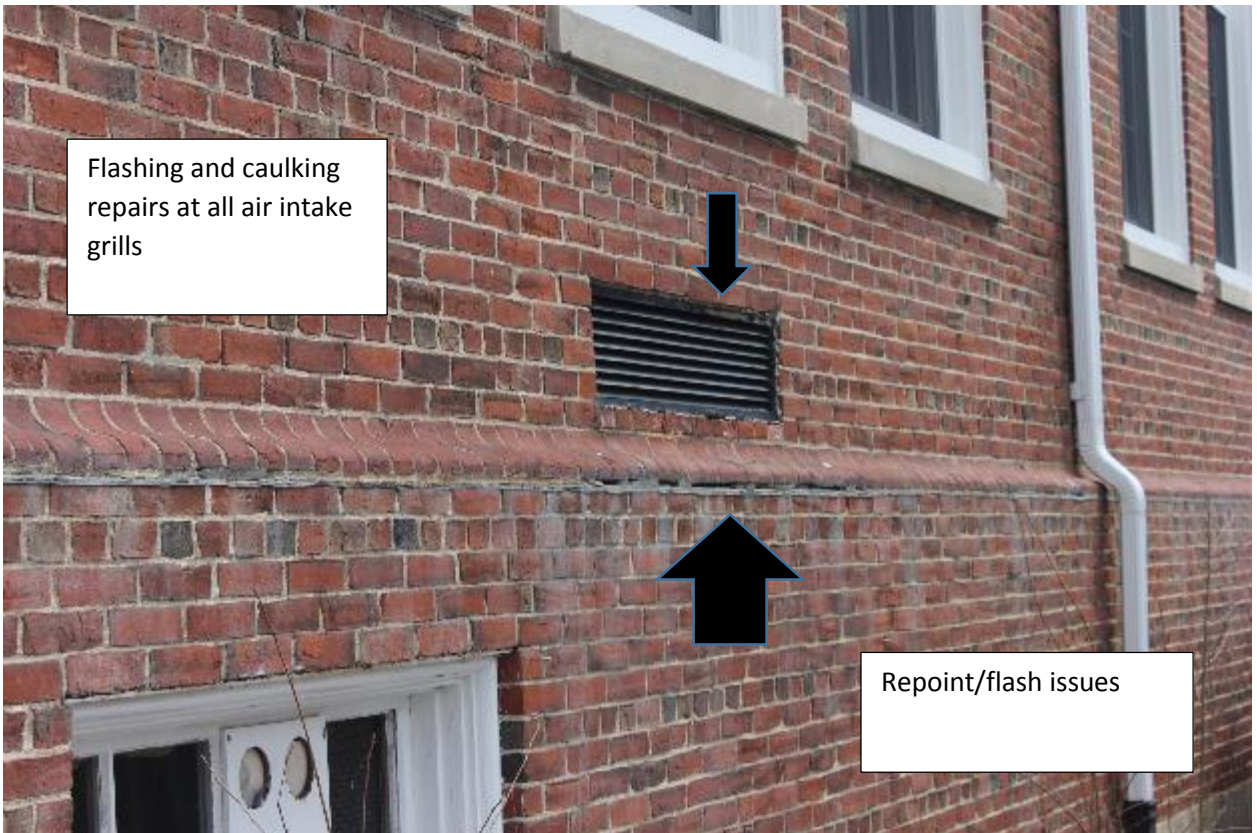
Flashing and caulking
repairs at all air intake
grills

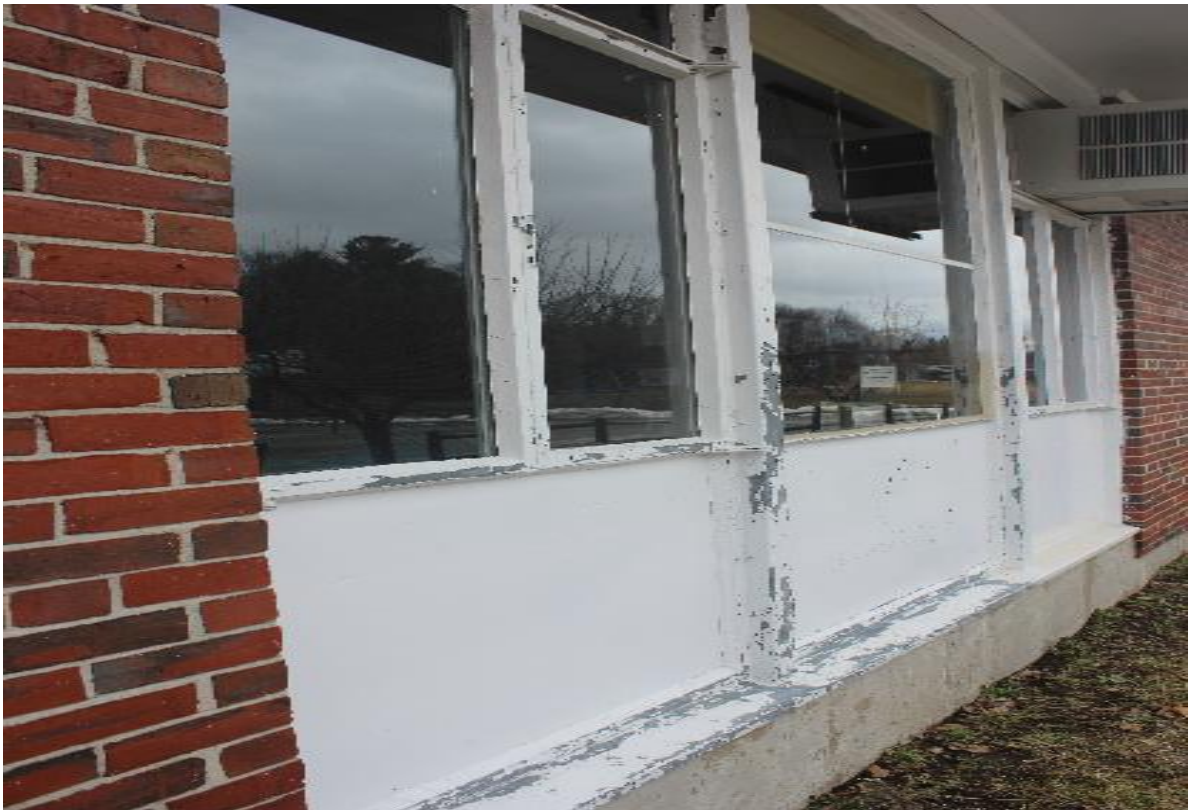
Typical 1960 window single pane, non insulated panel, failing caulking and paint

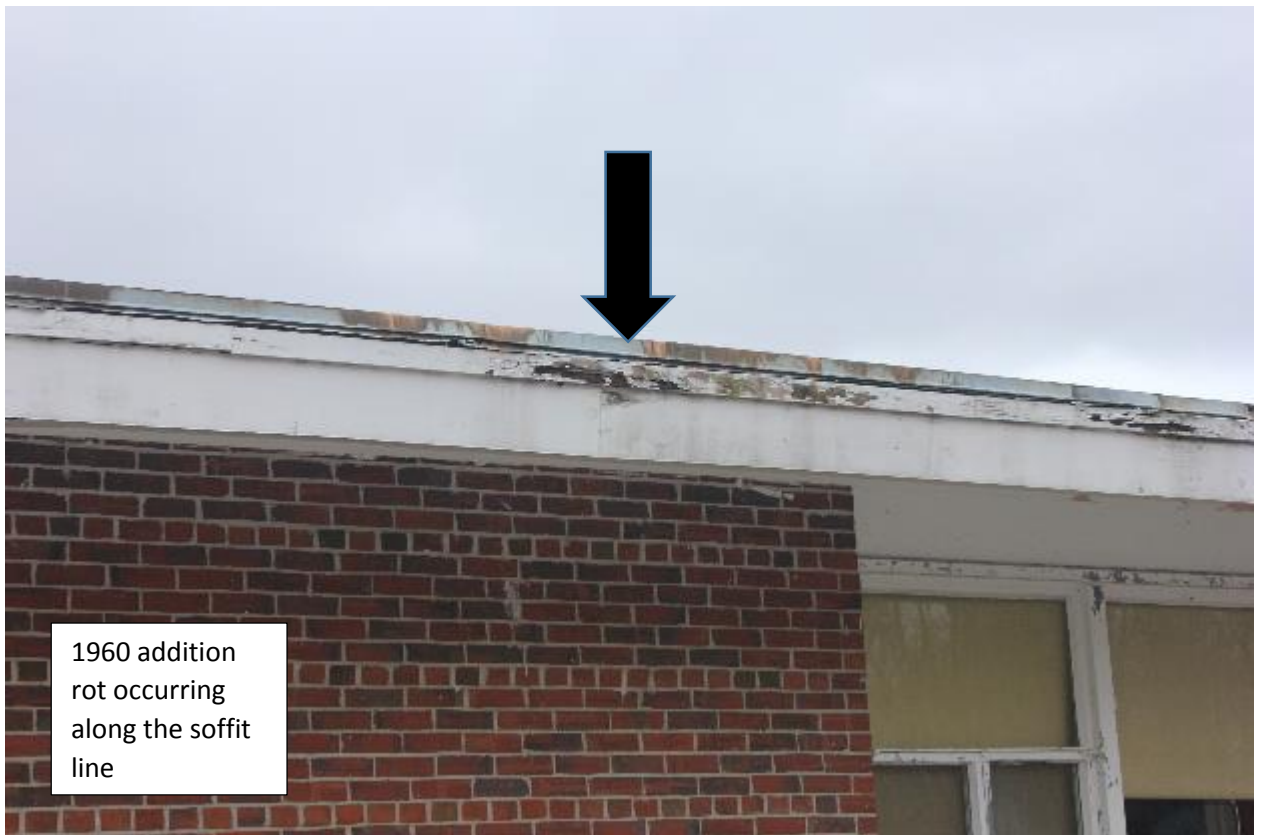
1960 addition
rot occurring
along the soffit
line

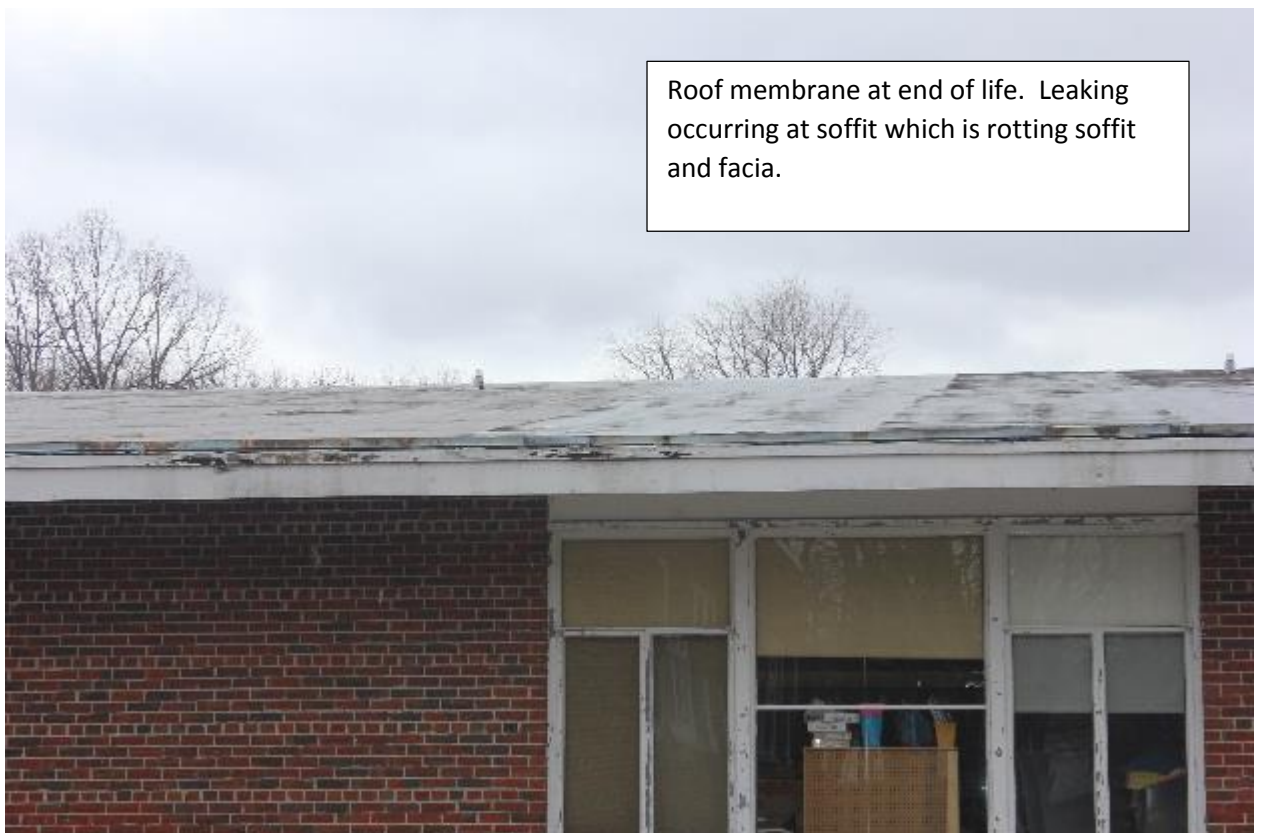
Roof membrane at end of life. Leaking
occurring at soffit which is rotting soffit
and fascia.

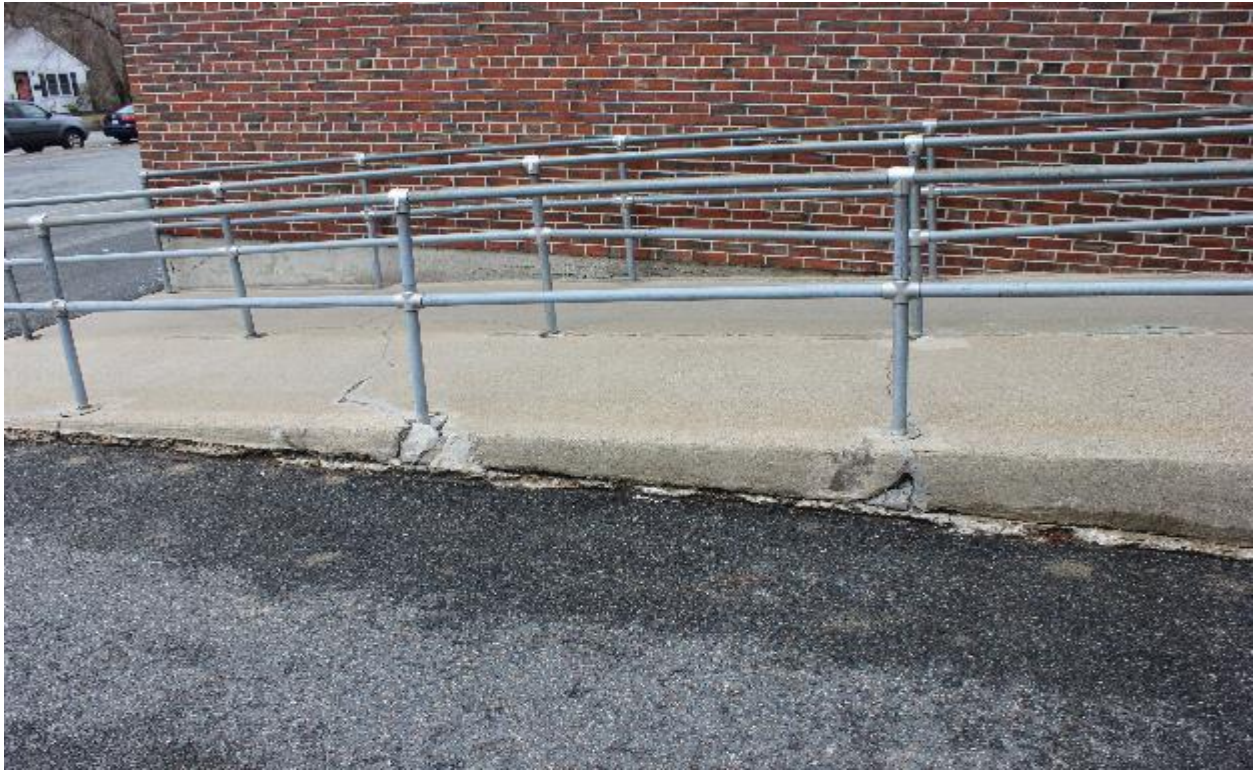
Non-Compliant Handicap ramp and rail system

Upgrades address in the 1996 addition met the codes at that time for compliance. Because of age, a full Accessible study should be performed to assess compliance throughout the structure.
