TOWN OF MEDFIELD

Municipal Facilities

Evaluation and Capital Plan

October 6, 2017

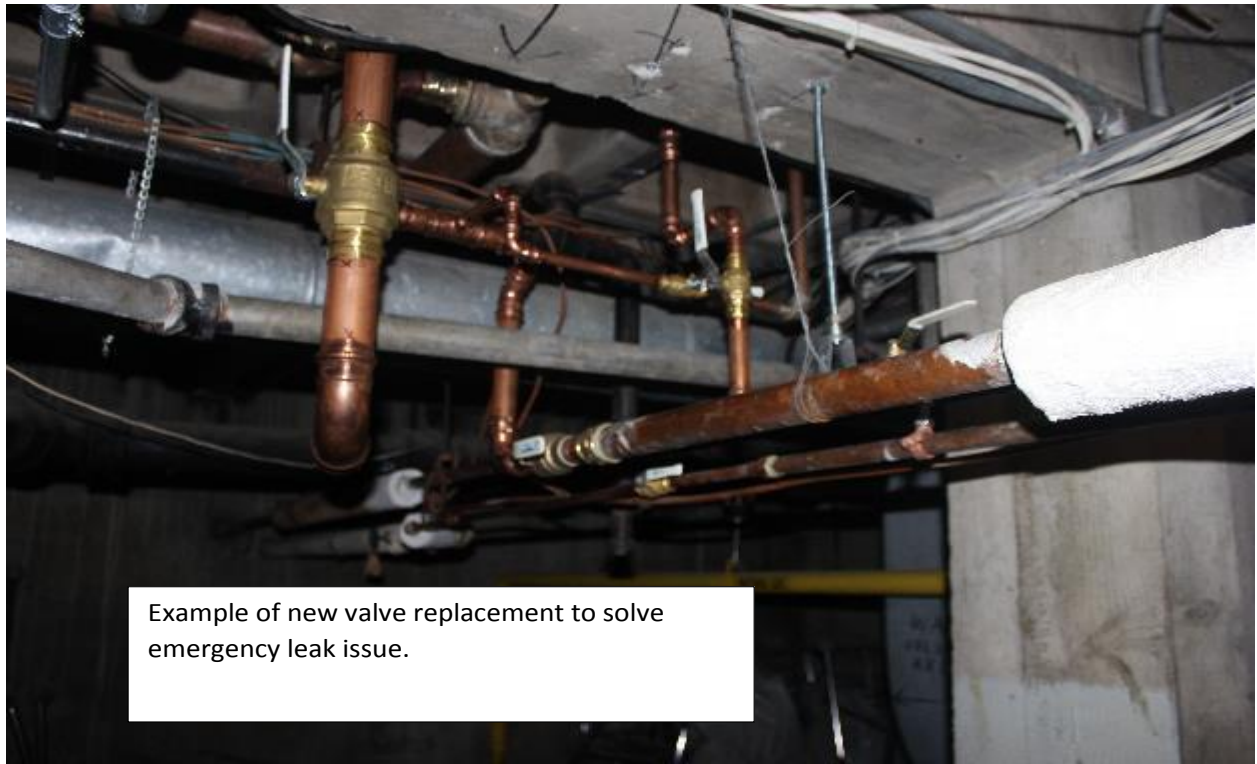
Example of new valve replacement to solve emergency leak issue.

Upgrade all supply water piping to replace the brass piping with copper to avoid pipe failure.

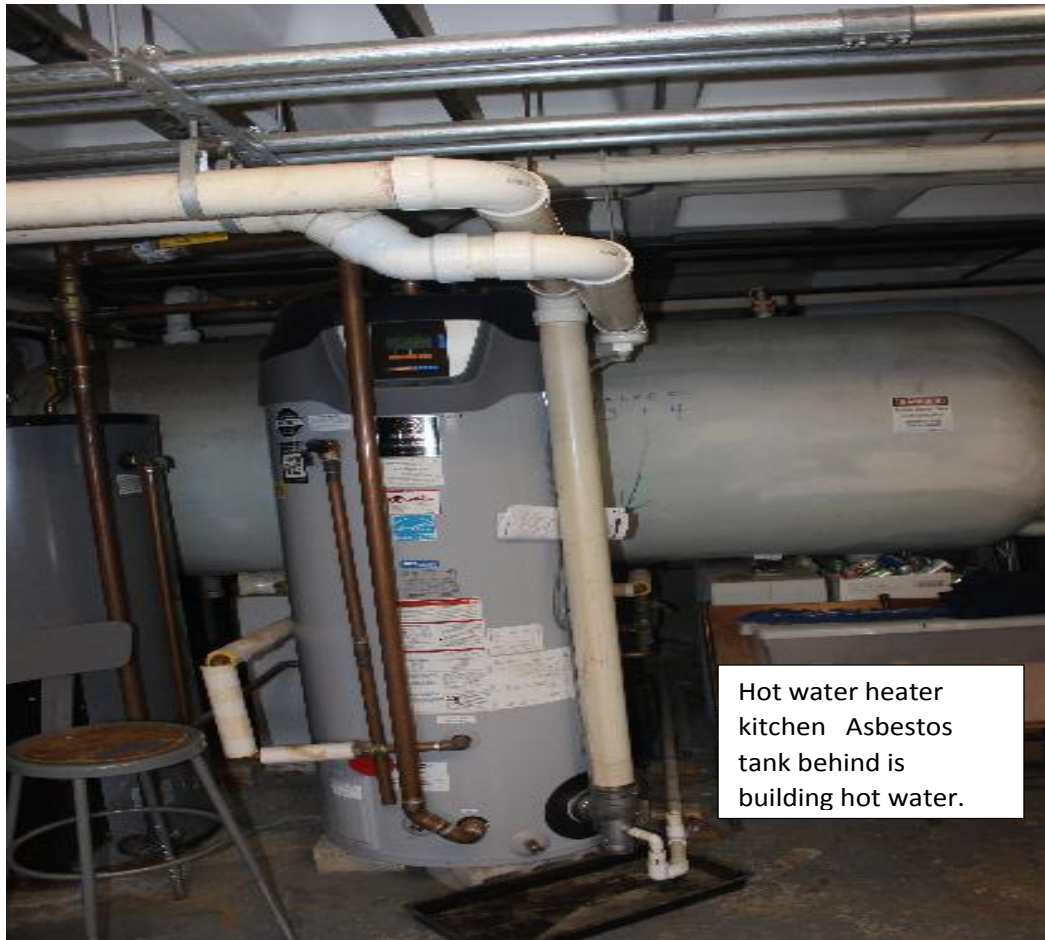
Hot water heater
kitchen Asbestos
tank behind is
building hot water.

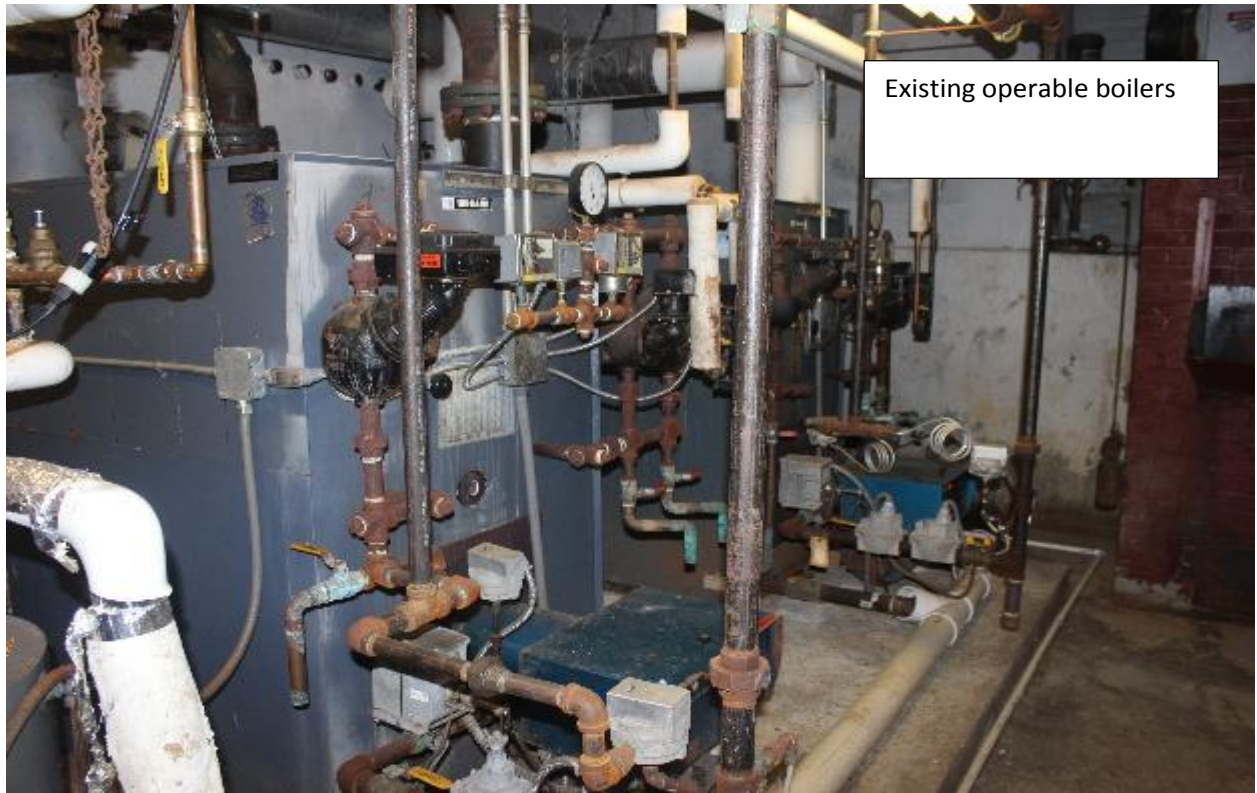
Existing operable boilers

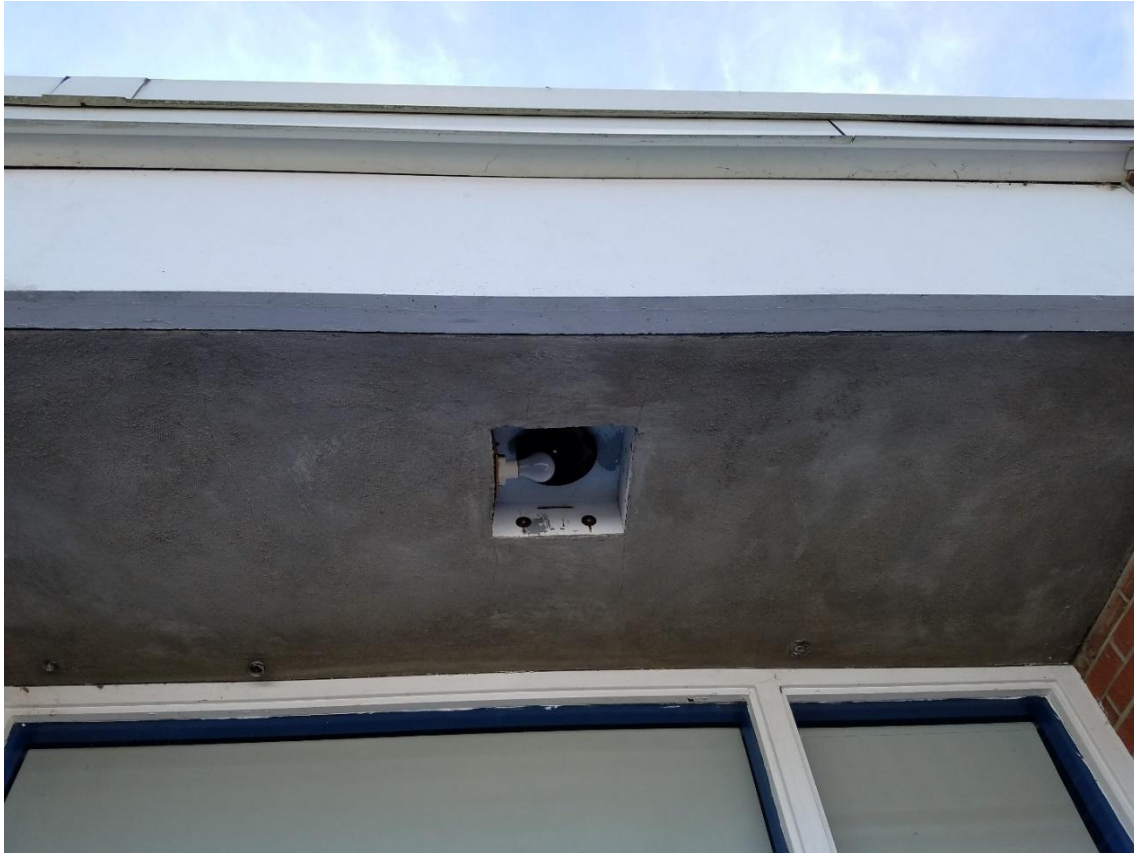
Outdated incandescent fixture and water-stained ceiling of covered entry

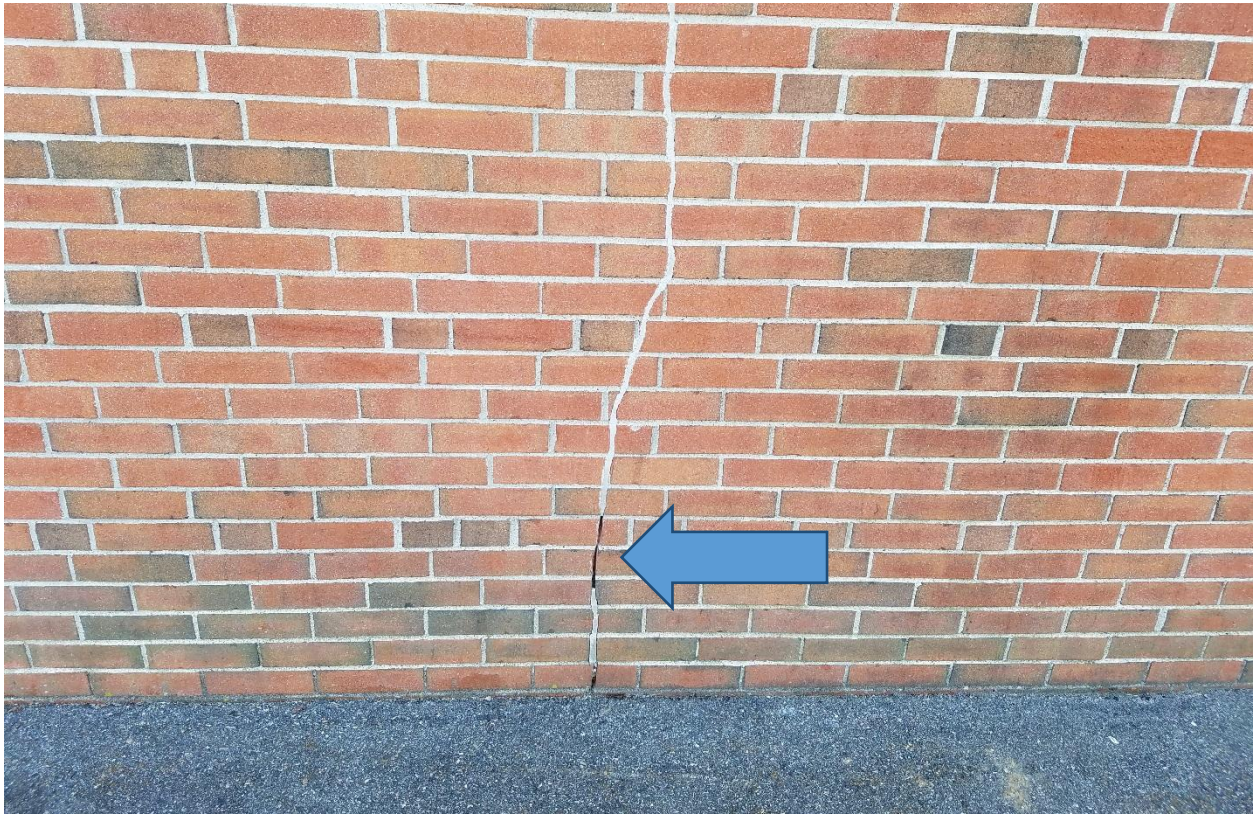
Example of cracks in brick veneer needing repair (north elevation)

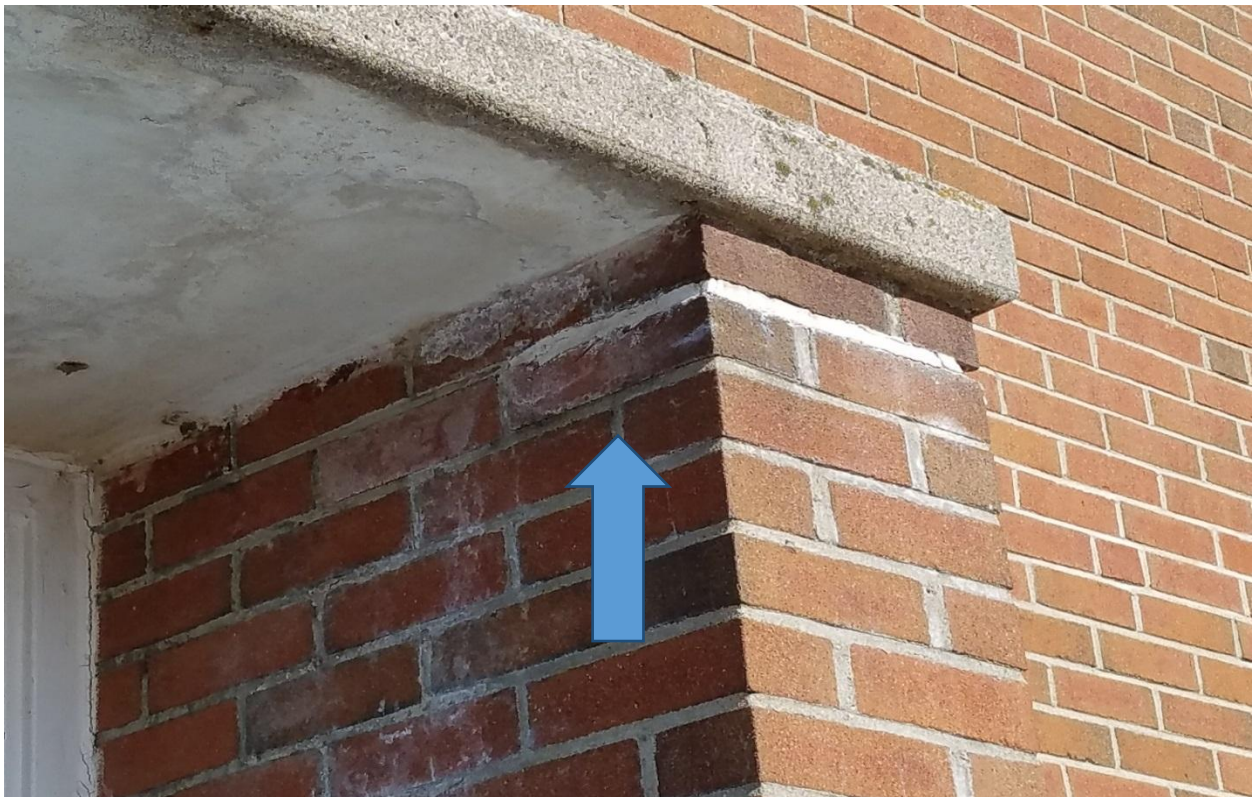
Showing water penetration through concrete entry cap deteriorating brick (efflorescence shown)

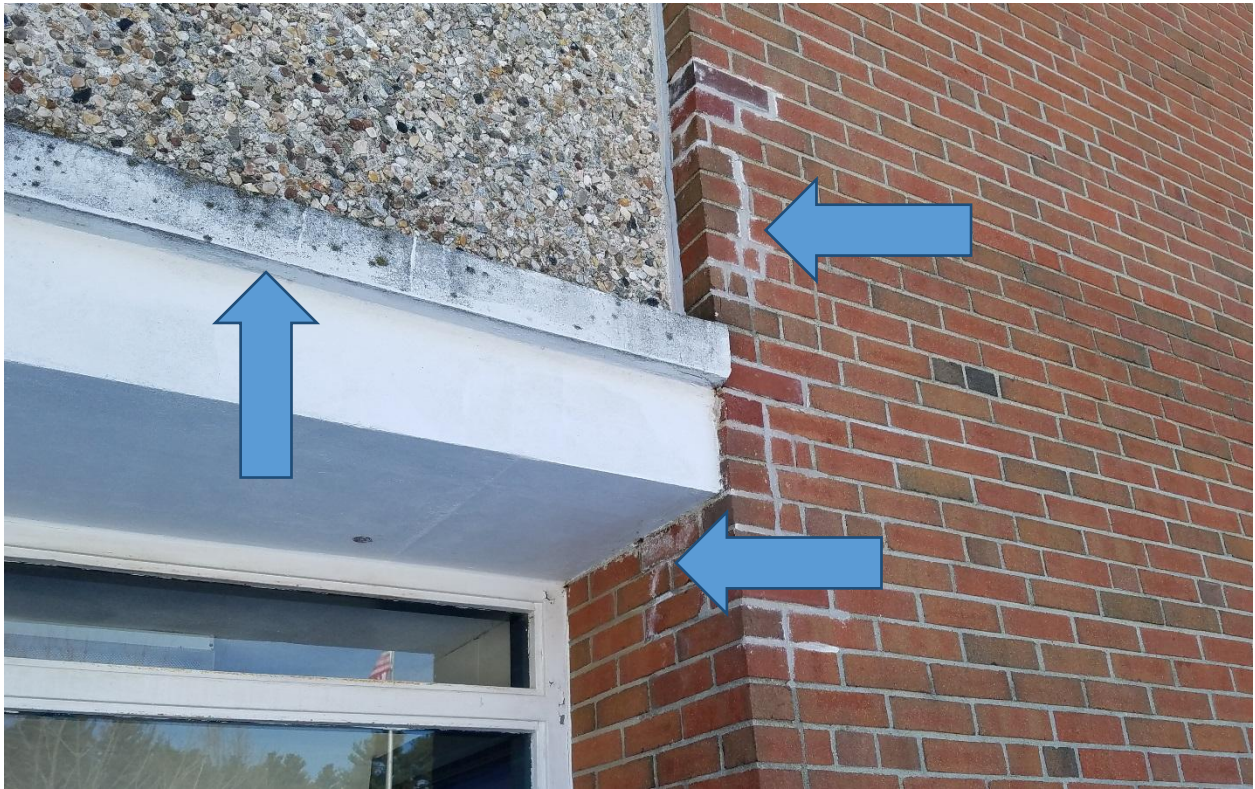
Signs of water infiltration and associated brick damage (previously repaired) and mildew on flashing

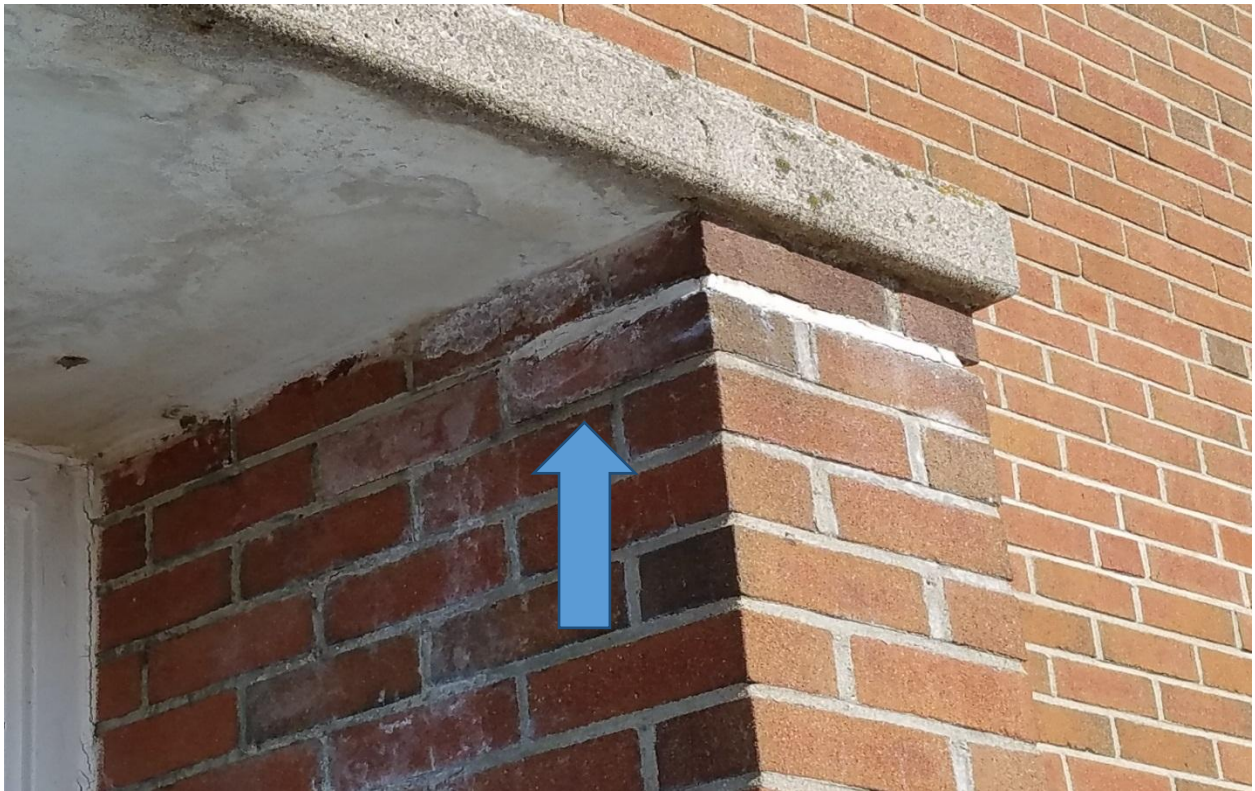
Another typical example of porous concrete entry cap that has caused brick deterioration

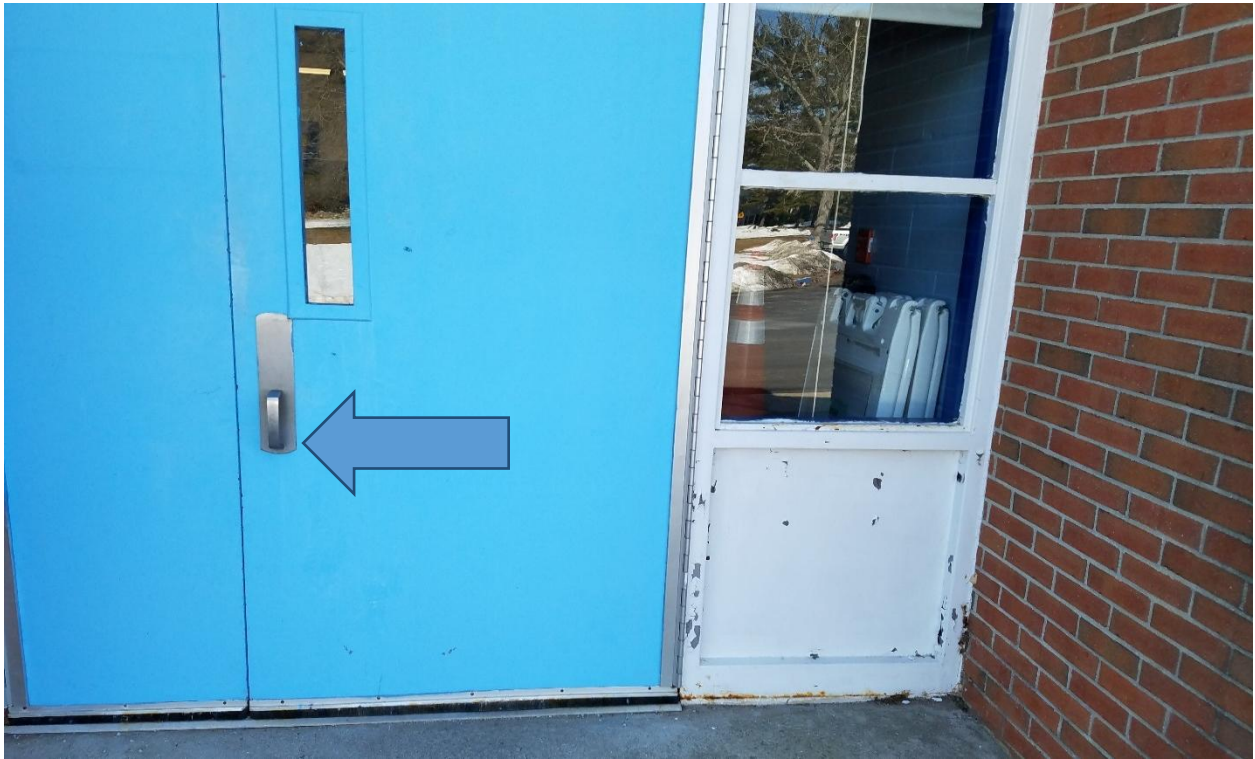
Typical entry showing non-compliant door latching hardware and hollow metal frames needing paint

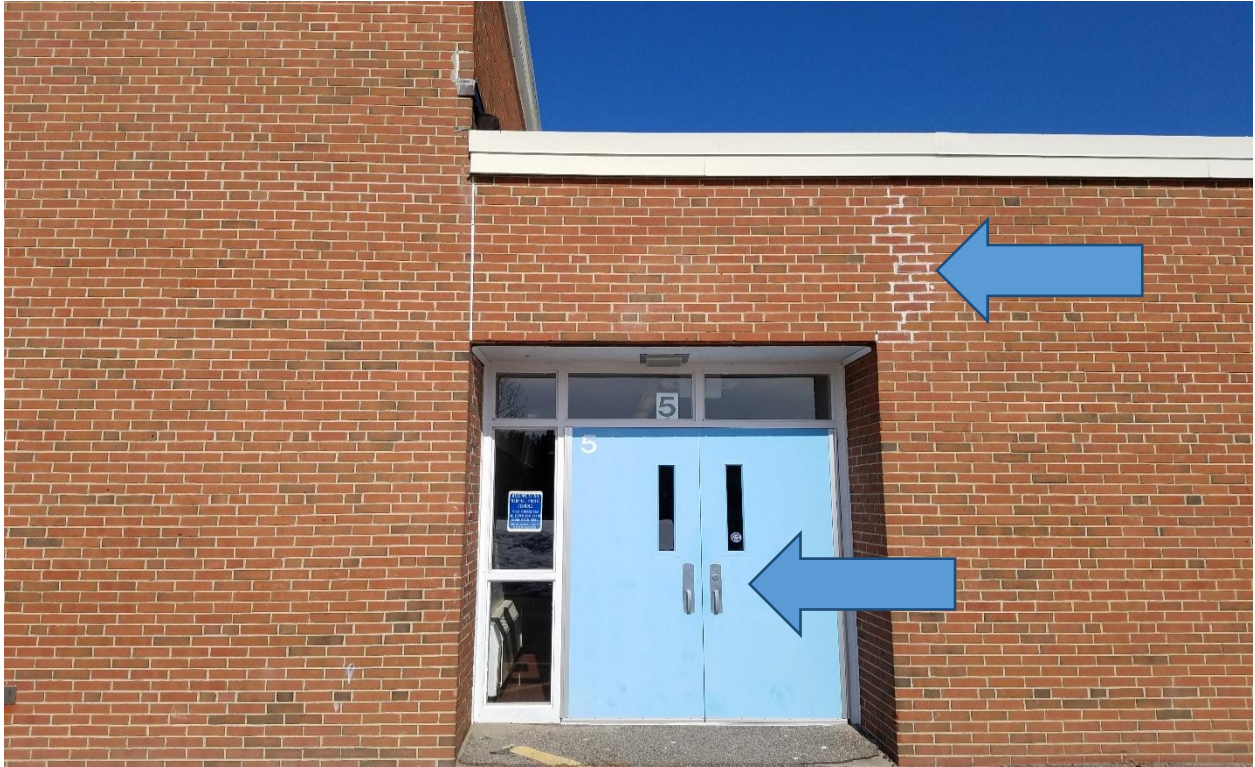
Another example of non-compliant hardware and previous repair of brick damage

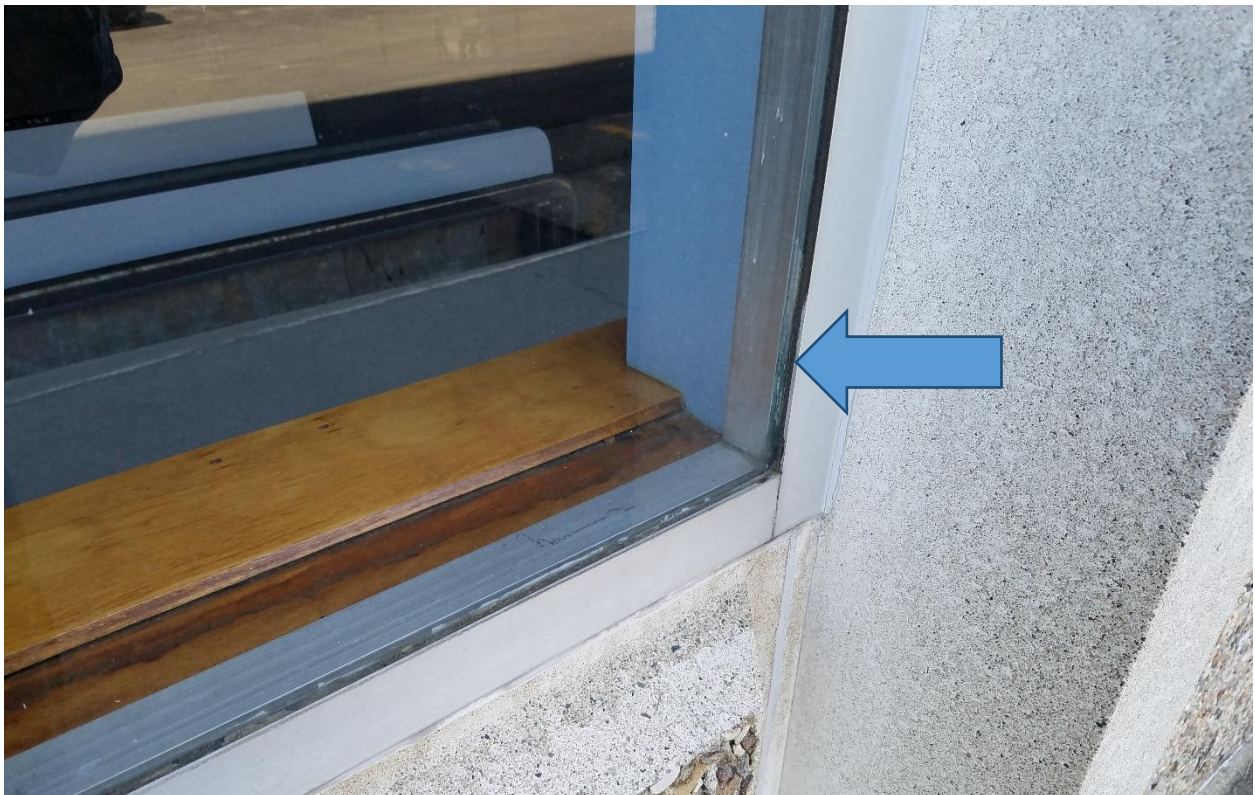
Typical window with single-pane, uninsulated glass

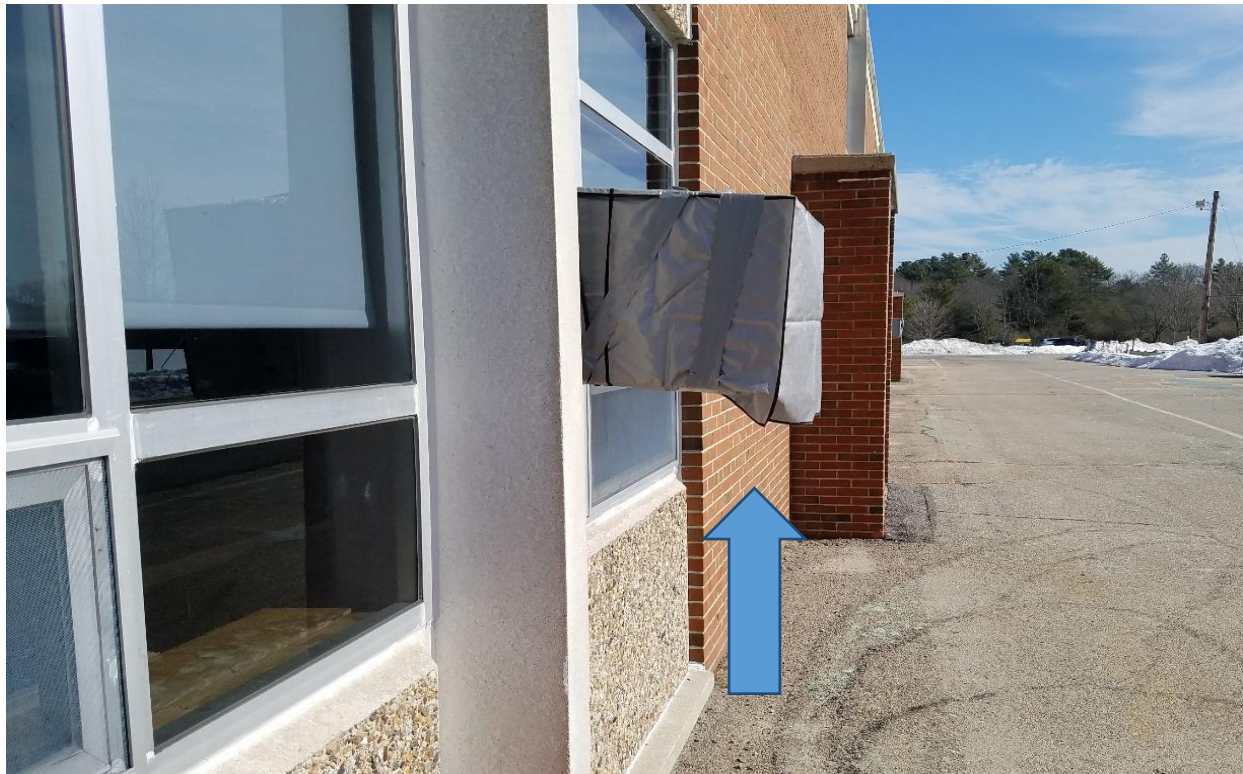
Potential hazard of protruding air-conditioner along walkway

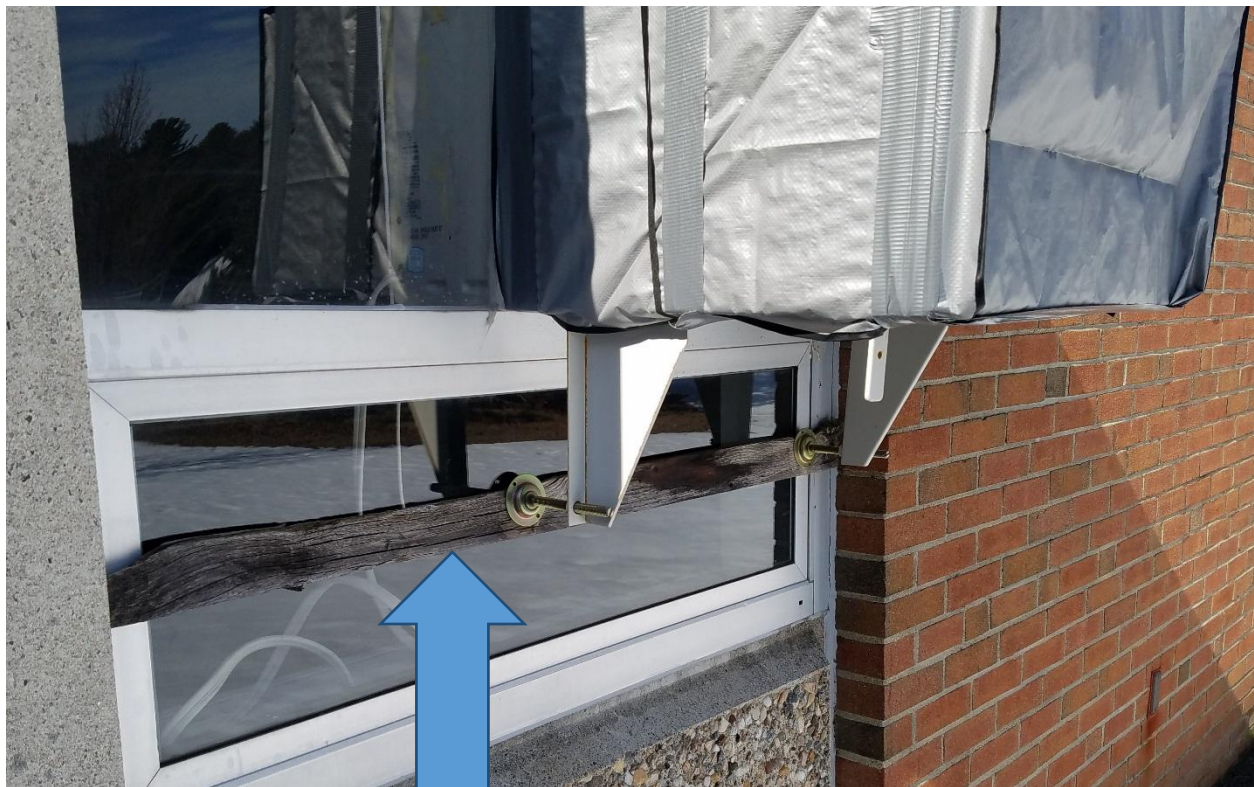
Poor installation of air-conditioner using scrap wood- potential to damage window glass

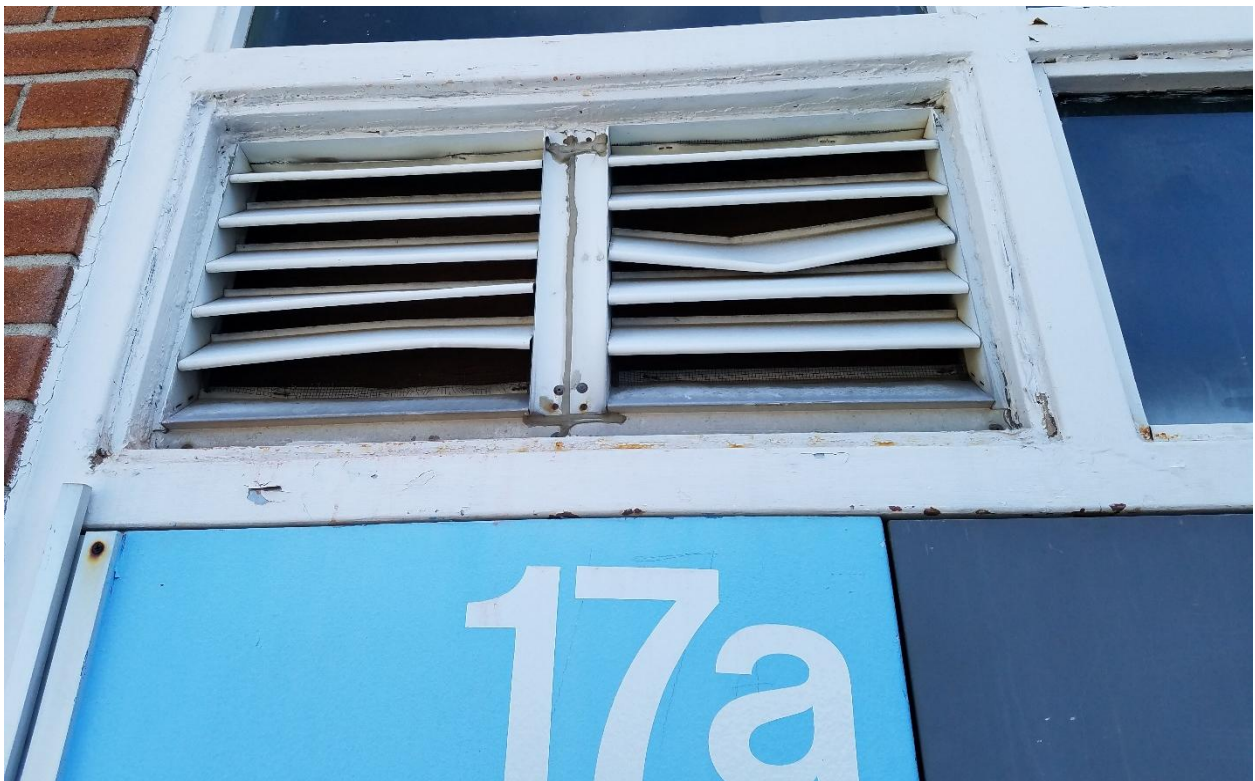
Example of mechanical louver needing repair/replacement

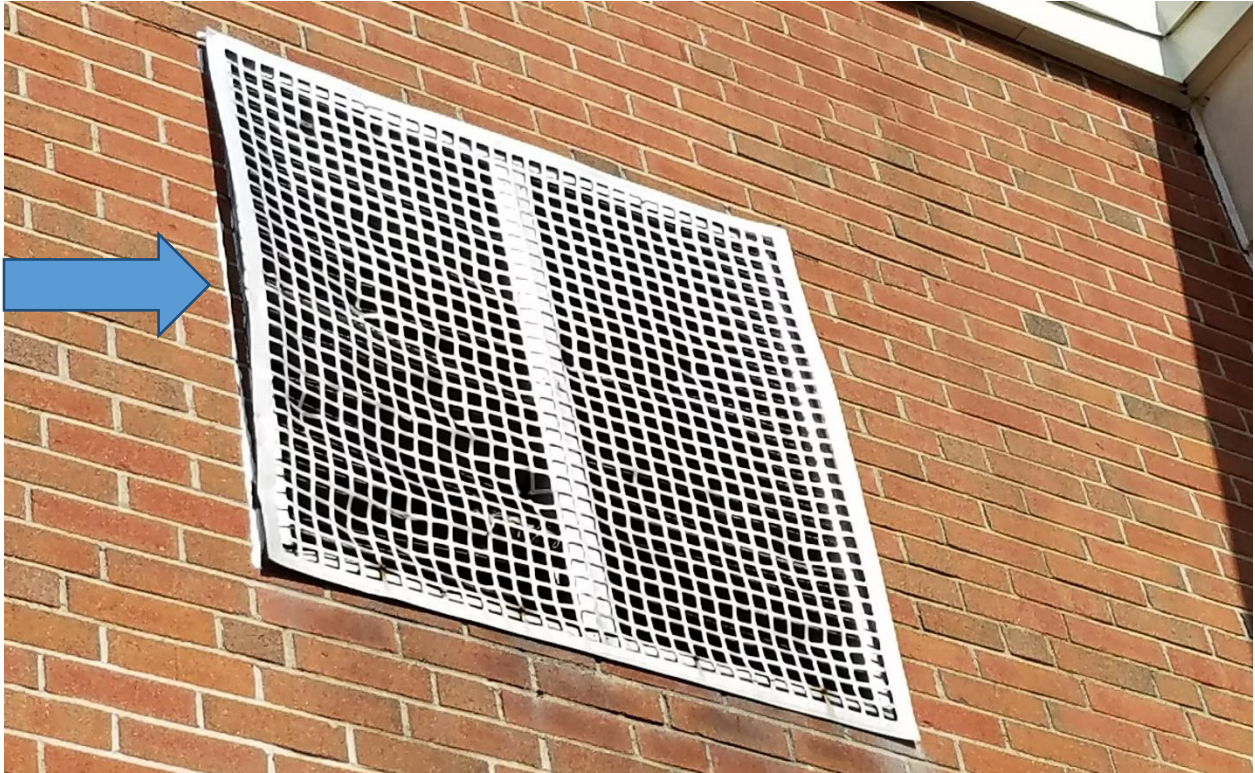
Mechanical louver needing replacement

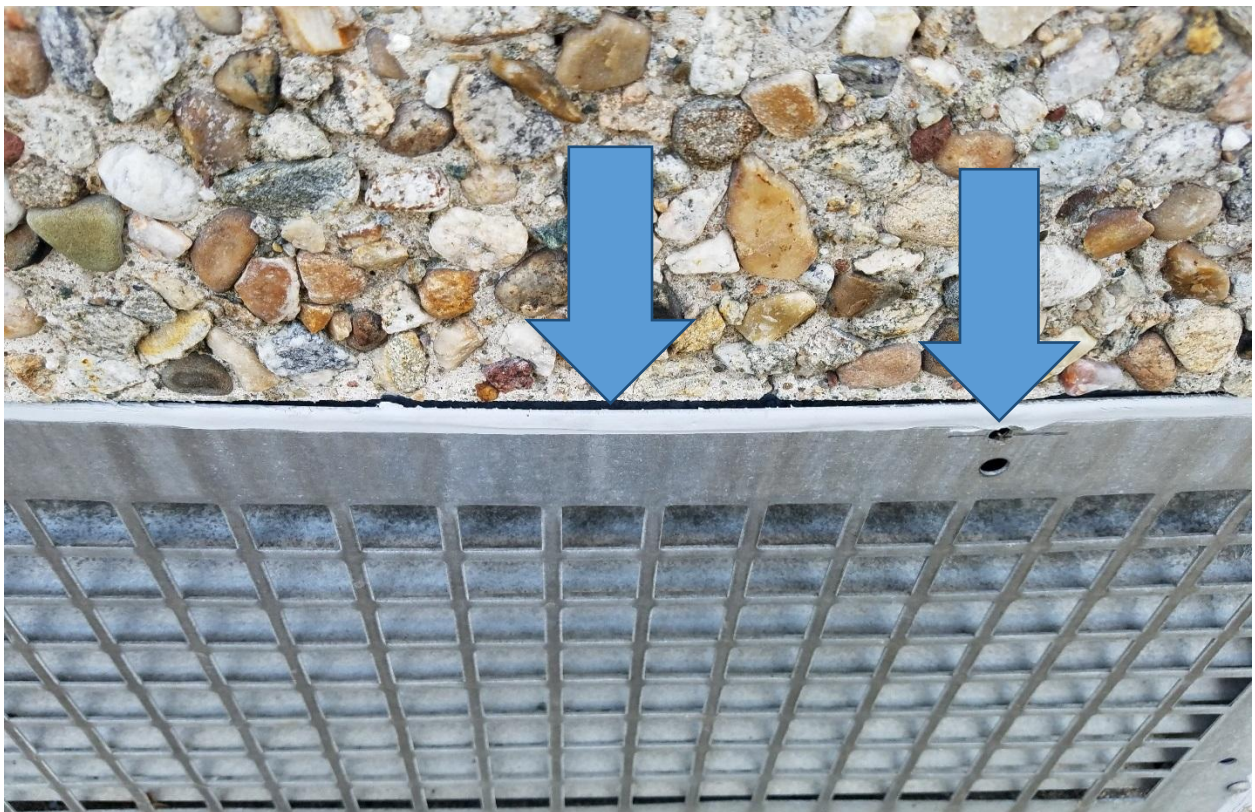
Gaps around UV louver needing refastening and new sealants

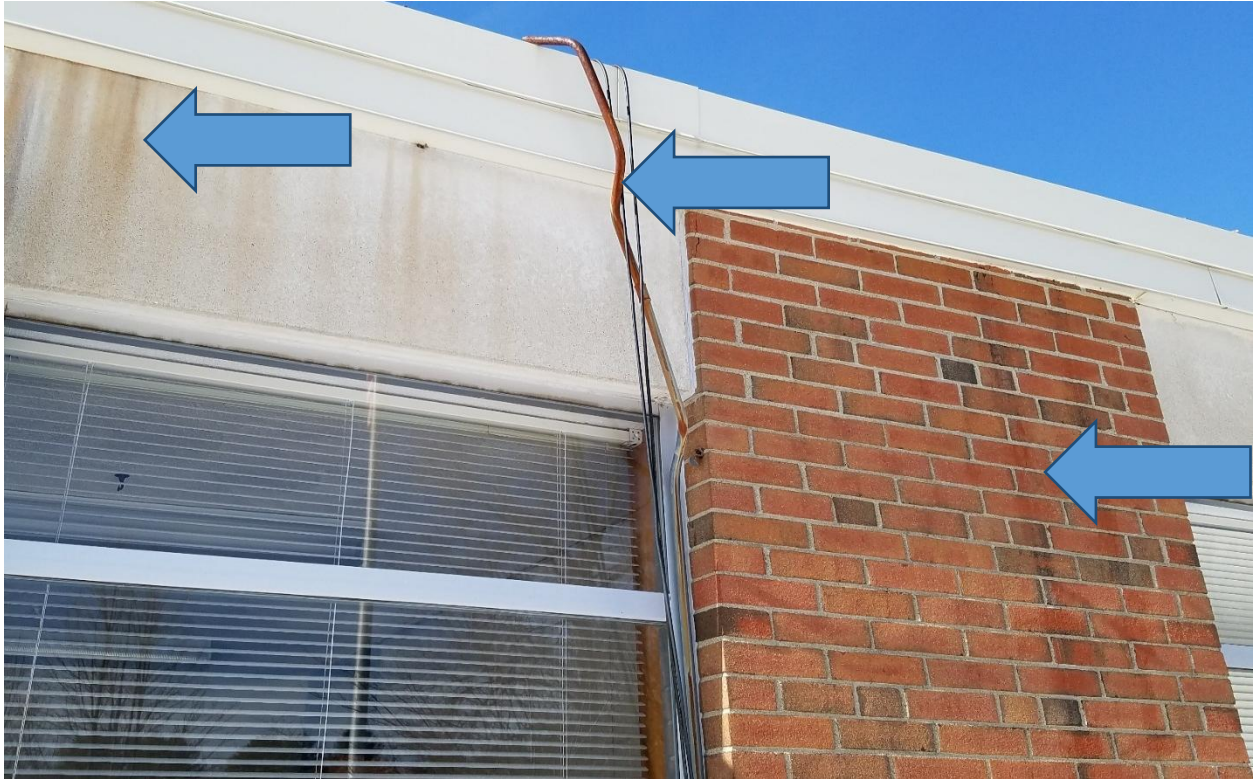
Showing stains from water infiltration from above / unsecured electrical conduits and moist brick

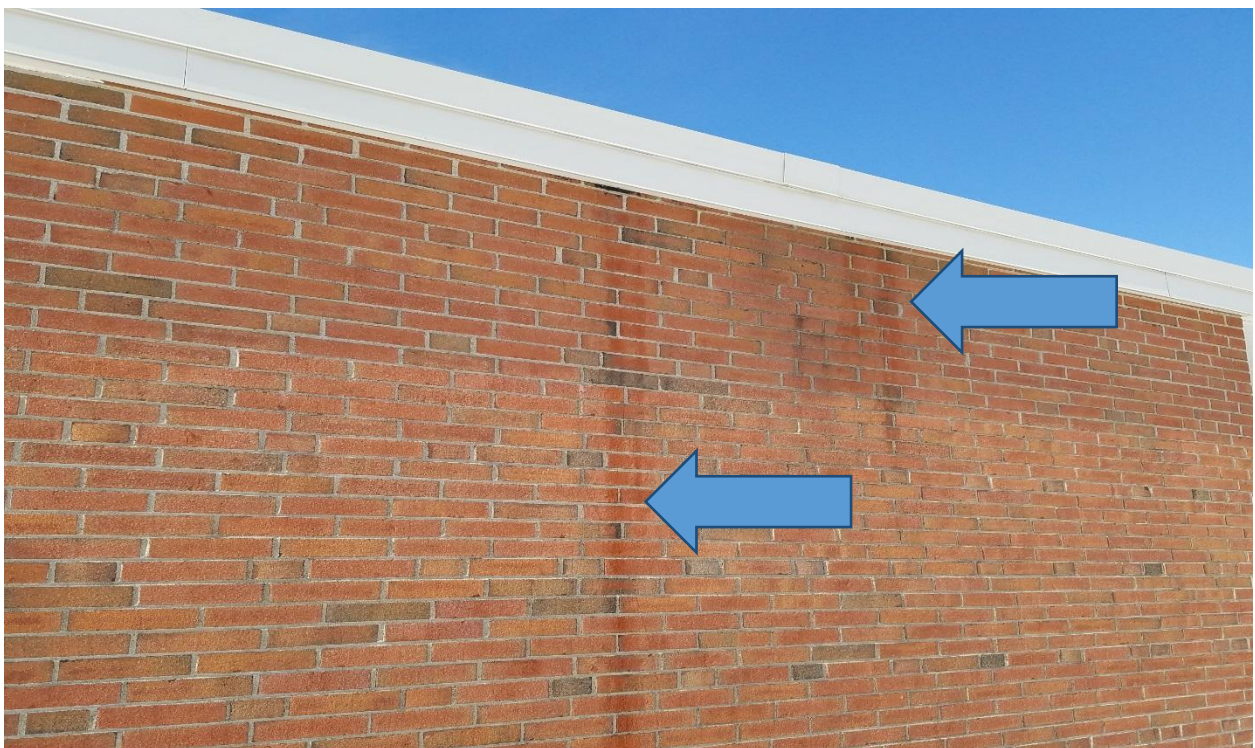
Additional example of moist brick from apparent leak in metal coping system above

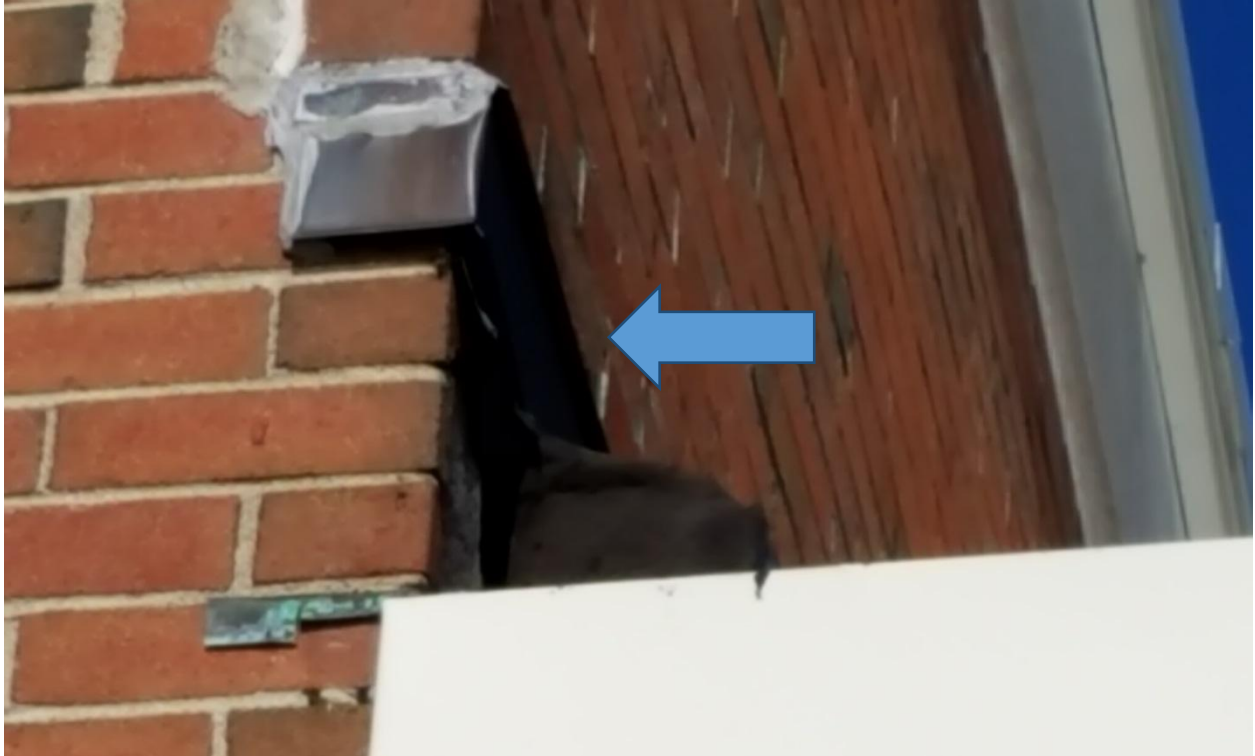
Another example of poor flashing transtion (South elevation)

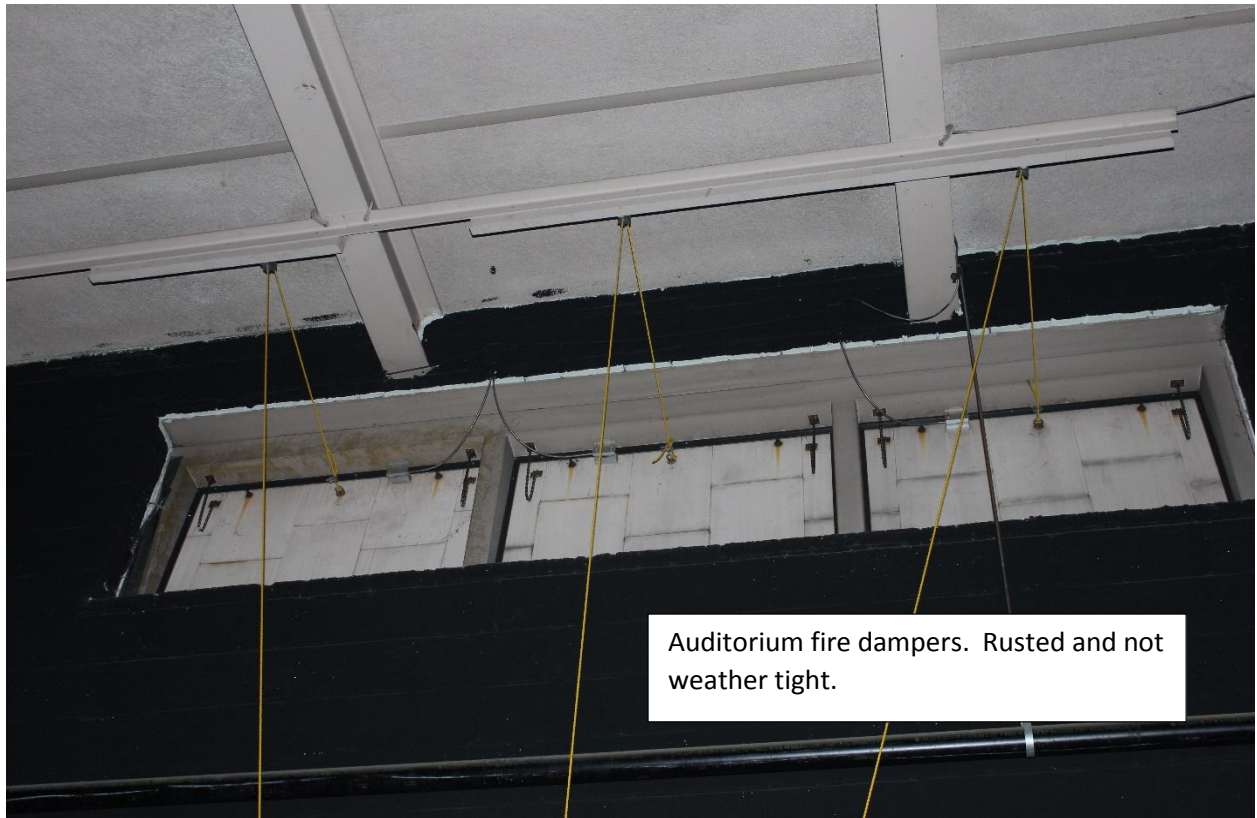
Auditorium fire dampers. Rusty and not weather tight.

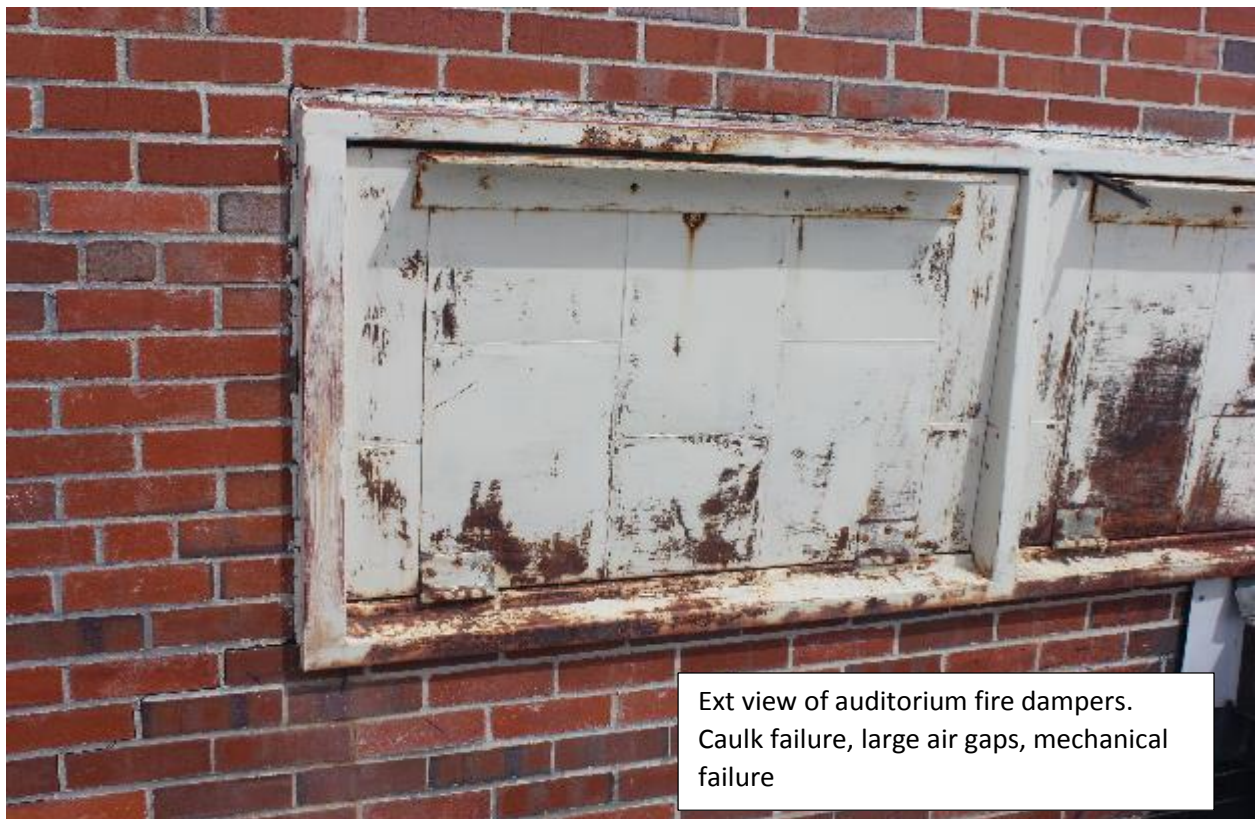
Ext view of auditorium fire dampers. Caulk failure, large air gaps, mechanical failure

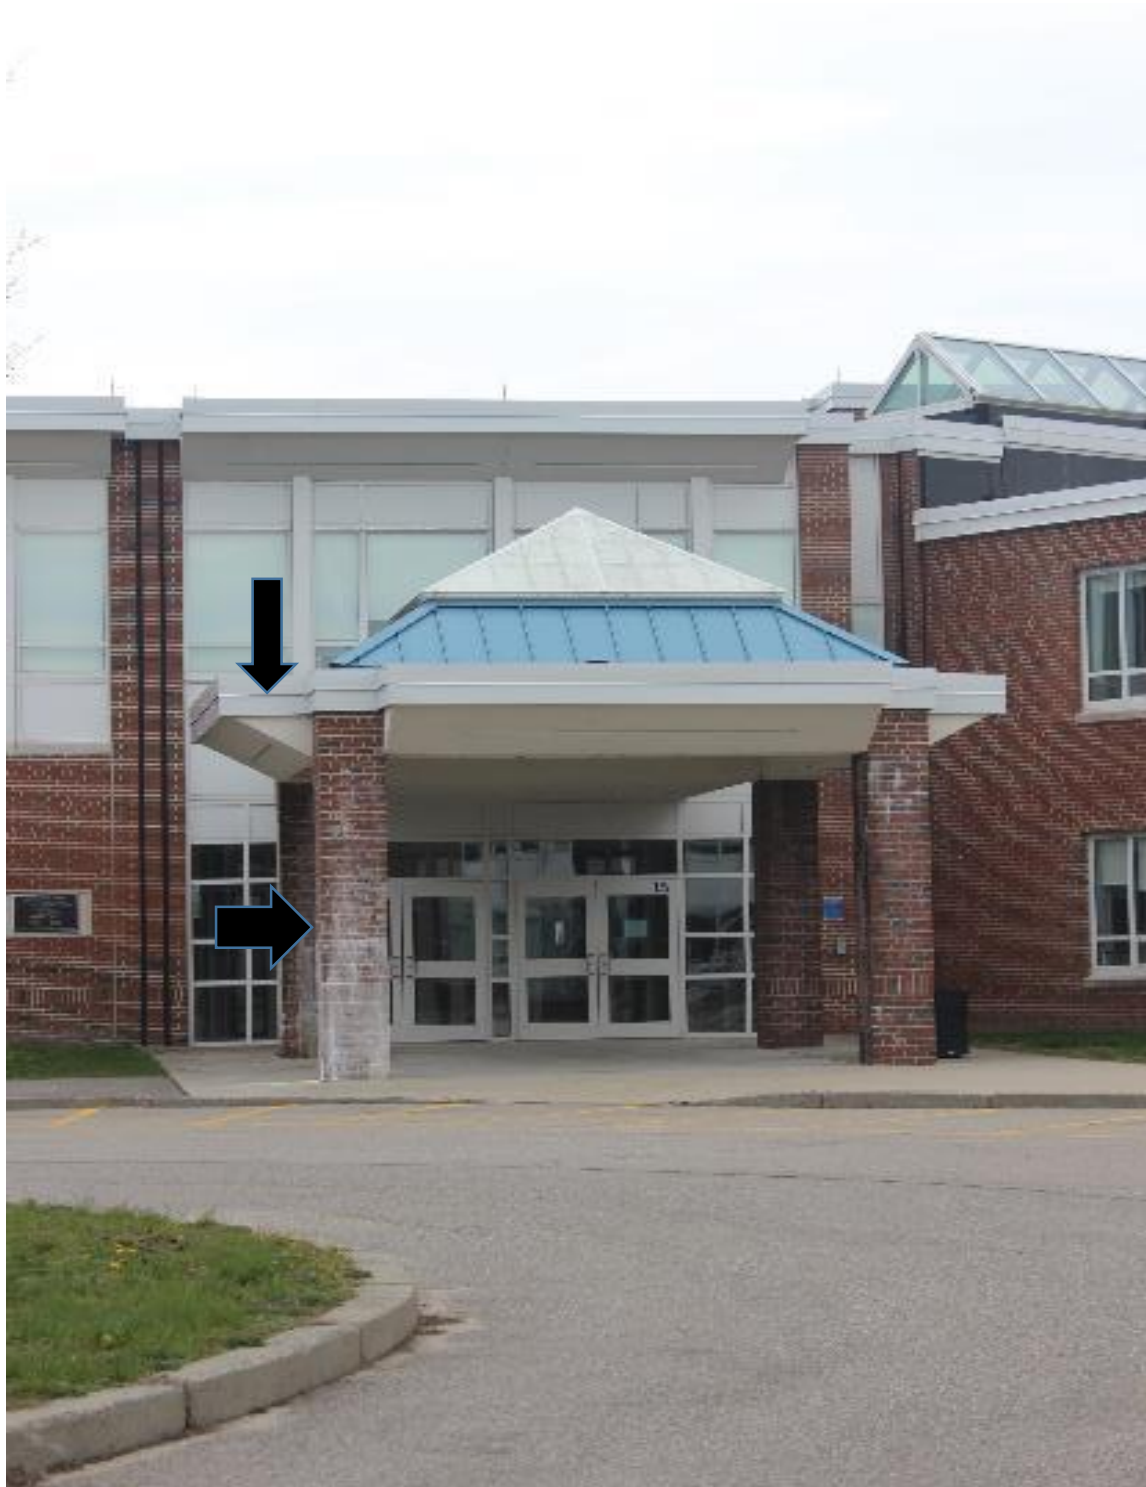
Internal roof drains may have split and come apart and allowed water to saturate the columns masonry from the interior to exterior. Excessive efflorescence, calcification, and structural cracking has occurred in the brick façade.

West side brick wall at the roof line/gym wall has cracking if the brick face. Further investigation of the cracking and repair required. \$50,000
