# **TOWN OF MEDFIELD**

## **Municipal Facilities**

### **Evaluation and Capital Plan**

October 6, 2017

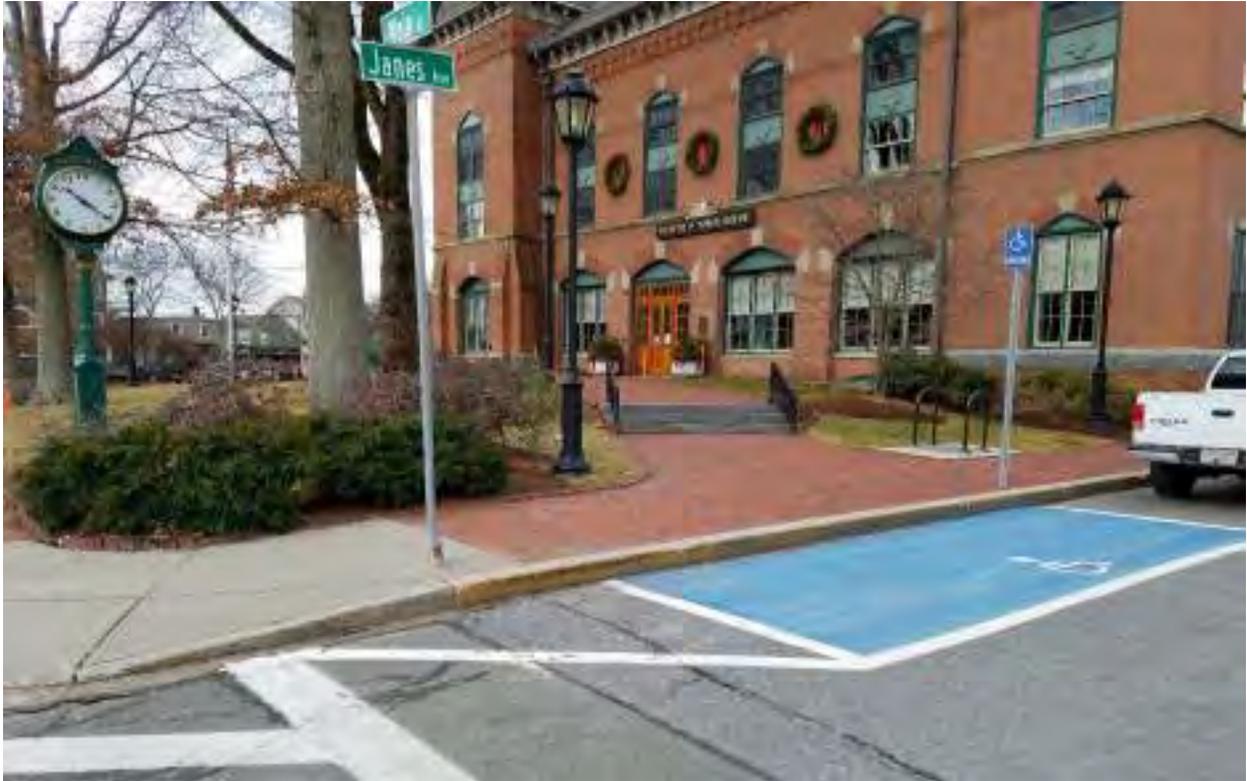
SHOWING ACCESSIBLE PARKING SPACE ALONG JANES AVE. (EAST)

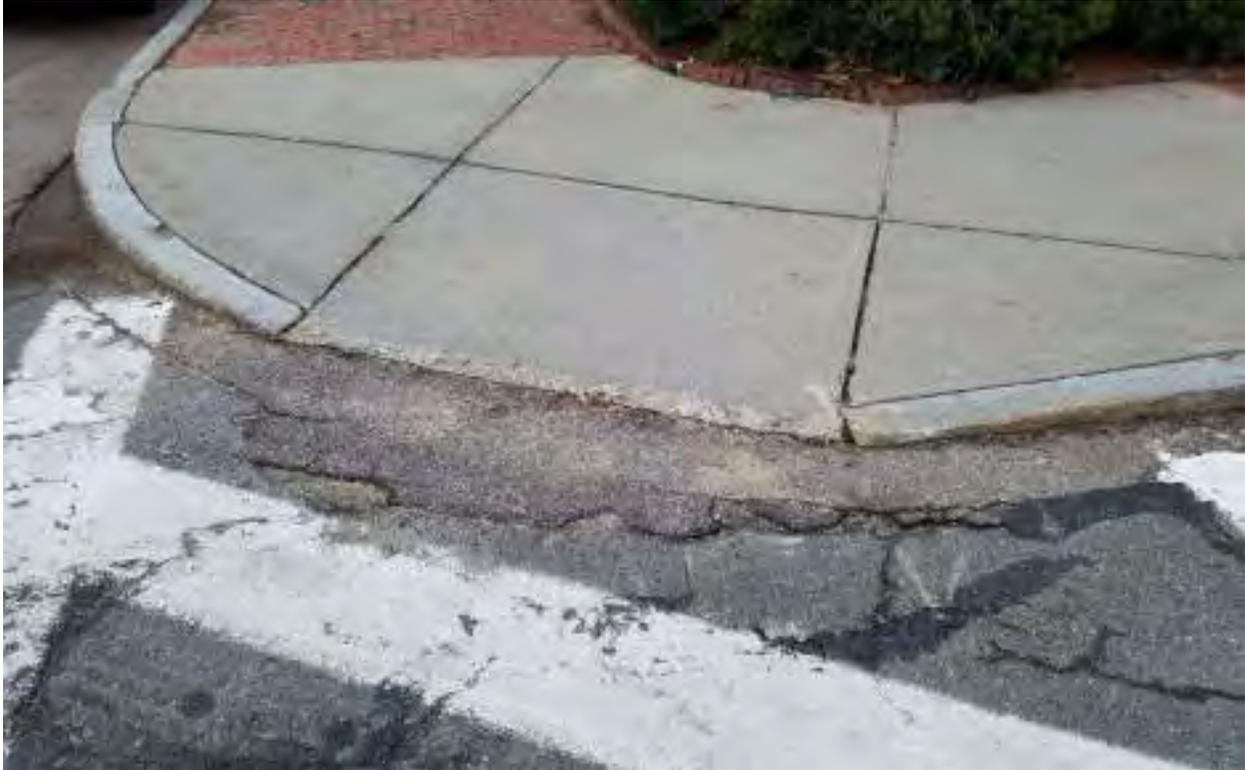
SHOWING POOR CONDITION OF CURB CUT AND PAVING AT JANES AVE CROSSWALK

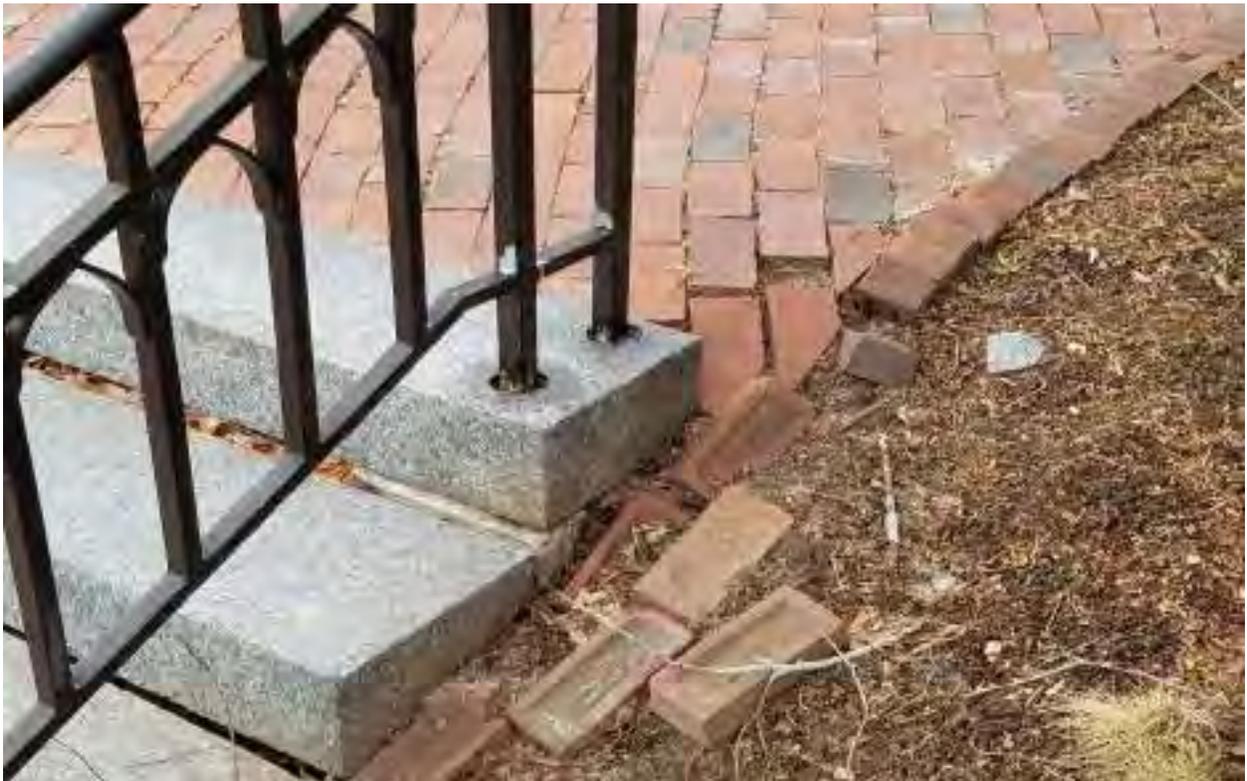
POOR CONDITION OF GRANITE STEPS AT FRONT ENTRANCE WALKWAY SHOWING GAPS IN GRANITE AND LOOSE BRICKS

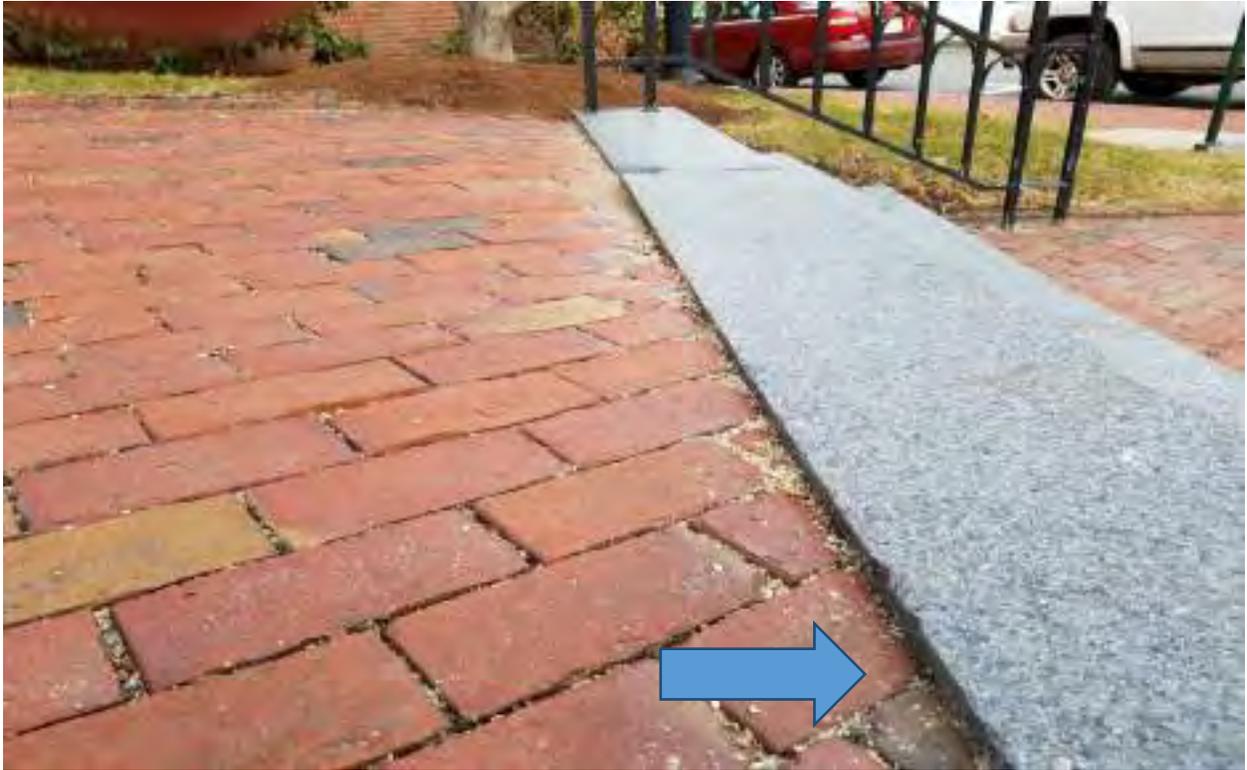
SHOWING LIP AT GRANITE TOP TREAD AND BRICK SETTLEMENT

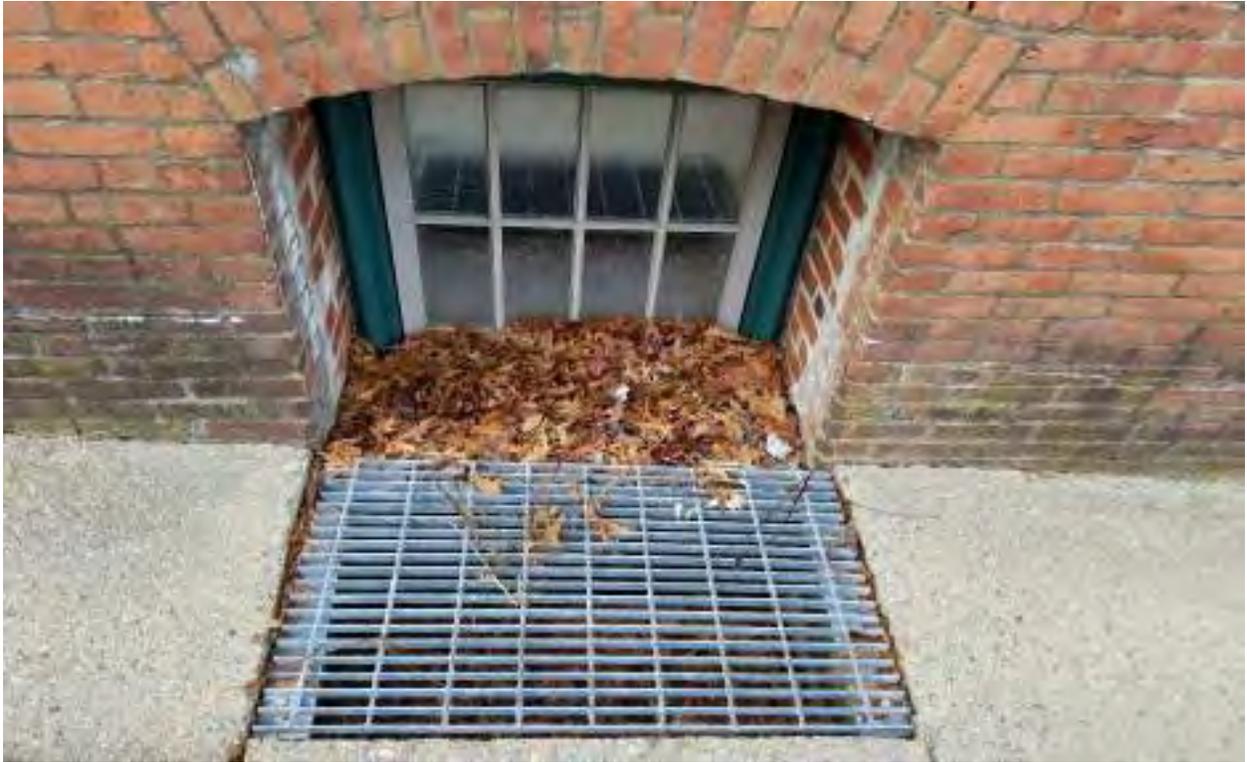
AREA WELL ALONG JANES AVE FILLED WITH LEAVES

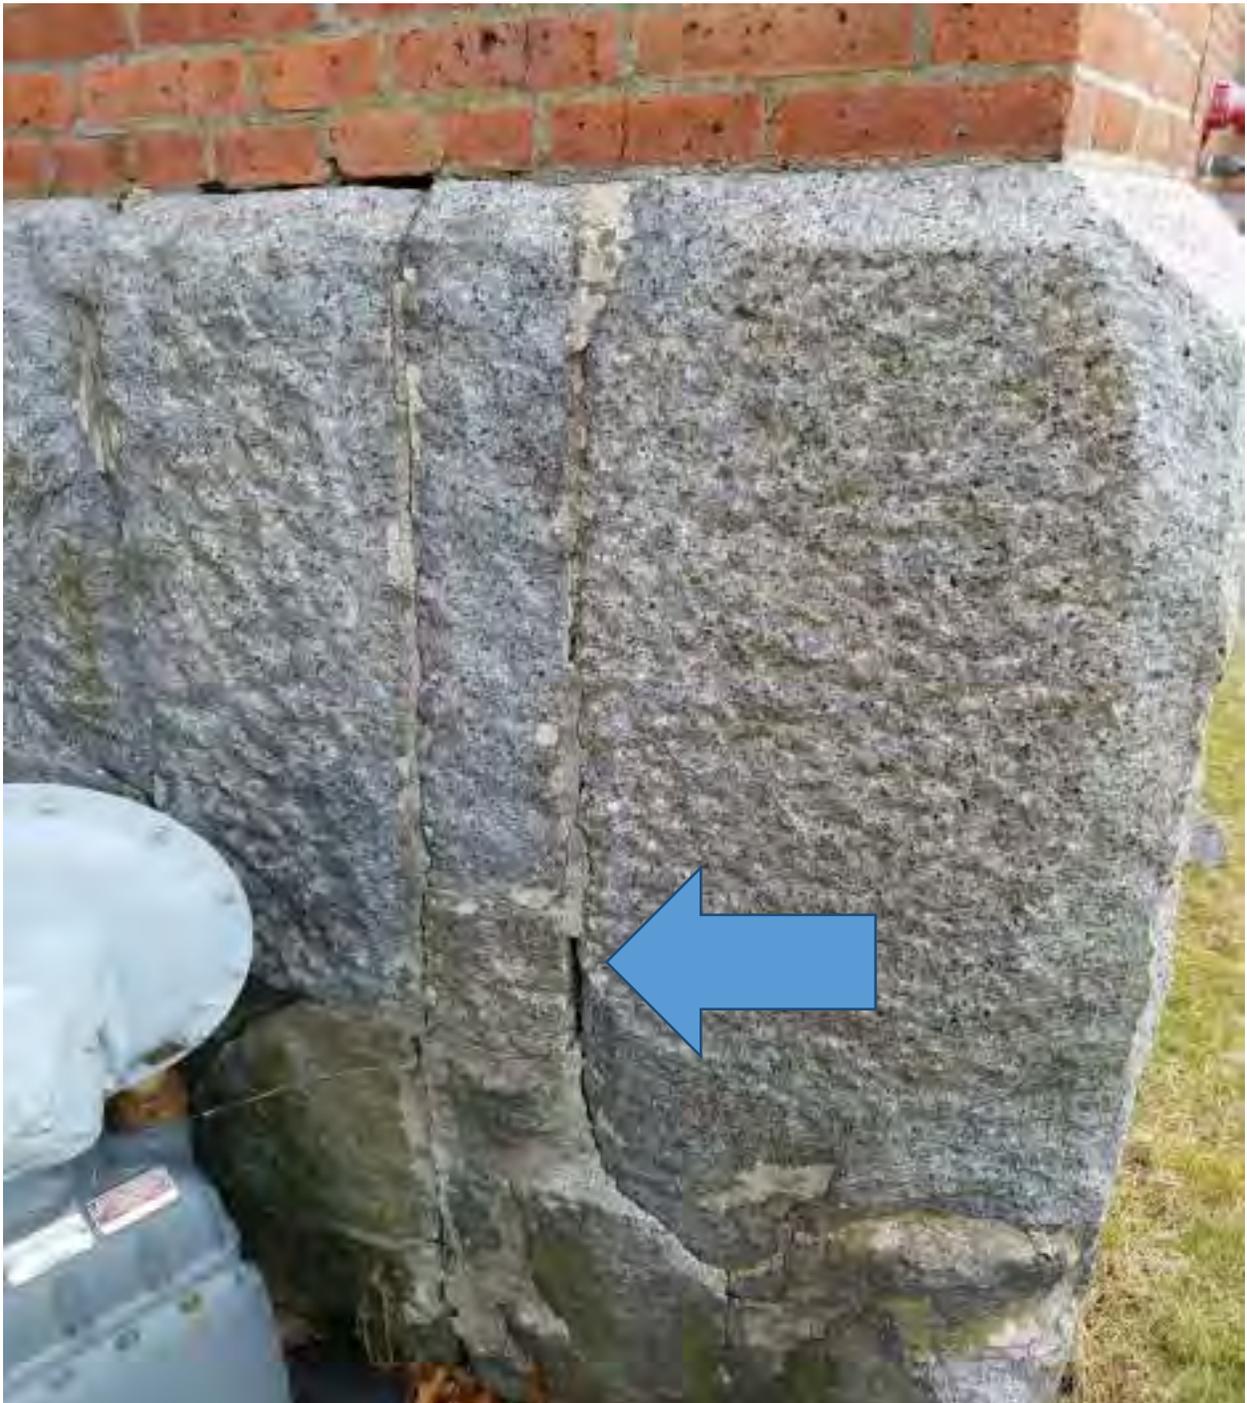
TYPICAL CRACKS IN GRANITE FOUNDATION CAP STONES

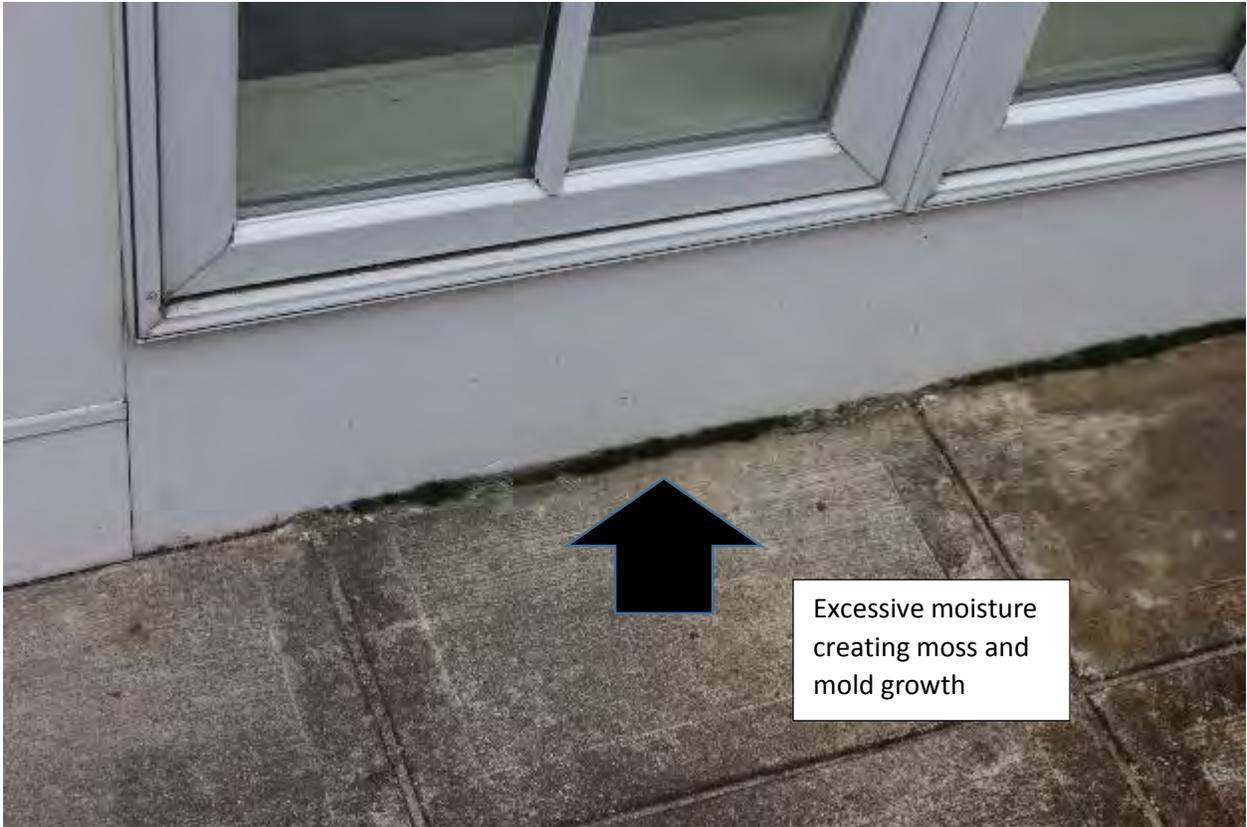
Excessive moisture creating moss and mold growth

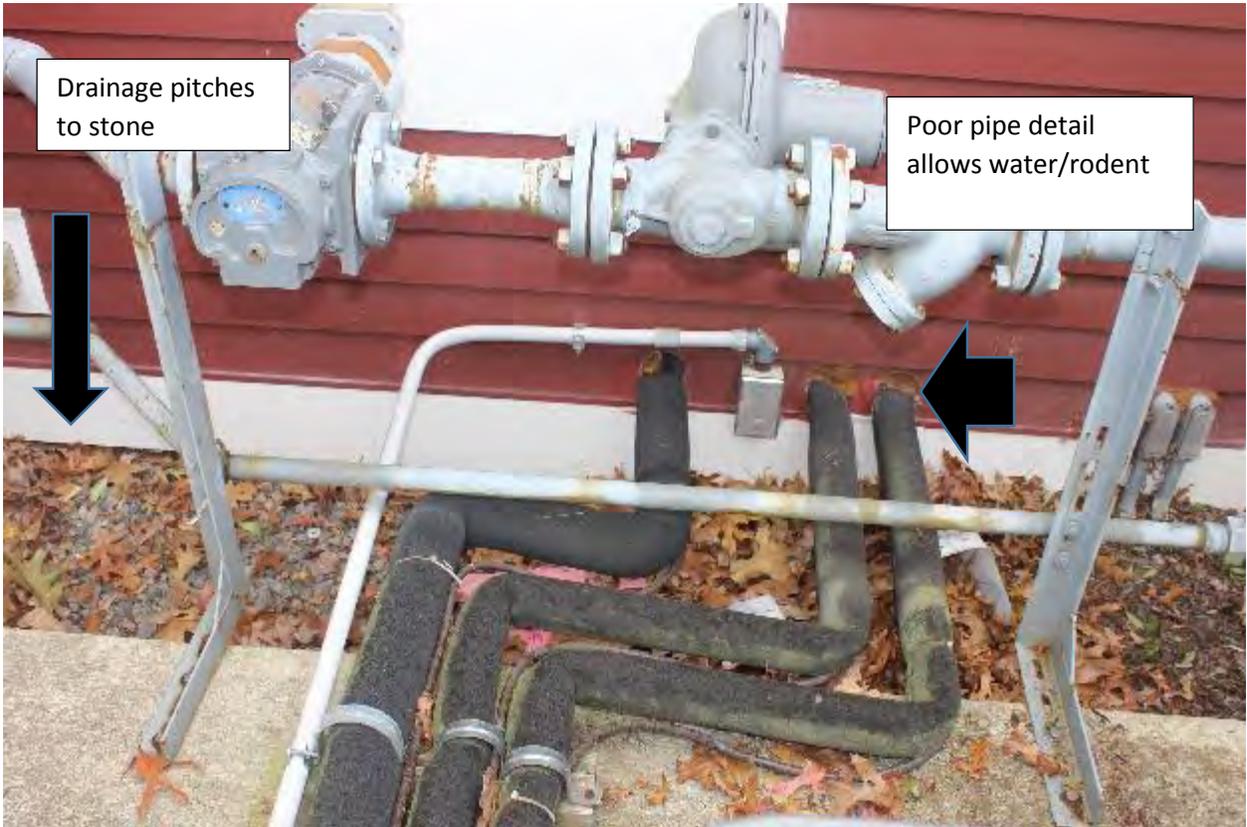
Drainage pitches to stone

Poor pipe detail allows water/rodent

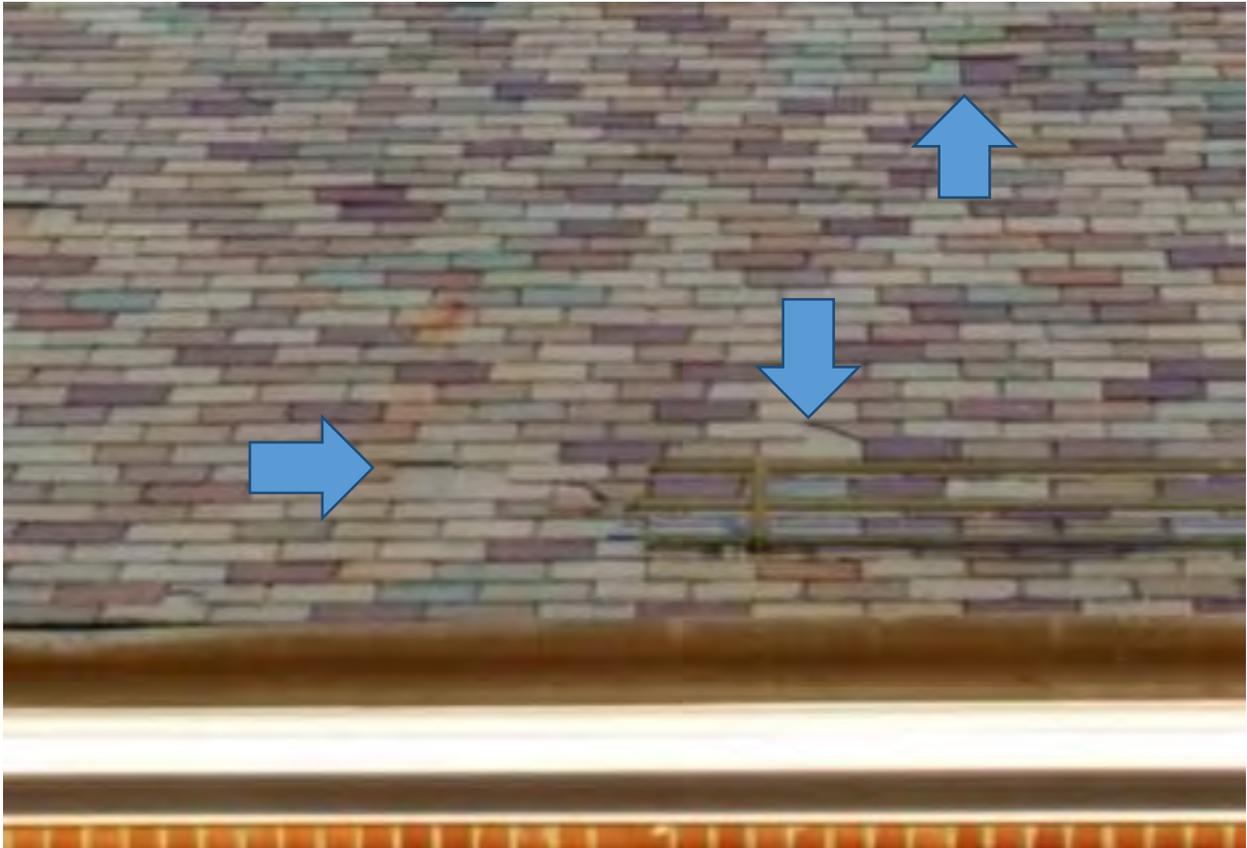
WEST-FACING SLATE ROOF SHOWING MISSING SLATES

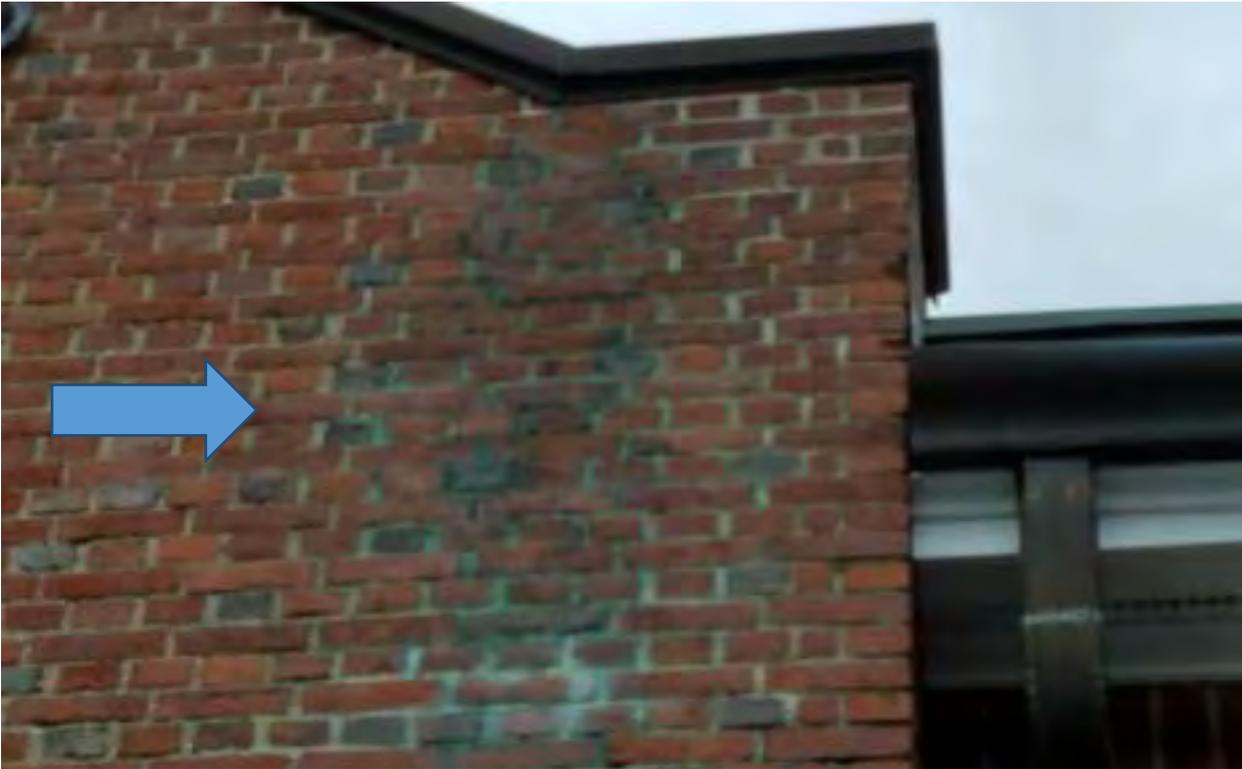
POSSIBLE LEAK AT PARAPET COPING CAUSING INFILTRATION INTO WALL & EFFLORESCENCE

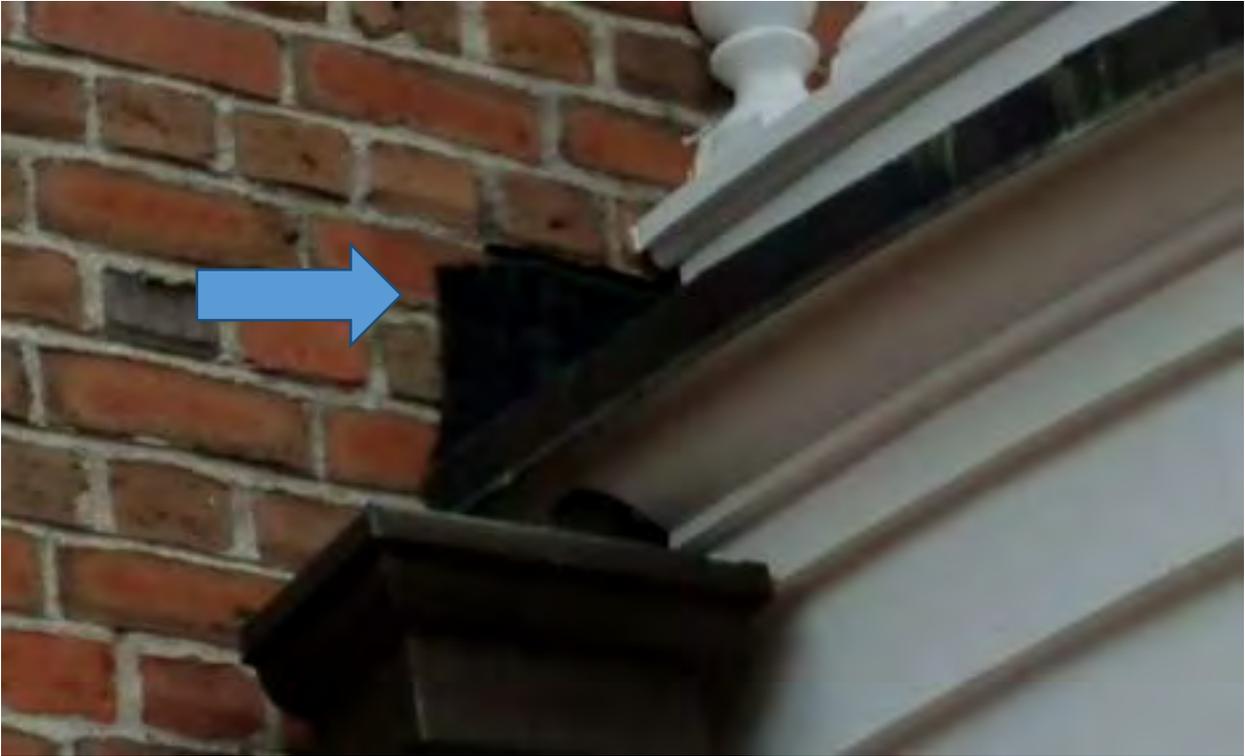
MEMBRANE ROOF AT EAST ENTRY NOT PROPERLY TERMINATED (ARROW)

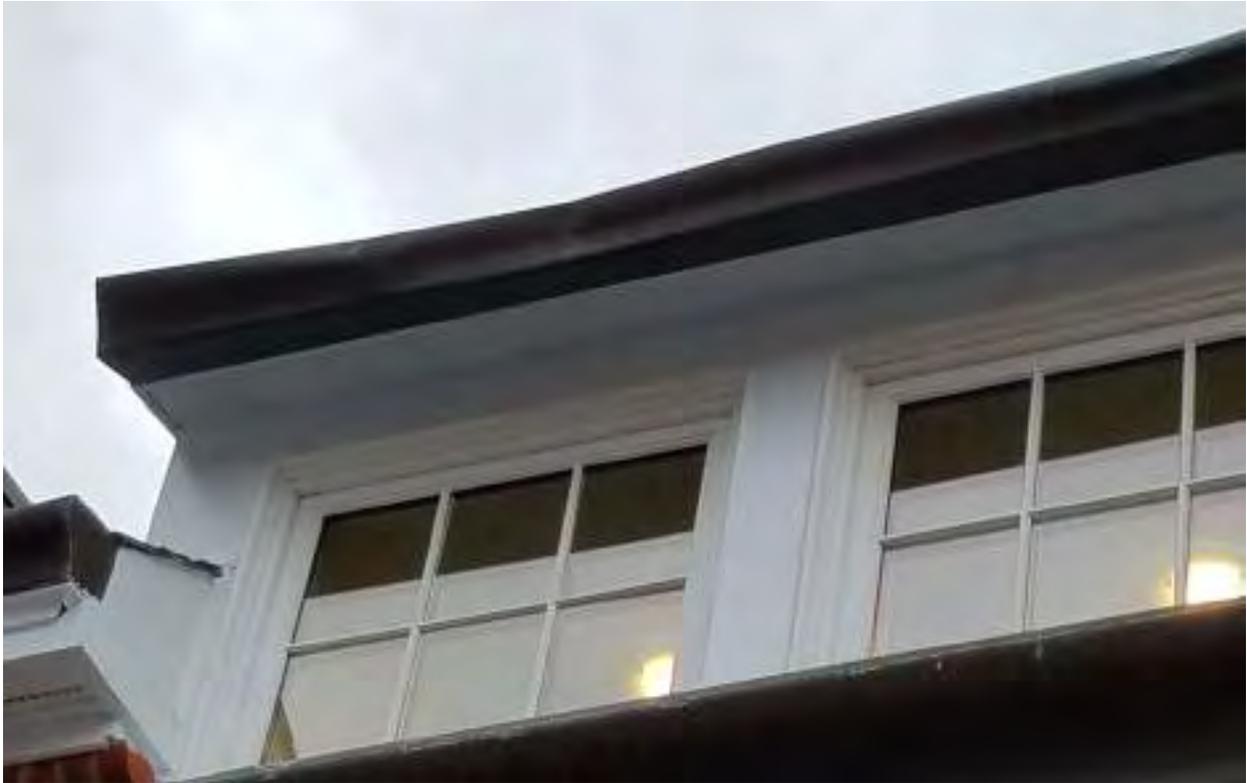
EXAMPLE OF DAMAGED GUTTERS (WEST ELEVATION)

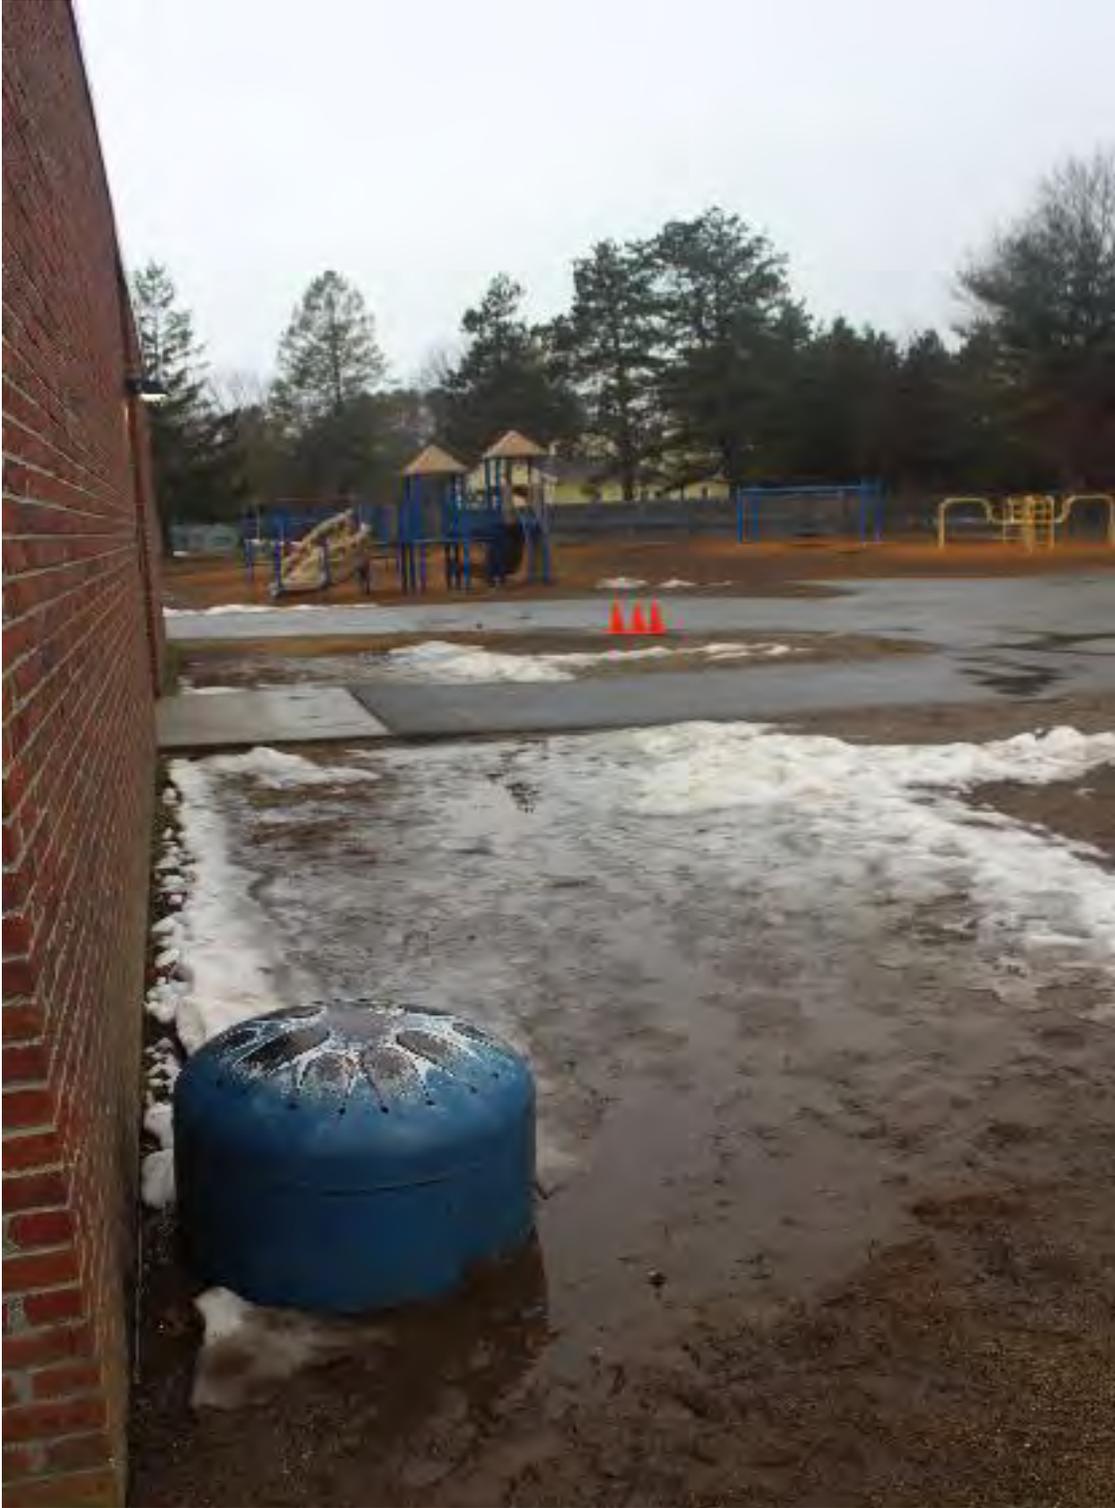
Main Recess door. Note traffic wear and north facing area does not permit grass/vegetation to grow.  
Install an impervious landscape material.

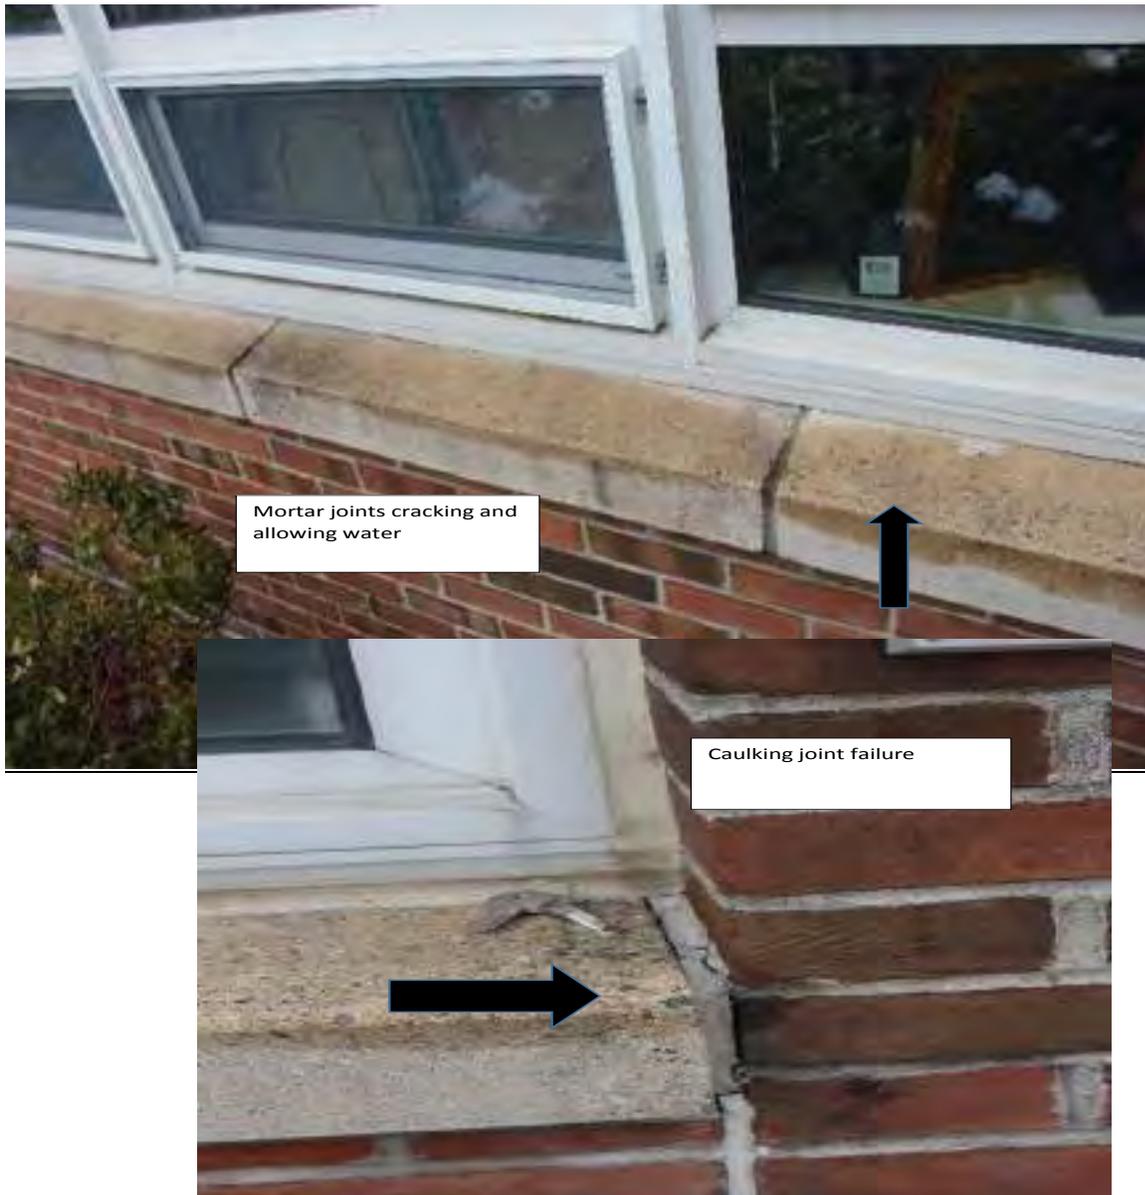
Water penetration at flashing

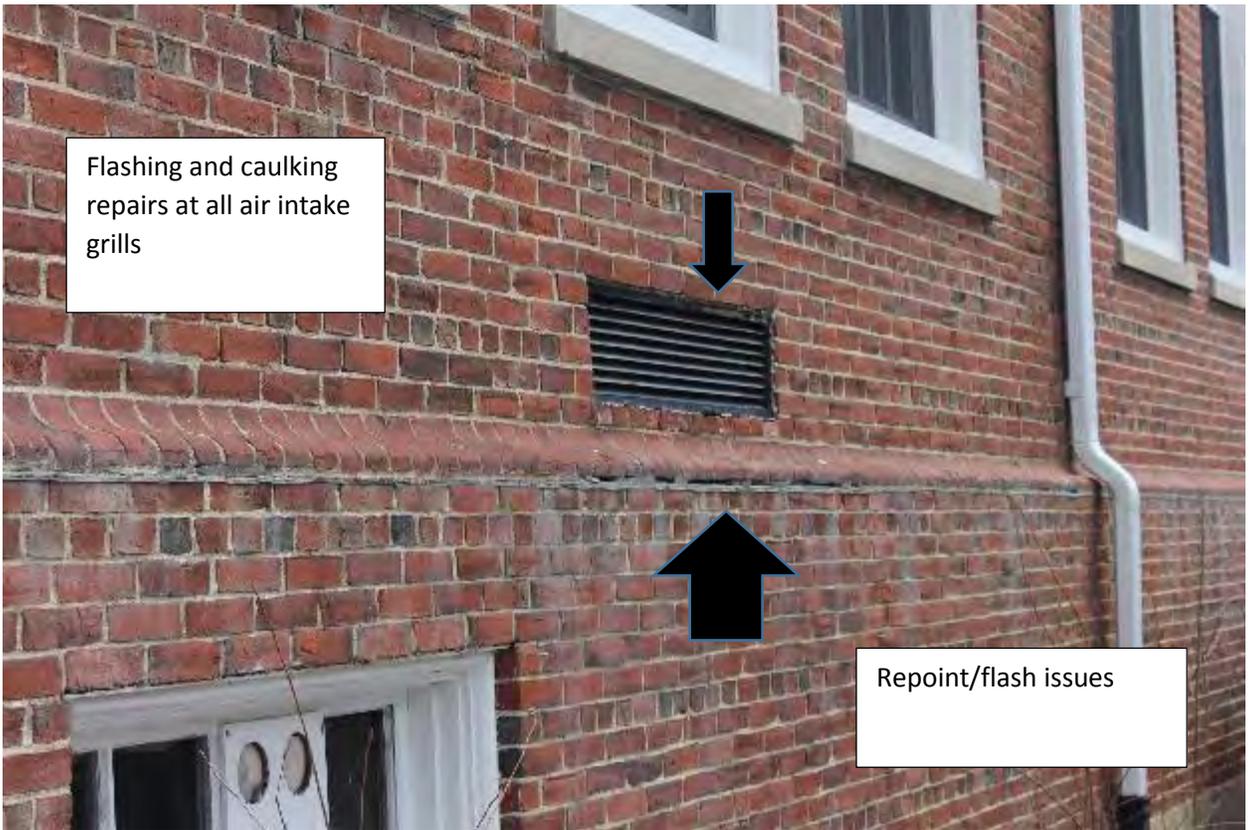
Flashing and caulking  
repairs at all air intake  
grills

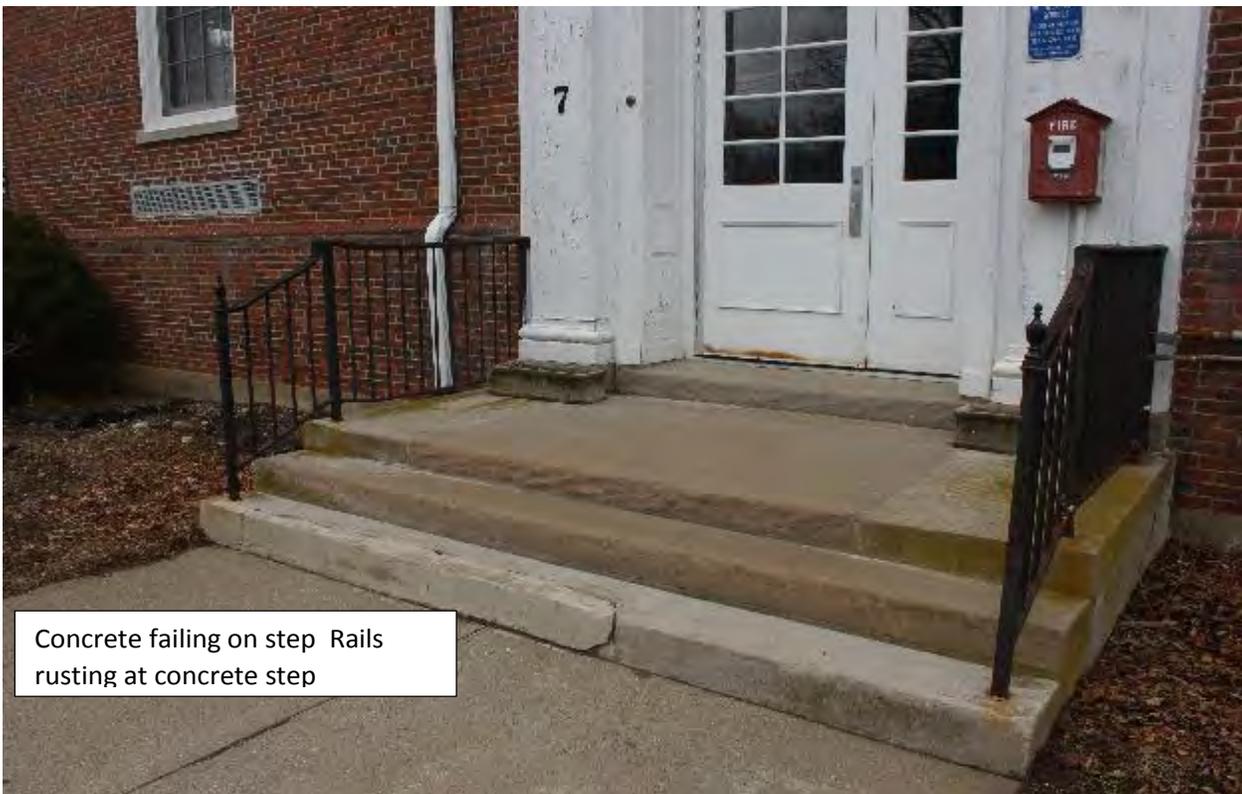
Concrete failing on step Rails rusting at concrete step

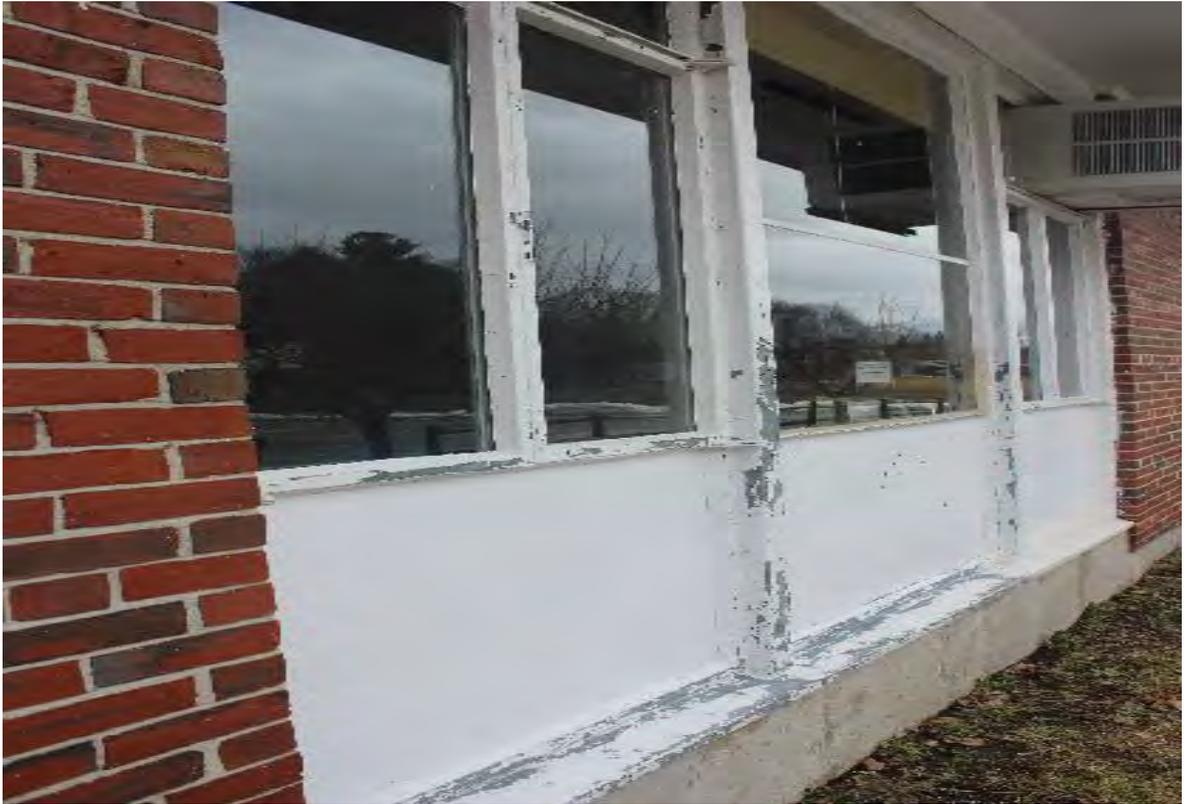
Typical 1960 window single pane, non insulated panel, failing caulking and paint

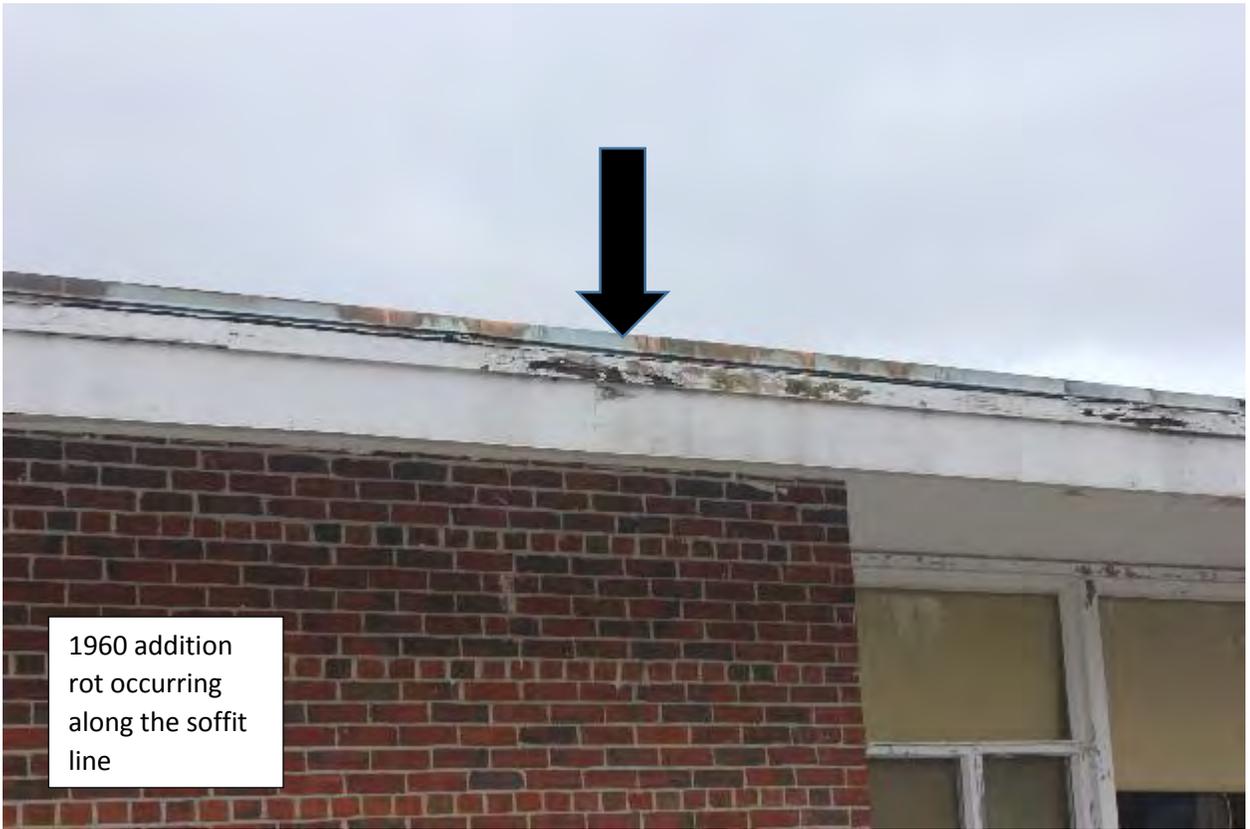
1960 addition  
rot occurring  
along the soffit  
line

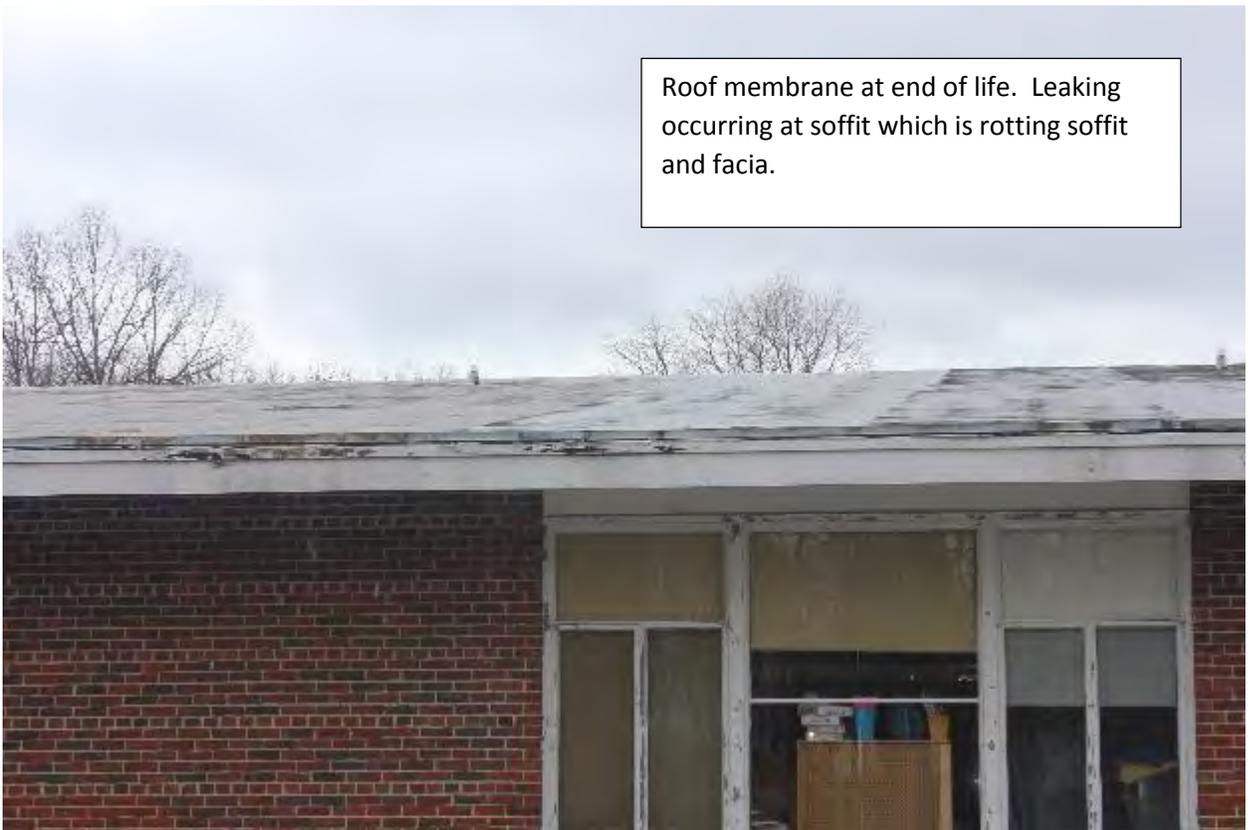
Roof membrane at end of life. Leaking  
occurring at soffit which is rotting soffit  
and fascia.

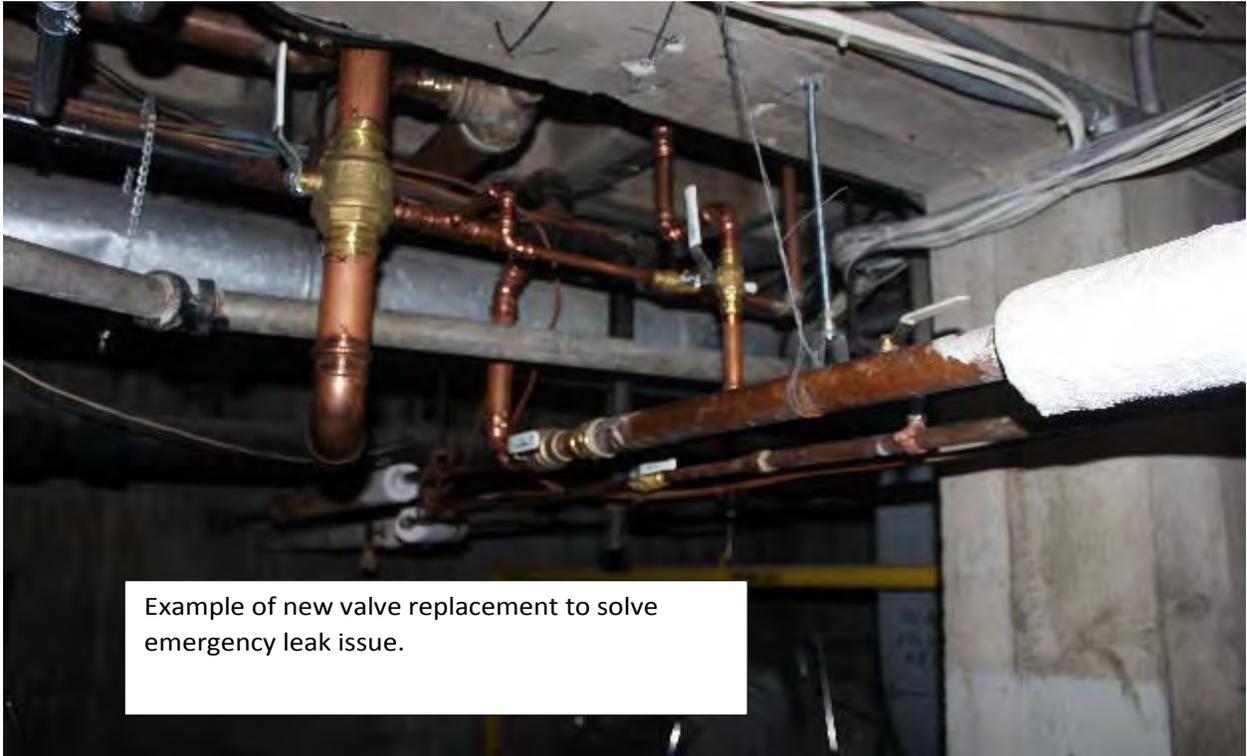
Example of new valve replacement to solve emergency leak issue.

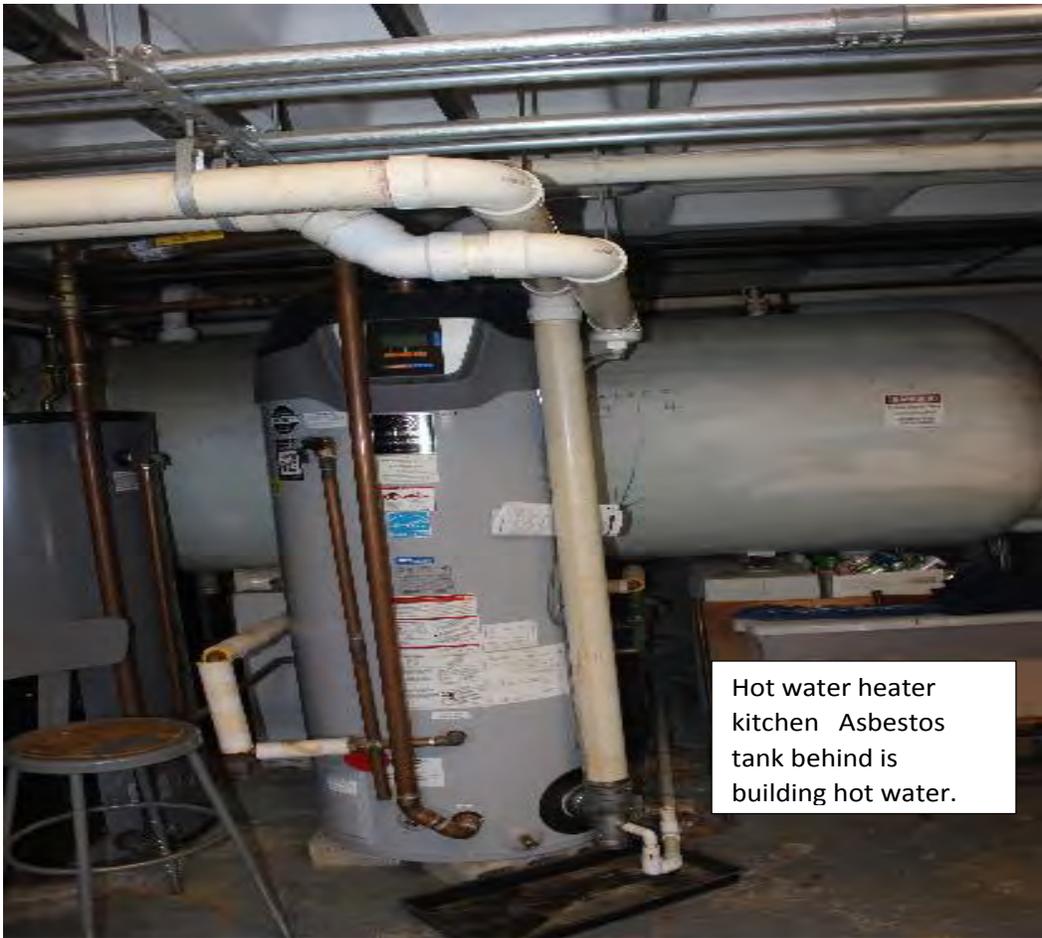
Hot water heater kitchen Asbestos tank behind is building hot water.
