# **TOWN OF MEDFIELD**

## **Municipal Facilities**

### **Evaluation and Capital Plan**

October 6, 2017

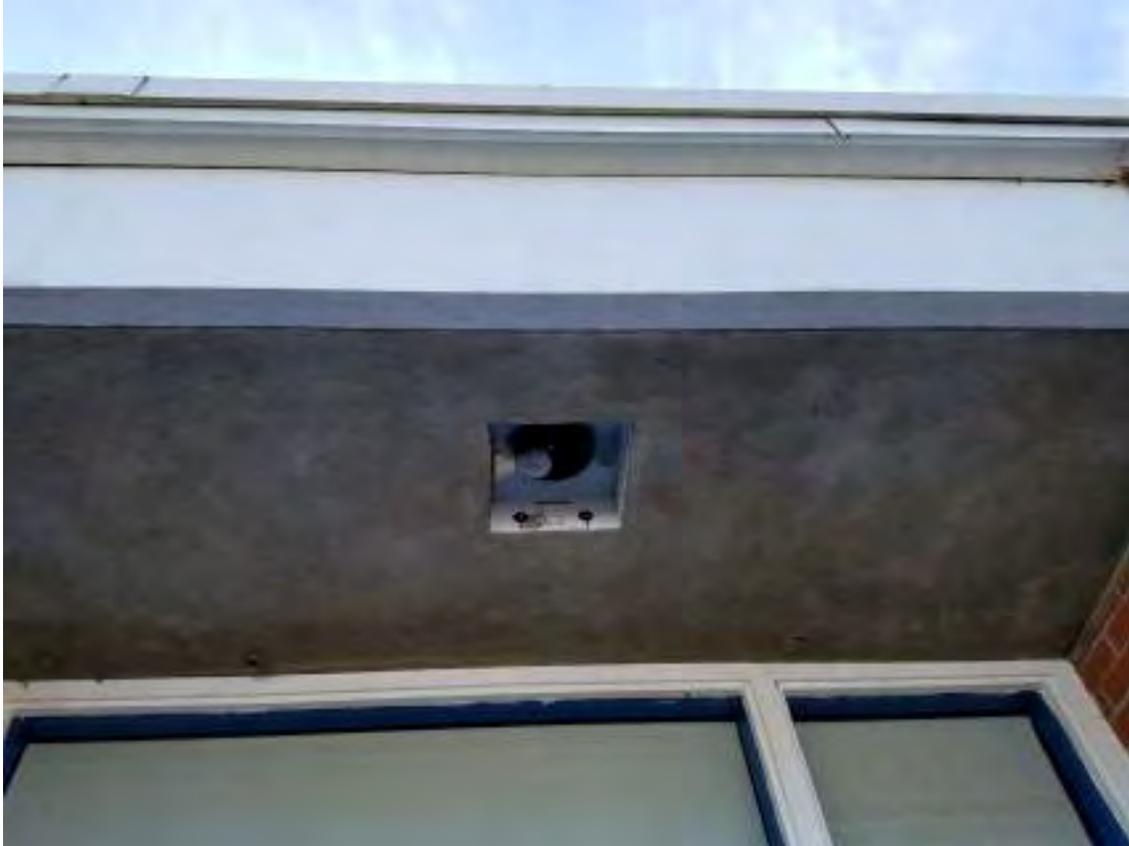
Outdated incandescent fixture and water-stained ceiling of covered entry

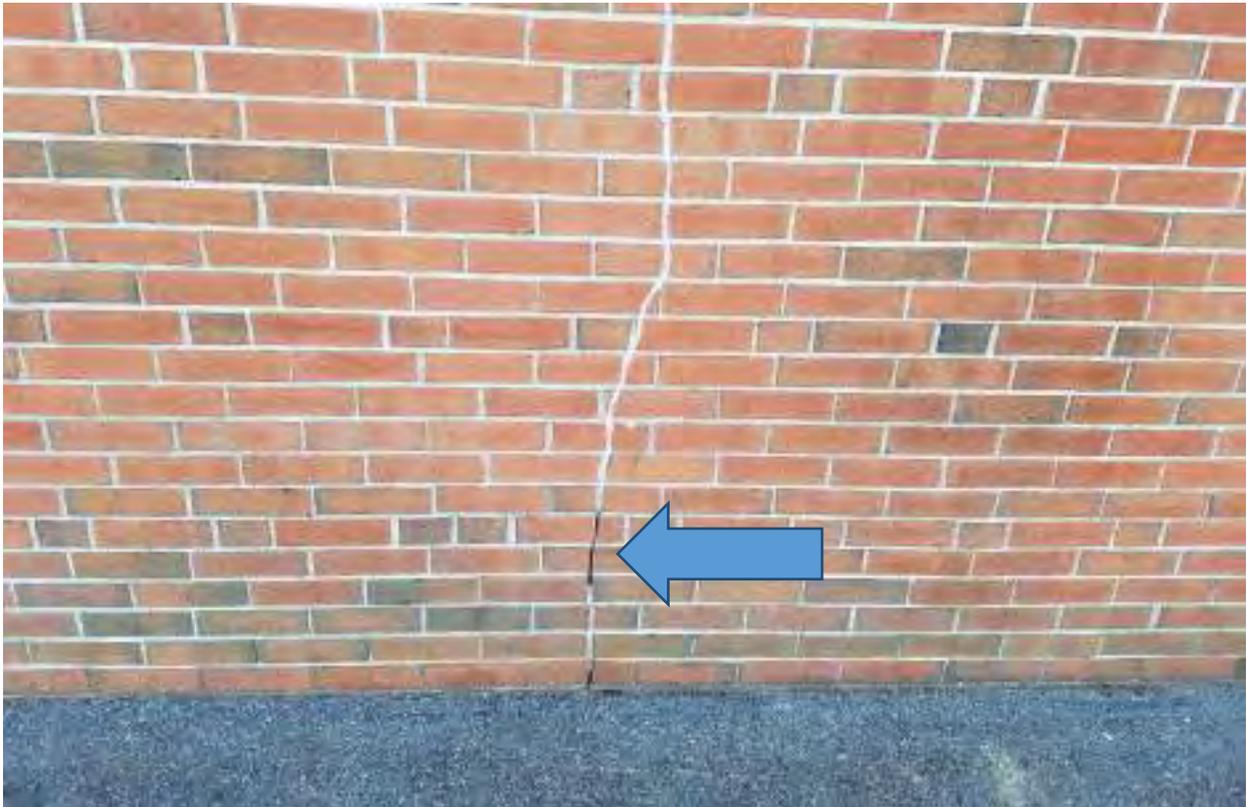
Example of cracks in brick veneer needing repair ( north elevation )

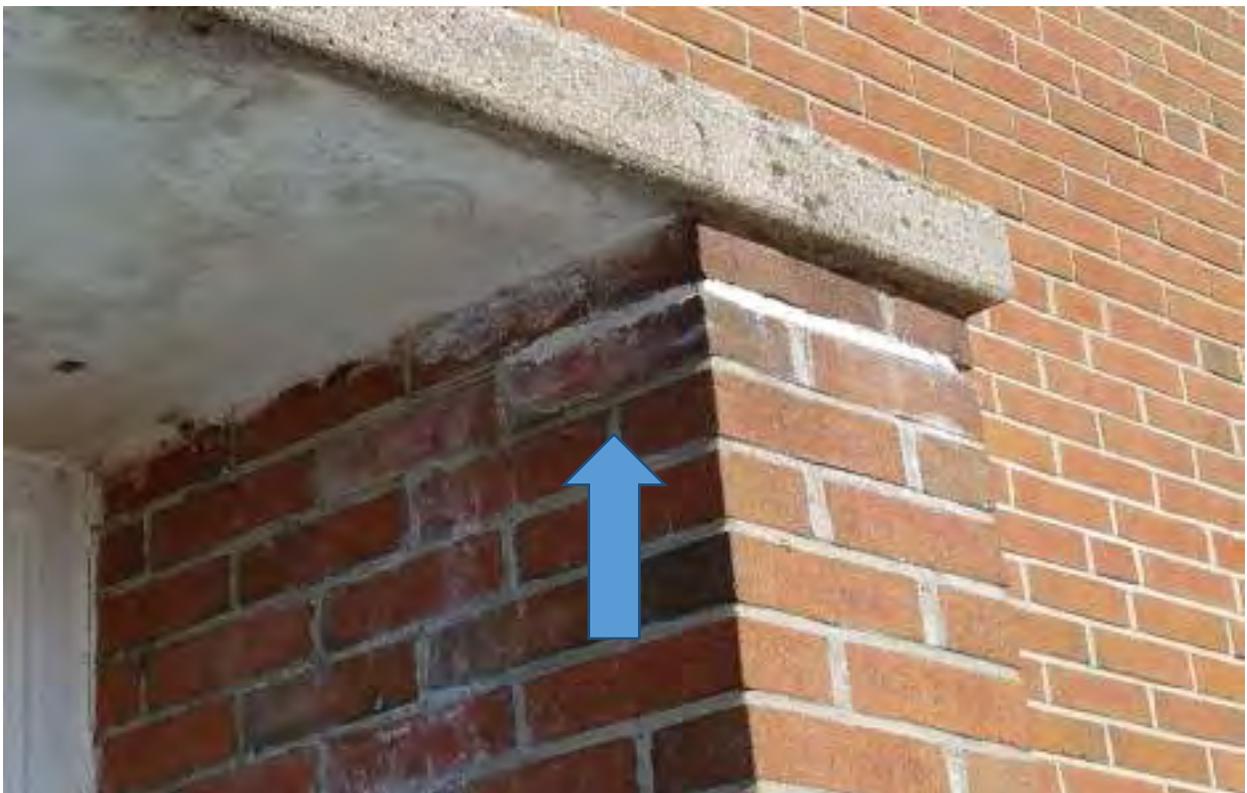
Showing water penetration through concrete entry cap deteriorating brick (efflorescence shown )

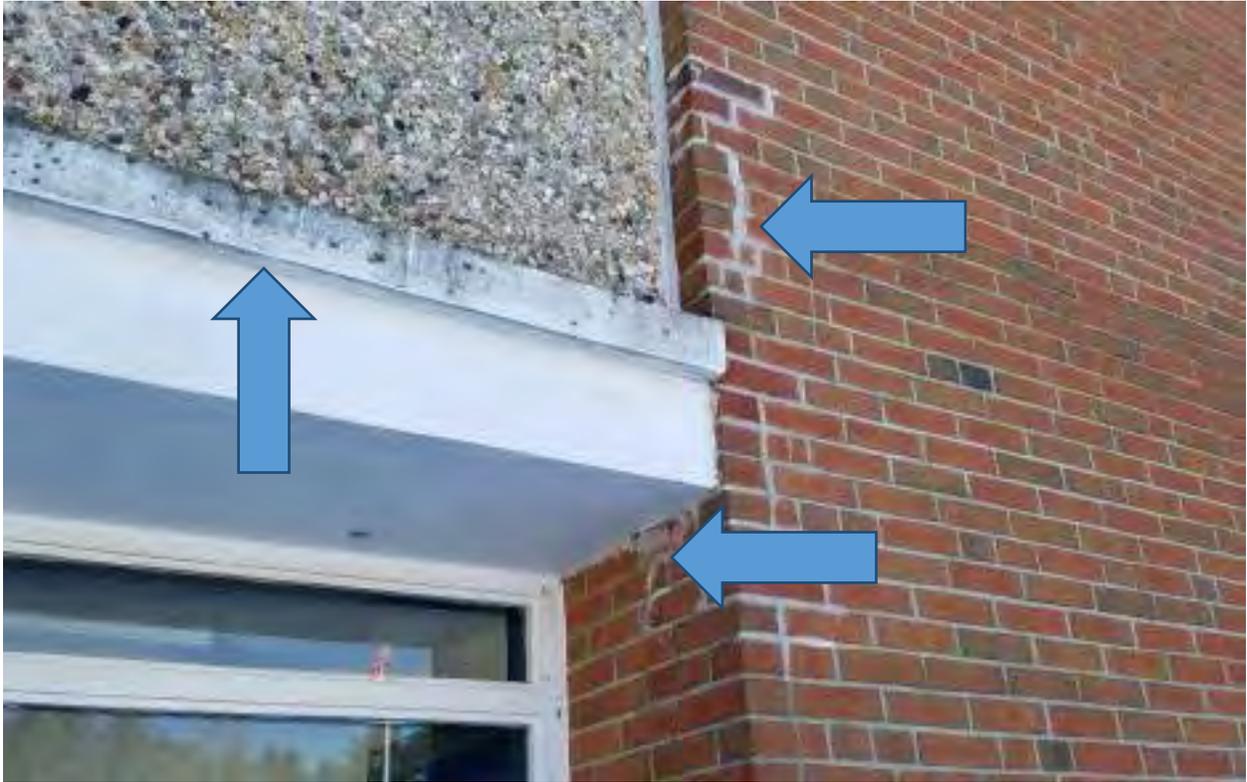
Signs of water infiltration and associated brick damage ( previously repaired ) and mildew on flashing

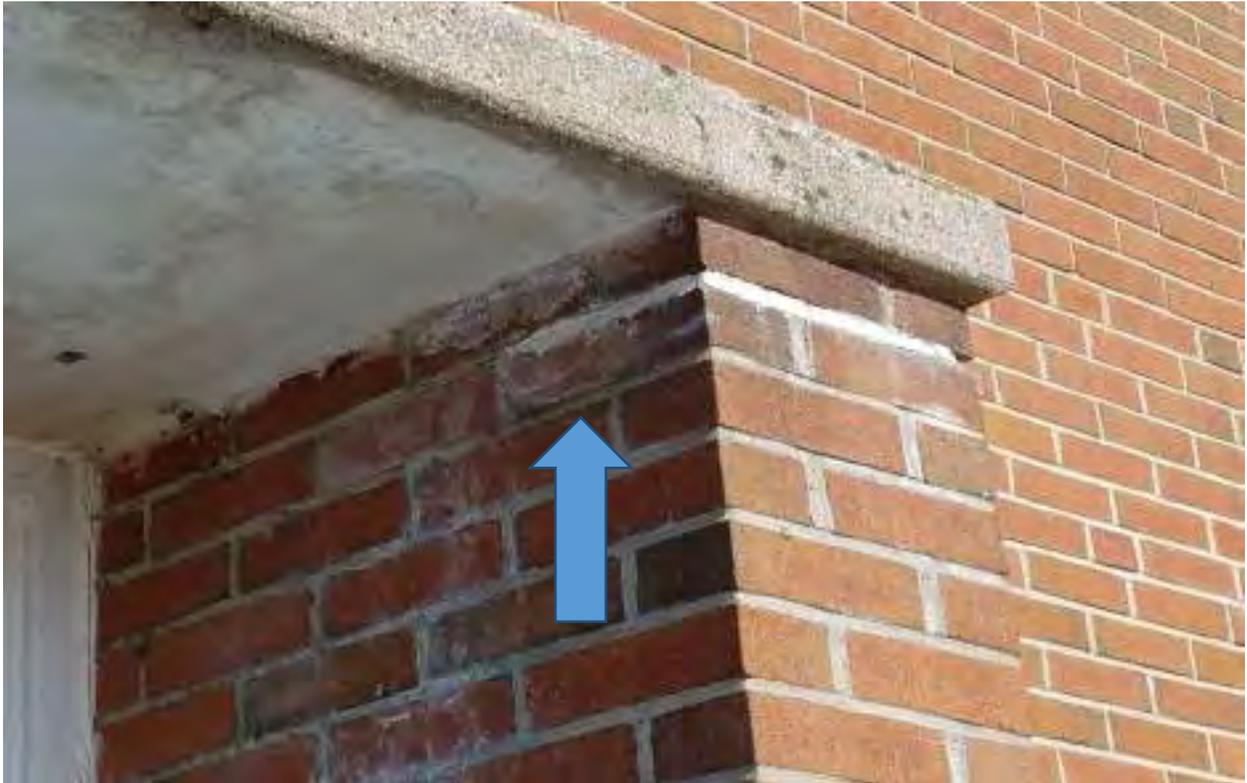
Another typical example of porous concrete entry cap that has caused brick deterioration

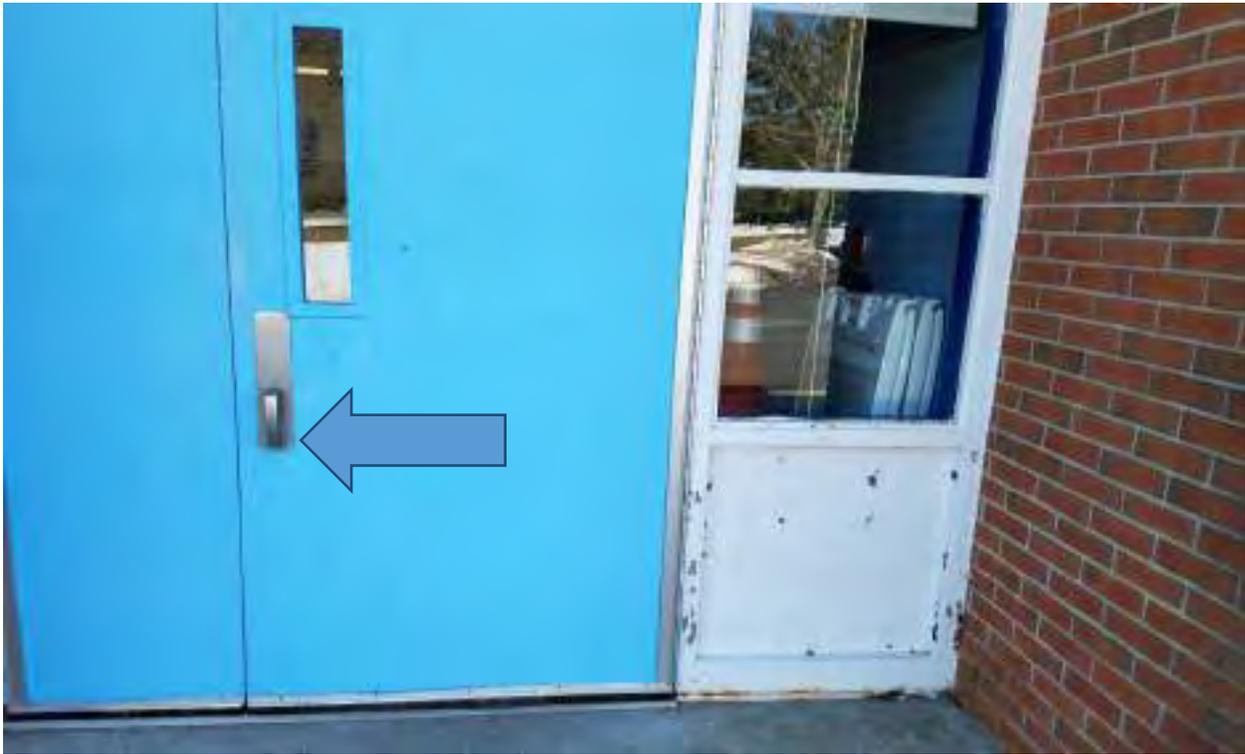
Typical entry showing non-compliant door latching hardware and hollow metal frames needing paint

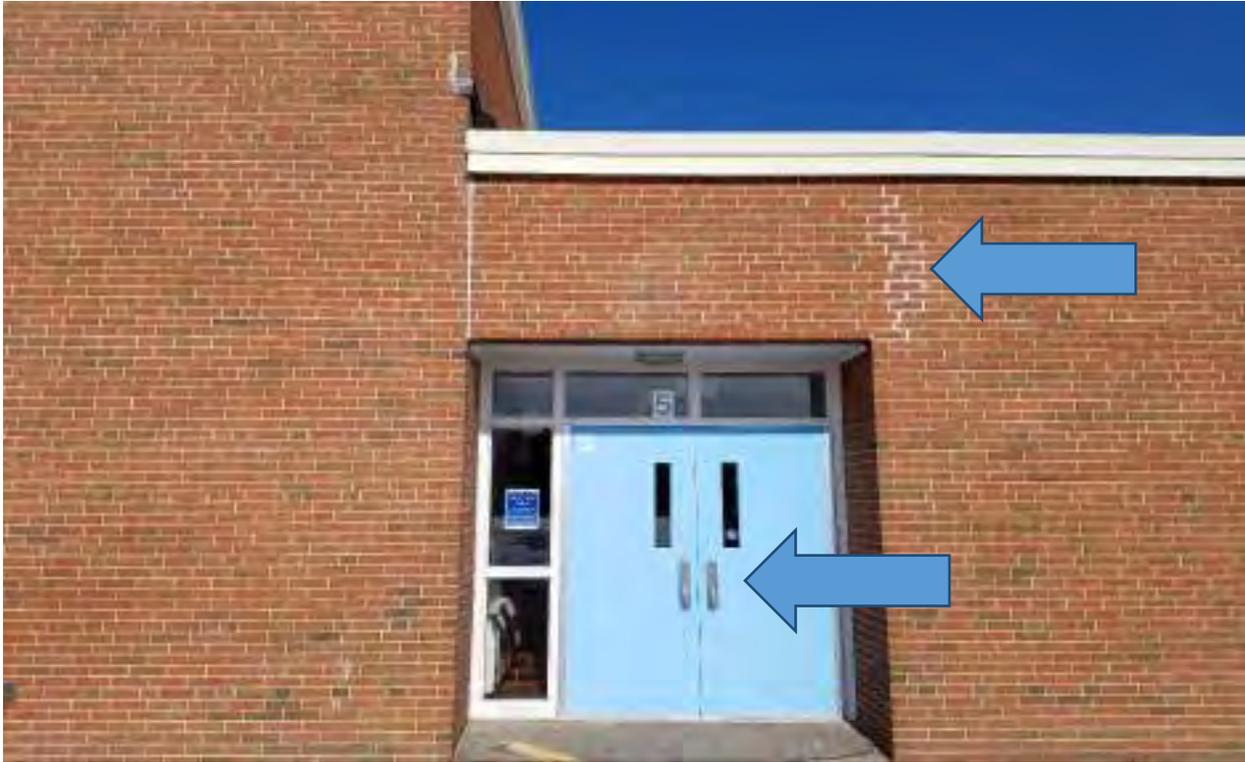
Another example of non-compliant hardware and previous repair of brick damage

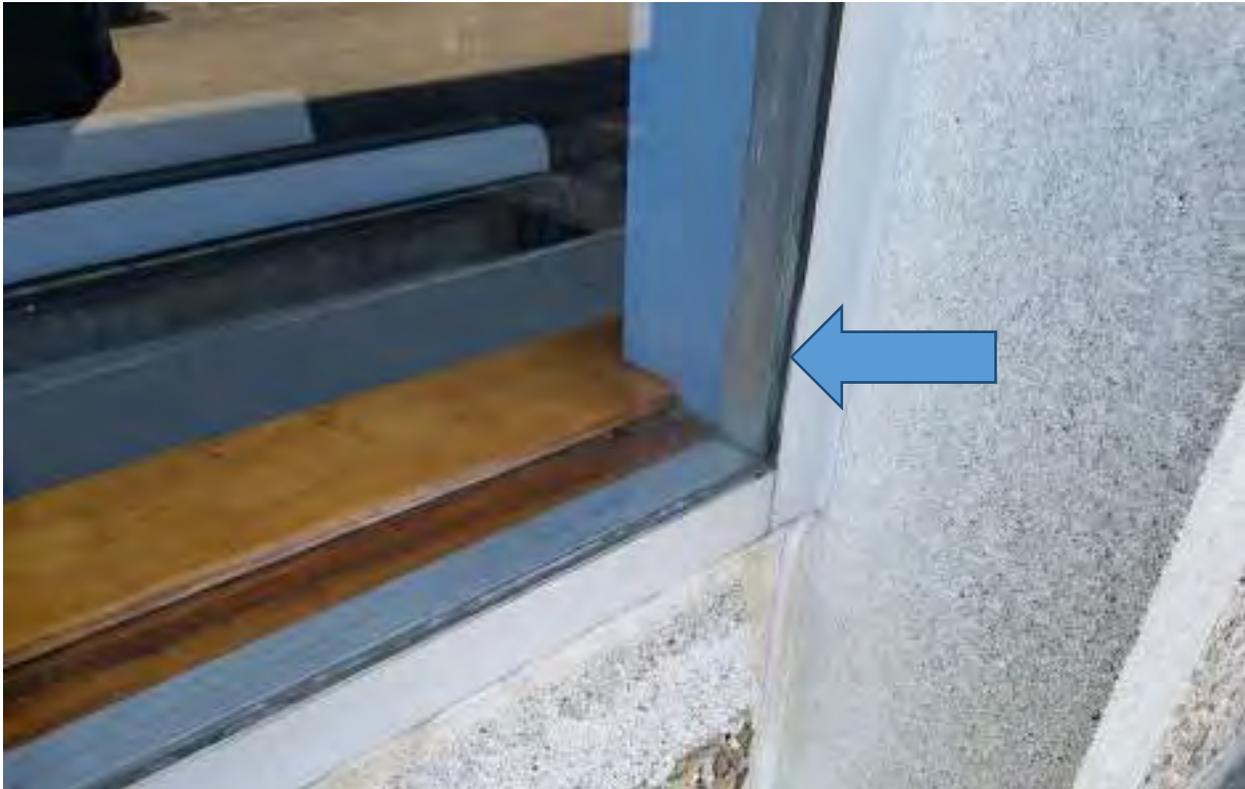
Typical window with single-pane, uninsulated glass

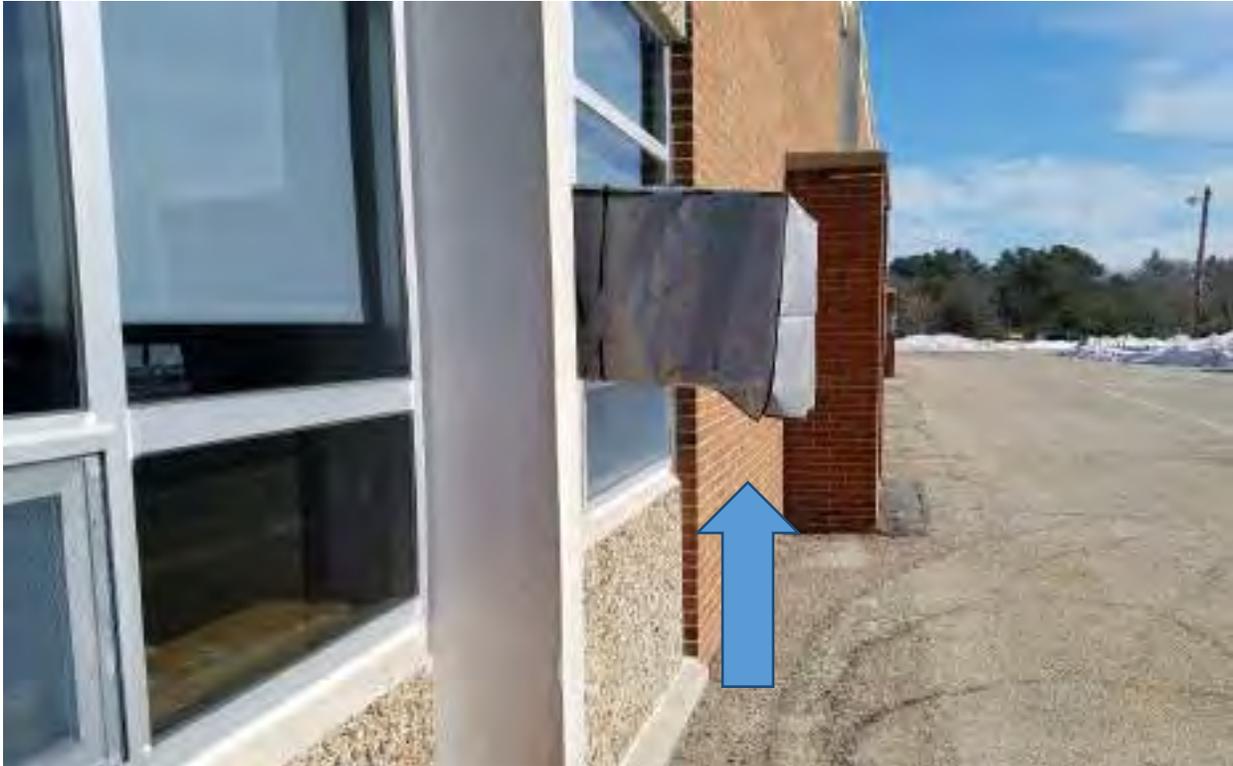
Potential hazard of protruding air-conditioner along walkway

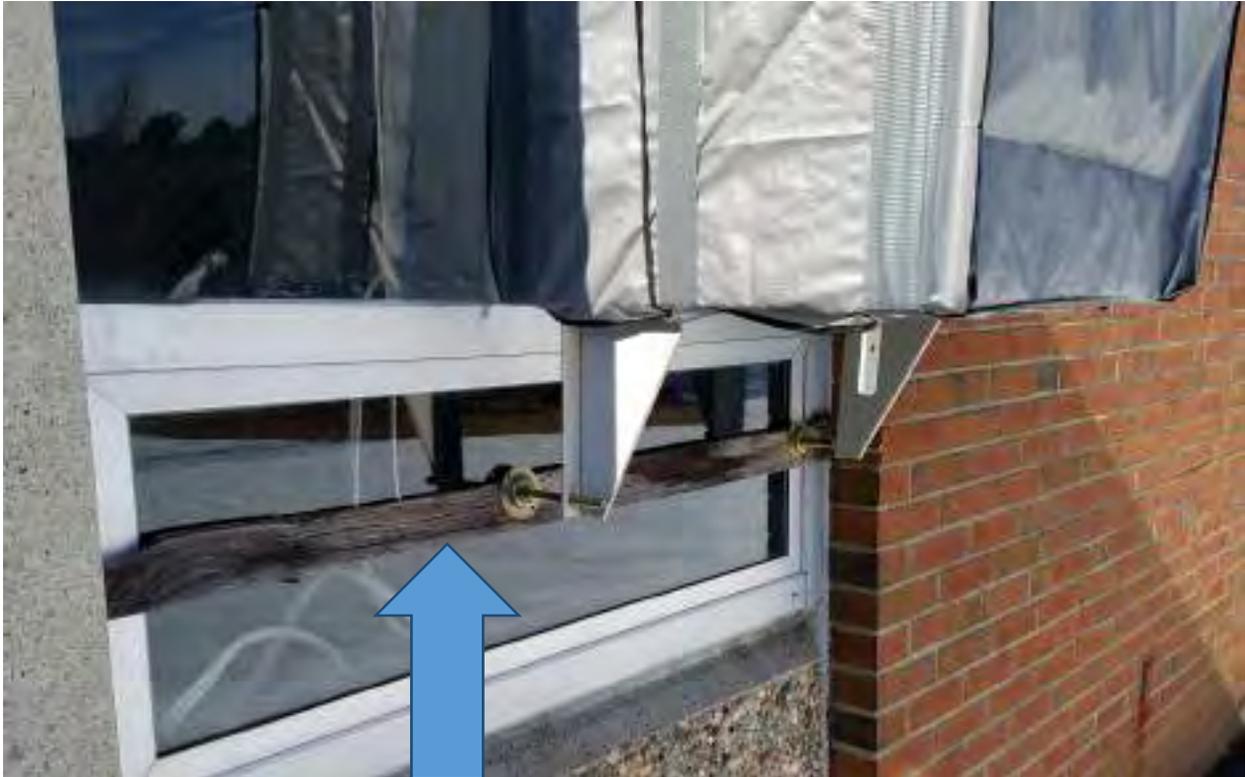
Poor installation of air-conditioner using scrap wood- potential to damage window glass

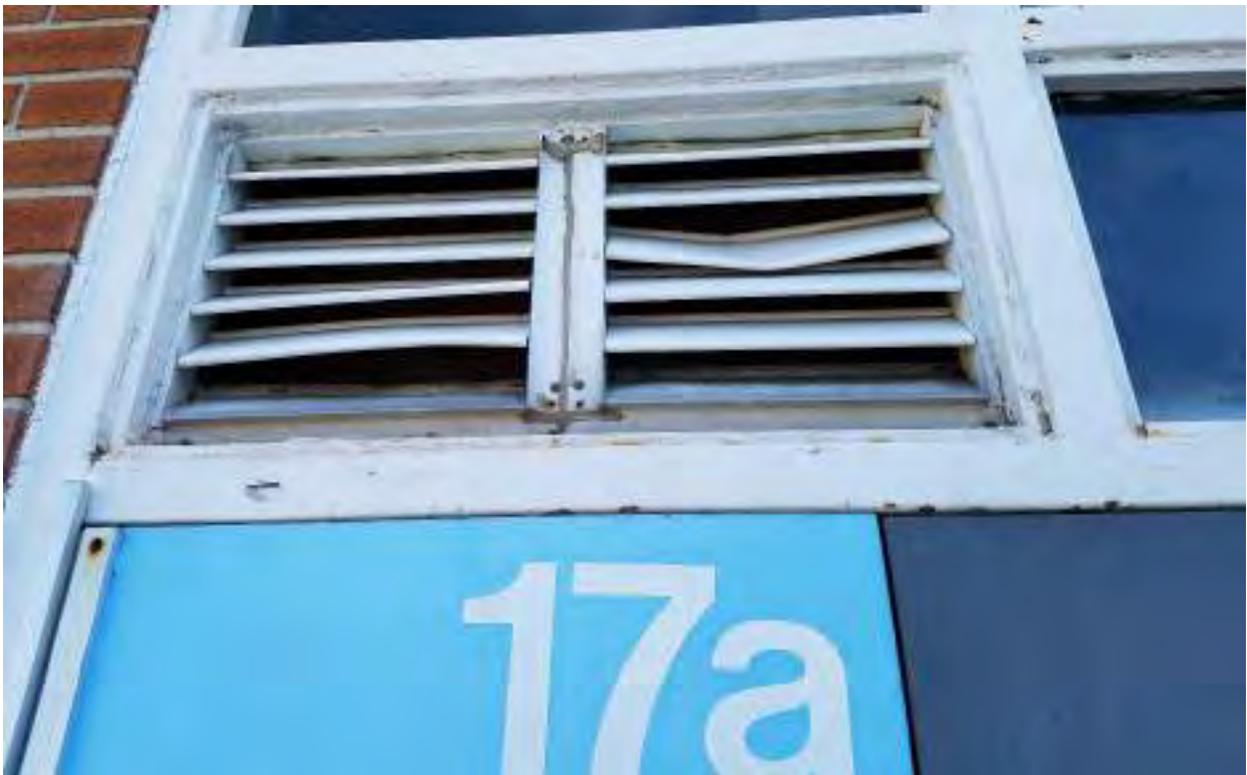
Example of mechanical louver needing repair/replacement

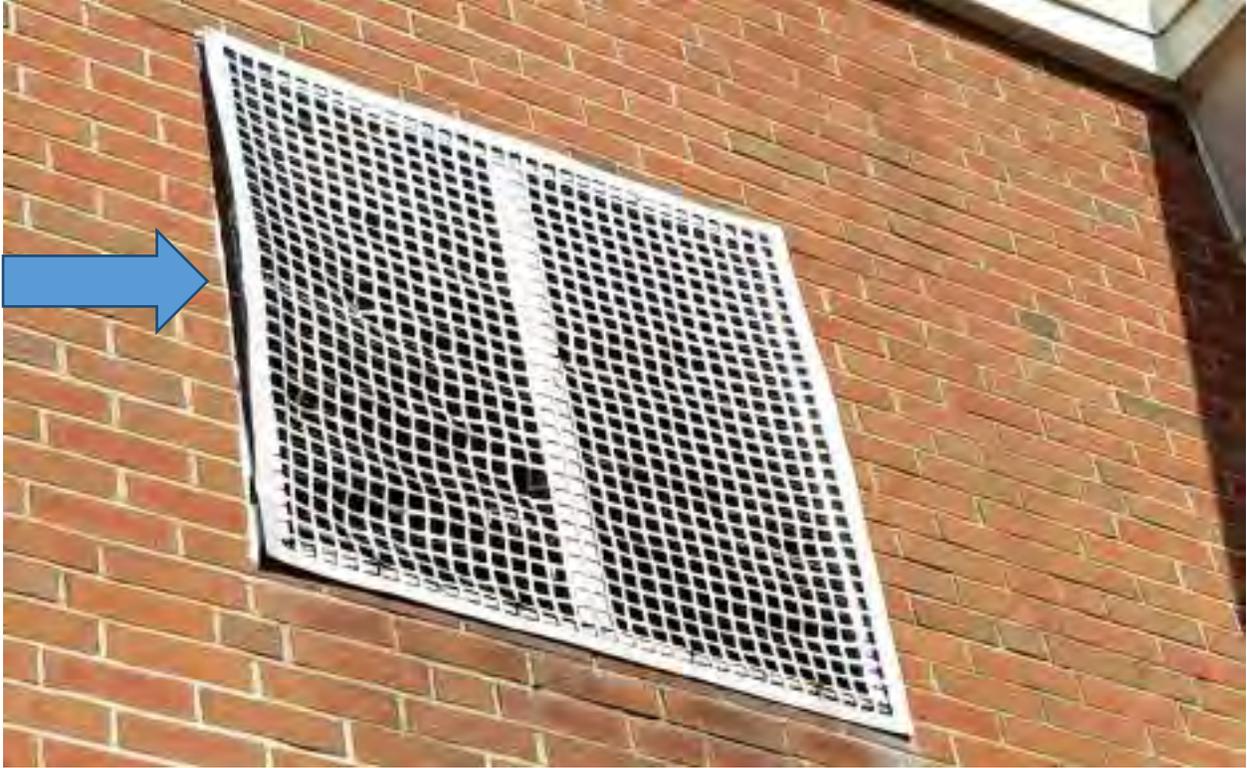
Mechanical louver needing replacement

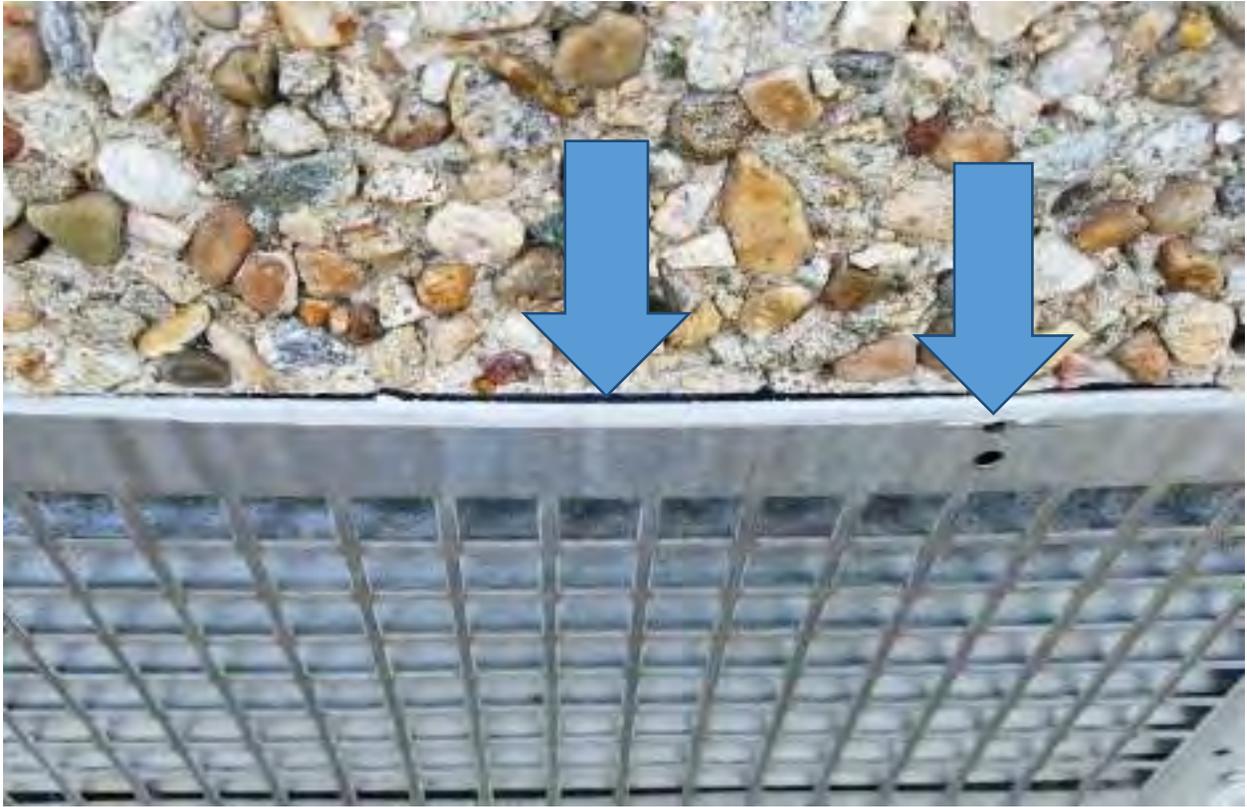
Gaps around UV louver needing refastening and new sealants

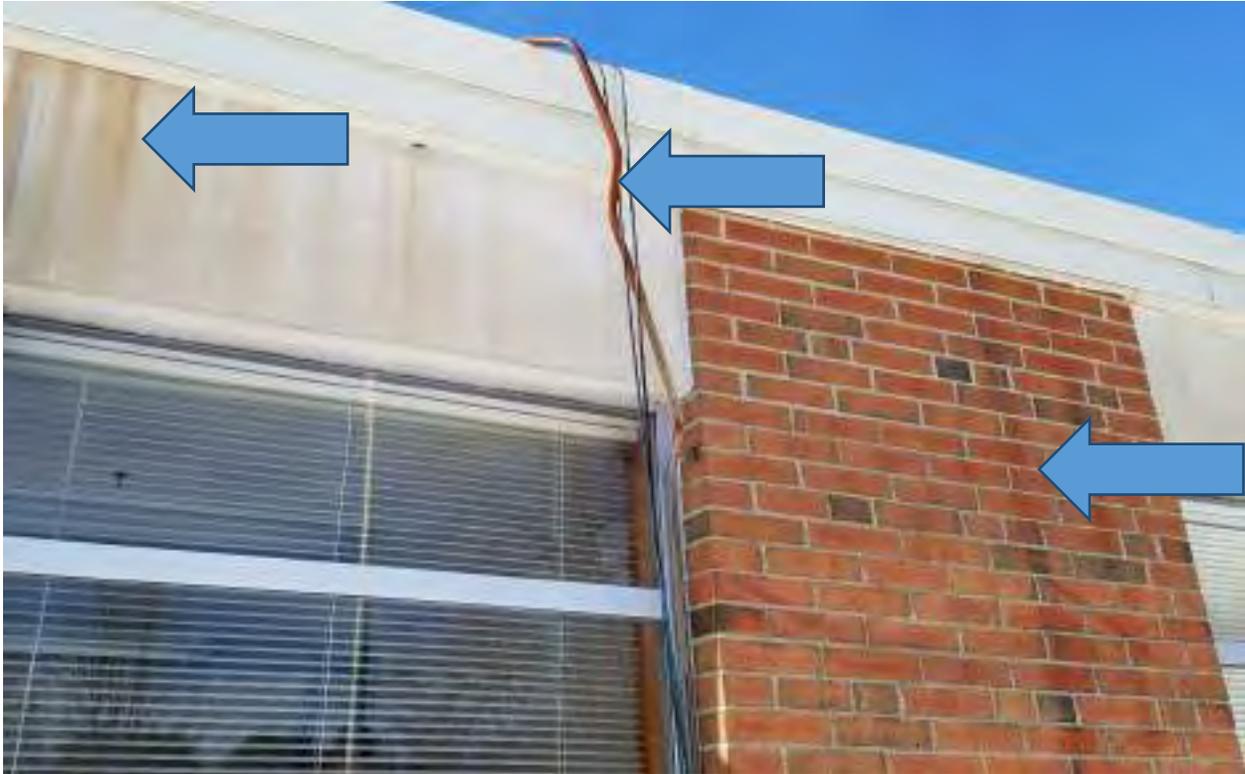
Showing stains from water infiltration from above / unsecured electrical conduits and moist brick

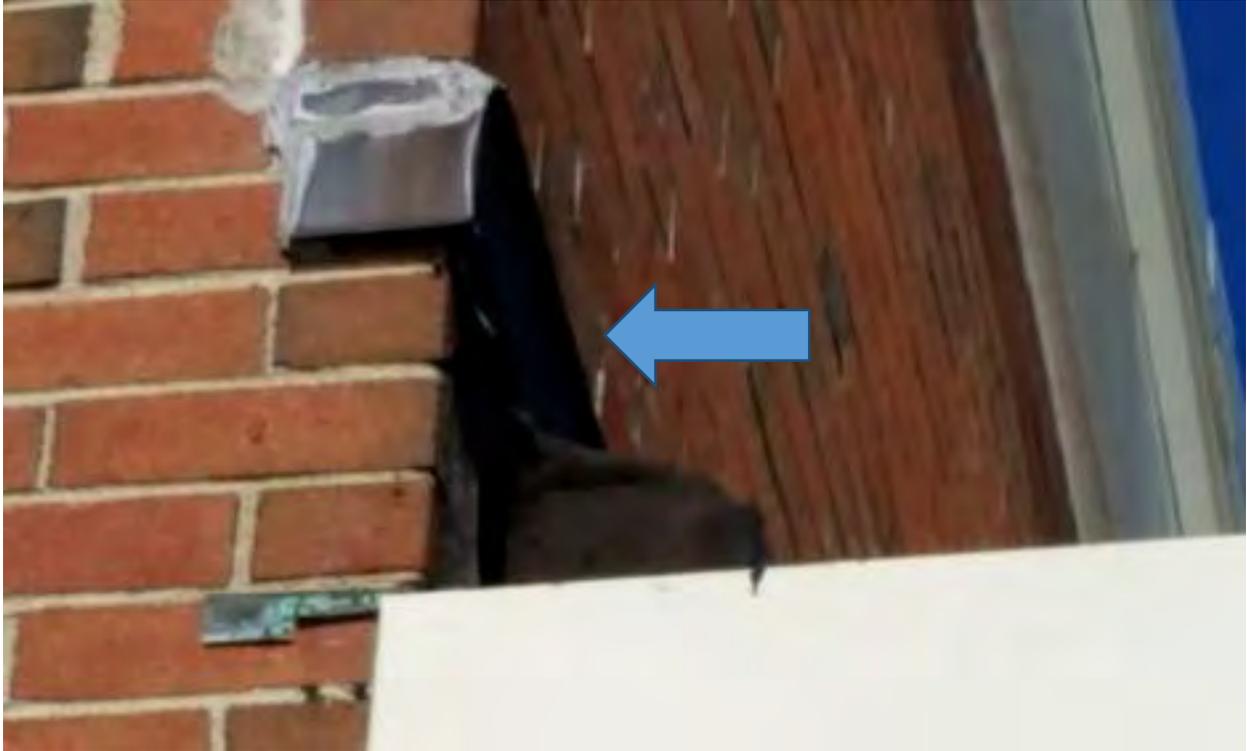
Another example of poor flashing transtion ( South elevation )

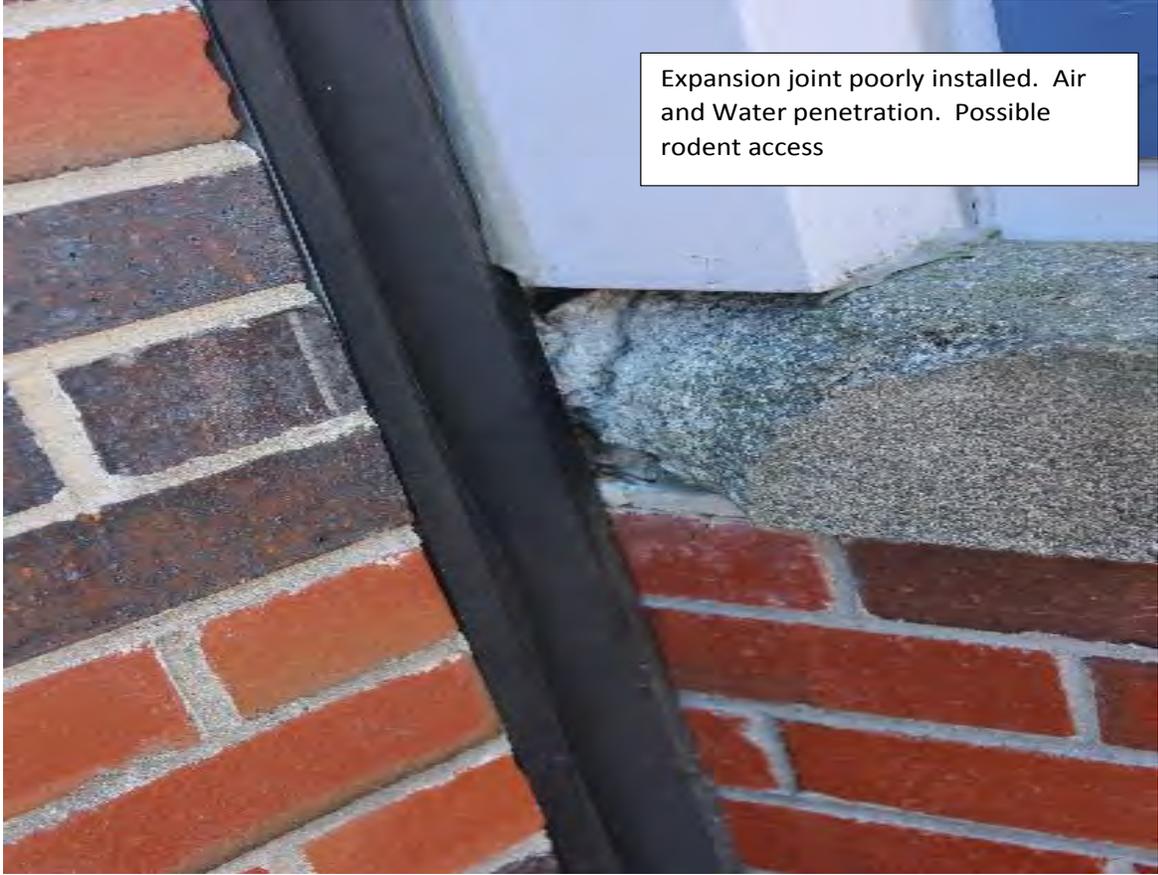
Expansion joint poorly installed. Air and Water penetration. Possible rodent access

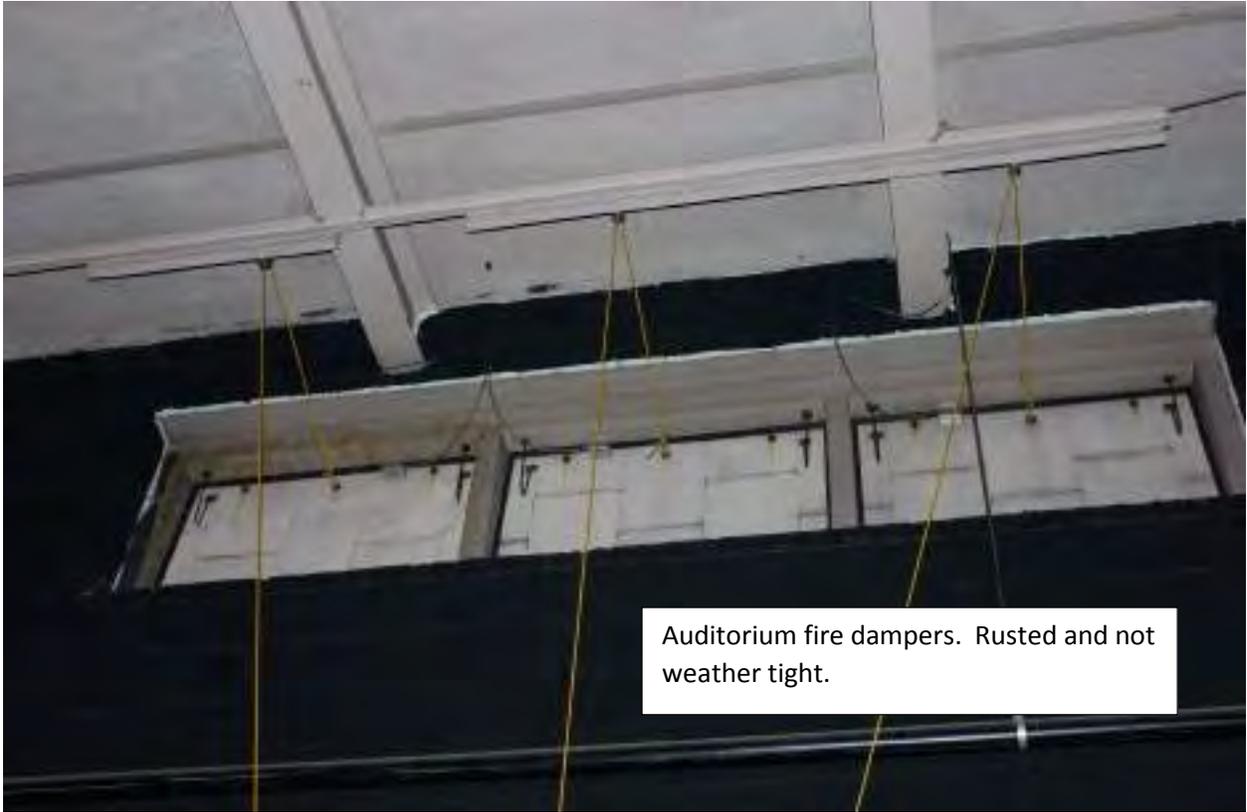
Auditorium fire dampers. Rusted and not weather tight.

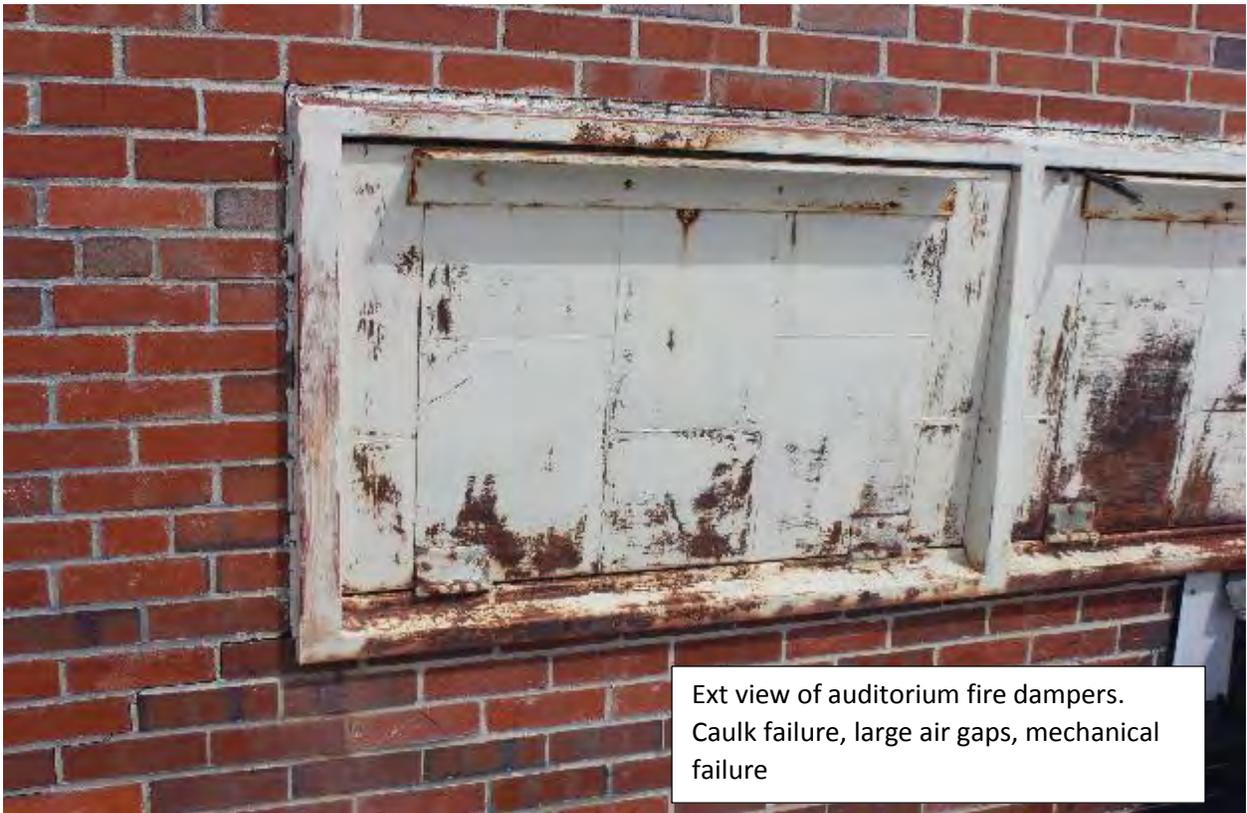
Ext view of auditorium fire dampers. Caulk failure, large air gaps, mechanical failure

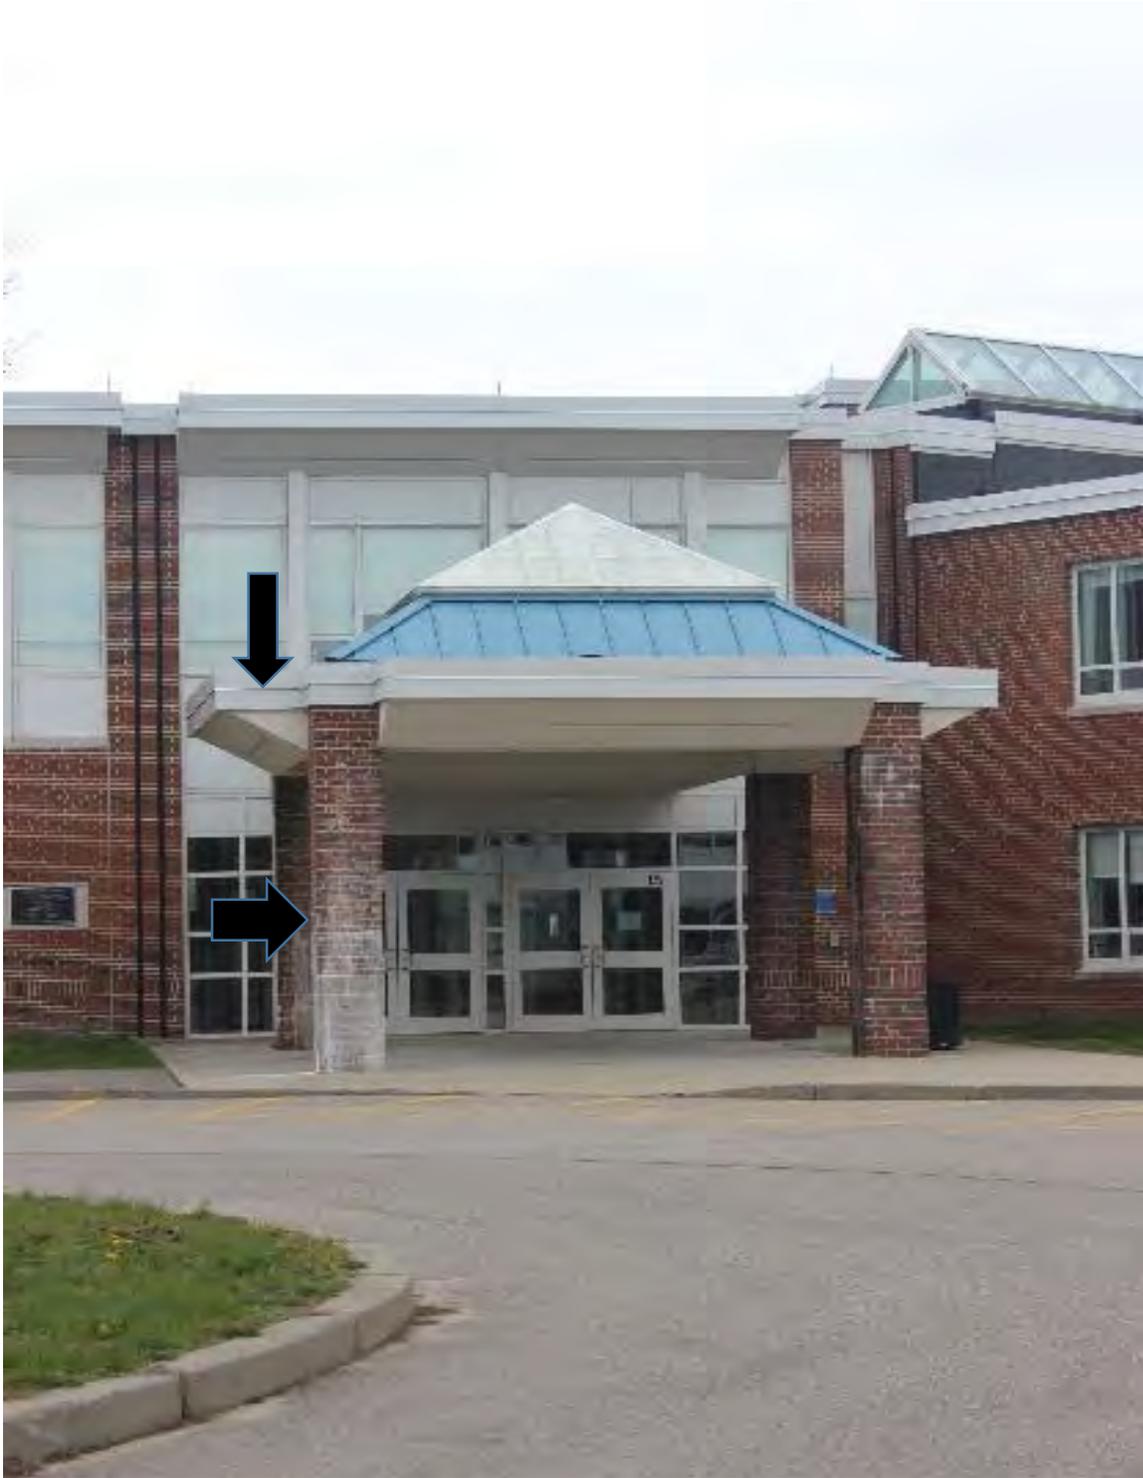
Internal roof drains may have split and come apart and allowed water to saturate the columns masonry from the interior to exterior. Excessive efflorescence, calcification, and structural cracking has occurred in the brick façade.

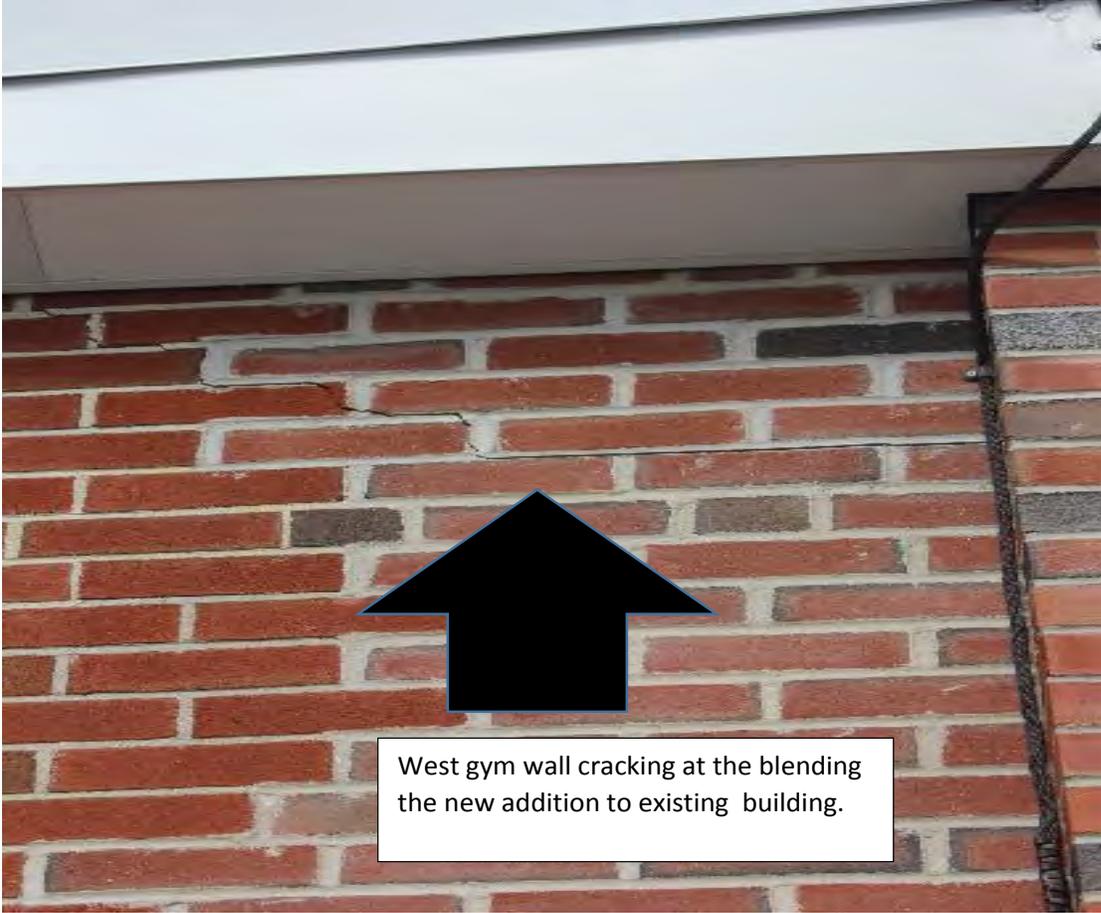
West gym wall cracking at the blending the new addition to existing building.
