MEDFIELD STATE HOSPITAL HISTORIC RESOURCES

EXISTING CONDITIONS

M E M O R A N D U M

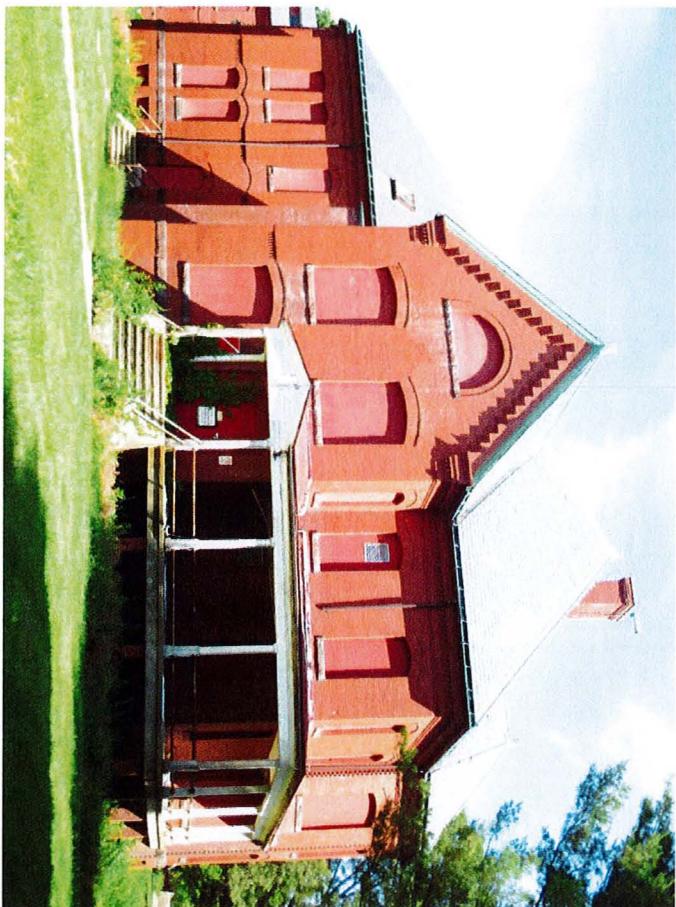
2A: Building 2, Ward B-2

Ward B-2 is in fair condition with localized areas of masonry deterioration. Further investigation may reveal more significant structural deterioration. Photographs 2A and 2B depict the existing exterior conditions of the building.

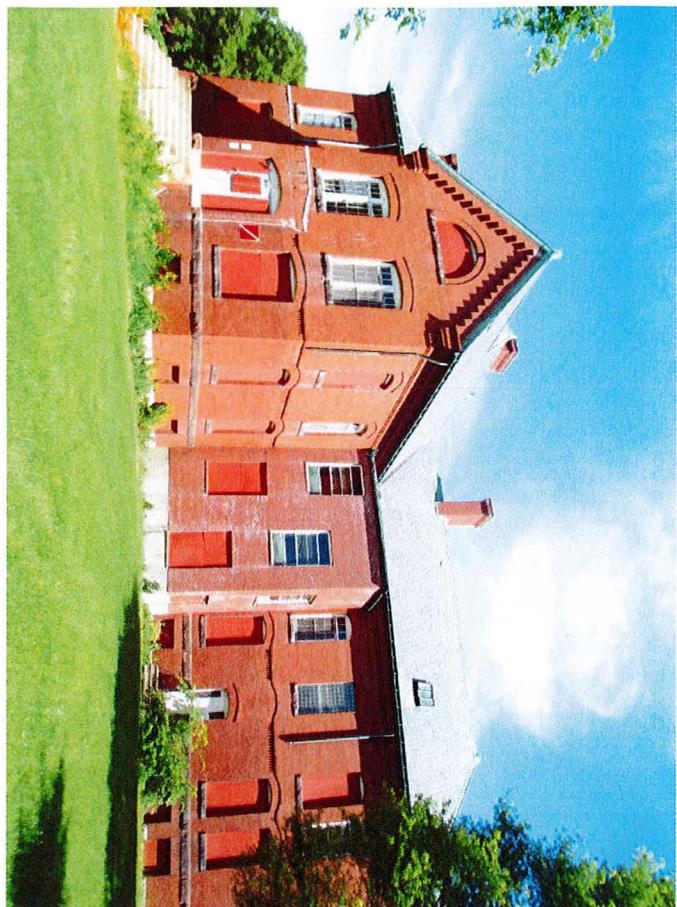
1A: Building 1, Ward B-1

Ward B-1 is in fair condition with localized areas of masonry deterioration. Further investigation may reveal more significant structural deterioration. Since the 1994 National Register listing, a wood porch on the south elevation has been removed. Removal of the porch was the subject of a 2012 MOA between DCAMM and MHC (MHC# RC.32990). Photographs 1A and 1B depict the existing exterior conditions of the building.

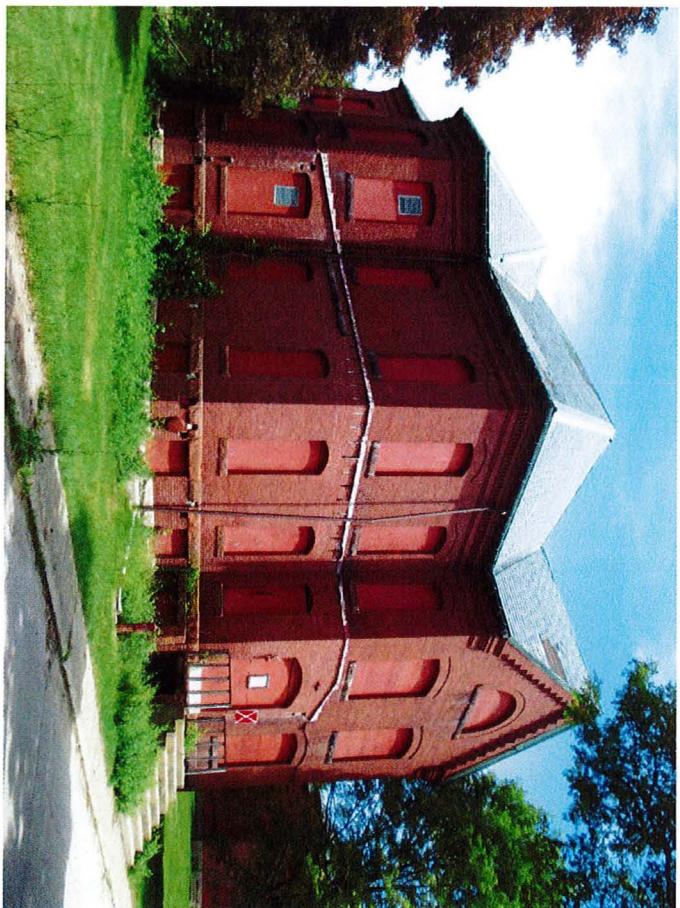
4A: Building 4, Ward B-4.

Ward B-4 is in fair condition with localized areas of masonry deterioration. Further investigation may reveal more significant structural deterioration. Since the 1994 National Register listing, a wood porch on the south elevation has been removed. Removal of the porch was the subject of a 2012 MOA between DCAMM and MHC (MHC# RC.32990). Photographs 4A and 4B depict the existing exterior conditions of the building.

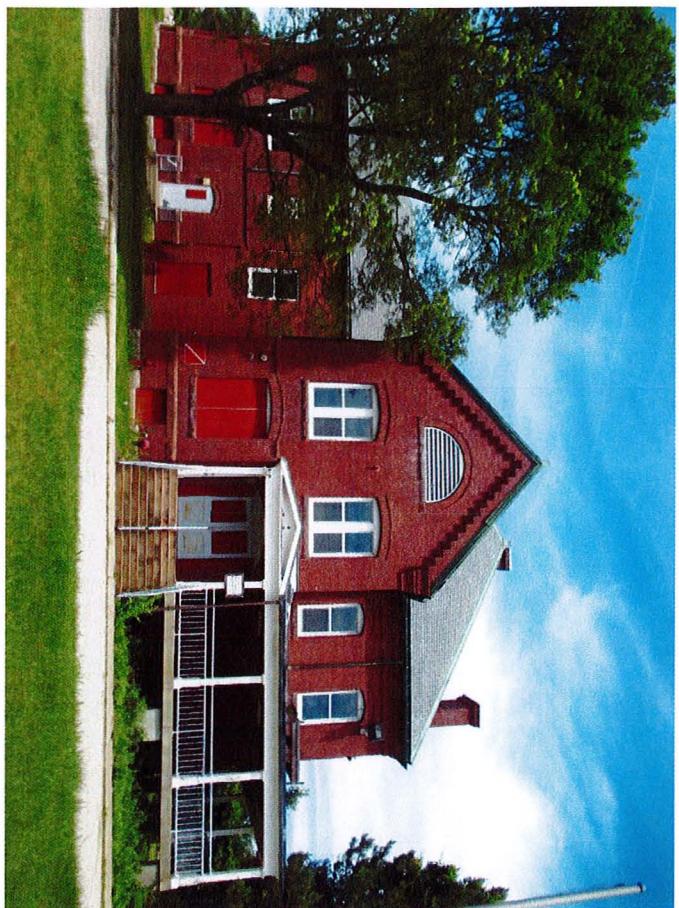
3A: Building 3, Ward B-3.

Ward B-3 is in fair condition with localized areas of masonry deterioration. Further investigation may reveal more significant structural deterioration. Photographs 3A and 3B depict the existing exterior conditions of the building.

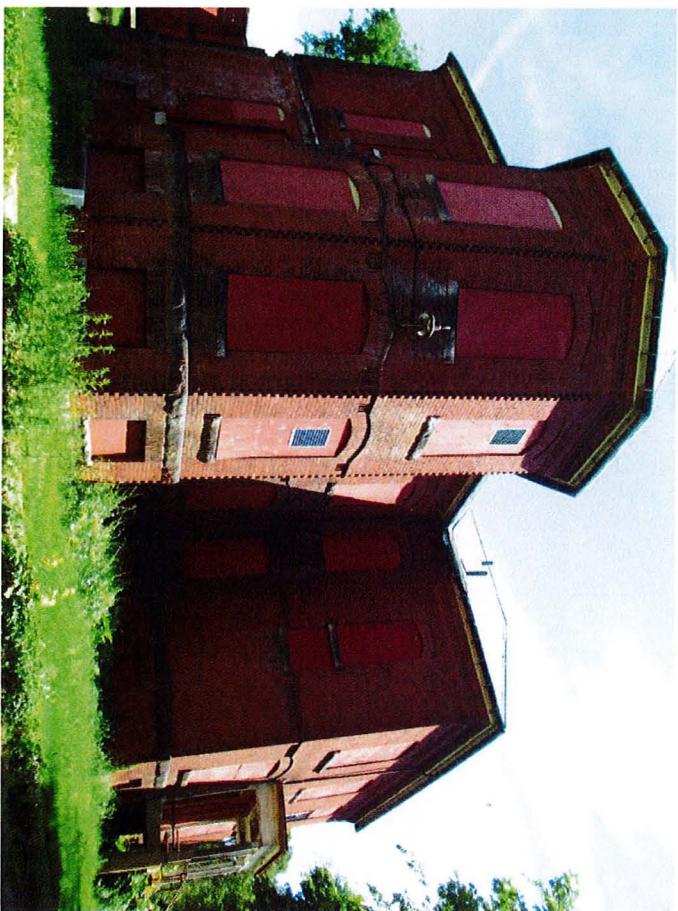
6A: Building 6, Ward C-2

Ward C-2 is in fair condition with localized areas of masonry deterioration. Further investigation may reveal more significant structural deterioration. Photographs 6A and 6B depict the existing exterior conditions of the building.

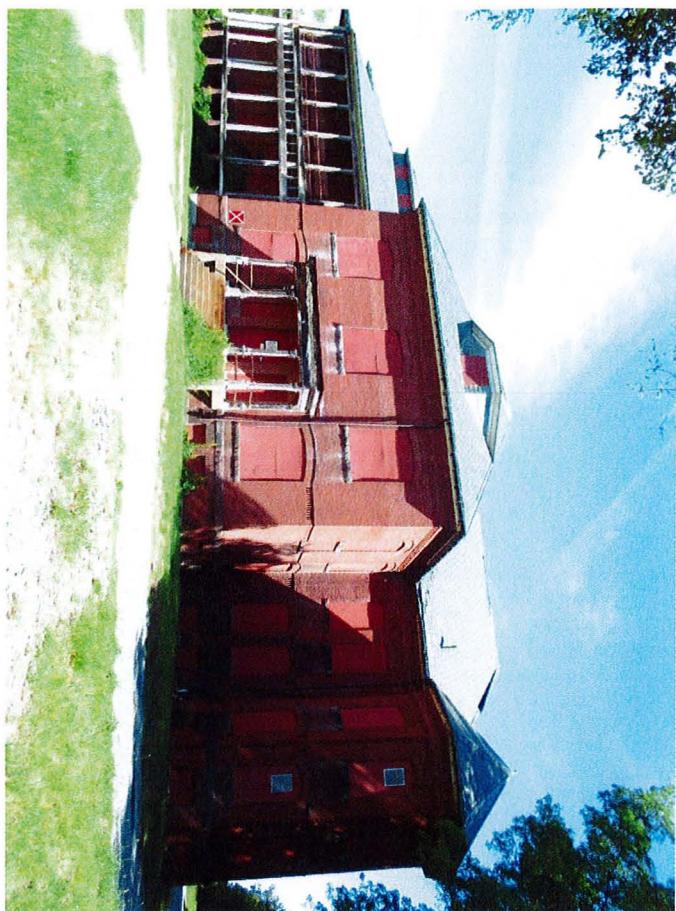
5A: Building 5, Ward C-1

Ward C-1 is in fair condition with localized areas of masonry deterioration. Further investigation may reveal more significant structural deterioration. Photographs 5A and 5B depict the existing exterior conditions of the building.

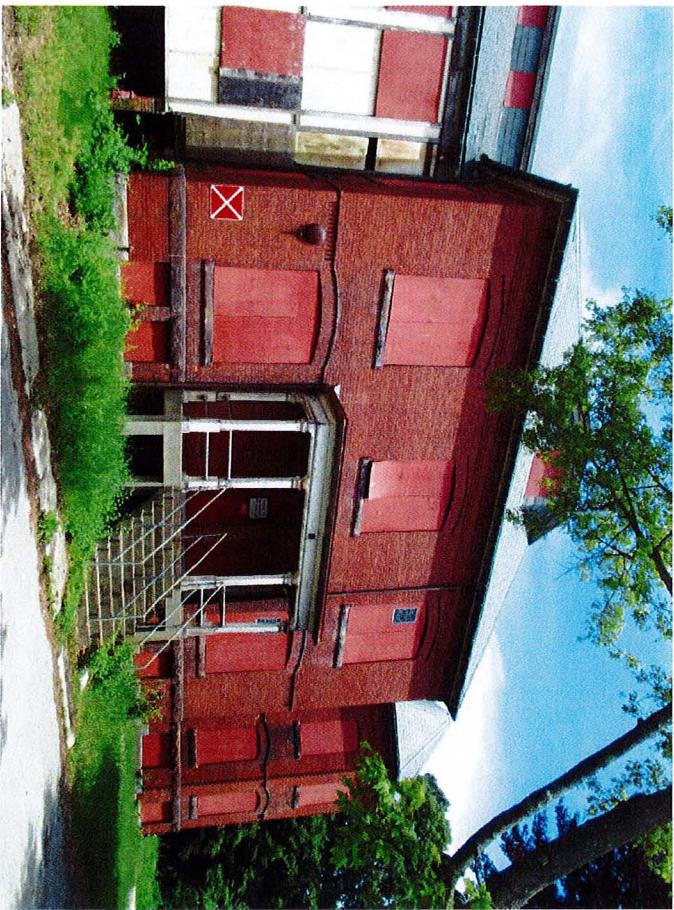
8A: Building 8, Ward C-4

Ward C-4 is in fair condition with localized areas of masonry deterioration. Further investigation may reveal more significant structural deterioration. Photographs 8A and 8B depict the existing exterior conditions of the building.

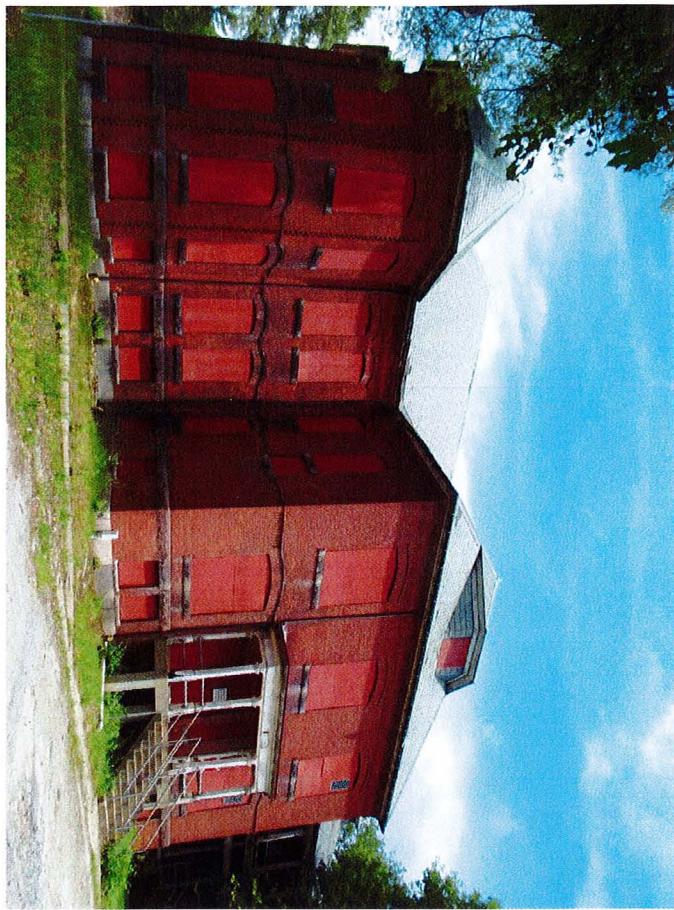
7A: Building 7, Ward C-3

Ward C-3 is in fair condition with localized areas of masonry deterioration. Further investigation may reveal more significant structural deterioration. Photographs 7A and 7B depict the existing exterior conditions of the building.

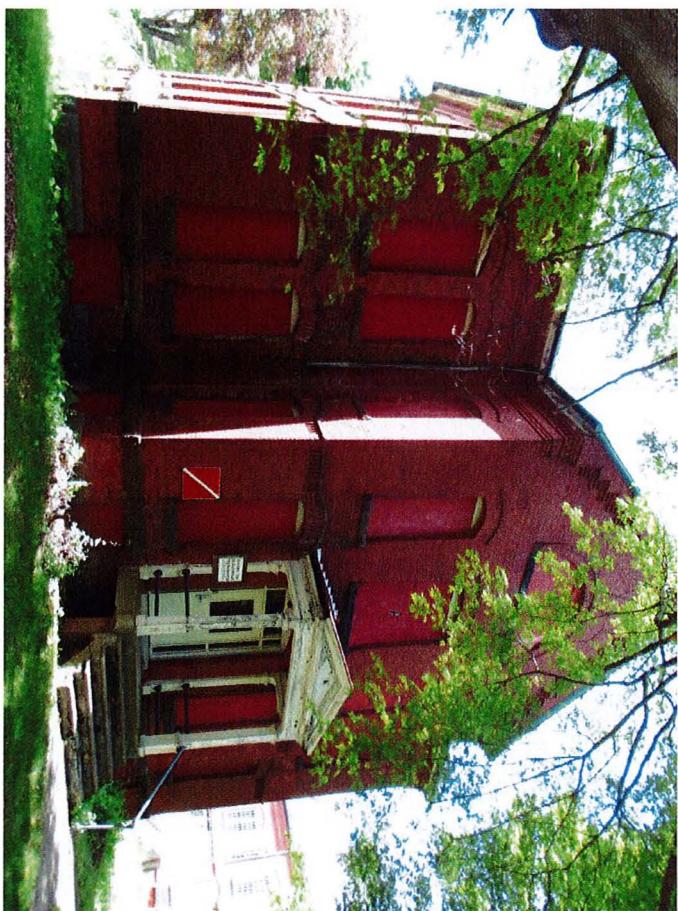
10A: Building 10, Ward D-2

Ward D-2 is in fair condition with localized areas of masonry deterioration. Further investigation may reveal more significant structural deterioration. A five-bay, single-story wood porch that extended along the full length of the rear ell has been removed. Removal of the porch was the subject of a 2012 MOA between DCAMM and MHC (MHC# RC.32990). Photographs 10A and 10B depict the existing exterior conditions of the building.

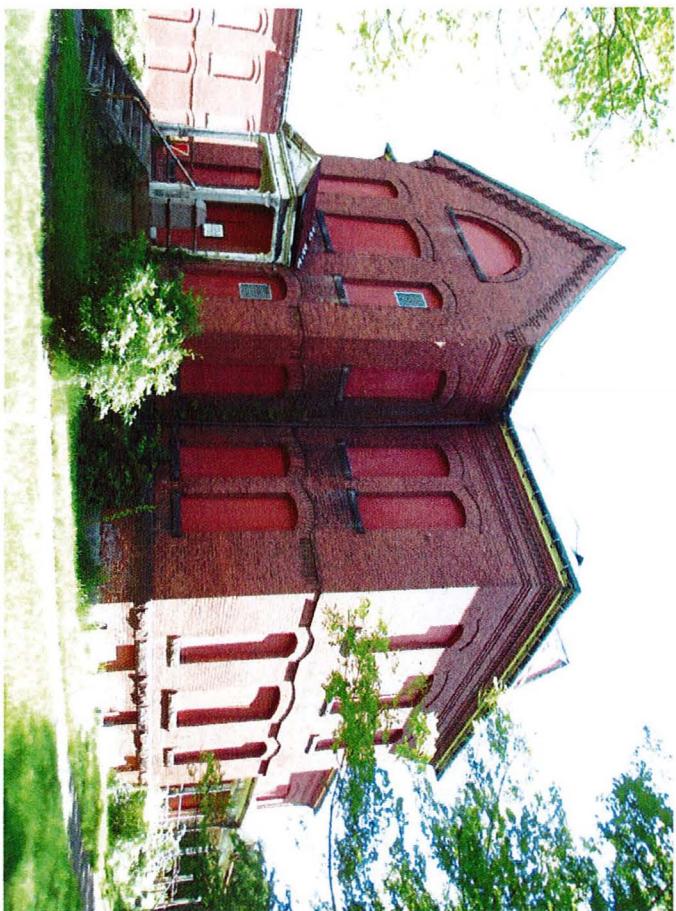
9A: Building 9, Ward D-1

Ward D-1 is in fair condition with localized areas of masonry deterioration. Further investigation may reveal more significant structural deterioration. Photographs 9A and 9B depict the existing exterior conditions of the building.

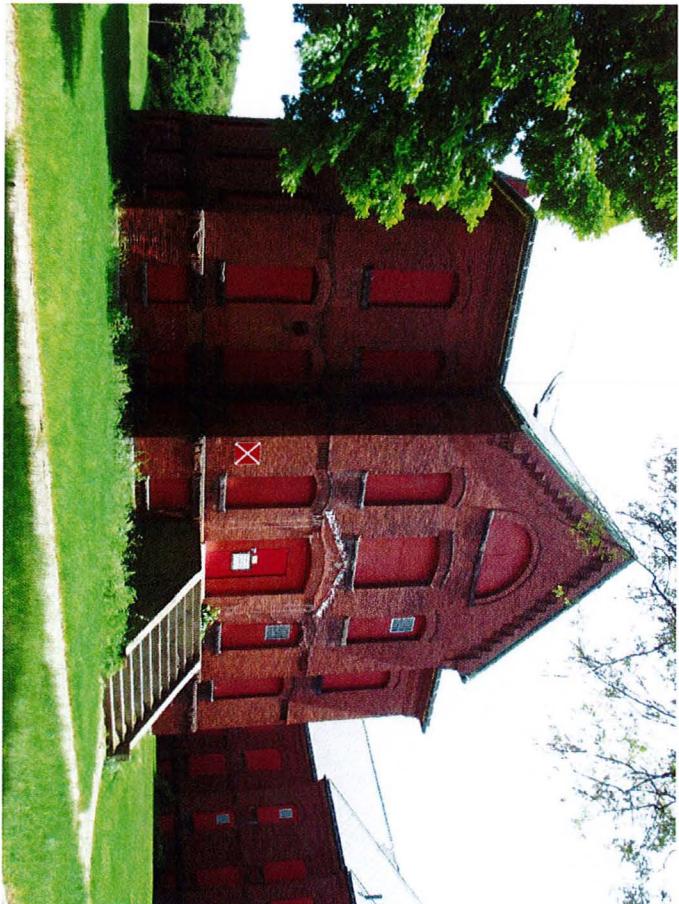
12A: Building 12, Ward D-4

Ward D-4 is in fair condition with localized areas of masonry deterioration. Further investigation may reveal more significant structural deterioration. A single-story wood entry porch at the east elevation and a five-bay, single-story wood porch that extended along the full length of the rear ell has been removed. Removal of the porches was the subject of a 2012 MOA between DCAMM and MHC (MHC# RC.32990). Photographs 12A and 12B depict the existing exterior conditions of the building.

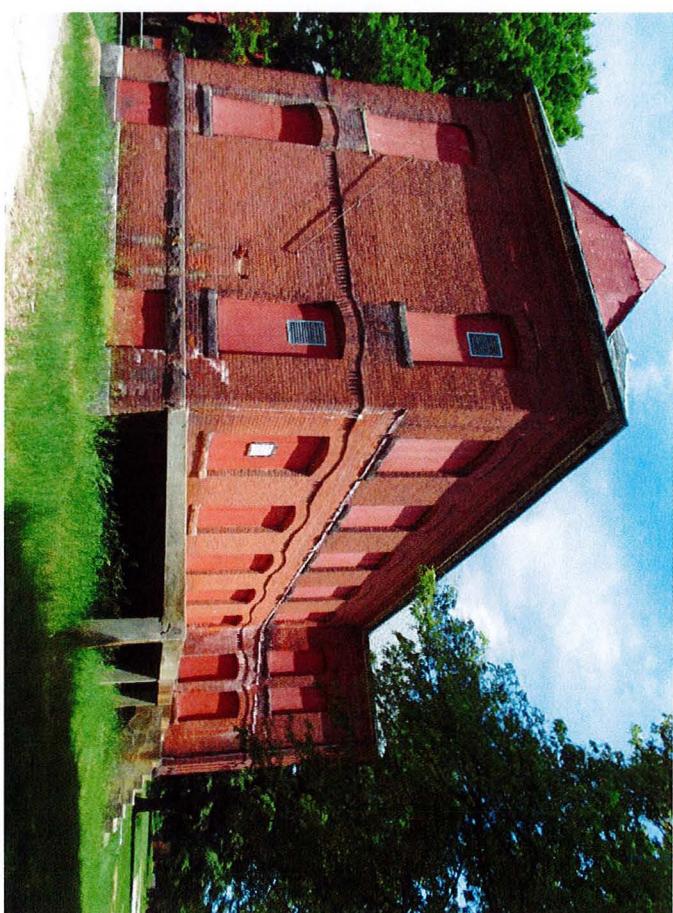
11B: Building 11, Ward D-3

Ward D-3 is in fair condition with localized areas of masonry deterioration. Further investigation may reveal more significant structural deterioration. A five-bay, single-story wood porch that extended along the full length of the rear ell has been removed. Removal of the porch was the subject of a 2012 MOA between DCAMM and MHC (MHC# RC.32990). Photographs 11A and 11B depict the existing exterior conditions of the building.

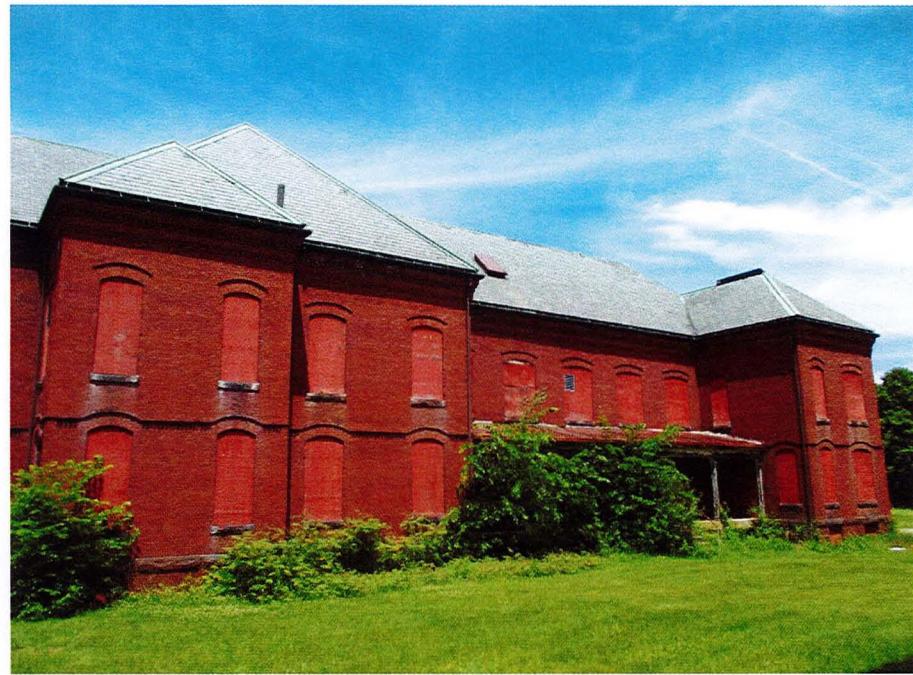
13A: Building 13, Ward E-1

Ward E-1 is in fair condition with localized areas of masonry deterioration. Further investigation may reveal more significant structural deterioration. Photographs 13A and 13B depict the existing exterior conditions of the building.

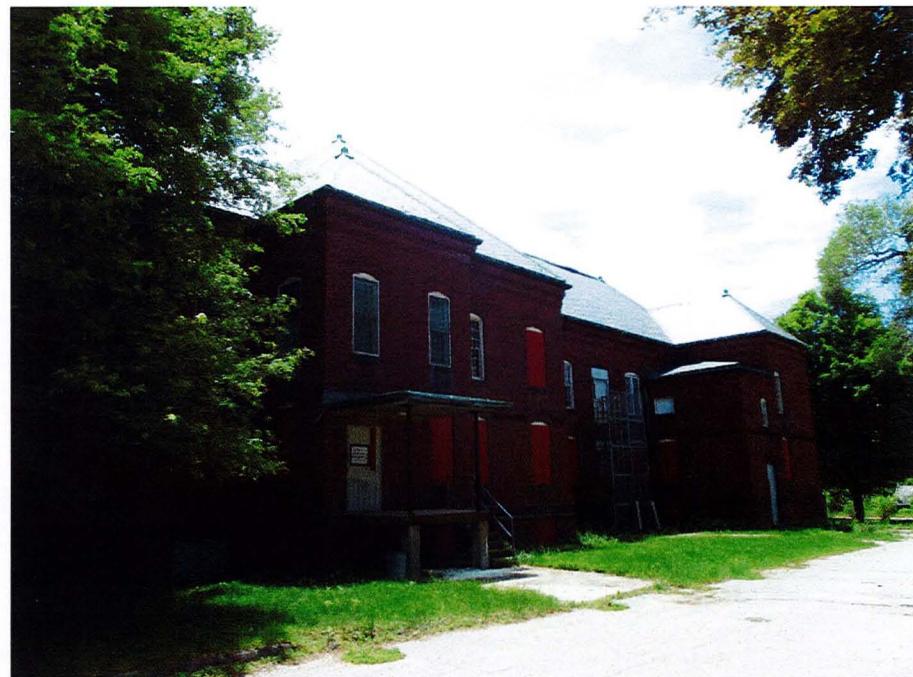
14A: Building 14, Ward E-2

Ward E-2 is in fair condition with localized areas of masonry deterioration. Further investigation may reveal more significant structural deterioration. A single-story wood entry porch at the east elevation has been removed. Removal of the porch was the subject of a 2012 MOA between DCAMM and MHC (MHC# RC.32990). Photographs 14A and 14B depict the existing exterior conditions of the building.

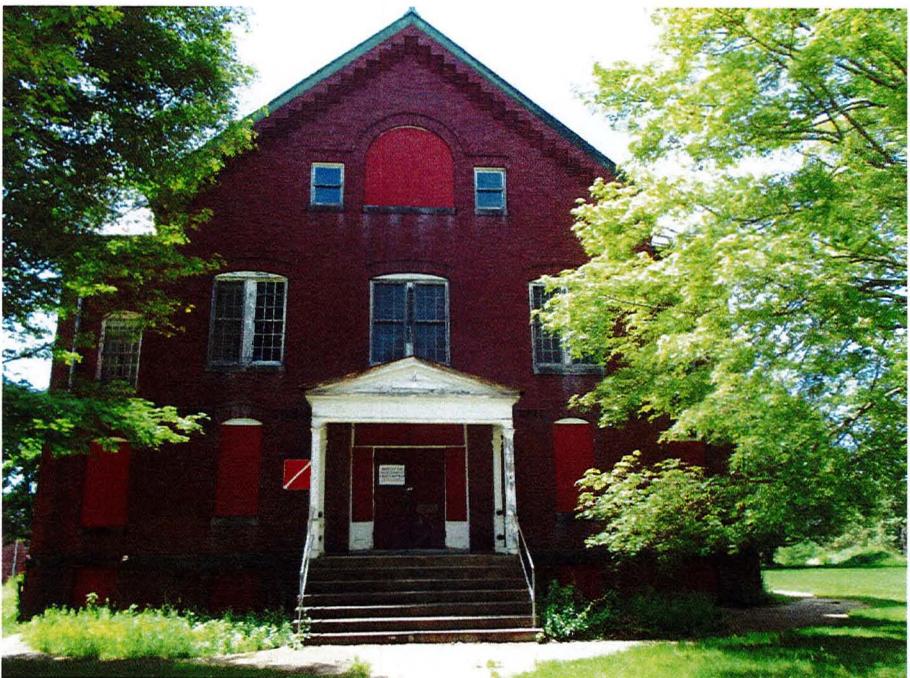
17B: Building 17, Ward L-1

Ward L-1 is in fair condition with localized areas of masonry deterioration. Further investigation may reveal more significant structural deterioration. A single-story wood entry porch at the west elevation has been removed. Removal of the porch was the subject of a 2012 MOA between DCAMM and MHC (MHC# RC.32990). Photographs 17A and 17B depict the existing exterior conditions of the building.

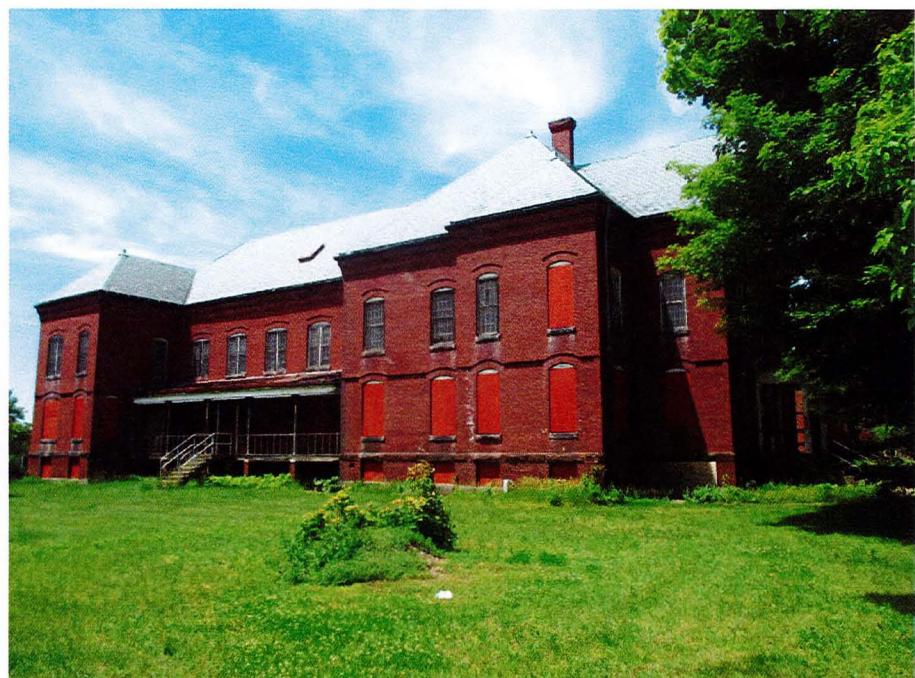
18A: Building 18, Ward L-2

Ward L-2 is in fair condition with localized areas of masonry deterioration. Further investigation may reveal more significant structural deterioration. A single-story wood entry porch at the east elevation has been removed. Removal of the porch was the

subject of a 2012 MOA between DCAMM and MHC (MHC# RC.32990). Photographs 18A and 18B depict the existing exterior conditions of the building.

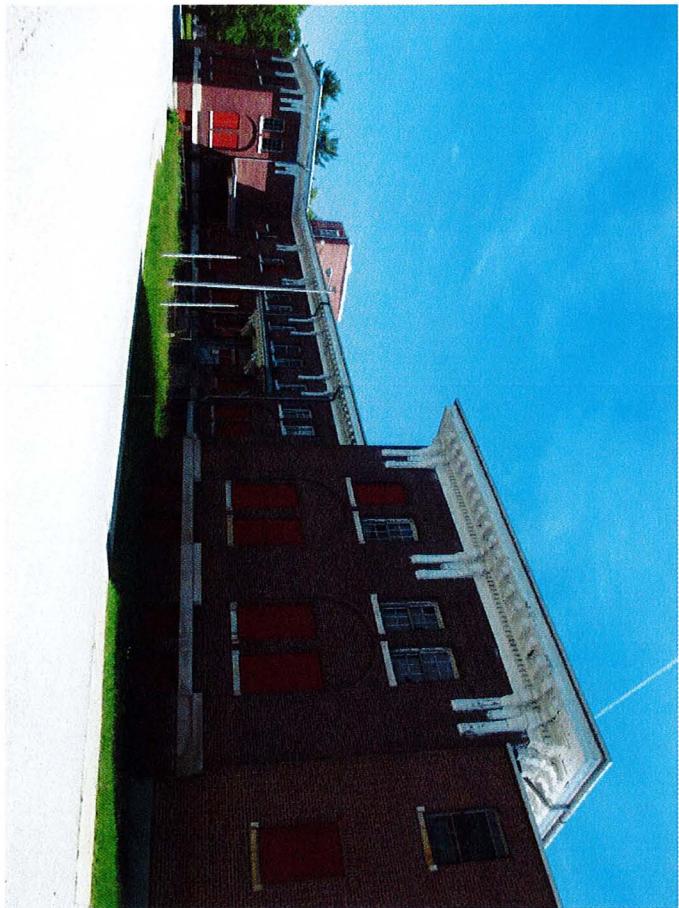
20A: Building 20, Ward S

Ward S is in fair condition with localized areas of masonry deterioration. Further investigation may reveal more significant structural deterioration. Photographs 20A and 20B depict the existing exterior conditions of the building.

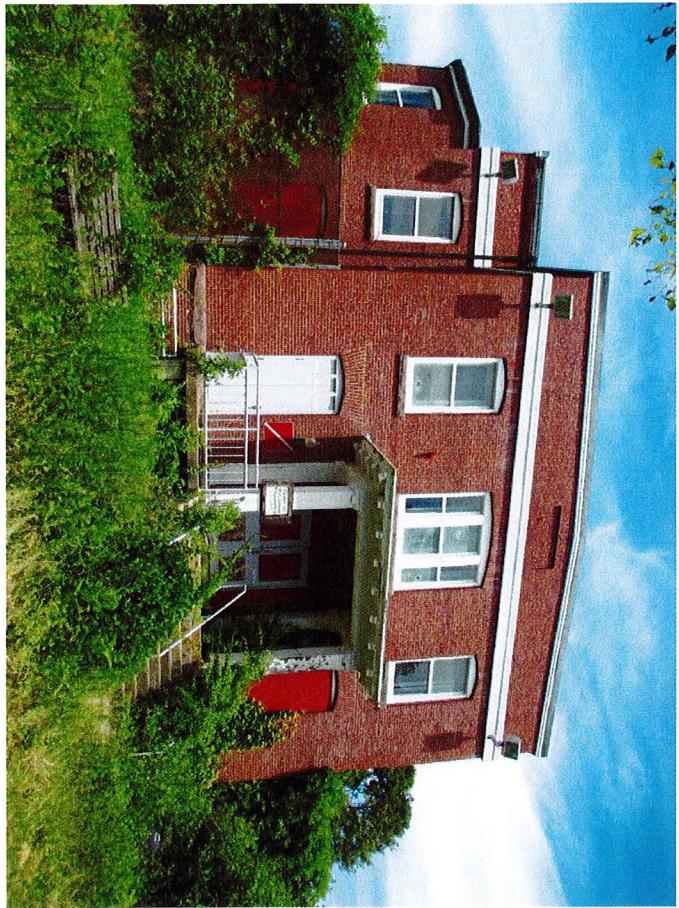
19A: Building 19, Ward R

Ward R is in fair condition with localized areas of masonry deterioration. Further investigation may reveal more significant structural deterioration. Photographs 19A and 19B depict the existing exterior conditions of the building.

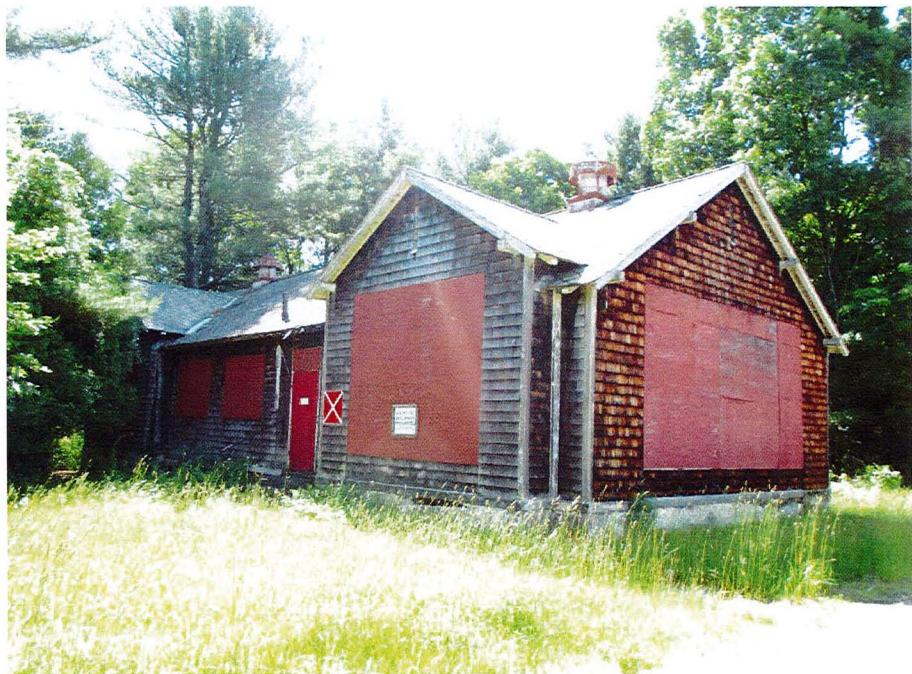
21A: Building 21, TB Cottage

The TB Cottage is in fair condition with localized areas of deterioration. Further investigation may reveal more significant structural deterioration. Photographs 21A and 21B depict the existing exterior conditions of the building.

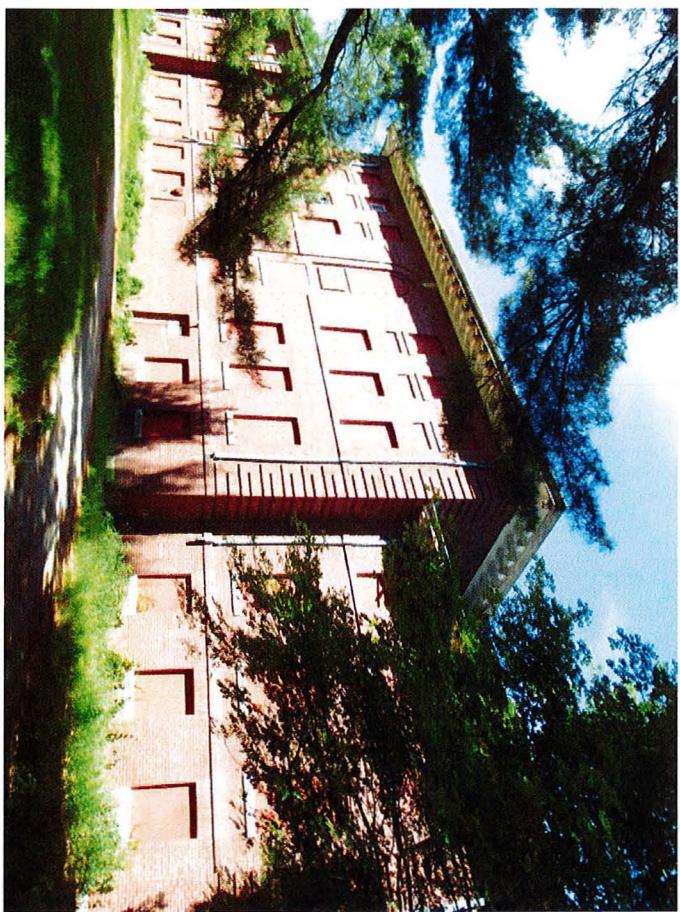
24B: Nurses Home

Building 24 is in fair condition with localized areas of masonry deterioration. Further investigation may reveal more significant structural deterioration. Photographs 24A and 24B depict the existing exterior conditions of the building.

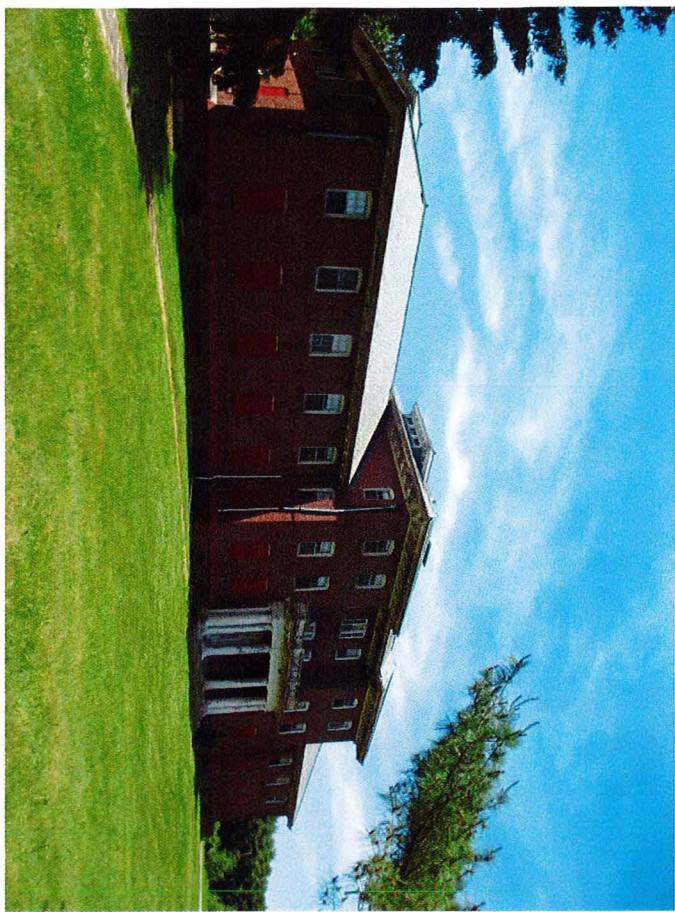
23B: Building 23, Male Employees Home

Building 23 is in fair condition with localized areas of deterioration. Further investigation may reveal more significant structural deterioration. Photographs 23A and 23B depict the existing exterior conditions of the building.

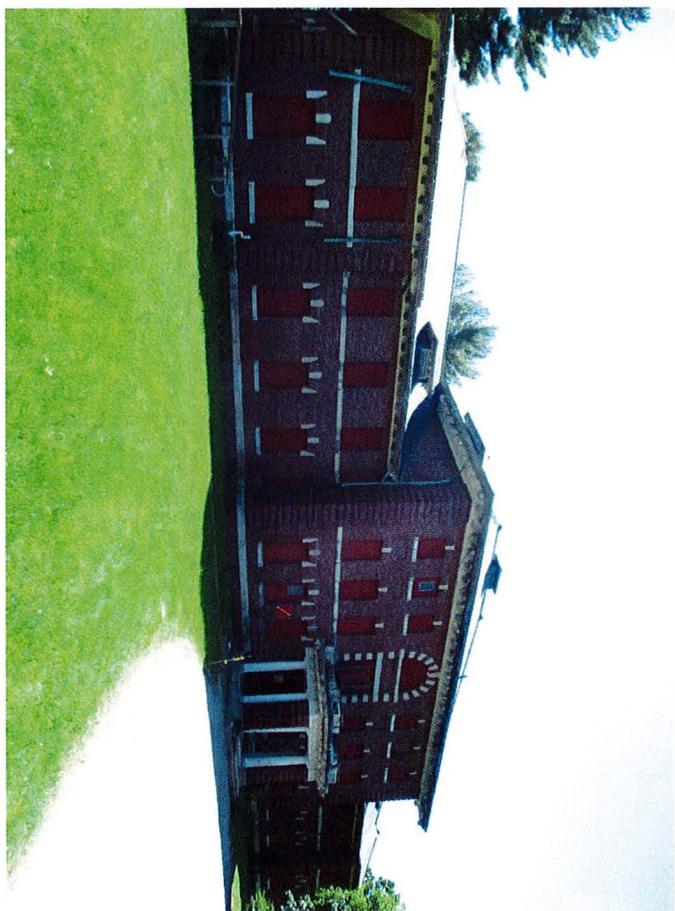
25A: Employee Cottage 1

Building 25 is in fair condition with localized areas of deterioration. Further investigation may reveal more significant structural deterioration. Photograph 25A depicts the existing exterior conditions of the building.

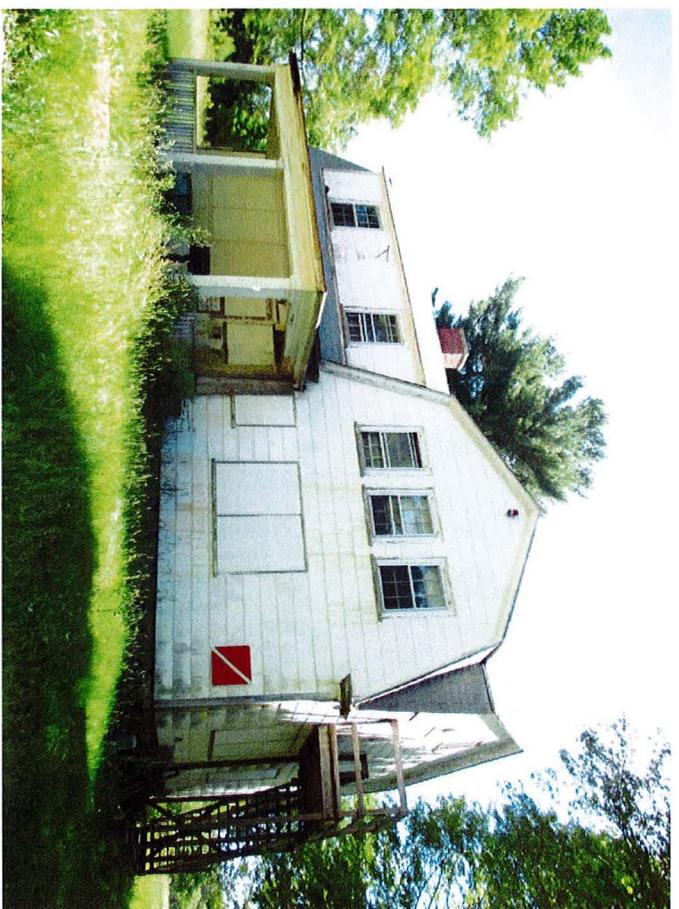
27A: Employee Cottage 3

Building 27 is in fair condition with localized areas of deterioration. Further investigation may reveal more significant structural deterioration. Photograph 27A depicts the existing exterior conditions of the building.

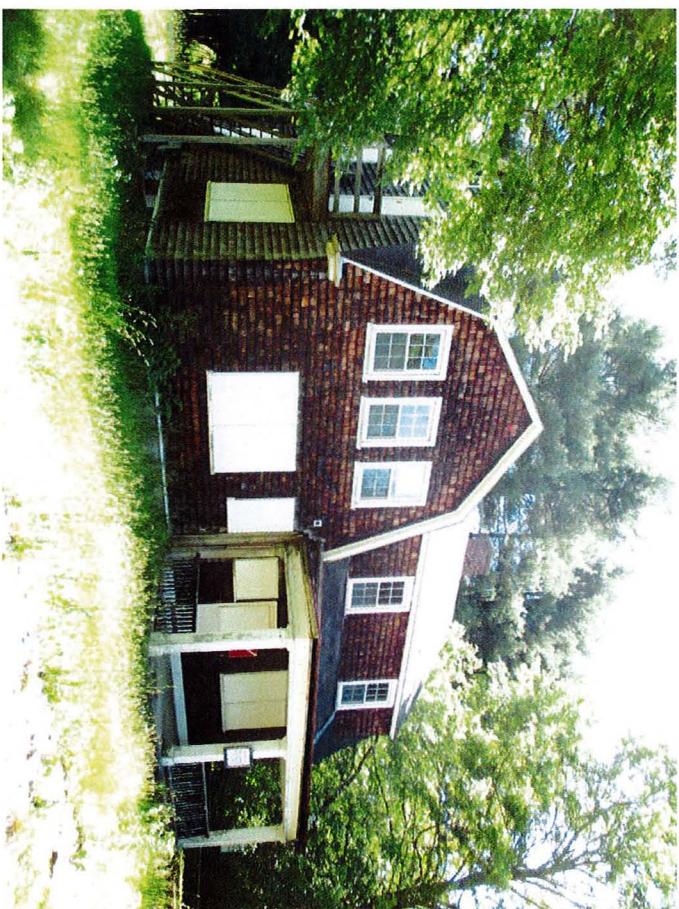
29A: Employee Cottage 5

Building 29 is in fair condition with localized areas of deterioration. Further investigation may reveal more significant structural deterioration. Photograph 29A depicts the existing exterior conditions of the building.

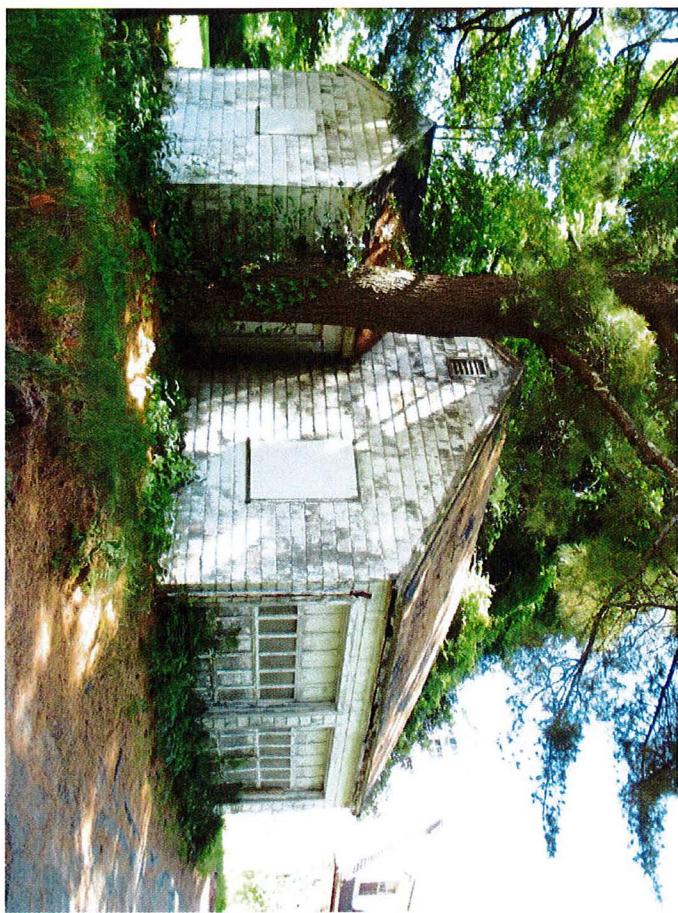
47A: Superintendent's Garage

Building 47 is in fair condition with localized areas of deterioration. Further investigation may reveal more significant structural deterioration. Photograph 47A depicts the existing exterior conditions of the building.

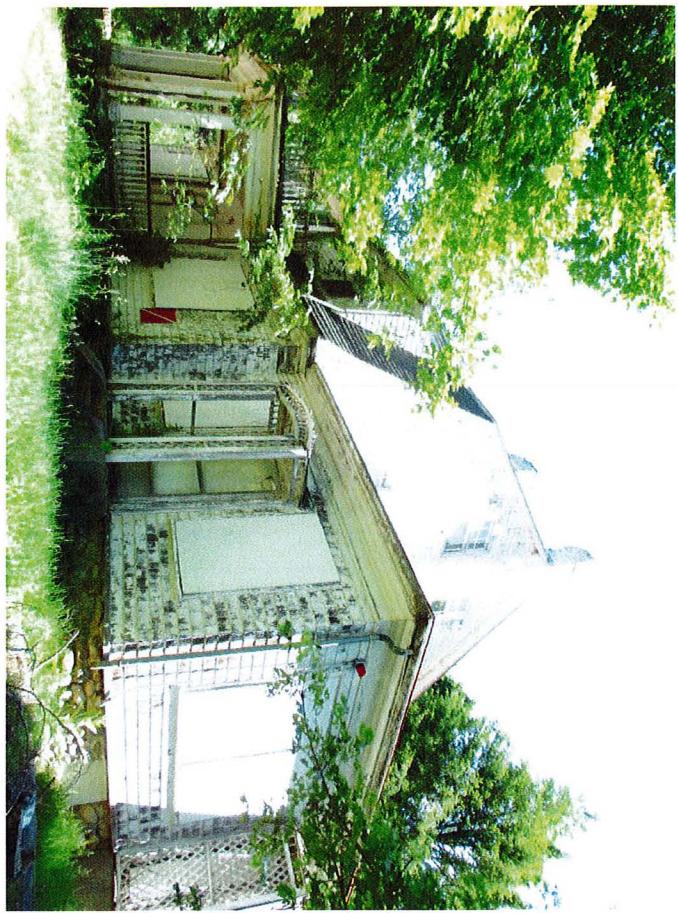
46A: Superintendent's House

Building 46 is in fair condition with localized areas of deterioration. Further investigation may reveal more significant structural deterioration. Photographs 46A and 46B depict the existing exterior conditions of the building.

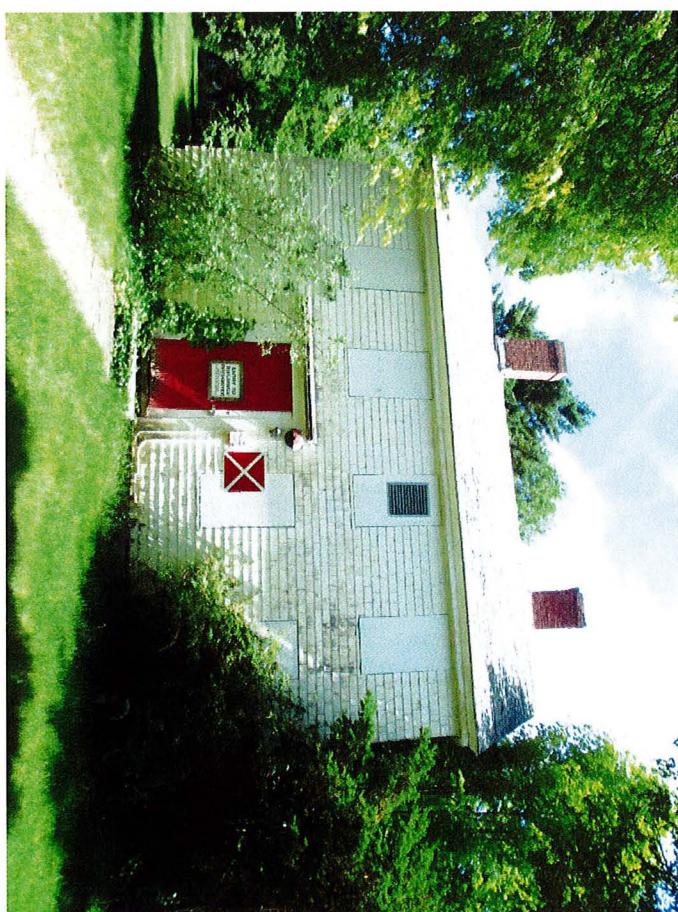
48A: Assistant Superintendent's House

Building 48 is in fair condition with localized areas of deterioration. Further investigation may reveal more significant structural deterioration. Photographs 48A and 48B depict the existing exterior conditions of the building.

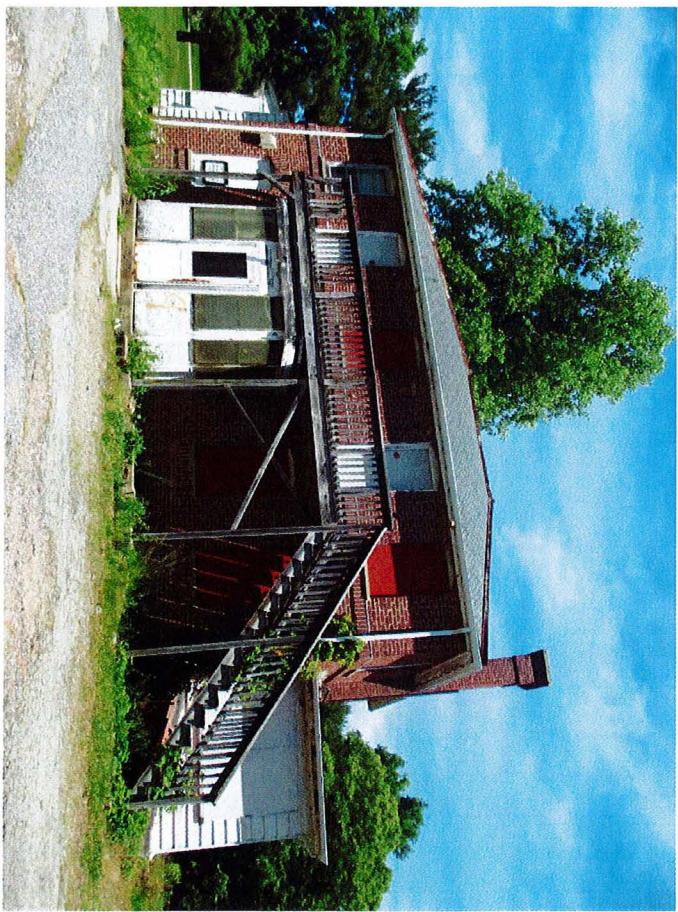
49B: Hillside Cottage S-8

Building 49 is in fair condition with localized areas of masonry deterioration. Further investigation may reveal more significant structural deterioration. Photographs 49A and 49B depict the existing exterior conditions of the building.

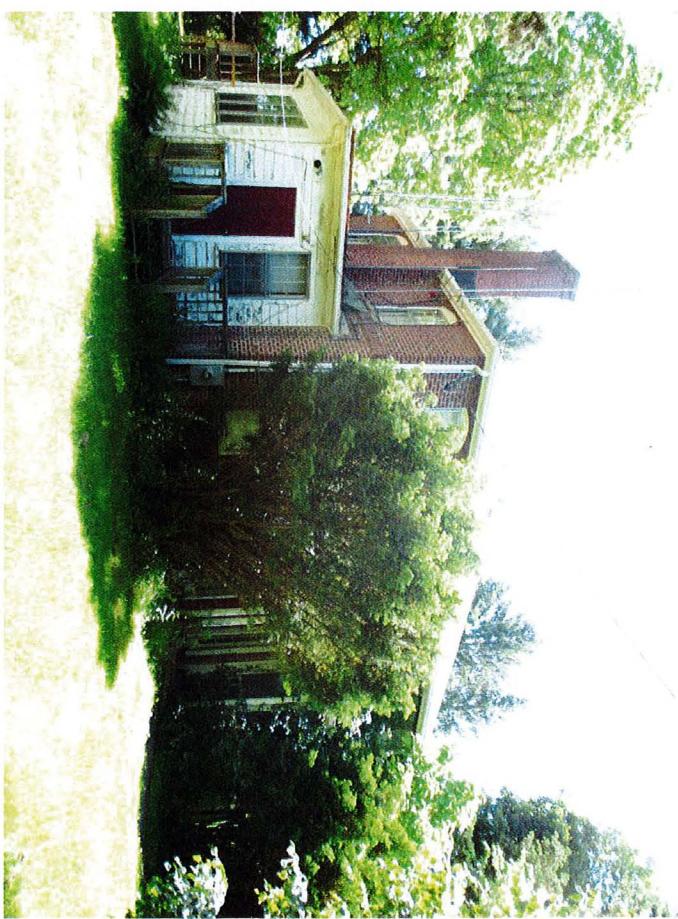
50A: Building 50, Cottage S-5

Building 50 is in fair condition with localized areas of masonry deterioration. Further investigation may reveal more significant structural deterioration. Photographs 50A and 50B depict the existing exterior conditions of the building.

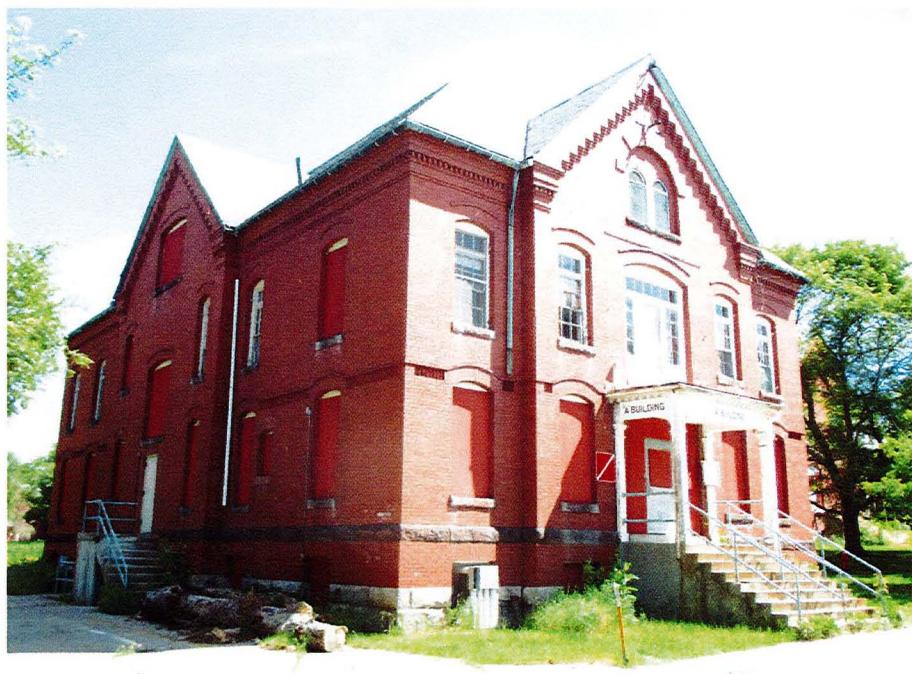
52A: Administration Building

Building 52 is in fair condition with localized areas of masonry deterioration. Further investigation may reveal more significant structural deterioration. Photographs 52A and 52B depict the existing exterior conditions of the building.

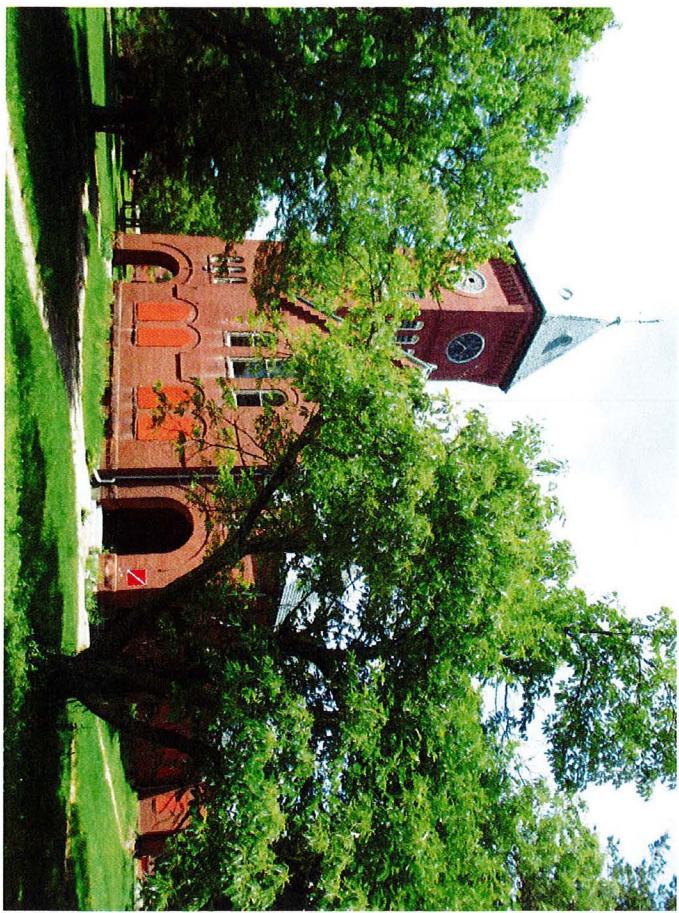
54A: Chapel

Building 54 is in fair condition with localized areas of masonry deterioration. Further investigation may reveal more significant structural deterioration. Photographs 54A and 54B depict the existing exterior conditions of the building.

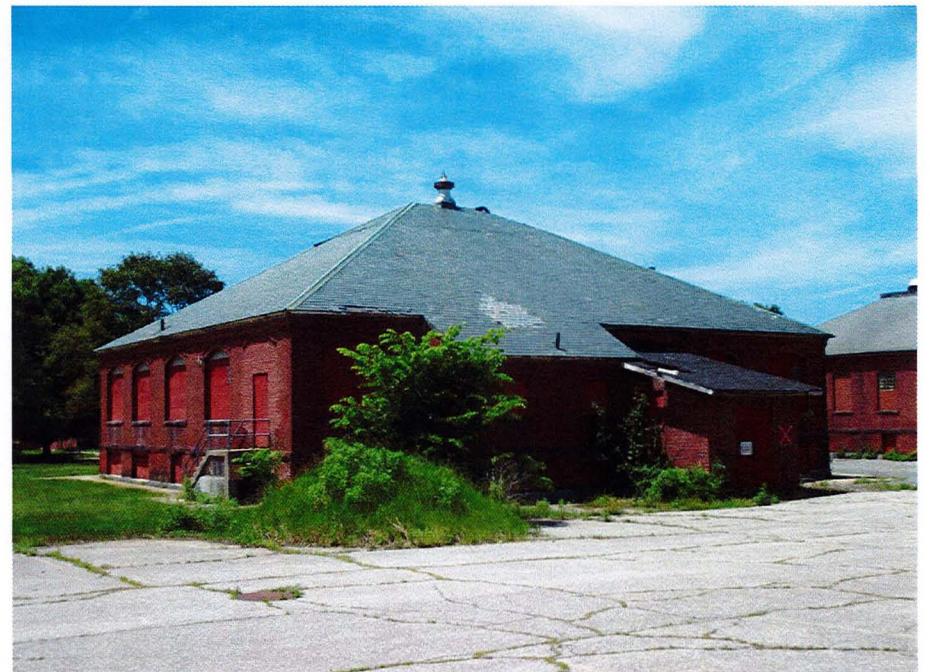
55A: Club/Recreation Building

Building 55 is in fair condition with localized areas of masonry deterioration. Further investigation may reveal more significant structural deterioration. Photographs 55A and 55B depict the existing exterior conditions of the building.
