MEDFIELD STATE HOSPITAL HISTORIC RESOURCES

EXISTING CONDITIONS

M E M O R A N D U M

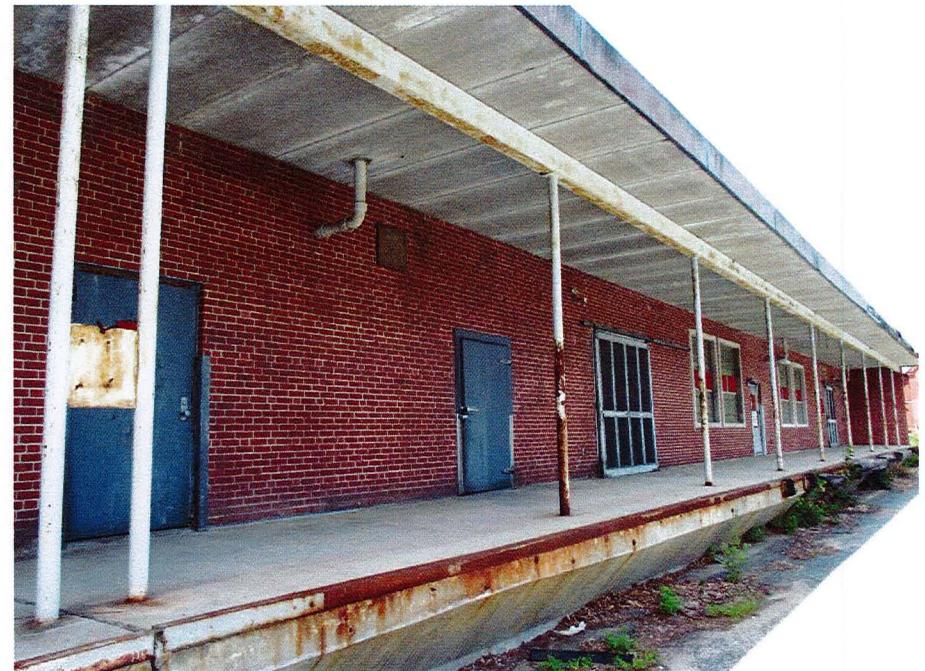
57B: Dining/Kitchen Building

Building 57 is in fair condition with localized areas of masonry deterioration. Further investigation may reveal more significant structural deterioration. Photographs 57A and 57B depict the existing exterior conditions of the building.

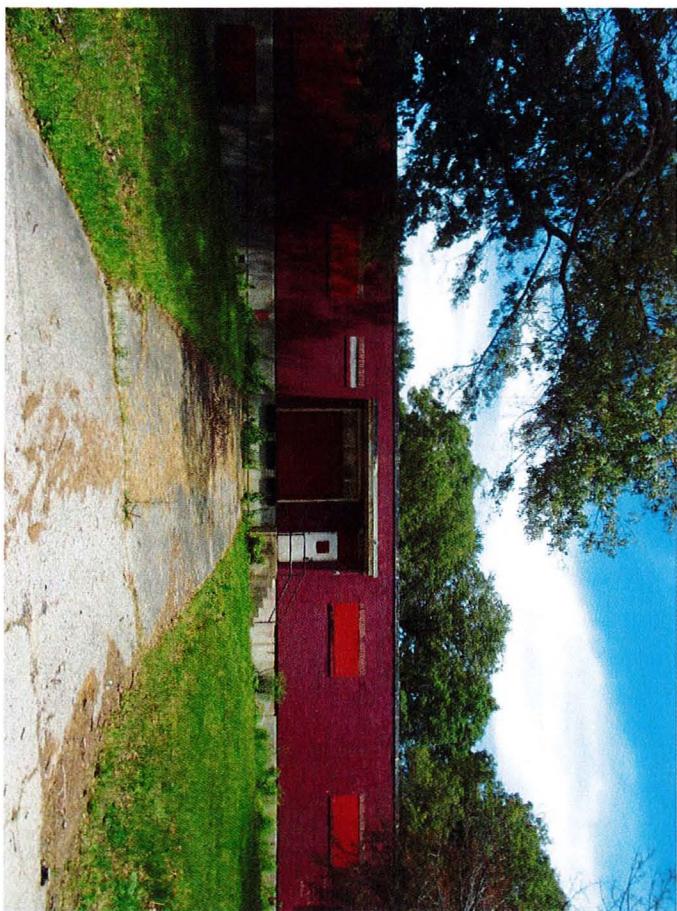
74A: Machine Shop Building

Building 74 is in fair condition with localized areas of masonry deterioration. Further investigation may reveal more significant structural deterioration. Photograph 74A depicts the existing exterior conditions of the building.

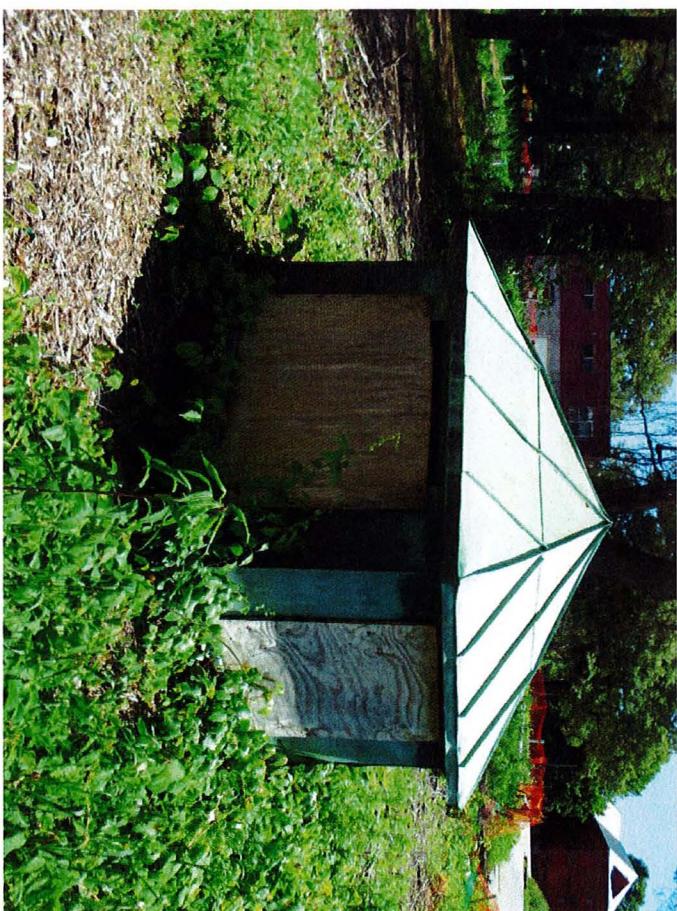
75A: Ventilator

- **Building 75, Ventilator:** The ca. 1920 copper ventilator is located west of the former Laundry Building (Building 56). The openings on all four sides are covered with plywood and the structure is topped by a hip copper roof. The ventilator is in fair condition with localized areas of deterioration. Further investigation may reveal more significant structural deterioration. Photograph 75A depicts the existing conditions of the building.

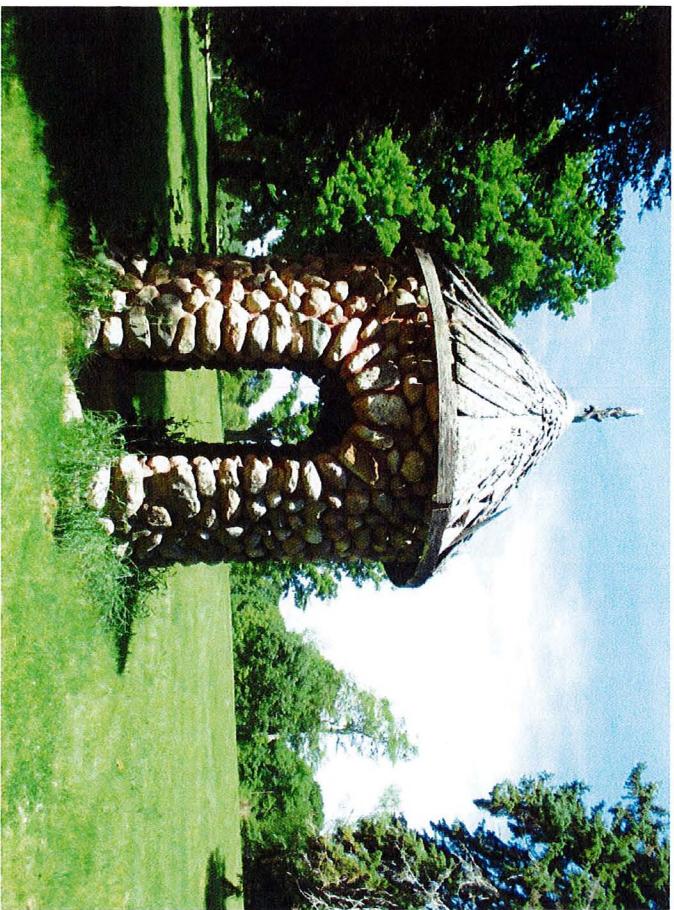
76A: Round Pavilion

- **Building 76, Round Pavilion:** The ca. 1920 circular stone pavilion structure is located west of Employee Cottage 5 (Building 29) near the main entrance to the campus. It features two arched entryways and is topped by conical wooden roof. Building 76 is in fair condition with localized areas of deterioration. Further investigation may reveal more significant structural deterioration. Photograph 76A depicts the existing conditions of the building.
