Re: **Follow-Up Inspection – August 2019**
Danielson Mill Dam (MA03351)
Medfield, Massachusetts
(PARE Project No.: 19126.00)

Commonwealth of Massachusetts
Department of Conservation and Recreation
Office of Dam Safety Poor Condition Dam Follow-up Inspection Form

Dam Name: Danielson Mill Dam

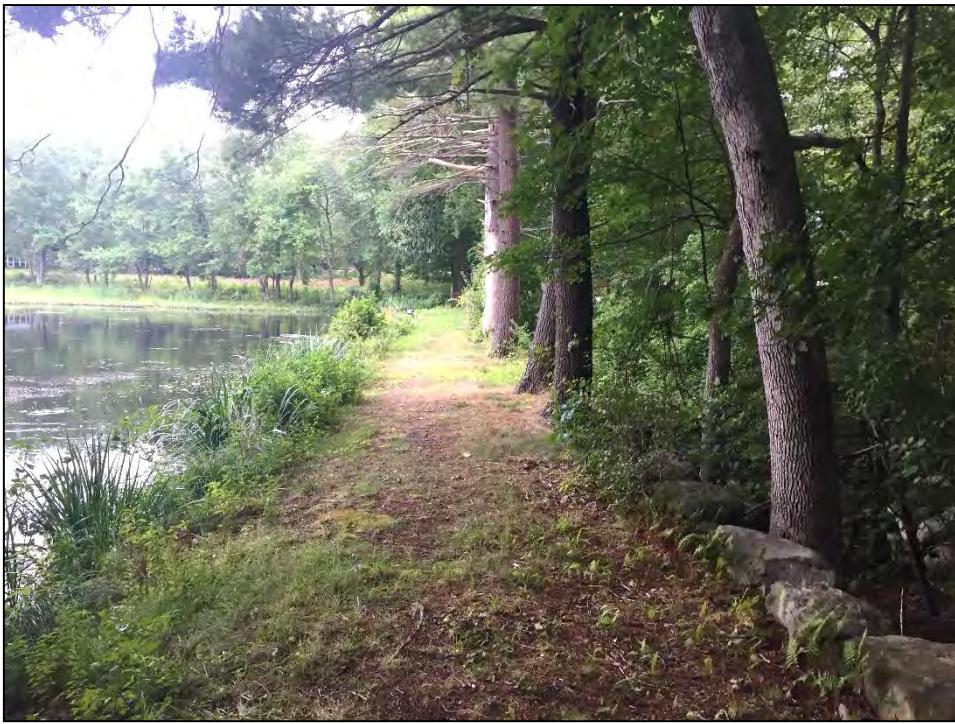
Photo No. 7: Crest near the right abutment looking left. Note large diameter trees along the top of the downstream side of the dam.

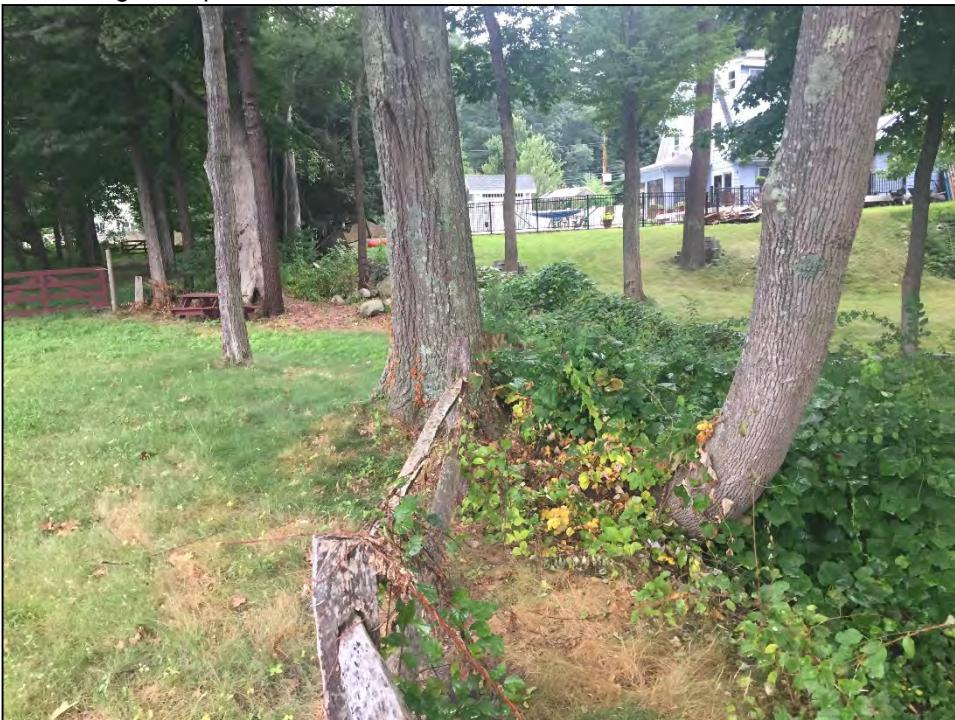
Photo No. 8: Downstream side of the dam from the spillway looking left. Note large diameter trees and underbrush limiting the inspection in this area.

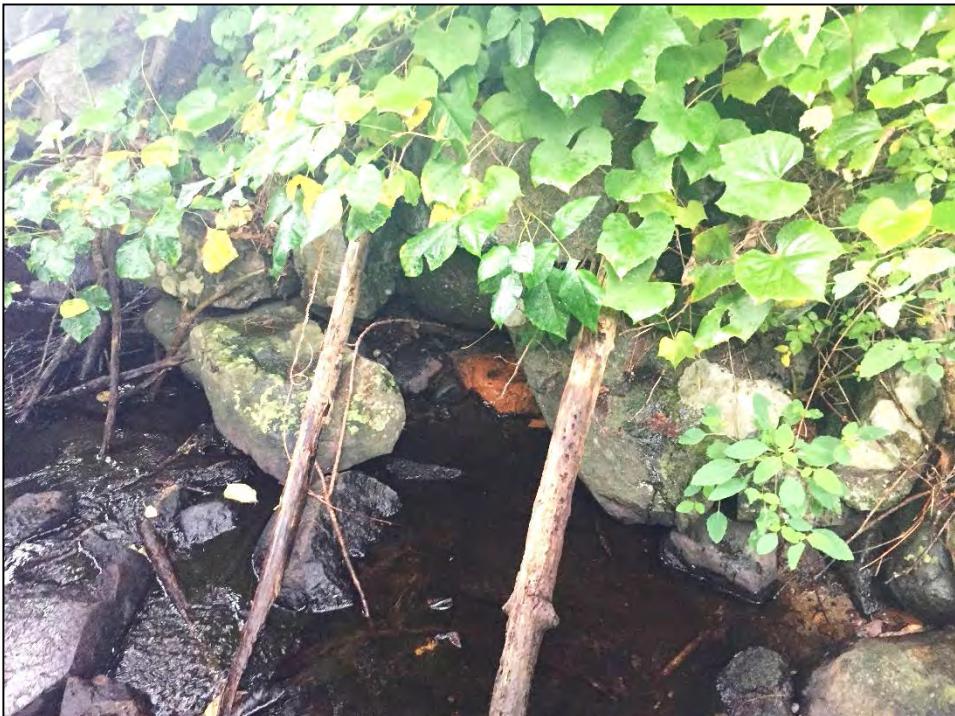
- iii. Areas of failed/displaced sections of the irregular boulder/stone wall right of the spillway were noted.
 - iv. Iron oxide staining was noted on one boulder located along the left side of the downstream channel, approximately 10 feet downstream of the spillway channel.

Photo No. 9: Iron oxide staining at toe of the downstream wall immediately left of the spillway downstream channel.

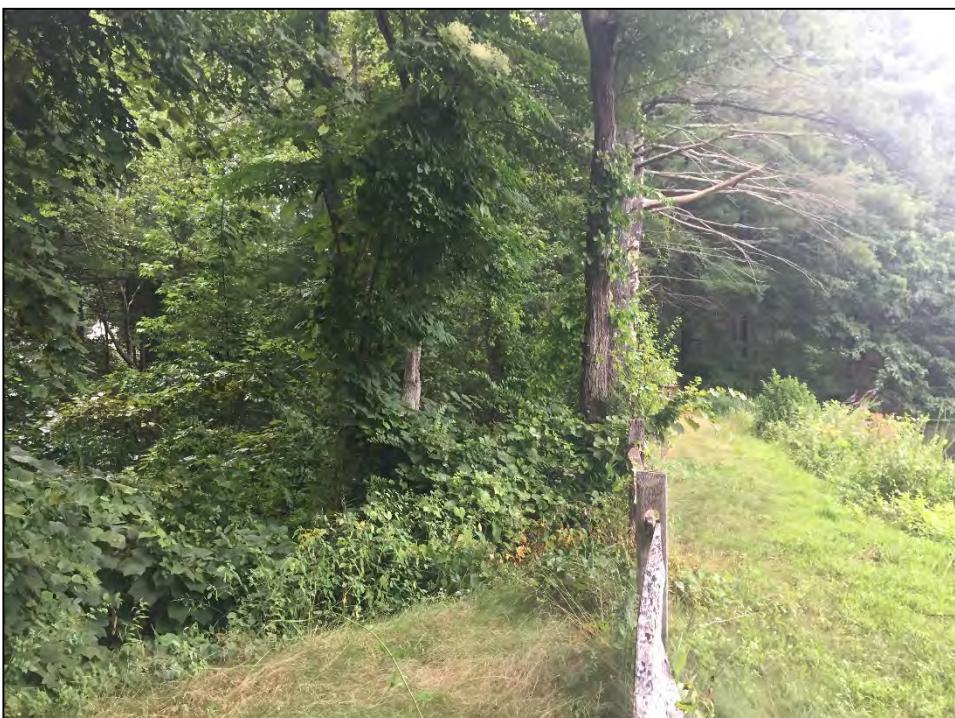
- c. The following was noted along the downstream side and downstream area:
 - i. Access/visibility of the area was limited due to dense tree and brush vegetation.

Photo No. 10: Downstream side of the dam from the spillway looking right. Note large diameter trees and thick underbrush that limited the inspection of this area.

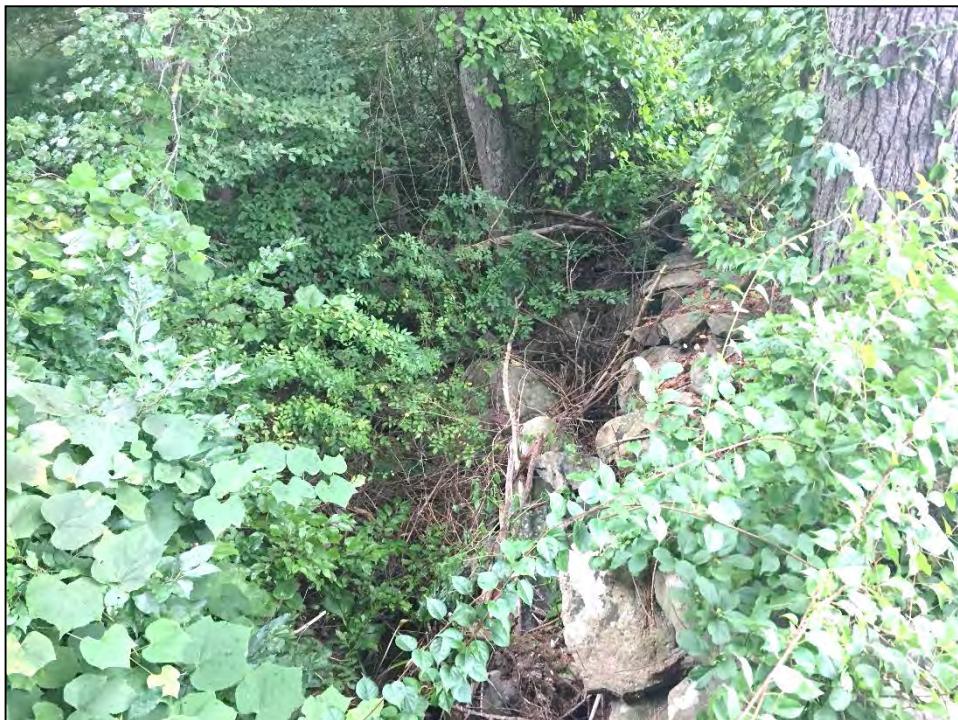
2. Irregular downstream boulder/stone wall with apparent failed/displaced sections
3. Unwanted vegetation in areas of the dam including:
 - a) Tree and brush growth along the downstream side and downstream area including large tree growth along the top of the downstream wall.

Photo No. 11: Failed/failing sections of the irregular stone masonry wall along the downstream side of the dam right of the spillway. Typical several locations. Note soft and saturated ground surface with wetland vegetation within the downstream area.

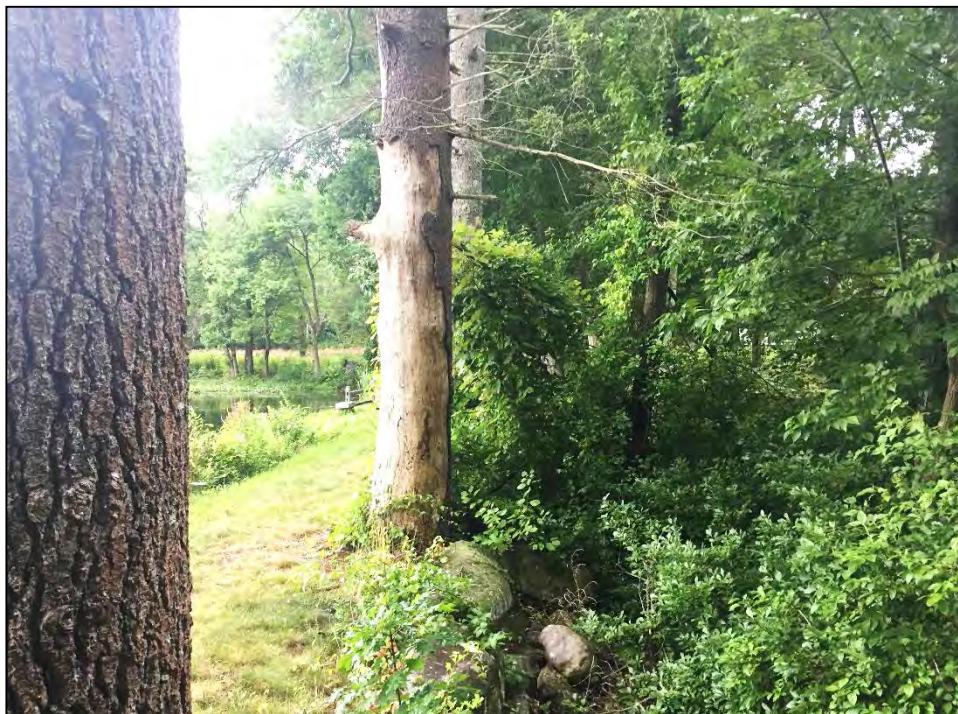
Photo No. 12: Another view of the irregular stone masonry wall along the downstream side of the dam.

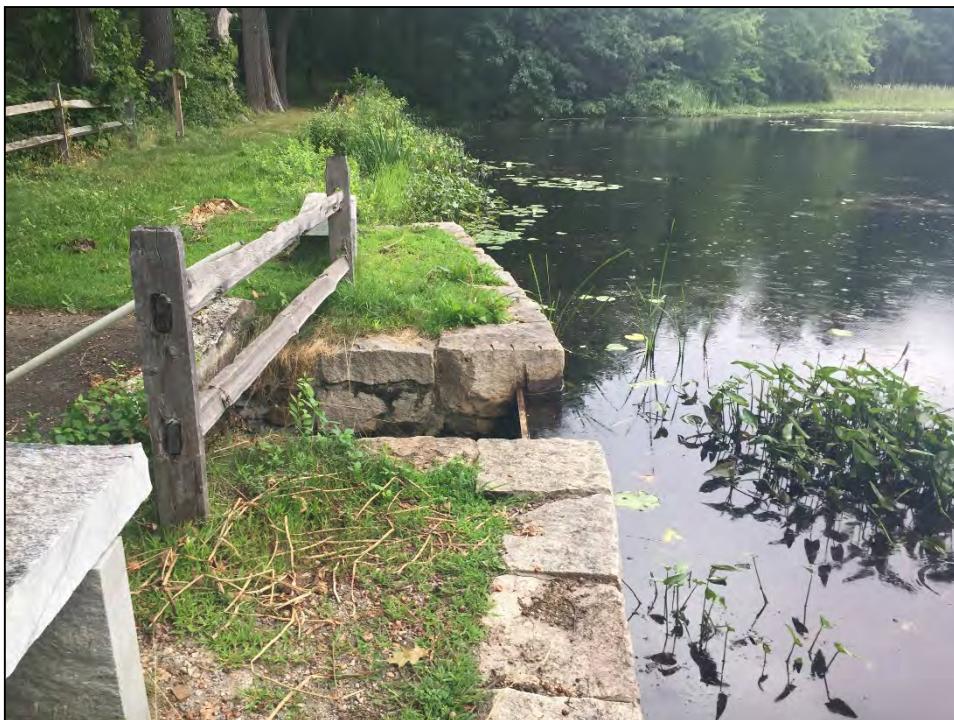
- ii. Mortar cracking and potential stone displacement were noted at the left end of the left upstream wall and the right end of the right upstream wing wall.

Photo No. 13: Approach and upstream wing/return walls of the spillway.

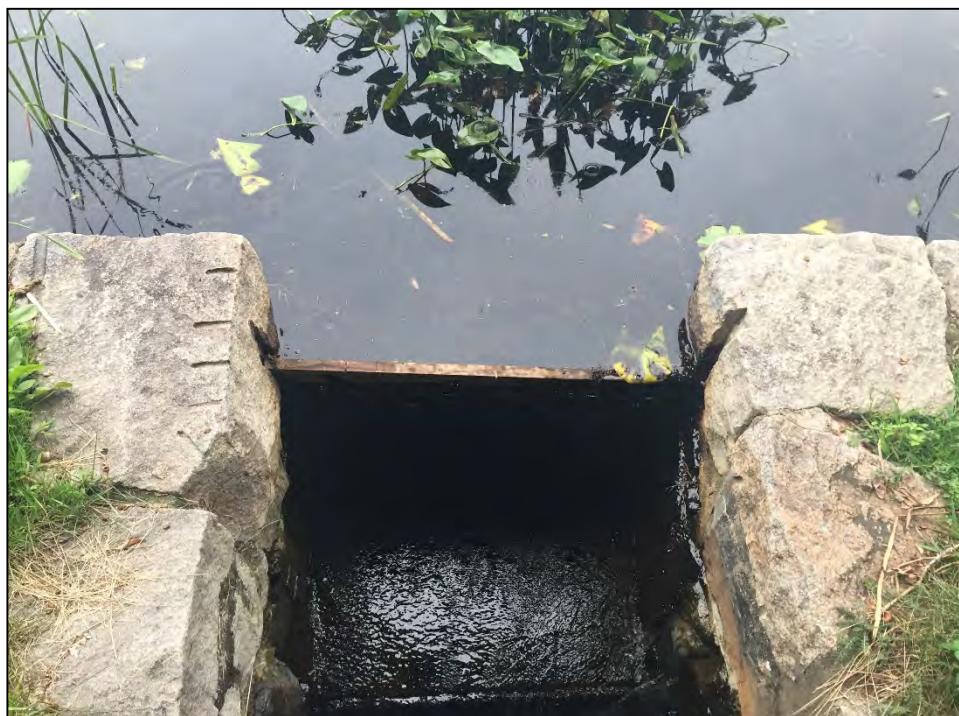
- a. The following was noted along the spillway system:
 - i. The stepped concrete weir and timber stop log controls generally appeared to be in fair condition with no major deficiencies noted. The top stop log was partially displaced at the left end.

Photo No. 14: Spillway stops logs and stepped concrete invert.

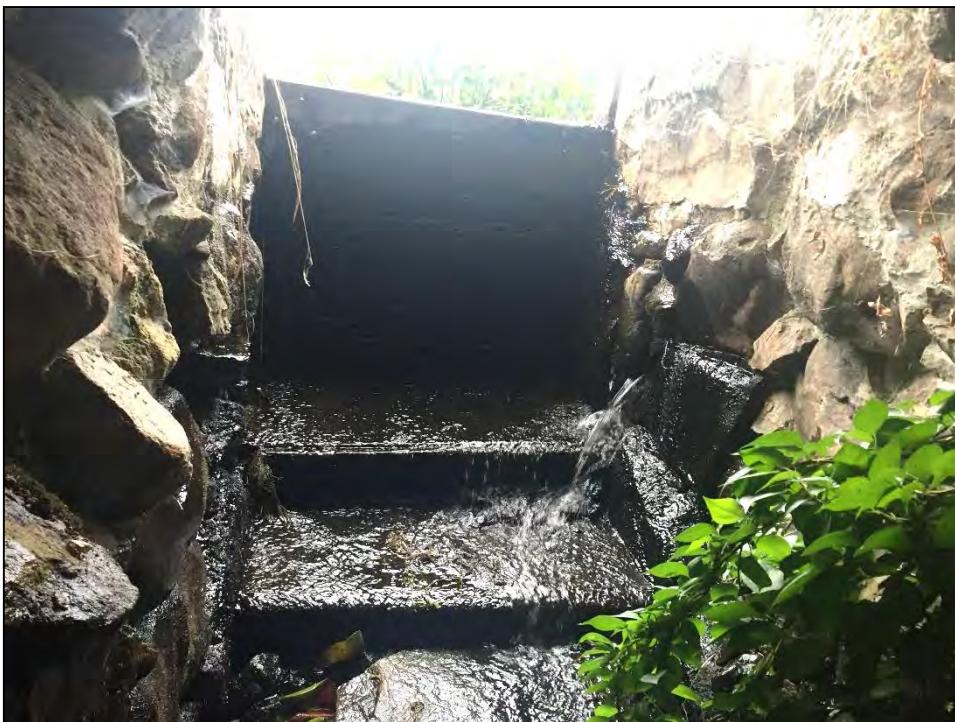
- iii. Leakage was observed through several joints of the stone masonry training walls of the spillway channel. The majority of the leakage was occurring within 5 feet of the weir with the highest leakage (estimated at 20-30 GPM) from one joint in the left wall located 3 feet downstream of the weir.

Photo No. 15: Leakage from the left and right training walls of spillway channel. Note the highest area of leakage from the left wall approximated at 20-30 GPM.

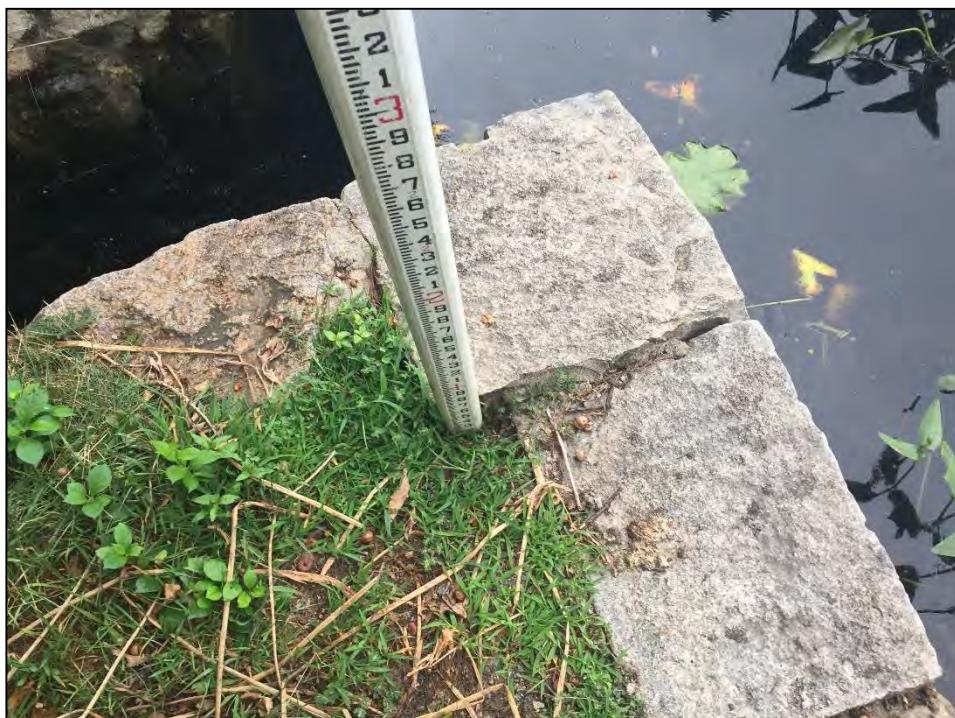
- iv. Two small sinkholes were noted along the crest left of the spillway:
 - a) A 6-inch diameter by 6-inch deep hole at the corner between the upstream wing wall and channel training wall.

Photo No. 16: 6-inch diameter by 6-inch deep potential subsidence behind the upstream end of the left training wall.

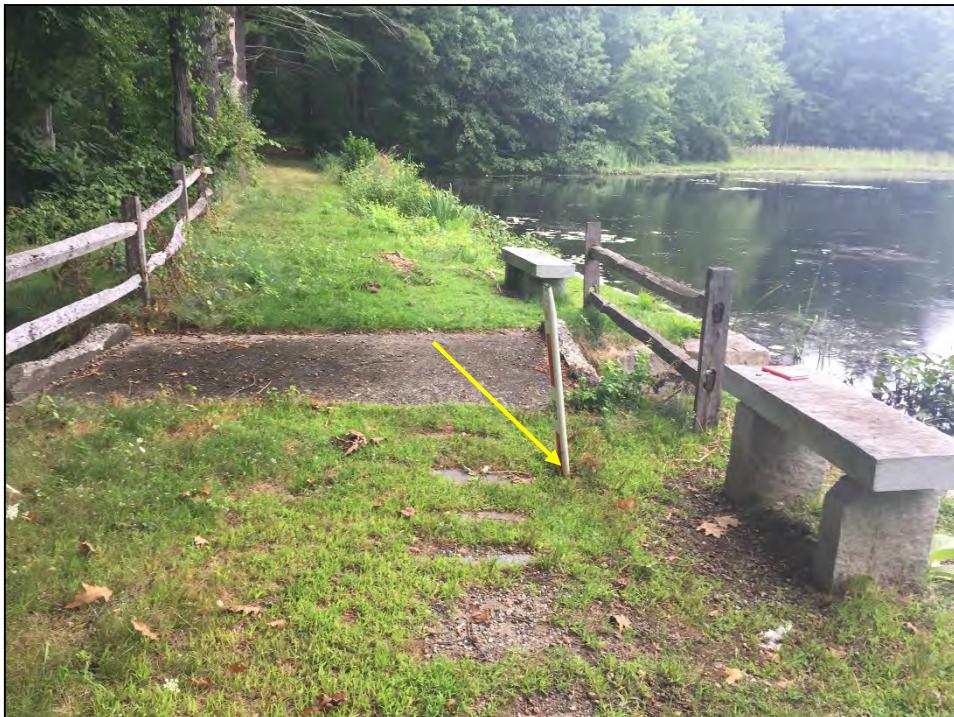
Photo No. 17: 12-inch diameter by 12-inch plus deep subsidence/sinkhole located 5 feet downstream and 3 feet left of the left training wall (Yellow Arrow).

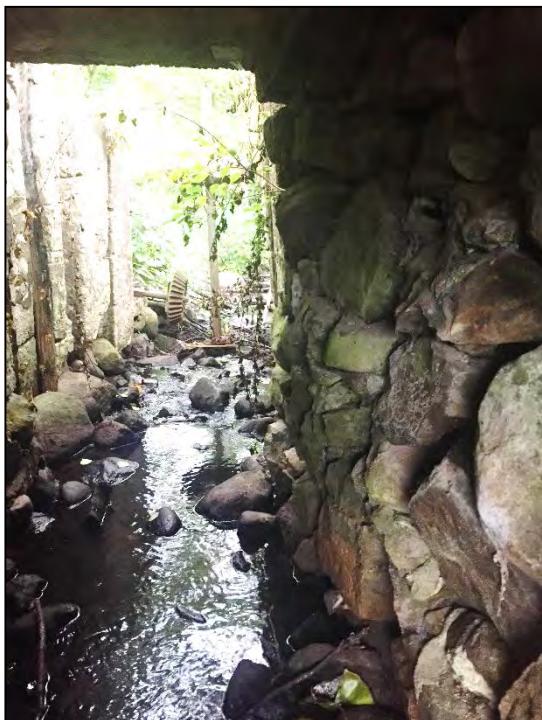
- b) A 12-inch diameter by >12-inch deep hole 5 feet downstream of the wing wall and 3 feet left of the channel wall.
 - v. The channel right wall was noted to be bulging in towards the channel from 15-20 feet downstream of the weir, just upstream of the transition to the concrete walls.

Photo No. 19: Potential bulge in the downstream portion of the right training wall within 5 feet of the transition to the concrete wall.

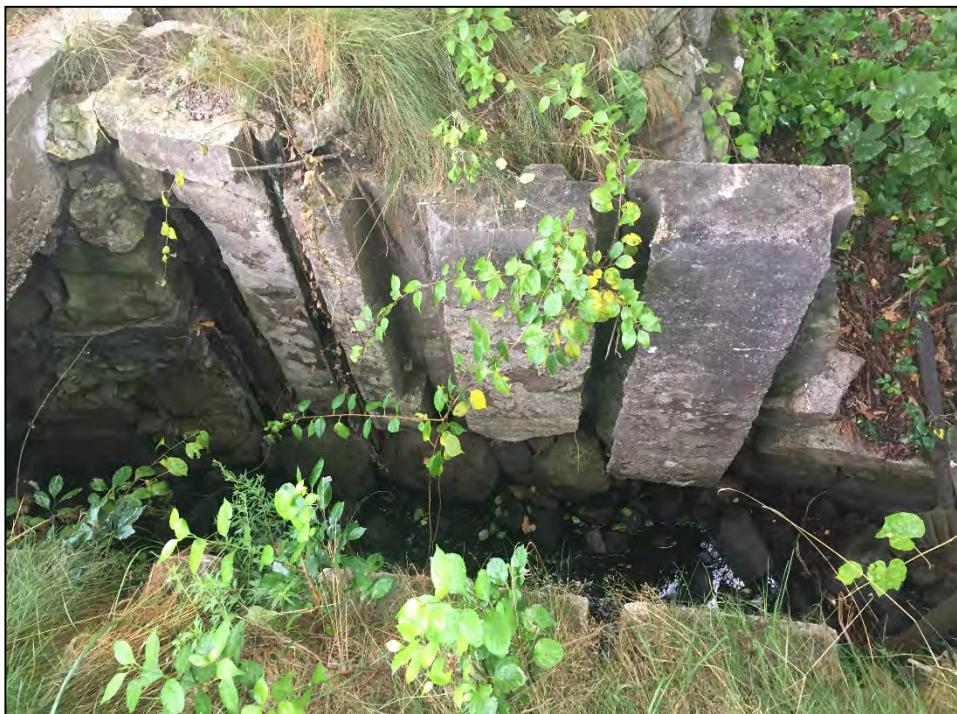
- vi. The concrete portion of the walls are significantly deteriorated with through cracking, apparent displacement, and undermined/missing bottom section of the walls. Potential embankment sliding was noted behind the right wall

Photo No. 20: Left concrete training wall. Note significant deterioration and apparent displacement of the wall. Right wall is similar

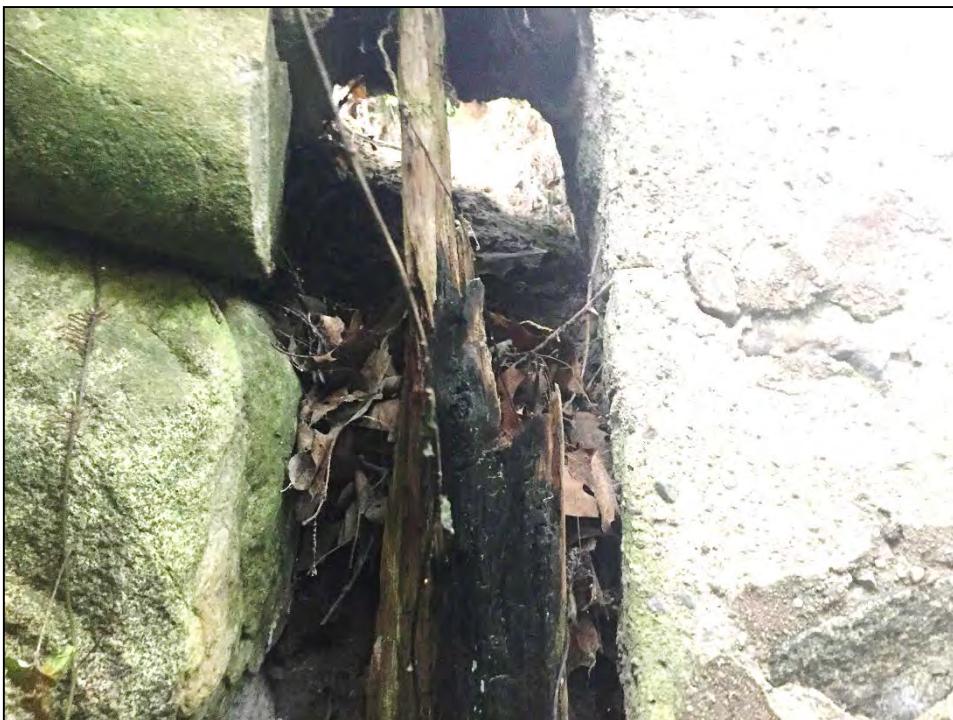
- vii. The vertical timbers located at the transition between the stone masonry and concrete training walls were deteriorated. Soil loss from apparent erosion was noted at the top of the walls at these locations.

Photo No. 21: View of the erosion of the ground surface behind the left training wall at the transition between the stone masonry and concrete sections. Note deteriorated timber at transition.
