Re: **Follow-Up Inspection – December 2020**
Danielson Mill Dam (MA03351)
Medfield, Massachusetts
(PARE Project No.: 19126.02)

Commonwealth of Massachusetts
Department of Conservation and Recreation
Office of Dam Safety Poor Condition Dam Follow-up Inspection Form

Dam Name: Danielson Mill Dam

Date of Inspection: December 3, 2020

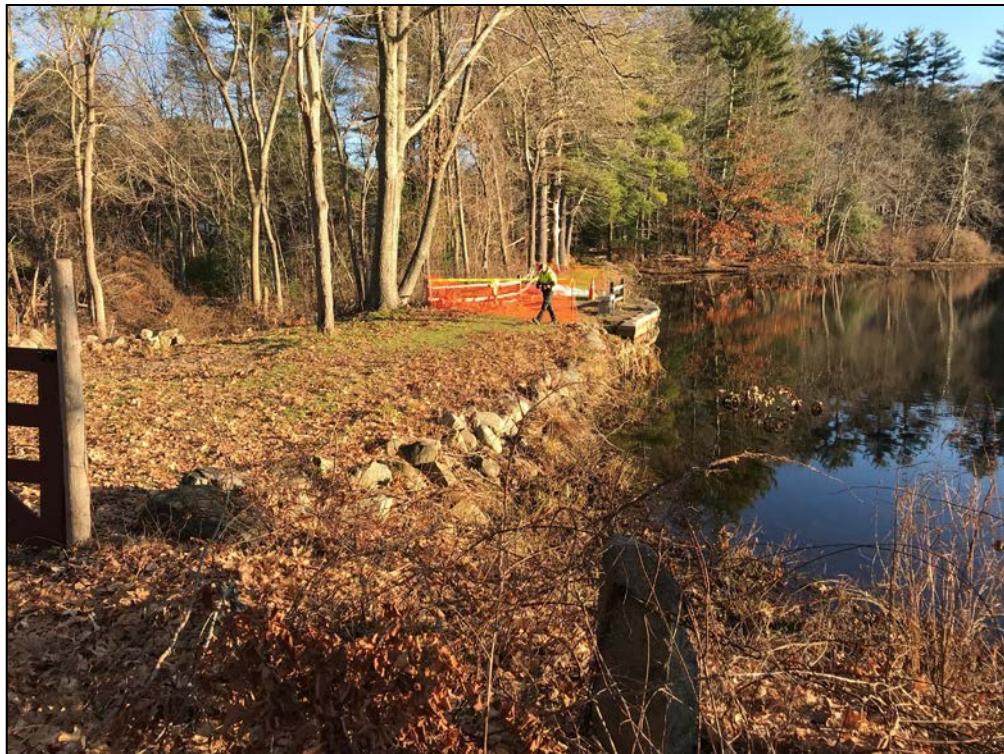
Photo No. 1: Overview of the upstream side of the dam.

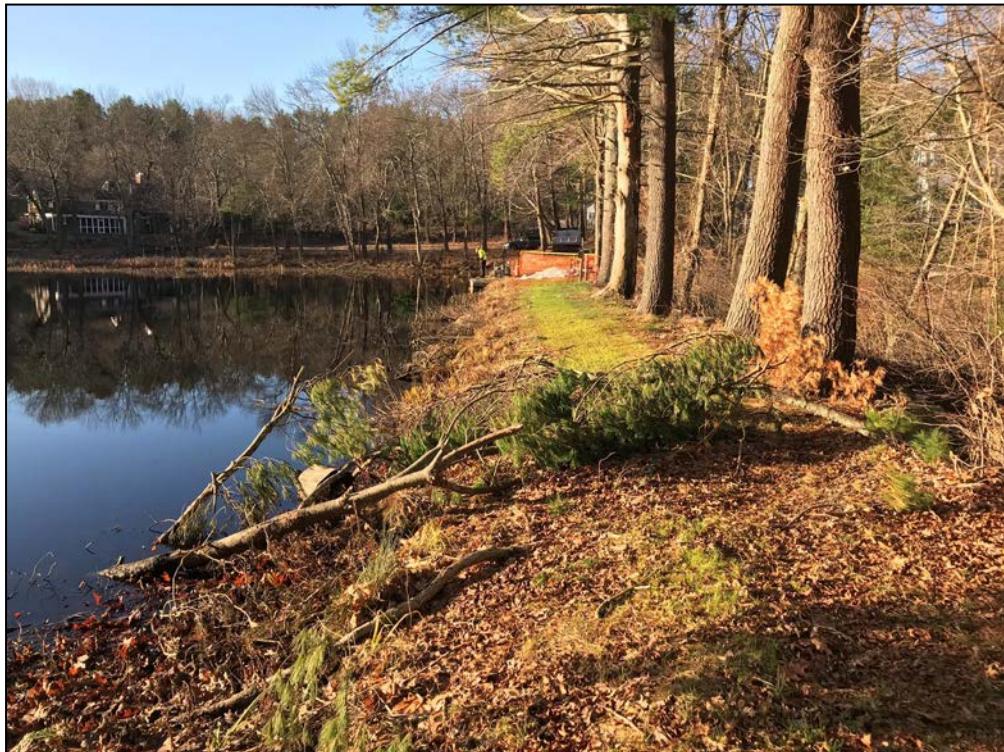
Photo No. 2: Upstream slope from the right abutment.

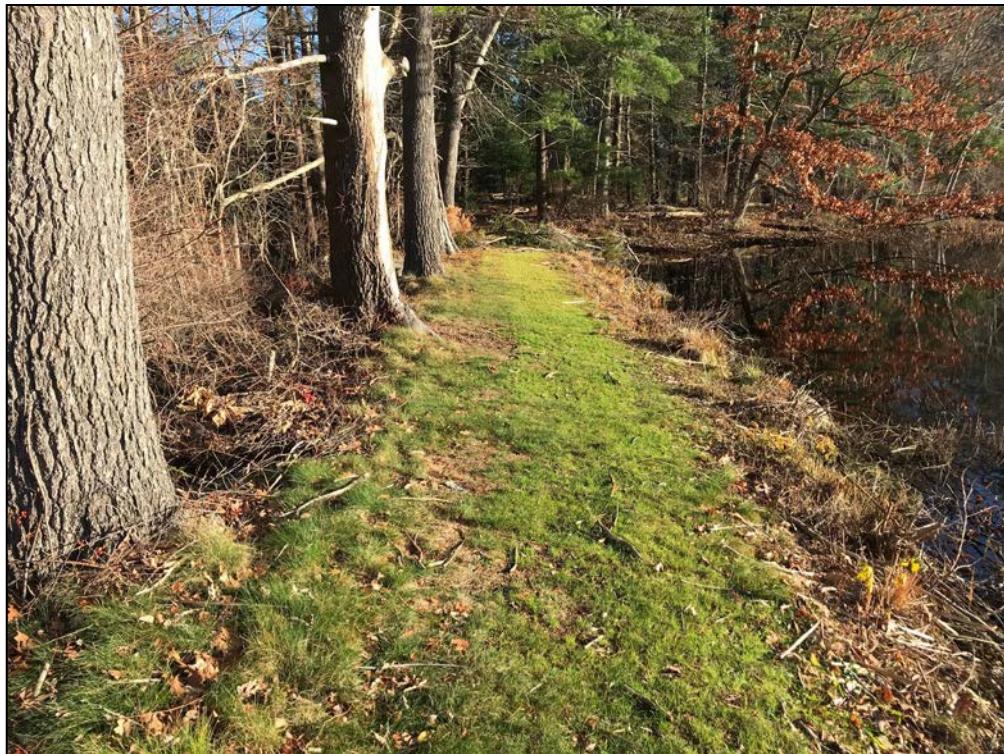
Photo No. 3: Crest right of the spillway.

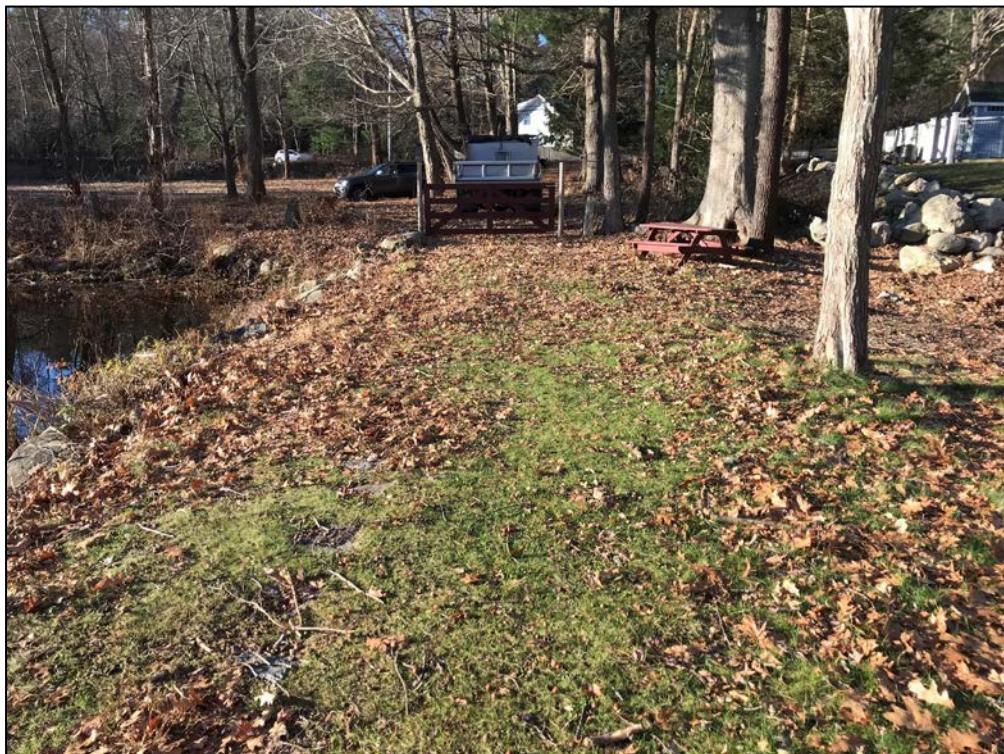
Photo No. 4: Crest left of the spillway.

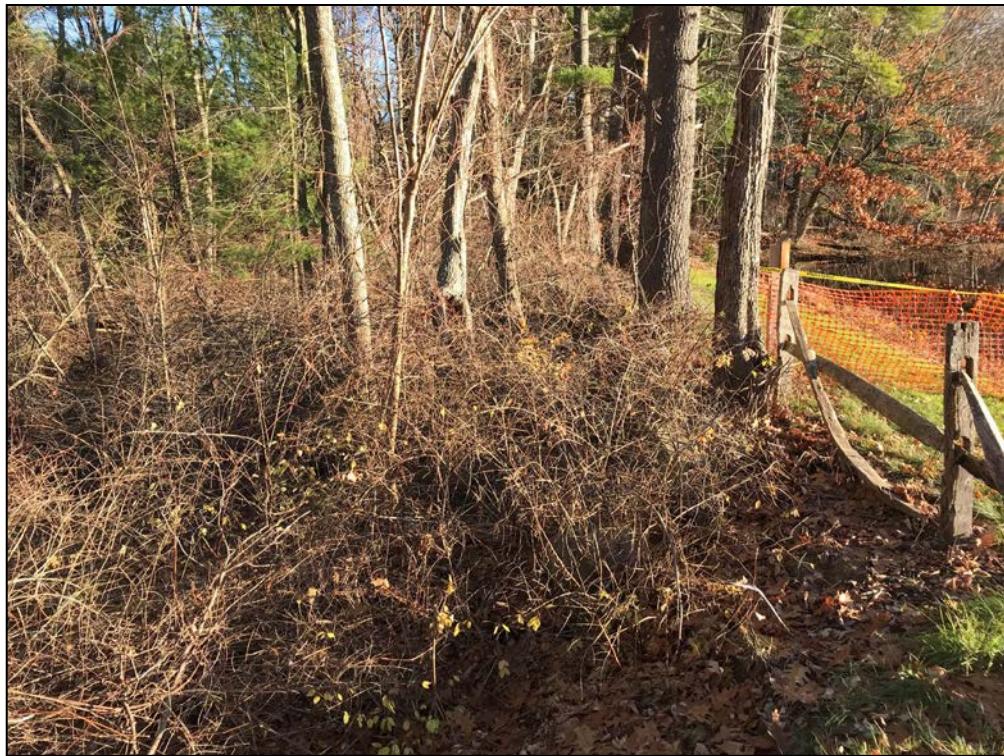
Photo No. 5: Typical downstream slope conditions.

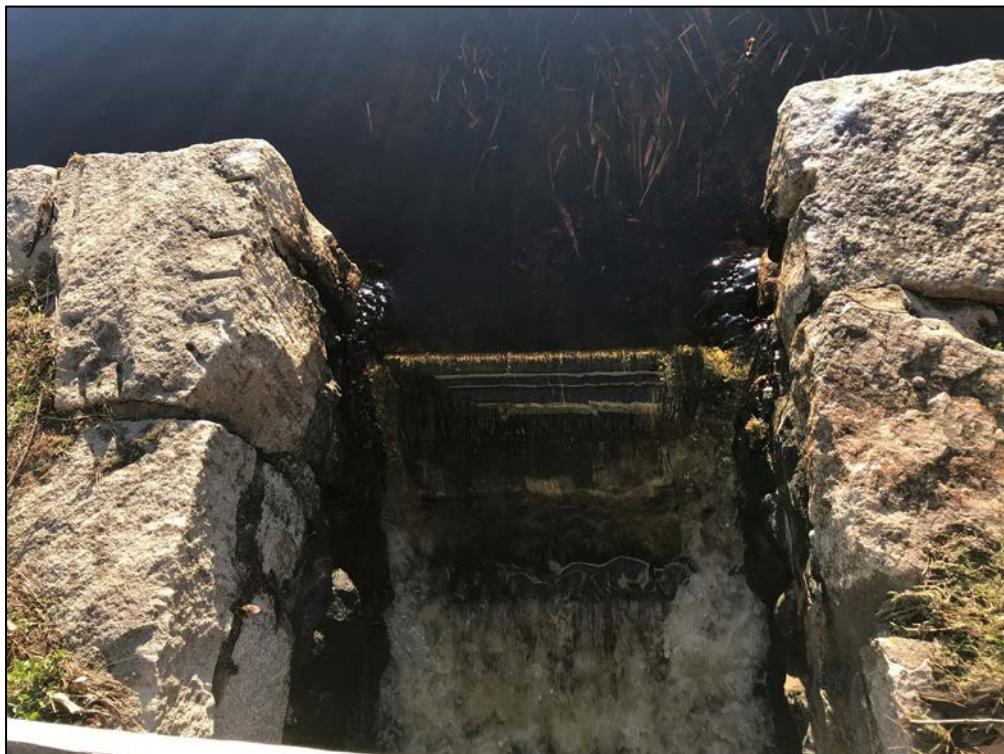
Photo No. 6: Overview of the spillway.

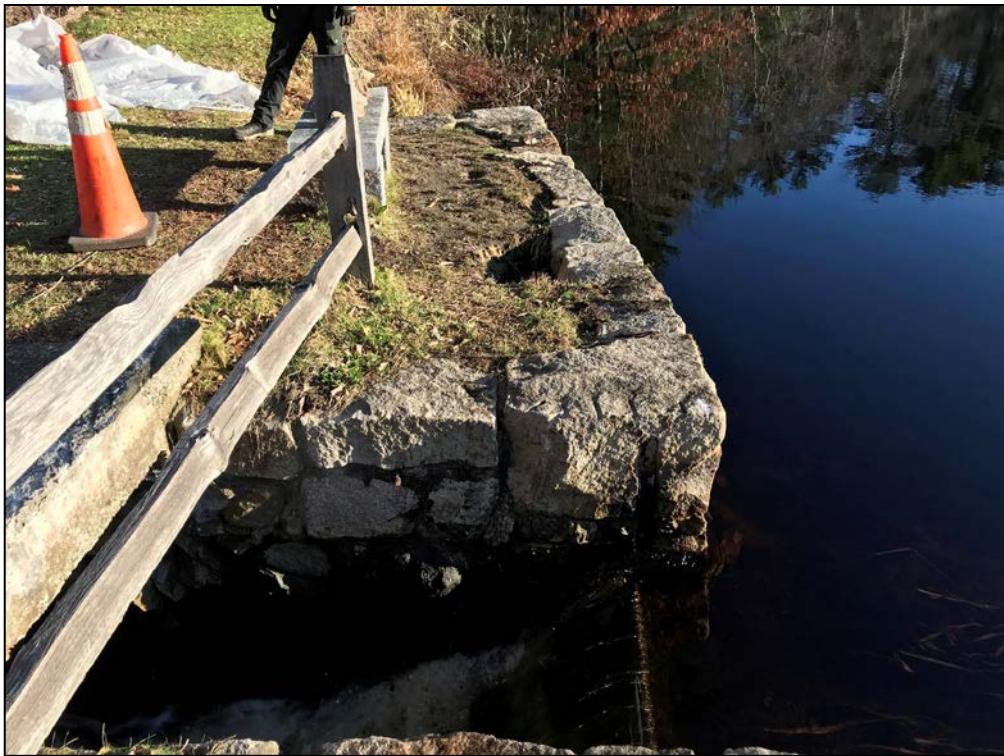
- a. The following voids were identified:
 - i. Behind upstream right return wall – approximately 15 inches deep; probed to right training wall of spillway (2.8 feet) and to the right of the sinkhole (2.4 feet)
 - ii. Behind right training wall, centerline embankment – probed to 2.4 feet deep; horizontal extent not clear
 - iii. Behind right training wall downstream of the downstream fenceline – probed to 2 feet deep; horizontal extent not clear

Photo No. 7: Right side of the spillway. Note sinkhole behind upstream wall.

- Continue to lower the level of the impoundment to a level of at least 1-foot below the elevation at which leakage no longer is flowing through the right training wall; maintain the drawdown until appropriate repair/stabilization is completed.
- Repoint the upstream masonry walls to eliminate the apparent source of leakage.
- Over excavate and backfill areas of voids, including along the upstream wall and the right training wall, that have been impacted by leakage through the embankment.

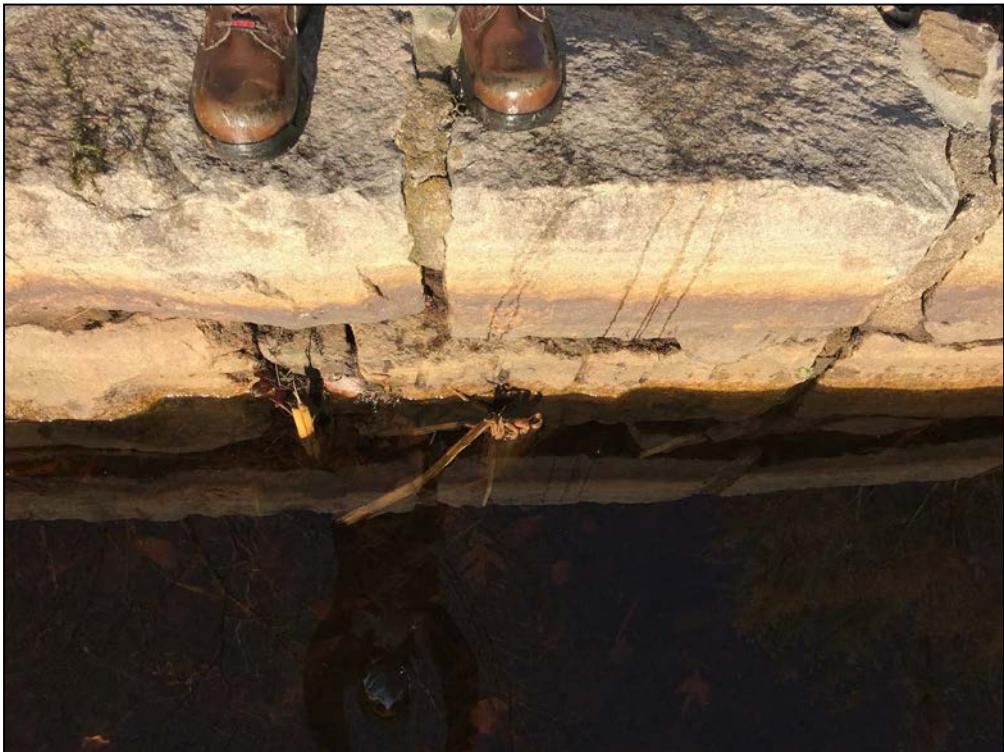
Photo No. 8: Typical upstream wall joint condition right of the spillway.

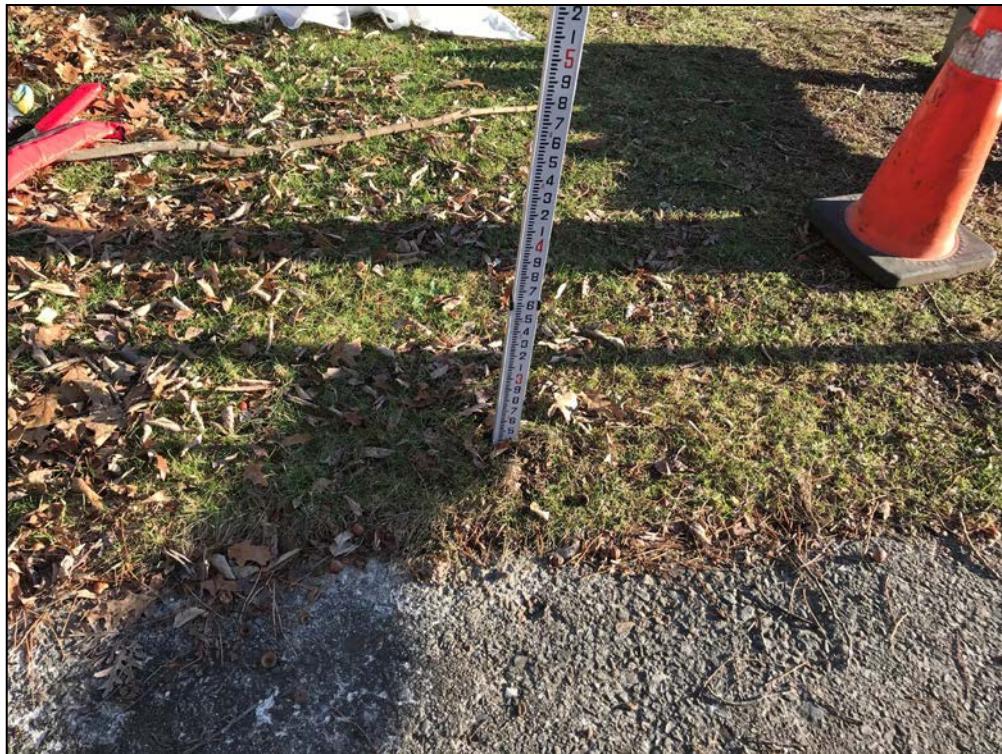
- Have any of the deficiencies listed in the previous Phase I Inspection Report worsened? Yes
- If yes, list the changes.
 - High water event resulted in progression of voids and leakage right of the spillway
- Are there any additional deficiencies that have been identified in the current inspection? Yes
- If yes, list the deficiencies and describe.
 - New sinkhole along the backside of the upstream wall right of the spillway
 - New void/sinkhole behind the right training wall near the centerline of the crest right of the spillway

Photo No. 9: Sinkhole behind right training wall probed to 2.4 feet.

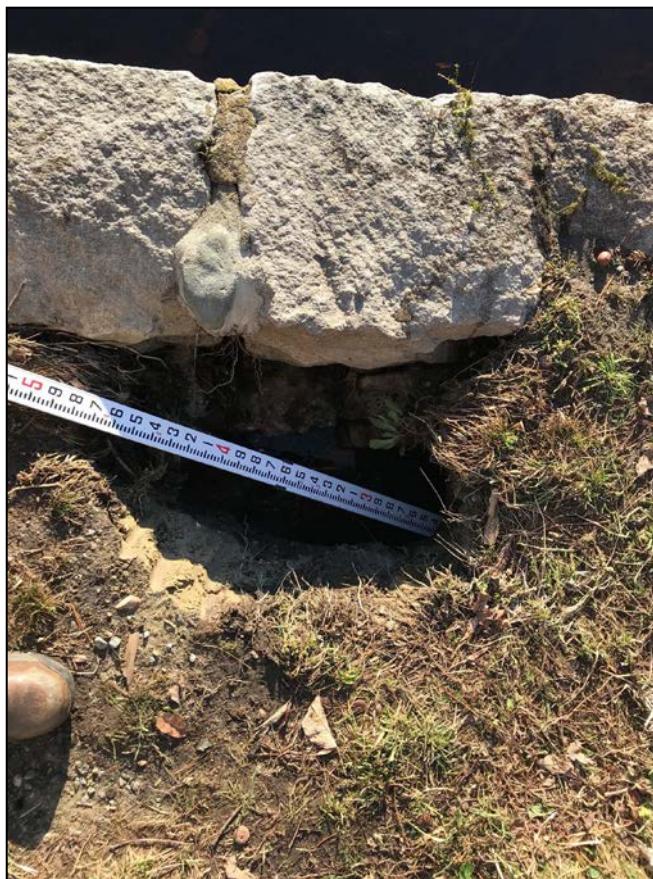
Photo No. 10: Sinkhole behind upstream right wall probed to 2.6 feet left of the sinkhole.

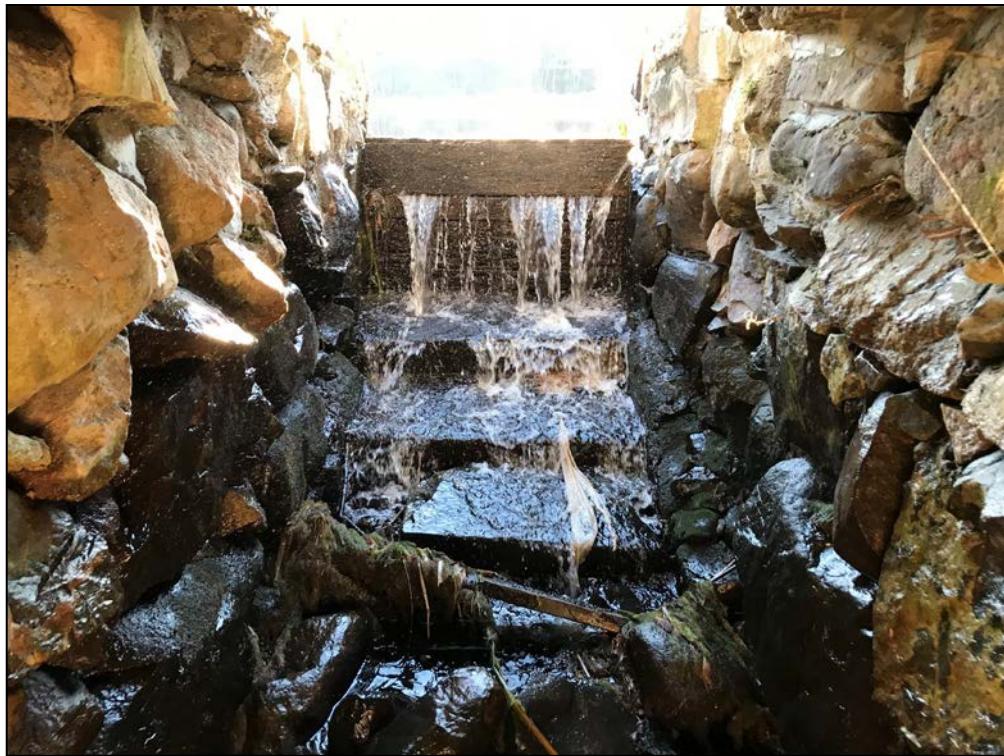
Photo No. 11: Downstream side of spillway (Note: Stoplog installed to stop flow and allow for inspection).

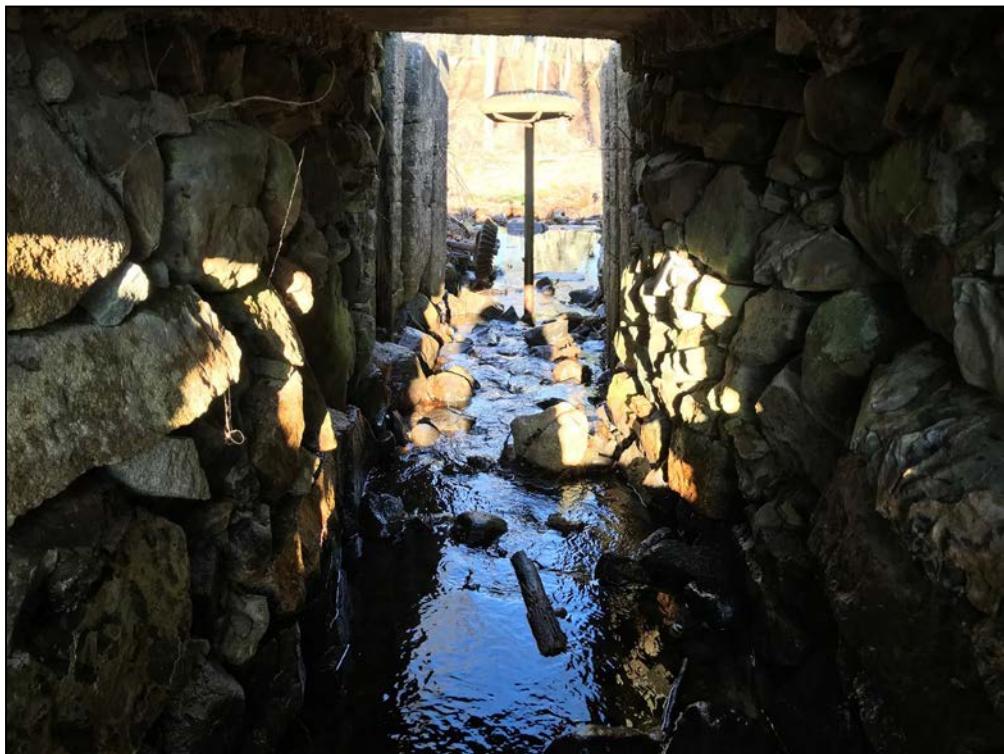
Photo No. 12: Channel and training walls downstream of the spillway (Note: Stoplog installed to stop flow and allow for inspection).

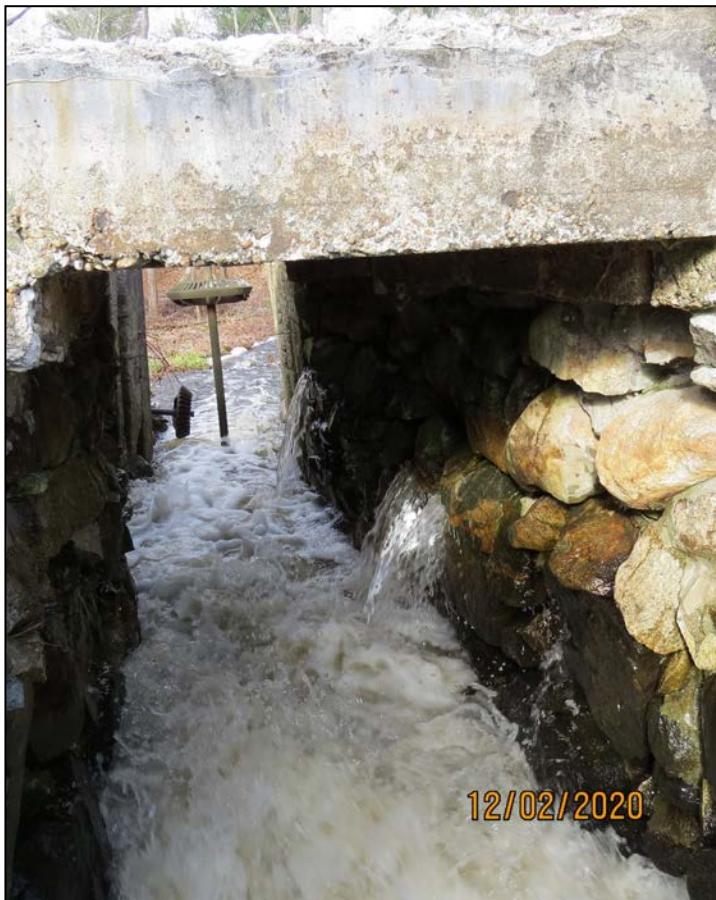
While the general condition of the dam is similar to that previously noted, a high water event as a result of significant rainfall on November 30, 2020 appears to have resulted in the progression of previously noted deficiencies. The significant rainfall (roughly 3-inches overnight) resulted in the pool level raising above the level of the left training wall; however, the dam crest was not overtopped. High water level combined with poor mortar condition in the upstream wall right of the spillway appears to have progressed previously noted leakage through the right side of the spillway, resulting in the development of sinkholes behind the right training wall along the spillway crest and high flow through the stone masonry training wall near the center line of the embankment and near the downstream end of the masonry wall section.

Photo No. 13: Flow through right training wall (Taken on 12/2; provided by Town).

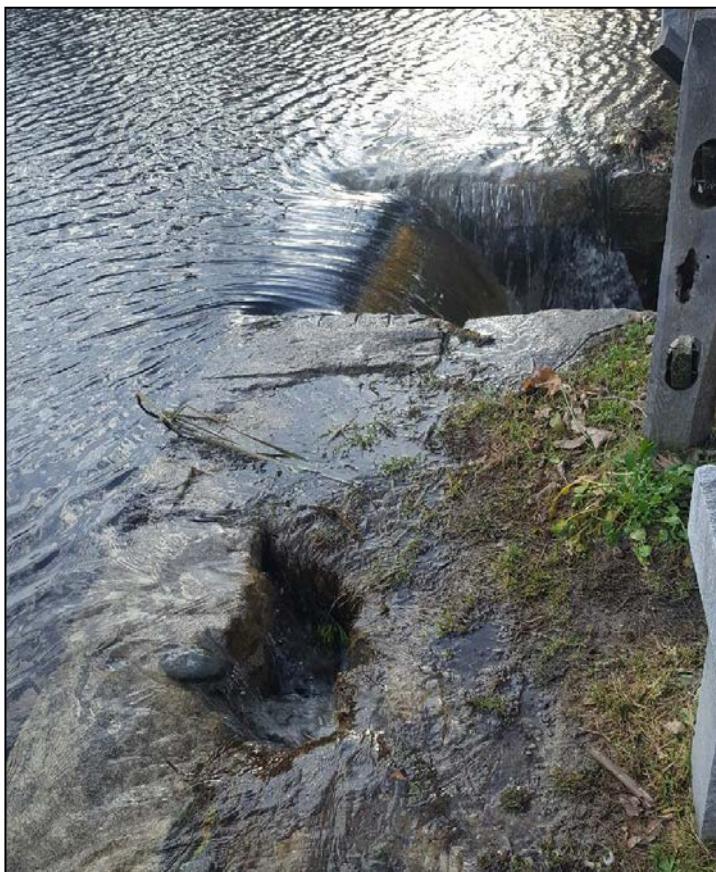
Photo No. 14: Flow overtopping training walls (Taken on 12/1; provided by Town).
