Re: **Follow-Up Inspection – February 2020**
Danielson Mill Dam (MA03351)
Medfield, Massachusetts
(PARE Project No.: 19126.00)

Commonwealth of Massachusetts
Department of Conservation and Recreation
Office of Dam Safety Poor Condition Dam Follow-up Inspection Form

Dam Name: Danielson Mill Dam

Nat. ID Number: MA03351

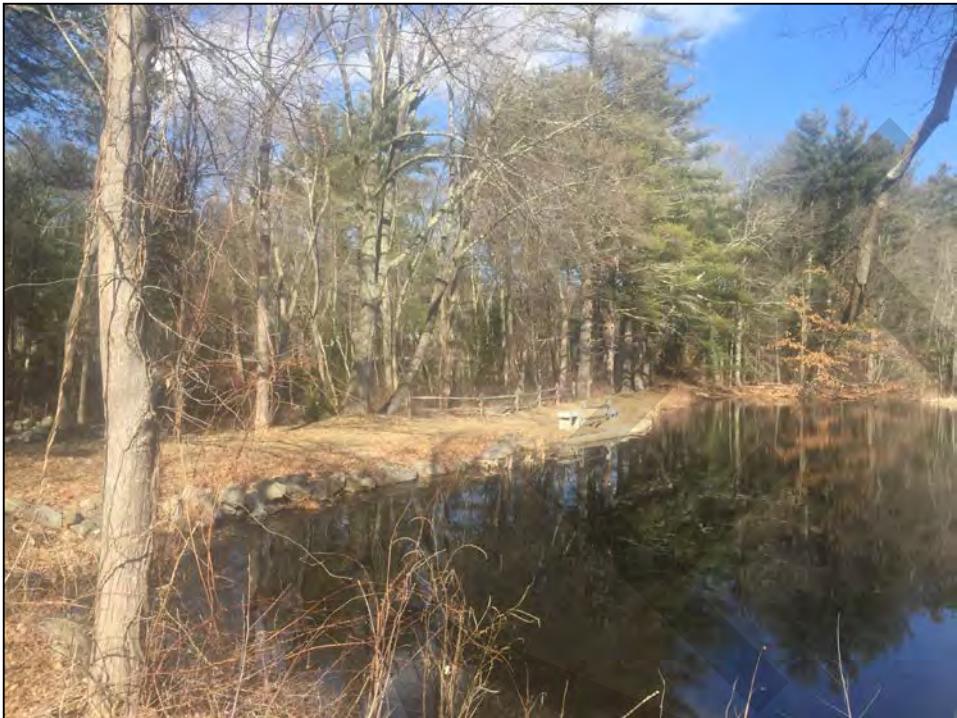
Photo No. 1: Overview of the upstream side of the dam as viewed from the left shoreline.

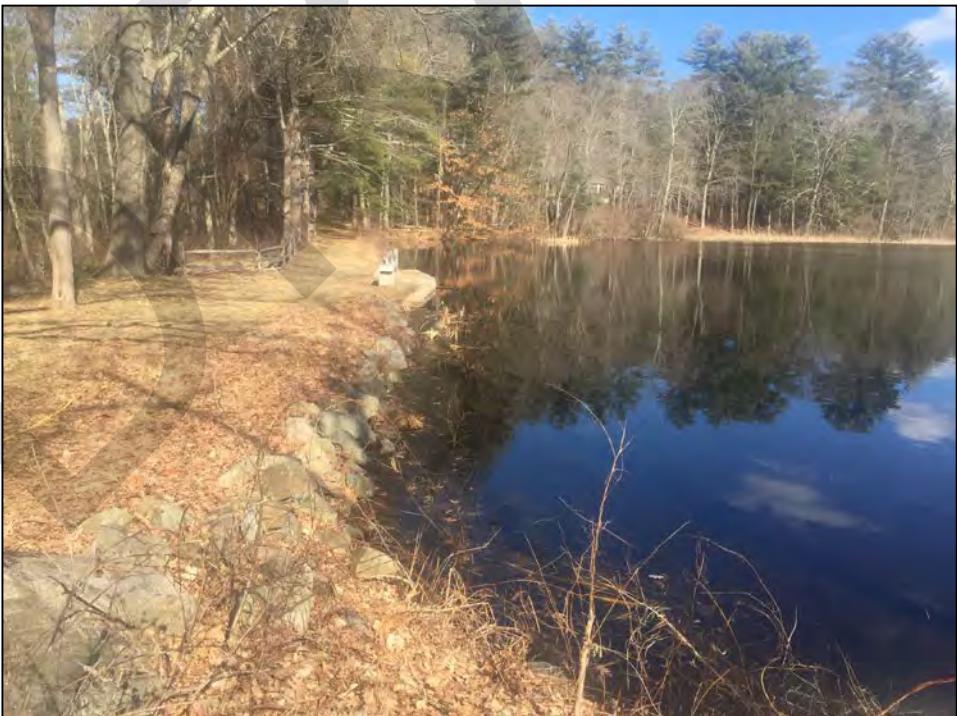
Photo No. 2: Upstream side of the dam as viewed from the left abutment looking right.

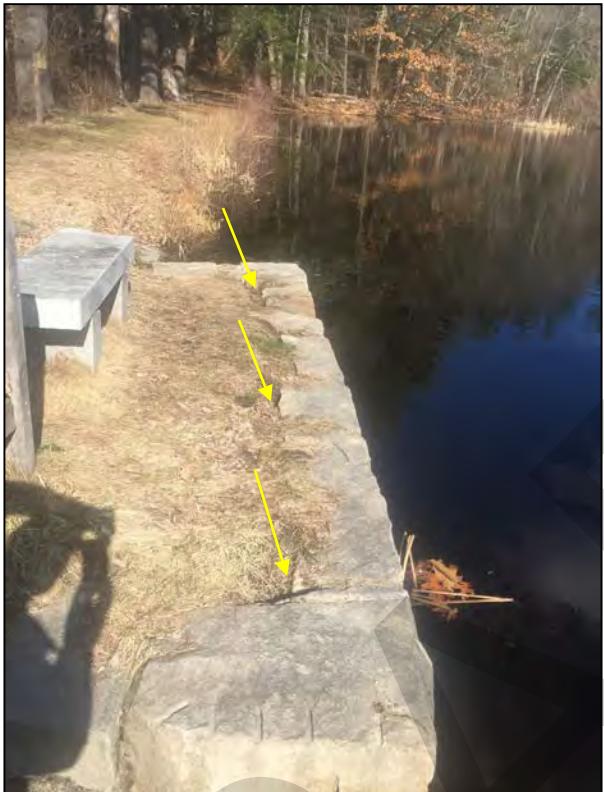
Photo No. 3: The upstream side of the dam as viewed from the primary spillway looking right. Note the sinkholes forming behind the spillway right return wall and the irregular shoreline beyond.

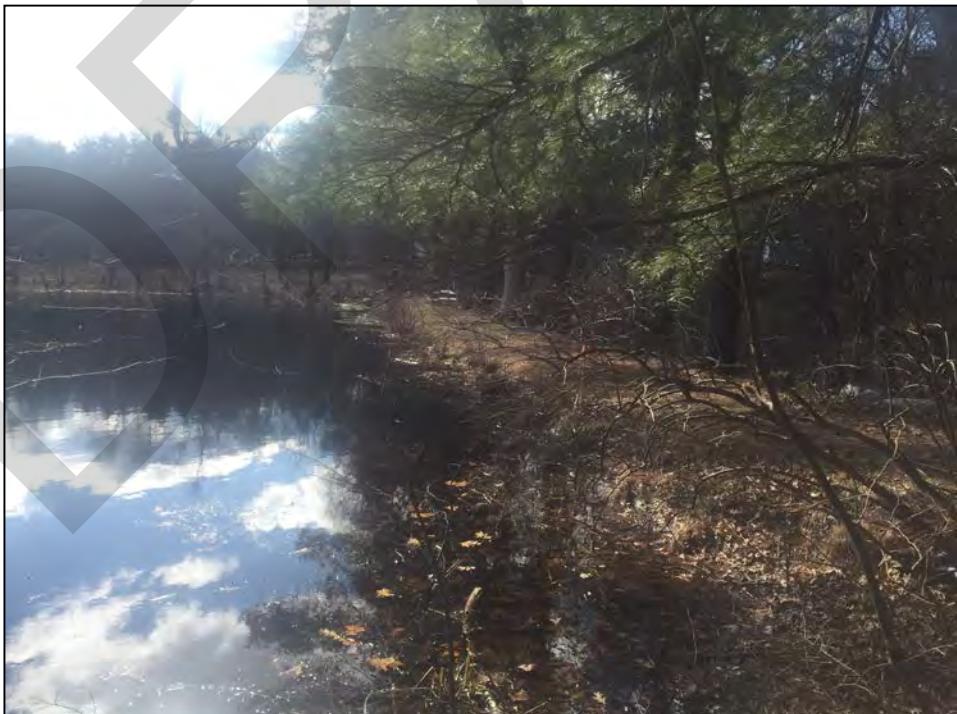
11. Scarping along the waterline of the upstream slope.
12. Unknown ability to accommodate the spillway design flood (SDF)
13. Additional areas of deterioration and dam safety concerns.

Photo No. 4: Overview of the upstream side of the dam as viewed from the right abutment looking left. Note the irregular shoreline due to scarping, and brush growth.

- a) Rehabilitate / reconstruct the spillway system to address the noted concerns.
- b) Remove the irregular downstream boulder wall and replace with an earthen slope.
- c) Clear and grub areas of unwanted vegetation. Fill resulting holes.
- d) Develop and install a seepage mitigation system at the dam to address the seepage concerns along the downstream side of the dam.
- e) Provide riprap slope protection along the upstream slope.

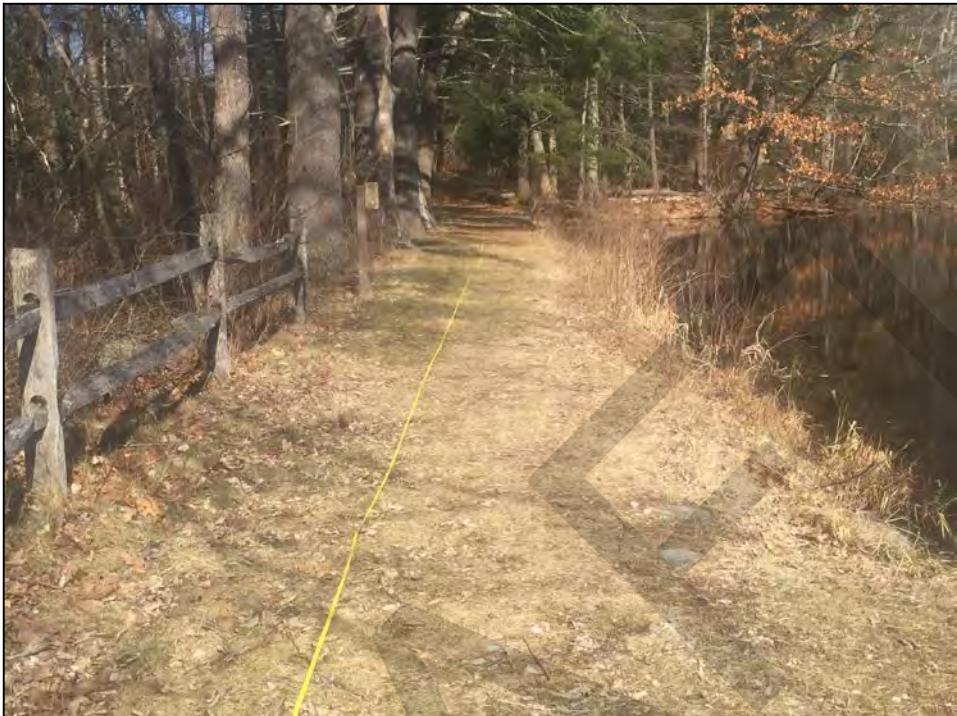
Photo No. 5: Crest as viewed from near the primary spillway looking right. Note the large trees along the downstream edge.

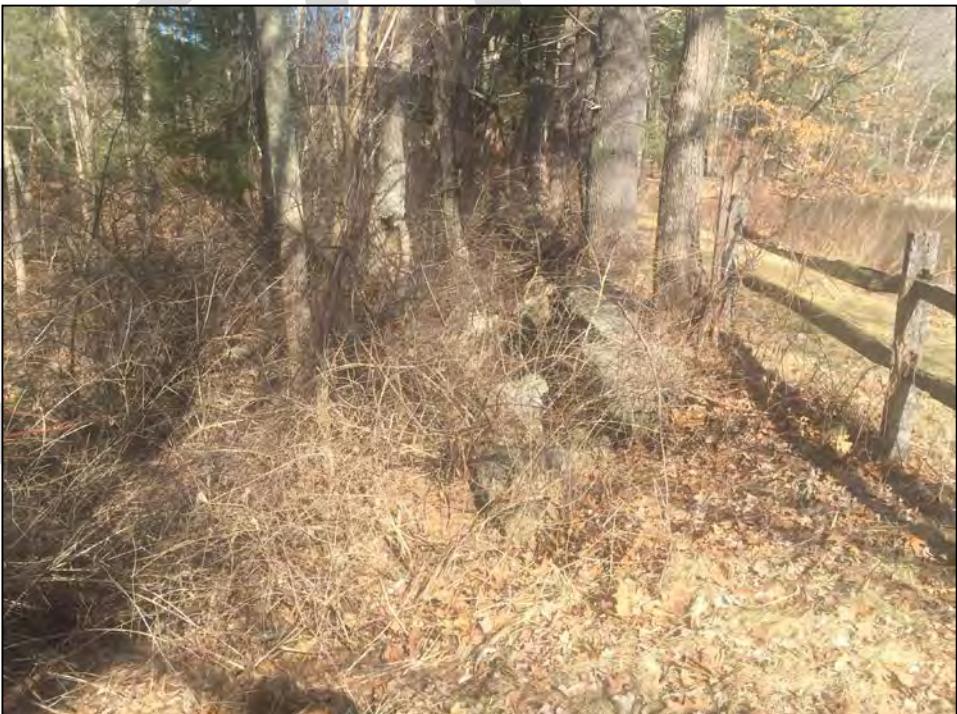
Photo No. 6: Downstream slope as viewed from near the primary spillway looking right. Note the overgrowth of trees, brush, vines, and briars.

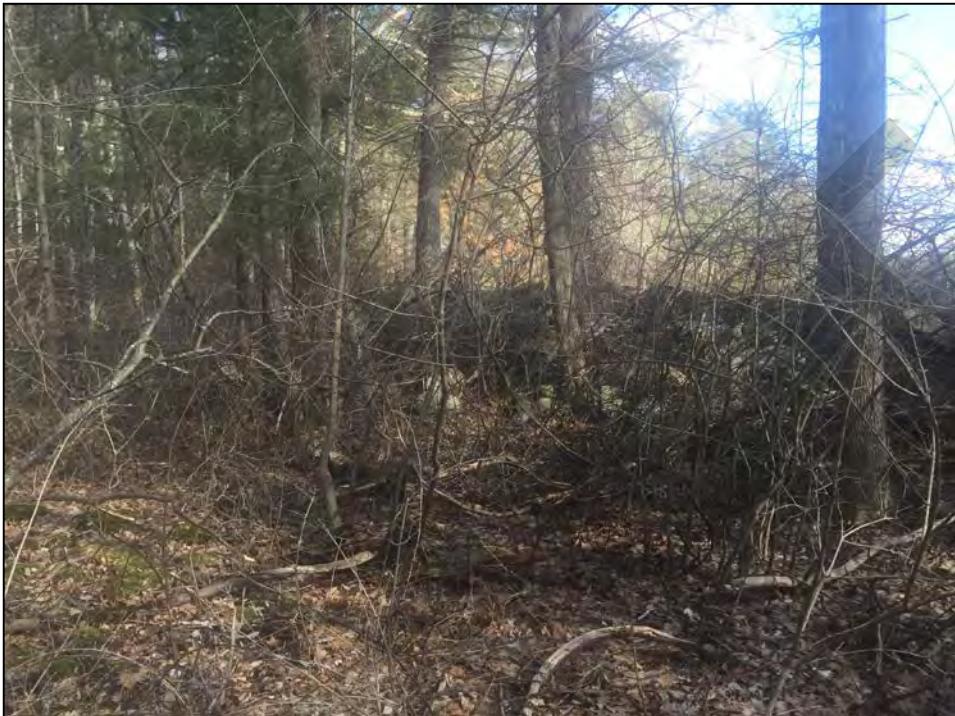
Photo No. 7: Downstream slope as viewed from the downstream area about 25 feet right of the primary spillway looking upstream and slightly right. The ground surface in this area is predominantly soft and saturated.

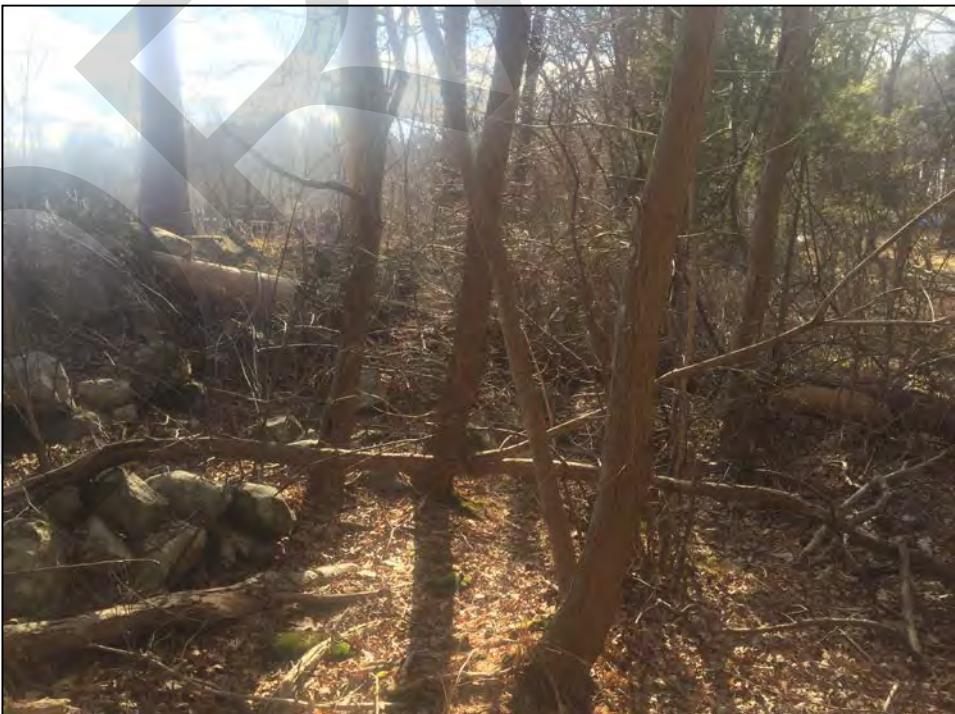
- a. Voids within the downstream stone masonry wall left of the spillway were probed up to 42 inches.
- b. Most of the immediate downstream surface areas, within 20 feet of the downstream wall, is saturated and soft with areas of standing water. The source of the water is likely from the dam as the ground surface pitches down from the dam. This condition was typical from approximately right of the primary spillway to the right abutment.

Photo No. 8: Downstream slope as viewed from the downstream area near the right abutment looking left and slightly upstream. The ground surface in this area is wet and soft.

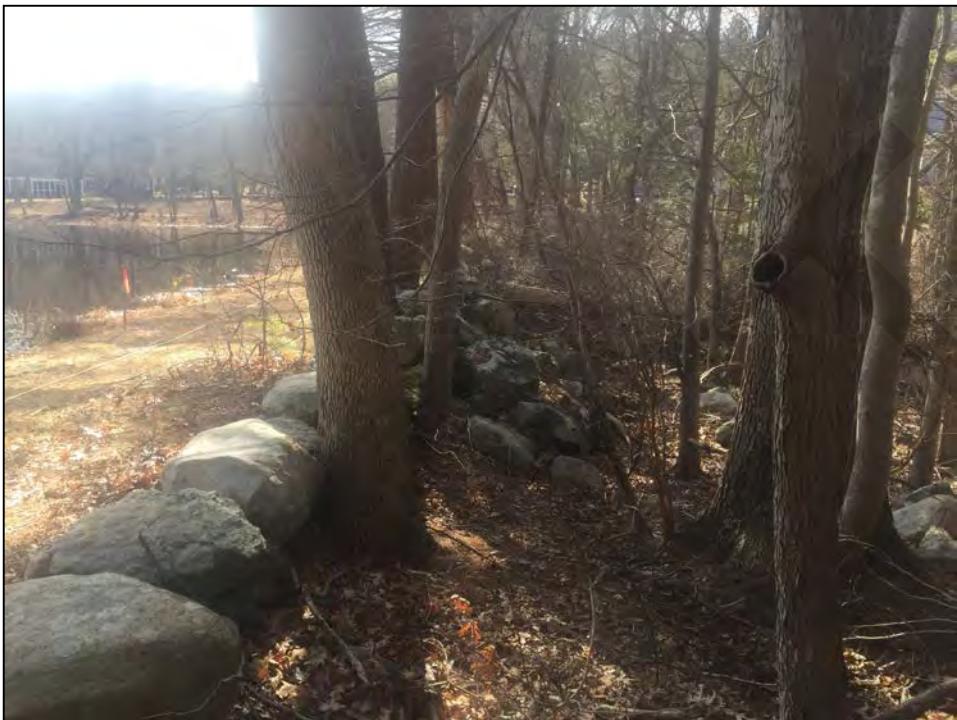
Photo No. 9: Downstream wall as viewed from the right abutment looking left.

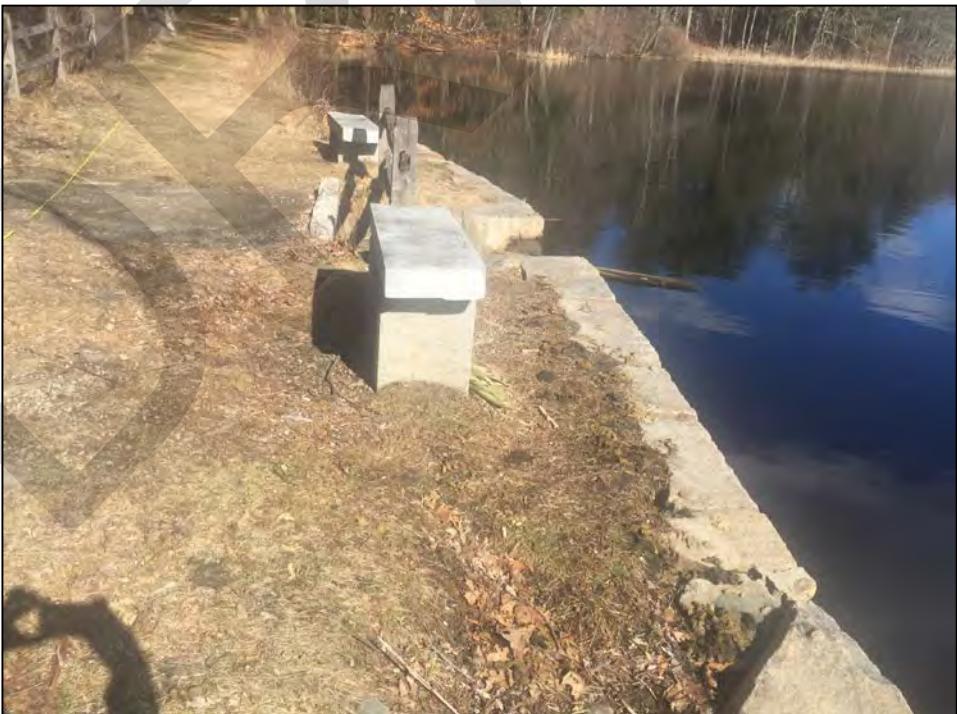
Photo No. 10: The primary spillway as viewed from the crest looking right.

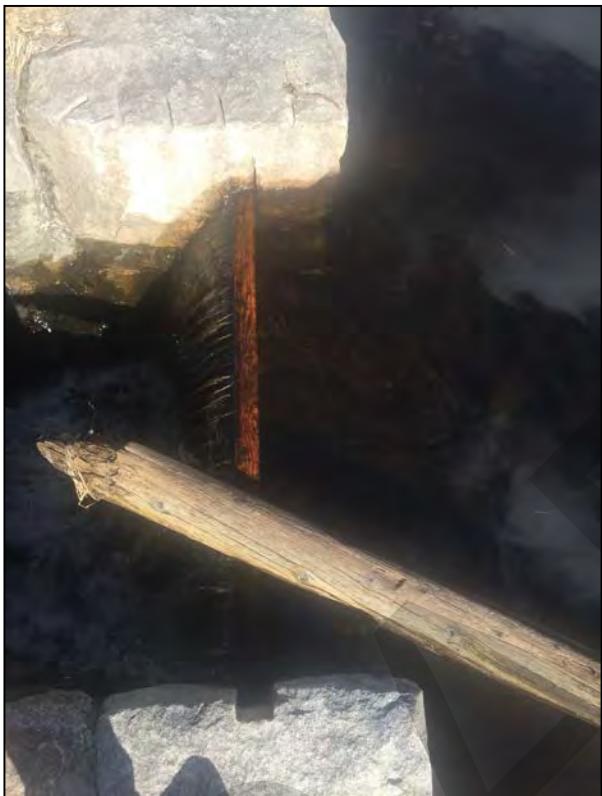
Photo No. 11: Primary spillway stop log section.

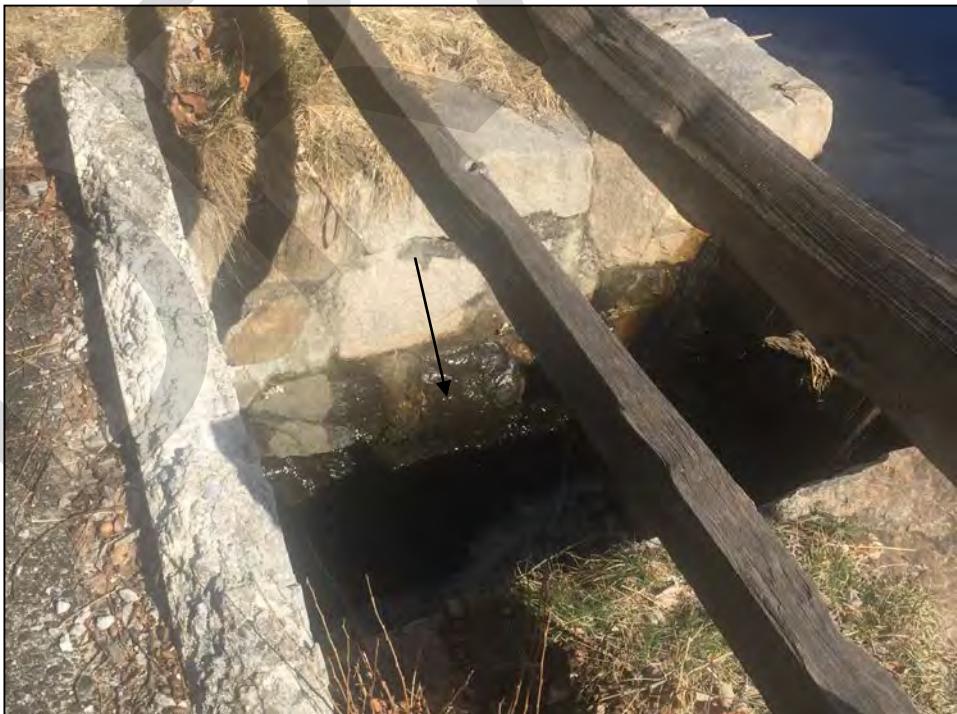
Photo No. 12: Primary spillway right training wall downstream of stop logs.
Note seepage/leakage.

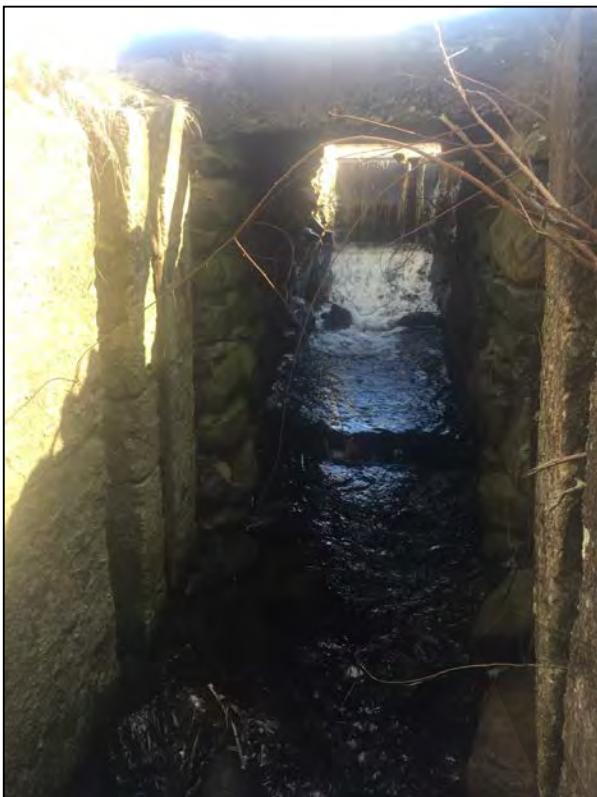
Photo No. 13: Primary spillway culvert looking upstream.

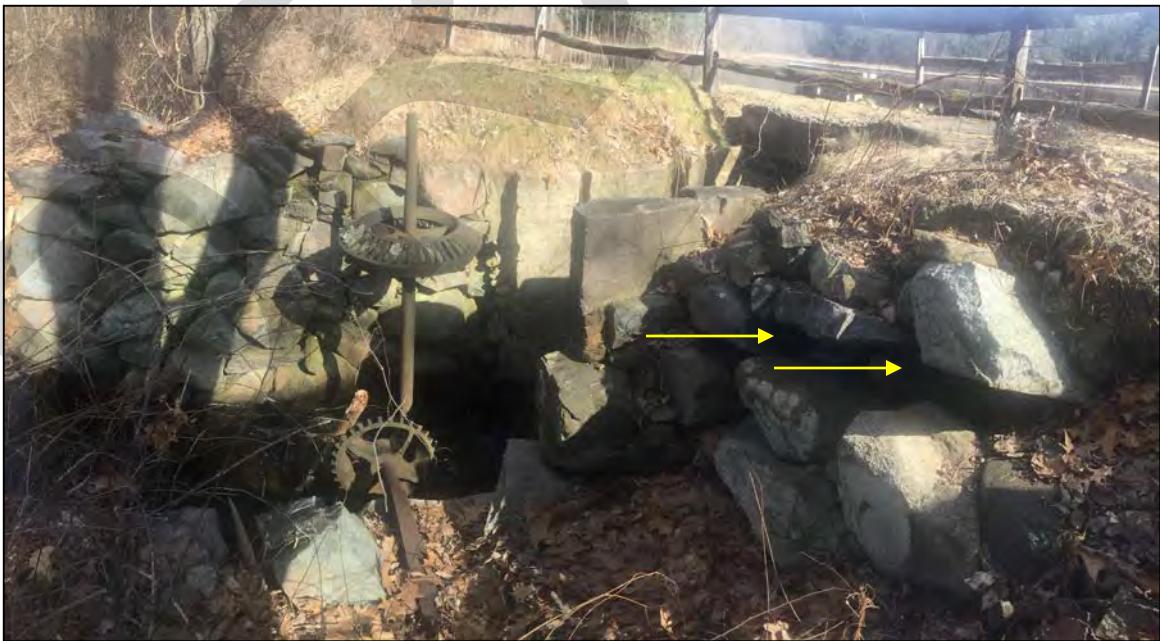
Photo No. 14: Overview of the primary spillway discharge and downstream walls. The left wall has at least two voids up to 42 inches deep.

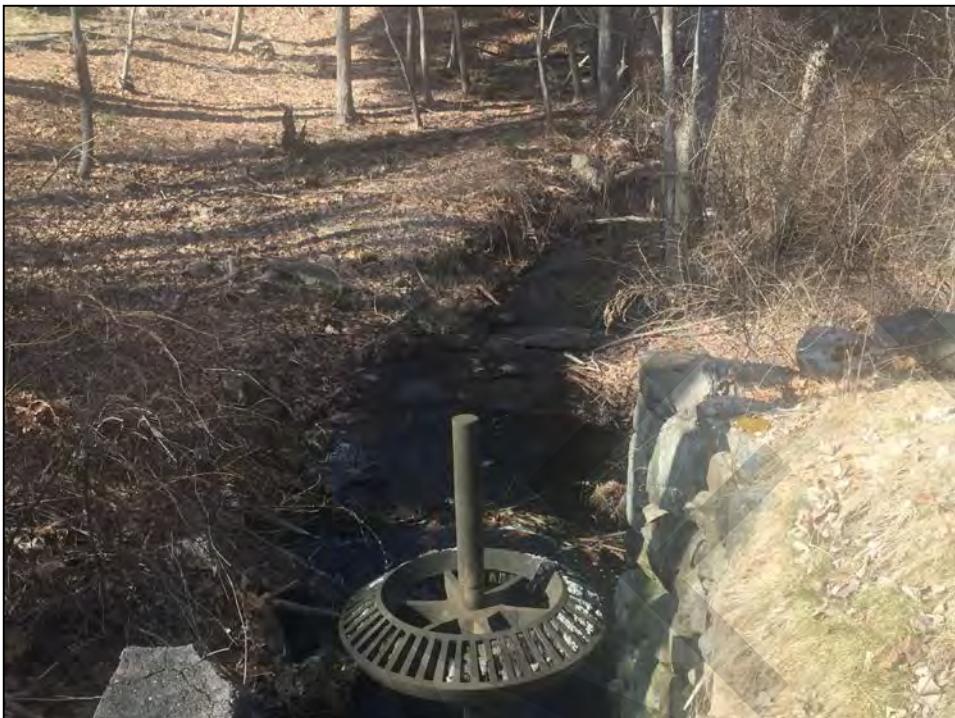
Photo No. 15: Primary spillway downstream channel.

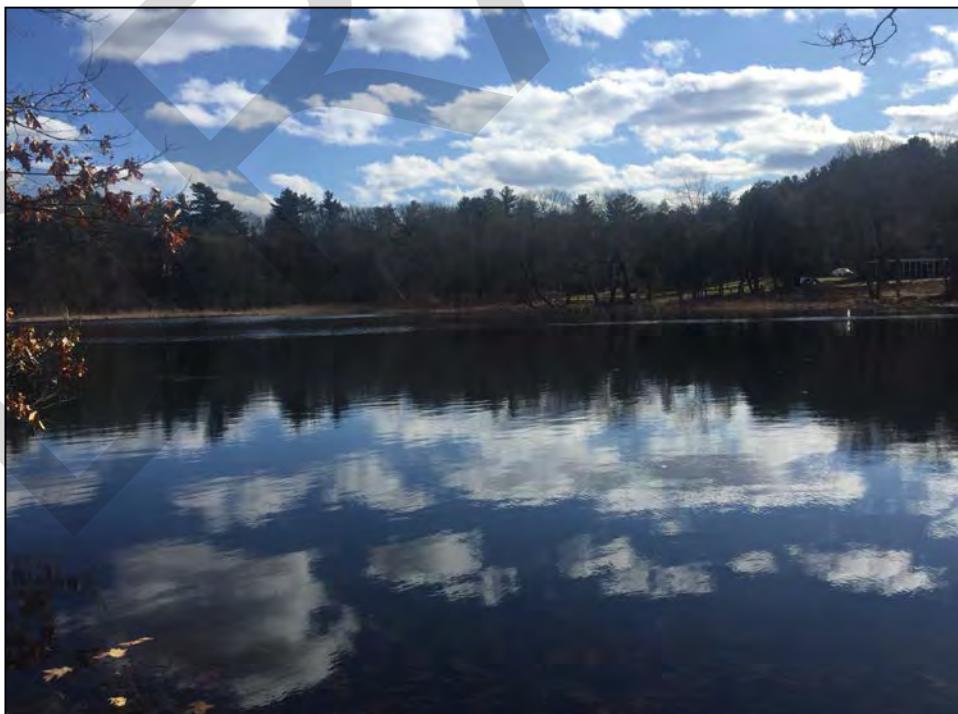
Photo No. 16: Impoundment as viewed from the right abutment.
