Re: **Follow-Up Inspection – July 2021**  
**Danielson Mill Dam (MA03351)**  
**Medfield, Massachusetts**  
(PARE Project No.: 21032.00 / Task 700)

**Commonwealth of Massachusetts  
Department of Conservation and Recreation  
Office of Dam Safety Poor Condition Dam Follow-up Inspection Form**

**Dam Name:** Danielson Mill Dam

**Nat. ID Number:** MA03351

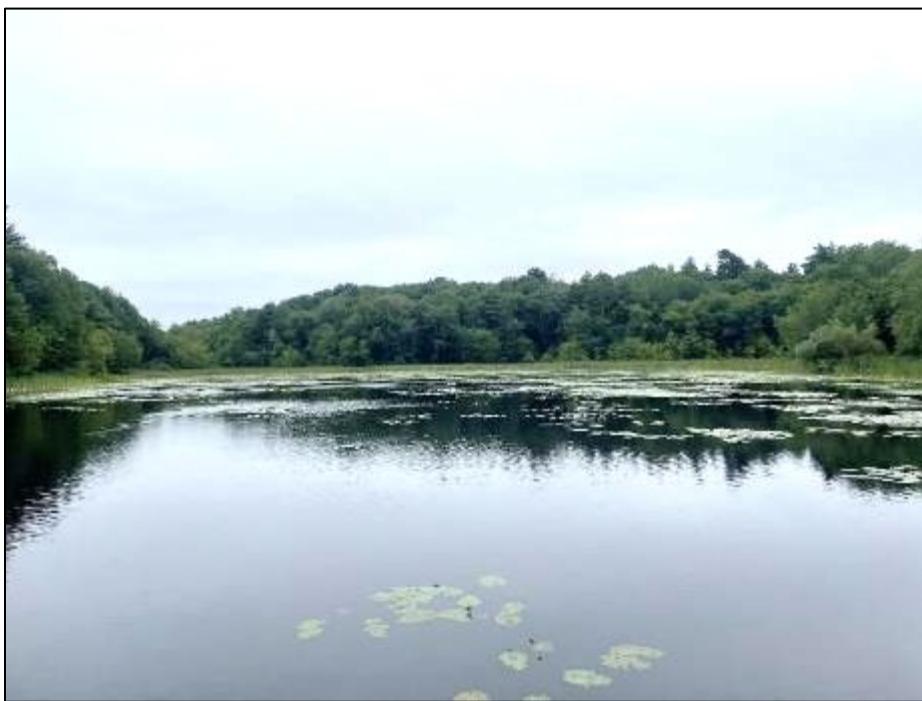
Photo No. 1.: Overview of the impoundment, Danielson Mill Pond, from the spillway looking upstream.

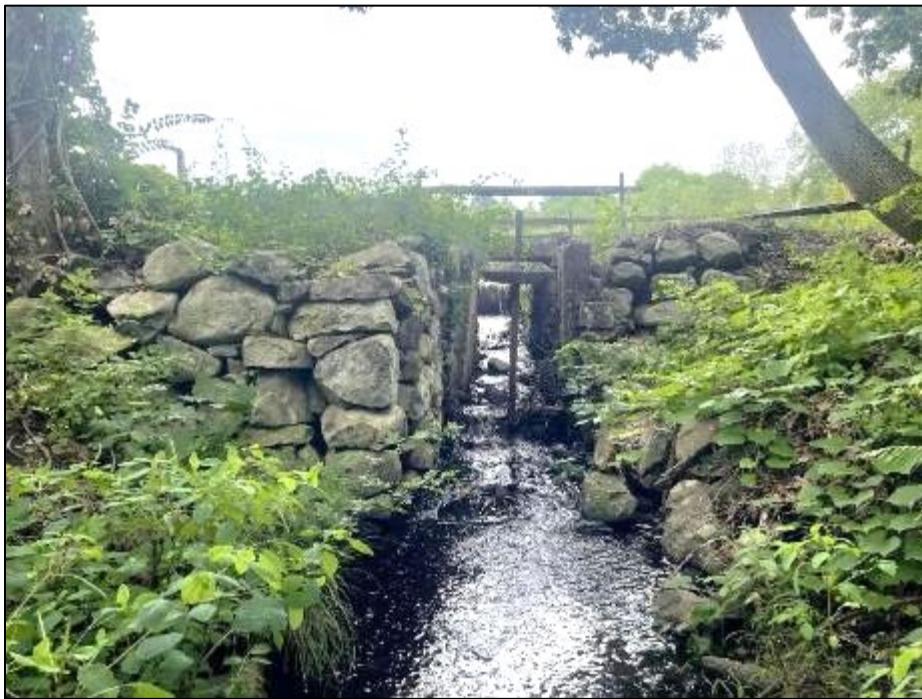
Photo No. 2.: Overview of the dam from the downstream channel looking upstream.

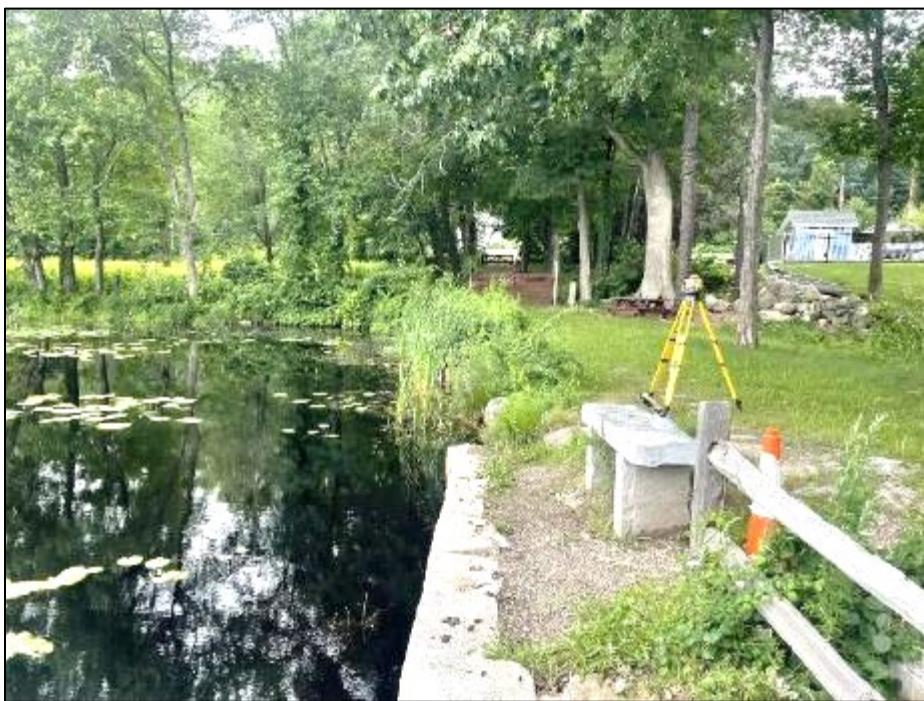
Photo No. 3.: Upstream side from the spillway looking left.

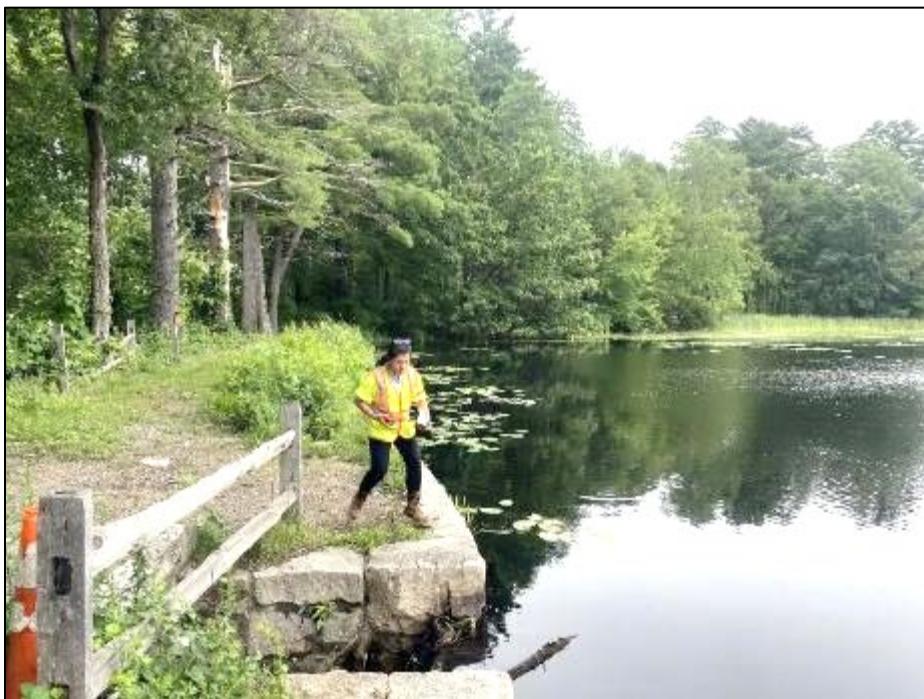
Photo No. 4.: Upstream side from the spillway looking right.

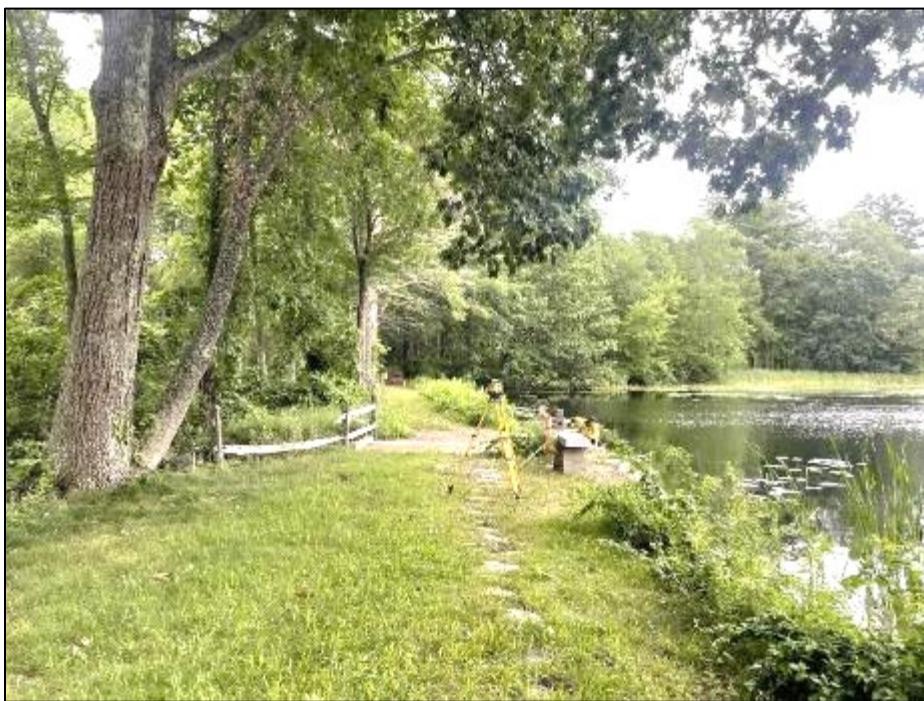
Photo No. 5.: Crest from the left abutment looking right.

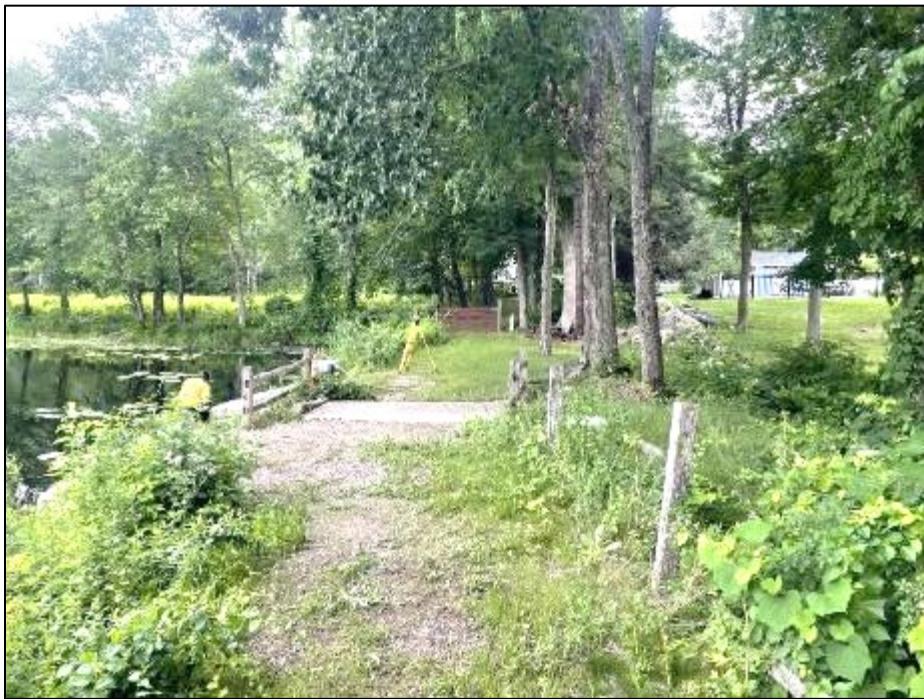
Photo No. 6.: Crest from 50 feet right of the spillway looking left.

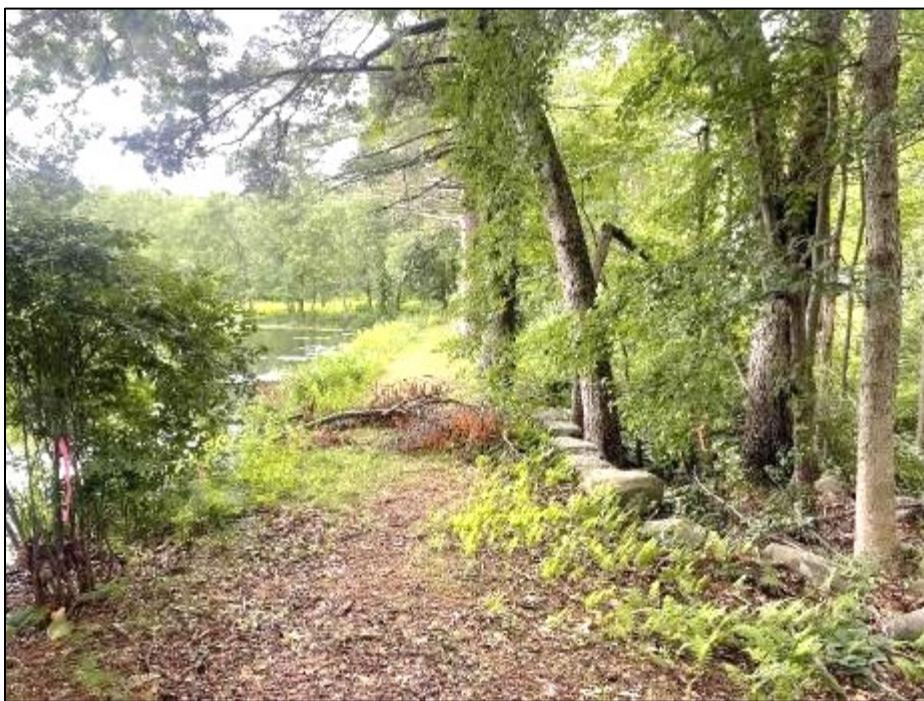
Photo No. 7.: Crest from the right abutment looking left.

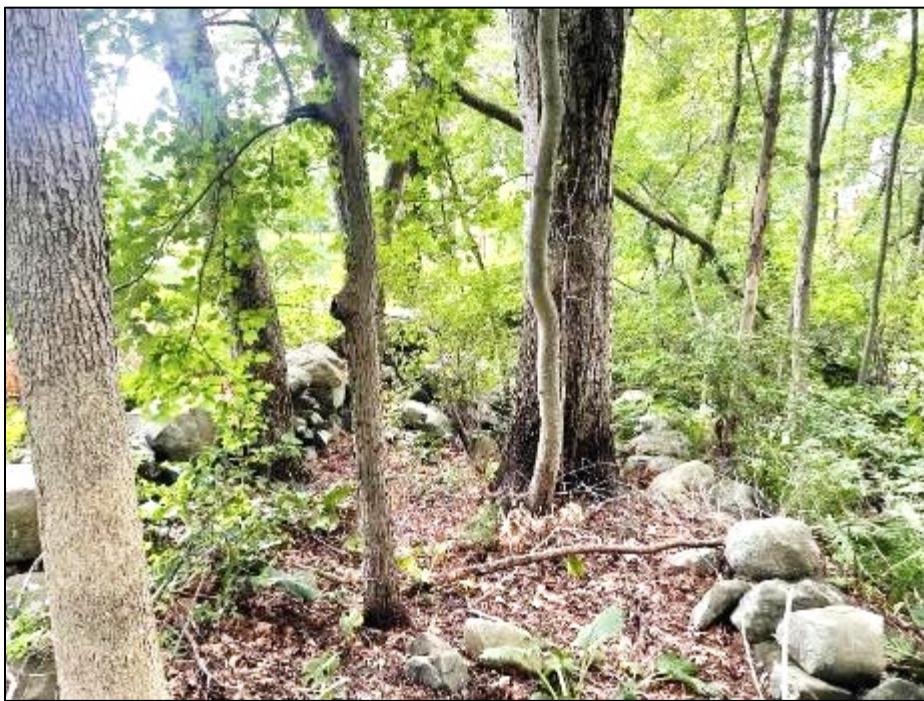
Photo No. 8.: Downstream side of the dam from the right abutment looking left.

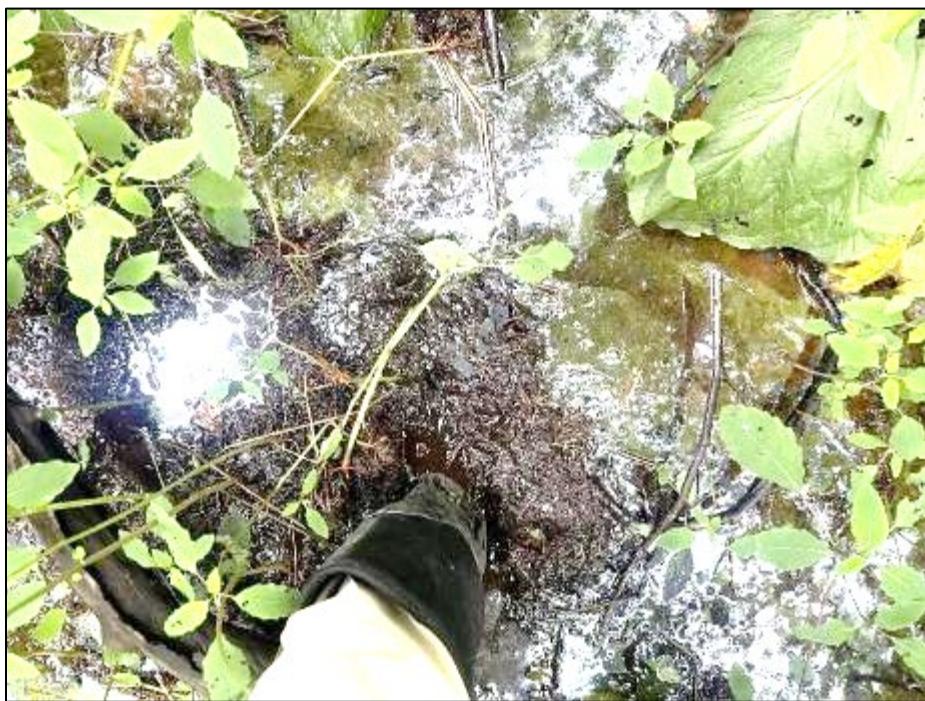
Photo No. 9.: View of the soft saturated ground surface with ponded waters that is typical within the majority of the downstream area right of the spillway.

- c) Evaluate seepage and saturation along the downstream side of the dam.
  - d) Complete a stability analysis for the embankment and gravity walls.
- ii. Recurring Monitoring and Maintenance*

- a) Modify the dam to accommodate the 100-year SDF.
- b) Pending result of the seepage evaluation, develop and install a seepage mitigation system at the dam to address the seepage concerns along the downstream side of the dam.
- c) Rehabilitate / reconstruct the spillway system to address the noted concerns.

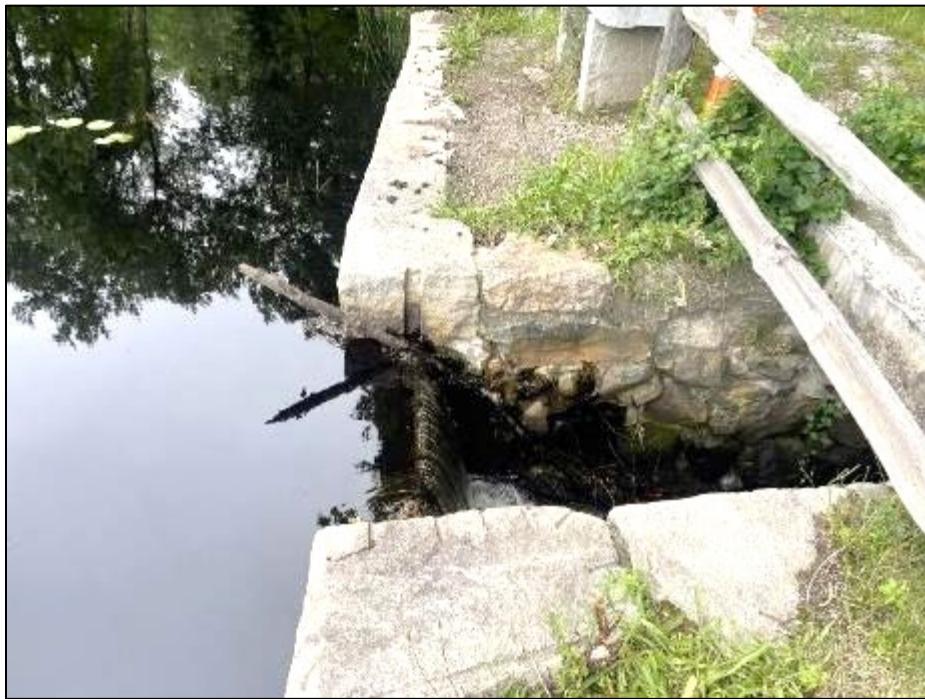
- ii. Flows over the spillway stop logs limited a detailed inspection of the spillway controls and channel; however, there were no significant changes apparent.

Photo No. 10.: Control section of the spillway looking left.

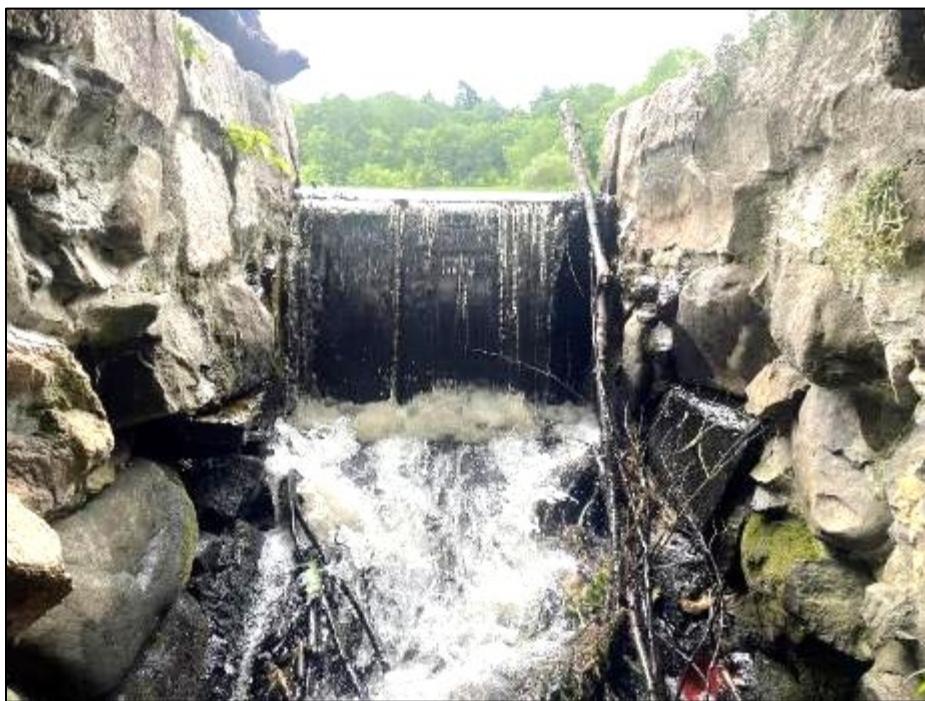
Photo No. 11.: Downstream face of the spillway control section looking upstream.

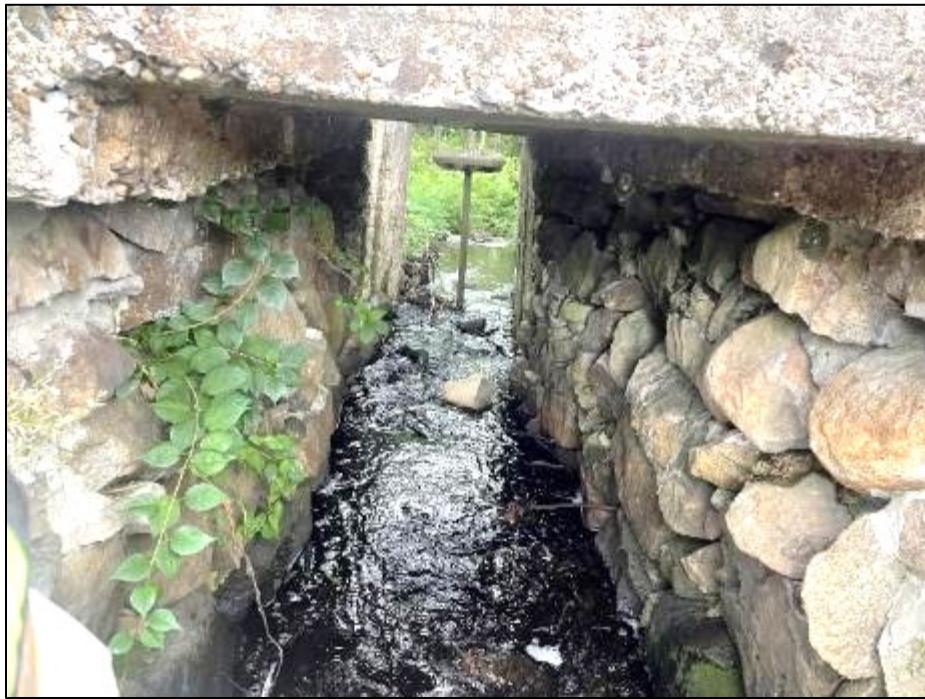
Photo No. 12.: Discharge channel of the spillway from the control section looking downstream.

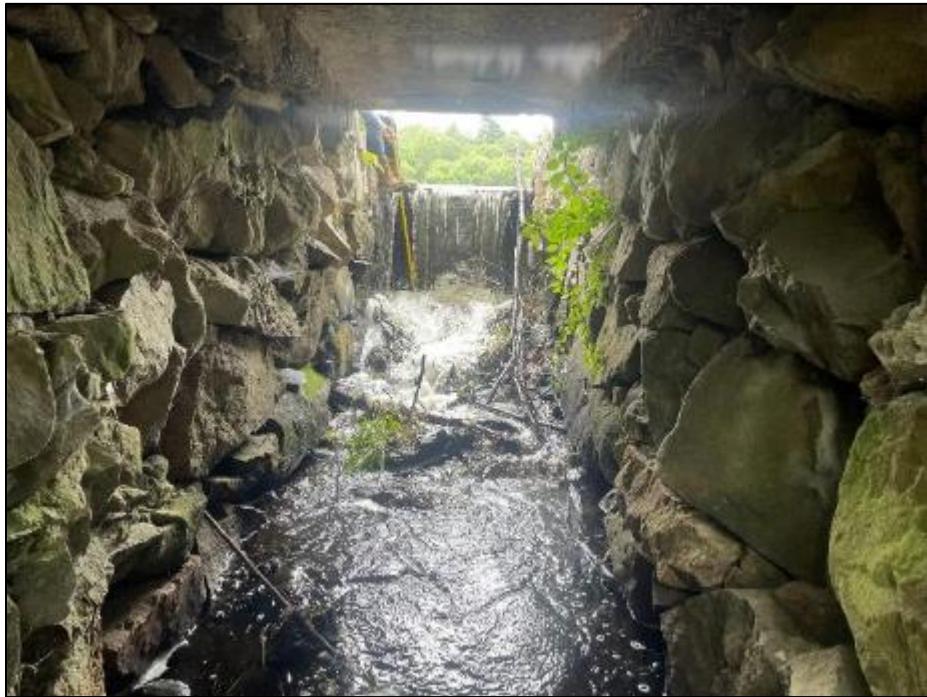
Photo No. 13.: Discharge channel of the spillway from the downstream end looking upstream.

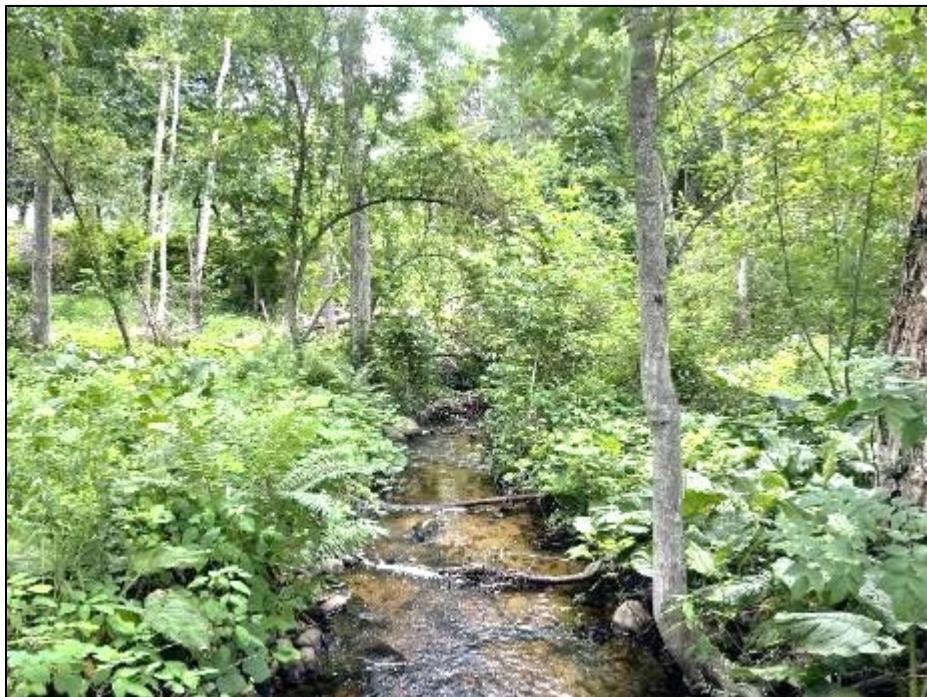
Photo No. 14.: Downstream channel from the downstream end of the spillway channel looking downstream.
