February 21, 2020

Re: **Danielson Mill Dam (MA03351)**
Hazard Potential Classification Review
Medfield, Massachusetts
Pare Project Number: 19126.00

The following report presents the Hydrologic and Hydraulic (H&H) analysis and hazard classification review completed by Pare Corporation (Pare) for the Danielson Mill Dam in Medfield, Massachusetts. In accordance with our scope of work, hydrologic and hydraulic evaluations and dam break analyses were completed to determine potential impacts to infrastructure in the downstream area associated with a failure of the Danielson Mill Dam.

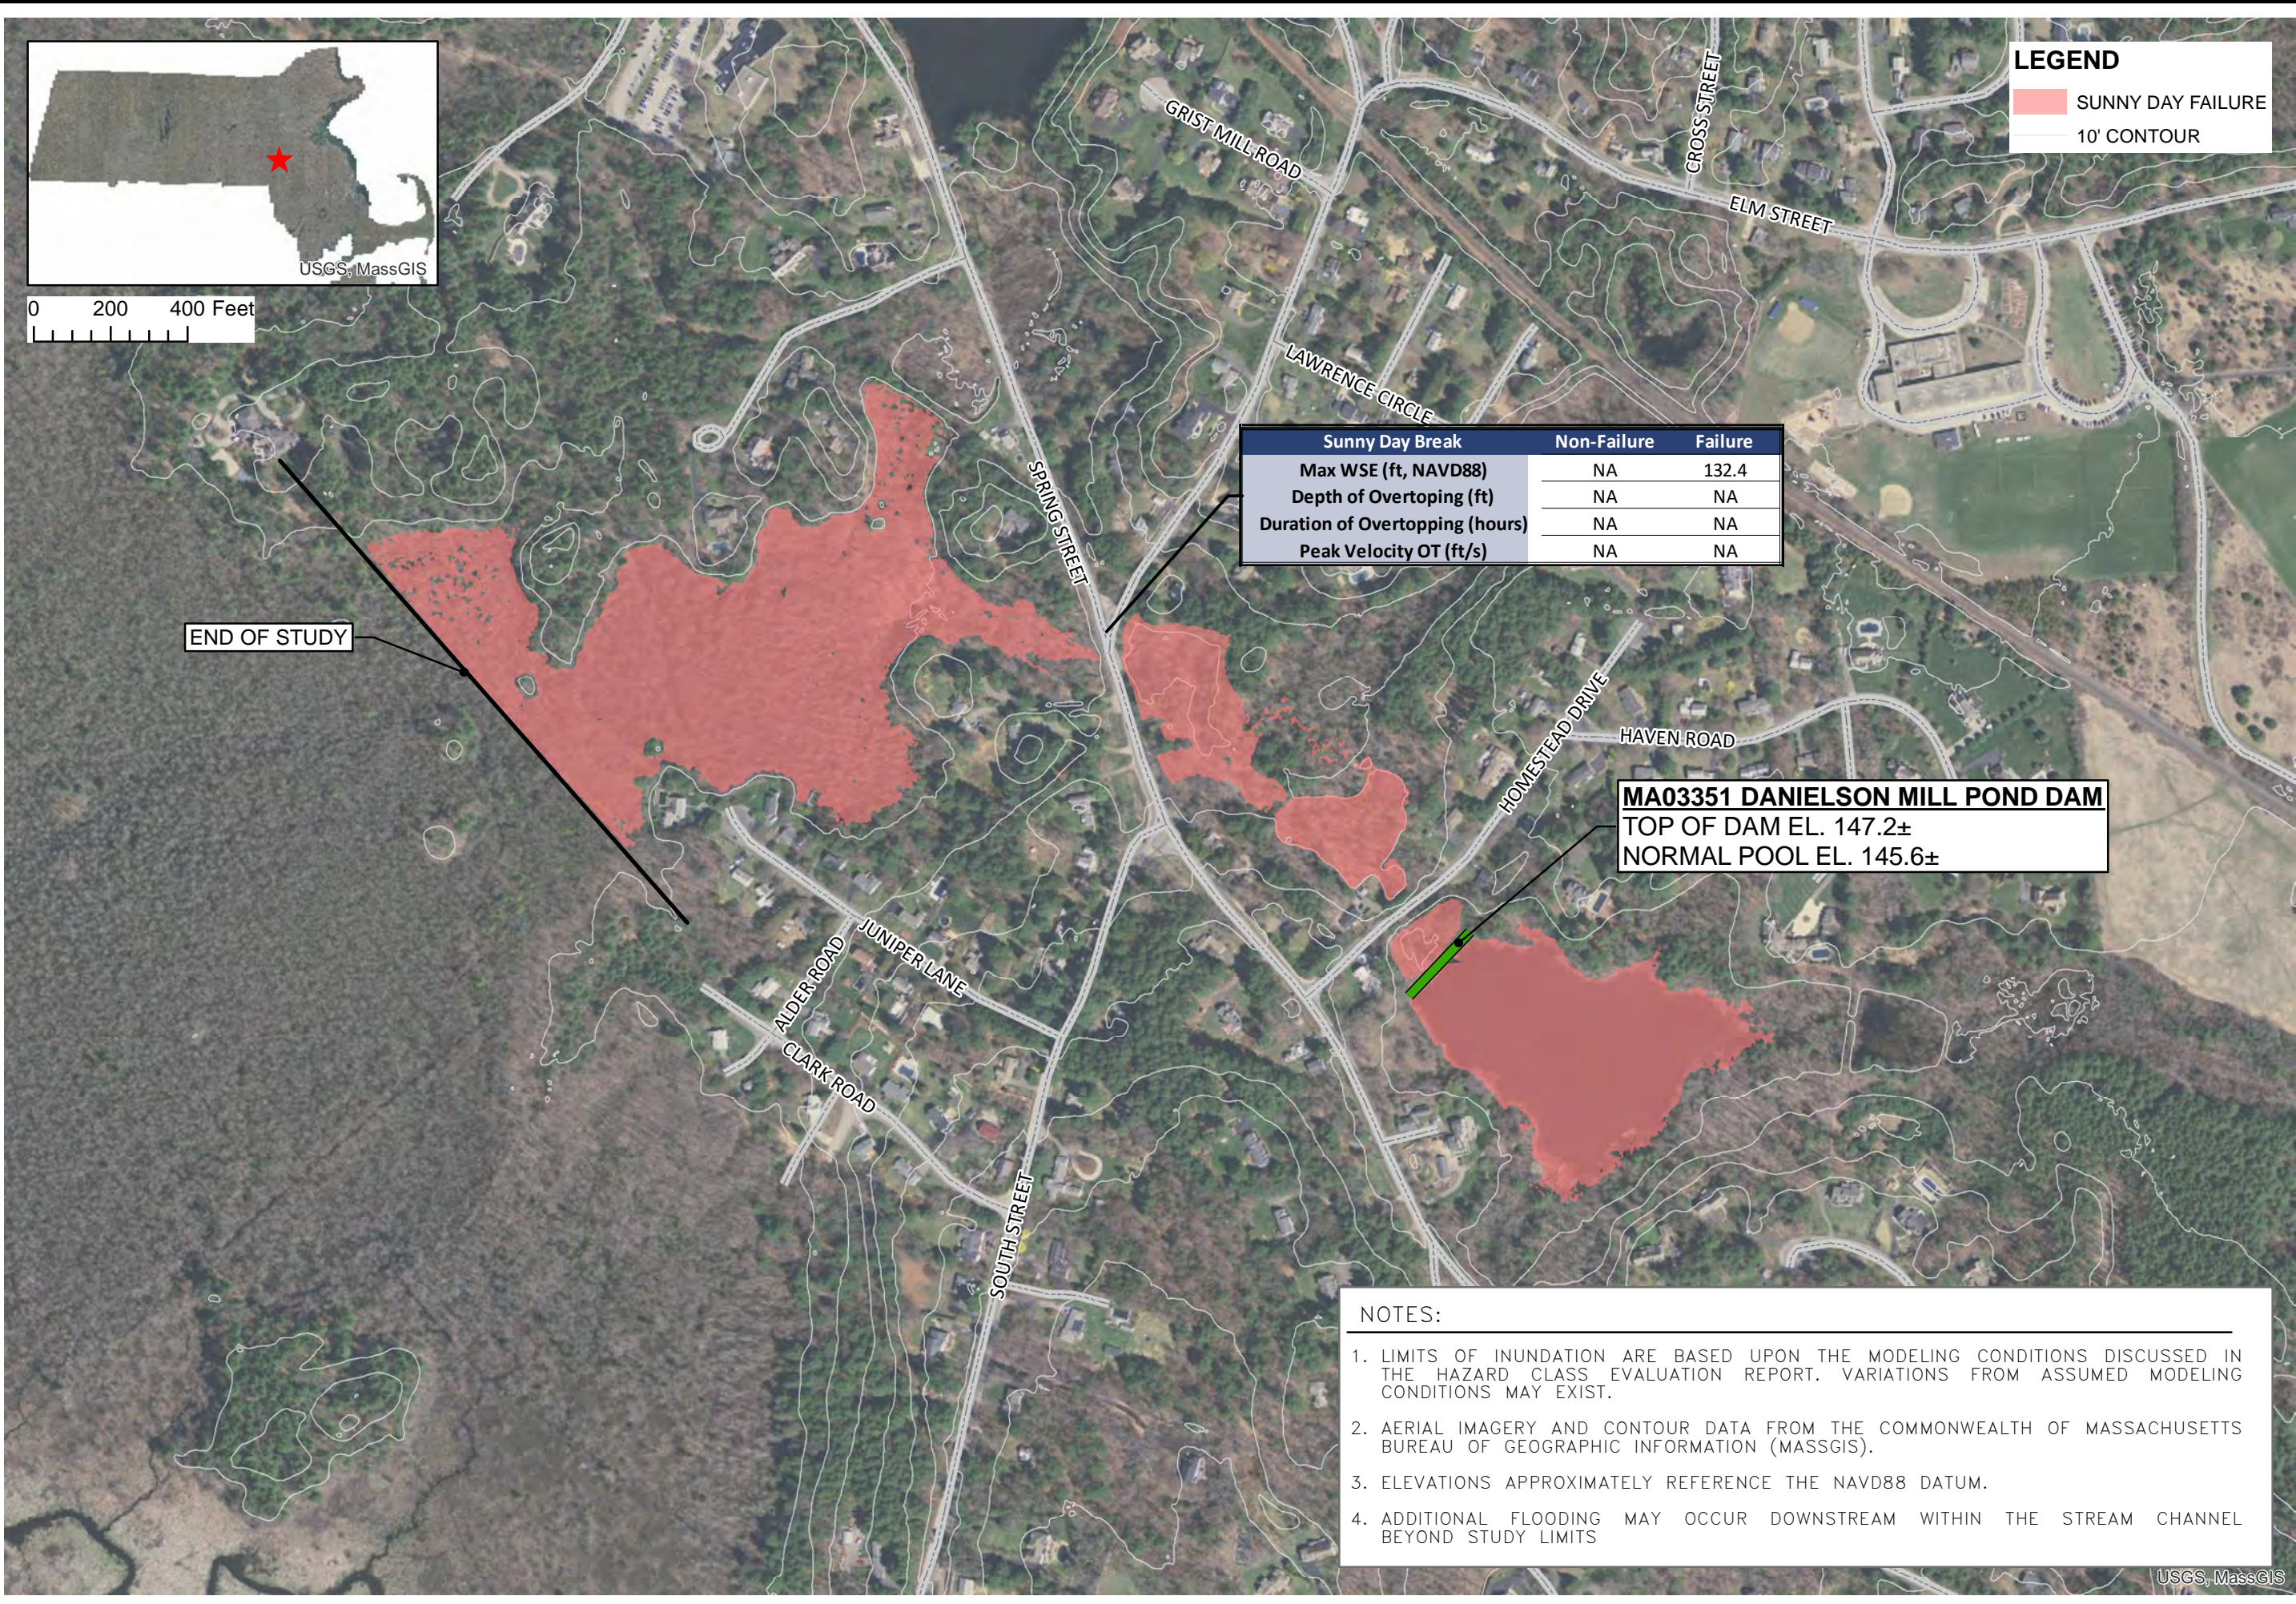
FIGURE 3A
SUNNY DAY
INUNDATION
MAP

Sunny Day Break	Non-Failure	Failure
Max WSE (ft, NAVD88)	NA	132.4
Depth of Overtopping (ft)	NA	NA
Duration of Overtopping (hours)	NA	NA
Peak Velocity OT (ft/s)	NA	NA

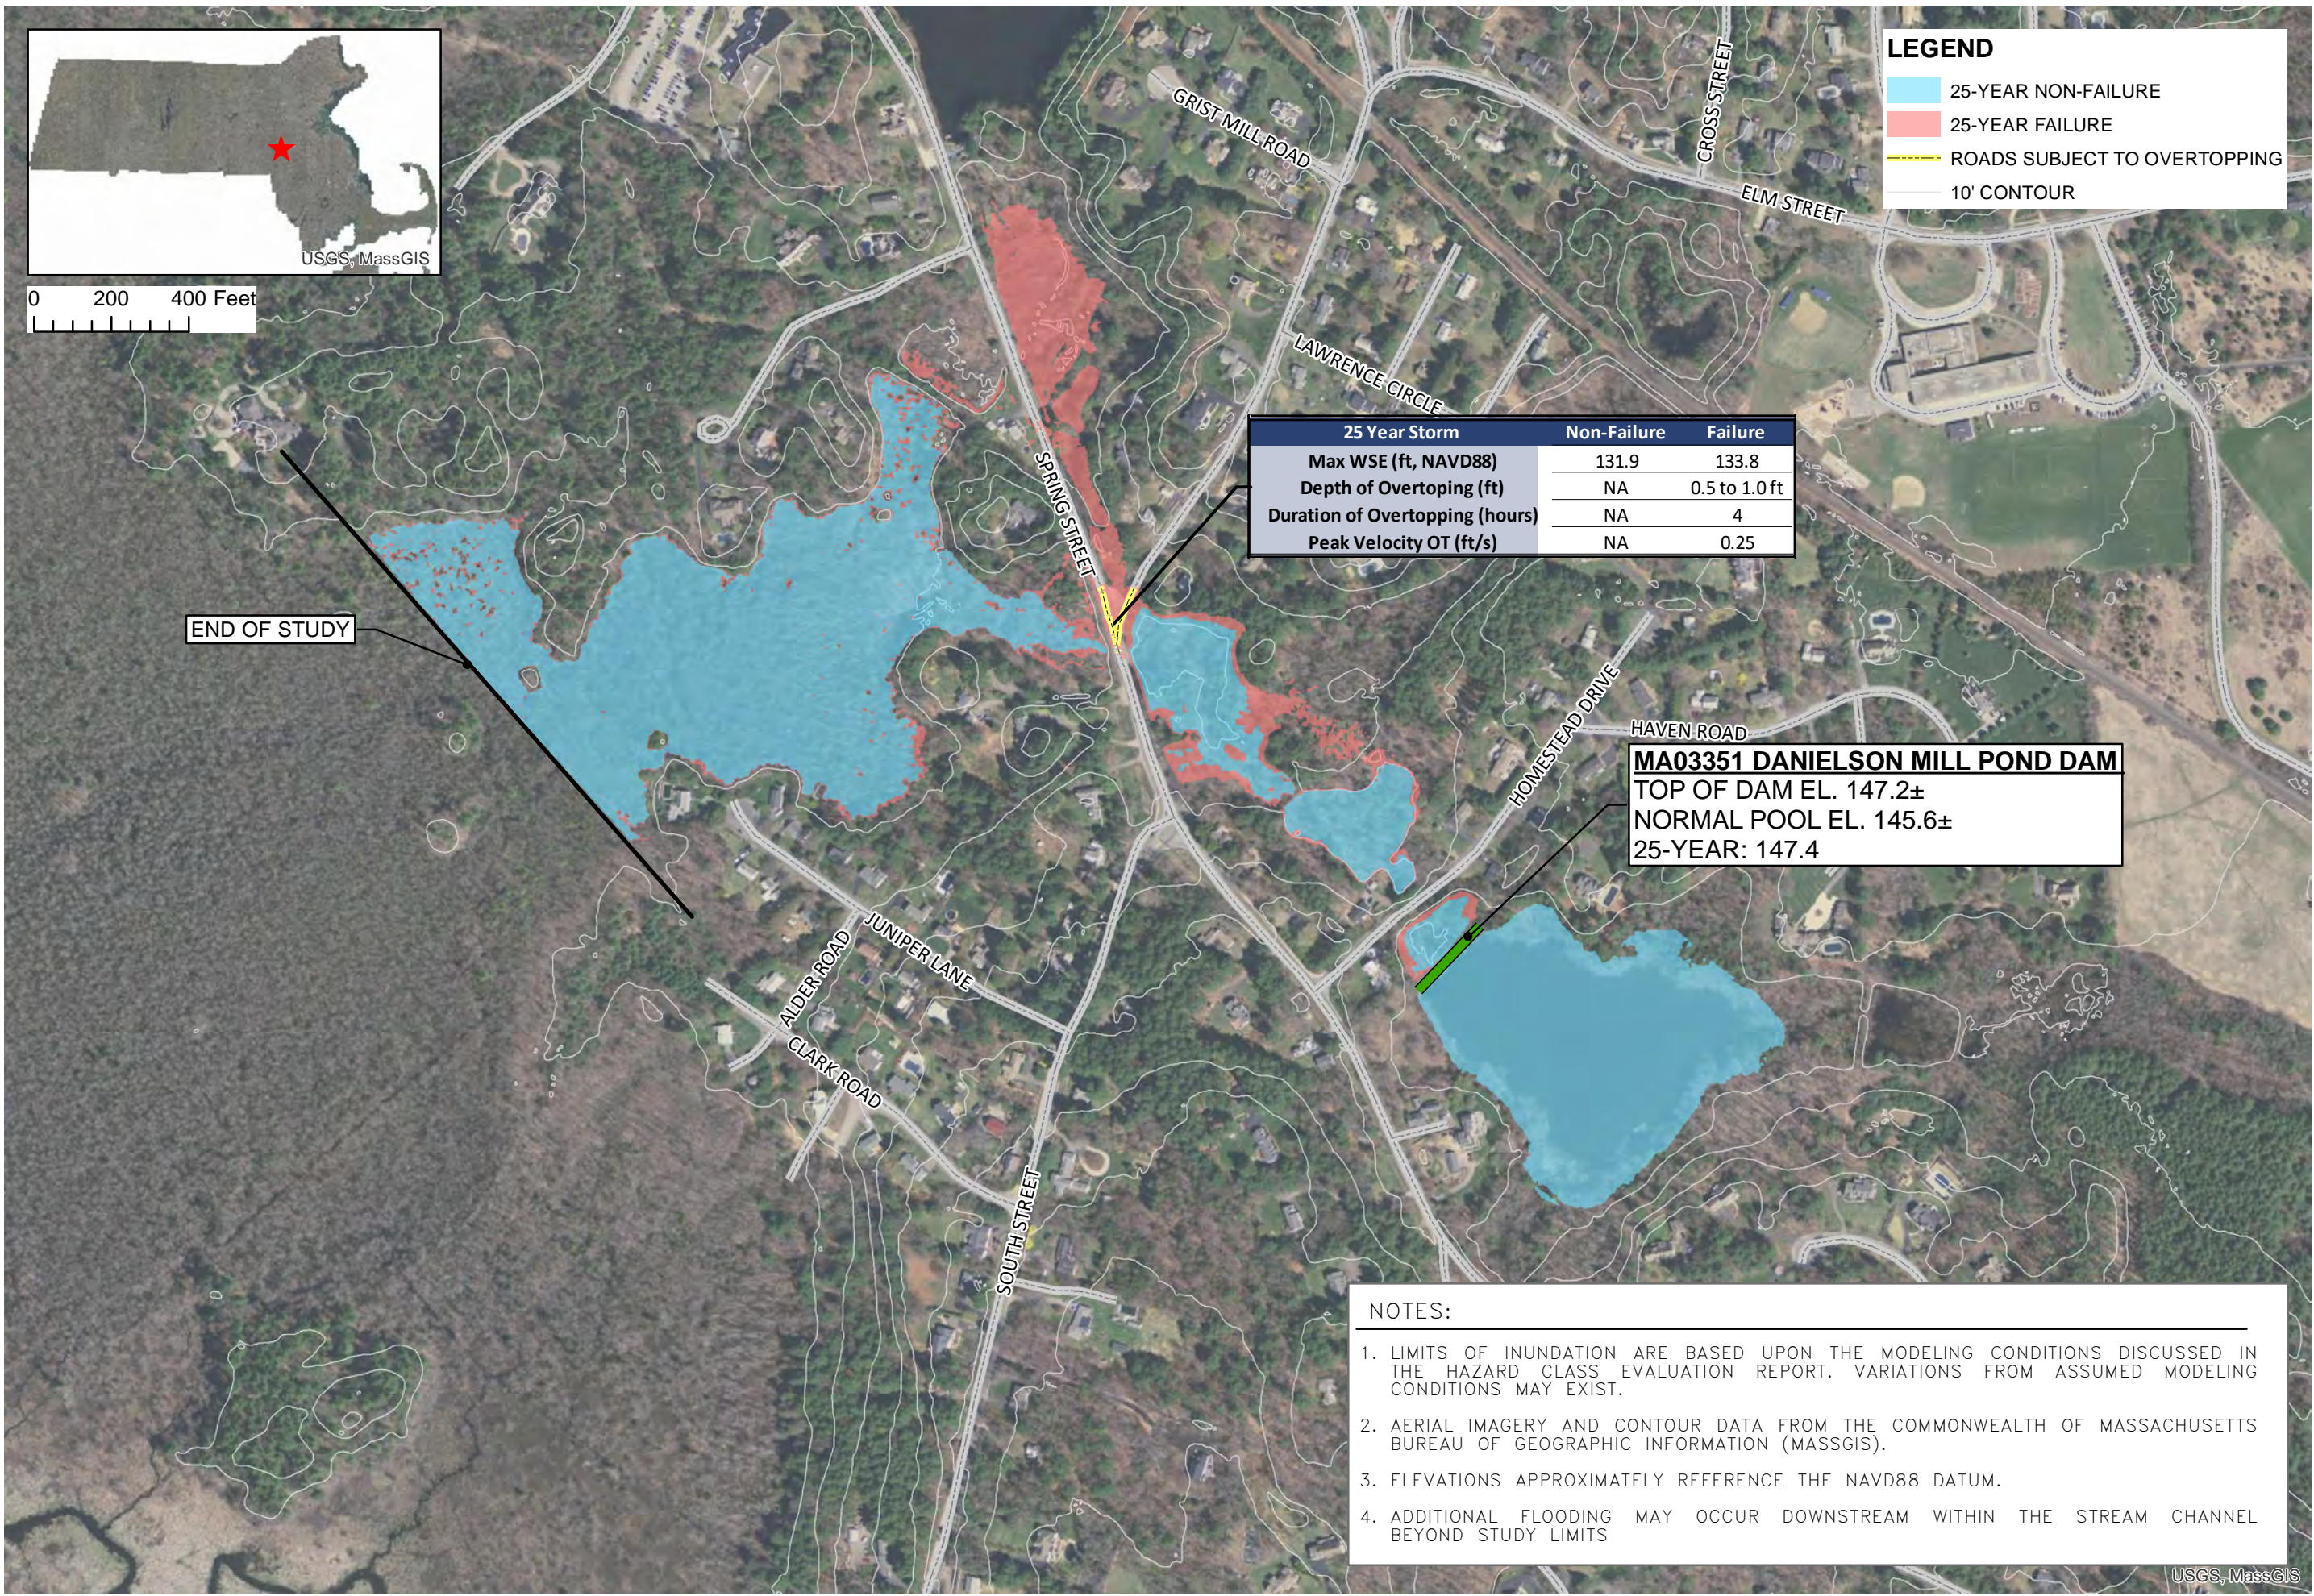
FIGURE 3B
25 YEAR
INUNDATION
MAP

25 Year Storm	Non-Failure	Failure
Max WSE (ft, NAVD88)	131.9	133.8
Depth of Overtopping (ft)	NA	0.5 to 1.0 ft
Duration of Overtopping (hours)	NA	4
Peak Velocity OT (ft/s)	NA	0.25
