DANIELSON MILL DAM

PHASE I

INSPECTION / EVALUATION REPORT

Date of Inspection: June 30, 2020

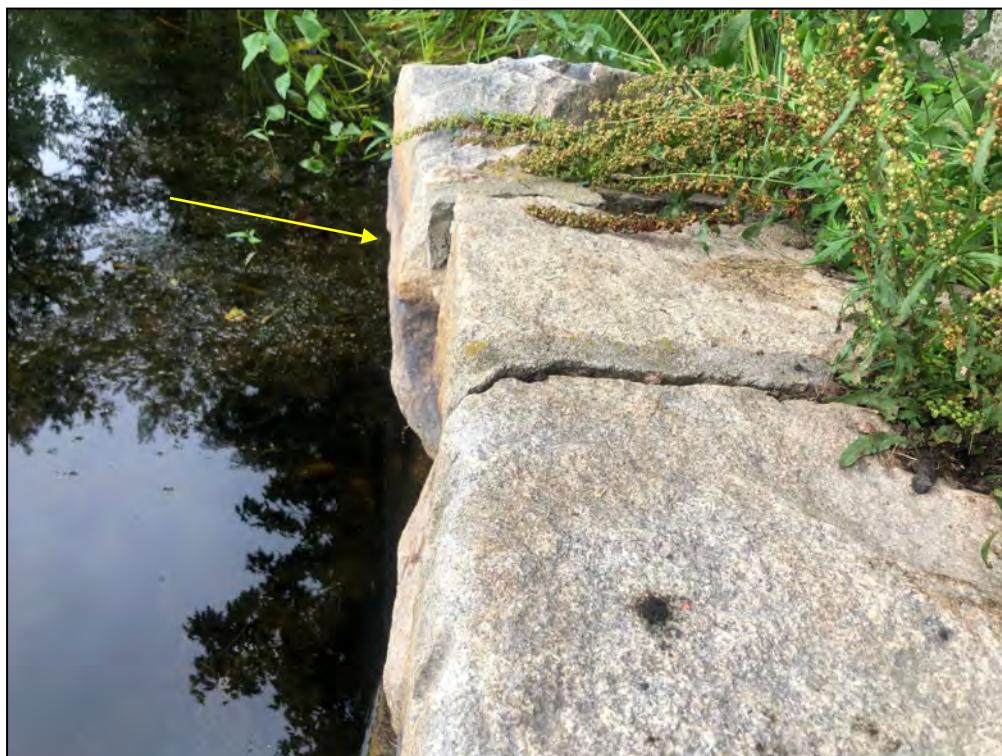
- Between STA 0+70 to the spillway and from the spillway to STA 1+00, the upstream slope consisted of a granite block wing wall.
 - The mortar within the joints was cracked and deteriorated with slight separation between stones.

Photo No. 4: Left end of the upstream wall. Note movement of the wall towards the impoundment.

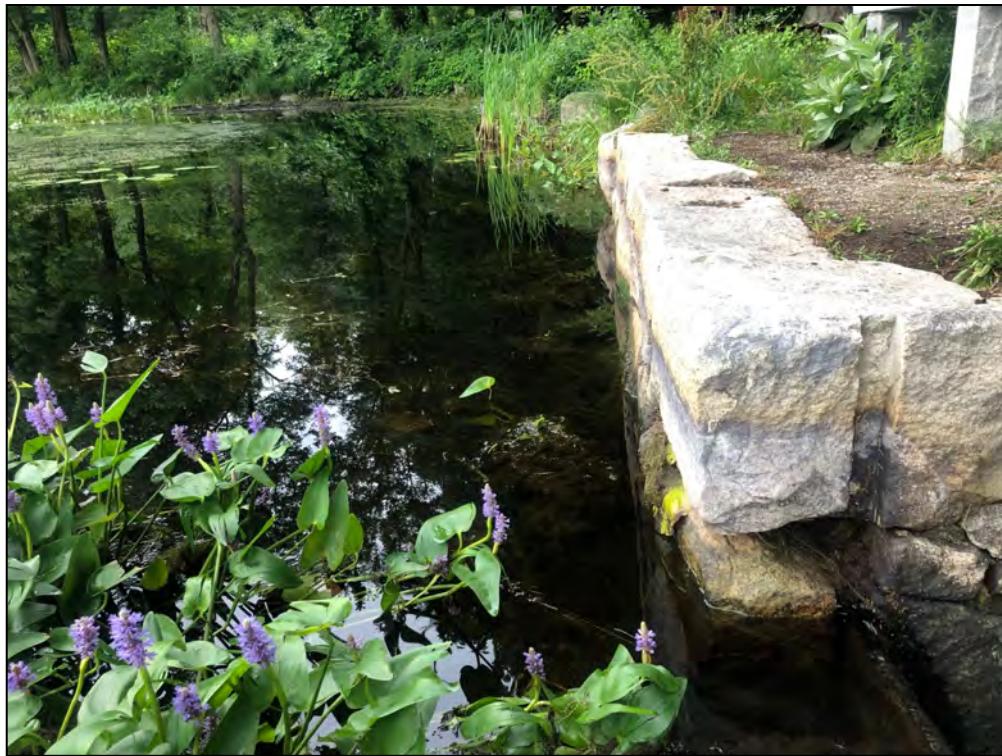
- Voids were present between stones. Animals, specifically snakes, were noted burrowing within the voids in the wall.
 - Depressions/sinkholes were noted at the following areas:

Photo No. 5: Upstream wall from the spillway looking left. Note voids within the wall.

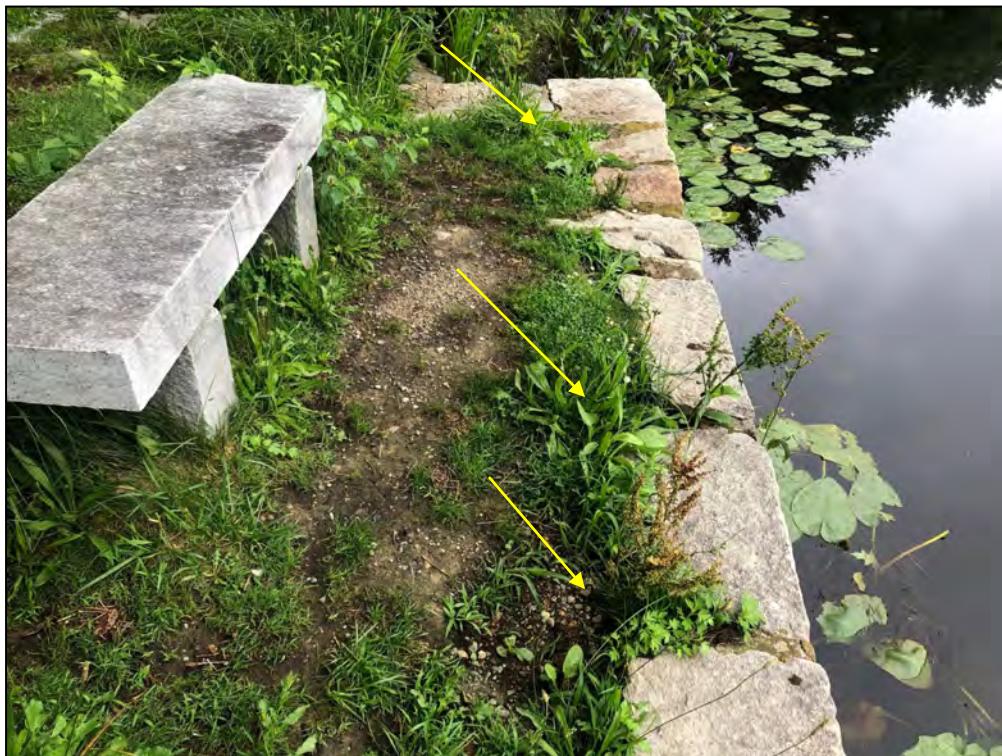
- STA 0+70: 1-inch deep
 - STA 0+90: 2-inches deep
 - STA 0+95: 2-inches deep
 - STA 1+00: 2-inches deep
- Between STA 1+00 and 1+75, the upstream slope consisted of riprap. Vegetation blocked full viewing of the slope in this area. No indications of gross movement was noted.

Photo No. 6: Upstream wall from the spillway looking right. Note arrows pointing to sinkholes behind wall.

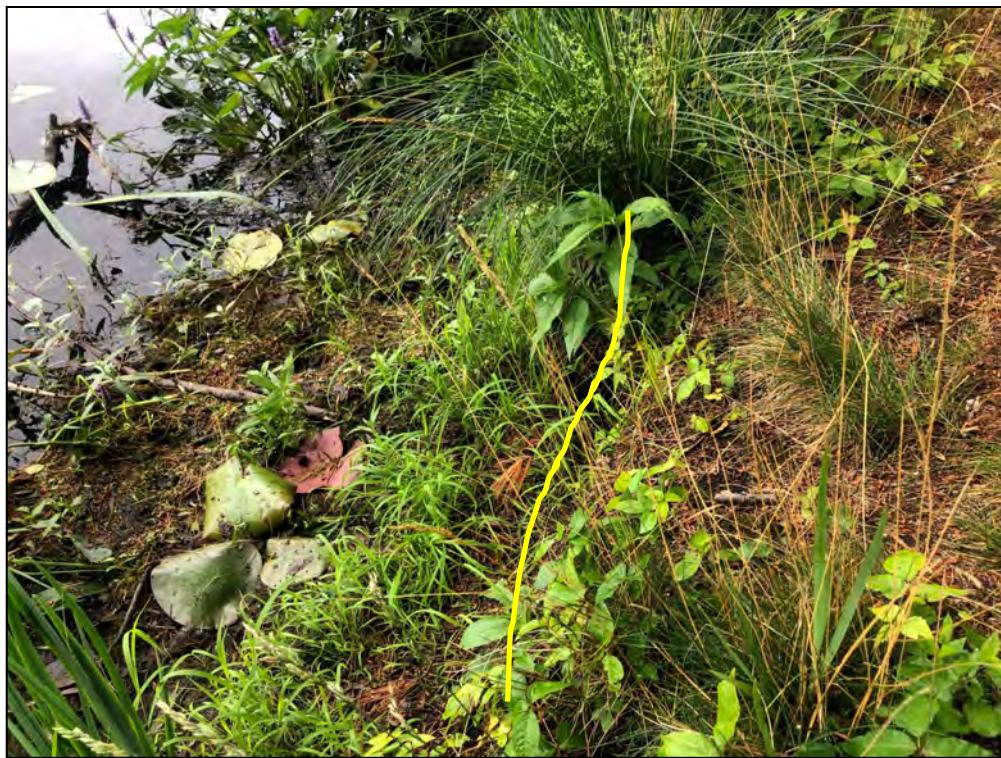
- Between 1+75 and the right abutment, the slope was unprotected. Scarping up to 12 inches deep was noted within this area.
- Abutment contact appeared good.

Photo No. 7: Scarping on the unprotected section of the upstream slope, near STA 2+00.

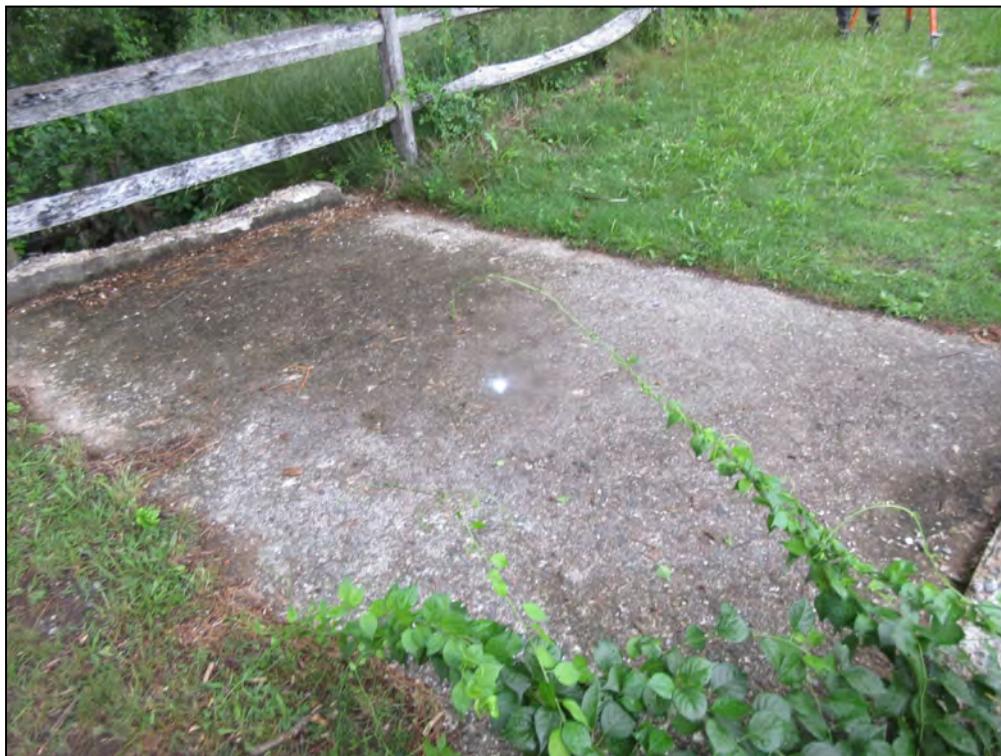
Photo No. 10: Concrete slab over the spillway near STA 0+85.

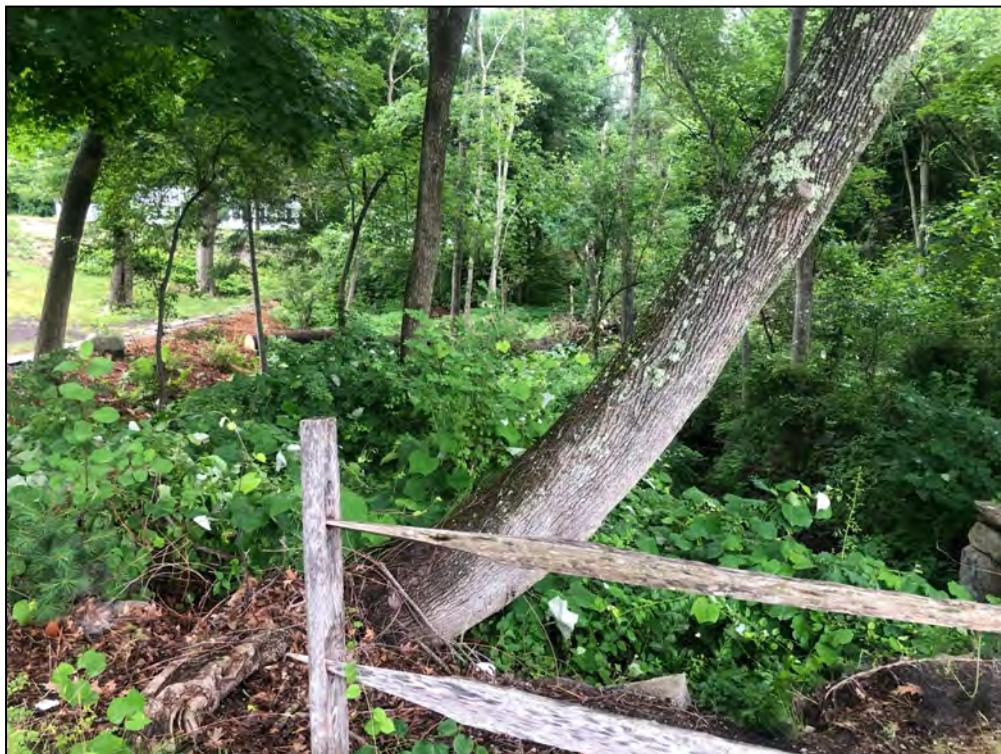
- The trees were leaning toward the downstream area at STA 1+45 1+50, and 1+75.
 - The tree located at STA 0+80 was noted to be leaning towards the downstream channel with a large root system observed going towards the crest center.

Photo No. 12: Large leaning tree to the left of the spillway near STA 0+80.

10. Remove unwanted vegetation from the crest to 20 feet beyond the downstream toe for the full width of the dam, including dead and dying conifers along the downstream crest, right side. Root ball removal and replacement with select backfill will be required.

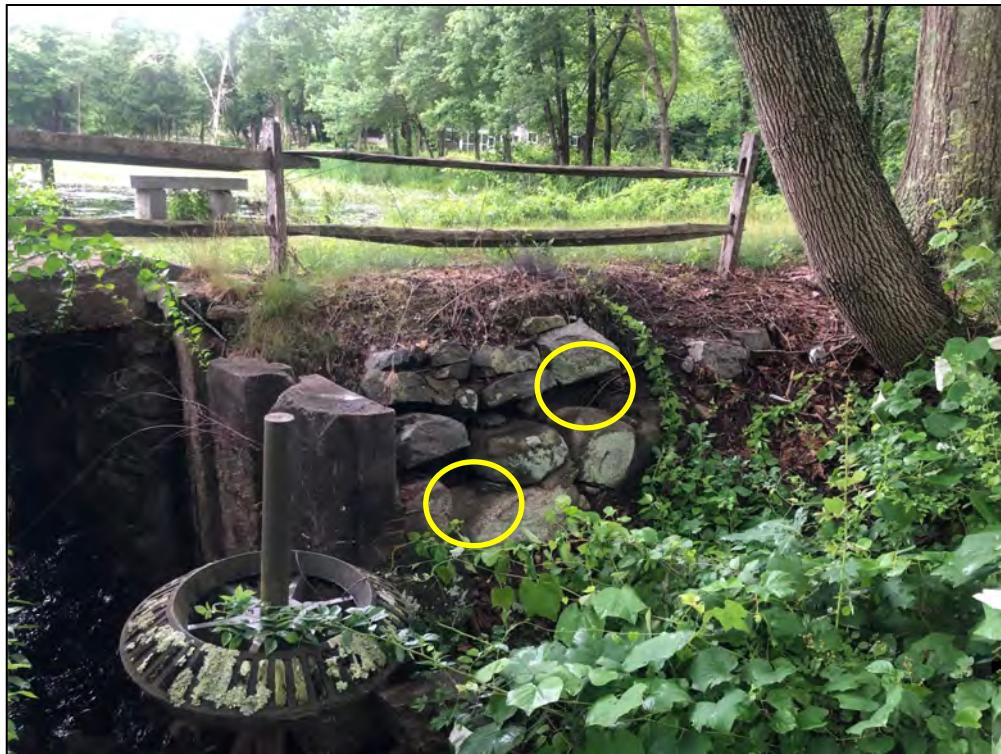
- The stone wall located from the spillway to STA 0+75 was in poor condition with voids that were probed to 48-inches.
- Abutment contact appeared good.

Photo No. 15: Stone wall to the left of the spillway. Note large voids that were probed to 48-inches.

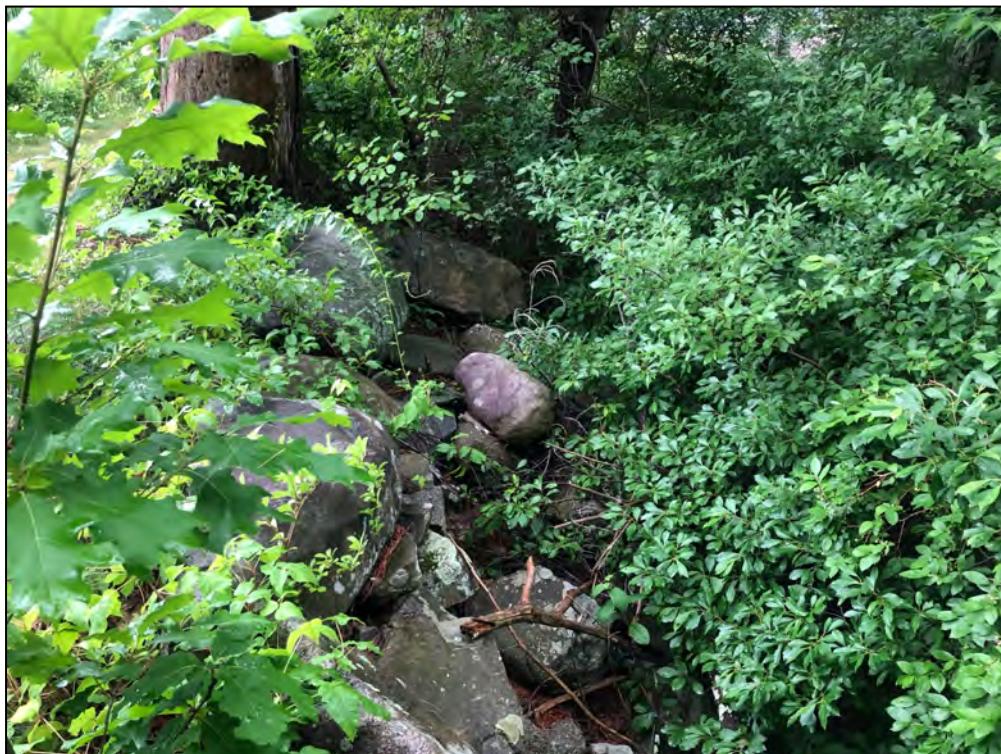
- The dry stacked stone wall from the spillway to the right abutment was in poor condition with large voids, failed areas, and an irregular alignment. The wall appeared to have failed near STA 2+10.

Photo No. 16: Downstream slope from near STA 1+75 looking left. Note irregular wall that appears to be failed.

8. Rehabilitate/reconstruct the spillway system.
9. Remove the downstream boulder wall and replace with a protected, earthen slope or rebuilt, fully grouted, boulder masonry gravity wall.

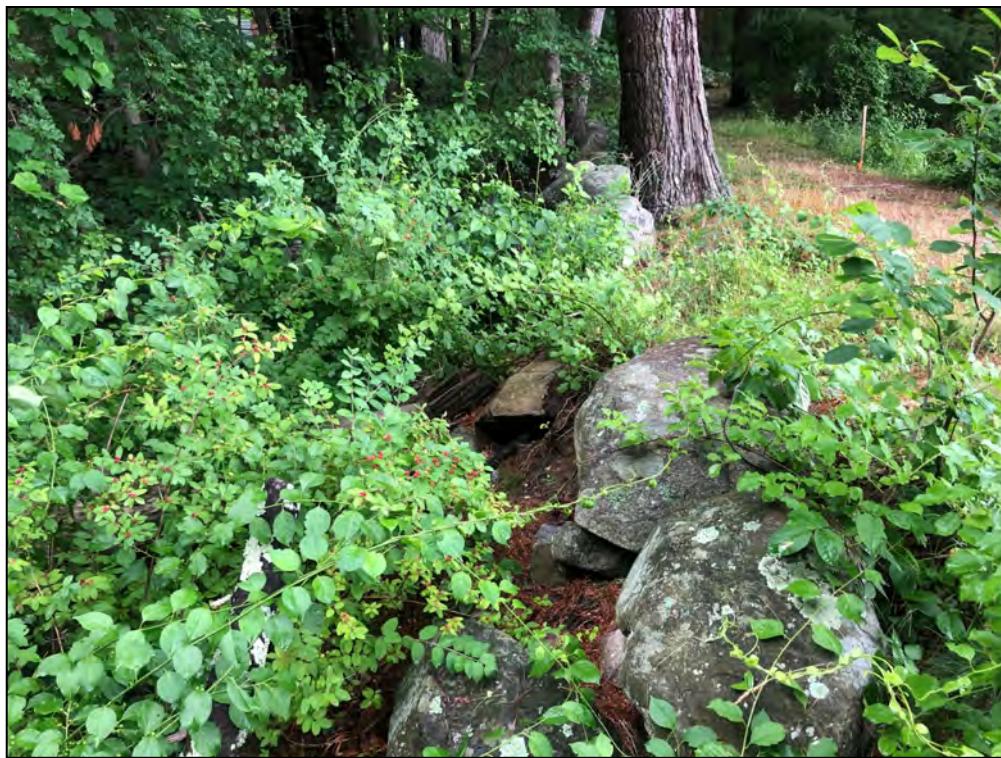
Photo No. 17: Downstream slope from near STA 1+75 looking right. Note large tree at top of slope.

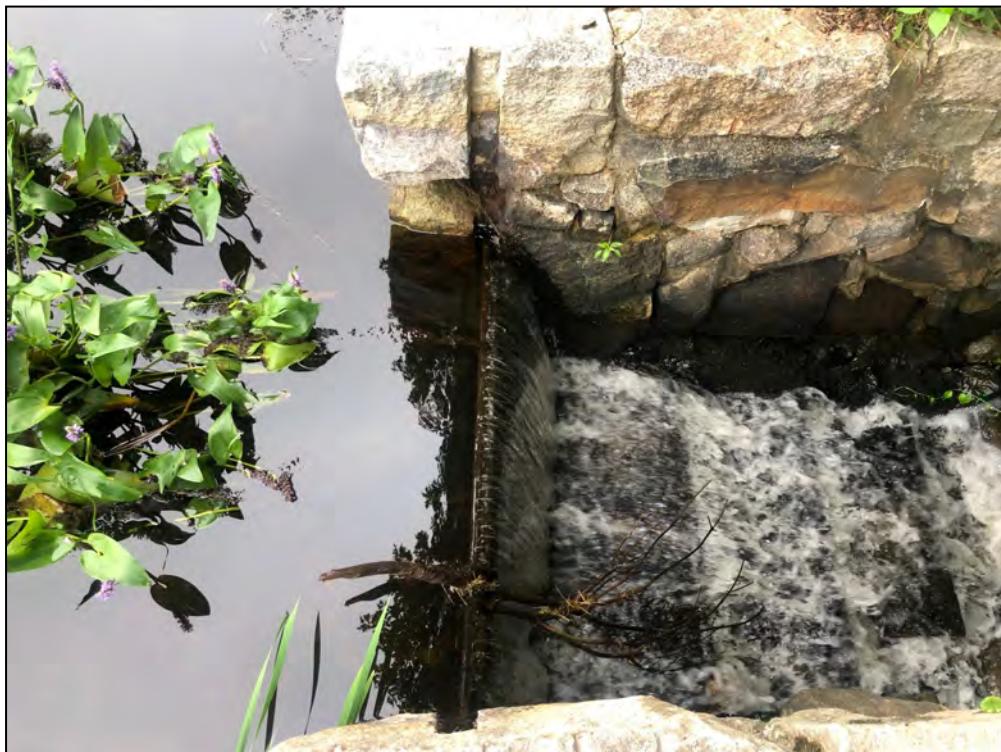
Photo No. 18: Approach and overview of the spillway. Note vegetation and debris.

2. Regular maintenance activities should be continued to control and prevent further growth of unwanted vegetation, and remove accumulated debris from the spillway and discharge channel, as was noted in areas during the inspection. Mowing grass should be performed at least twice per year (i.e., late spring and fall). Mowing and fertilizing should be continued and performed at least twice per year. Mowing at longer intervals will likely require that the clippings be bagged and disposed of offsite or fully mulched to limit the build-up of thatch and the potential for choking of the grass. All cuttings from brush or other vegetation should be removed from the site and properly disposed.
3. Routinely review, update, and exercise the Emergency Action Plan.

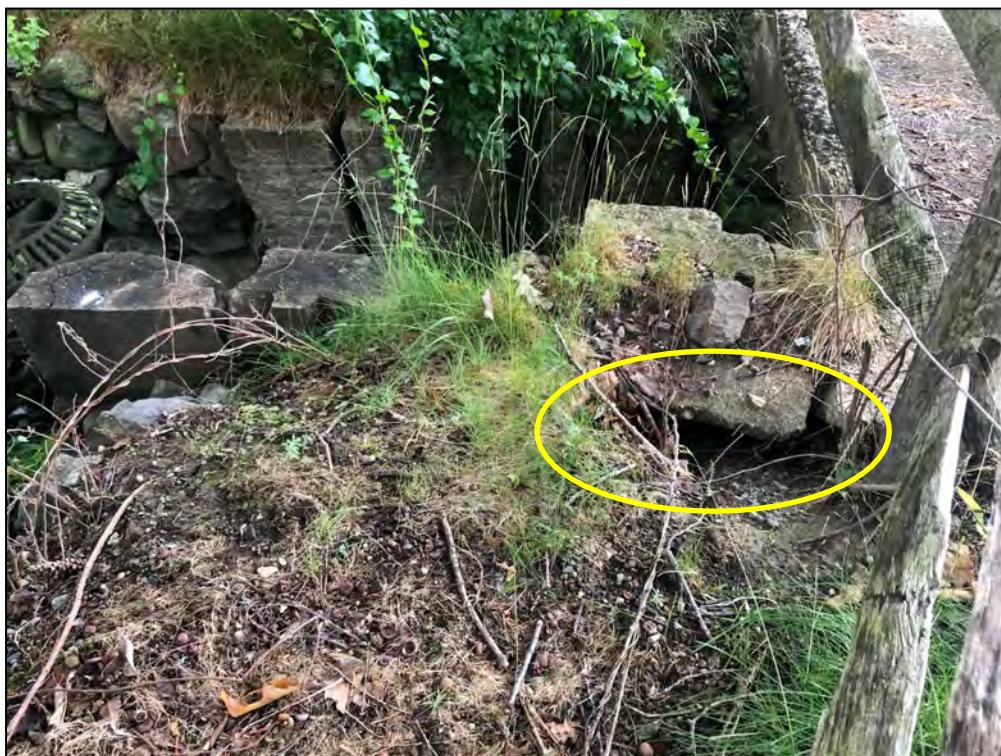
- No leakage was observed during the inspection; However, leakage has been previously reported through the stone masonry channel training walls.
- Erosion/sloughing of the soils behind the concrete section of the training walls was noted.
- Debris, including branches, logs, and vegetation, was present within the downstream channel. The capacity of the spillway does not appear to be affected by the debris.

Photo No. 22: Surface behind the left downstream training wall. Note apparent subsidence and sinkhole.

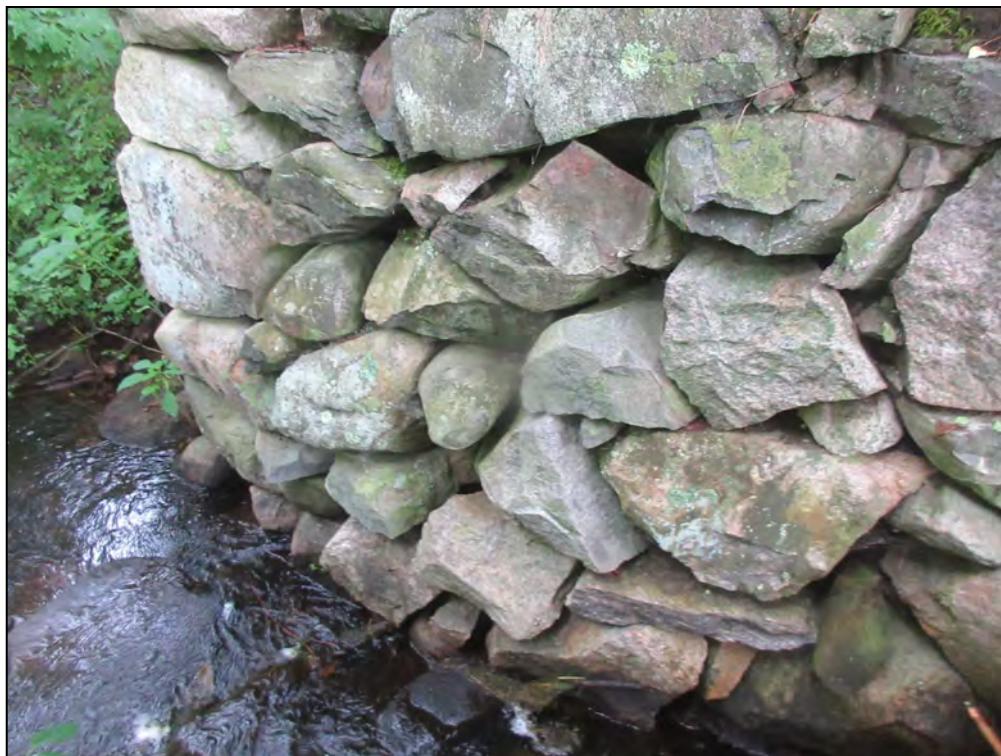
- Vegetation was developing within the approach.
- The spillway training walls were in poor condition with the following deficiencies noted:
 - Multiple voids were present within the stone training walls. Voids were present at the bottom of the concrete training walls.
 - The concrete training walls appeared to be leaning towards the channel.
 - Significant deterioration of the timber within the concrete training walls was observed.
 - A potential bulge/movement was noted toward on the downstream portion of the stone training wall.

Photo No. 23: Right downstream stone training wall. Note voids between the stones.
