## MEMORANDUM

TO: Robert Quinn, Director of Facilities, Town of Medfield  
FROM: Jim Martin, P.E., Senior Structural Engineer, Woodard & Curran  
DATE: November 15, 2024  
RE: Town of Medfield, MA  
Limited Structural Condition Assessment of PFAFF Building Exterior Masonry Walls

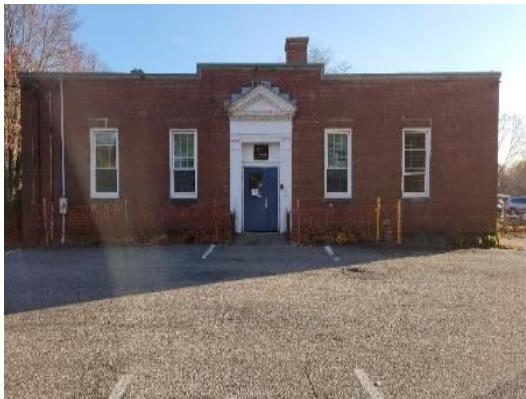
*North Elevation of PFAFF Building*

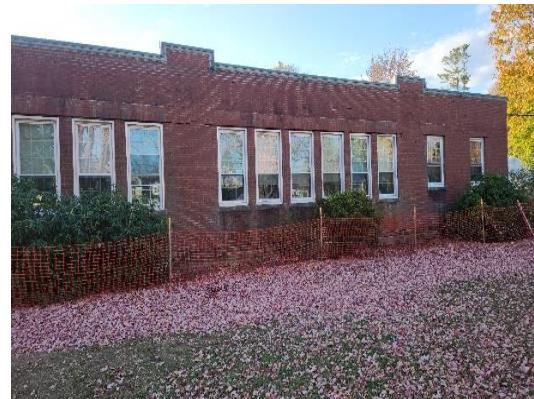
*Partial East Elevation of PFAFF Building*

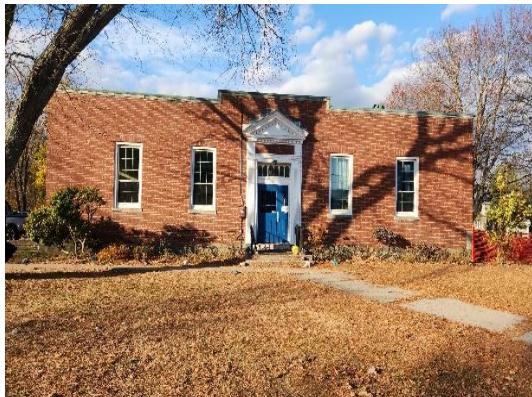
*South Elevation of PFAFF Building*

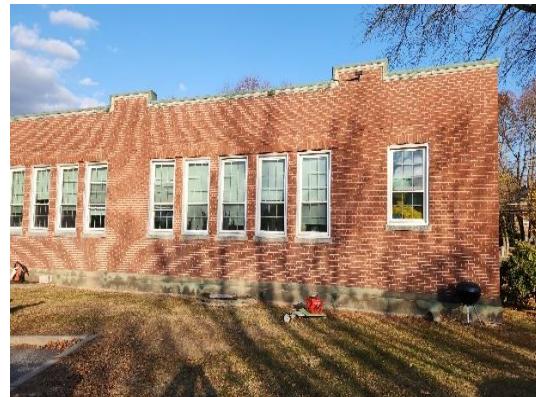
*Partial West Elevation of PFAFF Building*

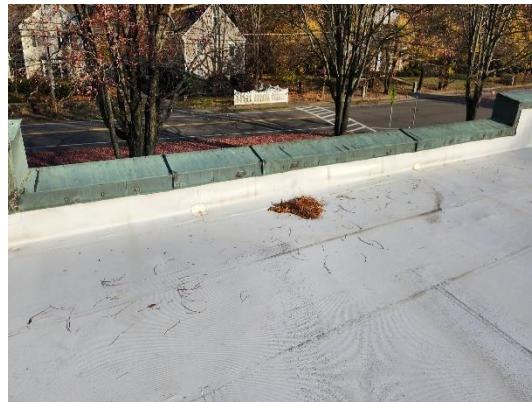
*Observations:* The existing adhered, non-ballasted EPDM roof system is in fair condition with no obvious signs of damage to the membrane, flashing, sealants or other components. The roof is approximately 15 years old (according to Town staff), with no reported roof leaks. The membrane extends up the parapet interior faces and underneath the metal coping atop the parapet walls. The metal coping has transverse seams (approximately 8 feet on center) that exhibit signs of cracking and separation to varying degrees, which provides an avenue for moisture to penetrate down through the coping and into the brick wall system. There is a brick chimney in the northwestern portion of the roof which extends several feet above the roof level; the chimney is in fair condition, with several mortar joints showing signs of deterioration, efflorescence, and moisture damage.

*Typical view of EPDM Roofing*

*Recommendations:* This roof is at or approaching the end of its expected useful design life and should be replaced with a new EPDM roofing system with tapered insulation. As further outlined below, the upper brick masonry walls and parapets should be demolished and rebuilt only to the roof level (not parapet level) with a typical metal edge flashing over pressure treated edge blocking. The brick chimney above roof level should be pressure washed and have minor repointing of mortar joints and receive a protective water repellent. See below for photos of the roof area.

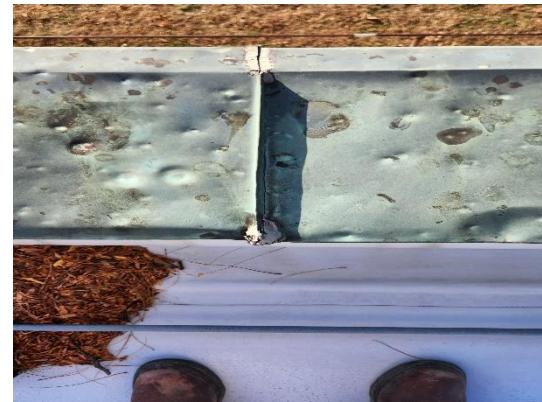
*Typical view of Roof Parapet Coping Seam*

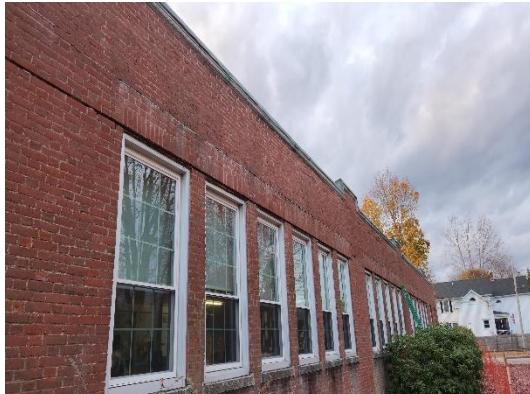
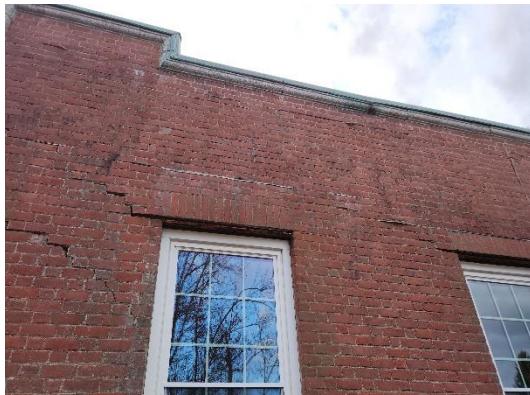
- Upper brick band between window headers and parapet: approximately 5'-4" to 7-6" above top of window lintel up to top of parapet walls; poor, unsound condition with many areas with cracked and unsound brick, deteriorated mortar joints, some out-of-plane movement, especially close to window lintel; all brick coursing across east wall (vertical soldier and horizontal running bond) between top of windows up to parapet wall flashing is completely cracked. Approximate horizontal and vertical crack widths were measured from  $\frac{1}{2}$ " to 1". The distance measured from the exterior brick wall face at the top of the parapet wall to the exterior face of the bottom of the vertical soldier course above the windows was measured to be outward by up to a full 1".

*Typical East Wall Masonry Cracking*

- Upper brick band between window headers and parapet: Provide continuous temporary structural shoring of all roof framing along the inside perimeter of the building; demolish all brick walls above window & door lintels and eliminate the masonry parapets; replace lintels with new steel lintels (see below); rebuild brick walls to roof level with no parapets (which would lower the building height as viewed from the exterior by 14 to 26 inches); apply water repellent.

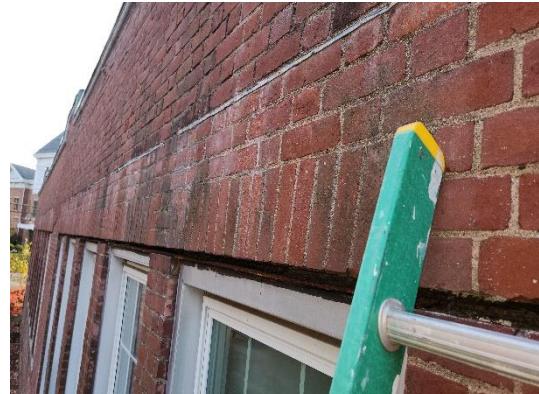
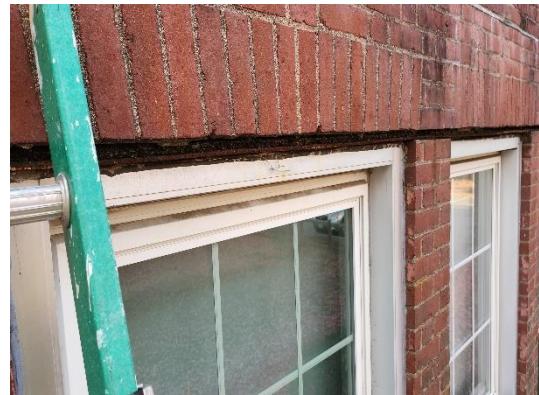
- Window & door steel lintels: mostly concealed by brick; exposed-to-view bottom flanges of exterior face lintels appear to have extensive, severe corrosion; this corrosion has resulted in expansion of the steel (in layers), compromised load carrying capacity due to varying degrees of apparent material loss, and damage to adjacent brick in the form of cracking, out-of-plane movement, freeze-thaw damage, etc.

*Typical East Wall Lintel Corrosion*

- Window & door lintels: Demolish all corroded steel lintels and replace them with new engineered, hot-dip galvanized steel lintels with through-wall flashing and weep holes.

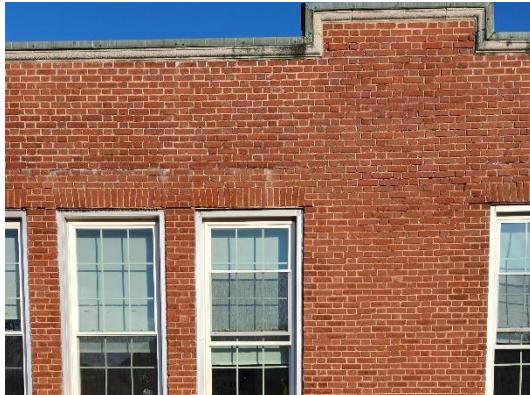
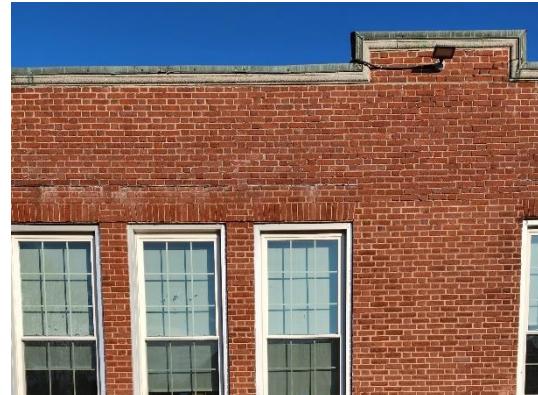
- Upper brick band between window headers and parapet: approximately 5'-4" to 7-6" above top of window lintel up to top of parapet walls; poor, unsound condition with many areas with cracked and unsound brick, deteriorated mortar joints, some out-of-plane movement, especially close to window lintel; all brick coursing across east wall (vertical soldier and horizontal running bond) between top of windows up to parapet wall flashing is completely cracked. Approximate horizontal and vertical crack widths were measured from 1/2" to 1". The distance measured from the exterior brick wall face at the top of the parapet wall to the exterior face of the bottom of the vertical soldier course above the windows was measured to be outward by up to a full 1".

*Typical West Wall Masonry Cracking*

- Upper brick band between window headers and parapet: Provide continuous temporary structural shoring of all roof framing along the inside perimeter of the building; demolish all brick walls above window & door lintels and eliminate the masonry parapets; replace lintels with new steel lintels (see below); rebuild brick walls to roof level with no parapets (which would lower the building height as viewed from the exterior by 14 to 26 inches); apply water repellent.

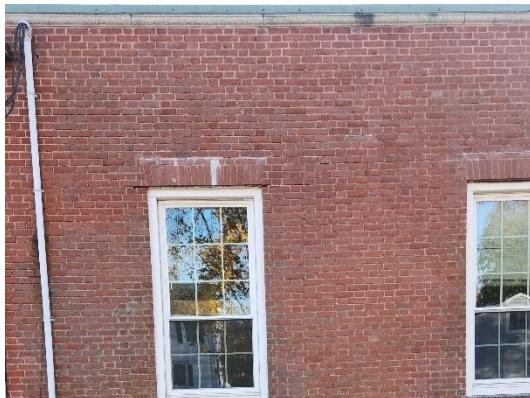
Due to the symmetry of this building when comparing wall sizes and extents, all the same items observed with the East & West walls pertain to the North and South walls but vary to a lesser degree because of a smaller wall size and less window openings. With these walls, the South wall appears to face more directly into the sun than the North wall, which would result in this wall being somewhat drier (on average) than the North wall throughout the year. Similar results of steel corrosion and brick cracking would take place from items such as re-occurring [rain and snow] storm events and the freeze/thaw cycle that follows as the seasons change. Observations and recommendations are very similar to the East and West walls.

*Typ. North Wall Lintel Corrosion & Cracking*

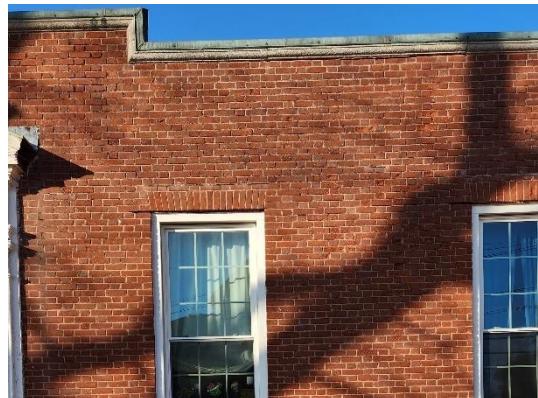
*Typ. South Wall Lintel Corrosion & Cracking*
