DIVISION OF
CAPITAL ASSET
MANAGEMENT &
MAINTENANCE

Weston & SampsonSM

SPD AREA Phase IV Remedy Implementation Plan Modification

Former Medfield State Hospital
February 17, 2021

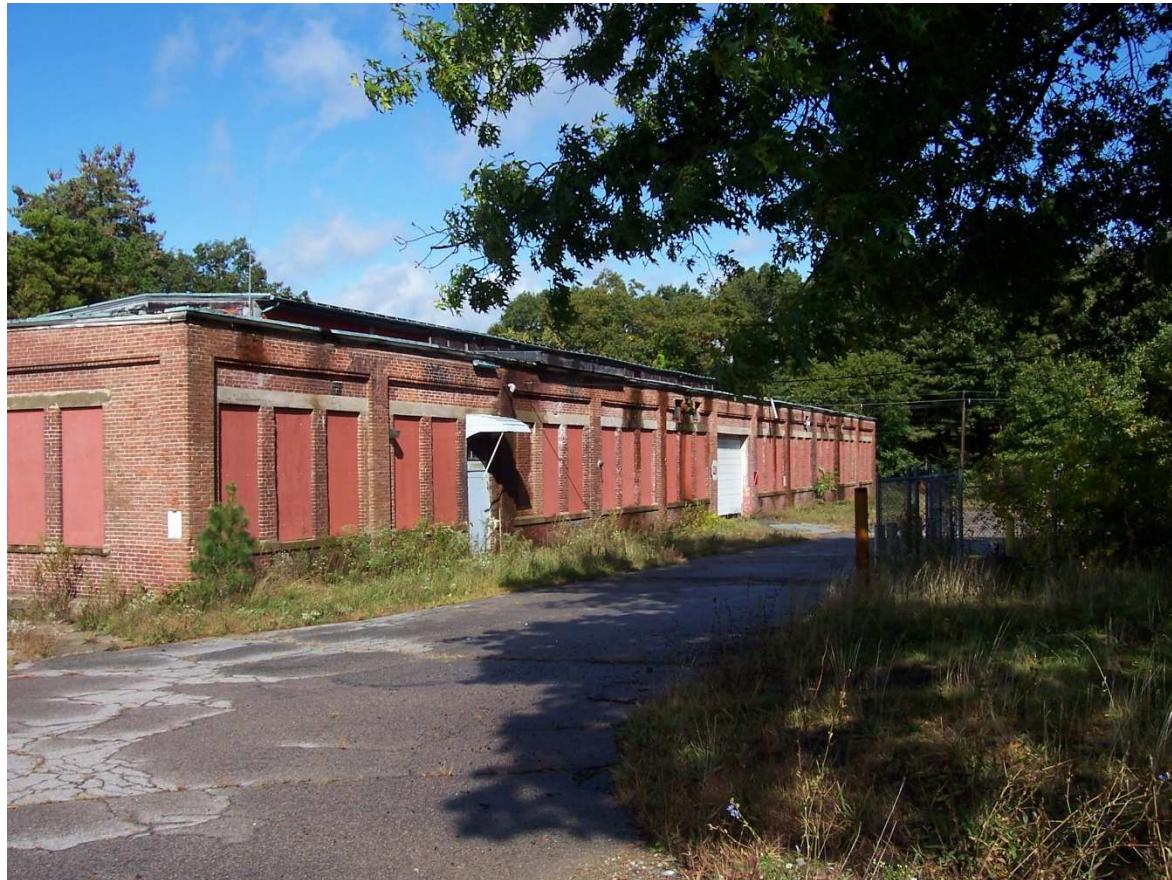
SPD Area

- Refined Source Area
- Non-Detect PCE in Soil < Cleanup Standard of 10 mg/kg
- PCE in Groundwater > Cleanup Standard
- Seasonal Groundwater Sampling Nov 2009 – Feb 2021

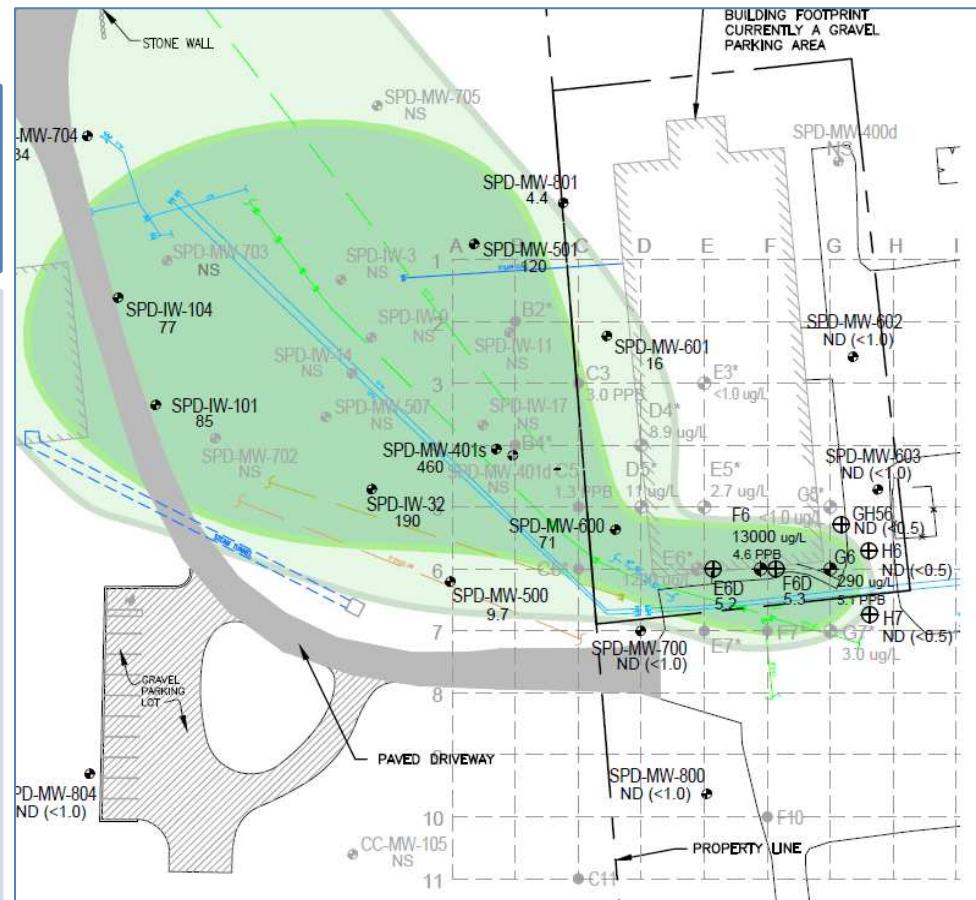
March 2020 Results with Supplemental Delineation Grid

- Achieved Horizontal & Vertical Delineation
- June & Sept 2019, March 2020:
 - 22 Soil Borings (18-23 ft bgs)
 - 14 Monitoring Wells
- Results
 - Elevated PCE Concentrations along South End of Former Laundry Building
 - PCE Present at Highest Concentration from Approximately 10 to 22 ft bgs

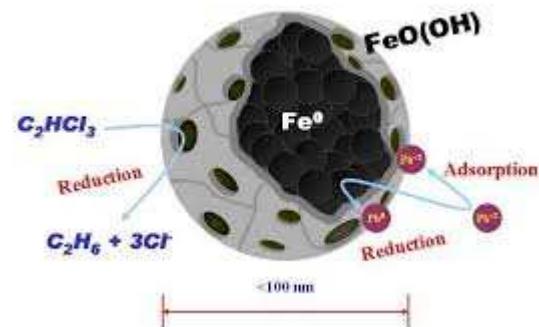
ZVI (Fe^0)

Chemical Reducing Agent

Initiates an Abiotic Oxidation-Reduction Reaction

Breaks Down PCE

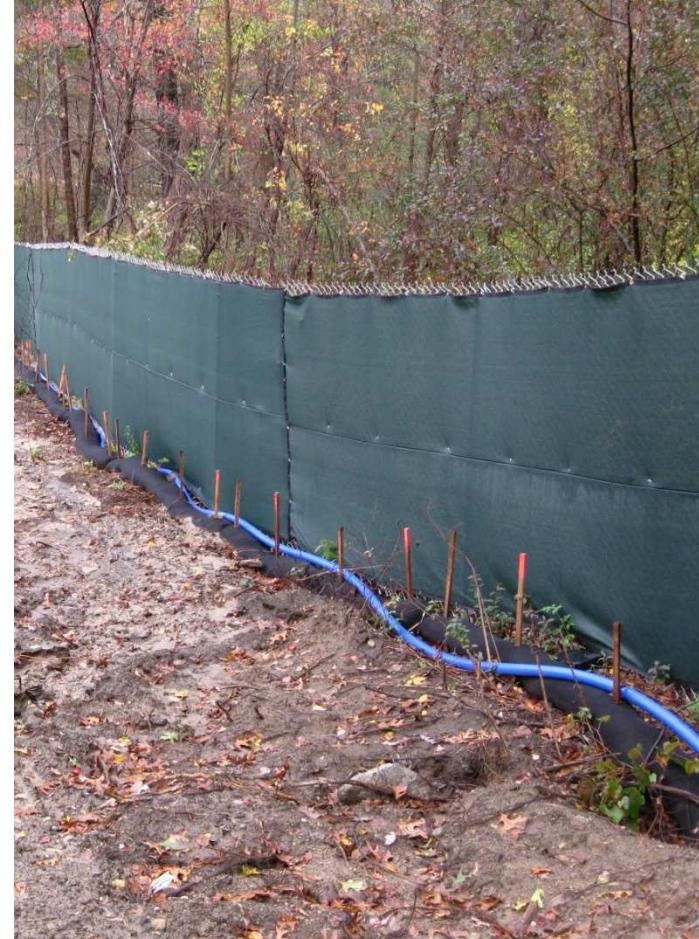
Site Preparation

- Erosion Controls
- Work Conducted Outside of Wetland Resource Area/Buffer Zone
- Utility Investigation Prior to Construction (GPR)
- Utility Abandonment

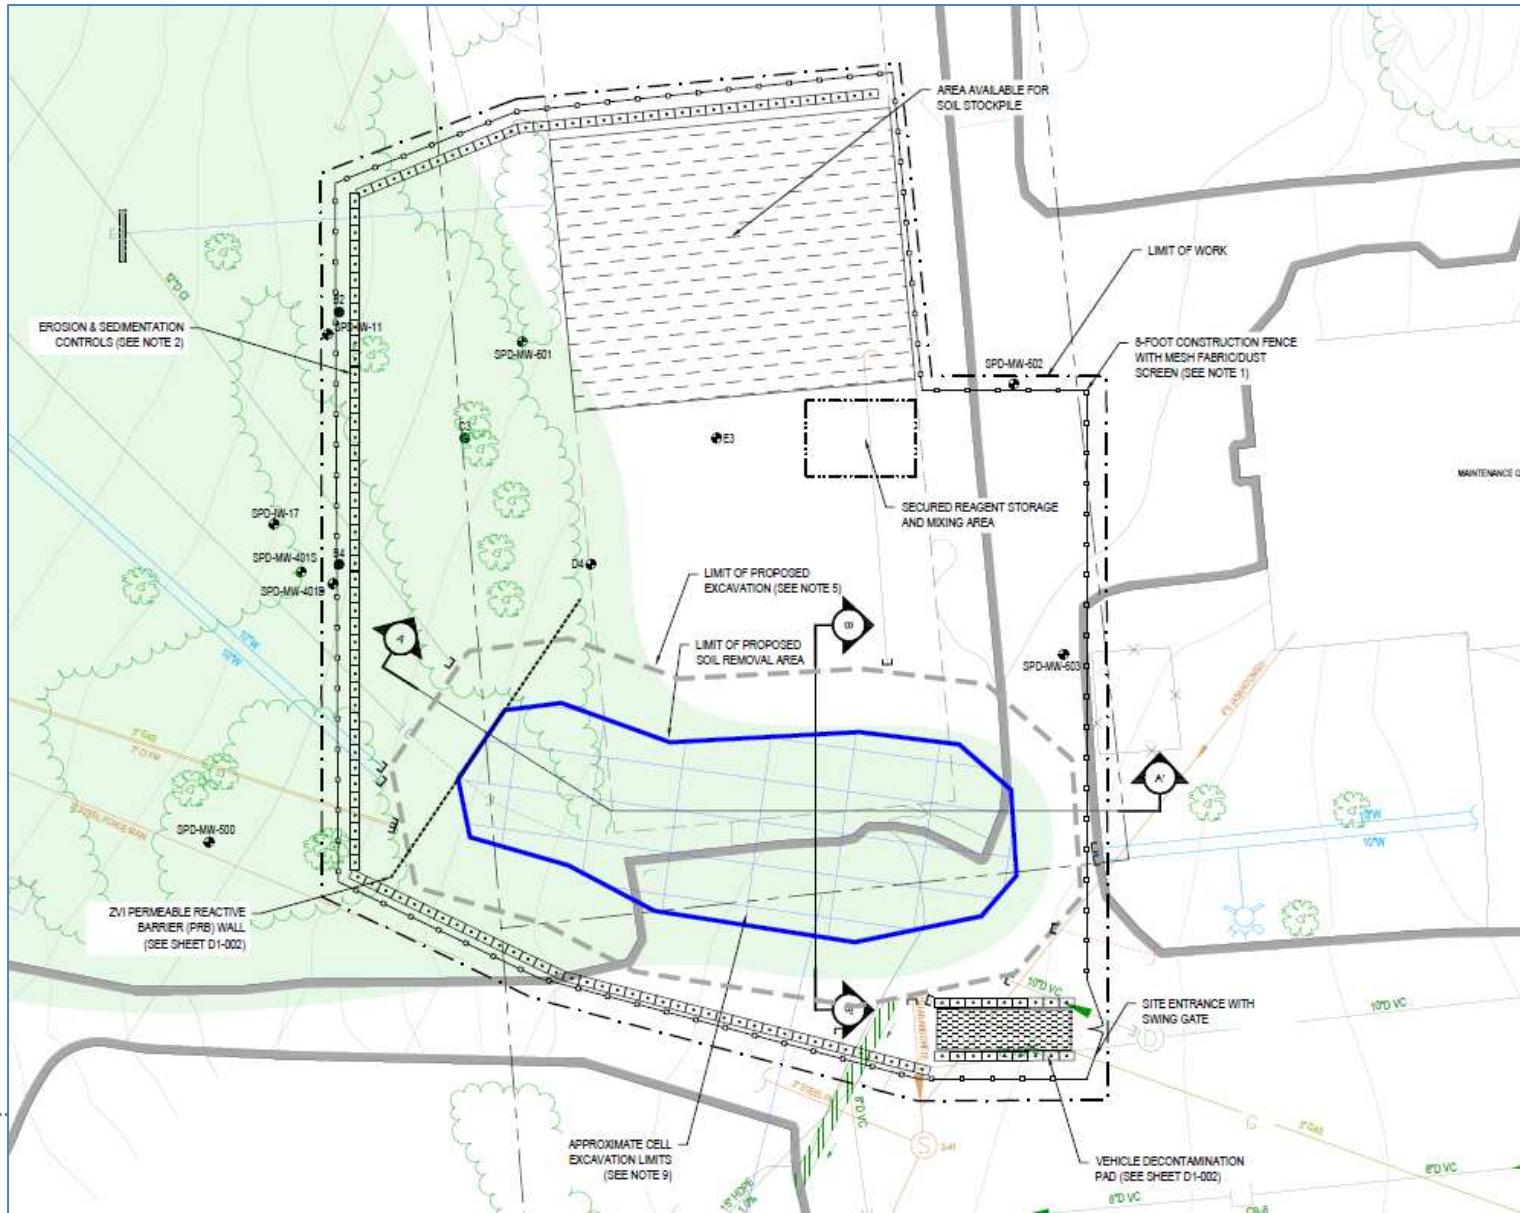
Source Area Treatment

DCAMM MEDFIELD SITE – SPD AREA REMEDIATION ANIMATION

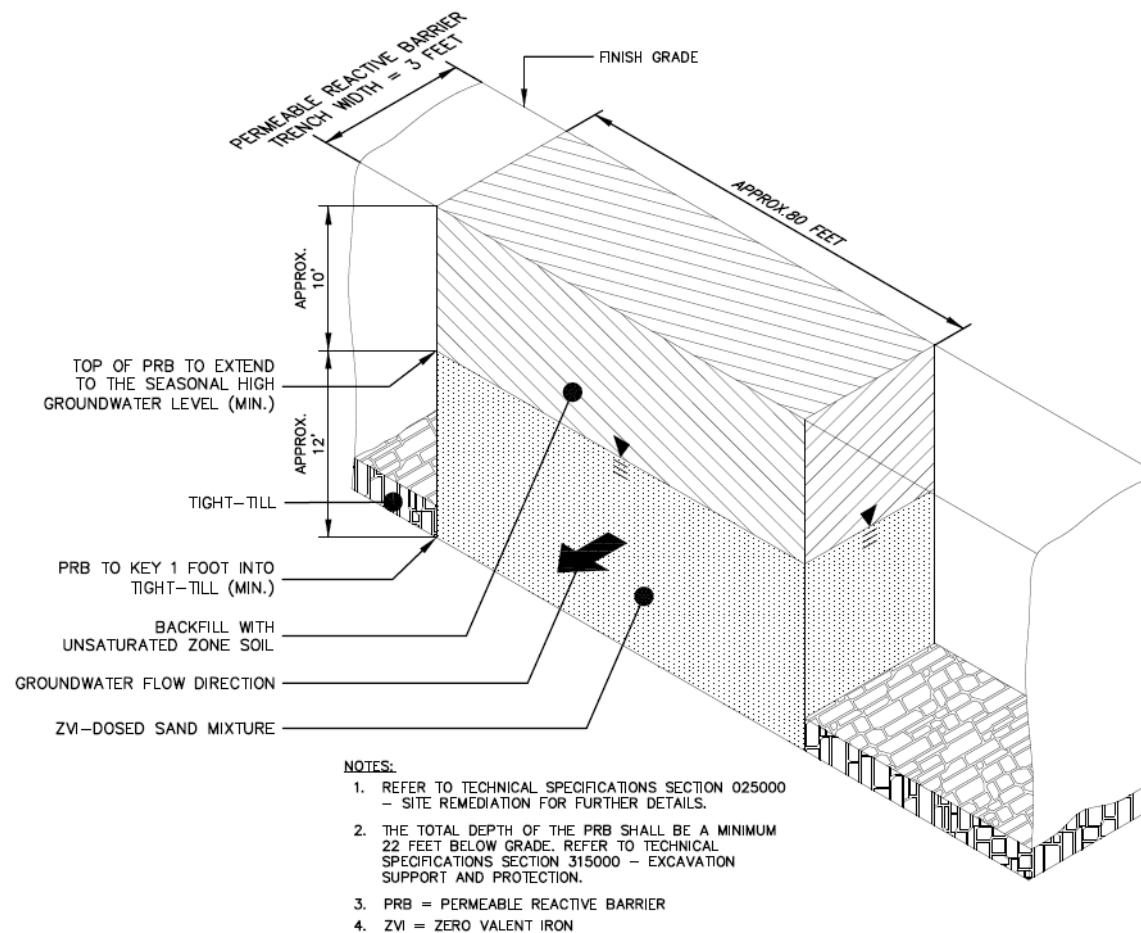
Permeable Reactive Barrier

PERMEABLE REACTIVE BARRIER DETAIL N.T.S.

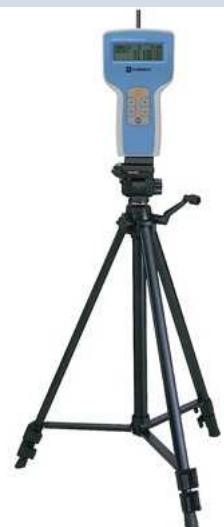
- Site Specific Health & Safety Plan
- Support of Excavation
- Truck Route for Traffic Control

- Signage
- Dust Screens & Controls
- Air/Dust Monitoring

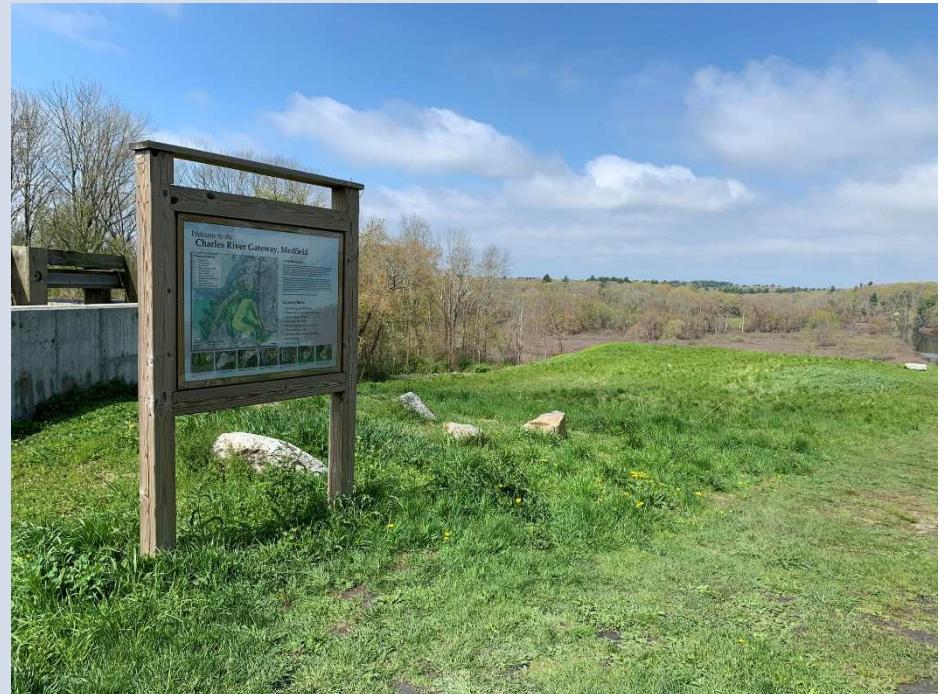
Restoration & Monitoring

- Construction Monitoring
 - pH, Conductivity, ORP, DO of Existing Wells
- Post Remedial Monitoring
 - Existing Quarterly GW Sampling
 - 4 consecutive rounds, but in no event, less than 2 years
 - New Monitoring Well Installation Expanding Network
- Site Restoration
 - Match Existing Conditions
