MEDFIELD STATE HOSPITAL

CAPITAL ASSESSMENT REPORT

RE-USE, REPAIRS & MAINTENANCE RECOMMENDATIONS

September 2014

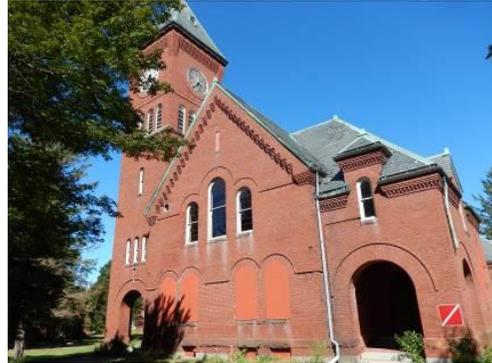
A. Chapel/Lee Building

Exterior brick masonry and the slate and copper roofs are original 1896 construction. Brick masonry on the Chapel is in the best condition of the 4 buildings included in this survey. The Chapel still suffers from extensive decay due to a complete lack of maintenance for the past 10+ years. 100% of the exterior solid load-bearing masonry walls require pointing. Numerous cracked and displaced brick have to be replaced. Exterior wood framing and cladding on dormers and windows is deteriorated and must be replaced. Windows are deteriorated and must be replaced including frames. The slate roof and copper flashing is original and must be replaced. Gutters are deteriorated and must be replaced along with all down leaders. Due to the advanced stage of deterioration of the slate roof we expect that 10% percentage of roof support rafters and decking will be replaced during the roof replacement work. Steel support bracing was added after the church was constructed that appears to be shoring the roof supports where they intersect the top of the side walls. This bracing will need to be replaced during the rehabilitation work.

The interior of the building is in fair condition. There is a roof leak in the Hall along the west elevation that has compromised the wood and post construction steel truss framing system.

There is another roof leak at the mezzanine level at the southwest corner that has caused wood rot to the roof truss system and damaged the wall and floor finishes.

- Point 100% of the exterior mortar joints.
- Replace all cracked, displaced, missing brick and stone masonry.
- Replace slate roofing including copper flashing and slate underlayment.
- Replace all deteriorated roof decking and supporting rafters.
- Replace all windows.
- Replace all exposed exterior wood sheathing and boards.
- Replace all copper gutters and downleaders including wood support lumber.
- Remove exterior wood entrances.

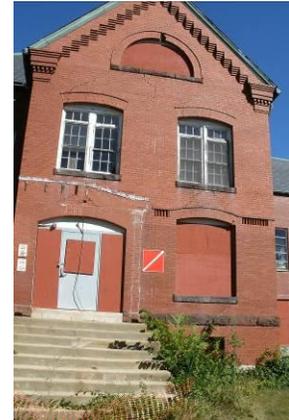
B. Ward B-1

Exterior brick masonry and the slate and copper roofs are original 1896 construction. Brick masonry exterior walls of Ward B1 are in worse condition than those on the Chapel. These exterior suffer from extensive decay due to a complete lack of maintenance for the past 10 years. 100% of the exterior solid load-bearing masonry walls require pointing. Masonry arches over the front door and a front window have cracked and displaced downward; a condition that will require extensive reconstruction of the full depth of the masonry. Around the façade there are numerous cracked and displaced brick that have to be removed and the sections of walls rebuilt. Brick has fallen from a chimney and we expect the entire chimney will require reconstruction. The “new” exterior stair tower exhibits efflorescence staining indicating water is penetrating the brick walls and decaying the mortar. Exterior wood framing and cladding on windows is deteriorated and must be replaced. Windows are deteriorated and must be replaced including frames. The slate roof and copper flashing is original and must be replaced. Gutters are deteriorated and must be replaced along with all down leaders. Due to the advanced stage of deterioration of the slate roof we expect that 25% percentage of roof support rafters and decking will be replaced during the roof replacement work.

The interior of the building is in fair to poor condition. There is water infiltration evident at the front corridor which has rotted the floor framing on the 1st & 2nd floor and is in unsafe condition. There are more examples of this type of deterioration throughout the building. Mold is evident throughout the interior. The enclosed stairwell structure located at southeast corner, which was built as an addition after the original construction, has water damage and has deteriorated past the point of rehabilitation and should be demolished and re-built.

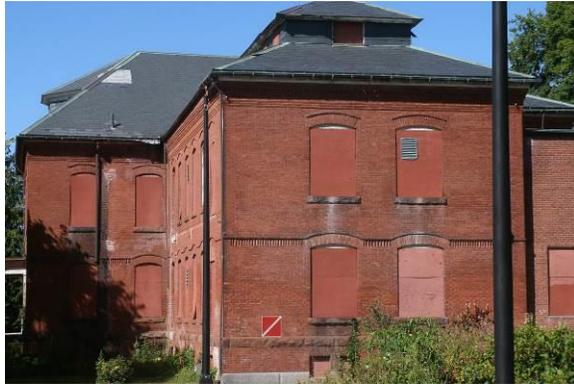
C. Ward C-2

Exterior brick masonry and the slate and copper roofs are original 1896 construction. Brick masonry facades of Ward C2 are most extensively deteriorated of the four buildings we inspected. Ward C2 suffers from extensive decay due to a complete lack of maintenance since the building was closed in 1977. We recommend demolishing this building. Test openings made during a previous condition assessment show the inner parts of the exterior walls are not fully filled with mortar; a condition that allows moisture to easily penetrate through the walls and to interior wood structure. 100% of the exterior solid load bearing masonry walls require pointing, large areas will require deep pointing were mortar joints have been deeply eroded. Numerous cracked and displaced brick have to be replaced. Exterior wood framing and cladding on dormers and windows is deteriorated and must be replaced. Windows are deteriorated and must be replaced including frames. The slate roof and copper flashing is original and must be replaced. Gutters are deteriorated and must be replaced along with all down leaders. Due to the advanced stage of deterioration of the slate roof we expect that up to 50% of roof support rafters and decking will be replaced during the roof replacement work.

The interior of the building is in poor condition. There is water infiltration and dry rot evident throughout which has caused wood rot at floor boards, structural floor joists, and floor framing on the 1st & 2nd floor and is in unsafe condition. Because of the existing failing conditions, we were only able to inspect the basement and the entrance of the 1st floor. We opine that this building is past the point of repair and should be demolished in its entirety.

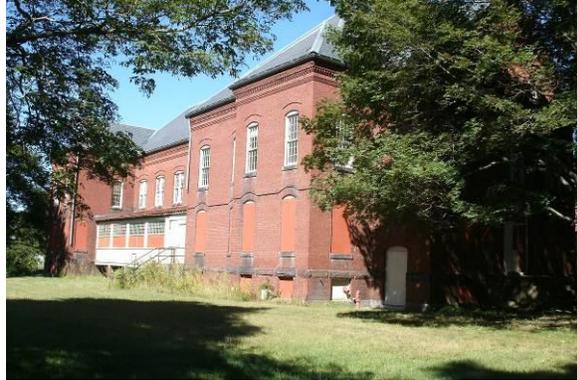
removed some but not all of the wood entrance stoops and porches. 100% of the exterior solid load-bearing masonry walls require pointing. Around the façade there are numerous cracked and displaced brick that have to be removed and the sections of walls rebuilt. Exterior wood framing and cladding on porches and windows is deteriorated and must be replaced. Windows are deteriorated and must be replaced including frames. The slate roof

and copper flashing is original and must be replaced. Gutters are deteriorated and must be replaced along with all down leaders. Due to the advanced stage of deterioration of the slate roof we expect that 25% percentage of roof support rafters and decking will be replaced during the roof replacement work.

The interior of the building is in good to fair condition. There is water infiltration and dry rot evident in the attic space (from the roof) which has caused wood rot at floor boards, structural floor joists, and floor framing. There is moisture in the basement and evidence of some wood rot at the floor joists. The wood porch located at the south elevation is in disrepair and should be demolished.

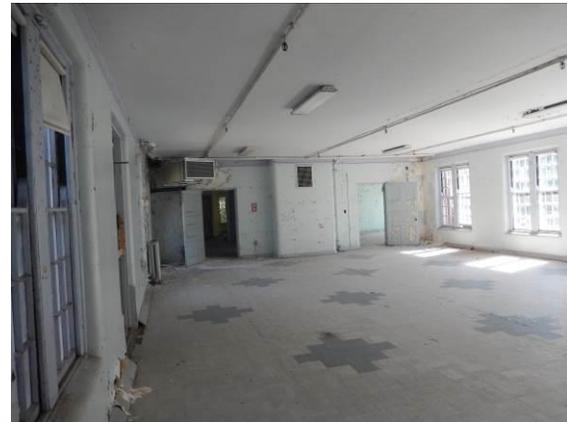
View of typical 9x9 vct floor tile.
