MEDFIELD STATE HOSPITAL HISTORIC RESOURCES

EXISTING CONDITIONS

M E M O R A N D U M

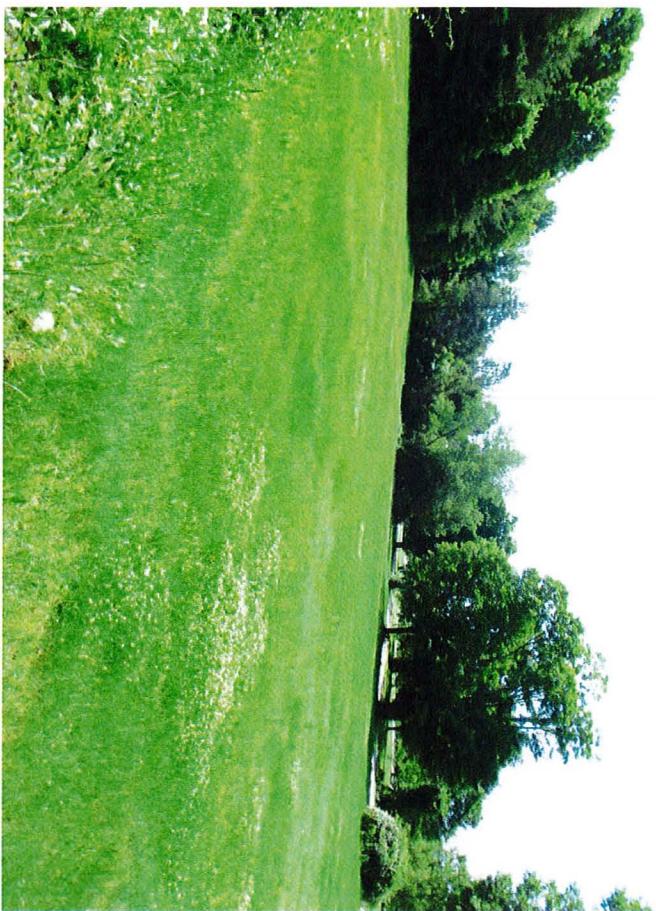
83A: Quadrangle

- **Building 83, Quadrangle/Green:** The 1896 rectangular Quadrangle/Green is located south of North Street. It is an open, flat, grassy area that serves as a greensward surrounded by trees and many of the hospital's original buildings. Photographs 83A and 83B depict the existing conditions of the Quadrangle/Green.

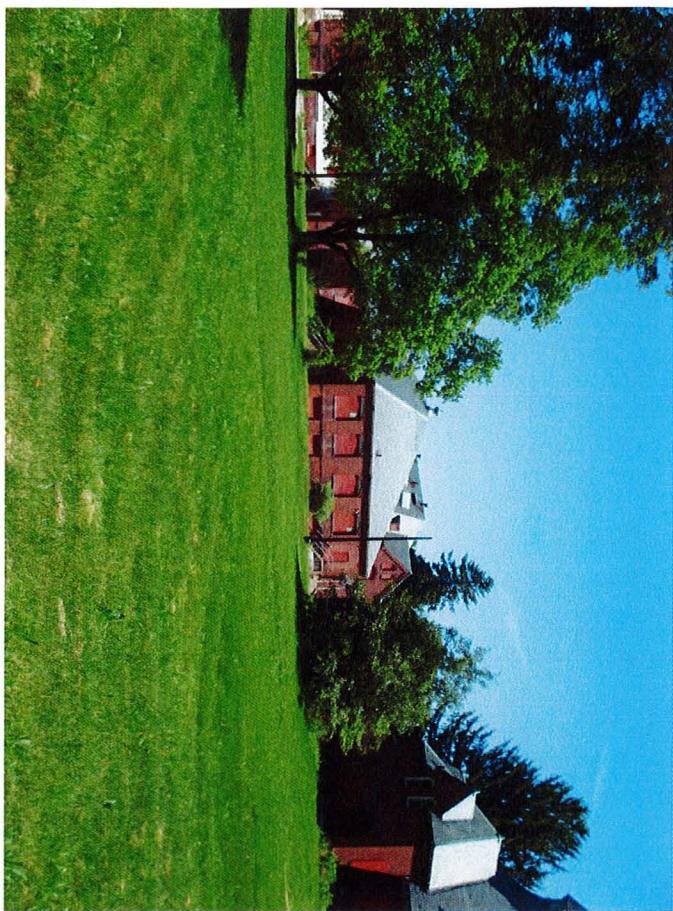
85A: Clark Building lawn

- **Building 85, Clark Building Lawn:** The ca. 1910 Clark Building Lawn is a triangular-shaped grassy open area located between Hospital Drive, Stonegate Drive and the former Clark Building (Building 72). The lawn slopes slightly northwest and is lined with trees. Photograph 85A depicts the existing conditions of the Clark Building Lawn.
