Re: **Follow-Up Inspection – December 2020**
Danielson Mill Dam (MA03351)
Medfield, Massachusetts
(PARE Project No.: 19126.02)

Commonwealth of Massachusetts
Department of Conservation and Recreation
Office of Dam Safety Poor Condition Dam Follow-up Inspection Form

Dam Name: Danielson Mill Dam

Date of Inspection: December 3, 2020

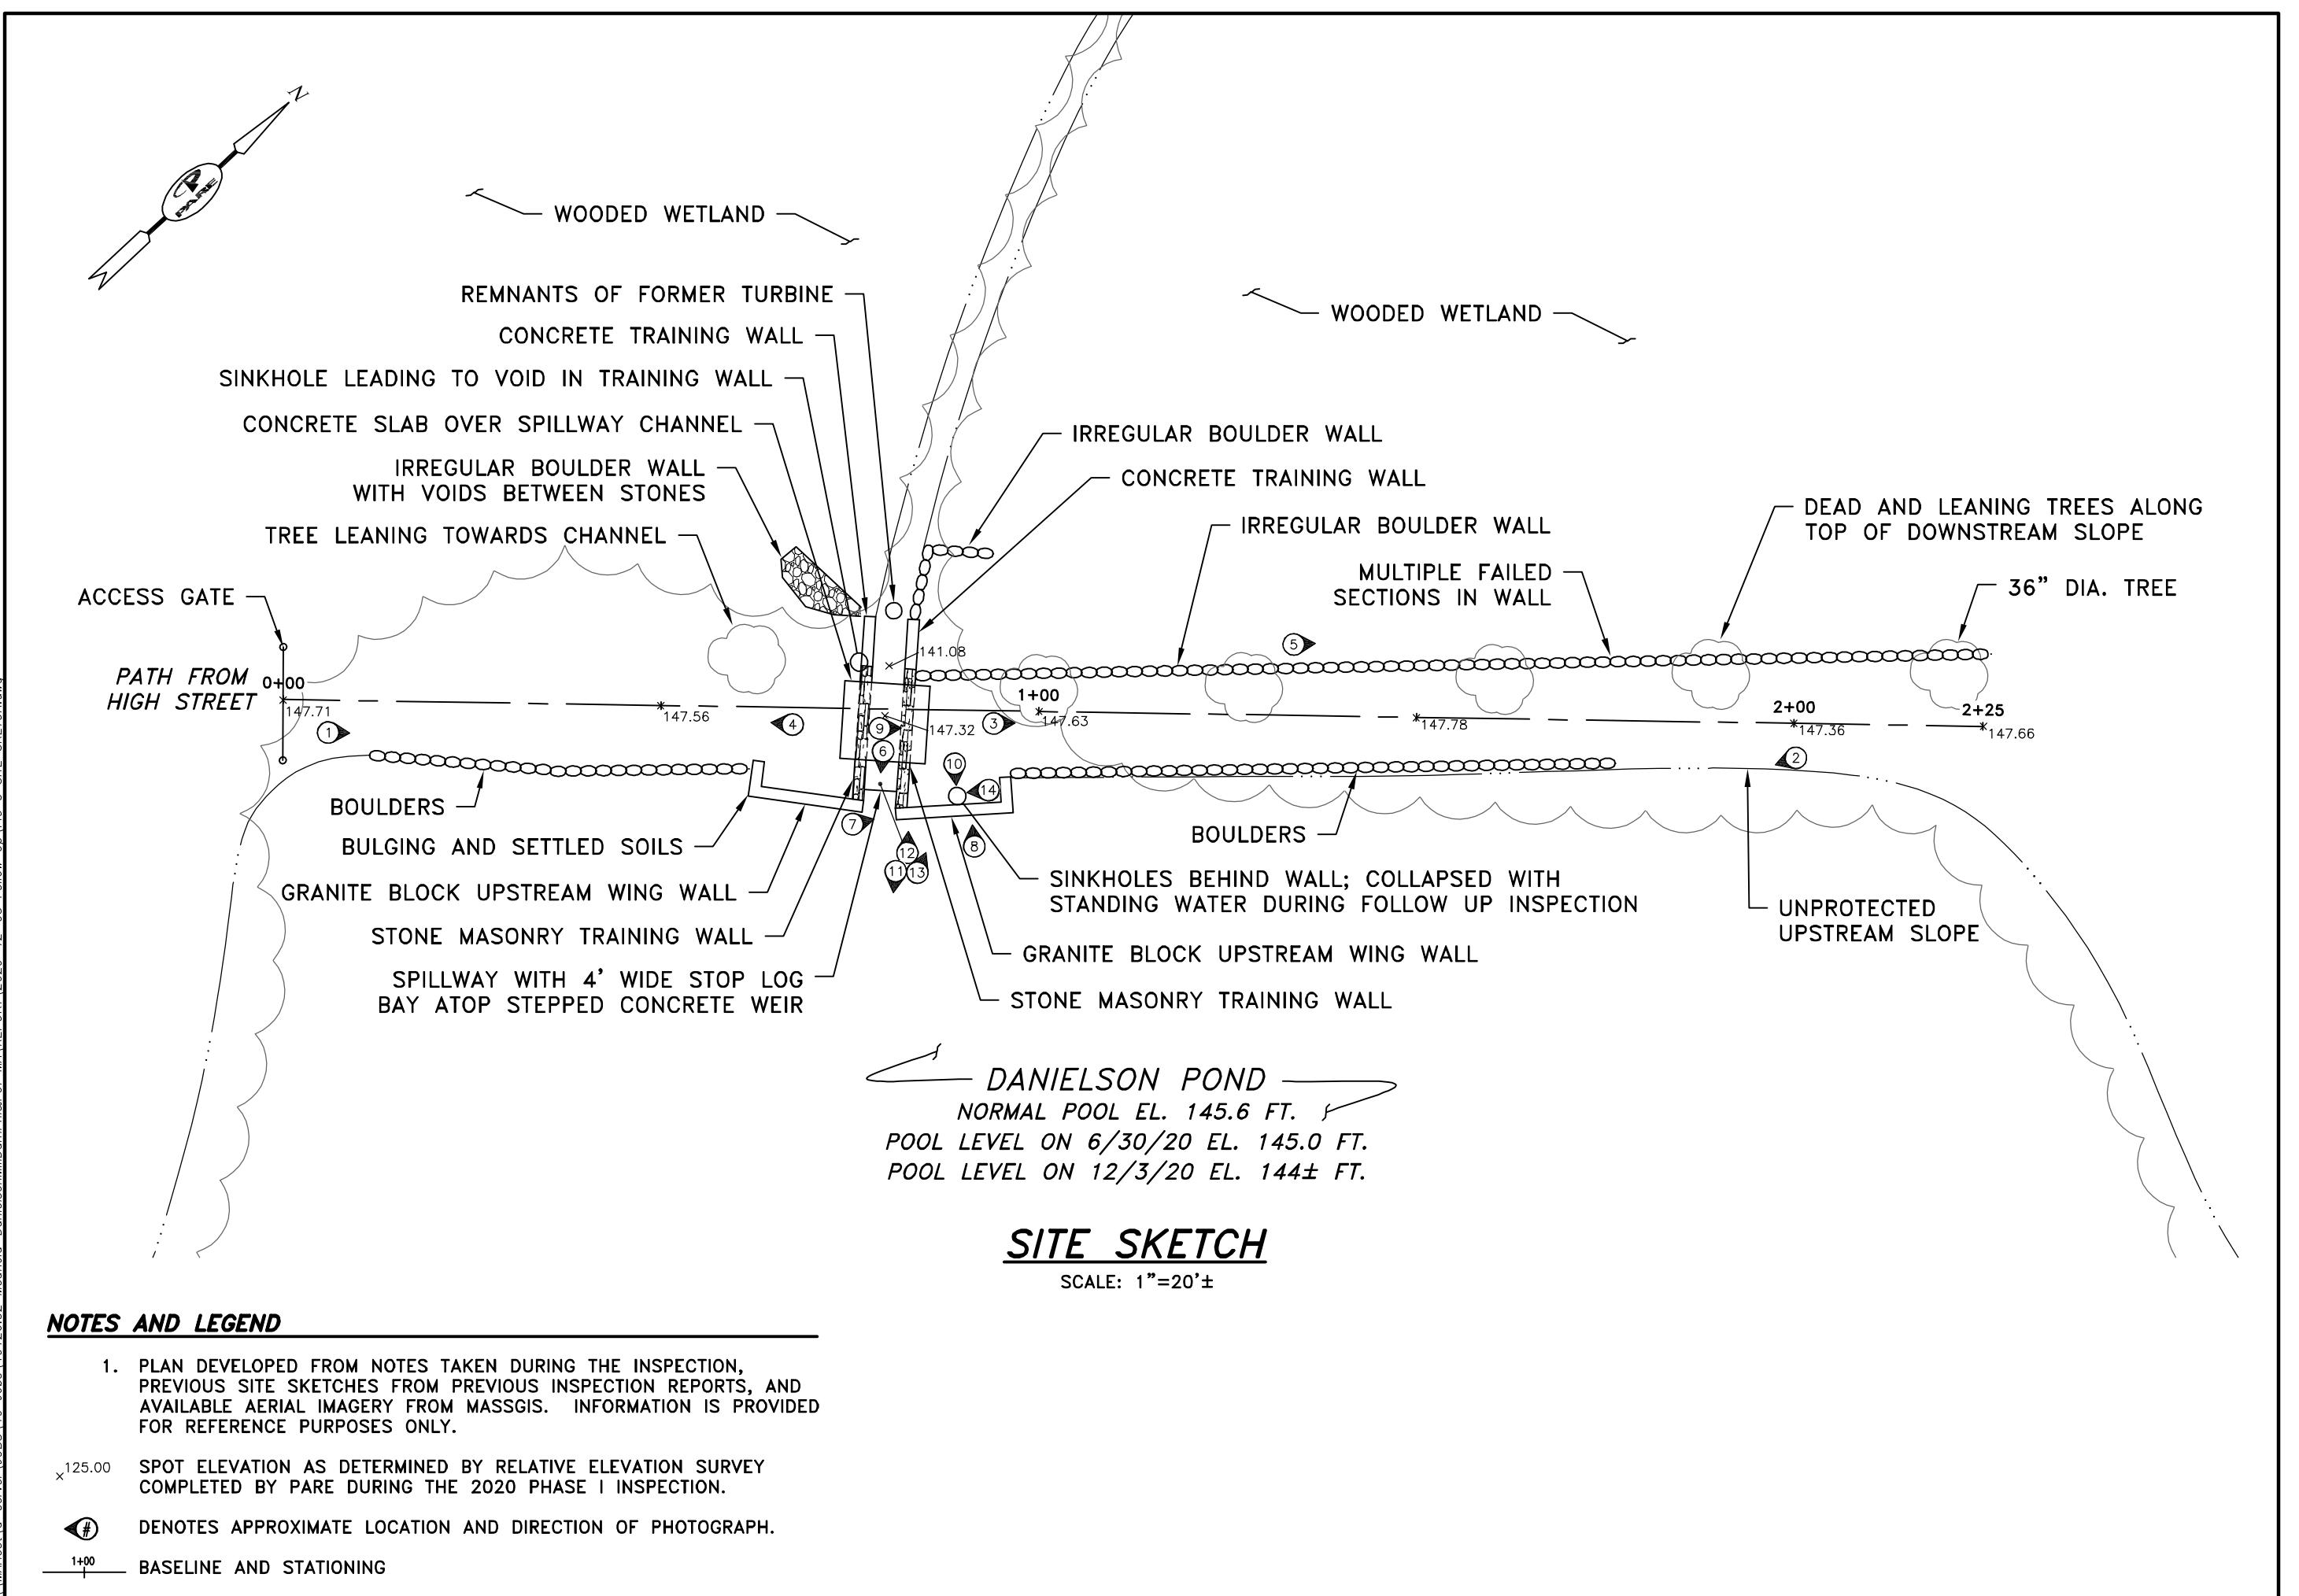
- Have any of the deficiencies listed in the previous Phase I Inspection Report worsened? Yes
- If yes, list the changes.
 - High water event resulted in progression of voids and leakage right of the spillway
- Are there any additional deficiencies that have been identified in the current inspection? Yes
- If yes, list the deficiencies and describe.
 - New sinkhole along the backside of the upstream wall right of the spillway
 - New void/sinkhole behind the right training wall near the centerline of the crest right of the spillway
