MEDFIELD MUNICIPAL BUILDING CAPITAL PLAN & DECARBONIZATION STUDY

20 YEAR MASTERPLAN

APRIL 2025

PREPARED FOR
TOWN OF MEDFIELD, MA

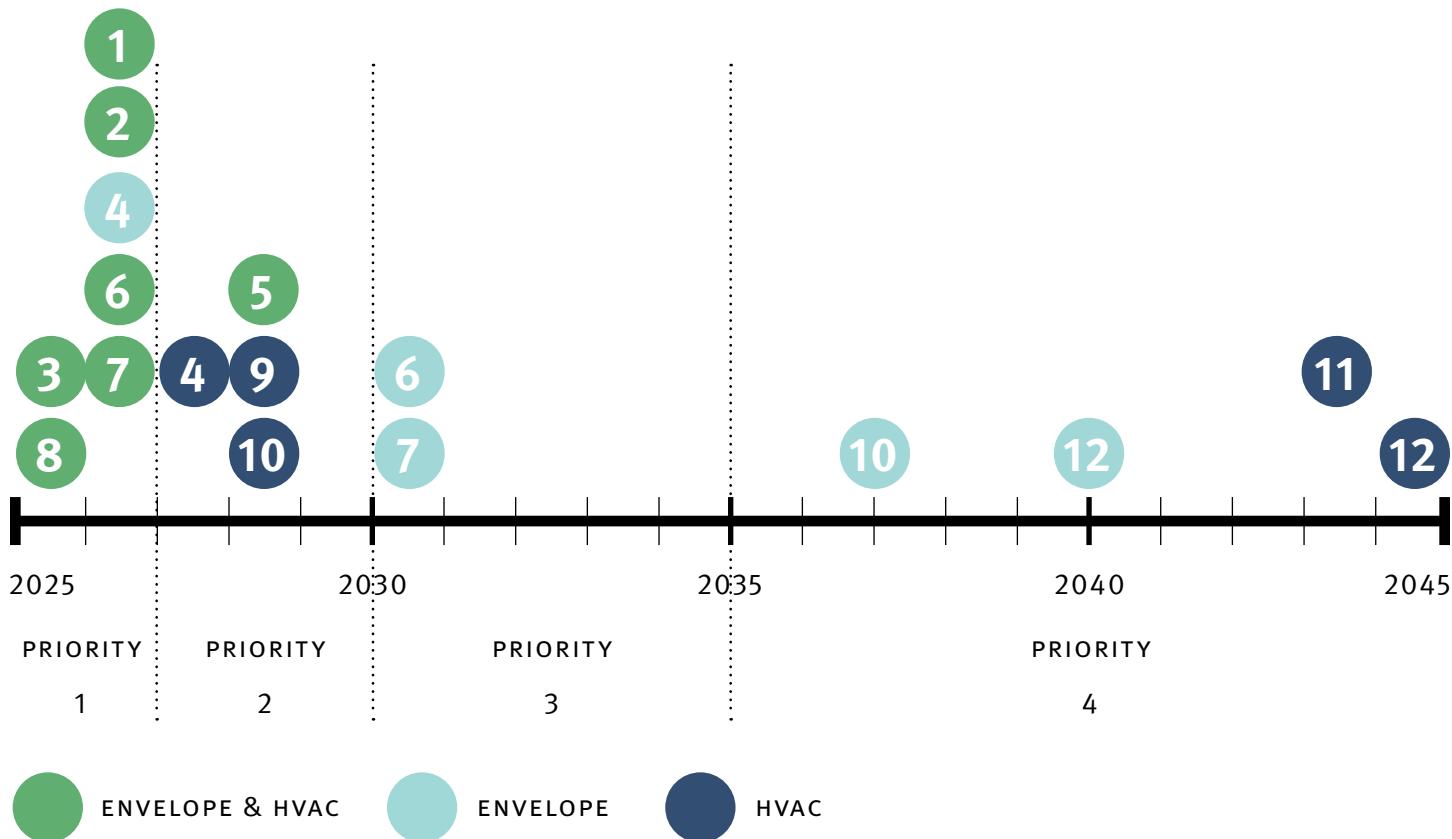
TIMELINE FOR UPGRADES TO BUILDINGS

The timeline on the next page lays out envelope upgrades (roofing and/or window replacement) projects in light blue, HVAC projects in dark blue, and combined HVAC and envelope upgrade projects in green for the buildings. Alignment to years is approximate and represents a potential ordering and prioritization of projects to address the major capital needs for HVAC and envelope.

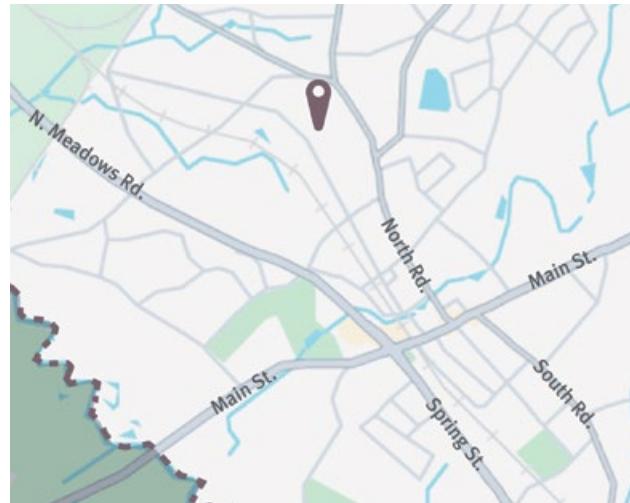
Electrification Information

EXISTING	PROPOSED	% CHANGE
Electric (KWH/yr)	363,346	681,360	88%
Natural Gas (kBtu/yr)	2,576,550	0	-100%
TOTAL Energy Use (kBtu/yr)	3,816,288	2,324,801	-39%
Electric Utility Cost (\$/yr)	\$46,690	\$87,555	88%
Natural Gas Utility Cost (\$/yr)	\$28,182	\$0	-100%
TOTAL Utility Cost (\$/yr)	\$74,872	\$87,555	17%
TOTAL Utility Cost w/ PV (\$/yr)	\$57,512	\$65,527	14%
TOTAL Emissions (MTCO2e/yr)	230	121	-47%
TOTAL Emissions w/ PV (MTCO2e/yr)	119	23	-81%

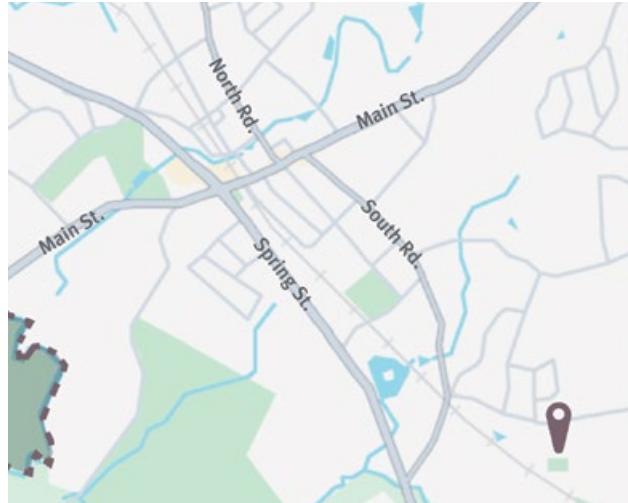
Electrification Information

EXISTING	PROPOSED	% CHANGE
Electric (KWH/yr)	192,056	574,880	199%
Natural Gas (kBtu/yr)	2,458,300	0	-100%
TOTAL Energy Use (kBtu/yr)	3,113,596	1,961,490	-37%
Electric Utility Cost (\$/yr)	\$24,679	\$73,872	199%
Natural Gas Utility Cost (\$/yr)	\$26,889	\$0	-100%
TOTAL Utility Cost (\$/yr)	\$51,568	\$73,872	43%
TOTAL Utility Cost w/ PV (\$/yr)	\$51,568	\$59,512	15%
TOTAL Emissions (MTCO2e/yr)	180	102	-43%
TOTAL Emissions w/ PV (MTCO2e/yr)	180	38	-79%

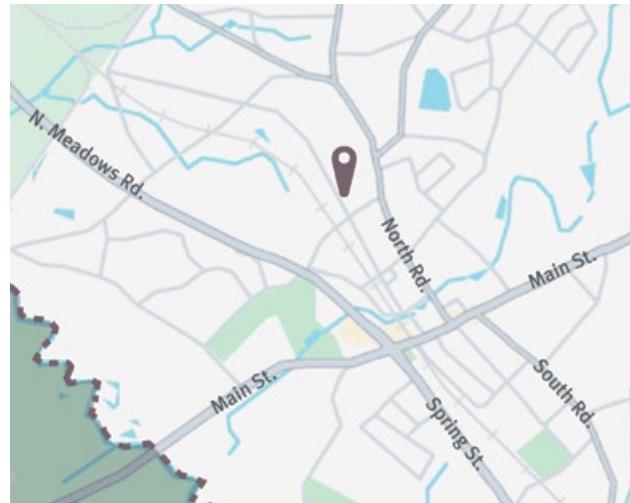
Electrification Information

EXISTING	PROPOSED	% CHANGE
Electric (KWH/yr)	147,763	830,564	462%
Natural Gas (kBtu/yr)	4,271,500	0	-100%
TOTAL Energy Use (kBtu/yr)	4,775,668	2,833,884	-41%
Electric Utility Cost (\$/yr)	\$18,988	\$106,727	462%
Natural Gas Utility Cost (\$/yr)	\$46,722	\$0	-100%
TOTAL Utility Cost (\$/yr)	\$65,710	\$106,727	62%
TOTAL Emissions (MTCO2e/yr)	265	148	-44%

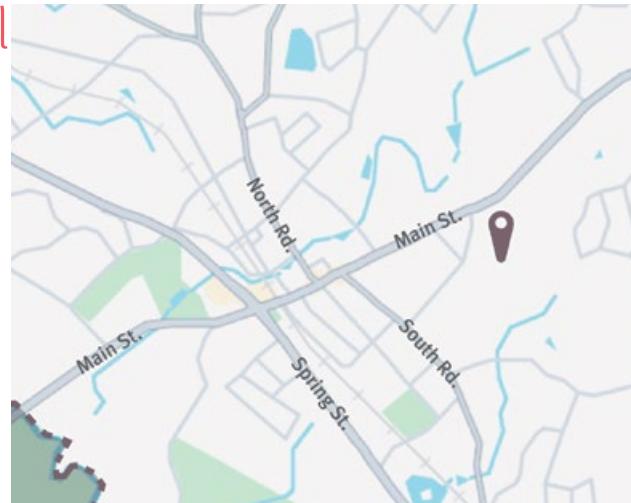
Electrification Information

EXISTING	PROPOSED	% CHANGE
Electric (KWH/yr)	592,278	1,263,551	113%
Natural Gas (kBtu/yr)	4,740,900	0	-100%
TOTAL Energy Use (kBtu/yr)	6,761,751	4,311,234	-36%
Electric Utility Cost (\$/yr)	\$76,108	\$162,366	113%
Natural Gas Utility Cost (\$/yr)	\$51,856	\$0	-100%
TOTAL Utility Cost (\$/yr)	\$127,964	\$162,366	27%
TOTAL Utility Cost w/ PV (\$/yr)	\$122,016	\$151,658	24%
TOTAL Emissions (MTCO2e/yr)	403	225	-44%
TOTAL Emissions w/ PV (MTCO2e/yr)	365	177	-52%

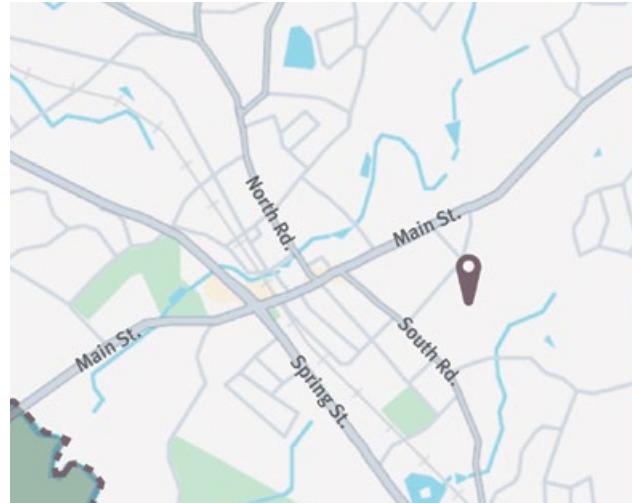
Electrification Information

EXISTING	PROPOSED	% CHANGE
Electric (KWH/yr)	1,197,831	1,962,500	64%
Natural Gas (kBtu/yr)	7,161,000	0	-100%
TOTAL Energy Use (kBtu/yr)	11,247,999	6,696,049	-40%
Electric Utility Cost (\$/yr)	\$153,921	\$252,181	64%
Natural Gas Utility Cost (\$/yr)	\$78,327	\$0	-100%
TOTAL Utility Cost (\$/yr)	\$232,248	\$252,181	9%
TOTAL Utility Cost w/ PV (\$/yr)	\$201,848	\$208,621	3%
TOTAL Emissions (MTCO2e/yr)	687	349	-49%
TOTAL Emissions w/ PV (MTCO2e/yr)	492	155	-68%

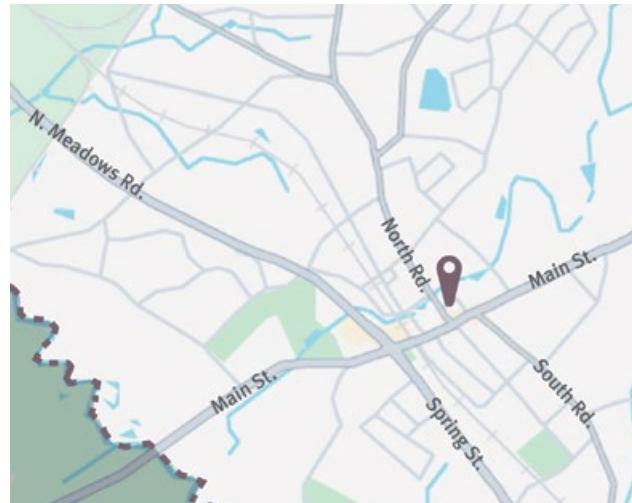
Electrification Information

EXISTING	PROPOSED	% CHANGE
Electric (KWH/yr)	99,149	133,200	34%
Natural Gas (kBtu/yr)	341,000	0	-100%
TOTAL Energy Use (kBtu/yr)	679,297	454,480	-33%
Electric Utility Cost (\$/yr)	\$12,741	\$17,116	34%
Natural Gas Utility Cost (\$/yr)	\$3,730	\$0	-100%
TOTAL Utility Cost (\$/yr)	\$16,471	\$17,116	4%
TOTAL Emissions (MTCO2e/yr)	43	24	-44%

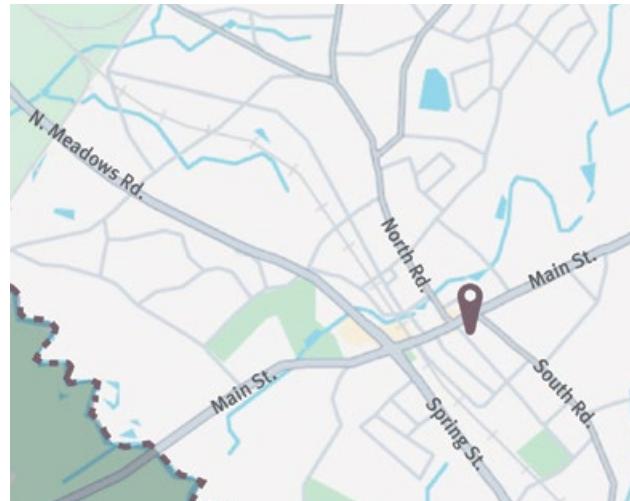
Electrification Information

EXISTING	PROPOSED	% CHANGE
Electric (KWH/yr)	75,542	147,735	96%
Natural Gas (kBtu/yr)	455,800	0	-100%
TOTAL Energy Use (kBtu/yr)	713,550	504,071	29%
Electric Utility Cost (\$/yr)	\$9,707	\$18,984	96%
Natural Gas Utility Cost (\$/yr)	\$4,986	\$0	-100%
TOTAL Utility Cost (\$/yr)	\$14,693	\$19,984	29%
TOTAL Emissions (MTCO2e/yr)	44	26	-41%

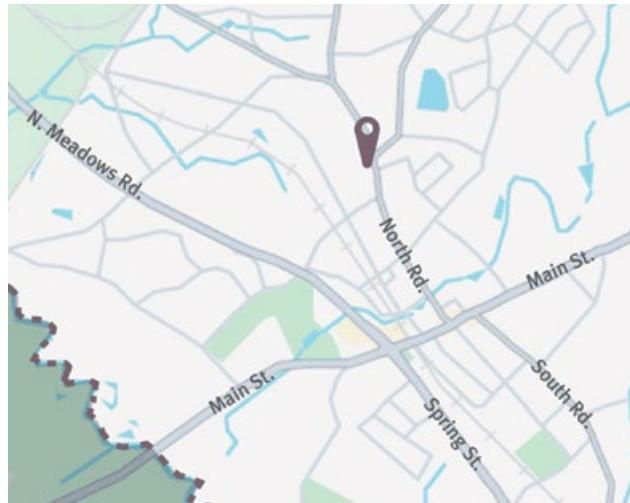
Electrification Information

EXISTING	PROPOSED	% CHANGE
Electric (KWH/yr)	12,362	148,277	1099%
Natural Gas (kBtu/yr)	715,400	0	-100%
TOTAL Energy Use (kBtu/yr)	757,578	505,923	-33%
Electric Utility Cost (\$/yr)	\$1,588	\$19,054	1100%
Natural Gas Utility Cost (\$/yr)	\$7,825	\$0	-100%
TOTAL Utility Cost (\$/yr)	\$9,413	\$19,054	102%
TOTAL Emissions (MTCO2e/yr)	41	26	-37%

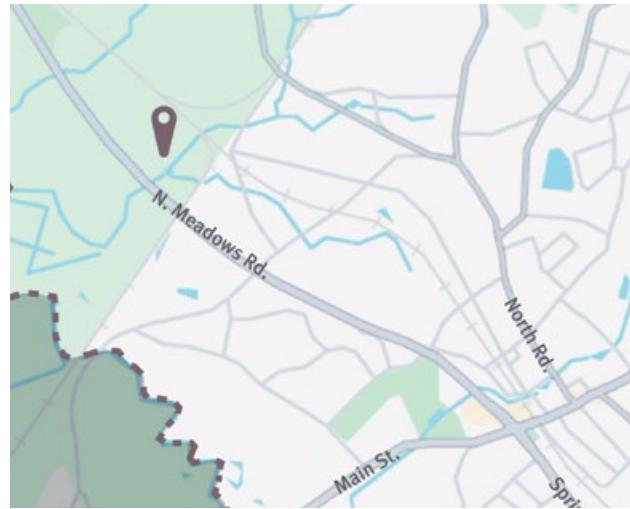
Electrification Information

EXISTING	PROPOSED	% CHANGE
Electric (KWH/yr)	32,830	28,890	-12%
Natural Gas (kBtu/yr)	-	-	-
TOTAL Energy Use (kBtu/yr)	112,015	98,573	-12%
Electric Utility Cost (\$/yr)	\$4,219	\$3,712	-12%
Natural Gas Utility Cost (\$/yr)	\$0	\$0	-12%
TOTAL Utility Cost (\$/yr)	\$4,219	\$3,712	-12%
TOTAL Emissions (MTCO2e/yr)	8	5	-38%

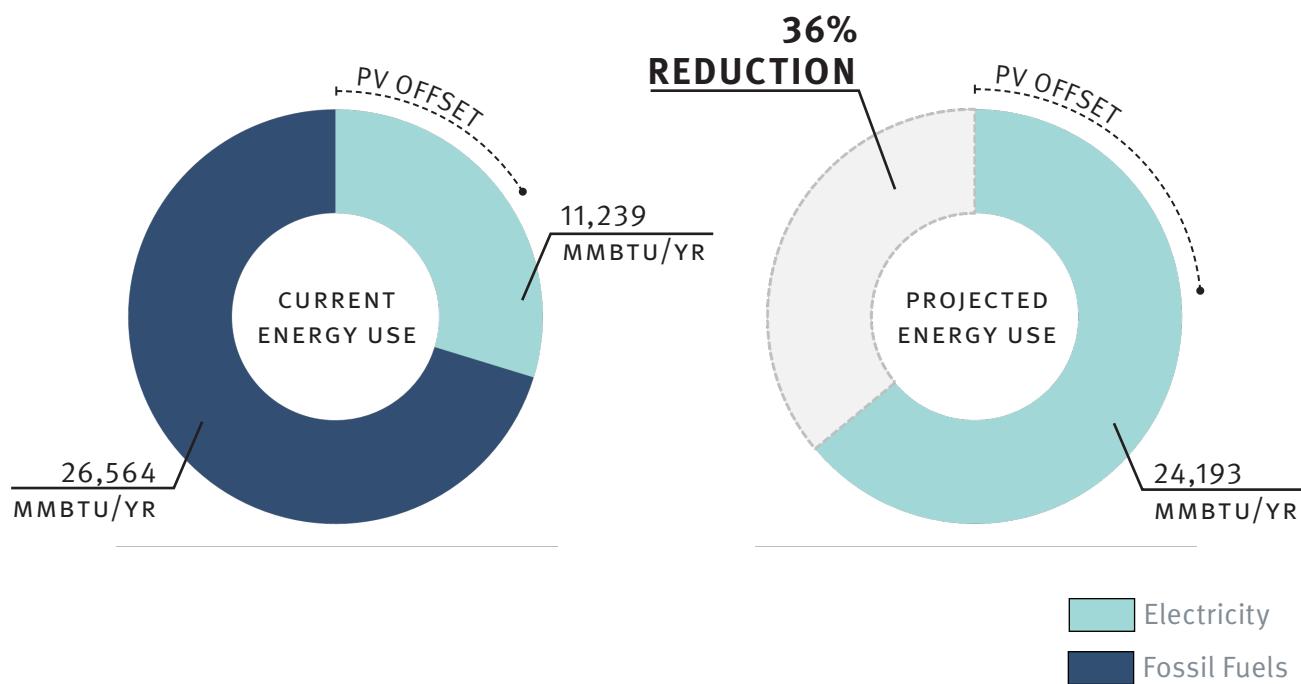
EXISTING & PROJECTED TOTAL ENERGY USE

The following charts illustrate the total portfolio-wide energy use, as well as individual building use, for the existing and proposed cases. The "Energy Use Charts" at the end of this section include detailed numerical values.

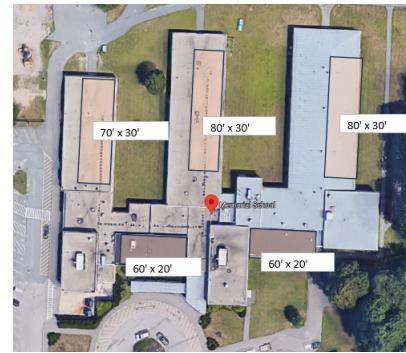
Memorial School

PV Panel Area: 984 SF

For visualization purposes, the roof plans are not in scale.

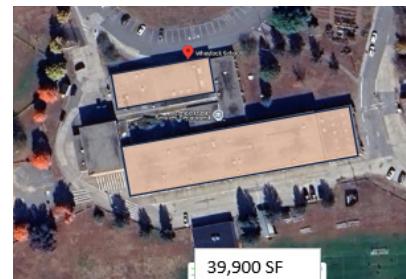
Wheelock School

PV Panel Area: 984 SF

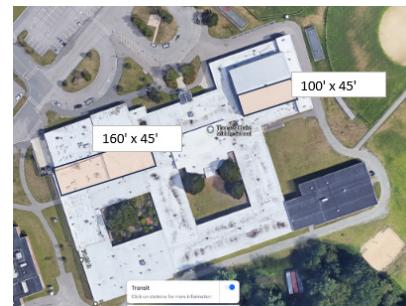
Blake Middle School

PV Panel Area: 984 SF

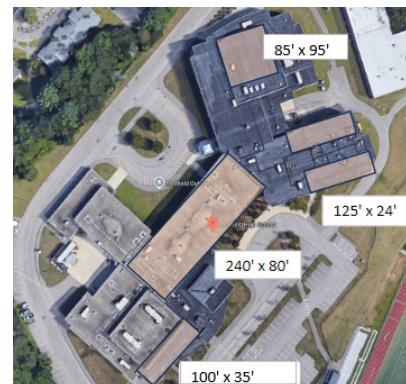
High School

PV Panel Area: 984 SF

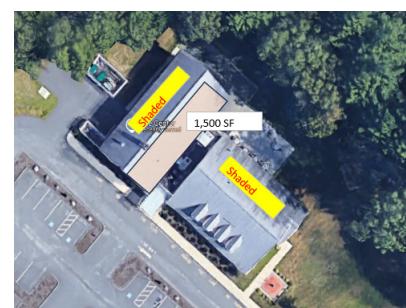
Council on Aging

PV Panel Area: 984 SF
