TOWN OF MEDFIELD

Municipal Facilities

Evaluation and Capital Plan

October 6, 2017

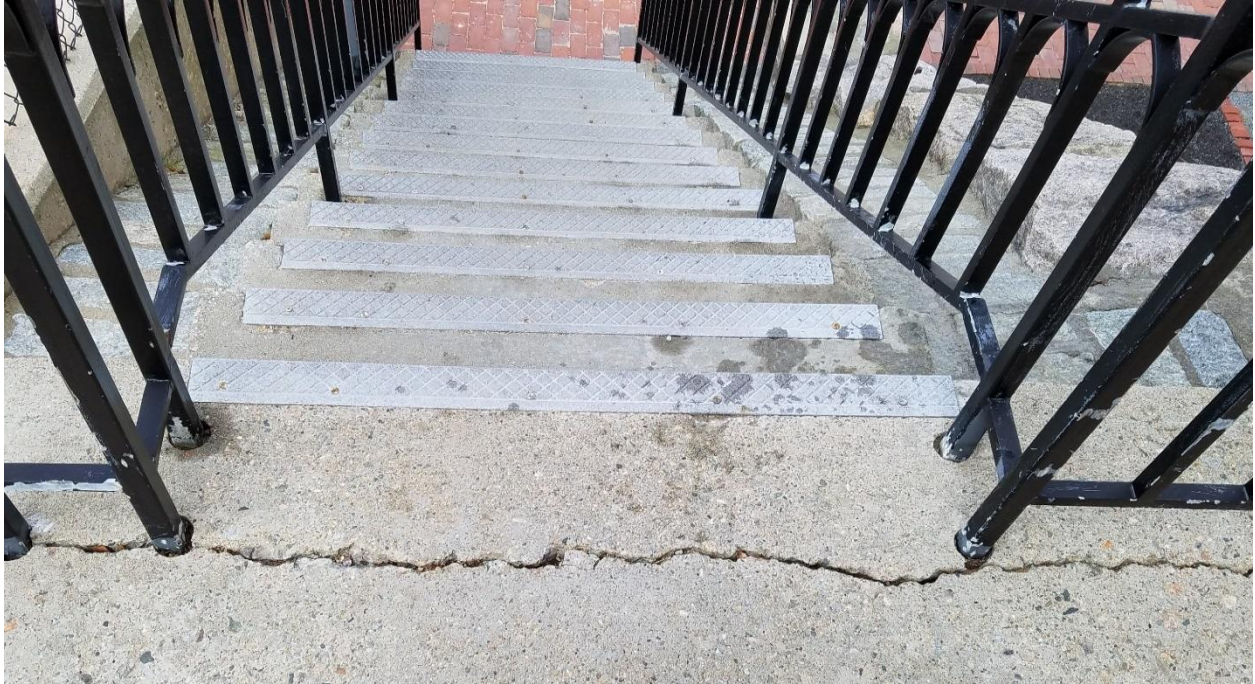
CONCRETE STAIRS & HANDRAILS FROM LOWER (REAR) LEVEL TO MAIN STREET ENTRANCE LEVEL
(Note crack at top tread)

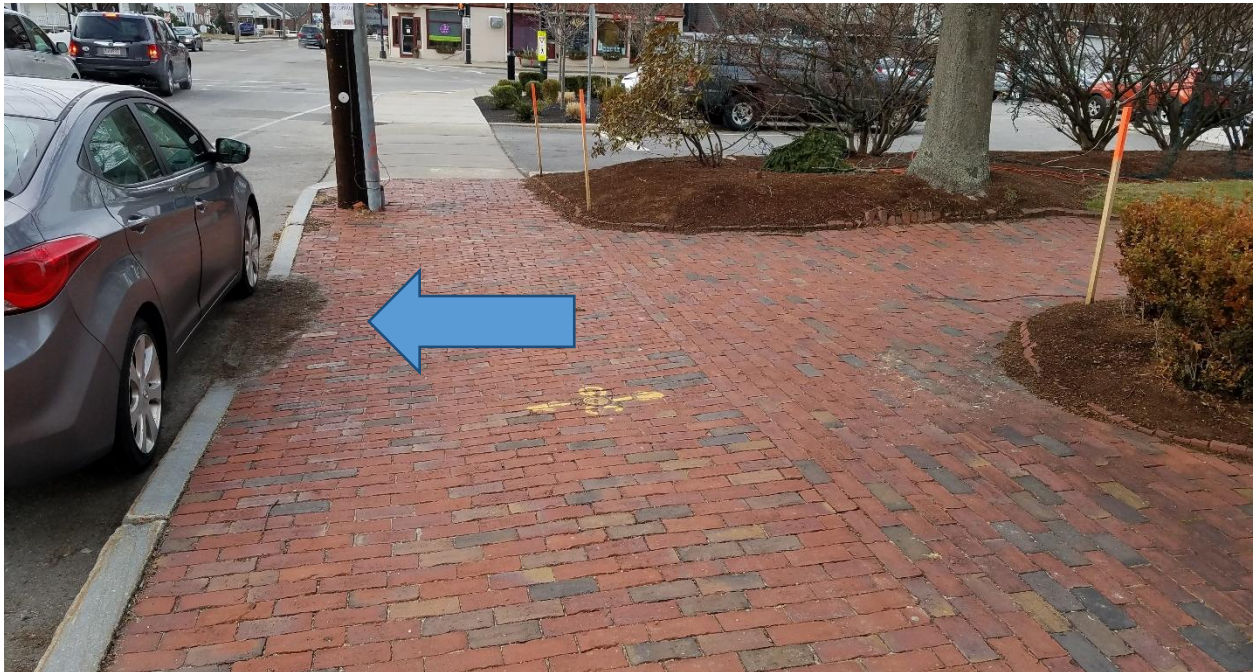
SHOWING MAIN STREET CURB CUT WITH NO DESIGNATION FOR ACCESSIBLE PARKING

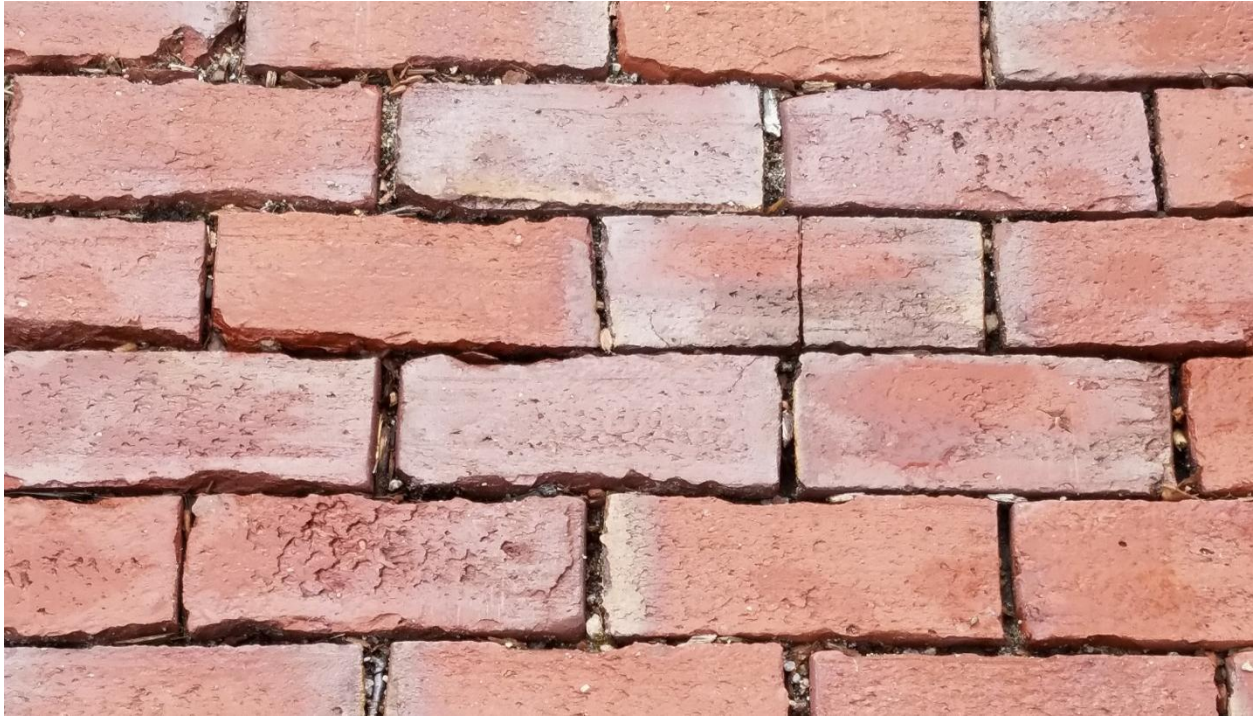
TYPICAL OPEN JOINTS OF BRICK WALKWAYS NEEDING SAND INFILL

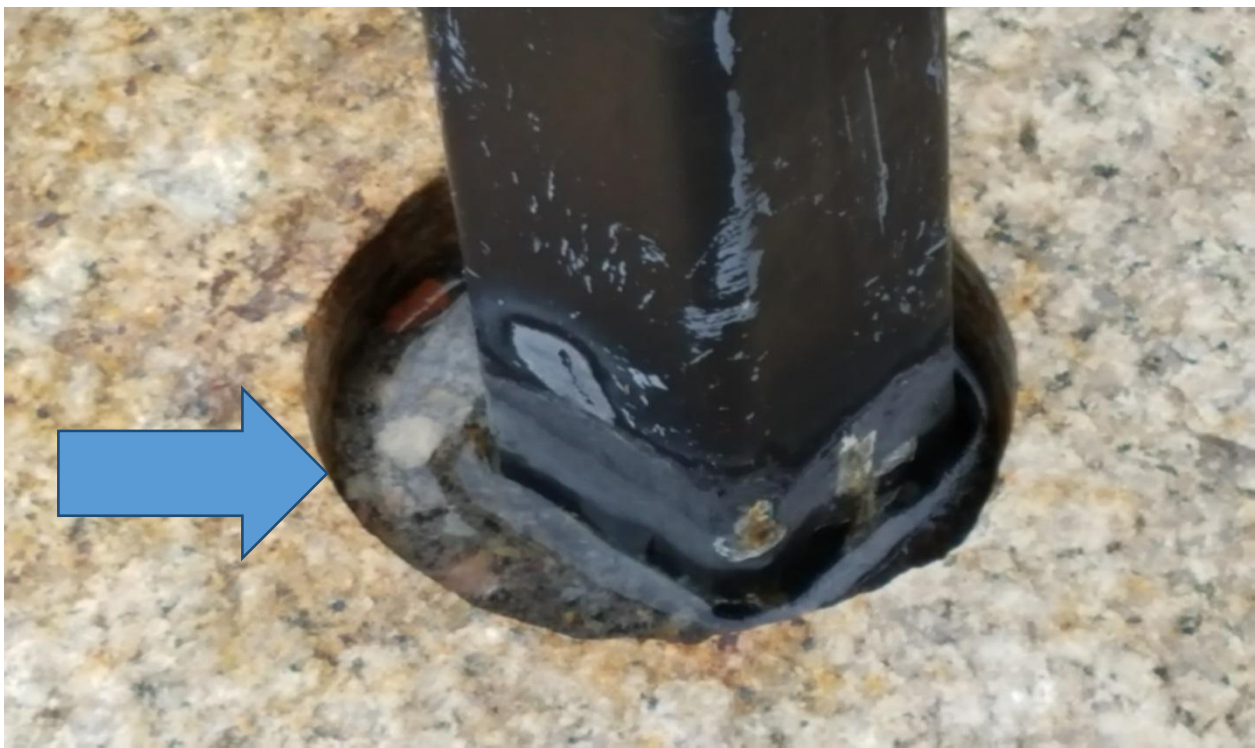
GAPS AROUND GUARDRAIL POSTS COLLECTING WATER & ICE

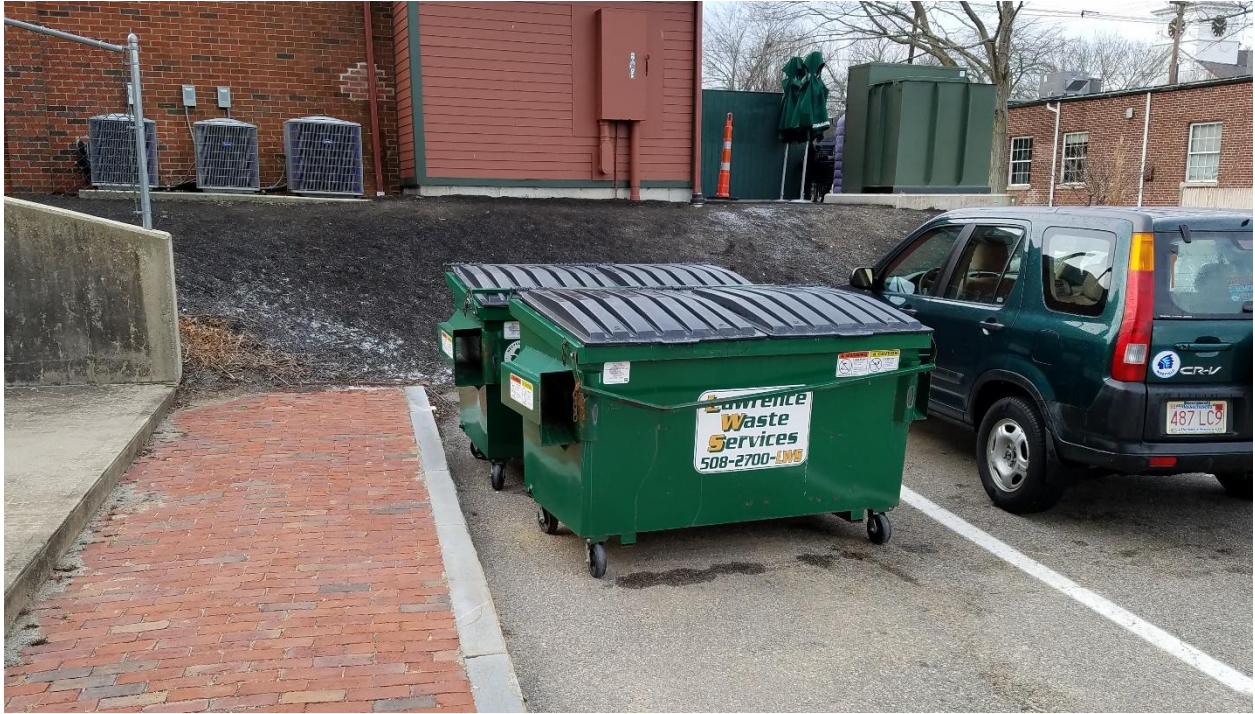
SHOWING UN-ENCLOSED DUMPSTERS NEAR CONCRETE GENERATOR PAD AT REAR

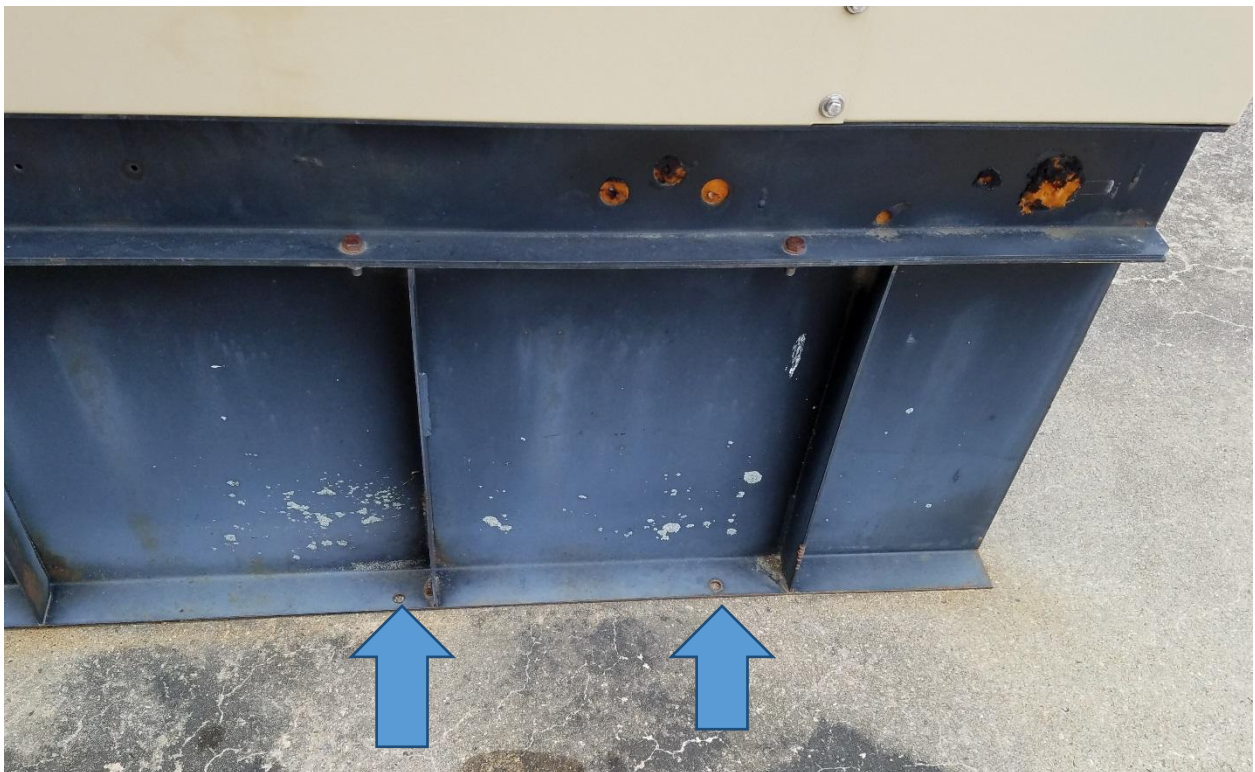
GENERATOR UNSECURED TO CONCRETE PAD

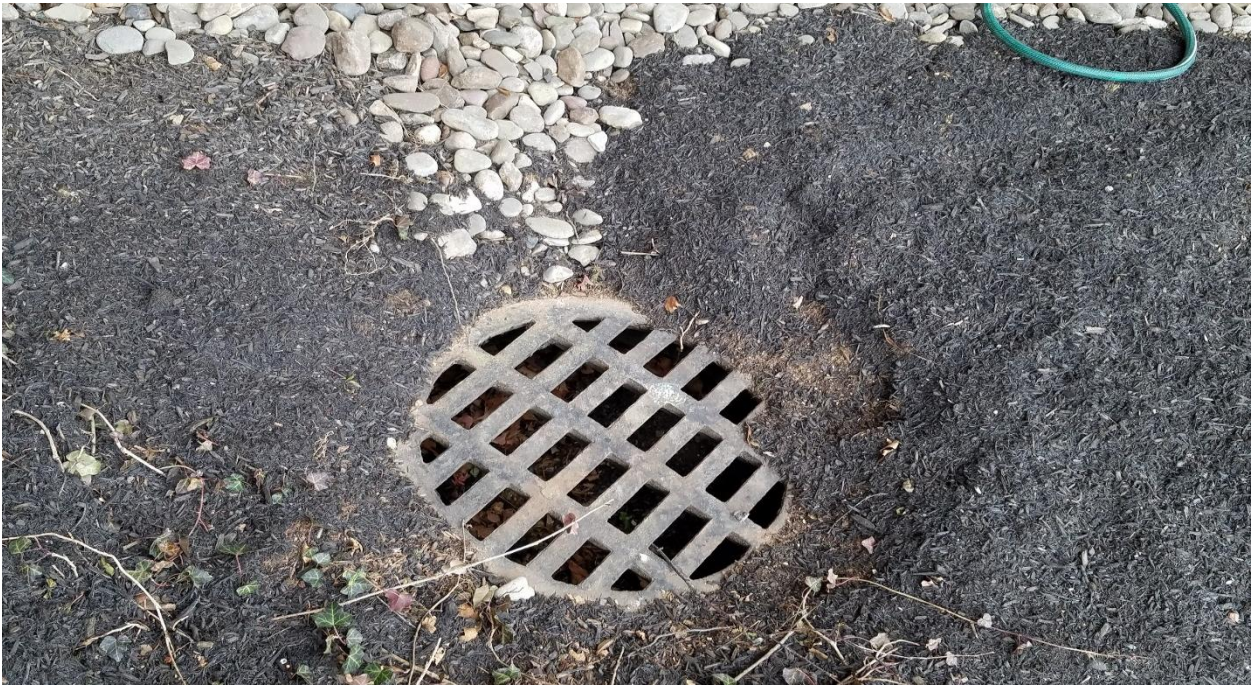
AREA DRAIN AT REAR LANDSCAPING AREA SHOWING MULCH WASHING INTO SUMP

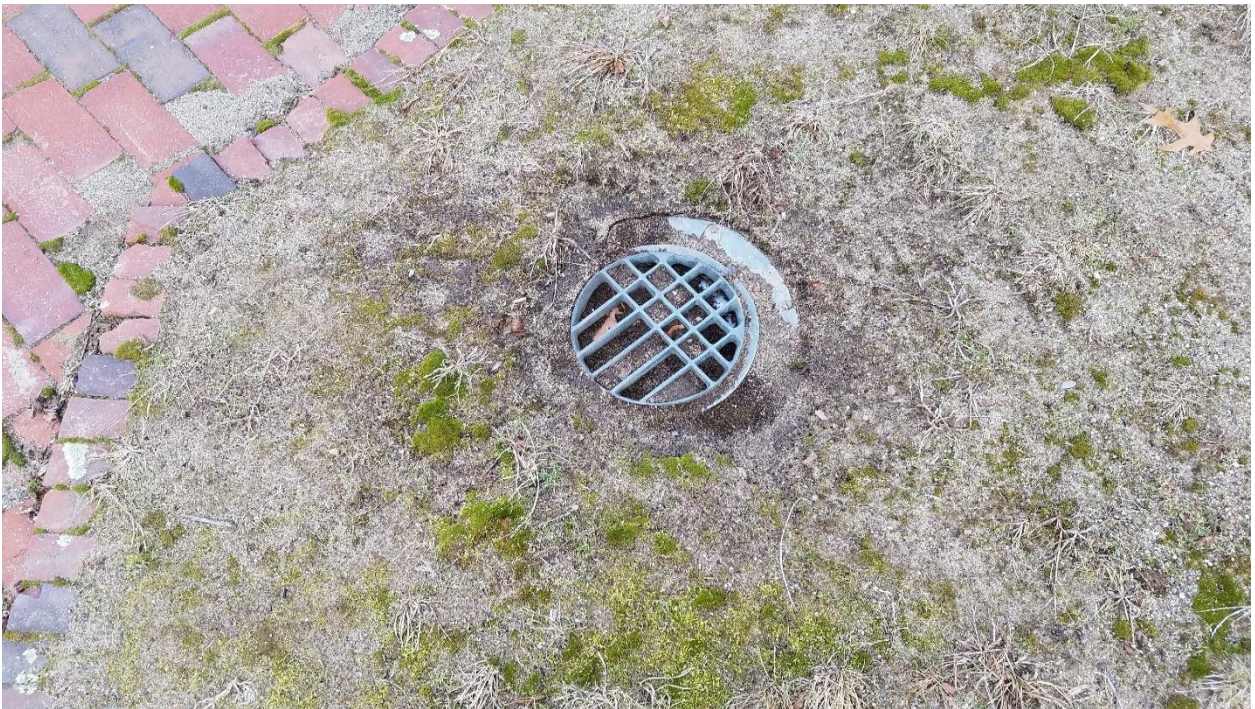
TYPICAL LANDSCAPING LIGHTS FILLED WITH DEBRIS

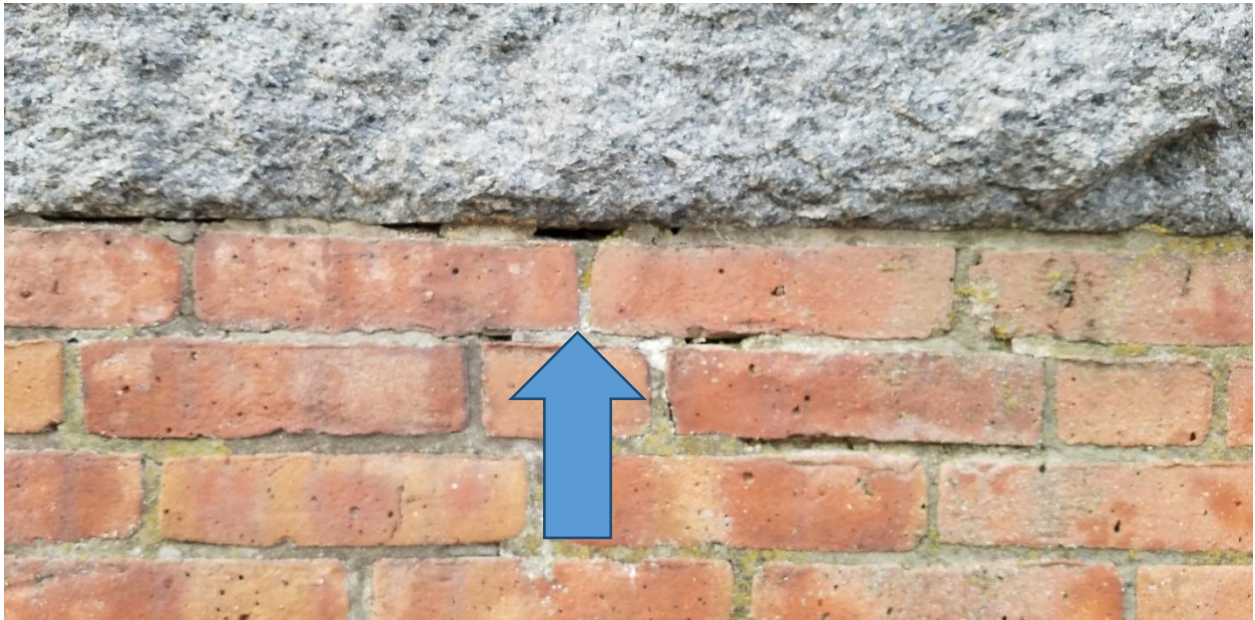
TYPICAL OPEN JOINTS IN EXISTING BRICK NEEDING REPOINTING

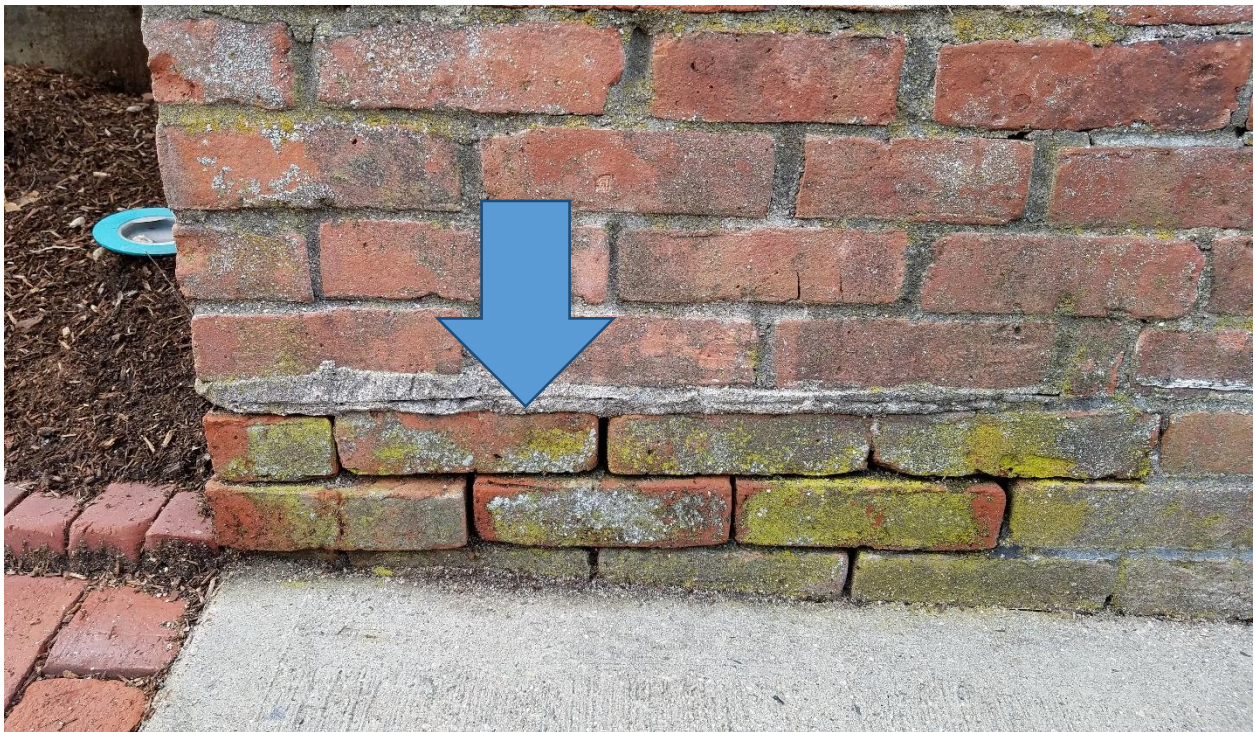
LOOSE BRICK AND TYPICAL ORGANIC GROWTH ON EXISTING BRICK

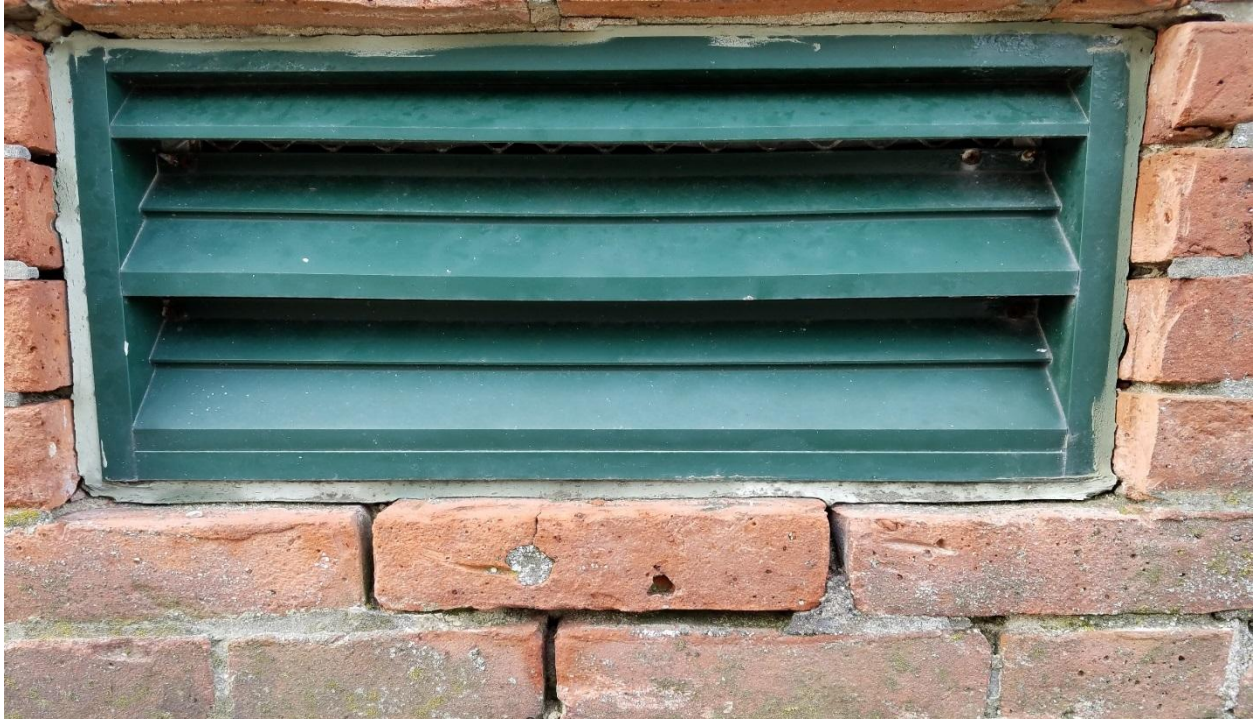
OPEN JOINTS IN BRICK AROUND OPENINGS CREATED DURING 1998 RENOVATIONS

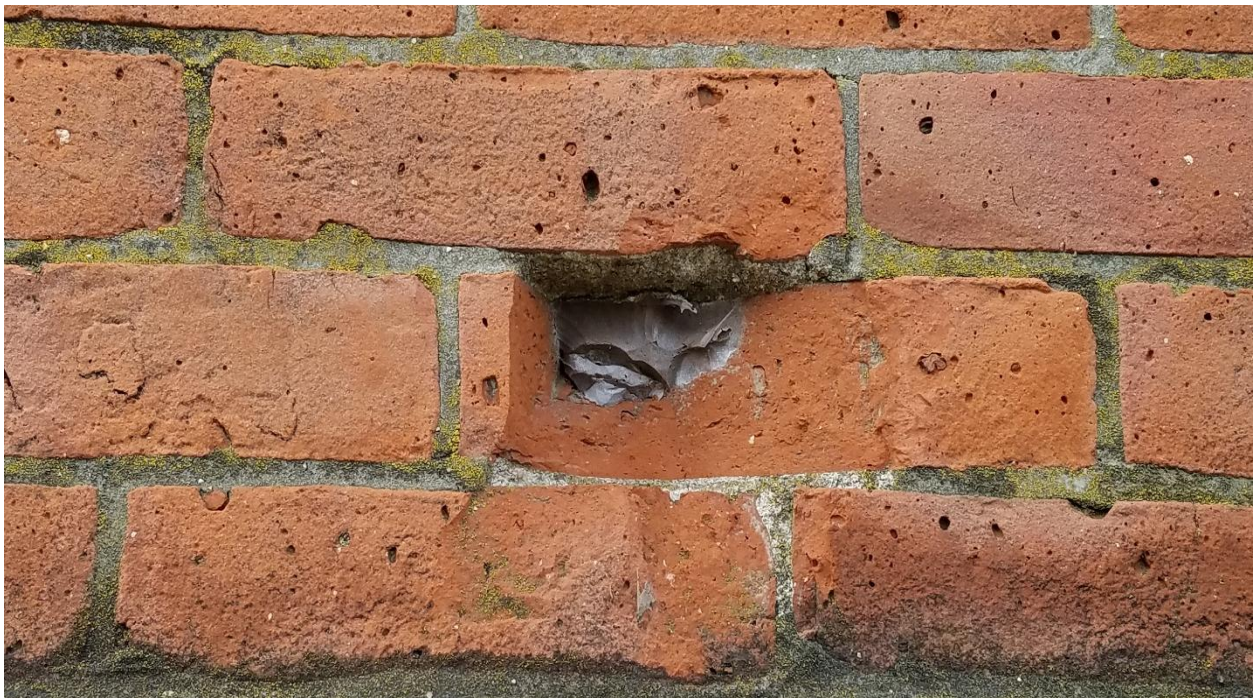
TYPICAL EXAMPLE OF SPALLED BRICK NEEDING REPLACEMENT and GROWTH ON BRICKS & MORTAR

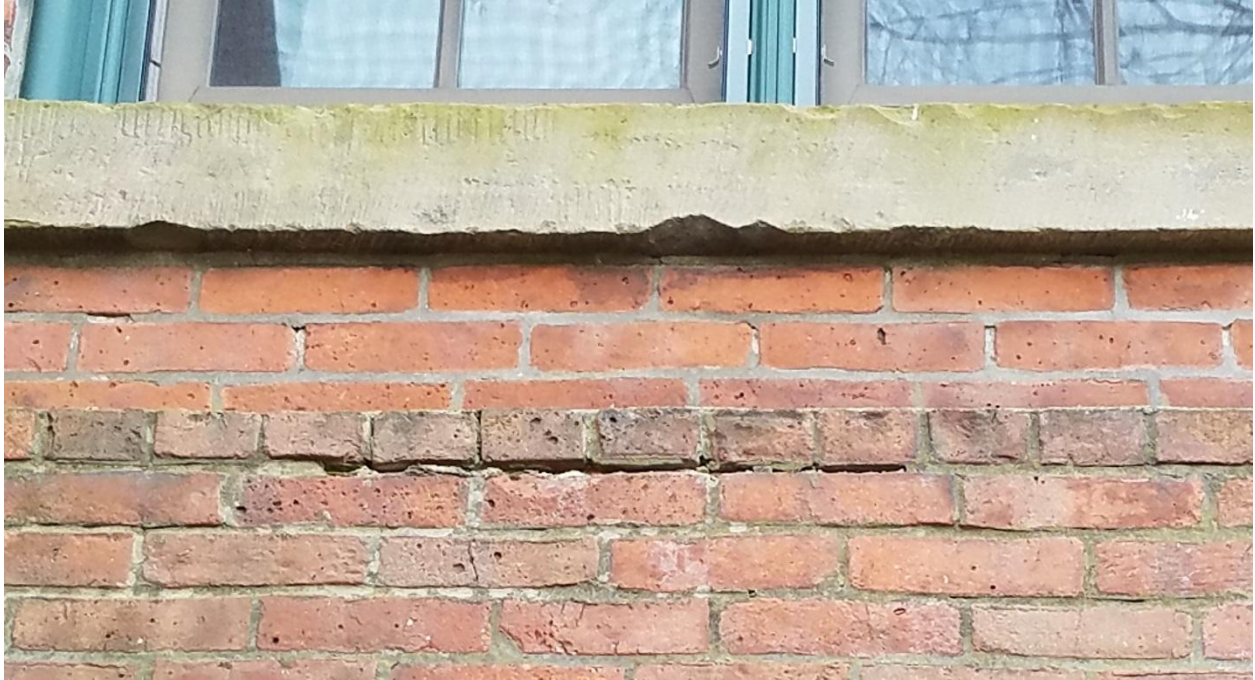
TYPICAL EXAMPLE OF DETERIORATED LIMESTONE SILL and OPEN JOINTS AT INTERMEDIATE WATER TABLE BRICK

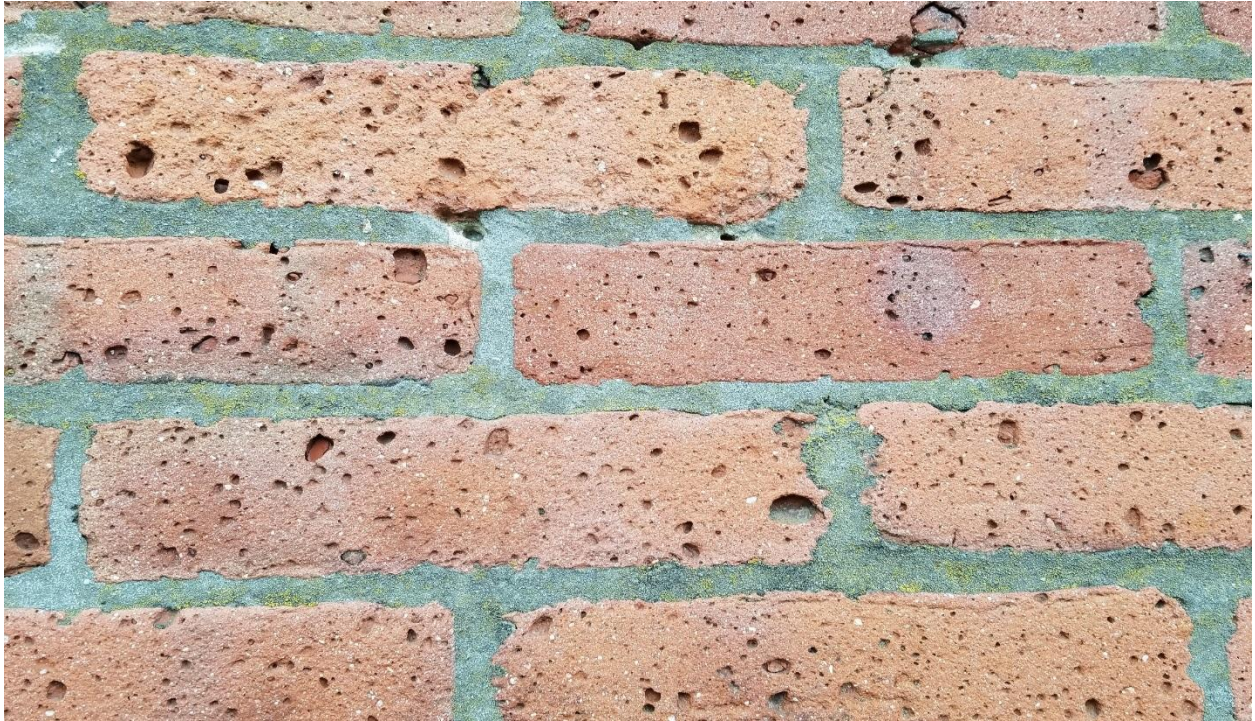
EXAMPLE OF EXTREMELY POROUS CONDITION OF EXISTING BRICK – SUSCEPTIBLE TO MOISTURE INFILTRATION AND FREEZE/THAW DAMAGE – ALSO ORGANIC GROWTH ON MORTAR

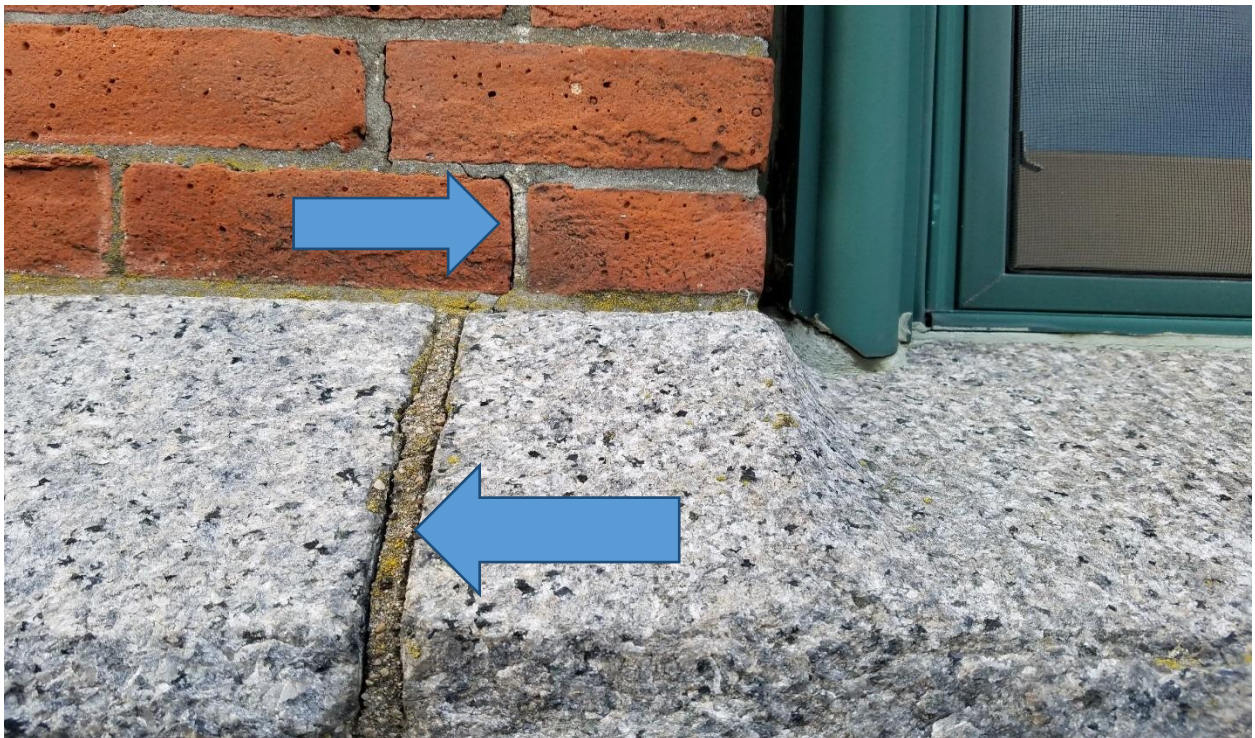
EXAMPLE OF OPEN JOINTS IN GRANITE SILLS and NOTE CRACKS IN MORTAR AT BRICK

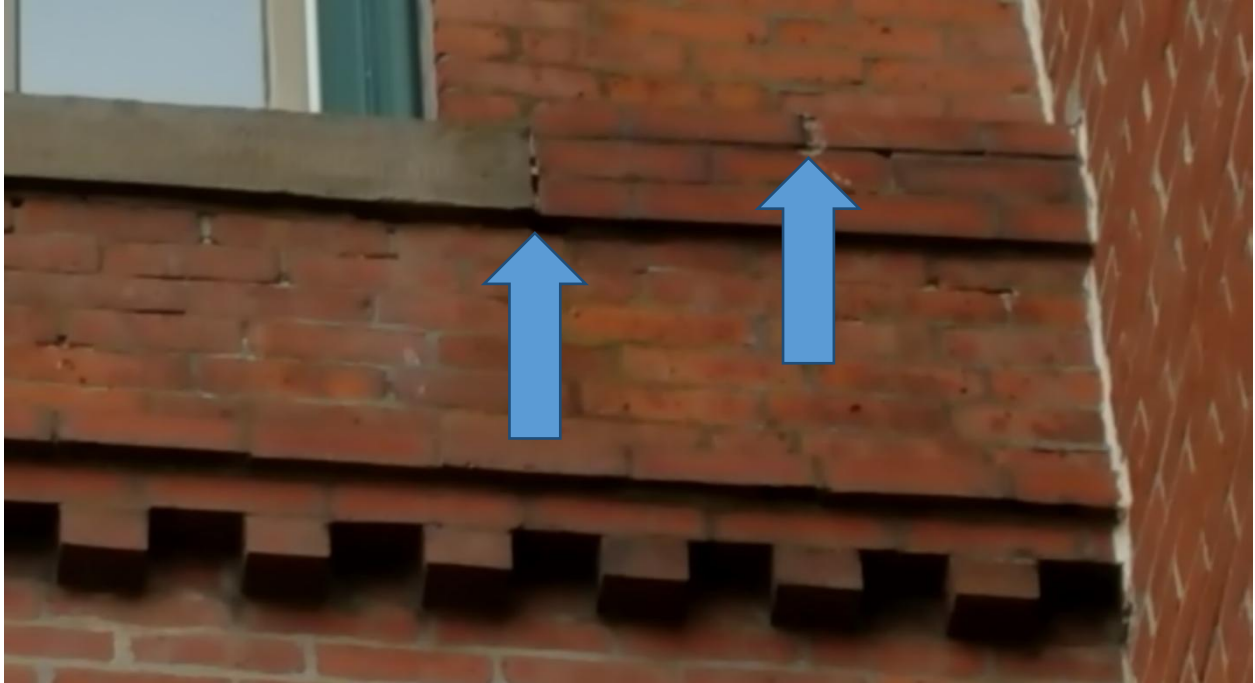
OPEN JOINTS IN BRICK/LIMESTONE

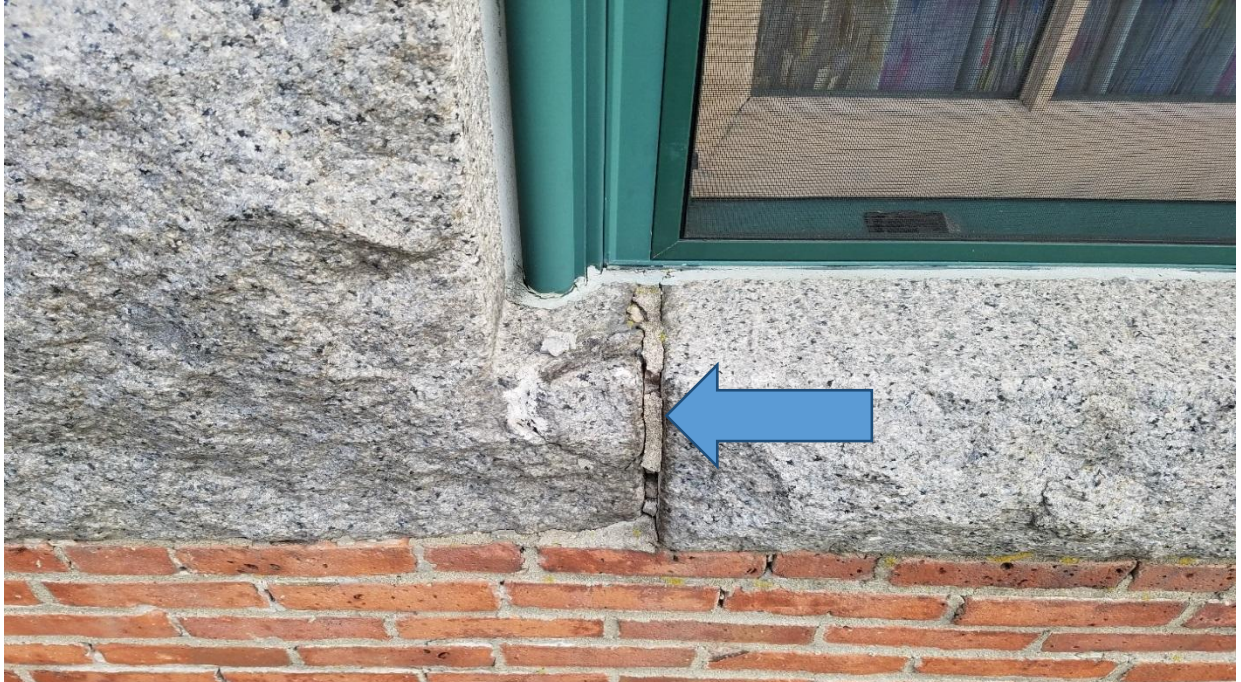
SHOWING REPOINTING NEEDED AT GRANITE SILLS

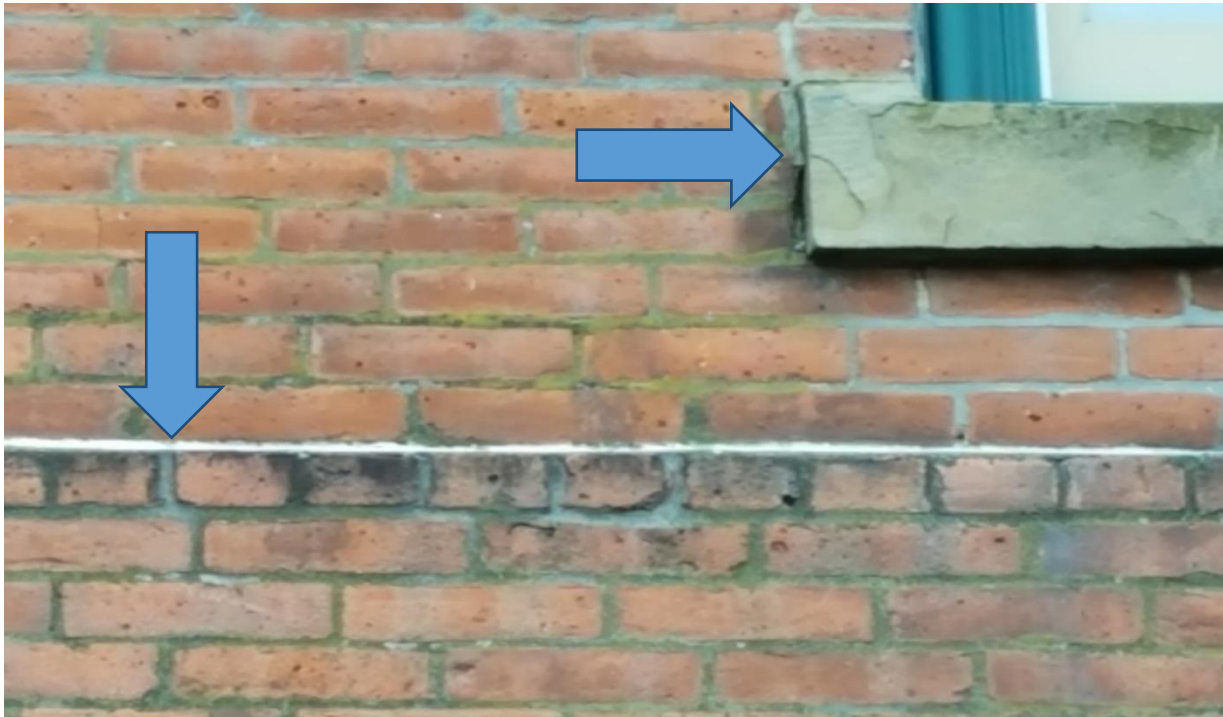
SHOWING POOR CONDITION OF LIMESTONE SILLS and CAULK JOINT ALONG TOP OF INTERMEDIATE BRICK WATERTABLE

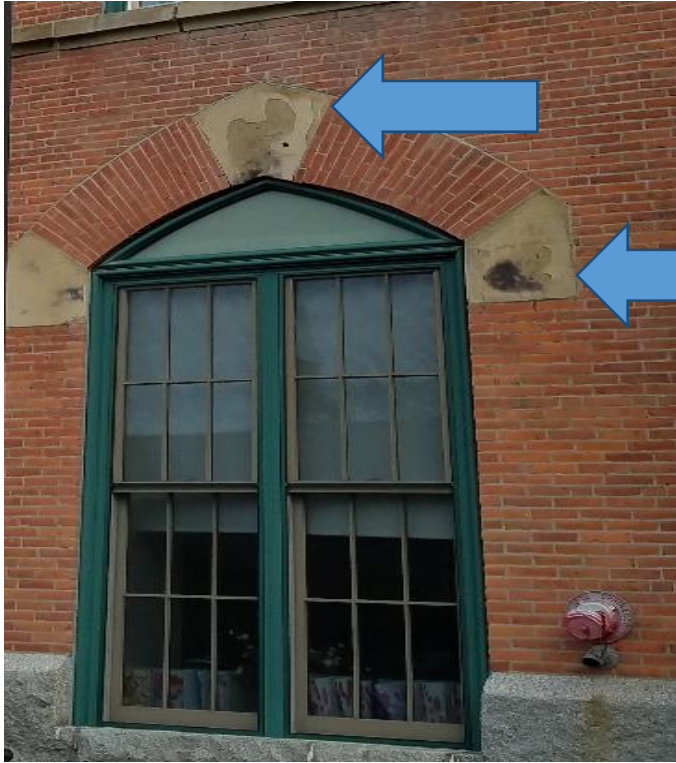
TYPICAL DETERIORATED LIMESTONE KEYS

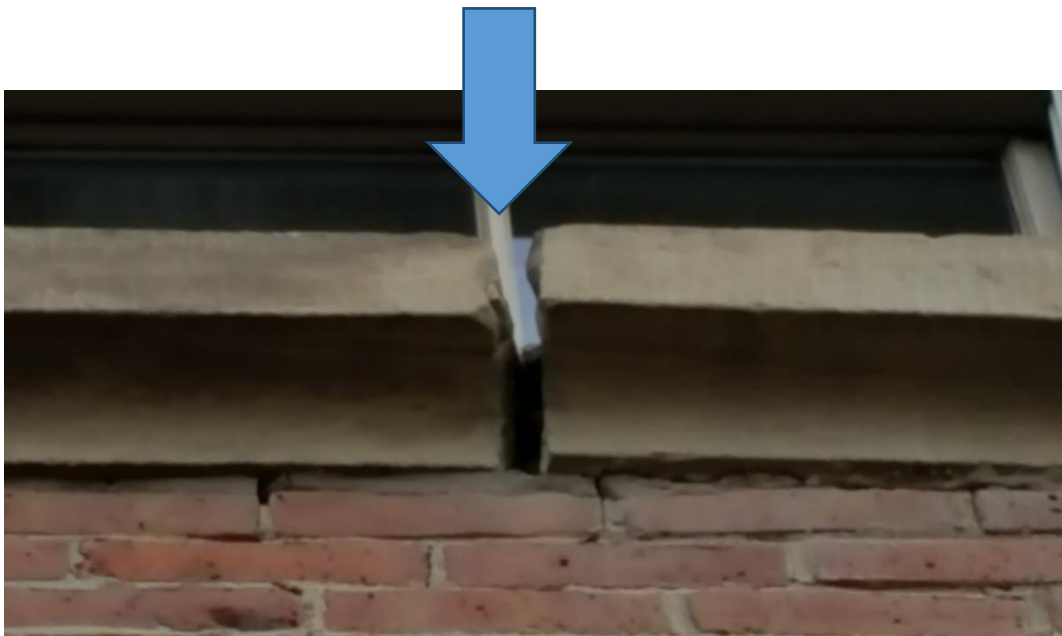
COMPLETELY DETERIORATED JOINTS IN LIMESTONE SILLS and SOURCE OF WATER INFILTRATION

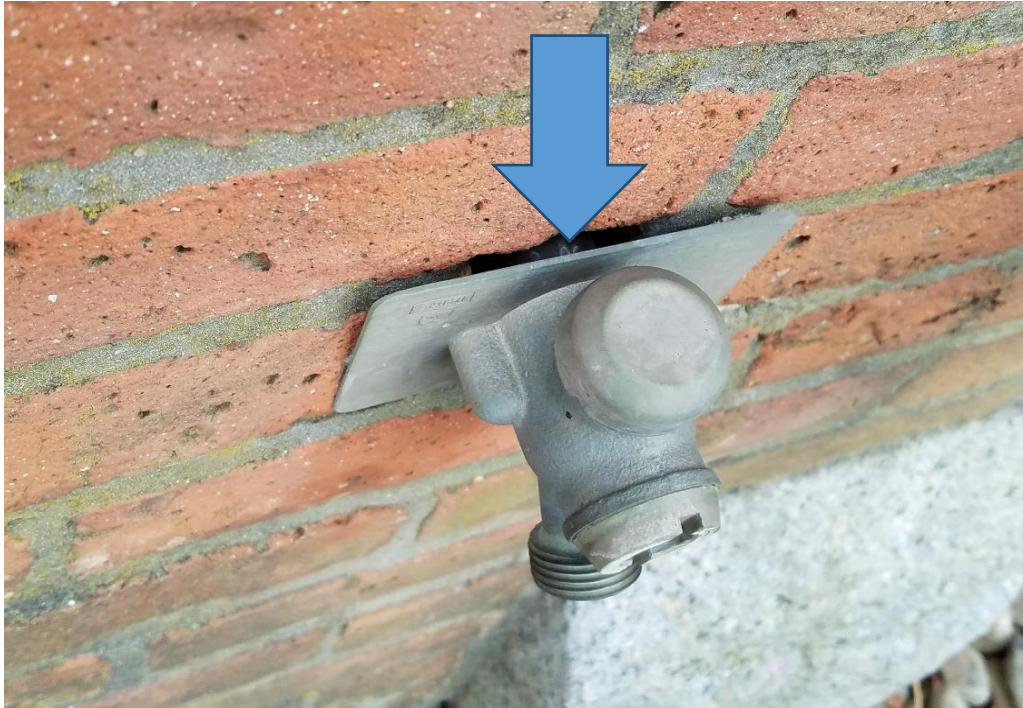
GAPS AROUND EXTERIOR HOSE BIBS NEEDING SEALANTS

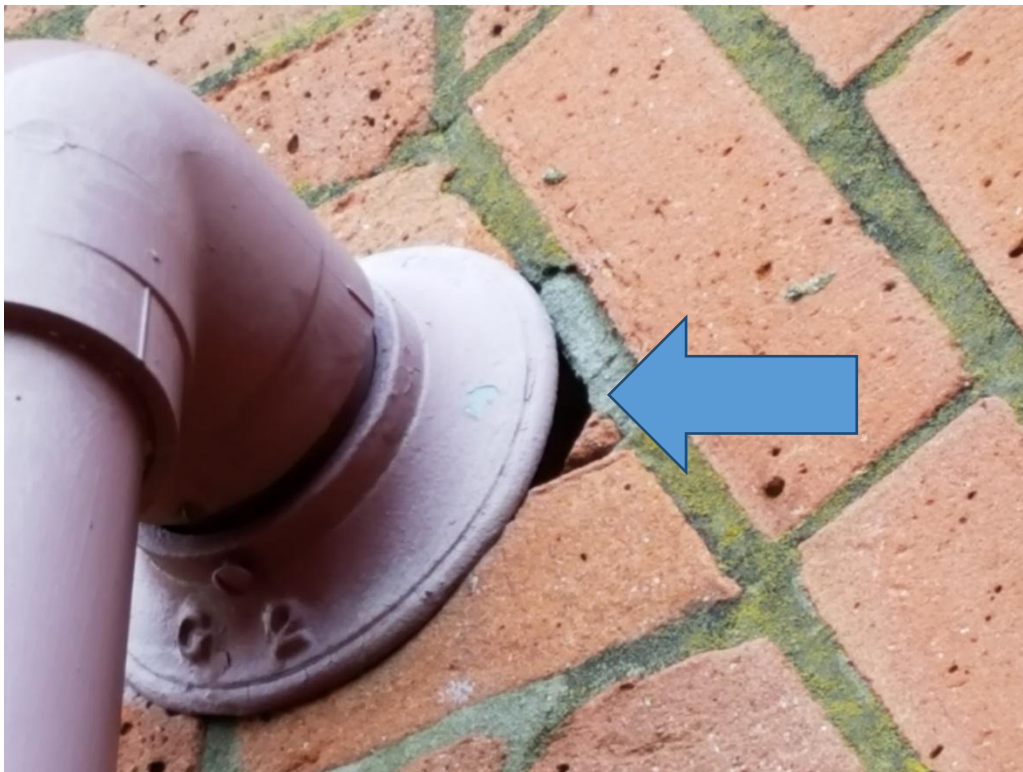
GAPS AROUND SPRINKLER DRAIN NEEDING SEALANTS

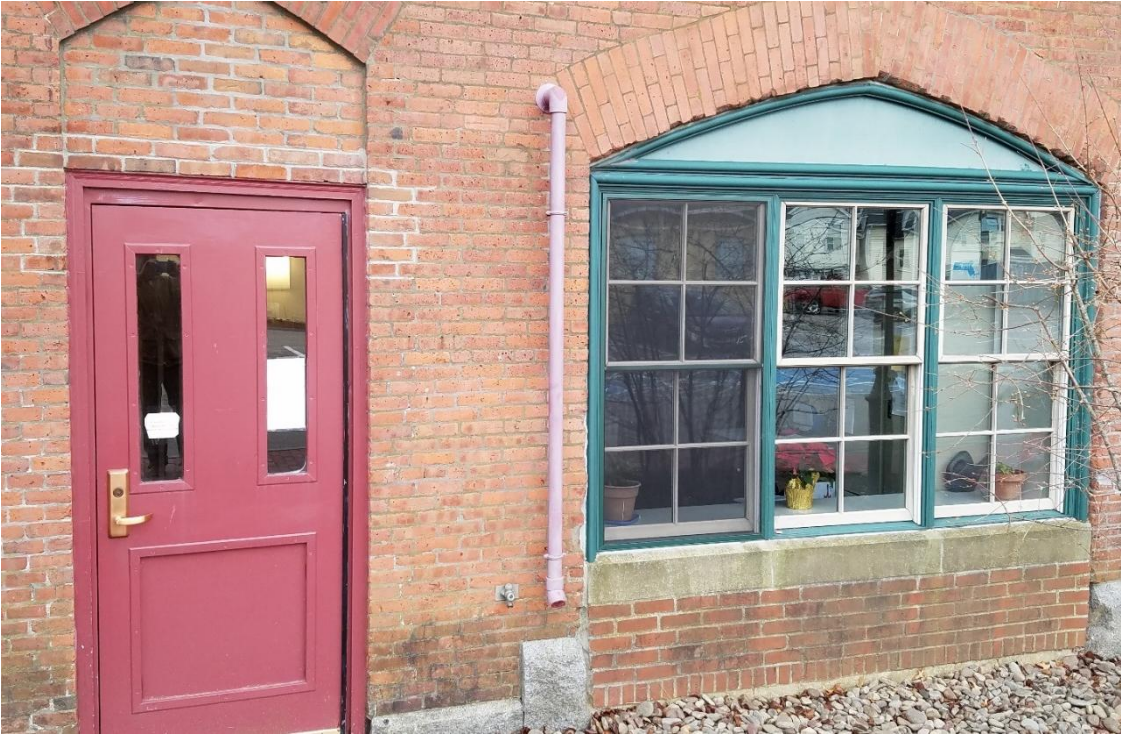
TYPICAL METAL DOORS and WINDOW UNIT (Note missing screens here & elsewhere)

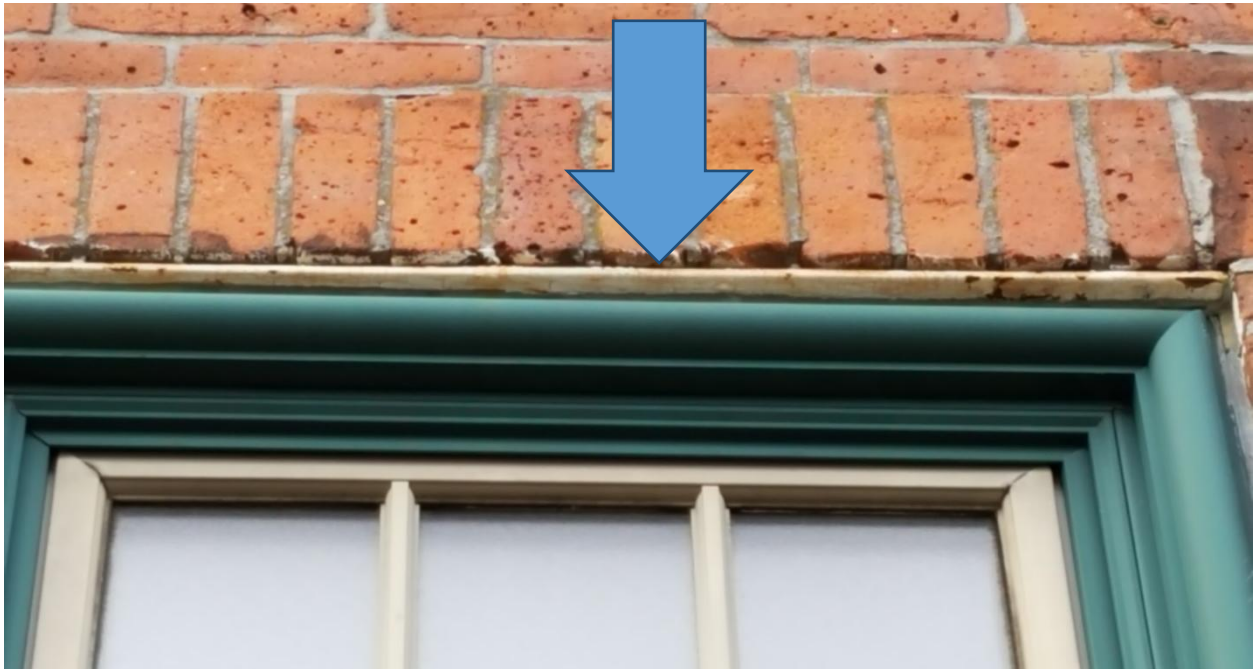
TYPICAL STEEL LINTEL NEEDING SCRAPE & PAINT

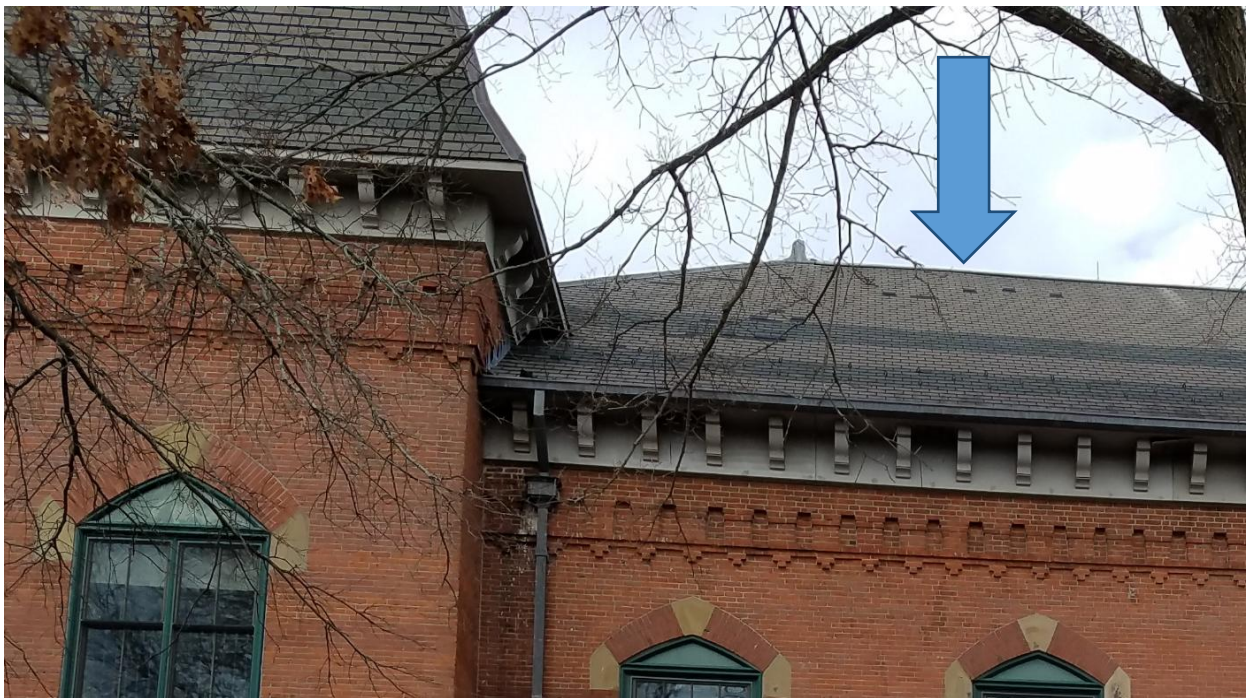
FRONT SHINGLED ROOF SHOWING MISSING SHINGLES

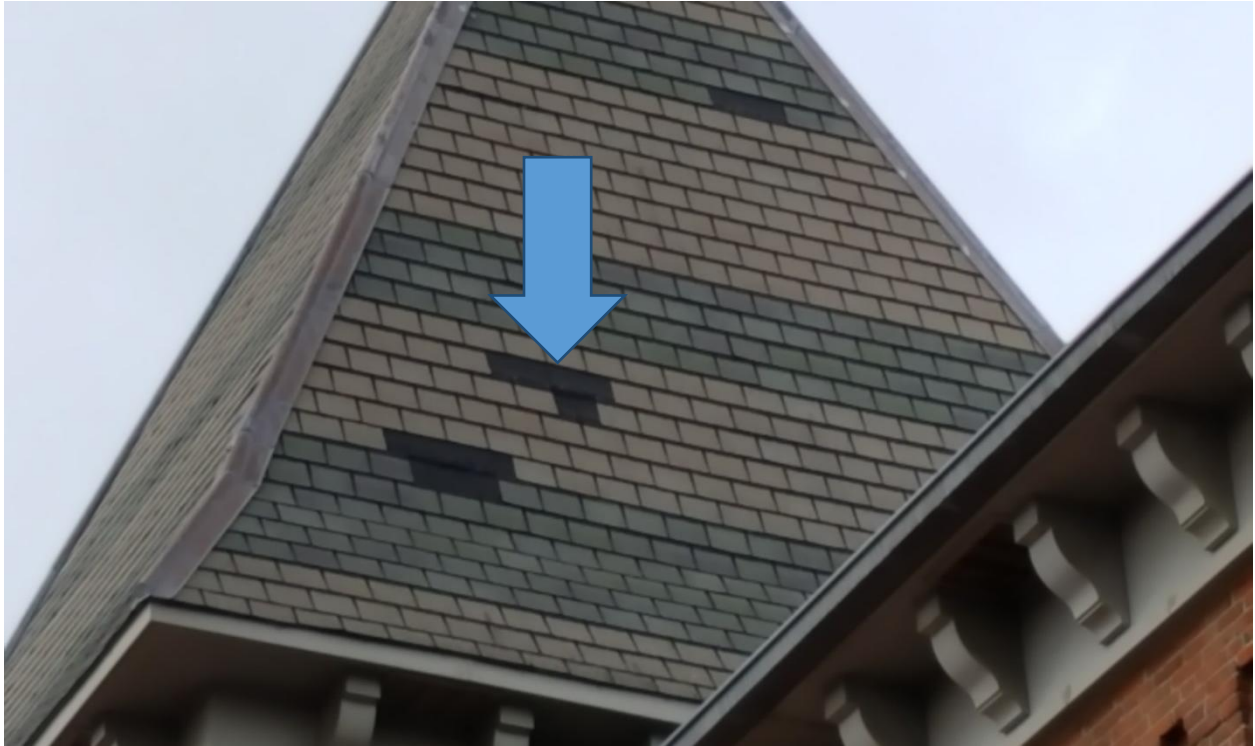
MISSING SHINGLES ON TOWER ELEMENTS
