TOWN OF MEDFIELD

Municipal Facilities

Evaluation and Capital Plan

October 6, 2017

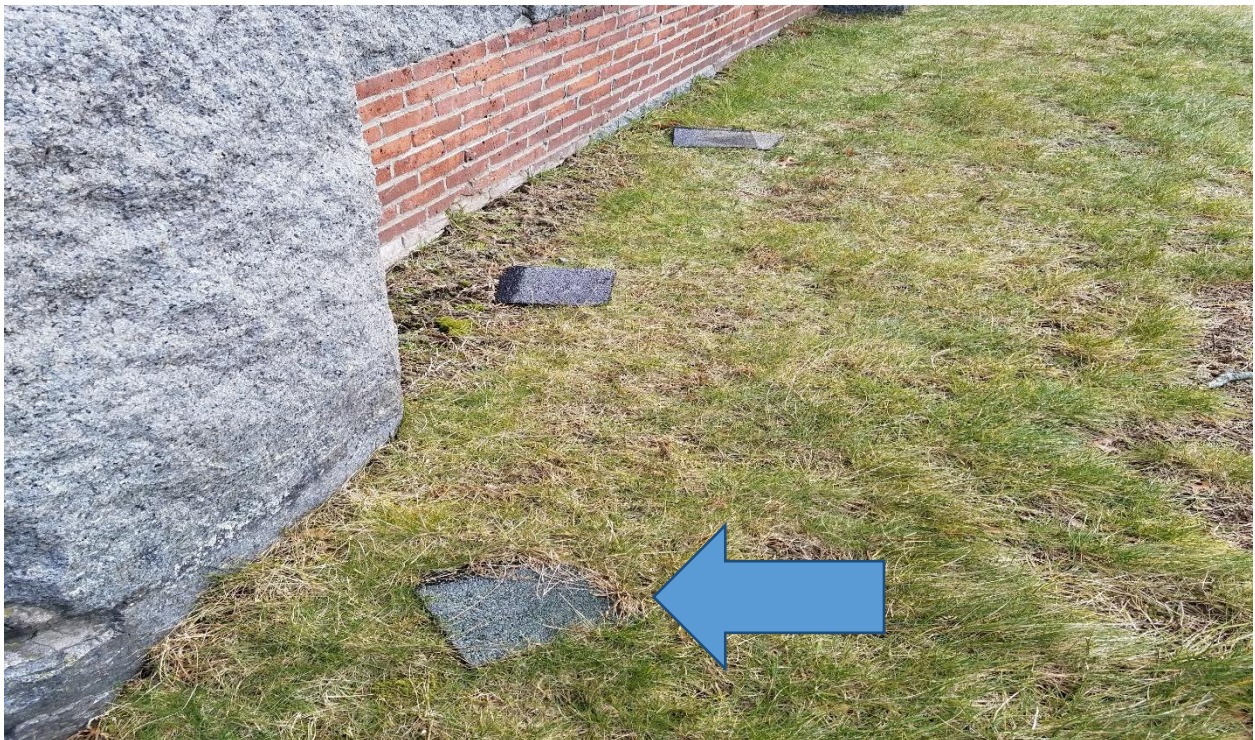
FALLEN ASPHALT SHINGLED SCATTERED AROUND BUILDING PERIMETER

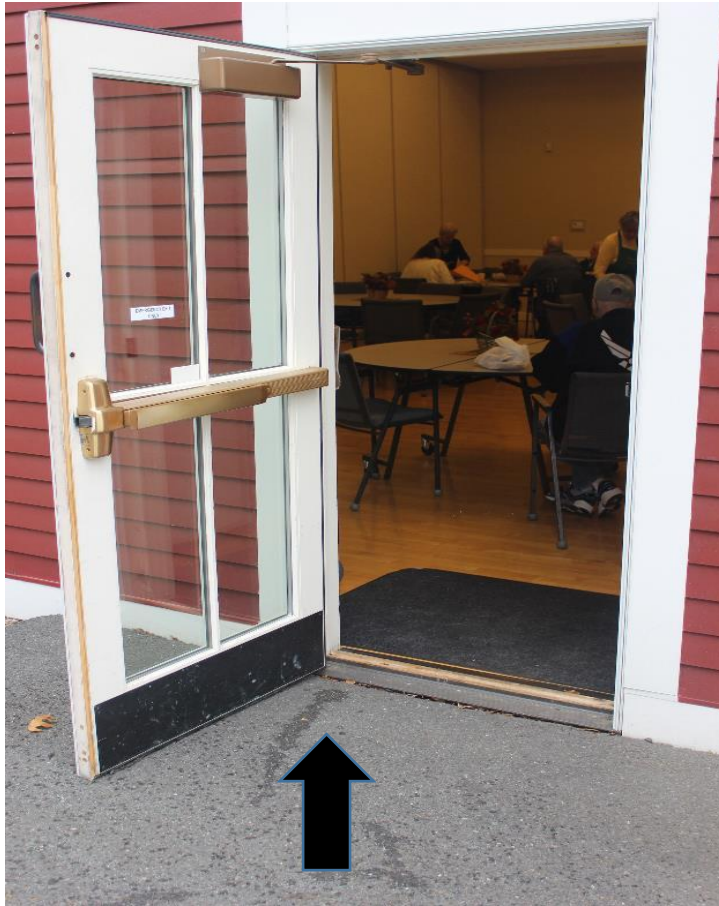
Poor drainage has led to frost heaving and door failure to open. All locations

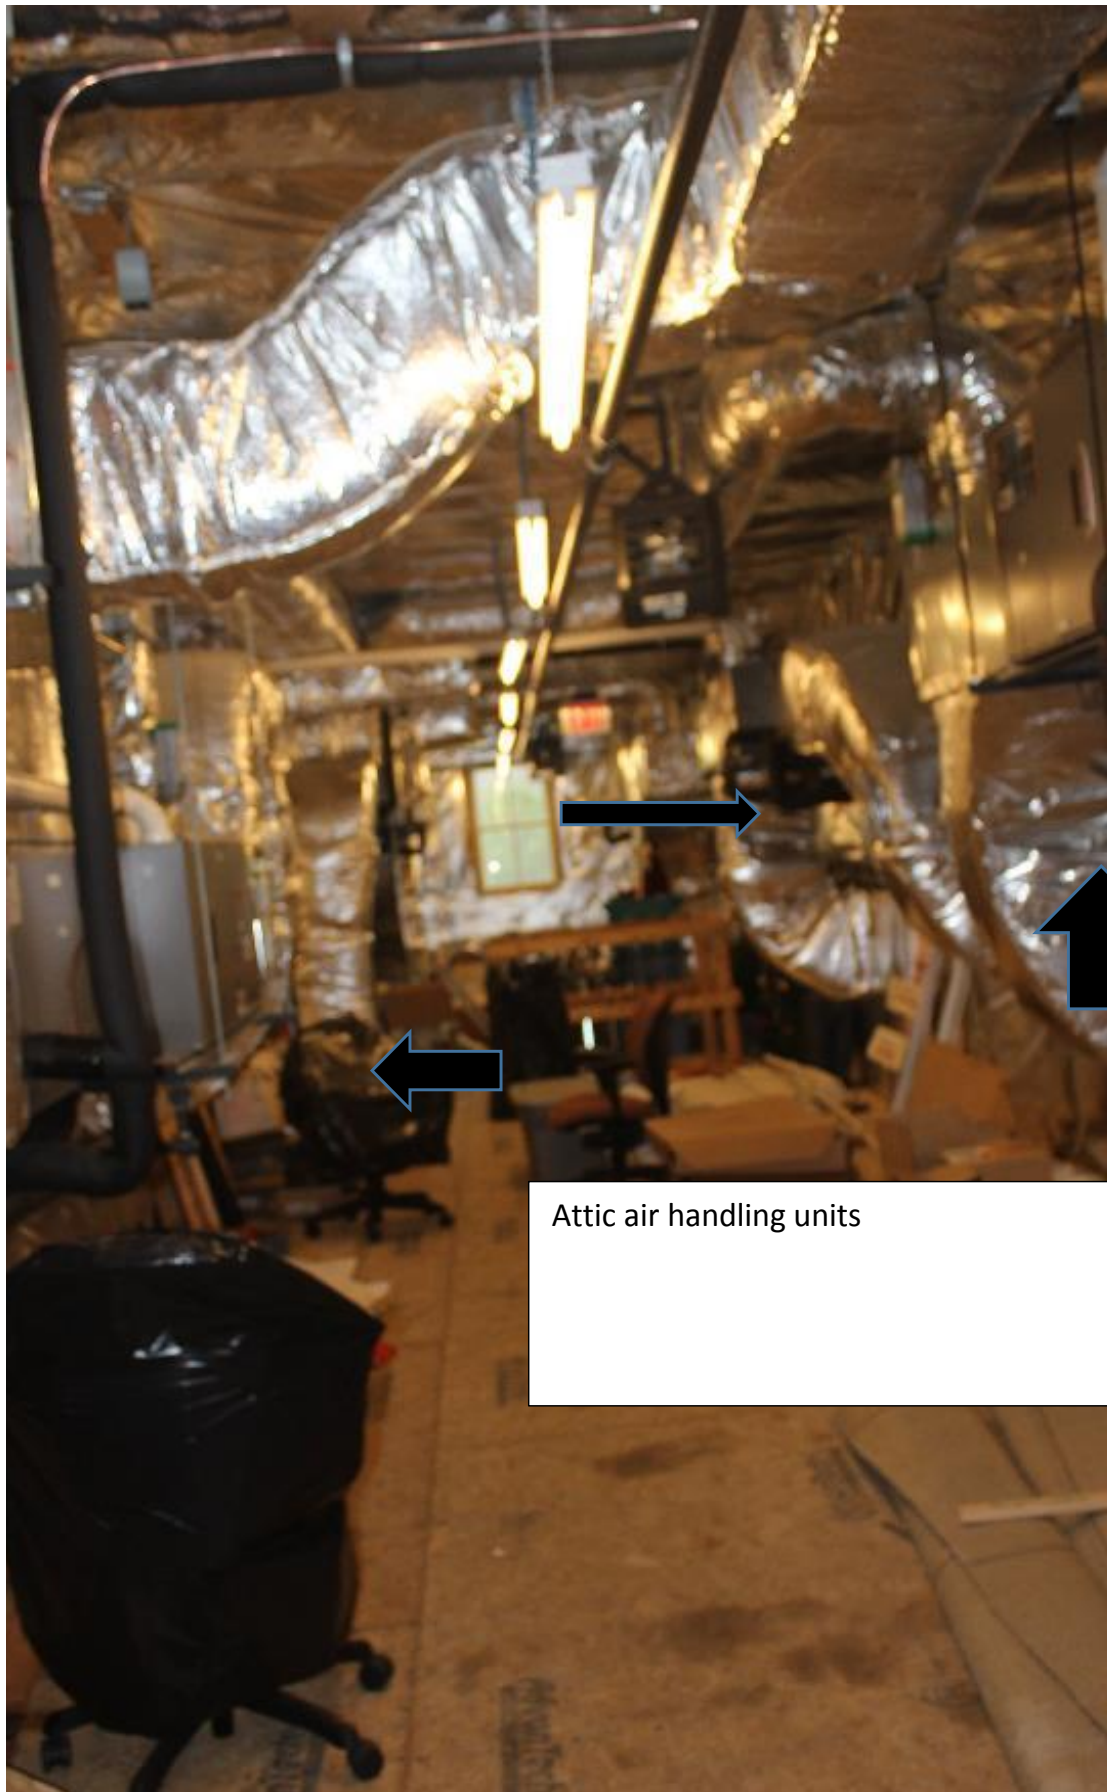
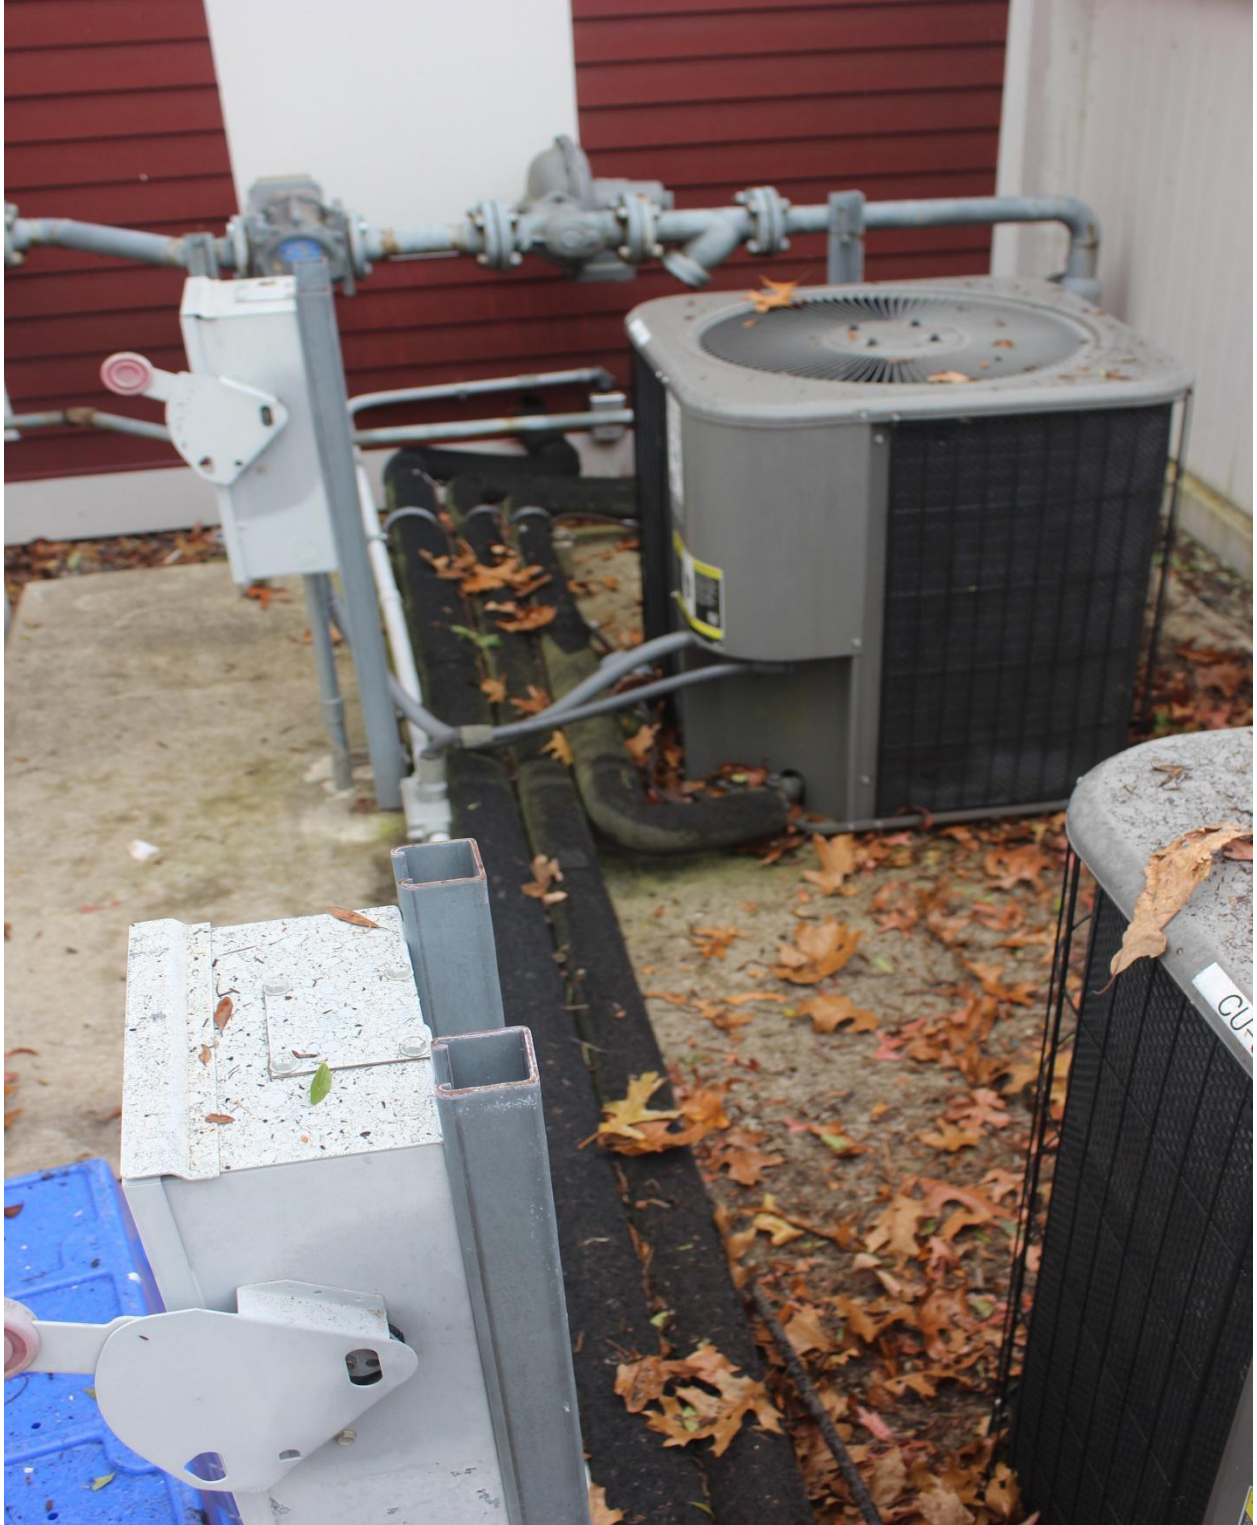
Ground mounted condensing units

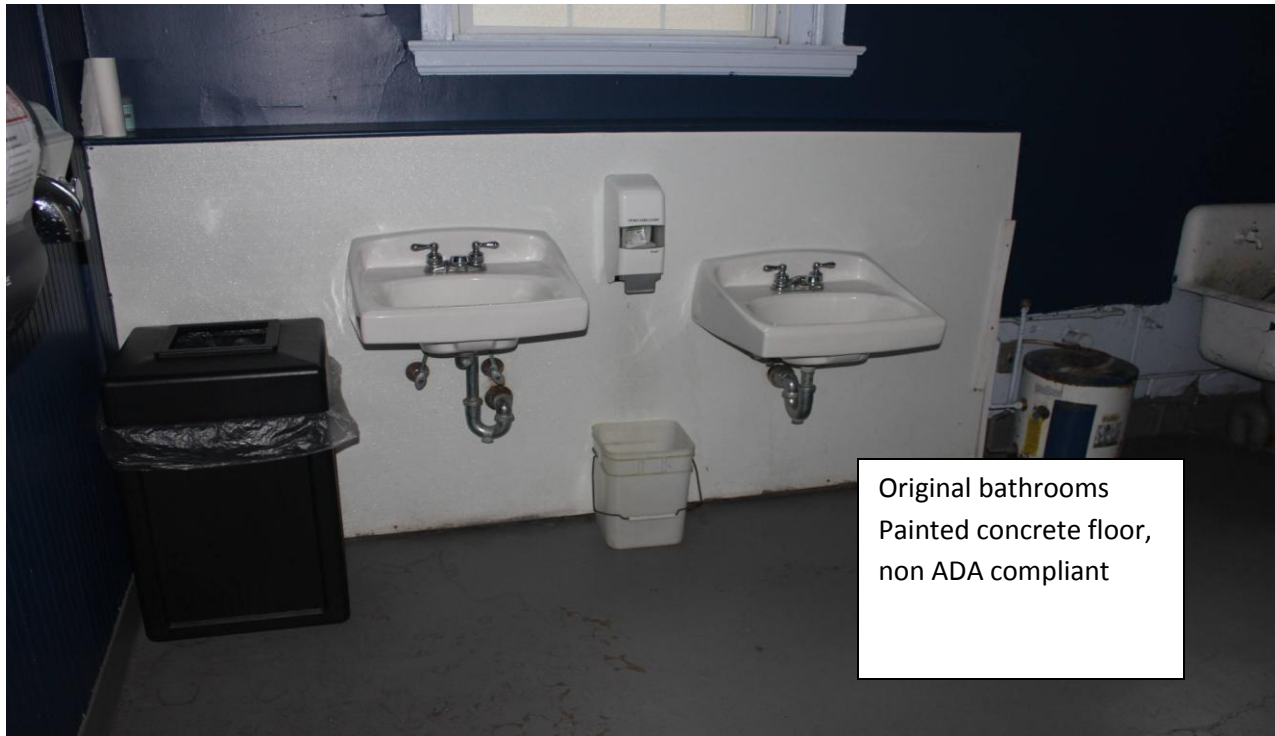
Original bathrooms
Painted concrete floor,
non ADA compliant

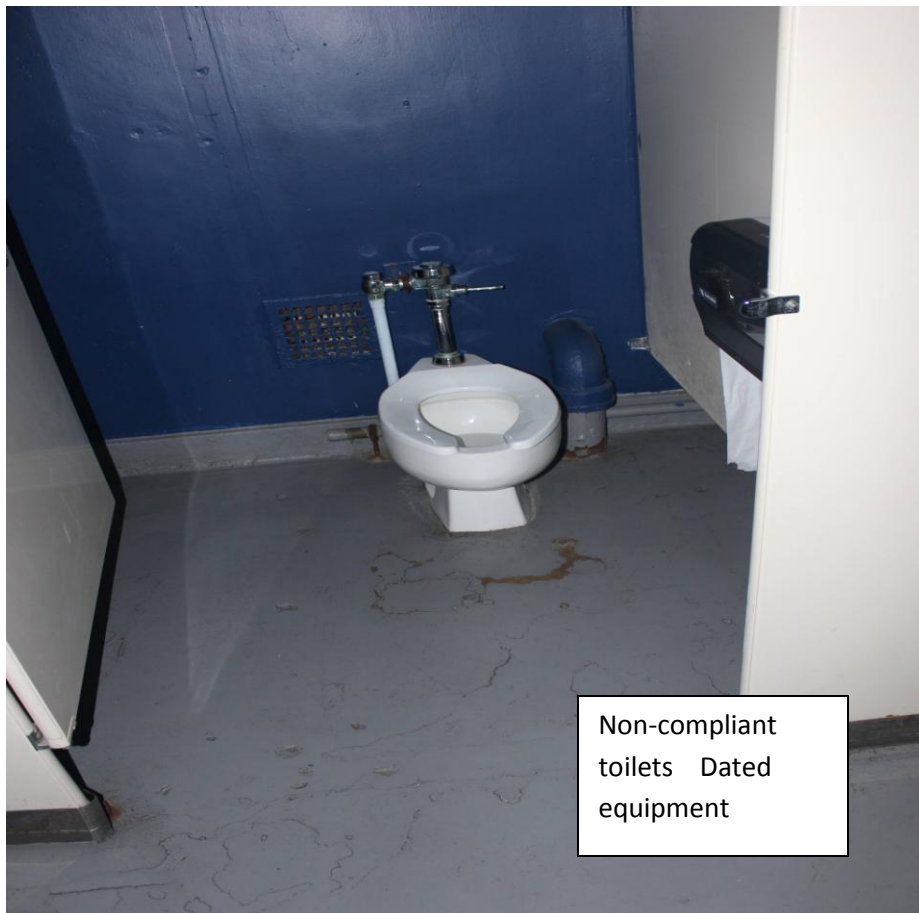
Non-compliant
toilets Dated
equipment

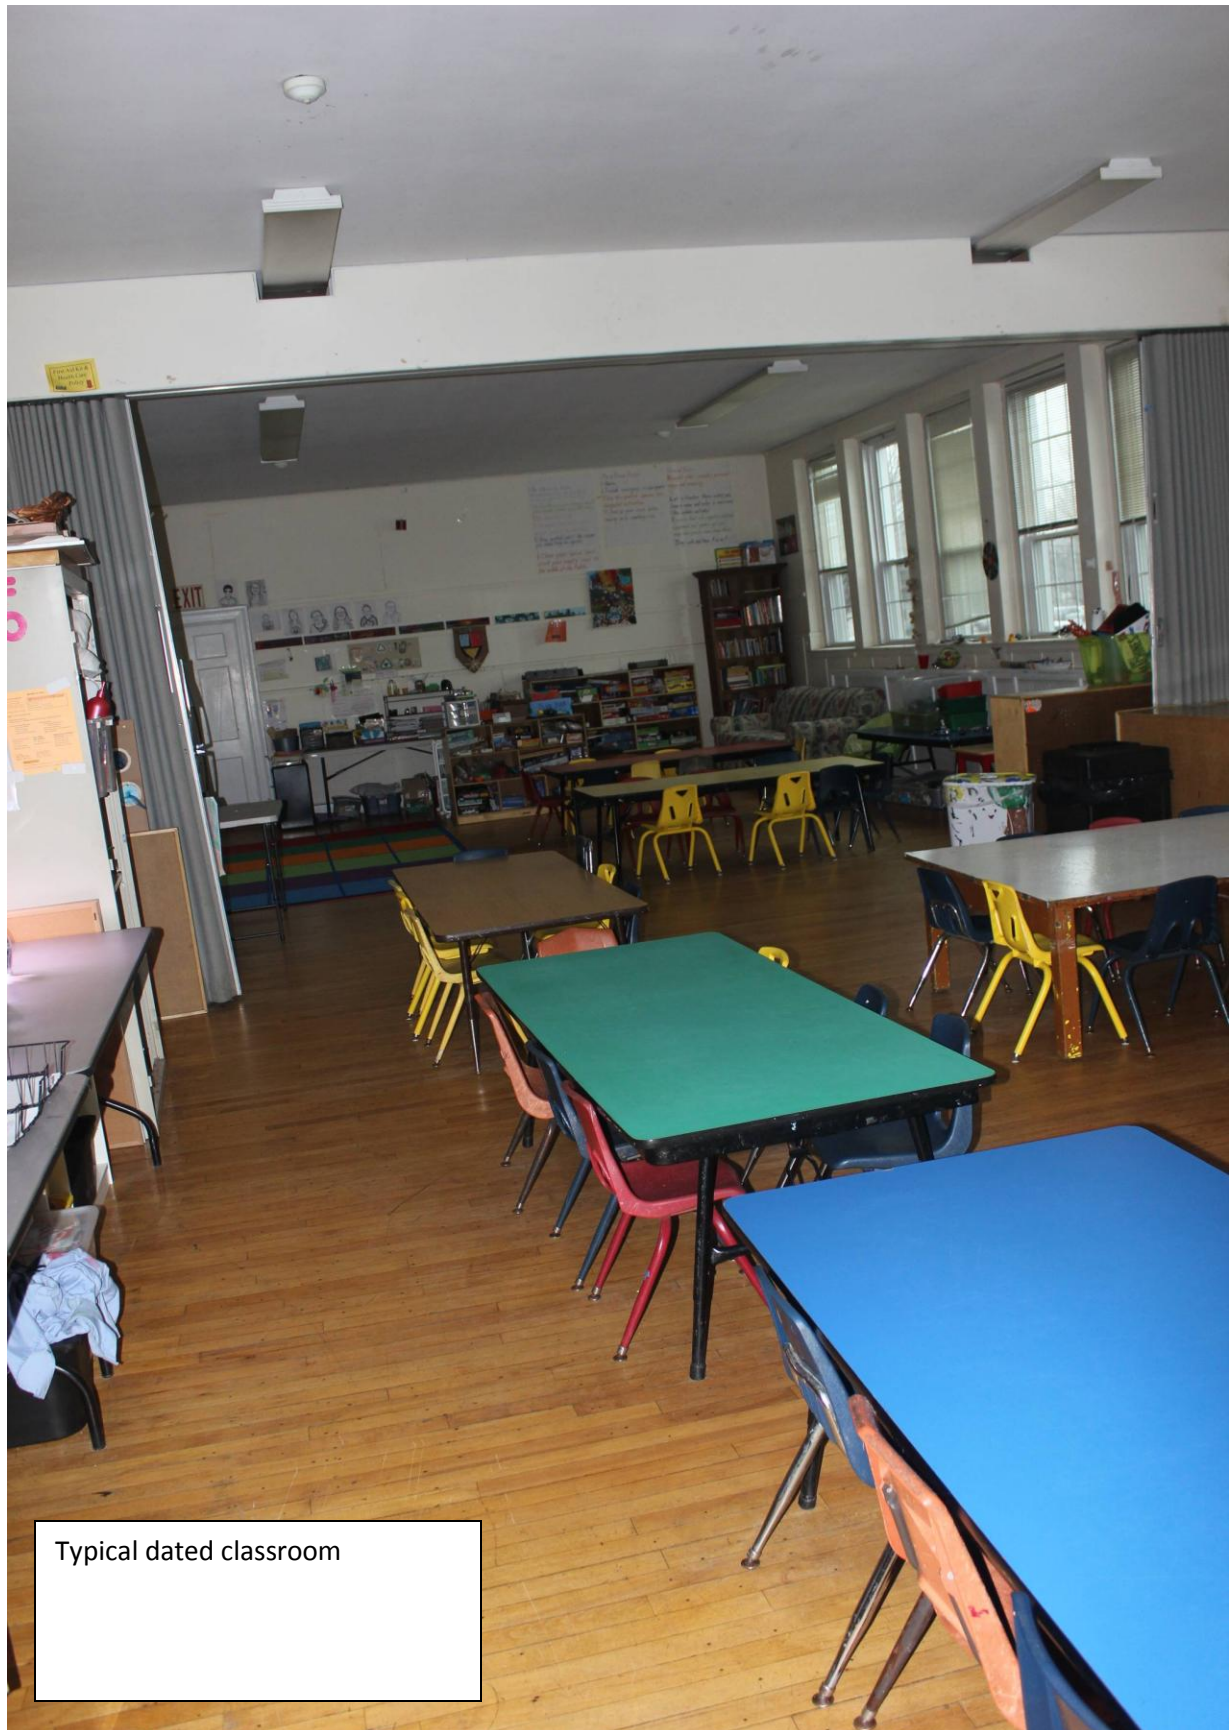
Typical dated classroom

Replacement reserves should be considered for upgrades to address all worn and dated materials as part of an interior restoration and upgrade. \$300,000

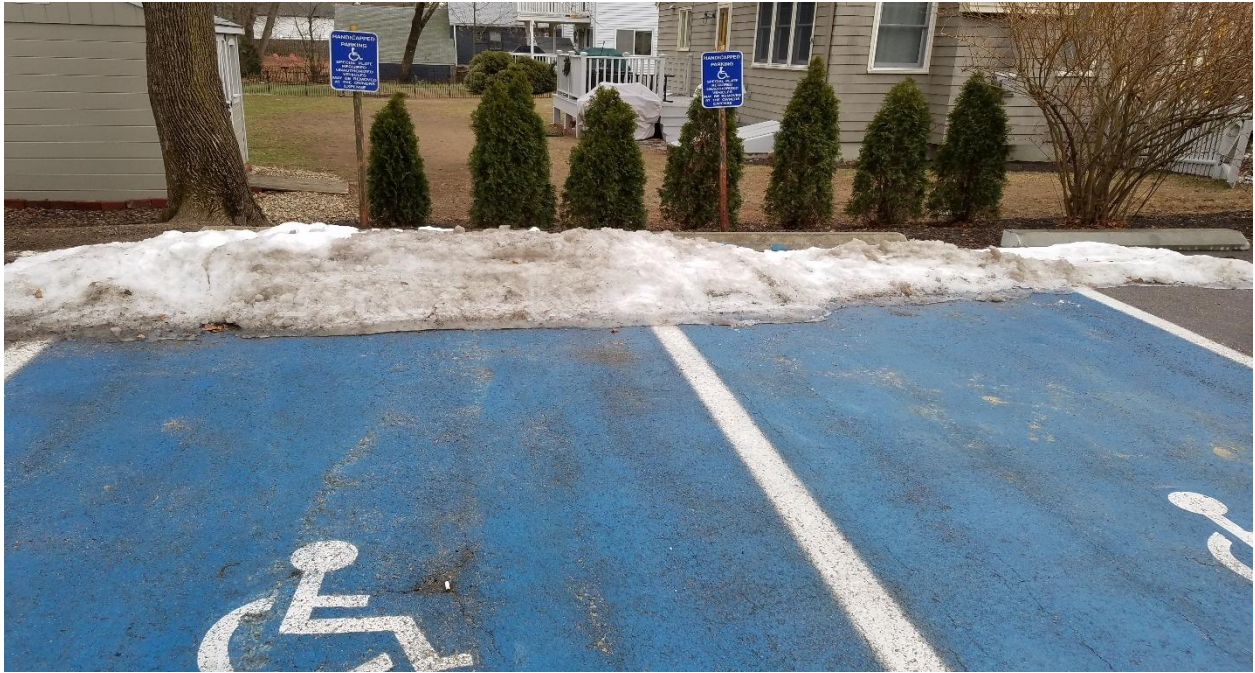
SHOWING HANDICAP PARKING SPACES & NON-COMPLIANT SIGNS

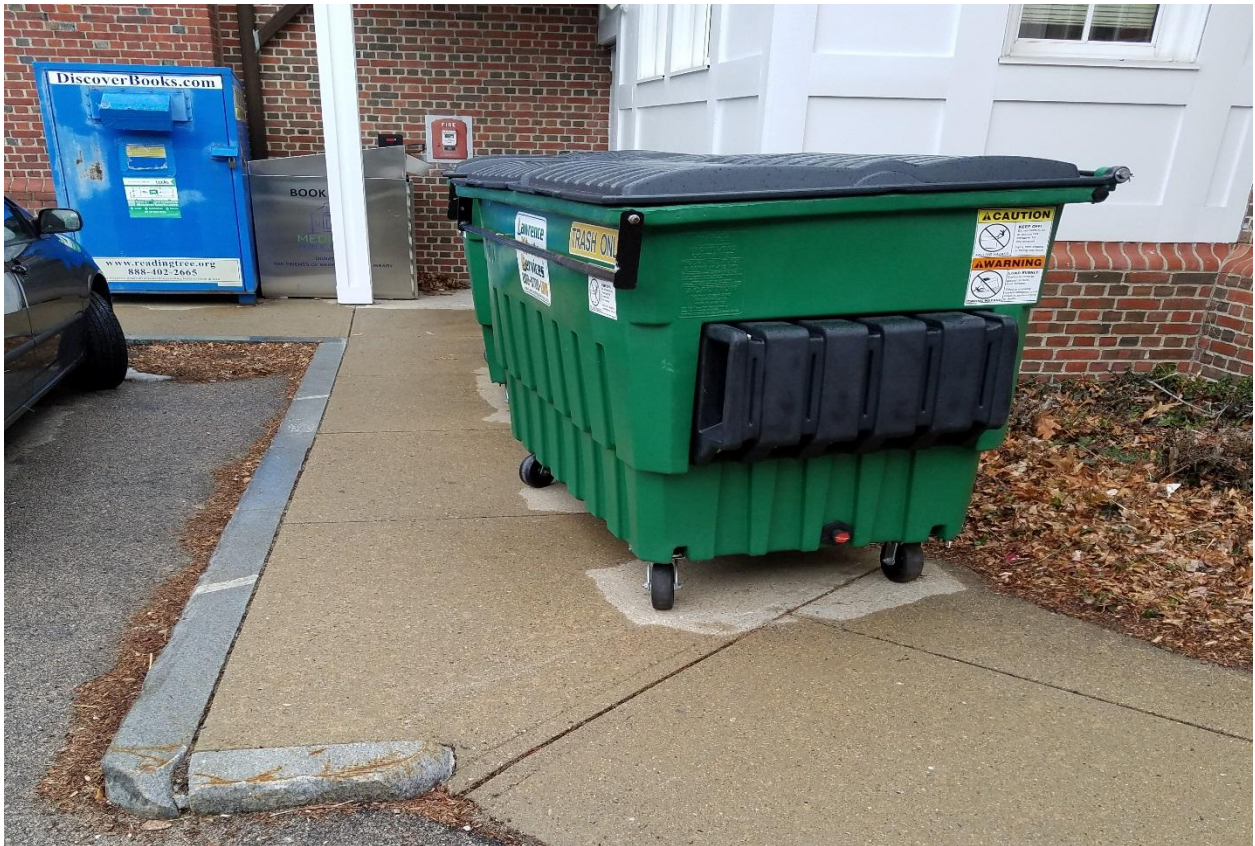
DUMPSTERS BLOCKING PATH OF TRAVEL AND BOOK DEPOSITORY BLOCKING KNOX BOX (ARROW)

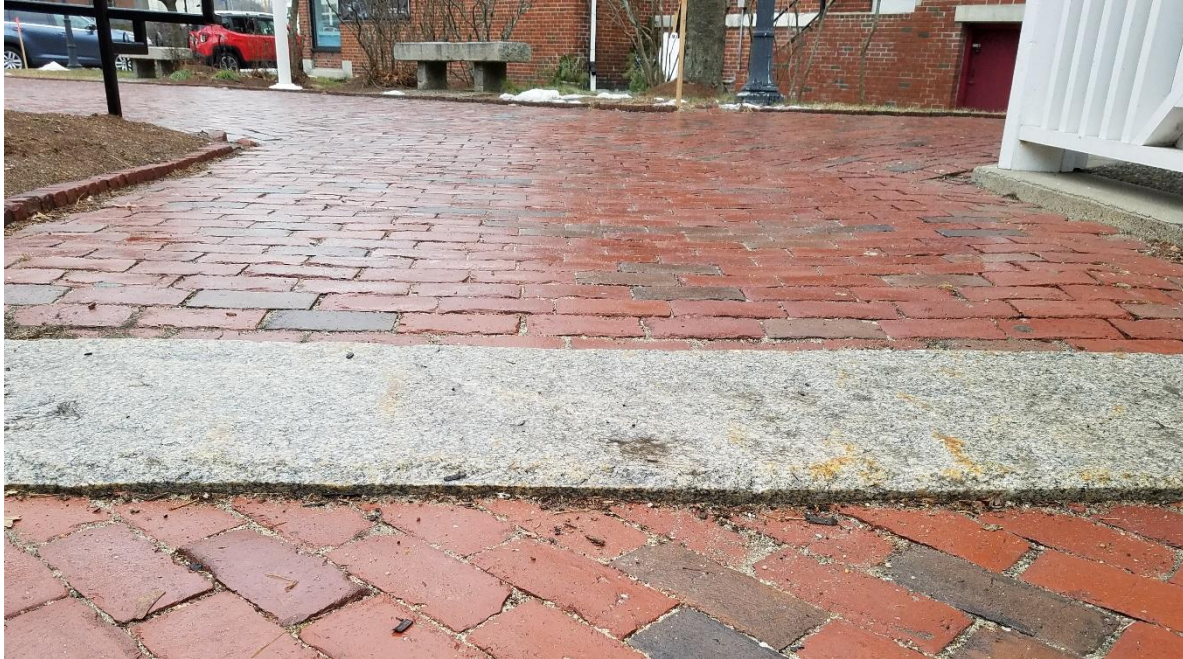
GRANITE ACCENT STRIP LIFTED CAUSING HAZARD ALONG ACCESSIBLE ROUTE

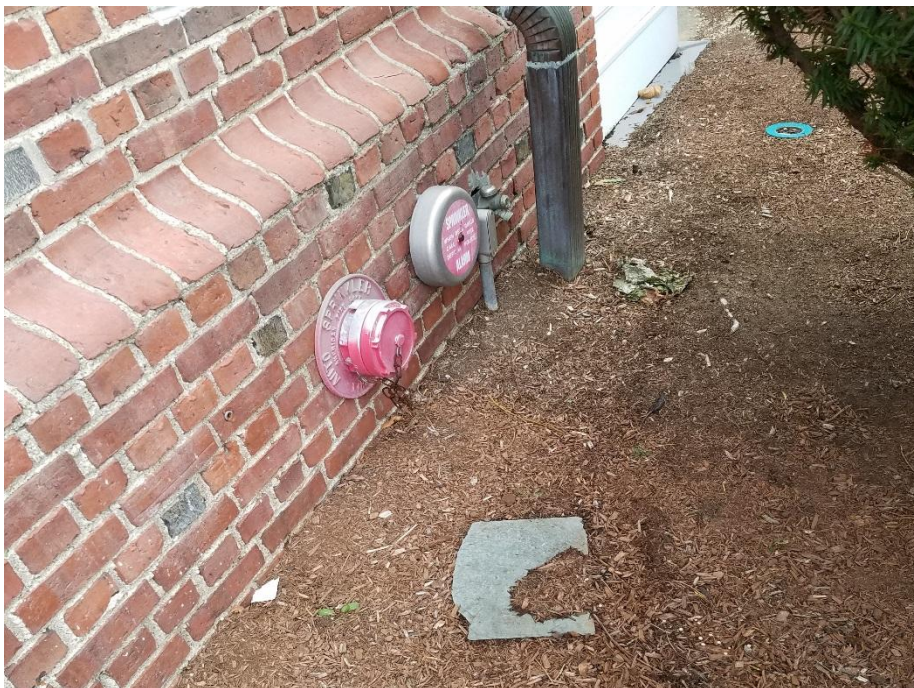
SHOWING DEMINISHED ACCESS TO FIRE DEPARTMENT CONNECTION (WEST)
(NOTE FALLEN ROOF SLATE IN FOREGROUND)

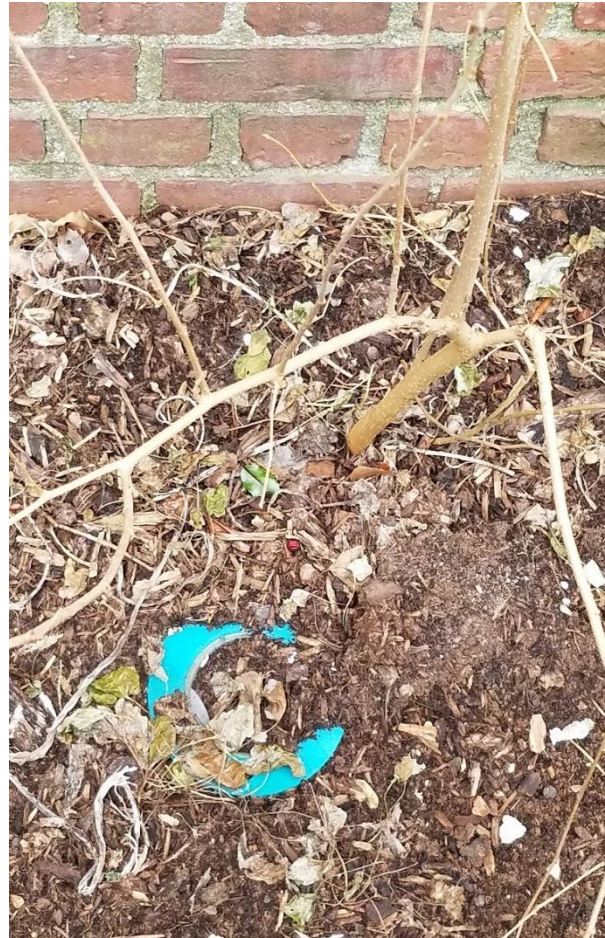
LANDSCAPING LIGHT NOT FUNCTIONING

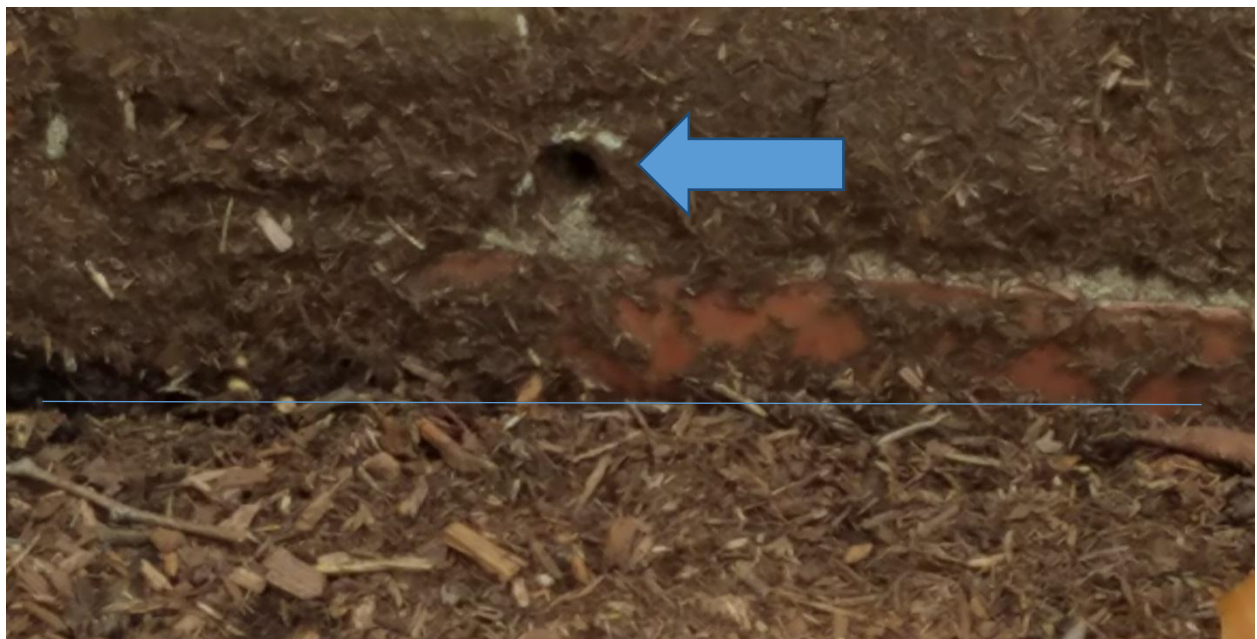
SHOWING TYPICAL CLOGGED WEEP HOLES DUE TO MULCH

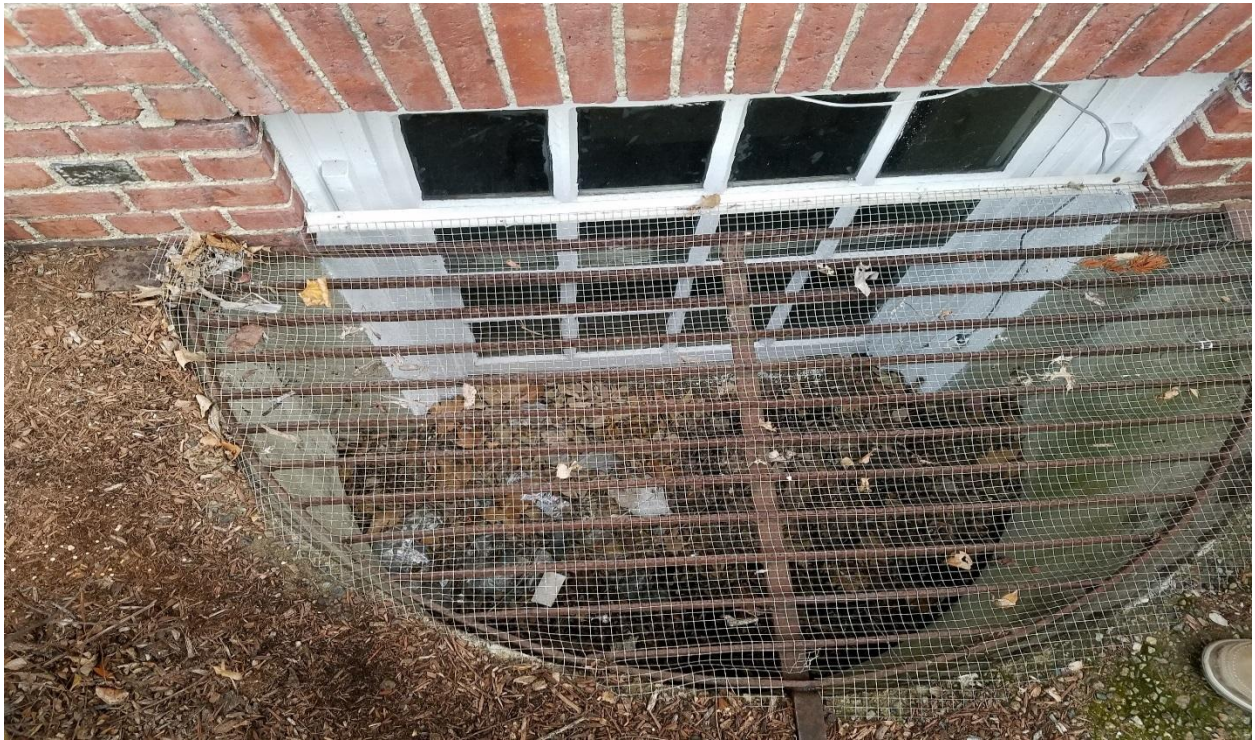
SHOWING TYPICAL AREA WELL NEEDING DEBRIS REMOVED

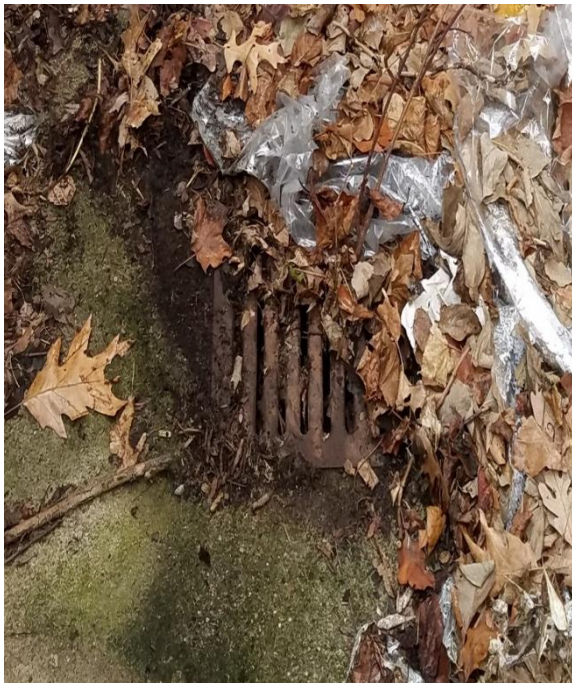
CLOGGED DRAIN IN EXTERIOR STAIRWELL

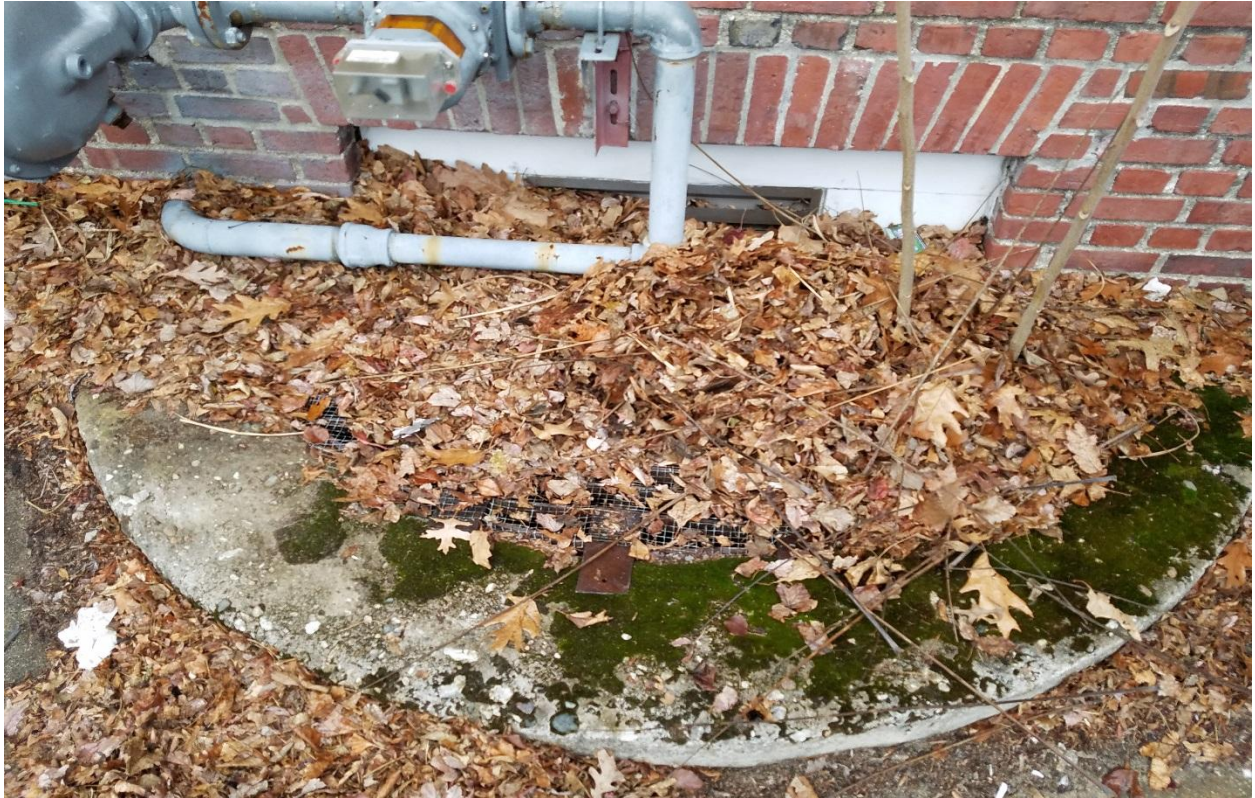
SHOWING AREA WELL DEBRIS BLOCKING MECHANICAL LOUVERS (REAR)

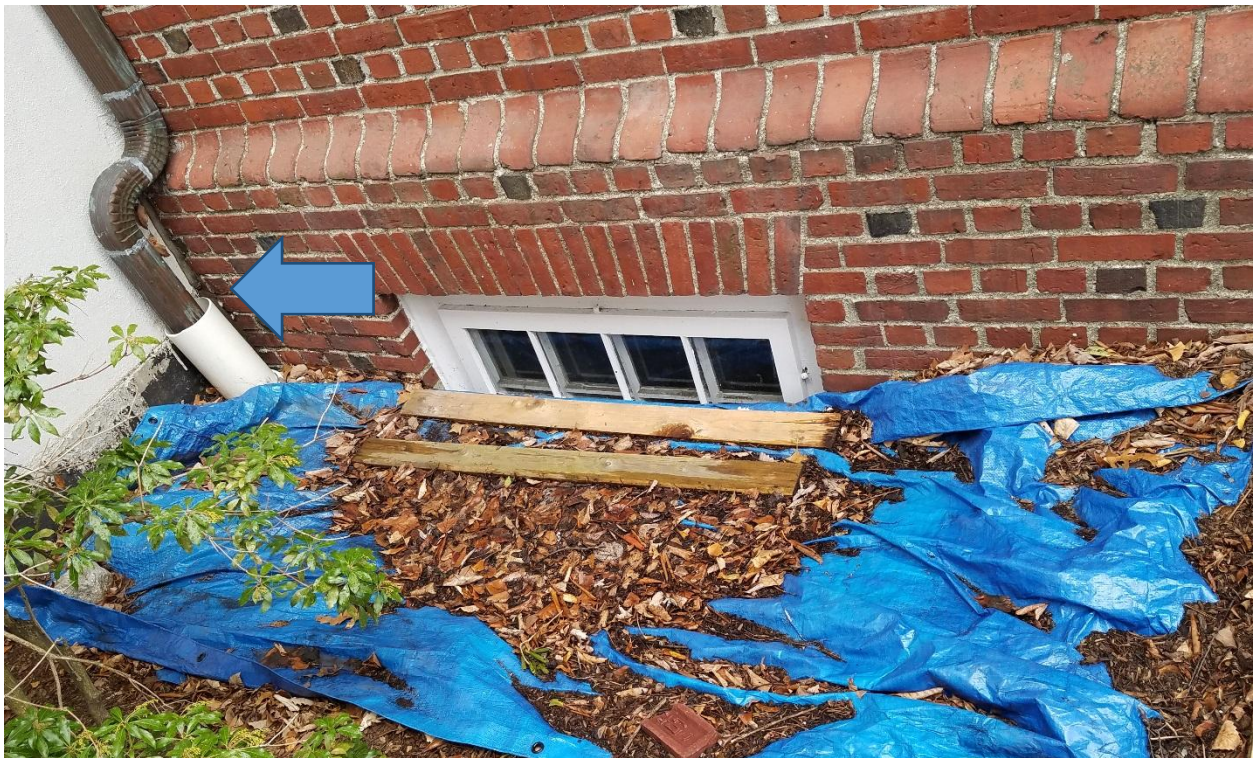
AREA WELL WITH TEMPORARY FIX and NOTE OPEN DOWNSPOUT JOINT (ARROW)

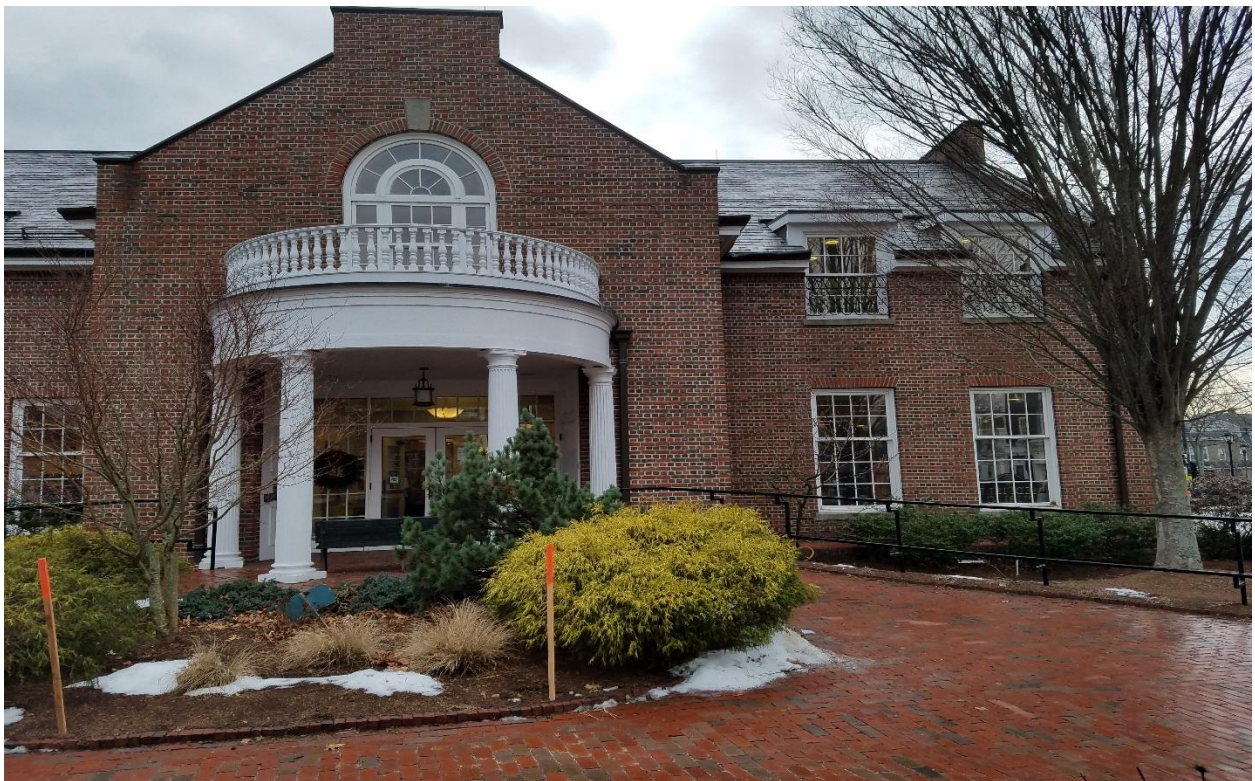
EASTERLY FACING ELEVATION SHOWING MAIN ACCESSIBLE ENTRANCE OF NEW ADDITION
NOTE ACCESSIBLE RAILS ARE ON ONLY ONE SIDE OF RAMP

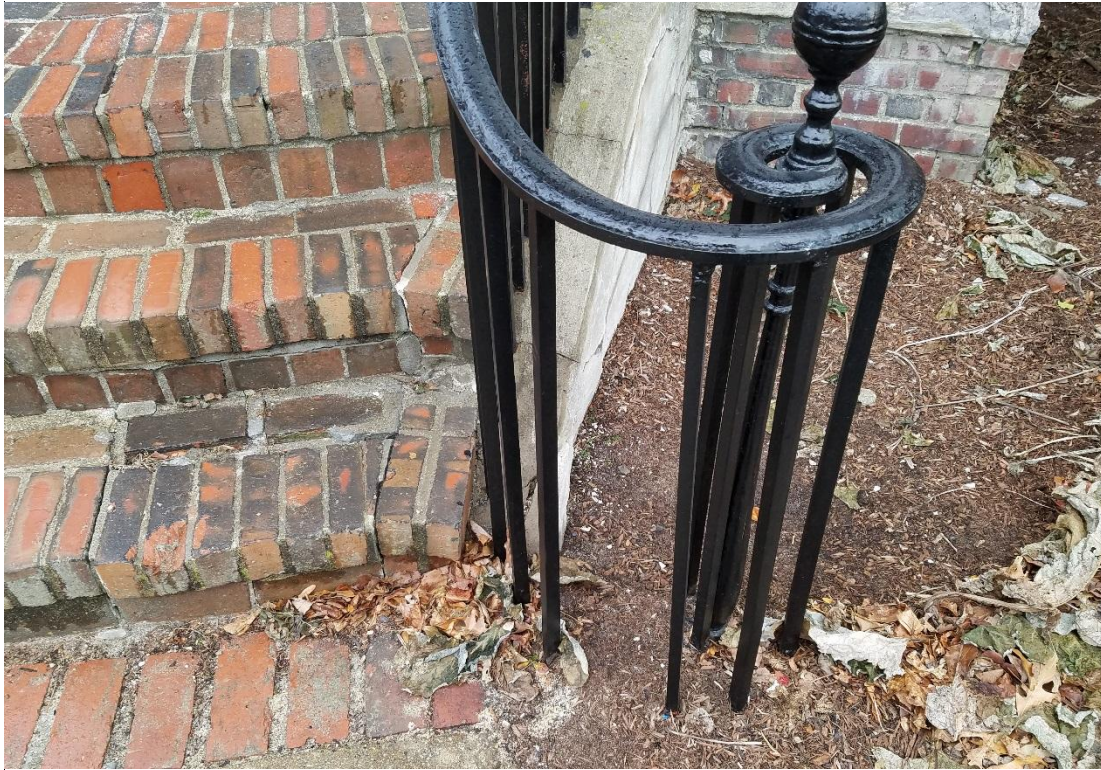
DETERIORATED BRICK STEPS AT ORIGINAL ENTRANCE STEPS (NORTH ELEVATION)

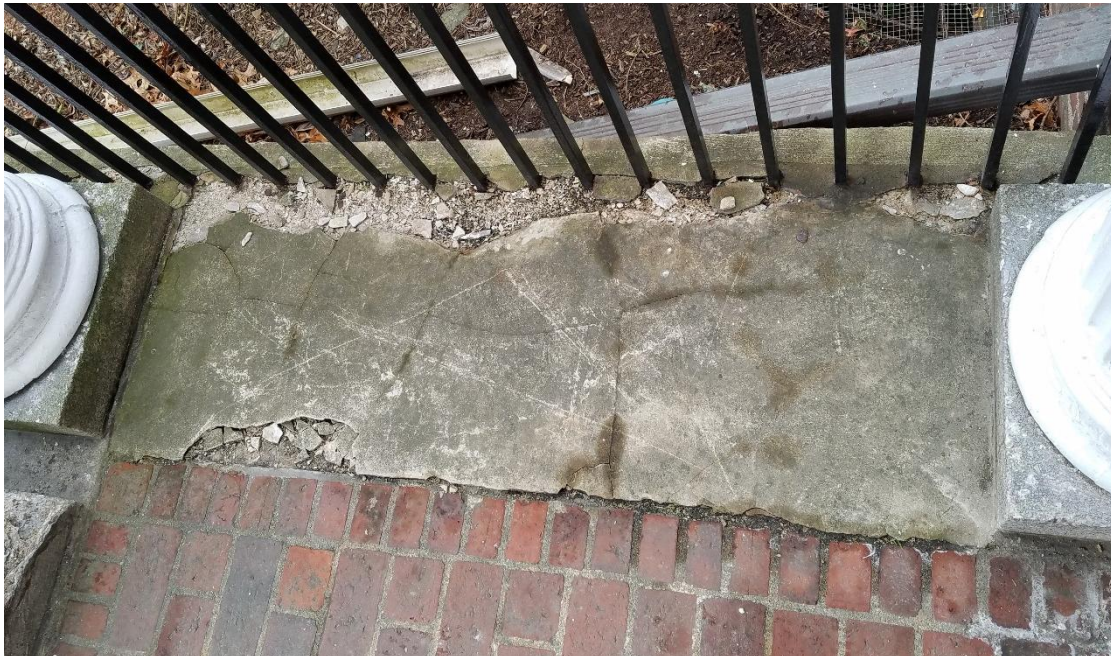
DETERIORATED EDGES OF ORIGINAL ENTRY PLATFORM (NORTH ELEVATION)

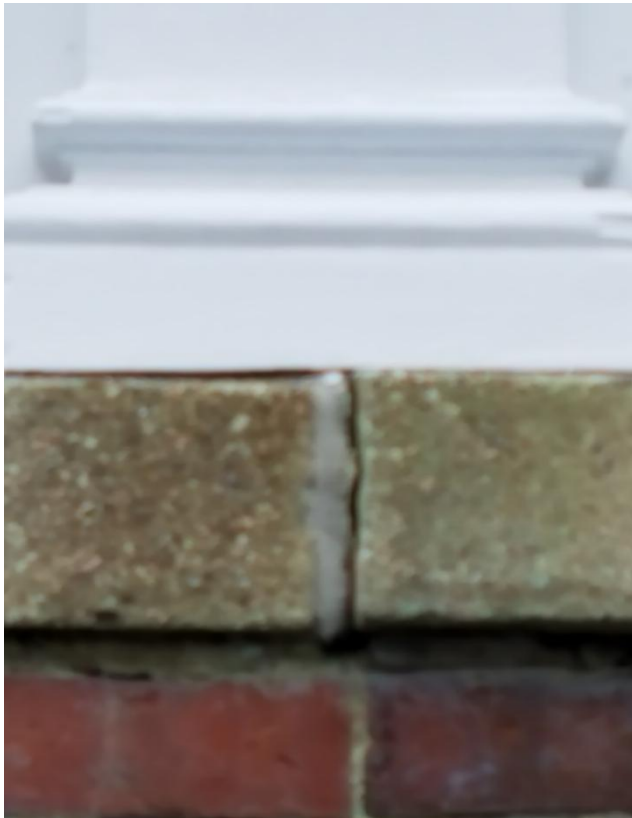
OPEN SILL JOINT TO BE REPOINTED and
SEALANT ADDED TO WINDOW SILL ABOVE

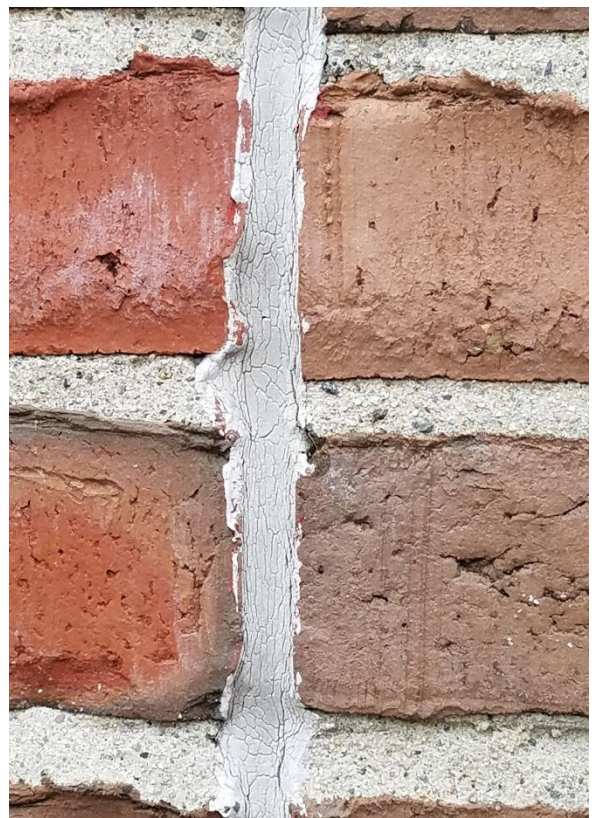
MASONRY CONTROL JOINT TO BE REDONE

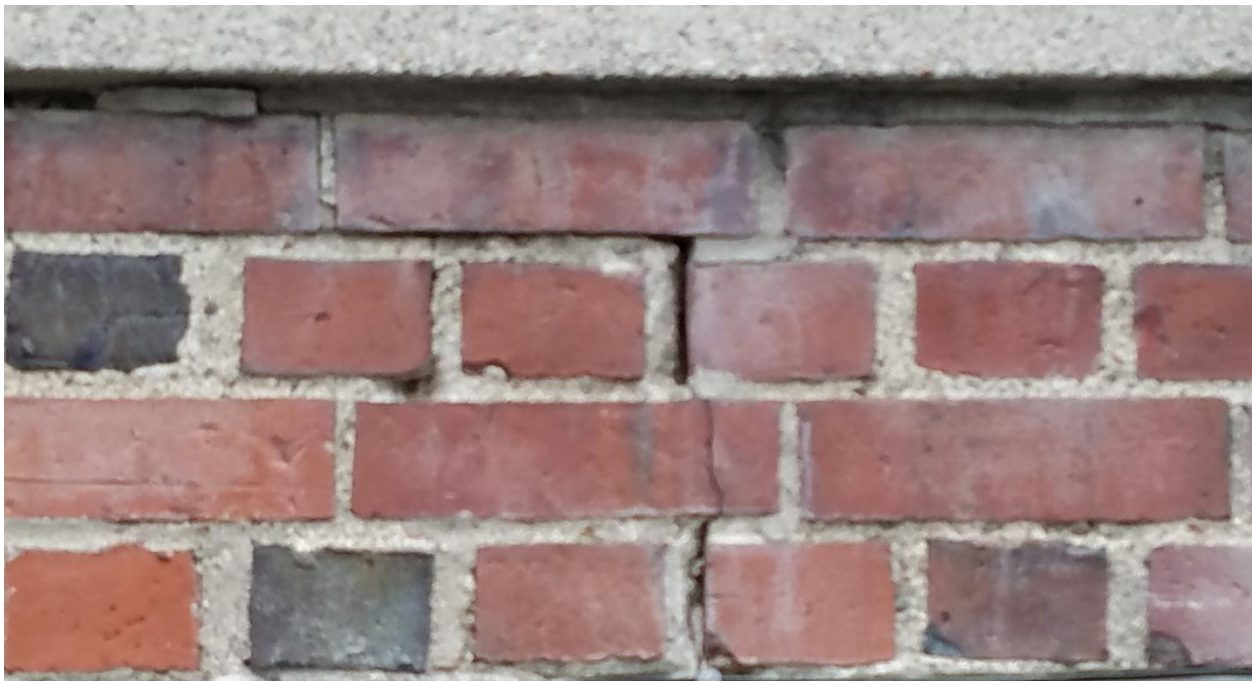
OPEN BRICK JOINTS TO BE REPOINTED (REAR ELEVATION)

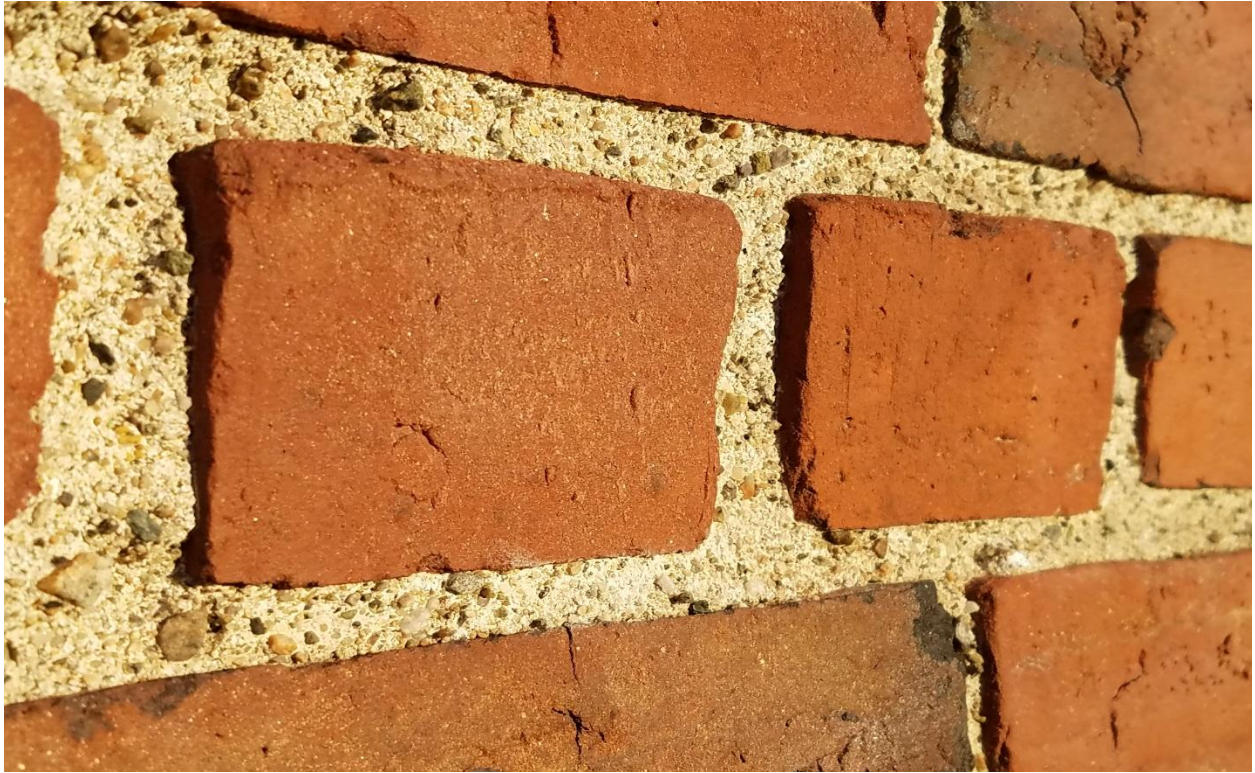
CLOSE-UP OF ORIGINAL MORTAR JOINTS SHOWING COURSE TEXTURE and WIDE SPREAD EFFLOREENCE
