TOWN OF MEDFIELD

Municipal Facilities

Evaluation and Capital Plan

October 6, 2017

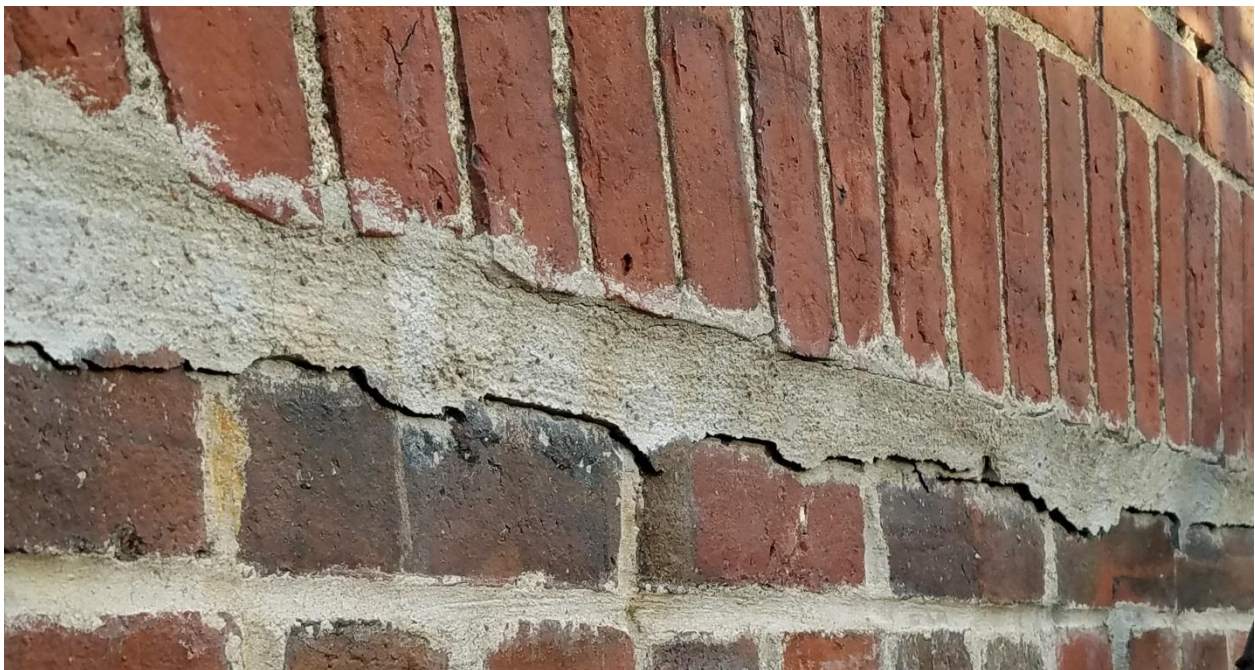
POORLY EXECUTED REPOINTING (WEST ELEVATION)

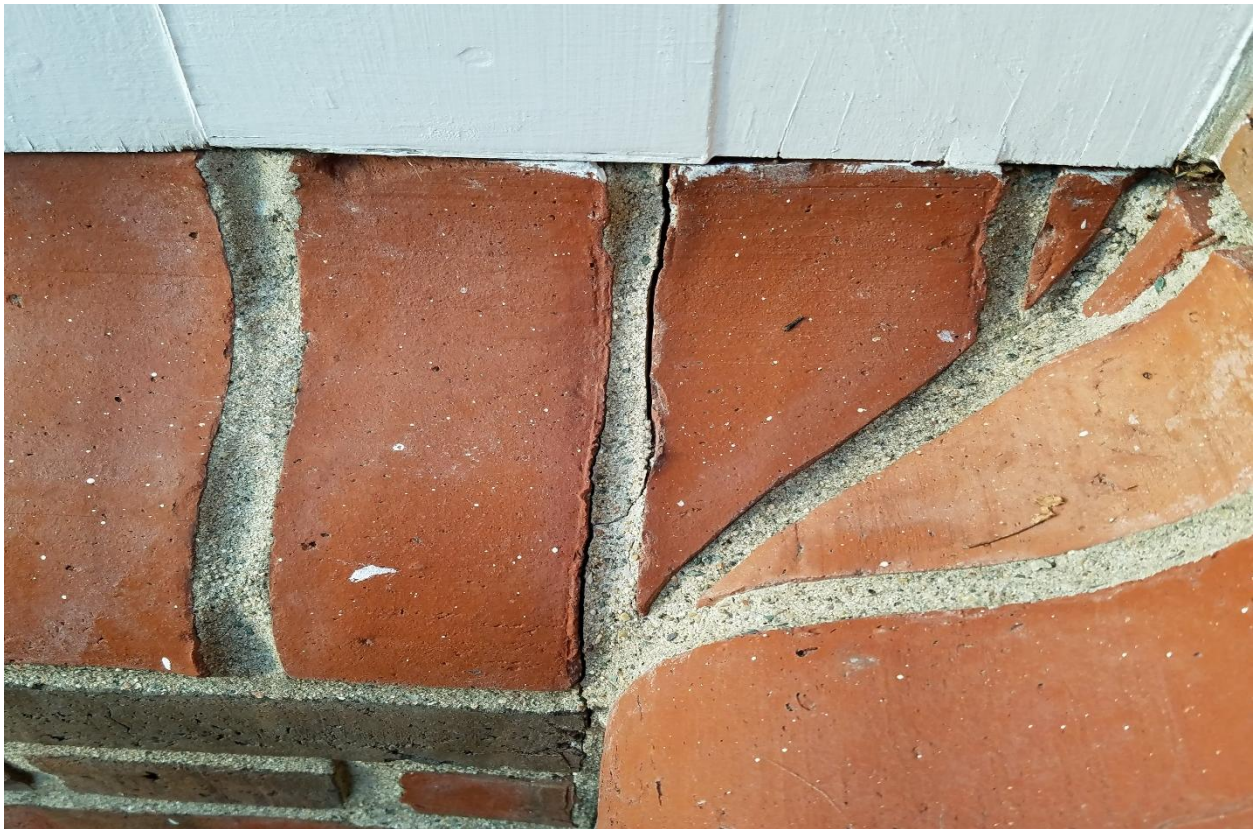
TYPICAL OPEN JOINTS IN WATER TABLE BRICK JOINTS NEEDING REPOINTING

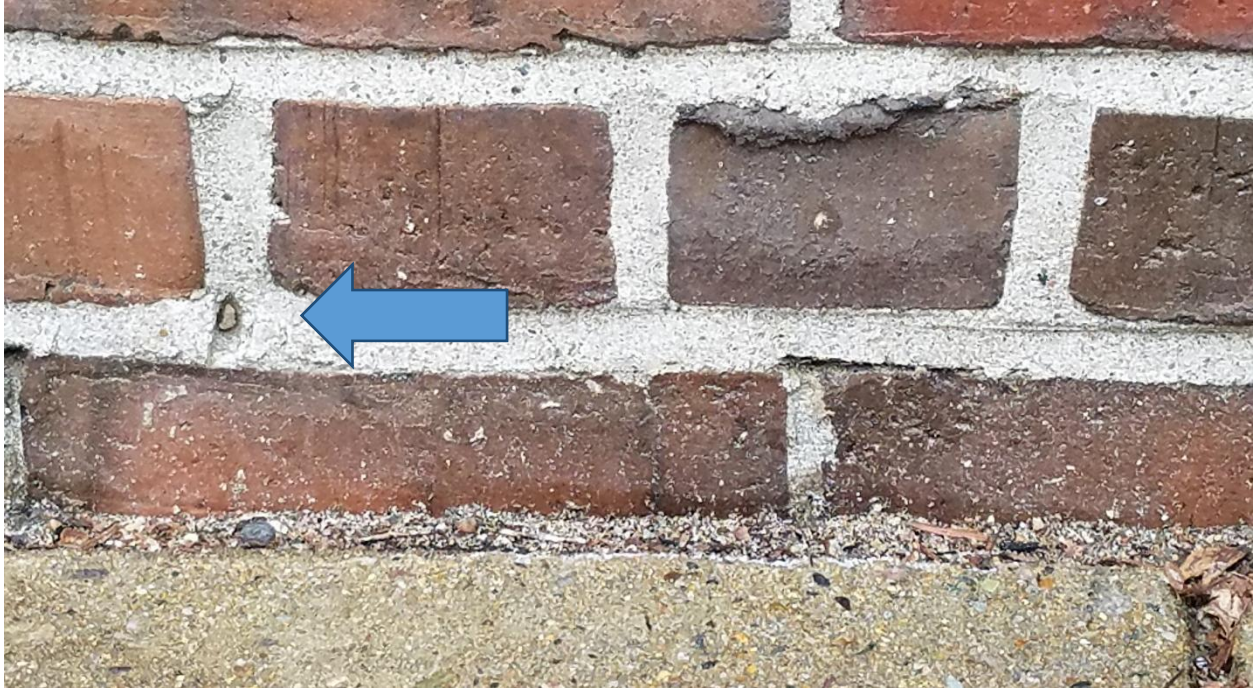
WEEP HOLES BLOCKED (REAR) ALONG SIDEWALK

TYPICAL WEEP HOLES BLOCKED BY MULCH BEDS

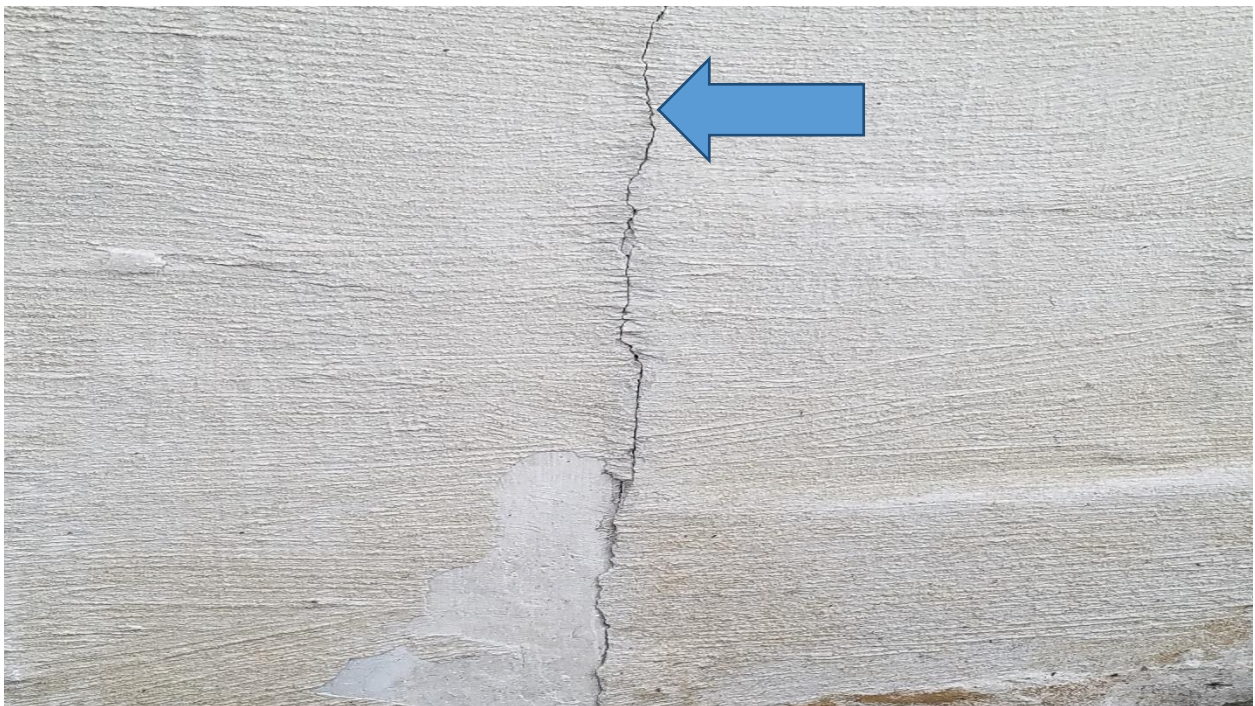
STUCCO PARGING IN EXTERIOR STAIRWELL NEEDING REPAIR and CONTROL JOINT

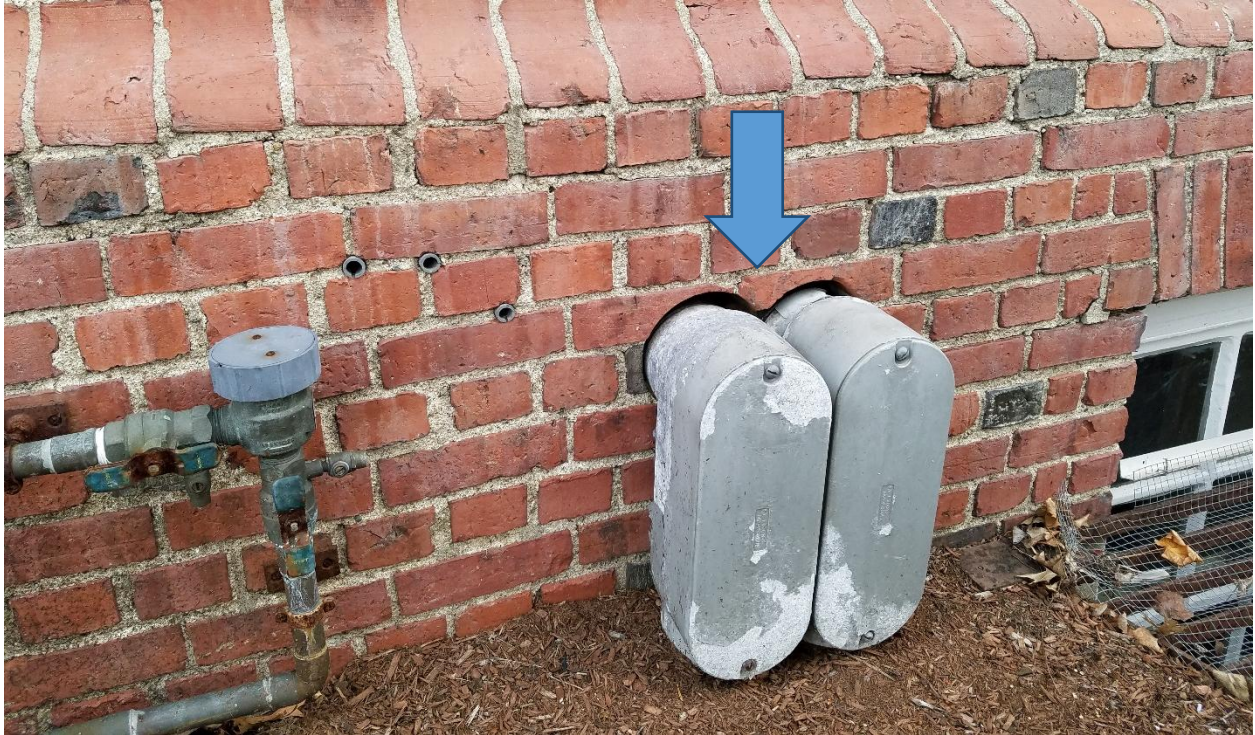
PROVIDE SEALANTS AROUND ELECTRICAL SERVICE PENETRATIONS (WEST)

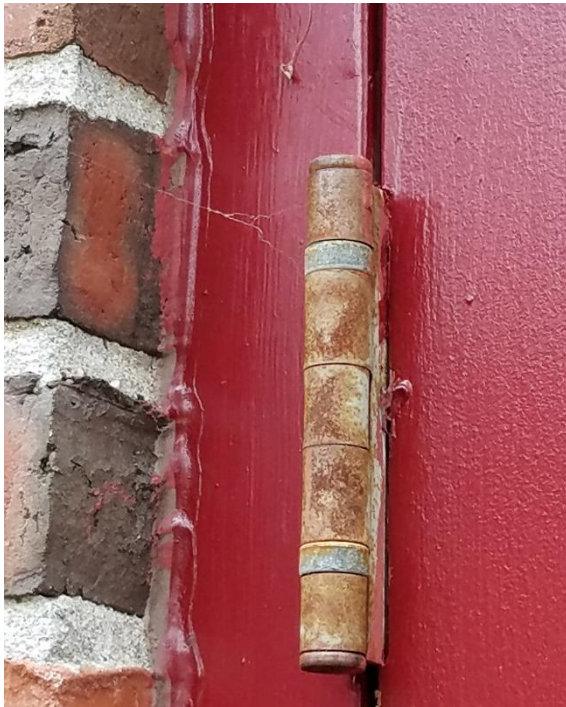
RUSTED DOOR HINGES (SOUTH ELEVATION)

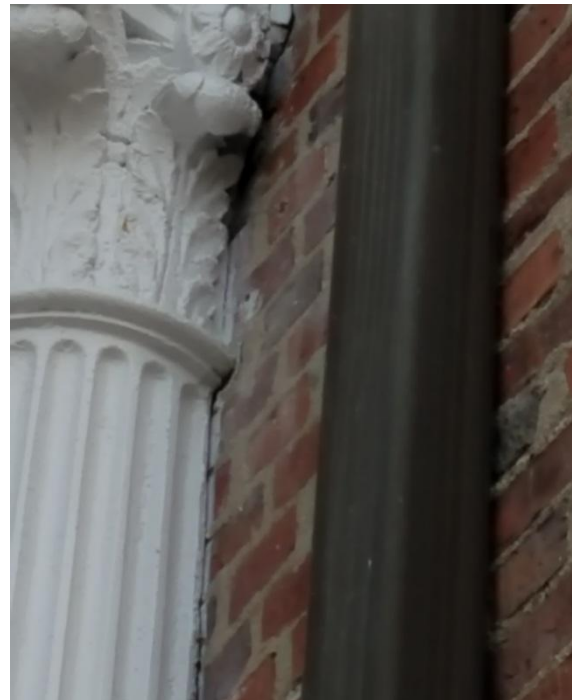
ORIGINAL FRONT COLUMN NEEDING SEALANT

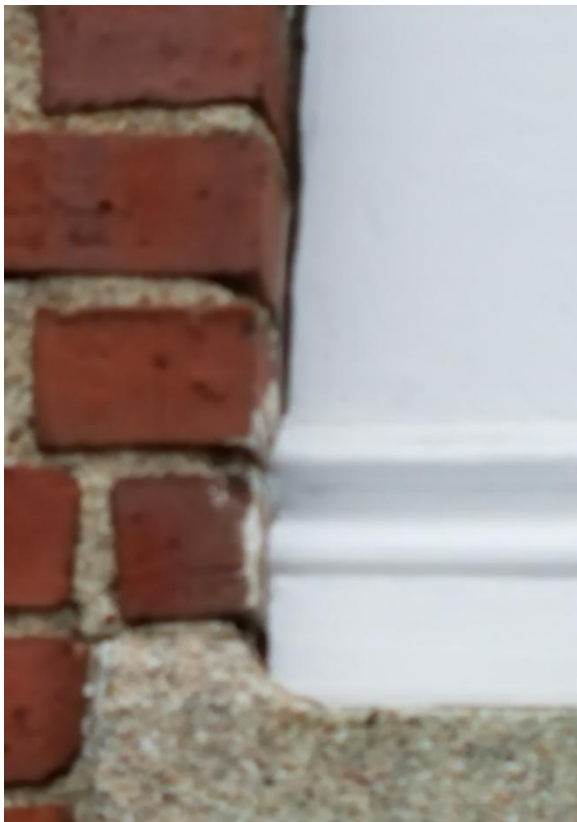
WOOD WINDOW TRIM NEEDING SEALANT

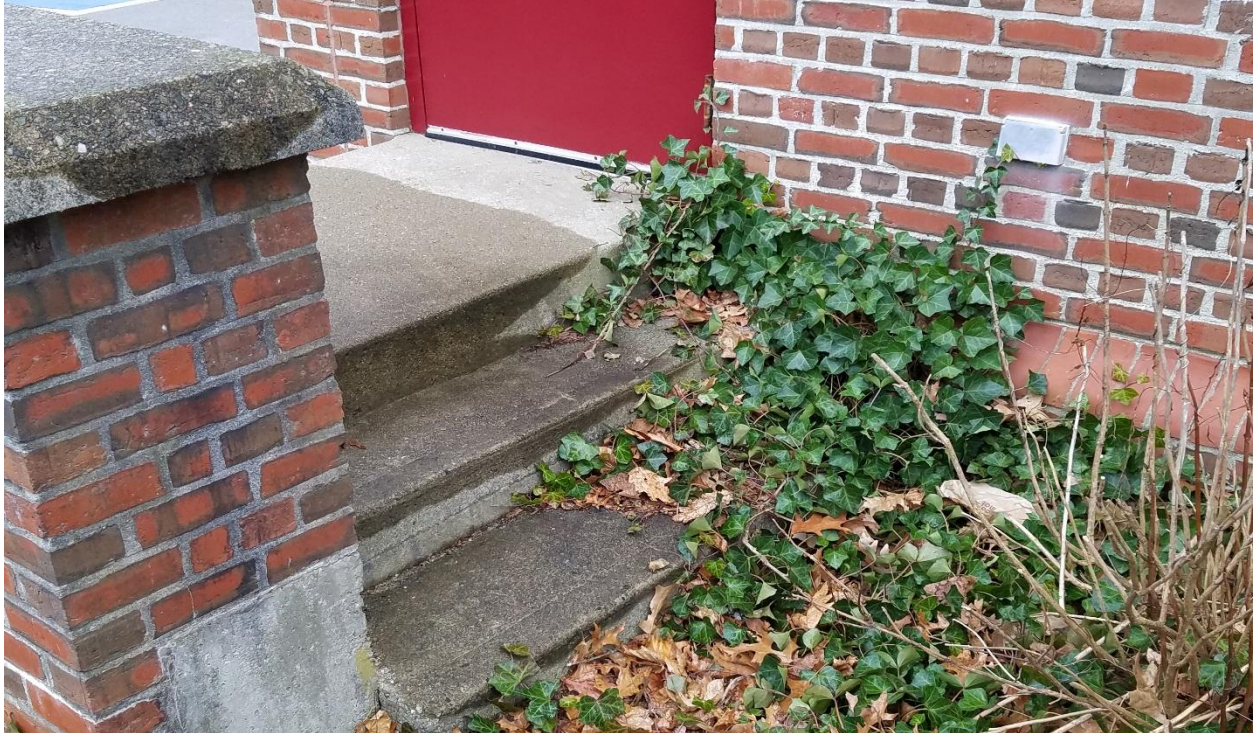
3-RISER STEPS WITH NO HANDRAILS and OVERGROWN WITH VEGETATION (EAST ELEVATION)

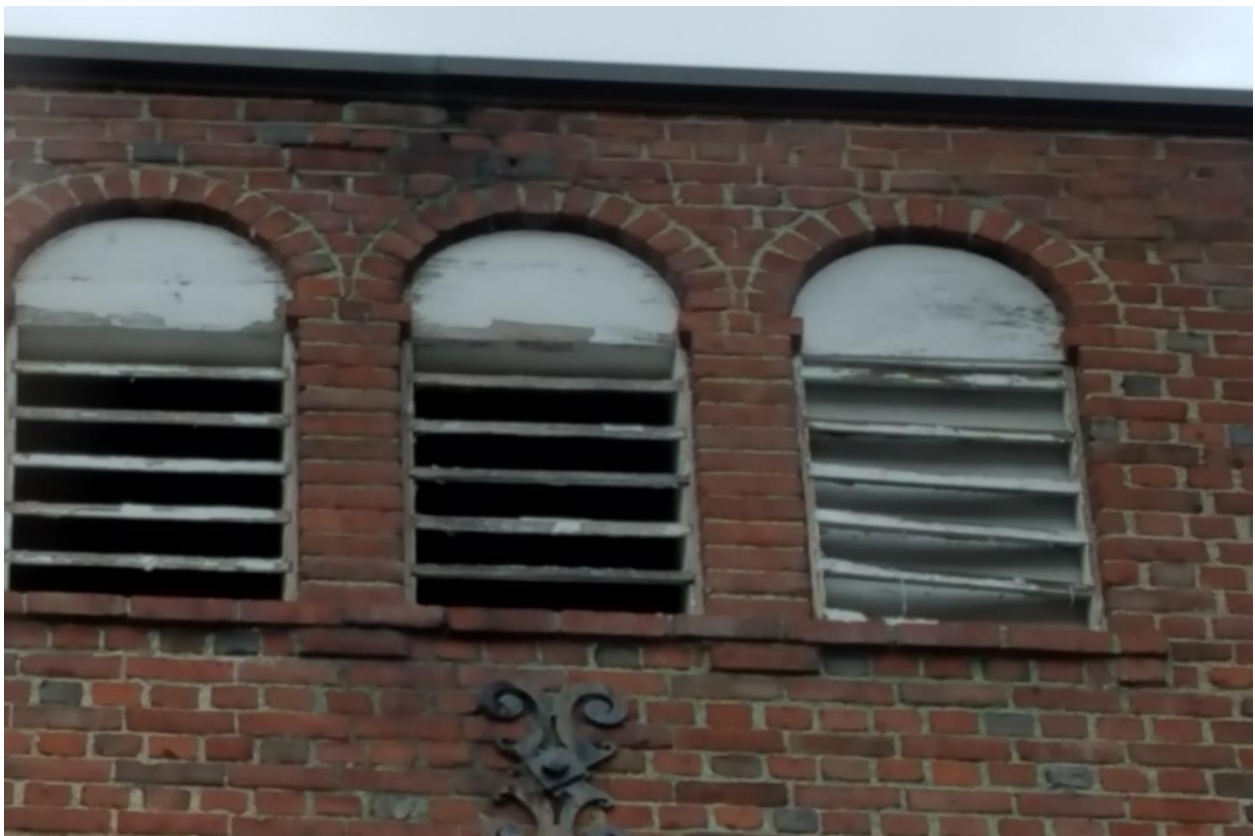
LOUVERS AND CAST IRON BRACKETS NEEDING PAINTING (REAR ELEVATION)

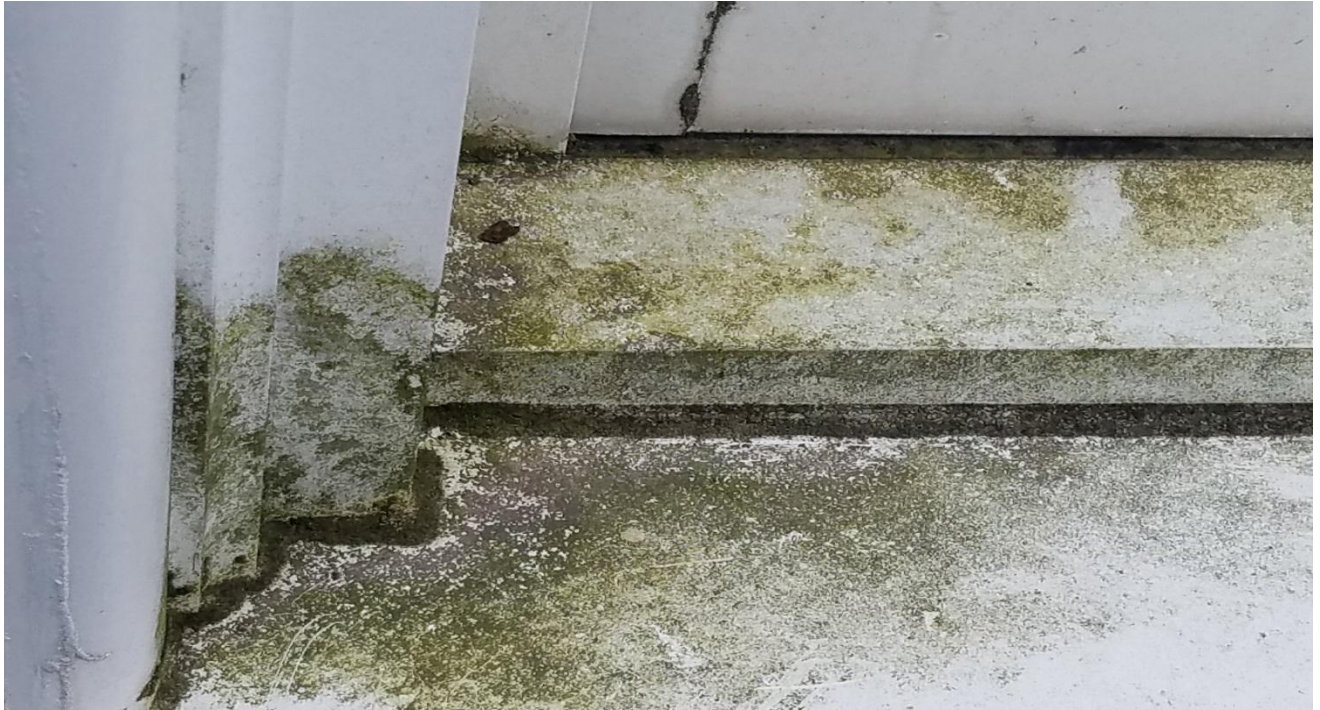
MILDEW & DETERIORATED SEALANTS SHOWN AT EASTERLY WINDOW UNIT WITH POSSIBLE REVERSE SLOPING SILL

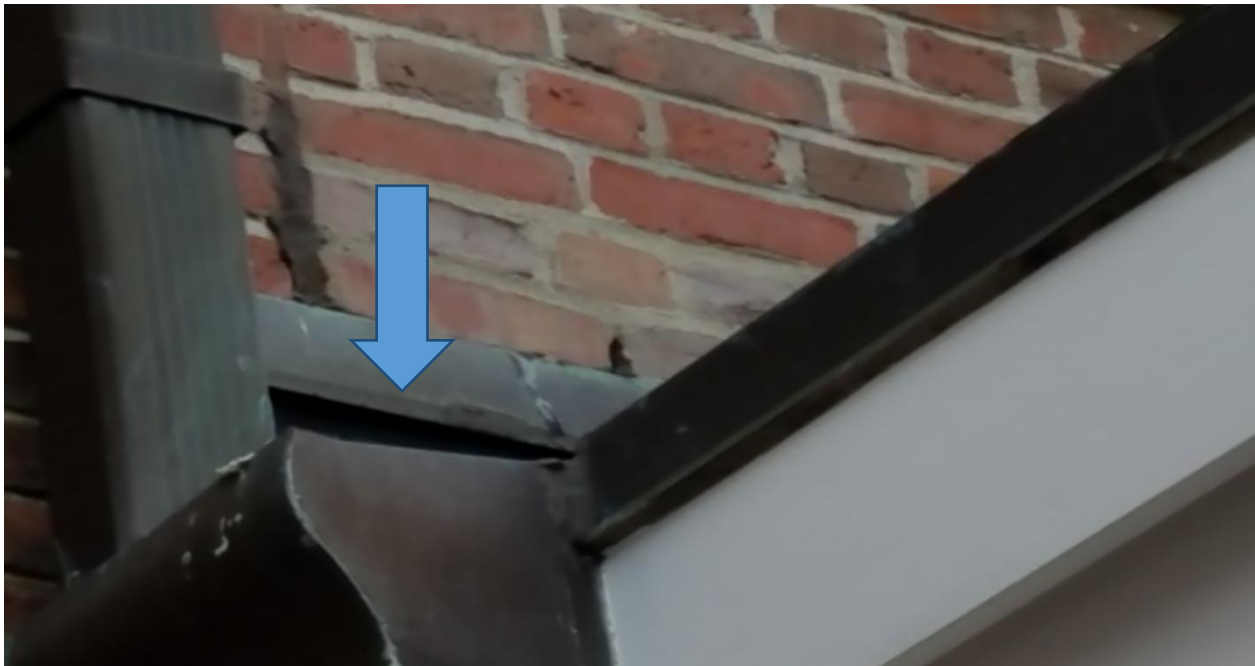
UPLIFTED COUNTER FLASHING (ARROW) ON REAR ELEVATION

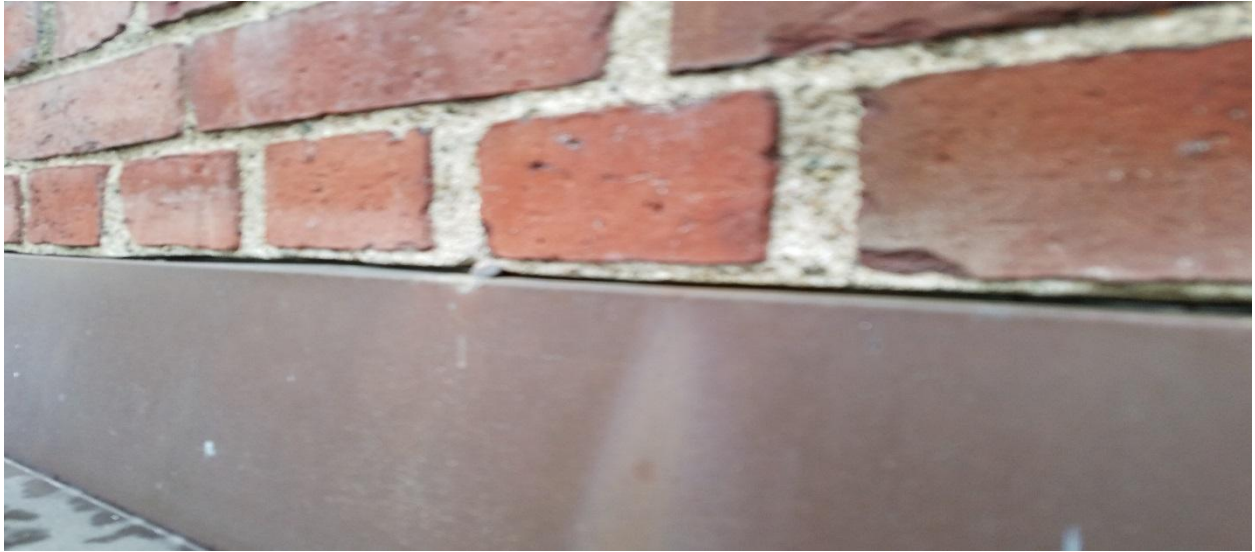
OPEN FLASHING JOINT AT REAR ELEVATION ABOVE STANDING SEAM ROOF

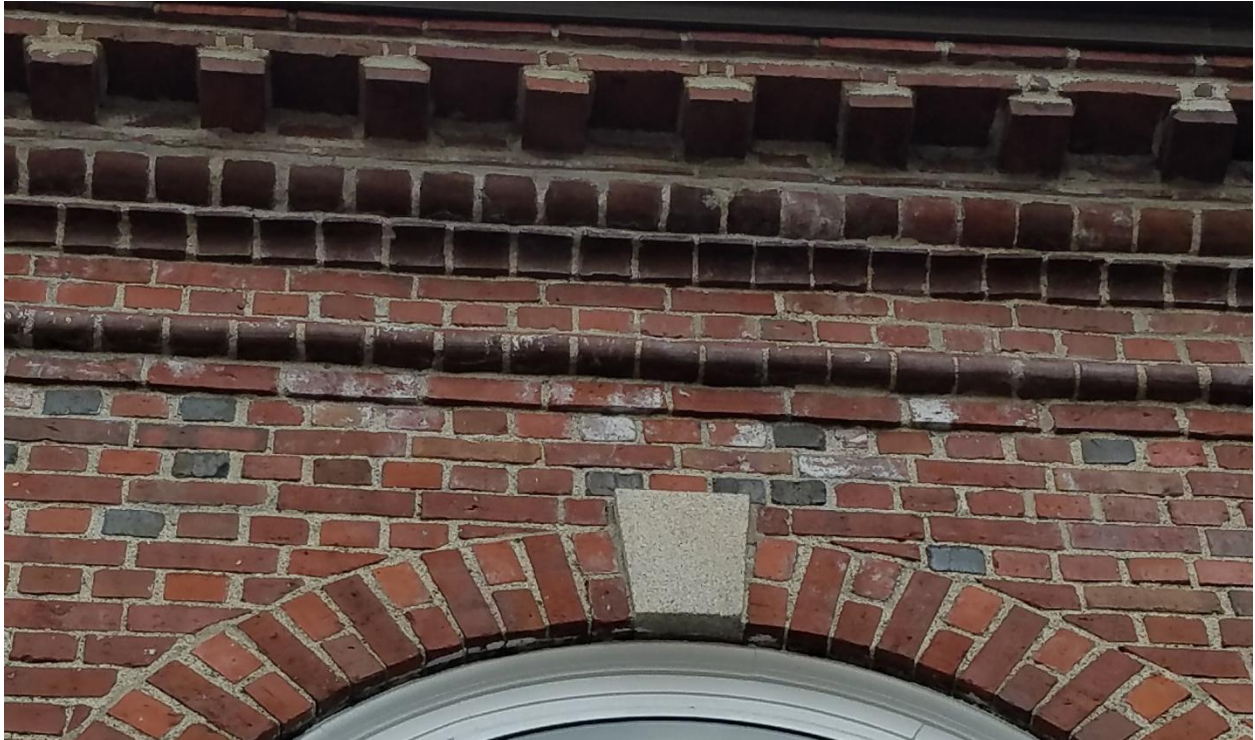
SHOWING POSSIBLE INFILTRATION ON WEST ELEVATION CAUSING EFFLORESCENCE

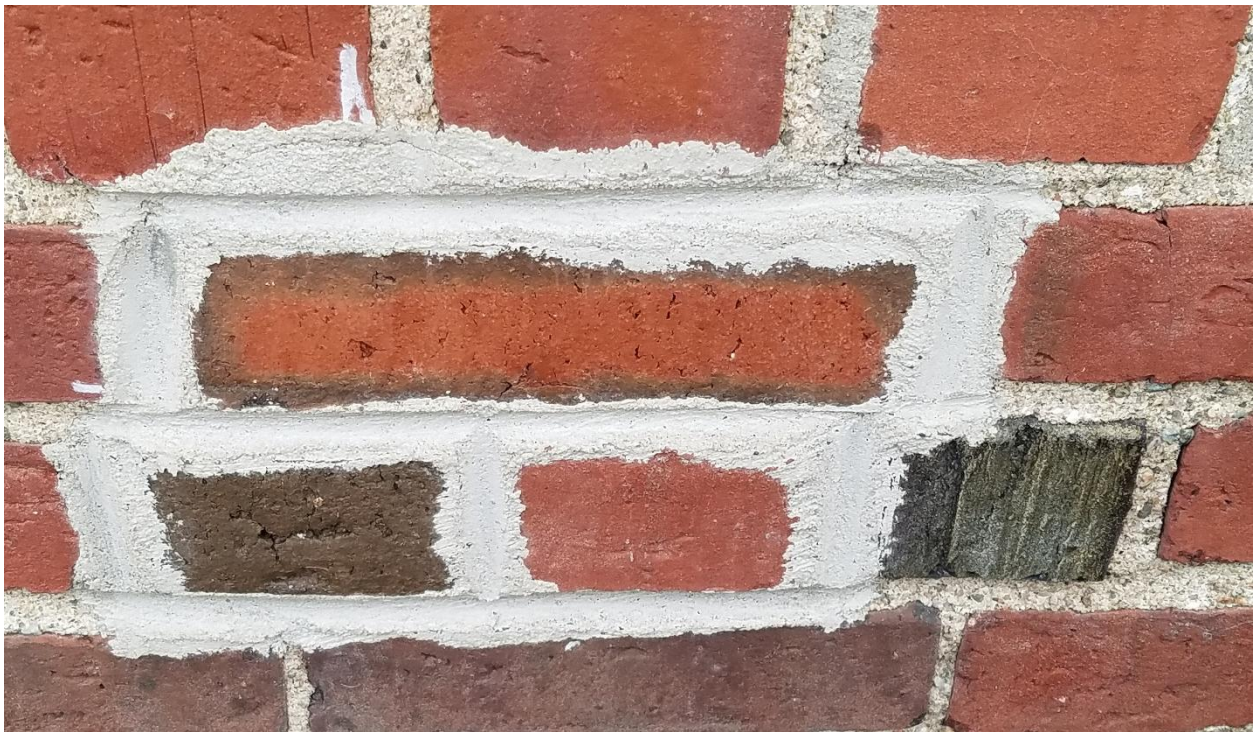
SHOWING POORLY EXECUTED REPOINTING DONE PREVIOUSLY (WEST ELEVATION)

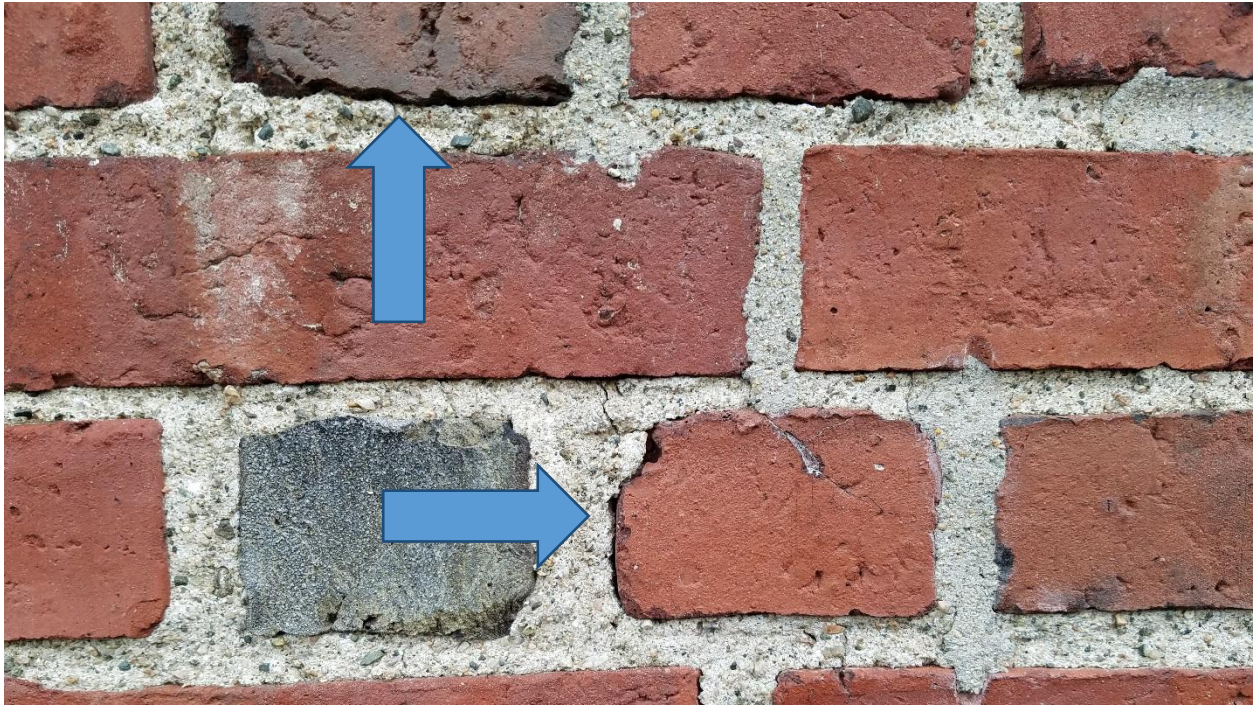
SHOWING TYPICAL JOINT DETERIORATION ON ORIGINAL BUILDING

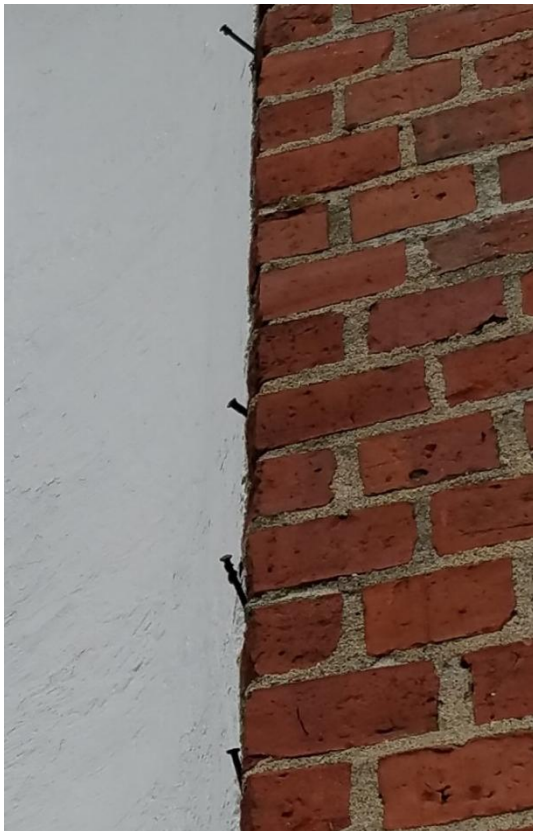
RUSTY OLD FASTENERS TO BE REMOVE

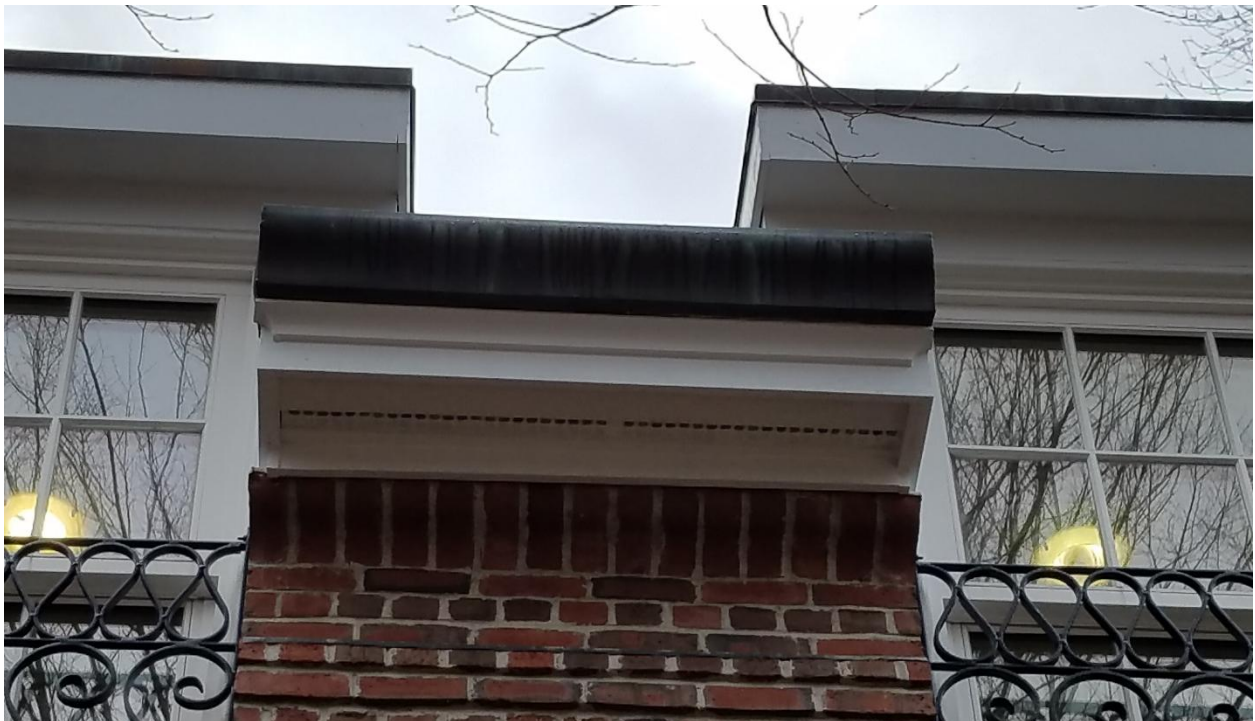
GUTTER WITH NO APPARENT DOWNSPOUT (EAST ELEVATION)

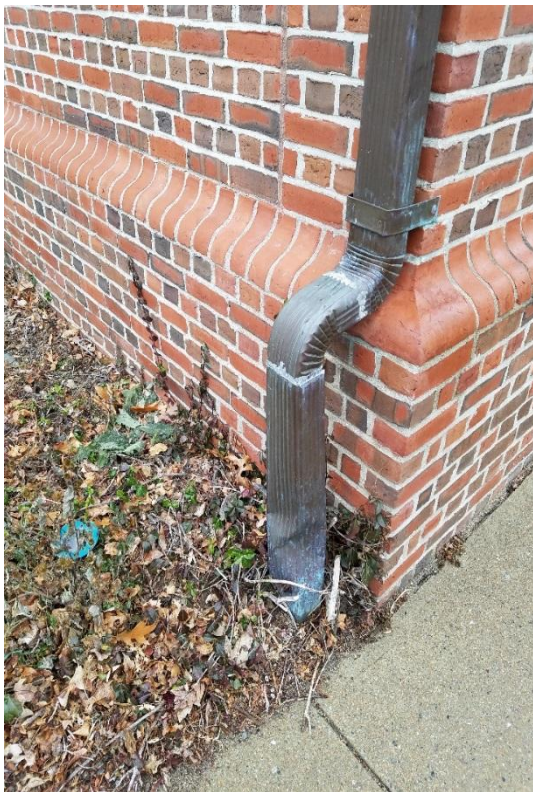
DAMAGED DOWNSPOUT

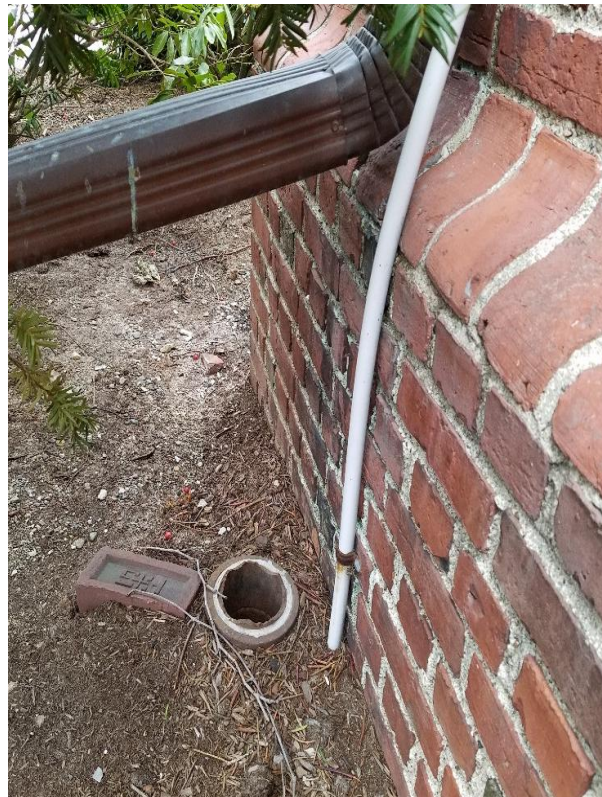
UNCONNECTED DOWNSPOUT

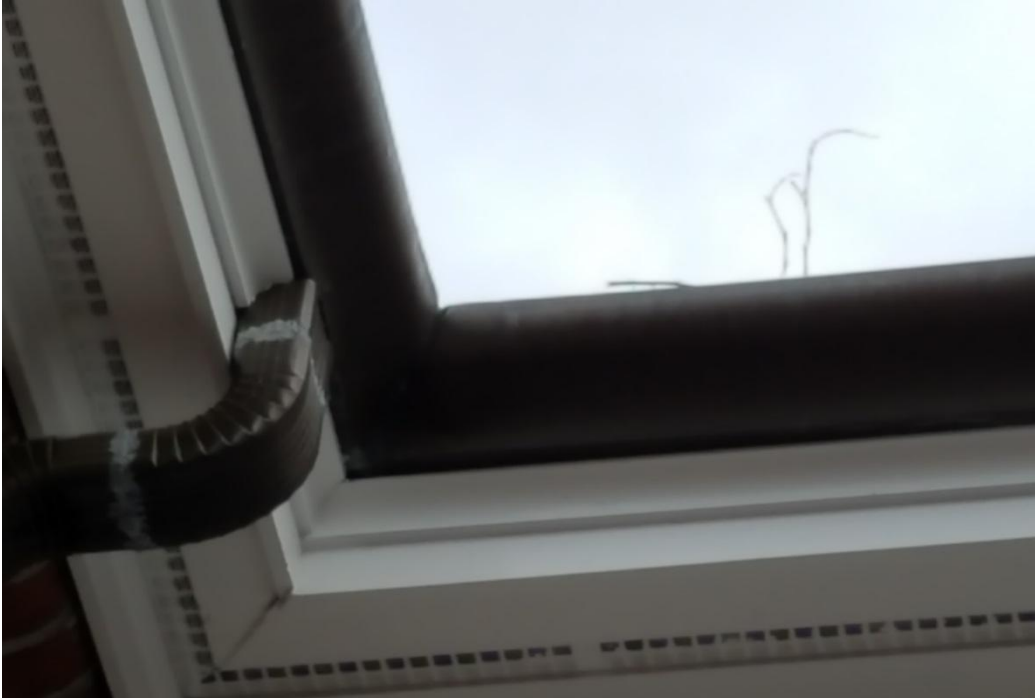
VEGETATION IN GUTTERS

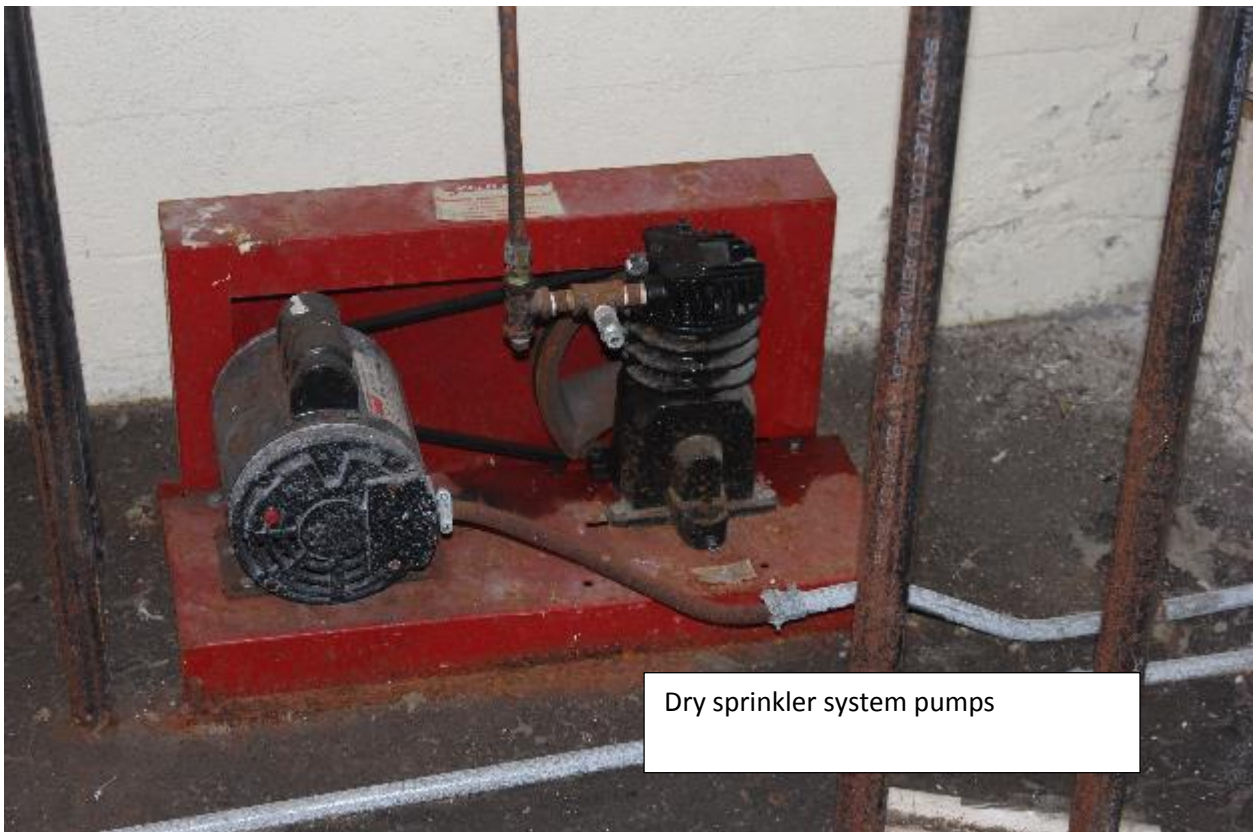
Dry fire suppression pumps are showing visible oil leakage at valves.

Dry sprinkler system pumps

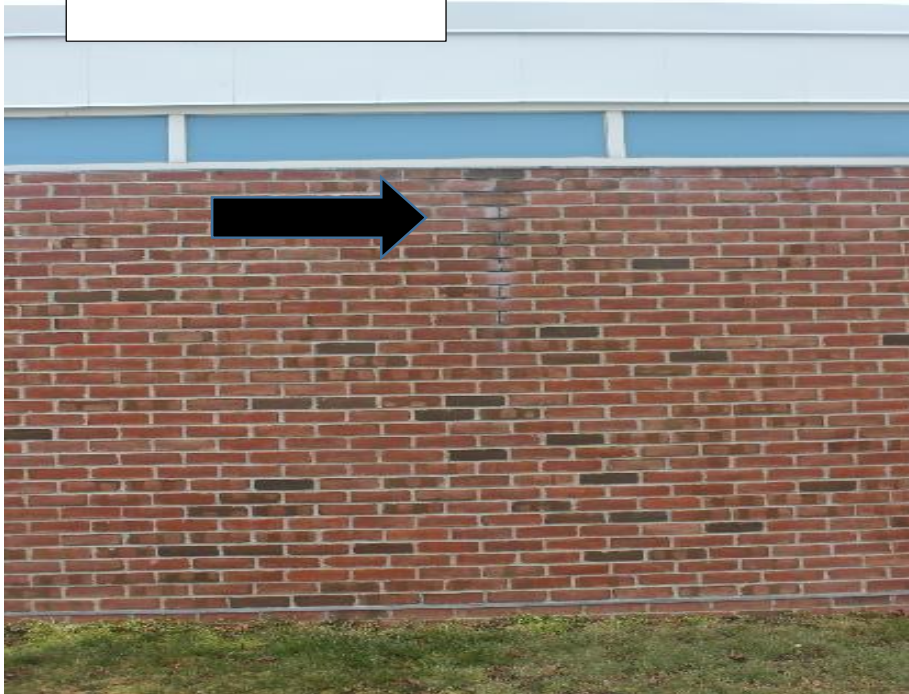
Water penetration at
flashing

Drip cap flashing at brick allows water
to penetrate brick and mortar. Early
degradation/efflorescence visible

Spot repointing and flashing repairs \$10,000 every five years

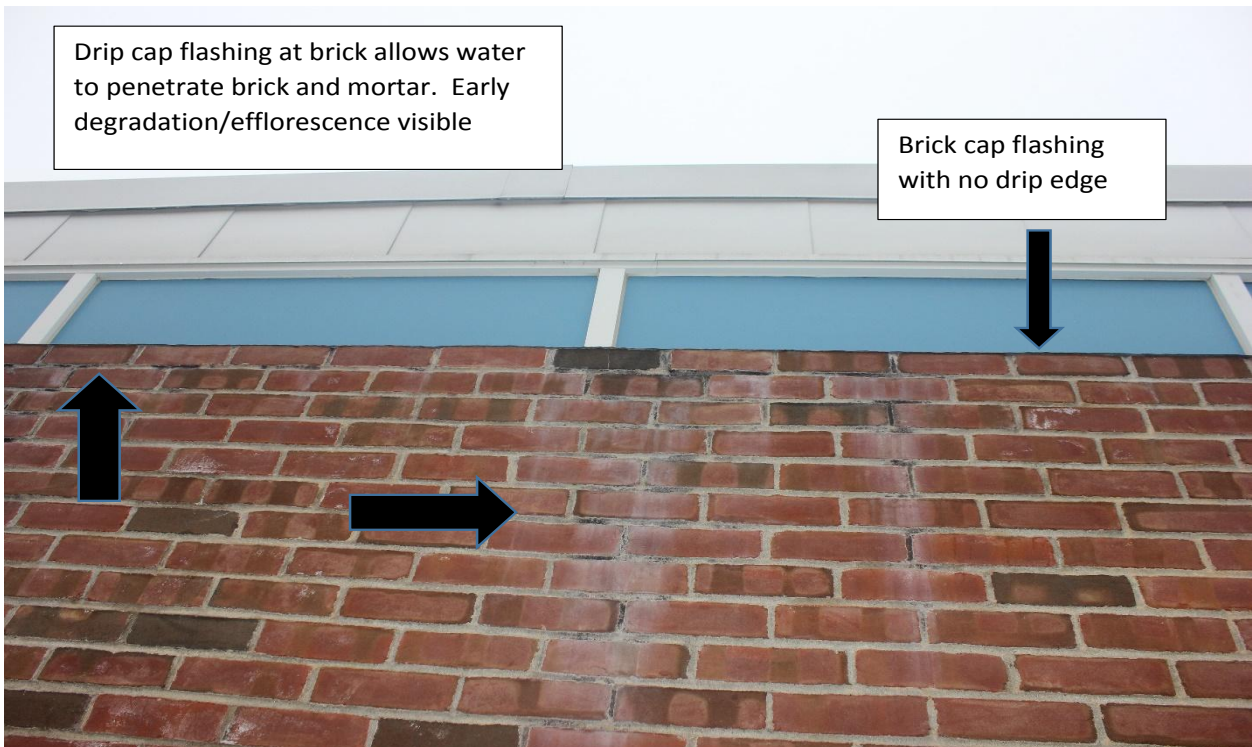
Brick cap flashing
with no drip edge

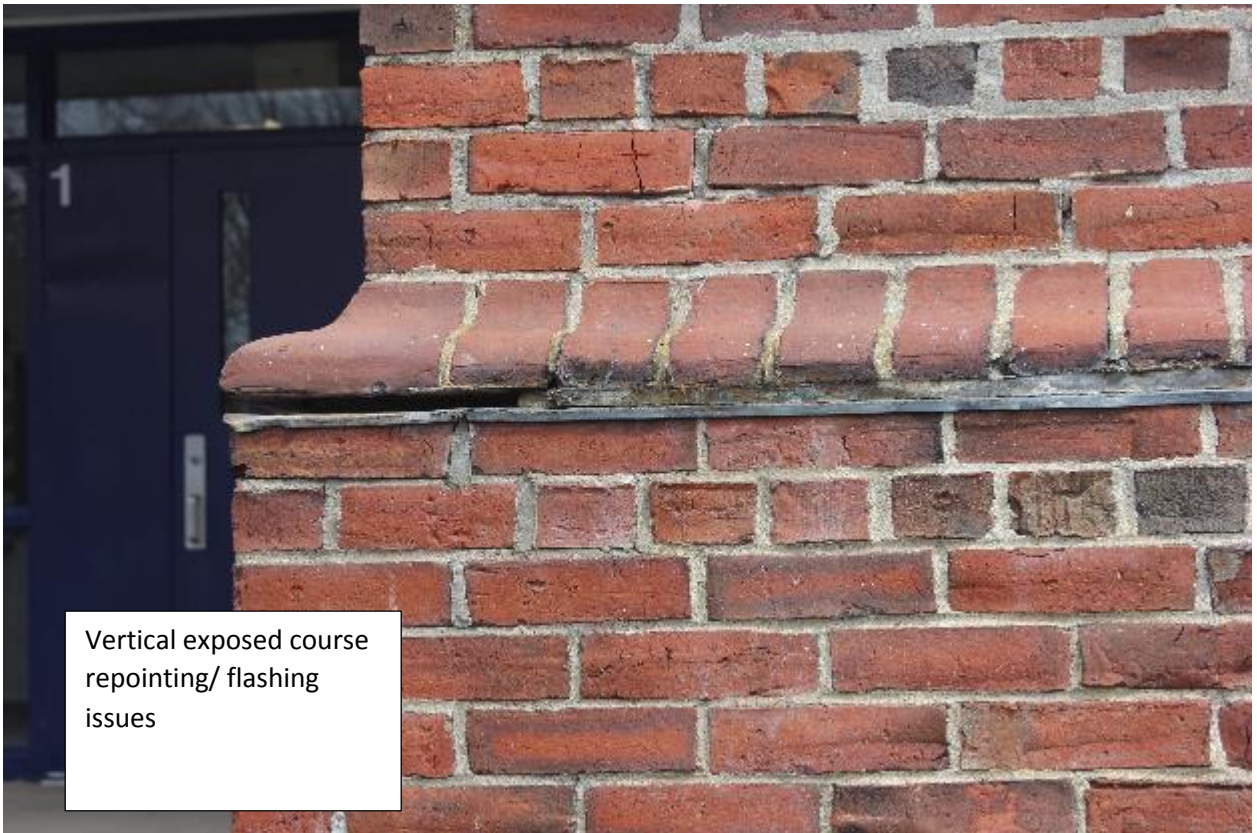
Vertical exposed course
repointing/ flashing
issues

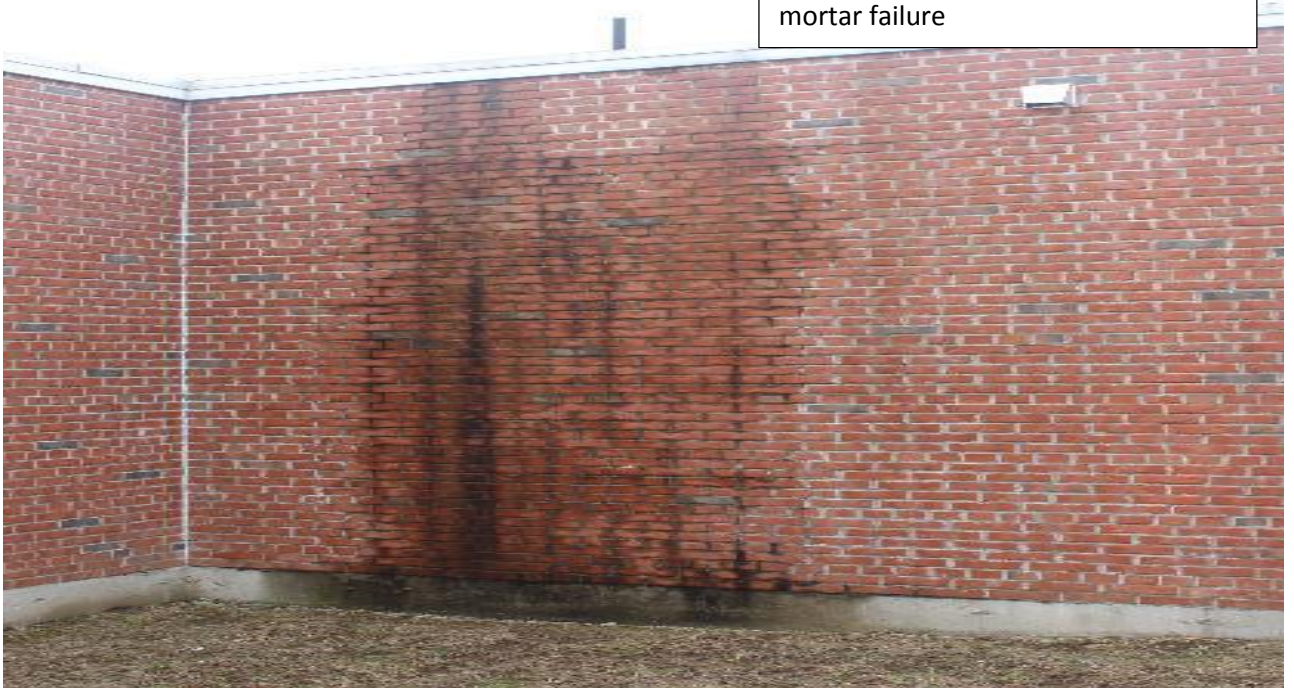
Water entering roof and getting into brick cavity. Roof failure and brick mortar failure

Replace the flat roof build up areas with new membrane roofing. Table 1

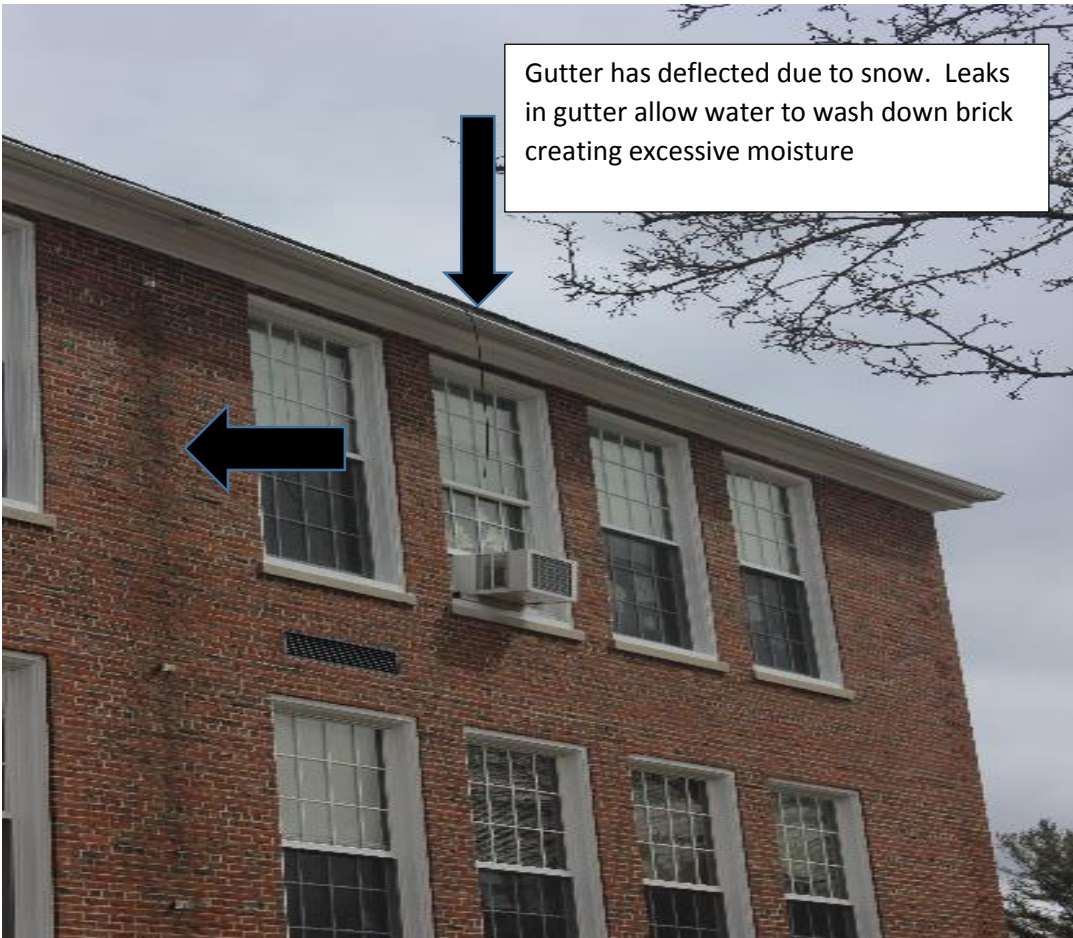
Gutter has deflected due to snow. Leaks in gutter allow water to wash down brick creating excessive moisture

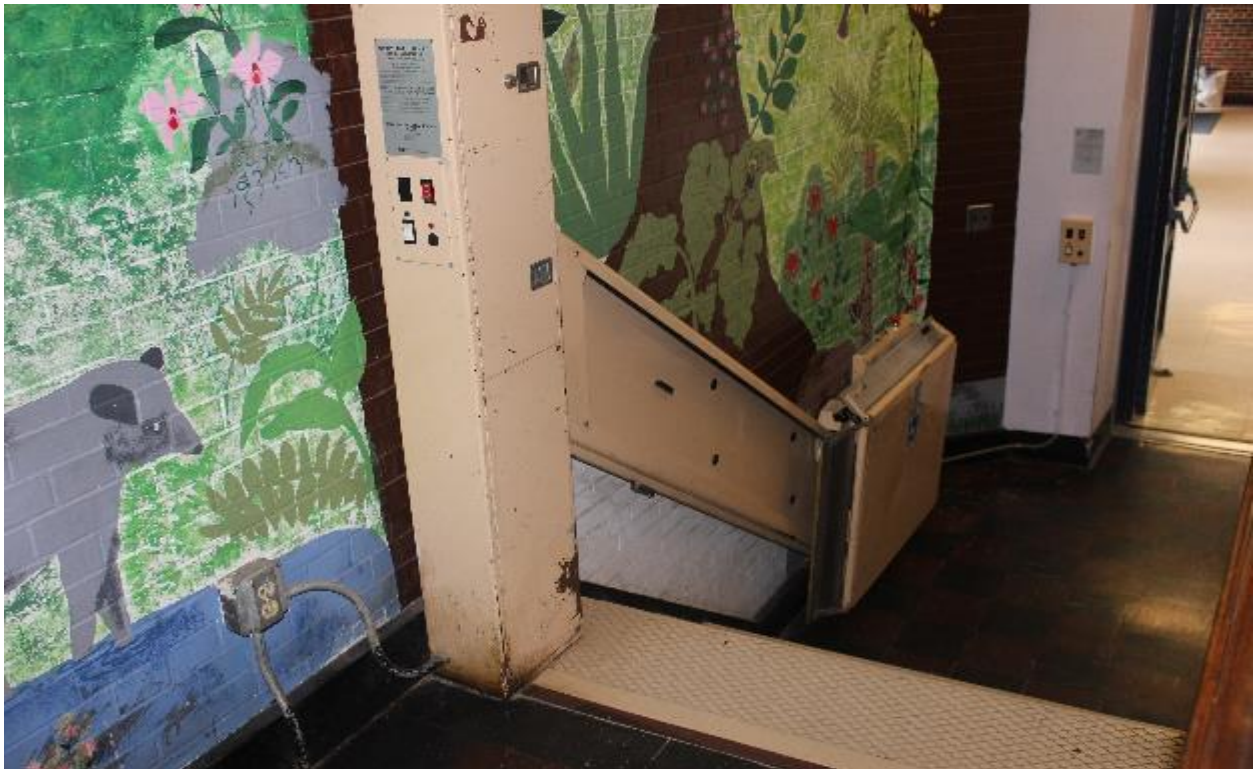
Non-Compliant Handicap ramp and rail system

Handicap accessible lift in stair (No longer allowed by code) Note no elevator to second floor.
