TOWN OF MEDFIELD

Municipal Facilities

Evaluation and Capital Plan

October 6, 2017

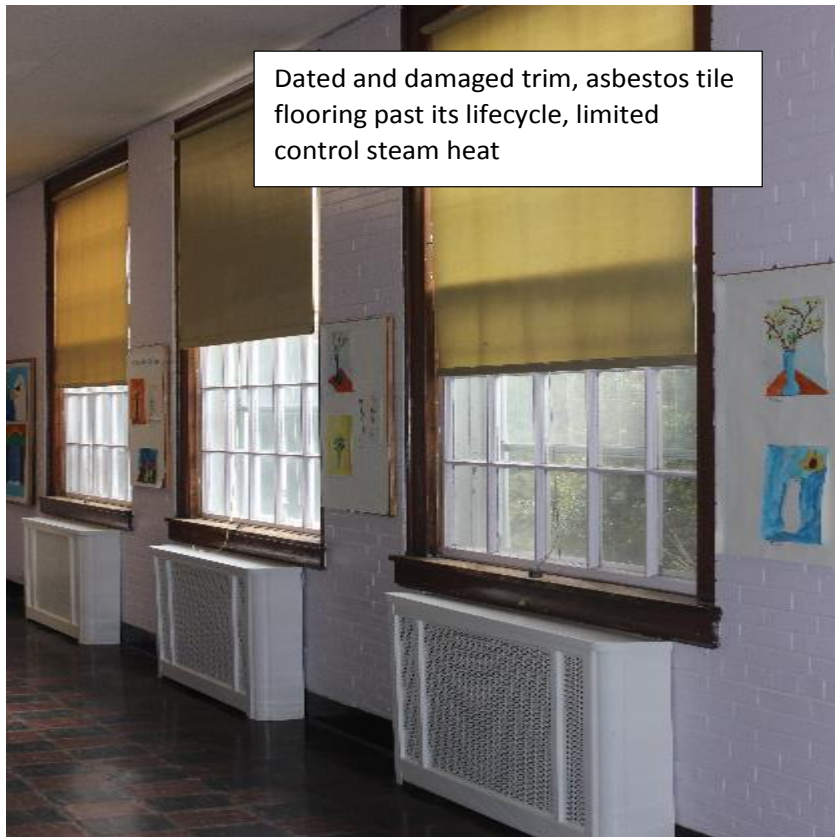
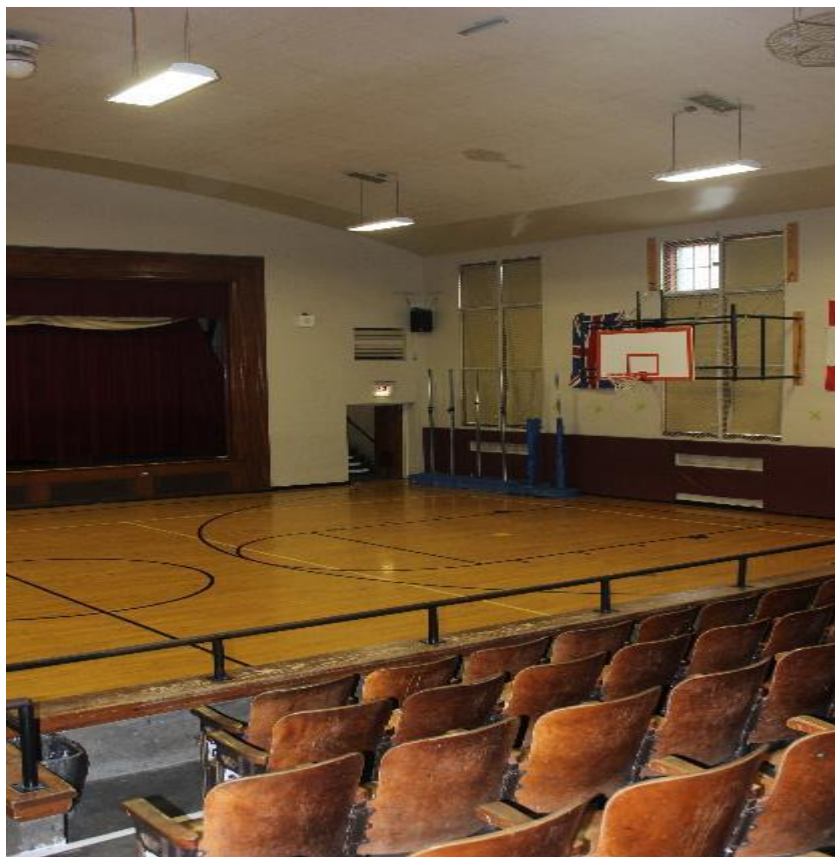
Dated interior fixtures

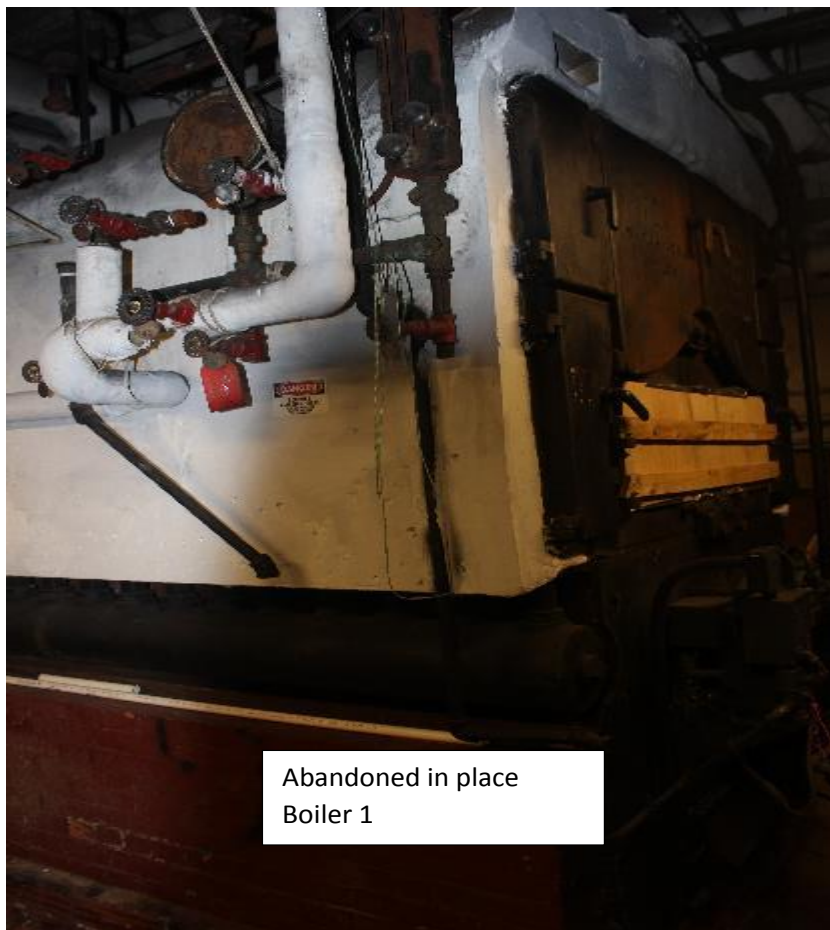
Existing operable boilers

Abandoned in place
Boiler 1

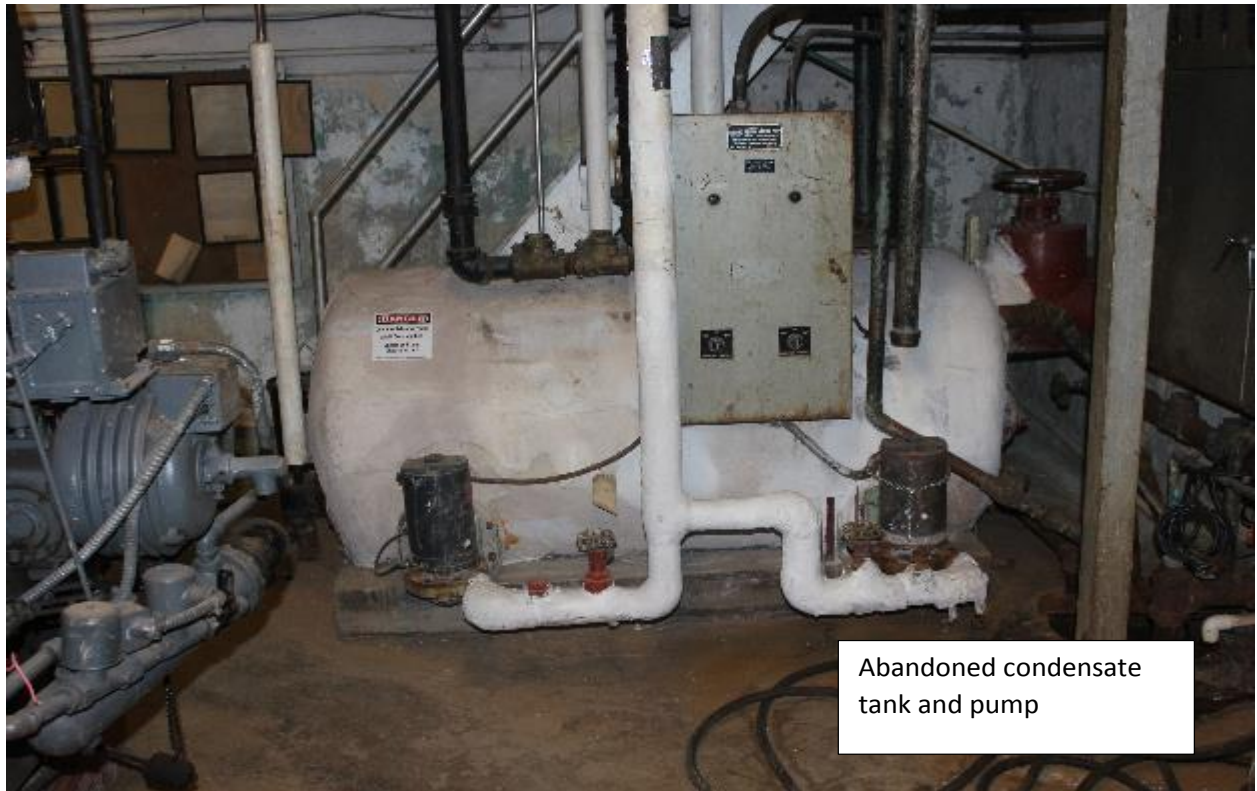
Abandoned condensate tank and pump

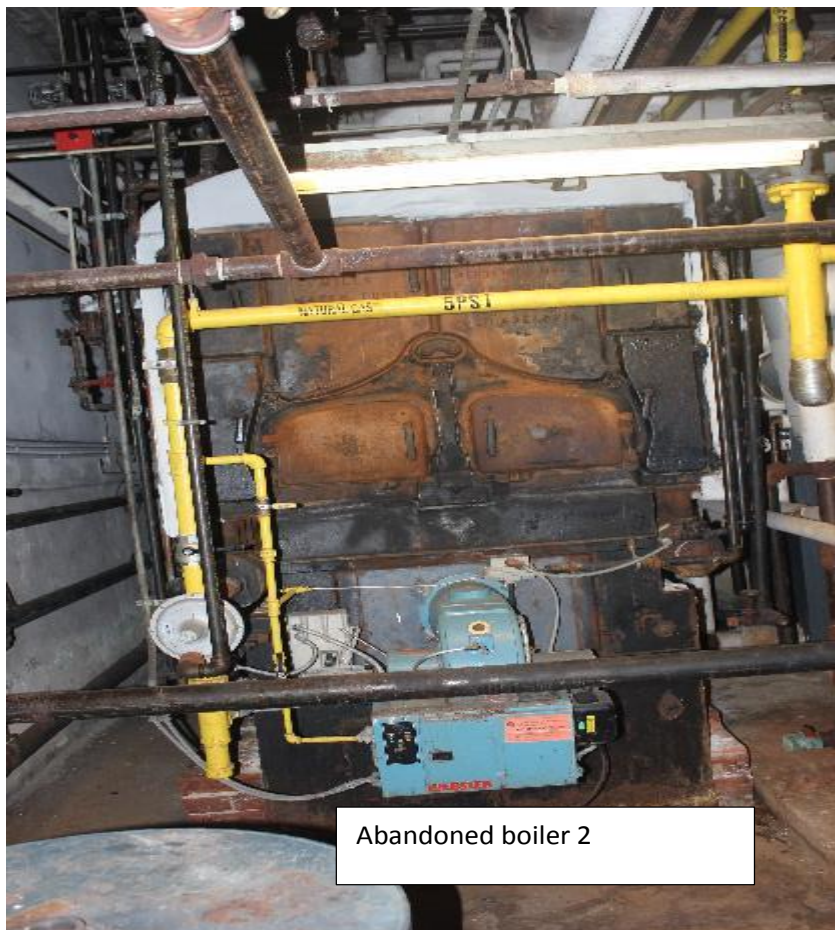
Abandoned boiler 2

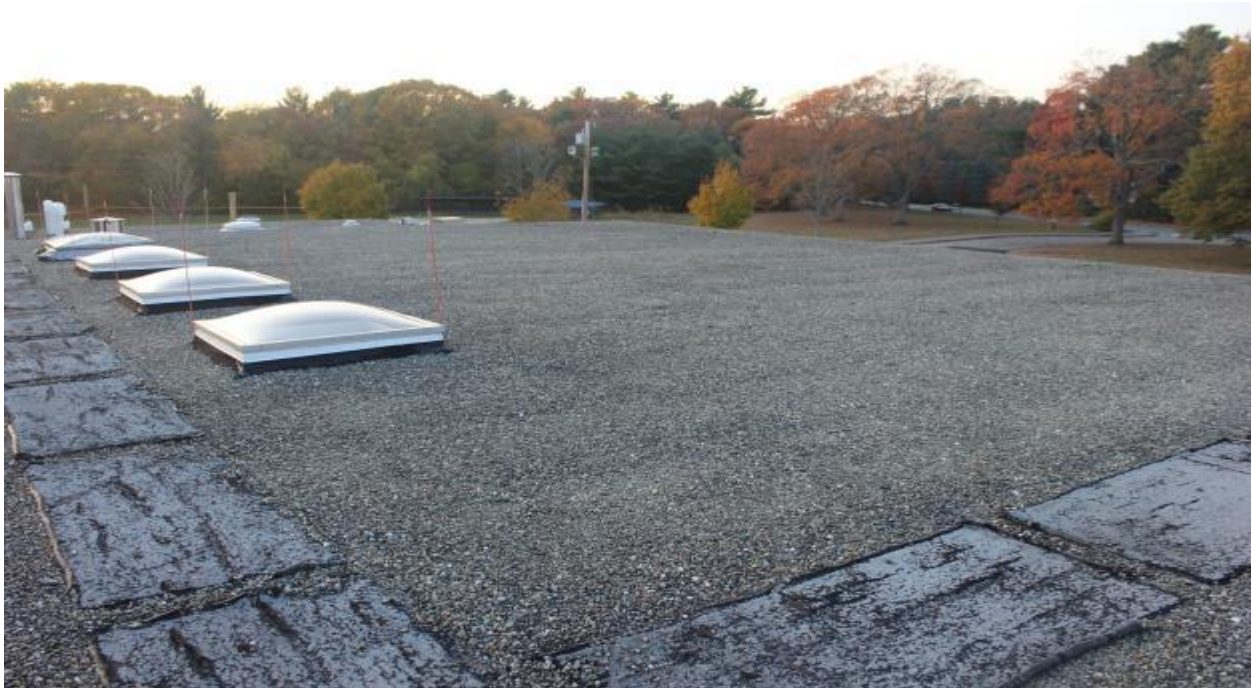
BUR roof Thinning stone ballast, walk pad failing, curb flashing is separating from vertical rise.

Roof engineer: \$150,000

Roof replacement: \$1,500,000

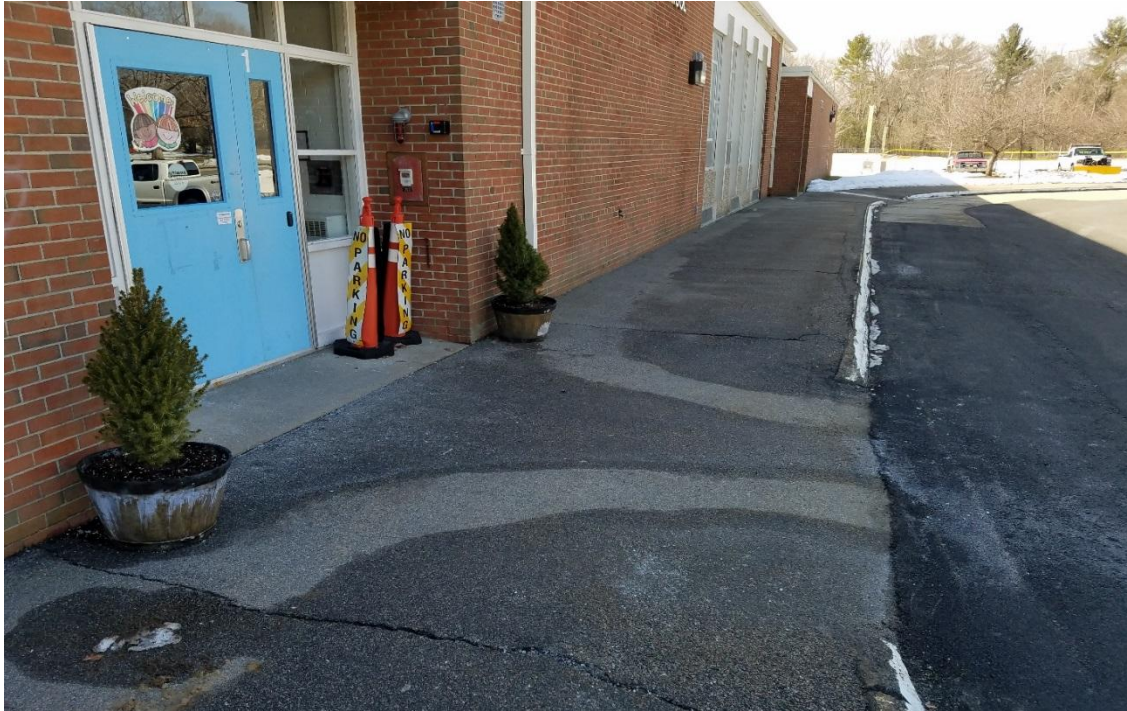
Main Entrance with no 5' level landing and non-compliant slopes. Continuation of egress path into driveway should have cross walk markings

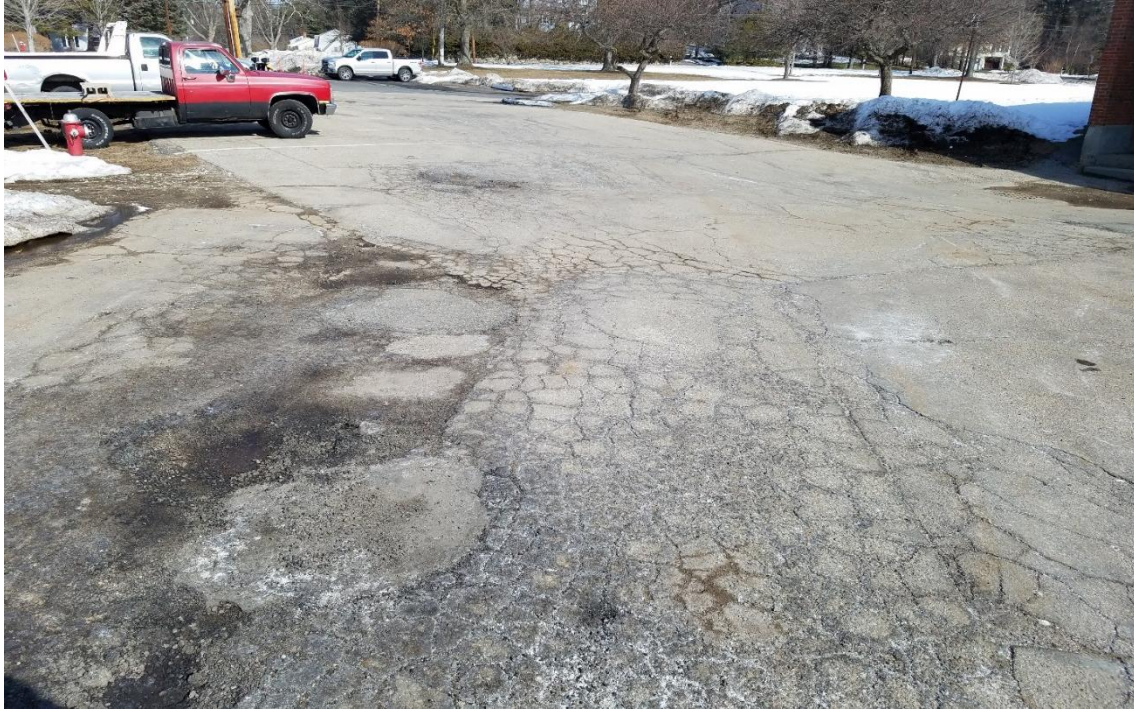
Showing poor condition of paving on west side and routine parking on lawn areas

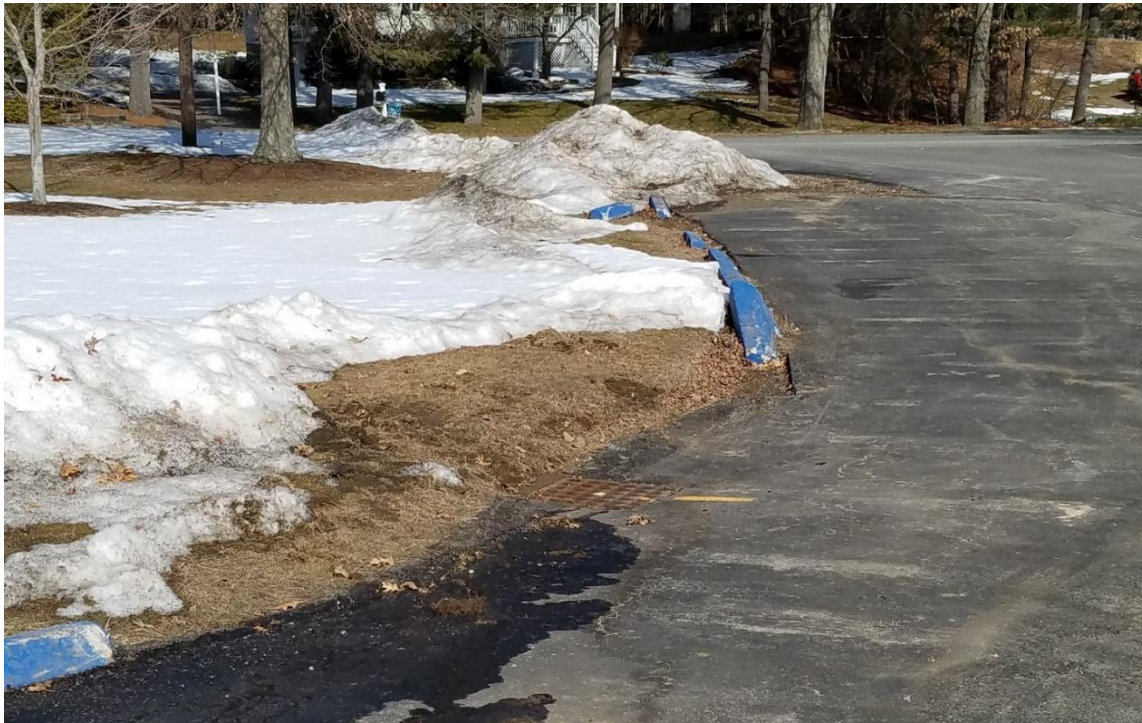
Showing front driveway / parking area with dislodged curb stops and lack of pavement markings

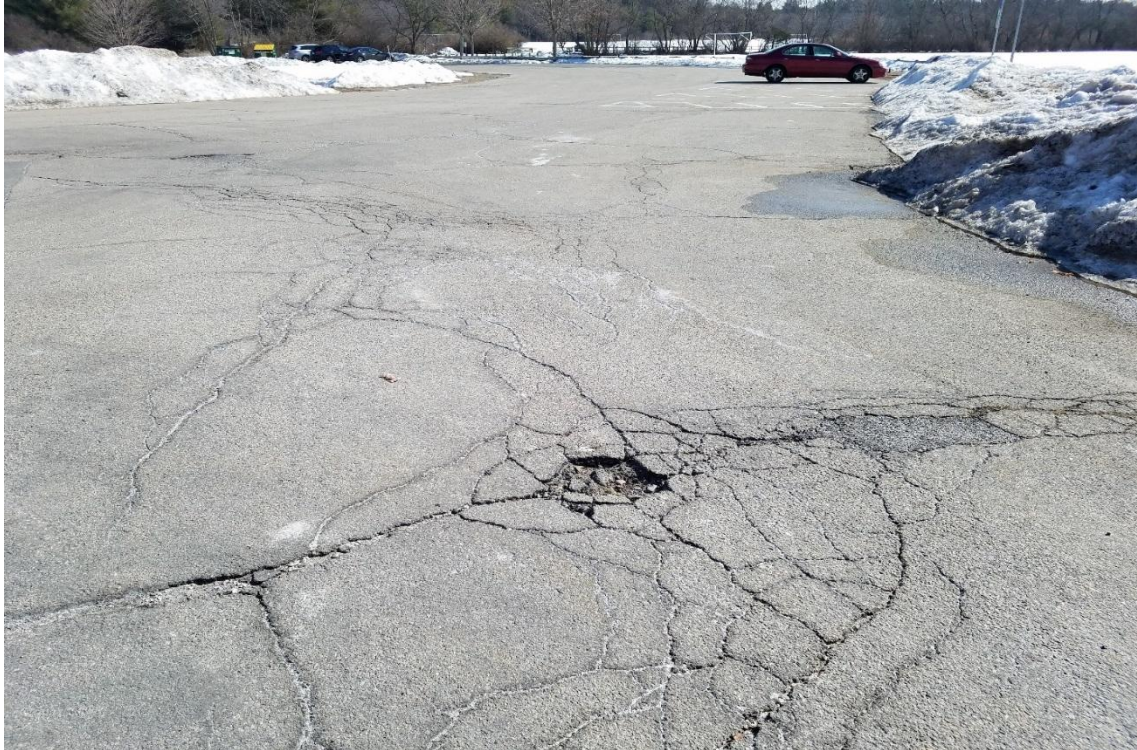
Showing deteriorated pavement and pothole at rear driveway area

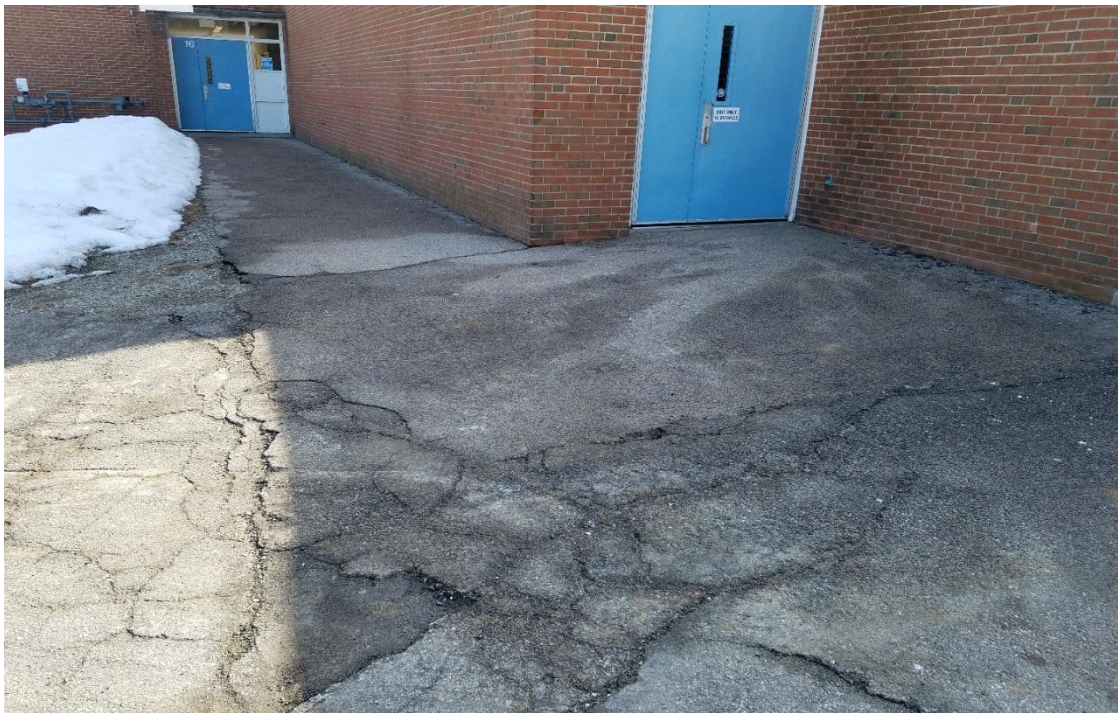
Deteriorated paving at egress path from exits

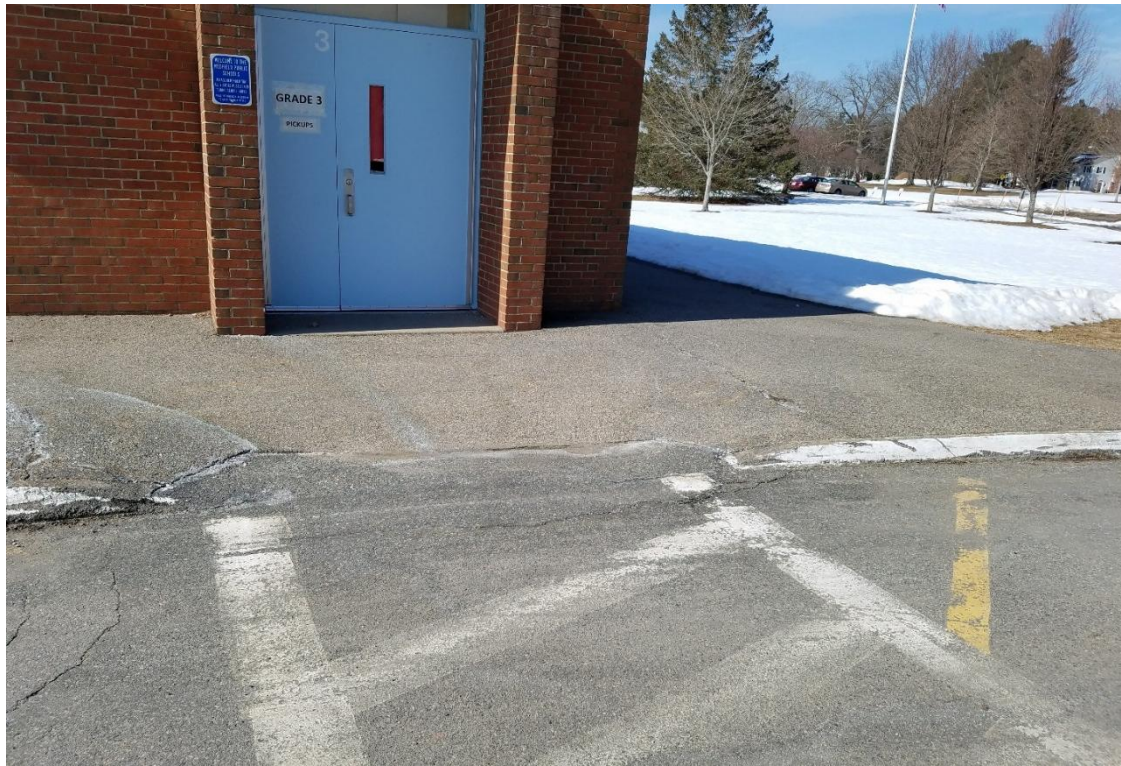
Poorly constructed curb cut and worn pavement markings

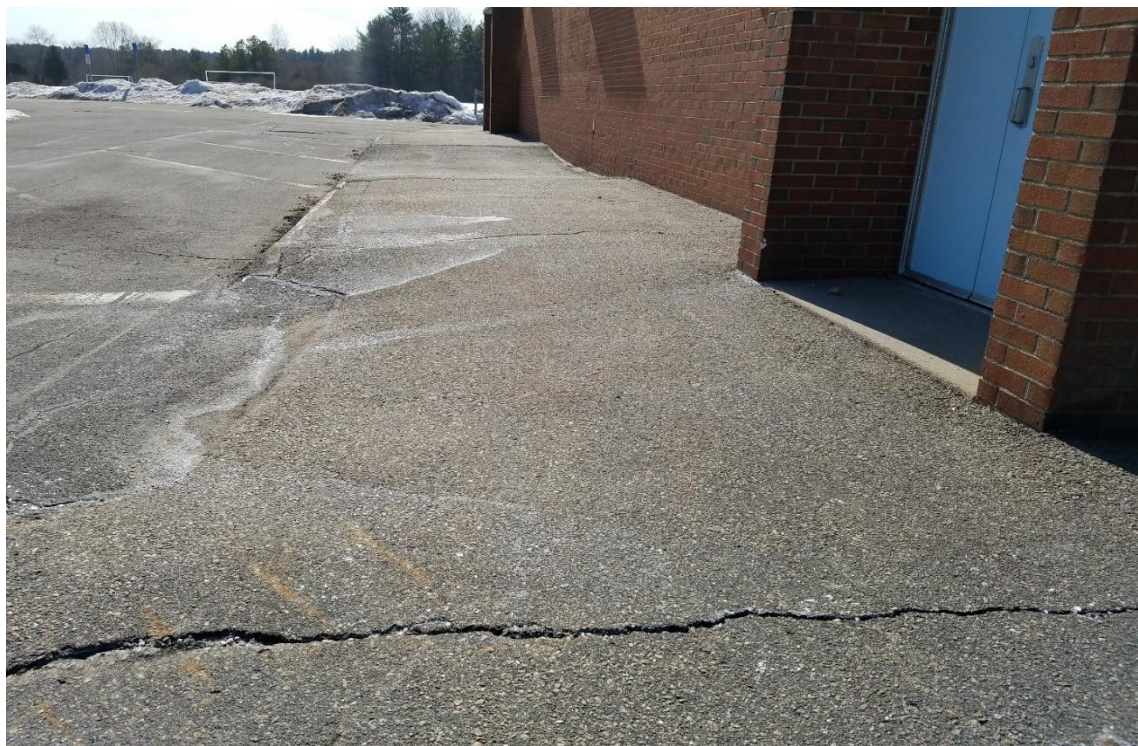
Egress door lacking 5' level landing before slope to curb cut, and deteriorated paved walkway

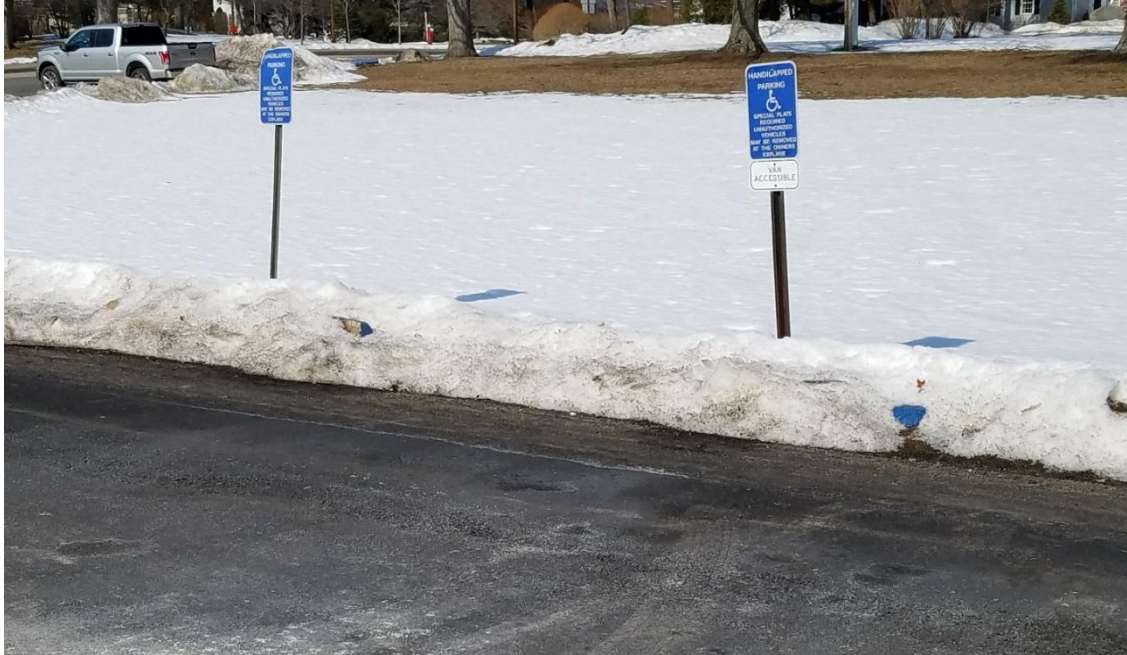
Accessible parking spaces lacking pavement markings & non-compliant sign height

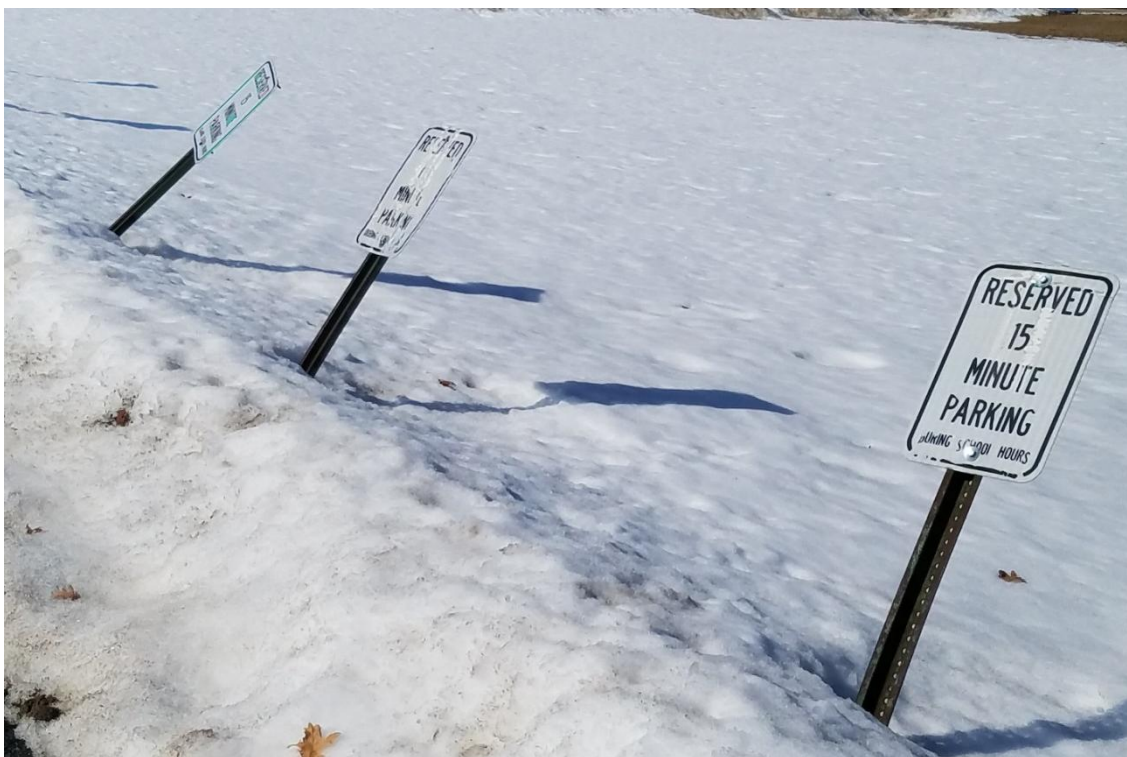
Signage needing repairs

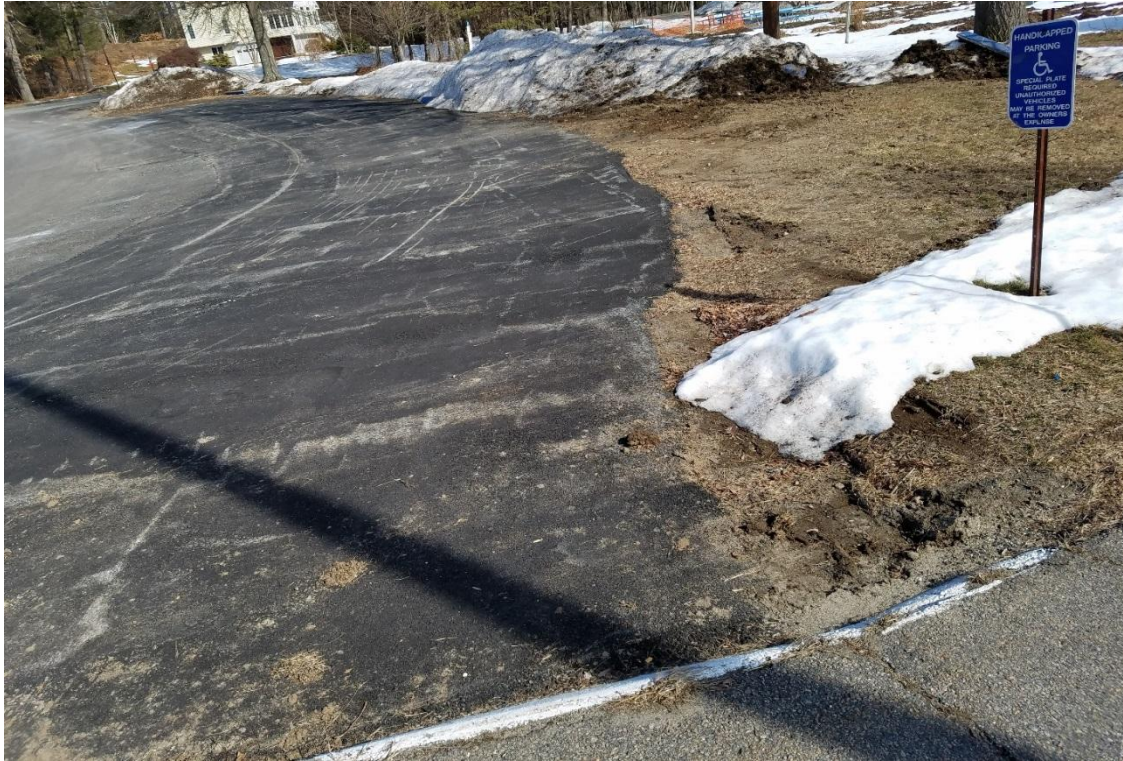
Showing lack of pavement markings and excessive slope at accessible parking space

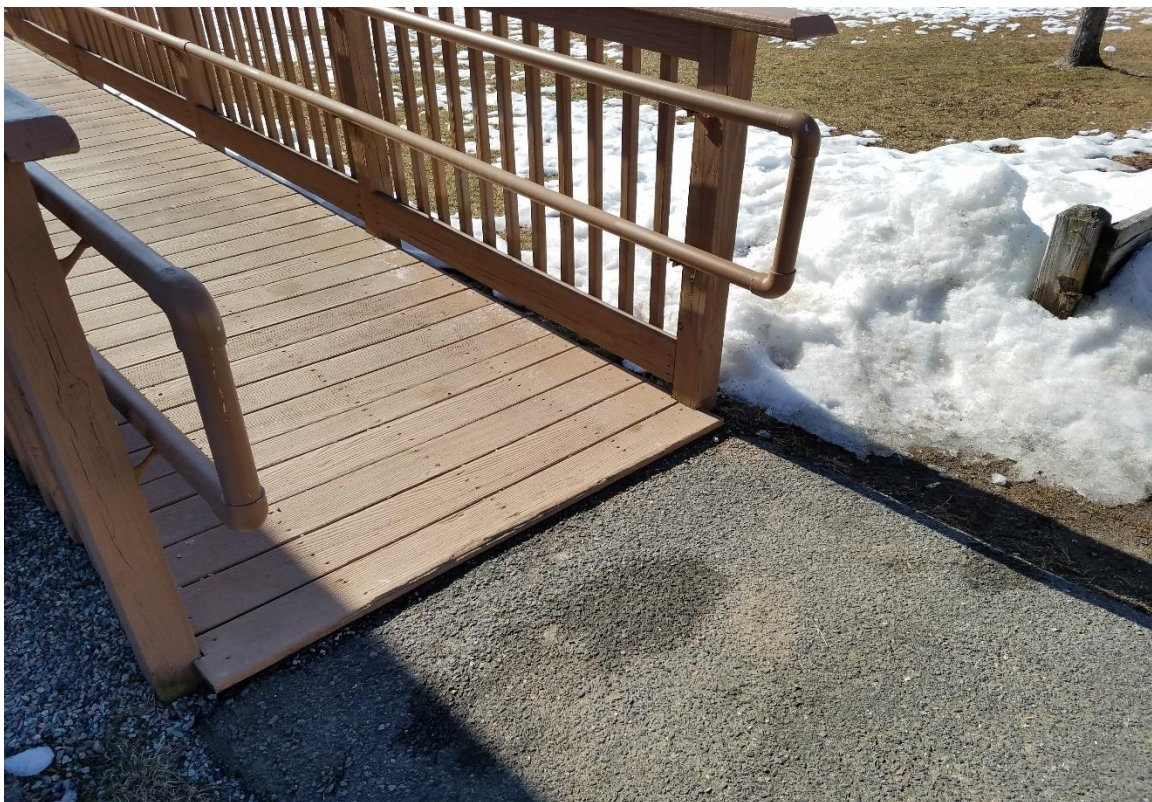
Showing tripping hazard lip at edge of ramp and non-compliant rail system at After School Center

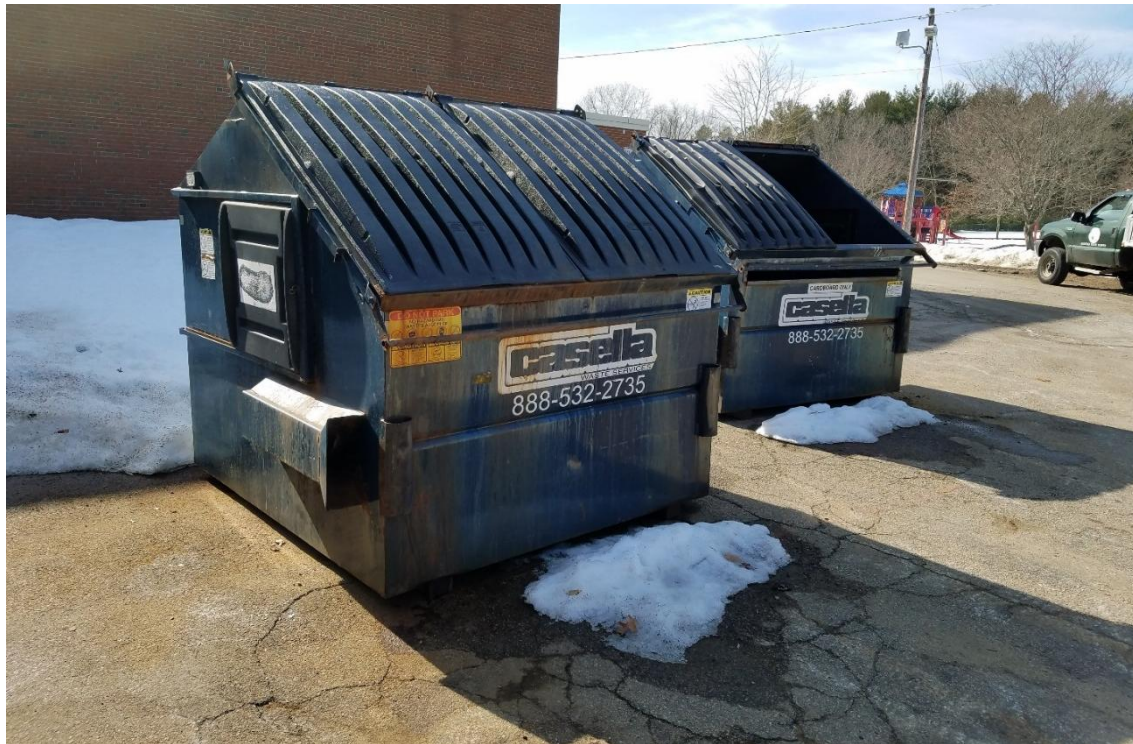
Showing unenclosed dumpsters in visually prominent location

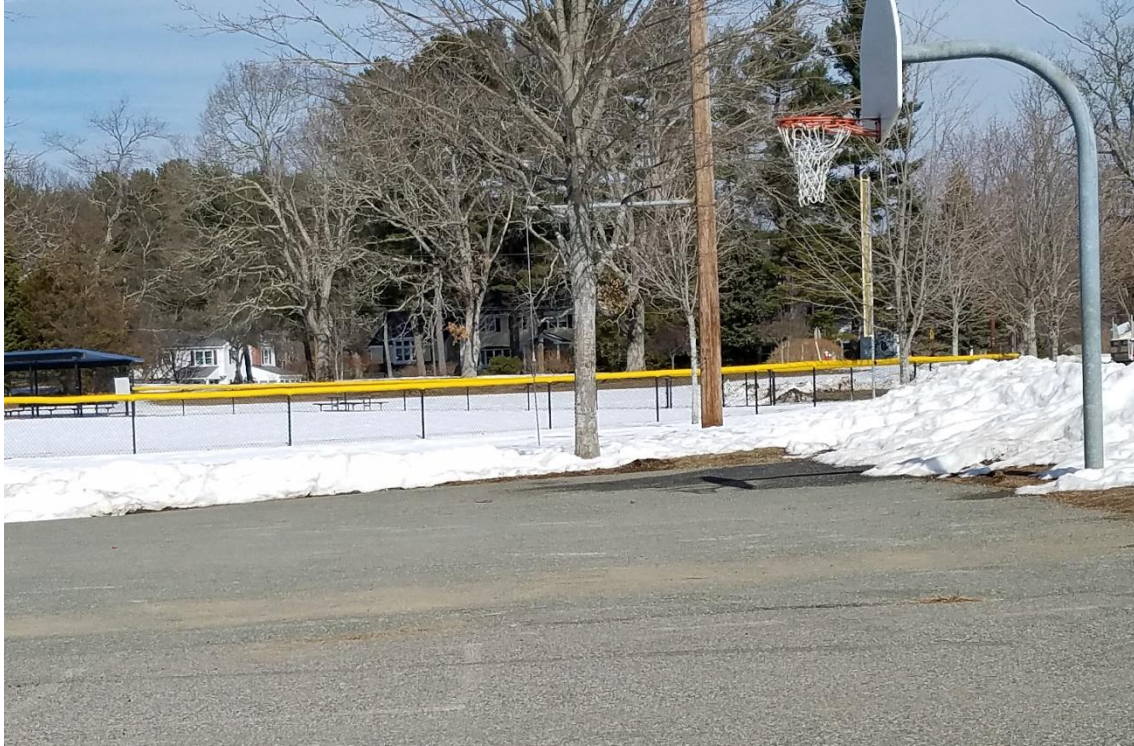
Showing excessive slope in basketball play area

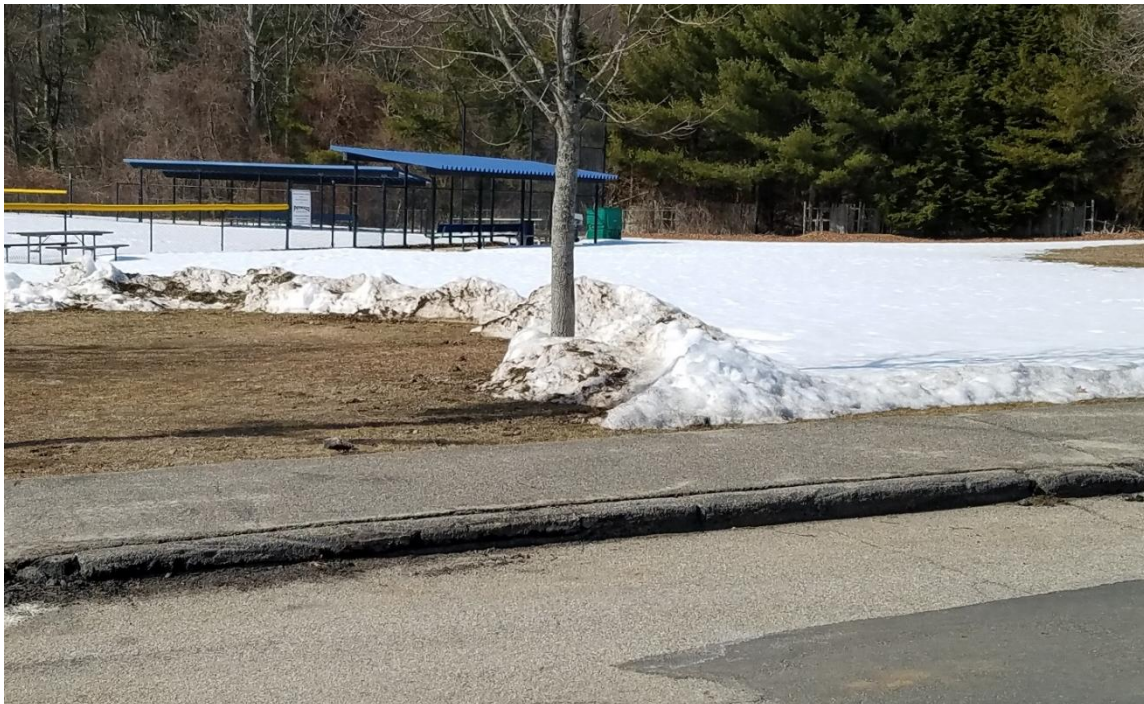
Showing lack of accessible route to ballfield from parking and lawn area used for parking

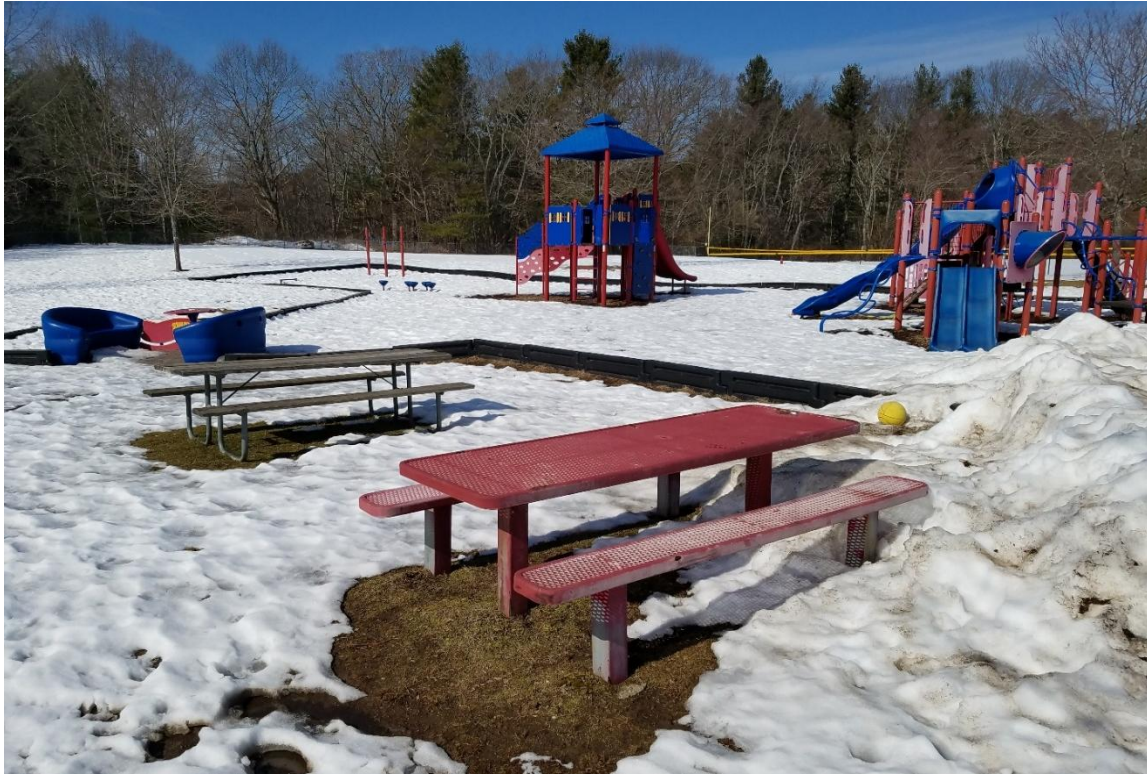
Showing non-accessible picnic area and berm obstacle around play area beyond

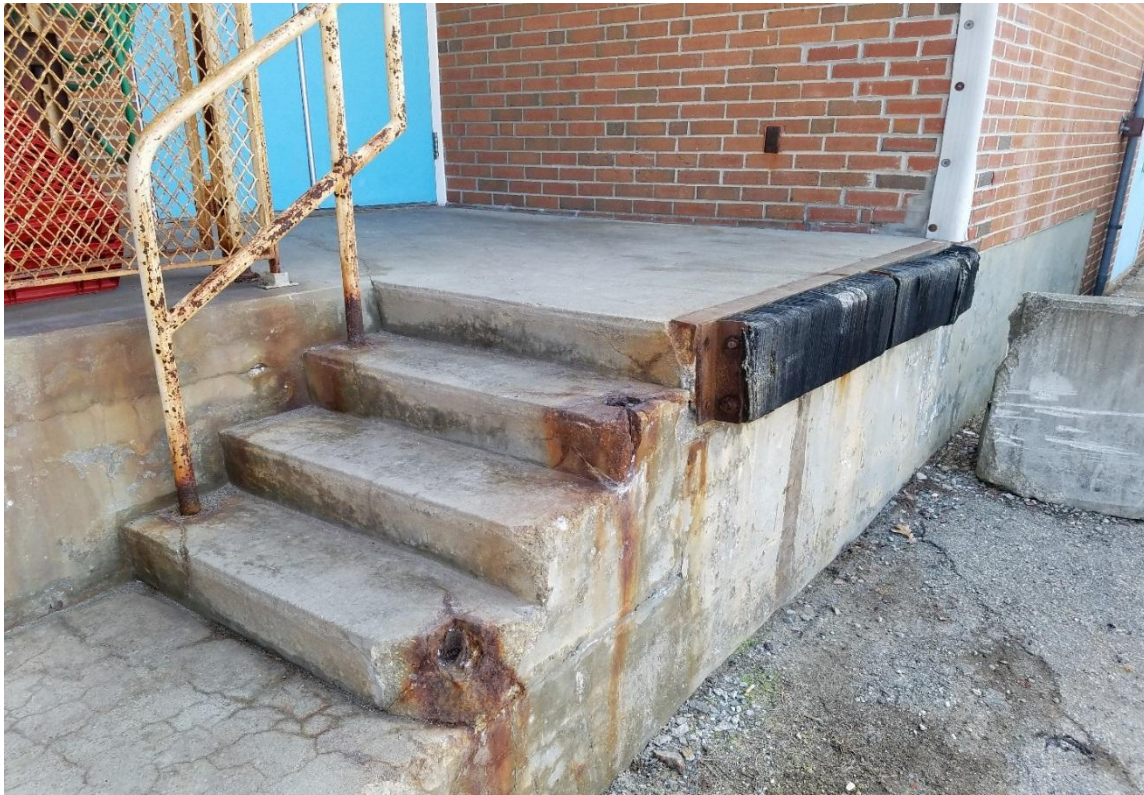
Showing deteriorated concrete steps, lack of handrail and areas needing paint

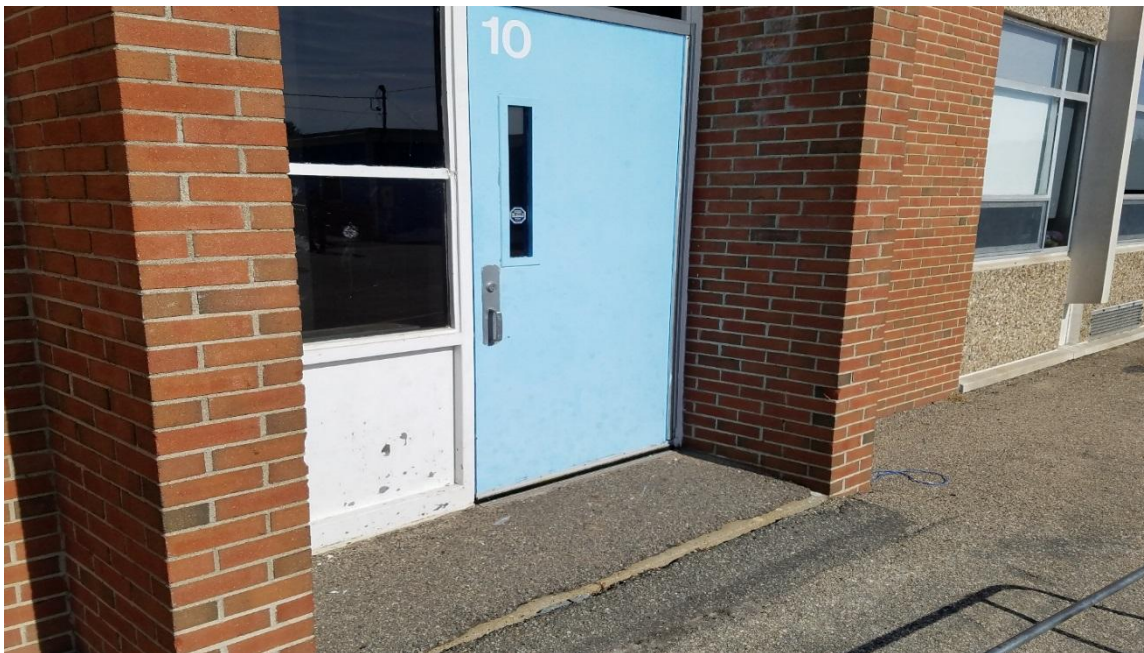
Showing lack of 5' level landing at egress door and HM frames needing paint

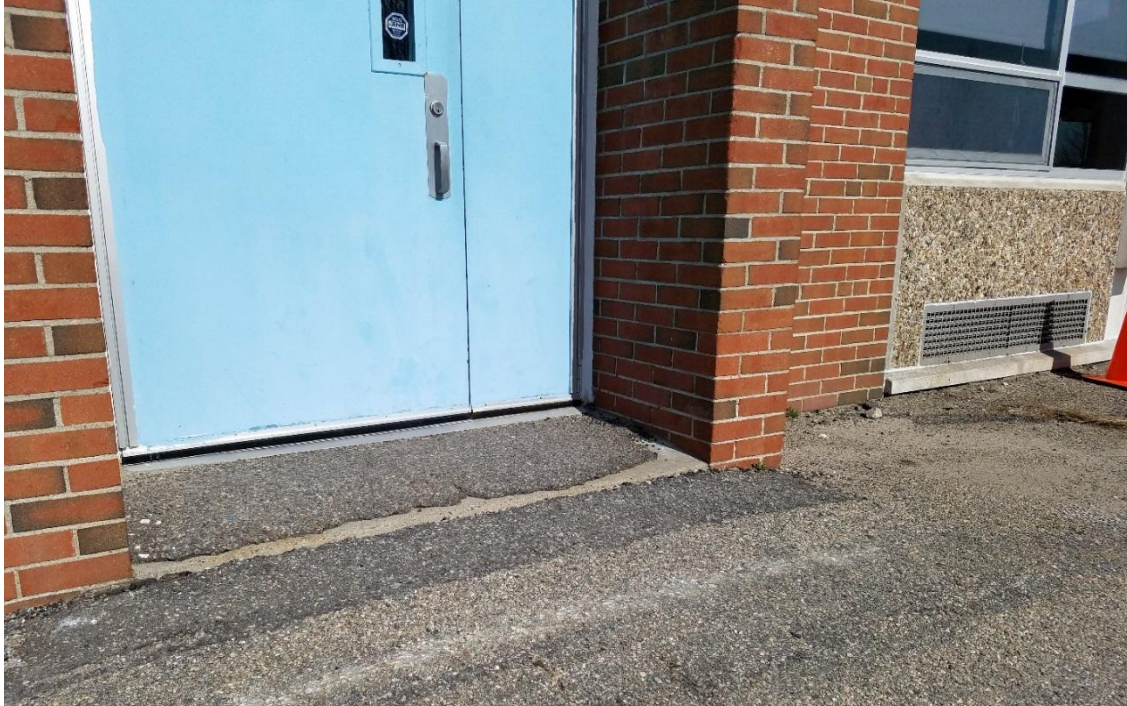
Another example of no 5' level landing at egress doors, currently poorly patched with bituminous

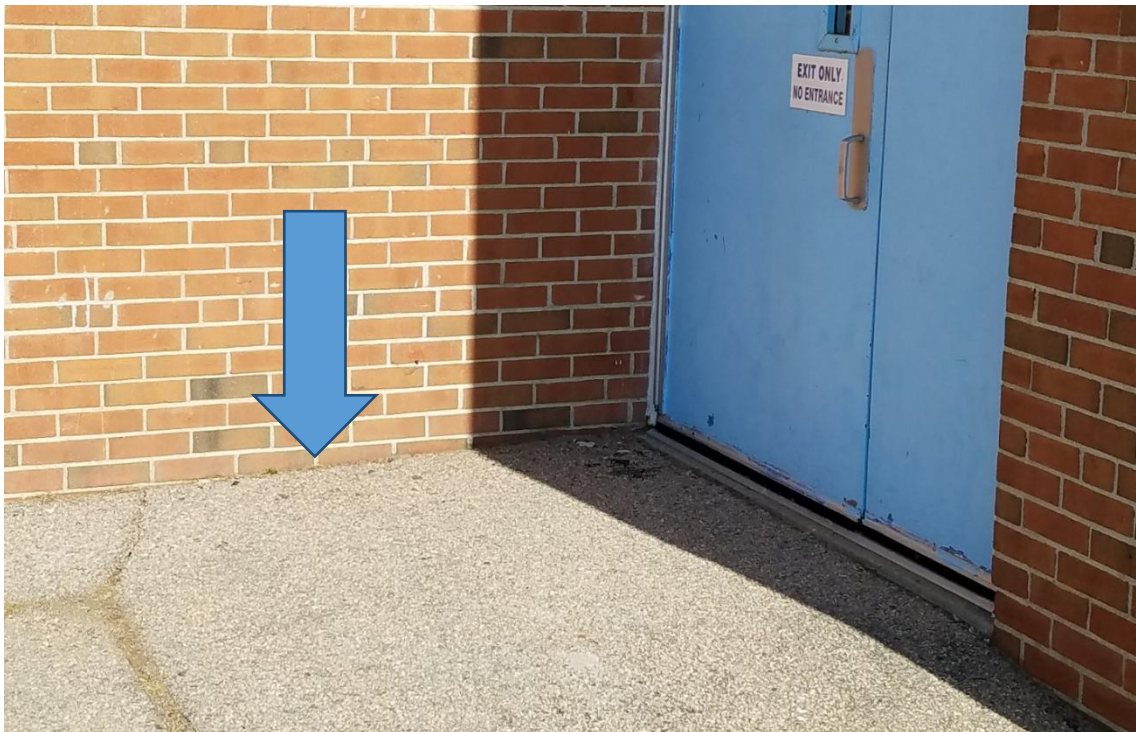
Another example of no 5' level landing at egress door

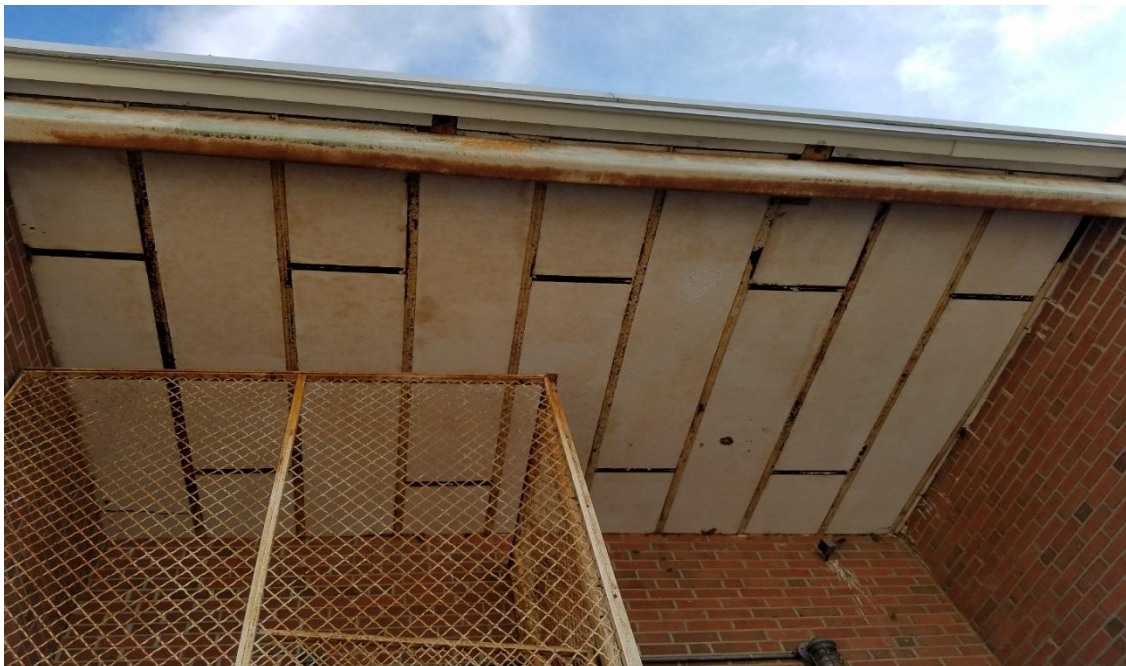
Rusted metal components at covered truck dock (West)

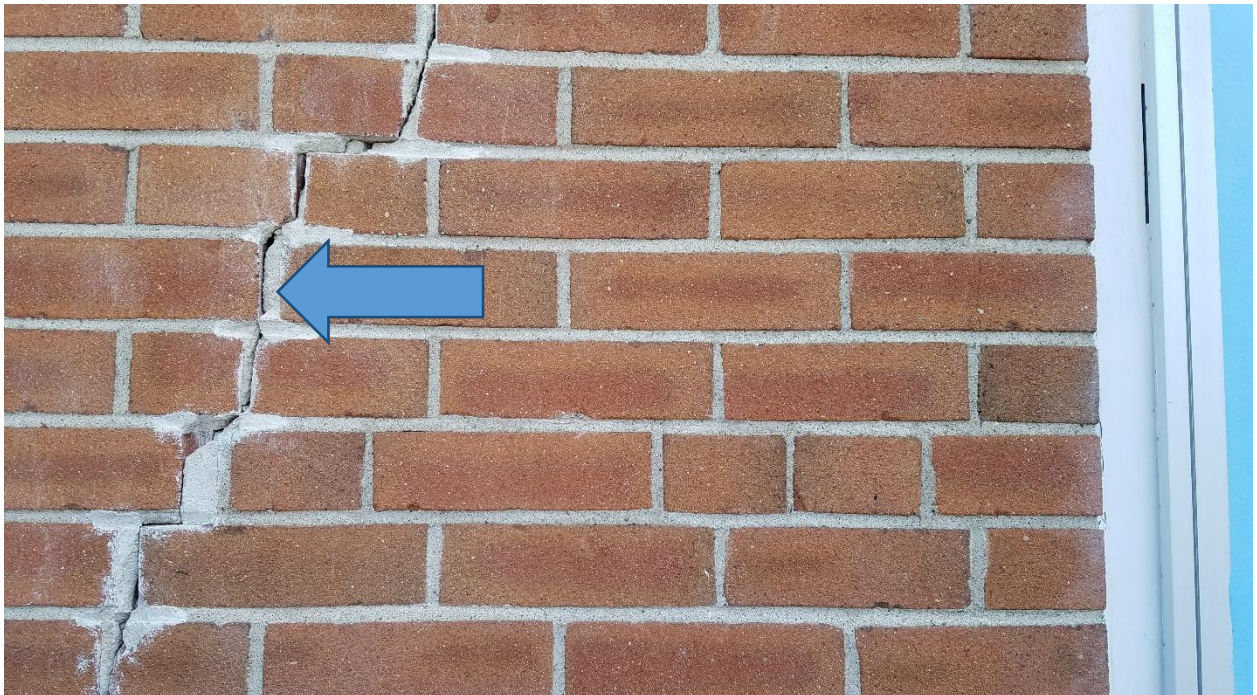
Example of cracks in brick veneer needing repair (west elevation)
