TOWN OF MEDFIELD

Municipal Facilities

Evaluation and Capital Plan

October 6, 2017

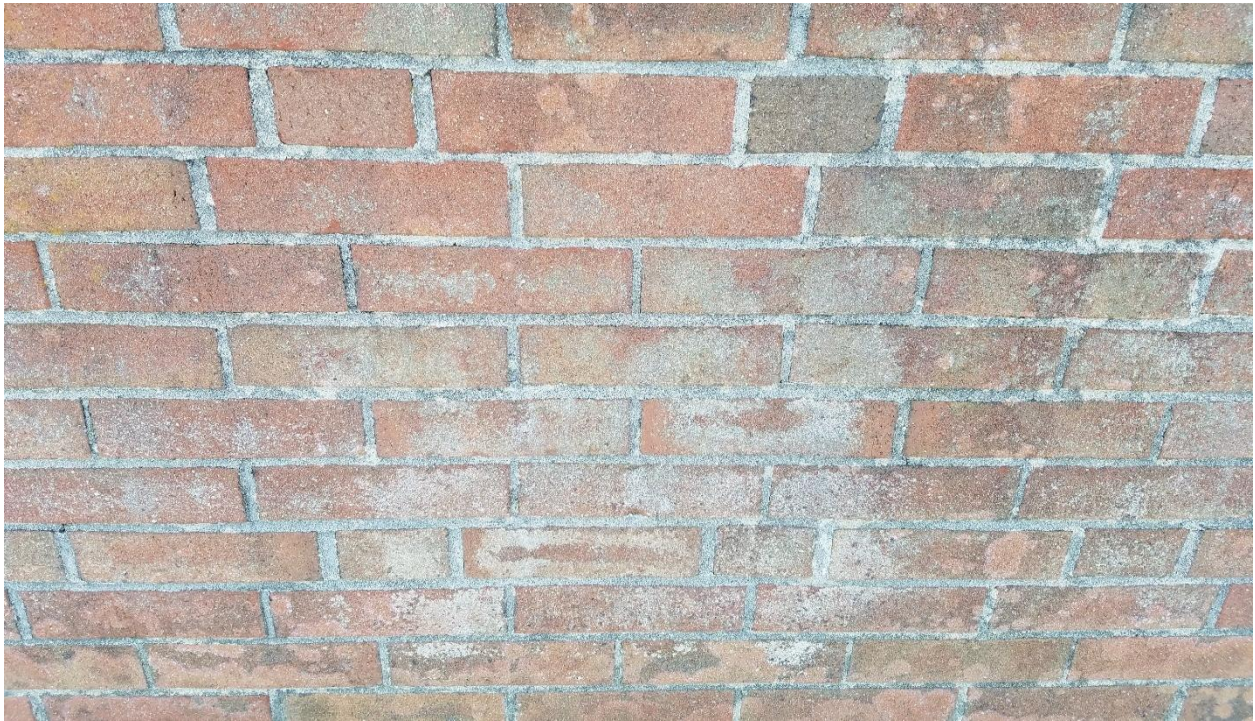
Example of brick veneer exterior surface condition needing cleaning & sealing

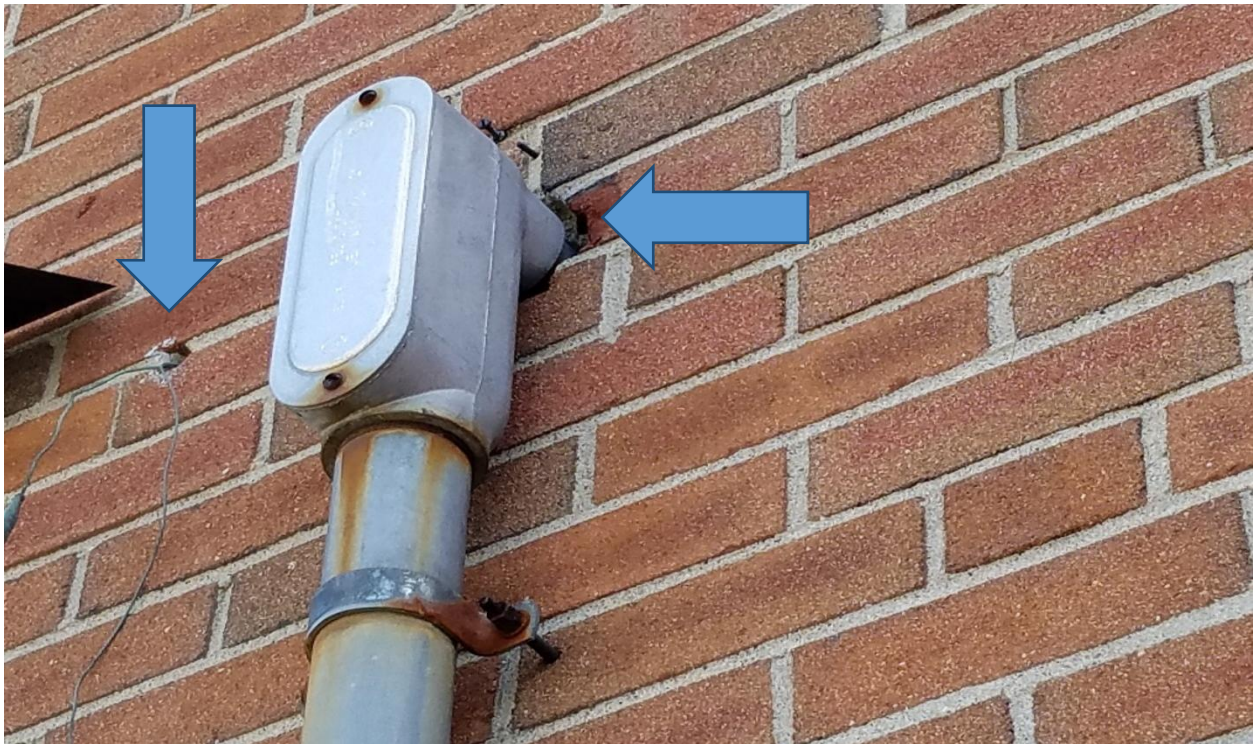
Example of brick penetrations needing sealant (west elevation)

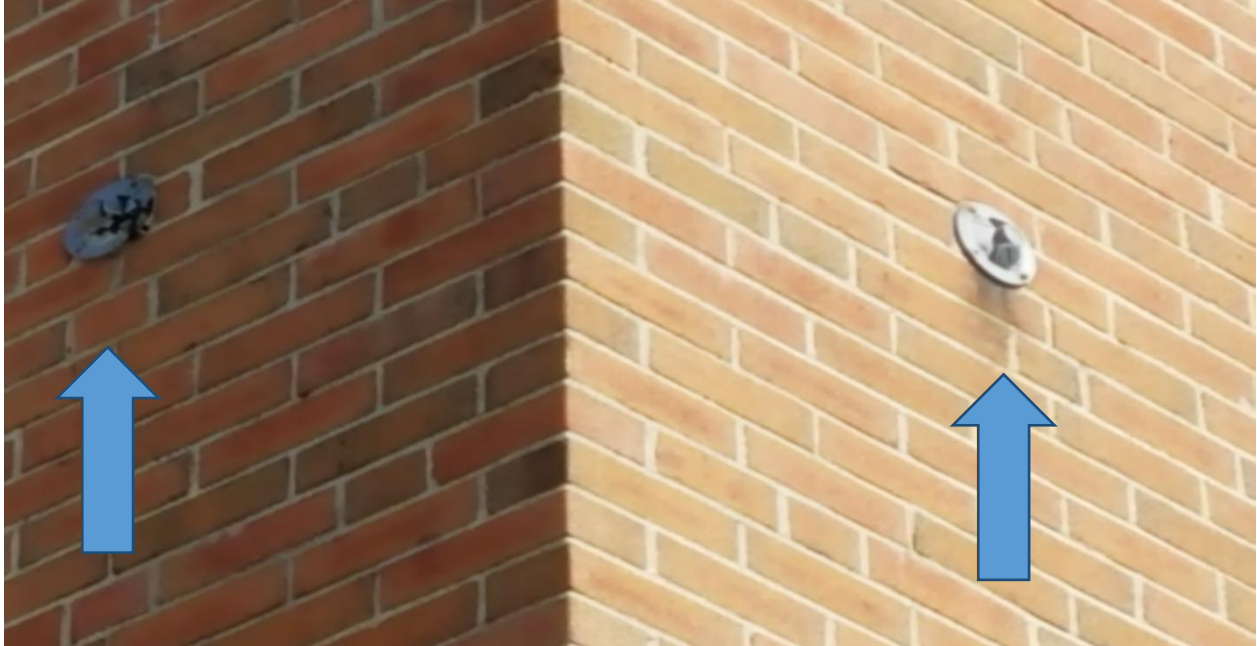
Example of abandoned exterior fixtures that should be capped or removed and infilled with brick

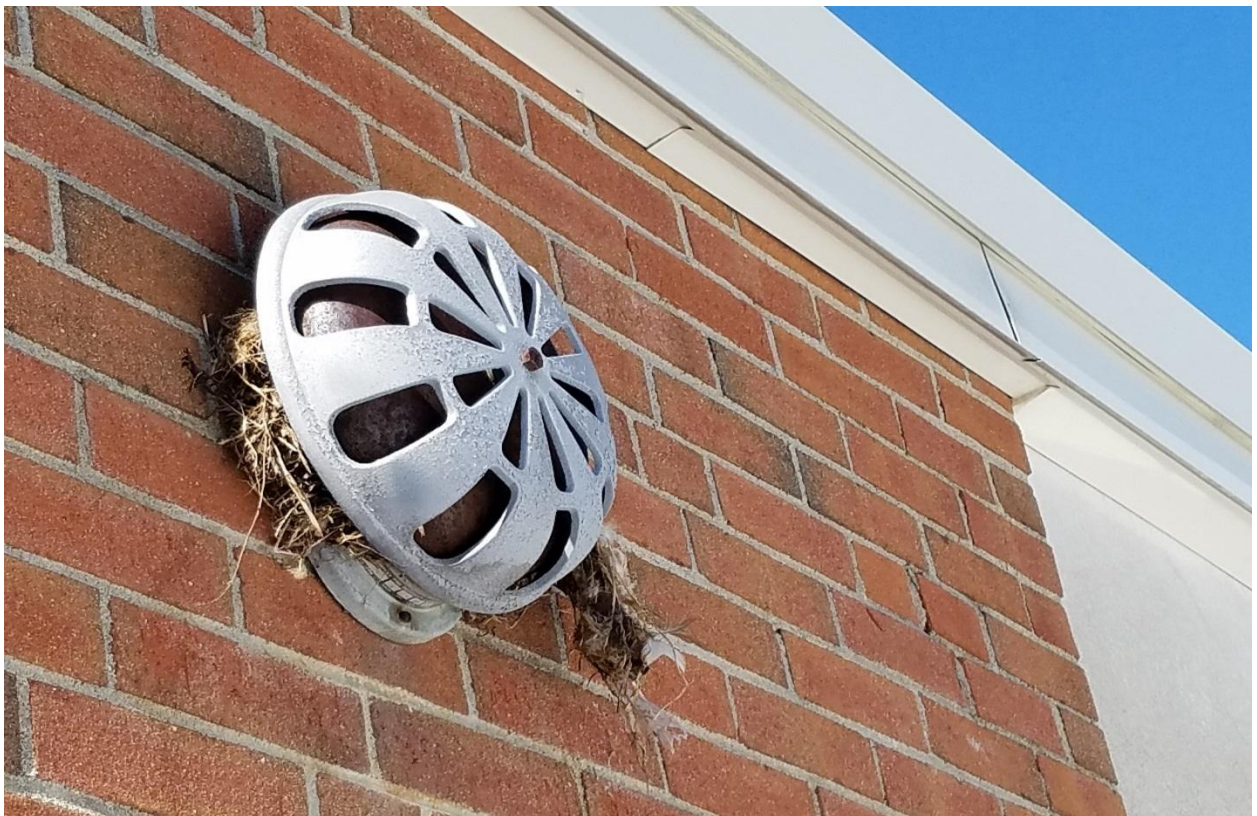
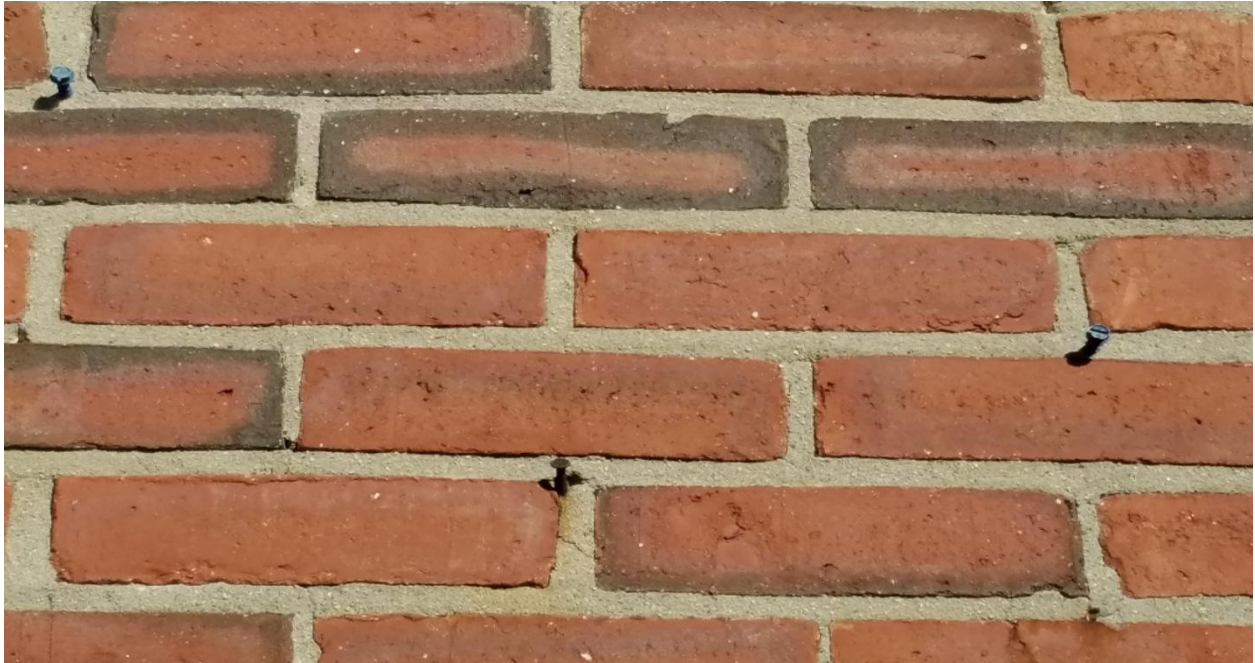
Example of old fasteners that should be removed and patched with mortar or caulking

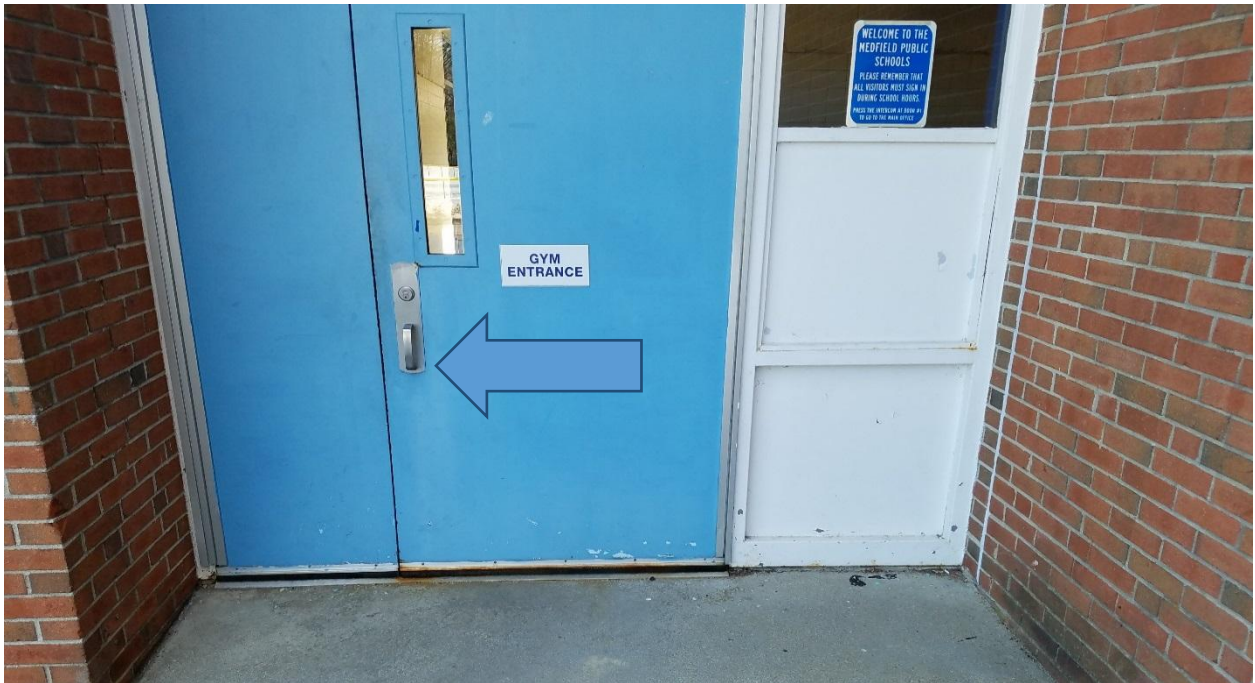
Another example of accessible entrance needing compliant latching hardware

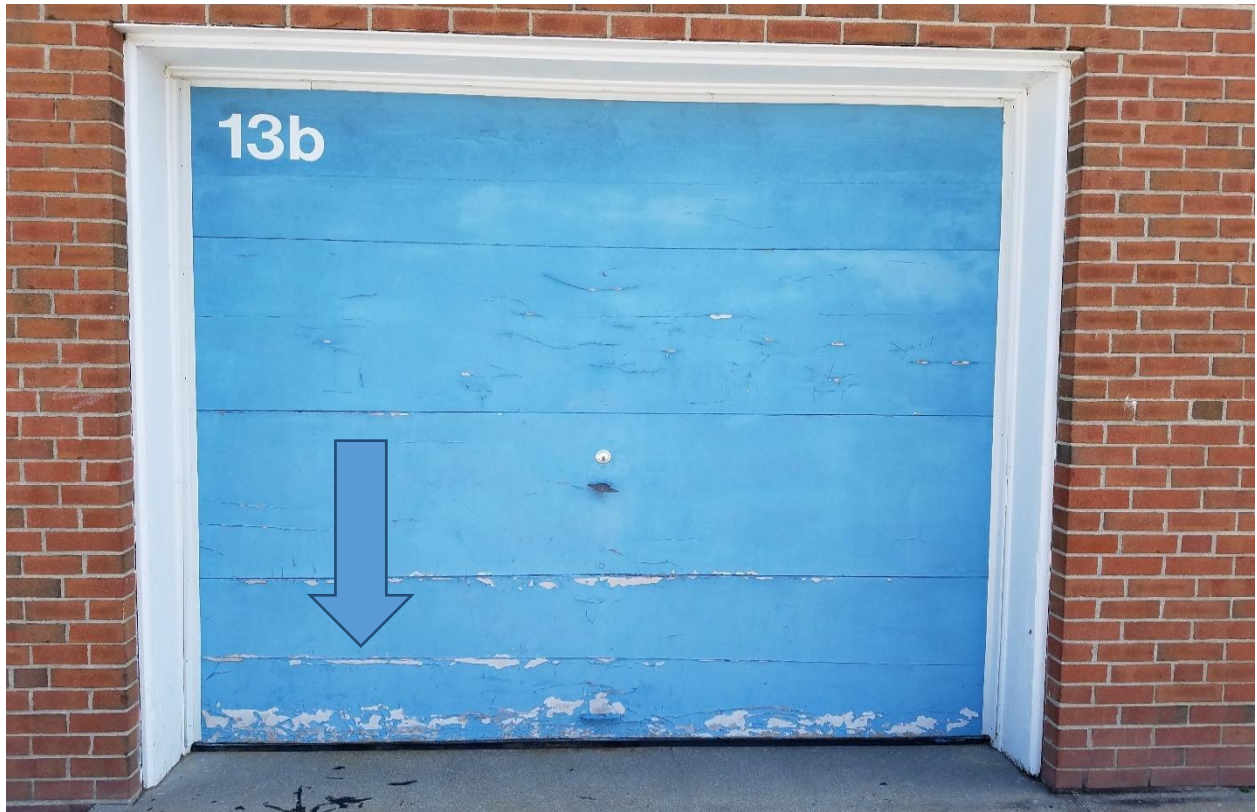
Showing delaminated veneer on garage doors

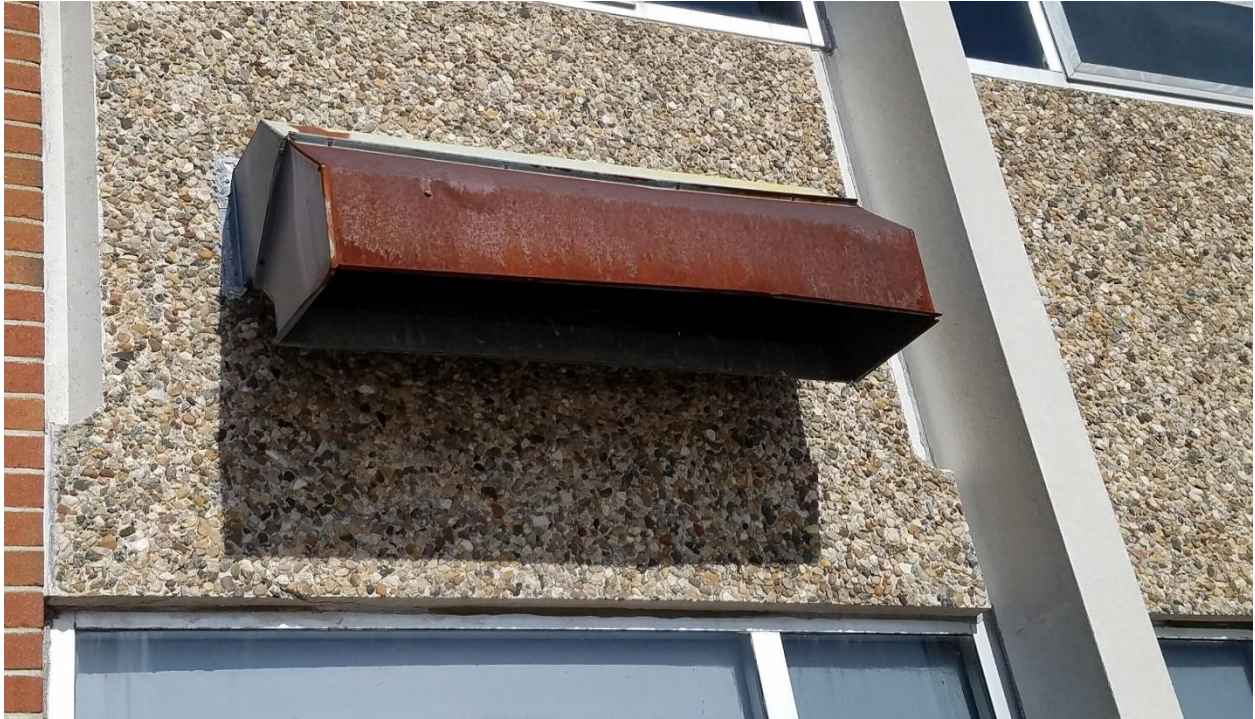
Typical rusted condition of second floor UV louver hood needing replacement

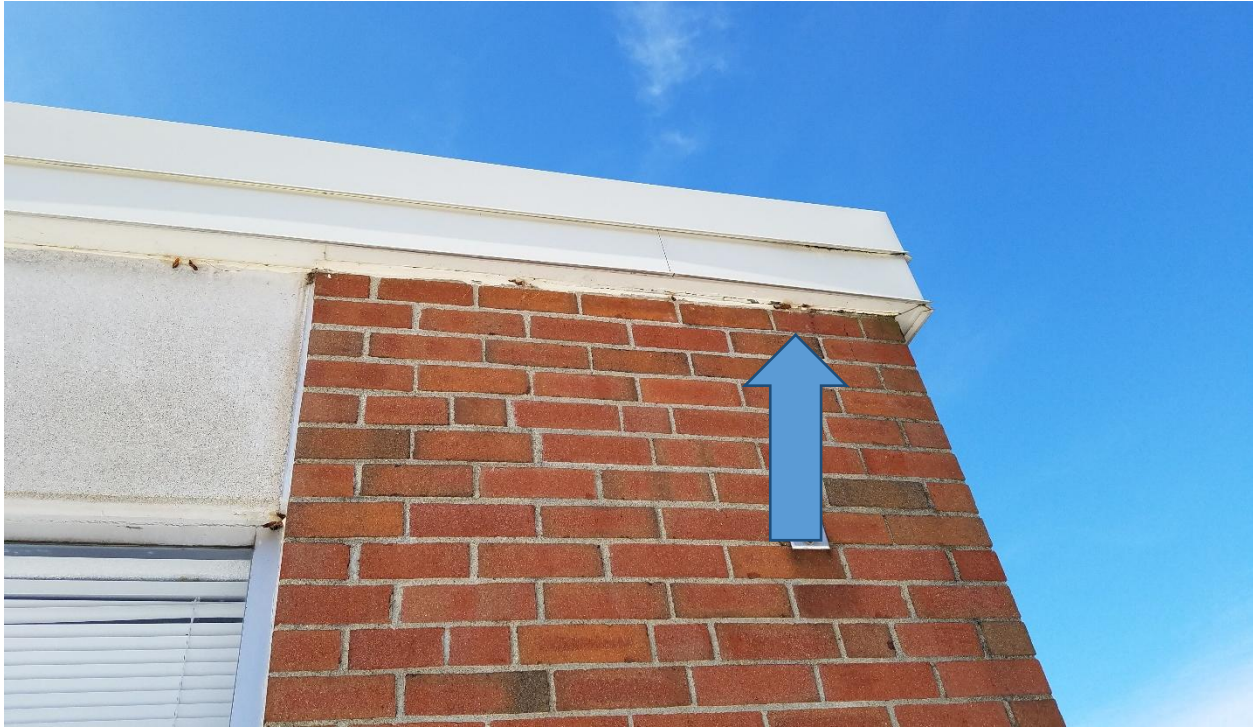
Typical horizontal joint needing to be resealed

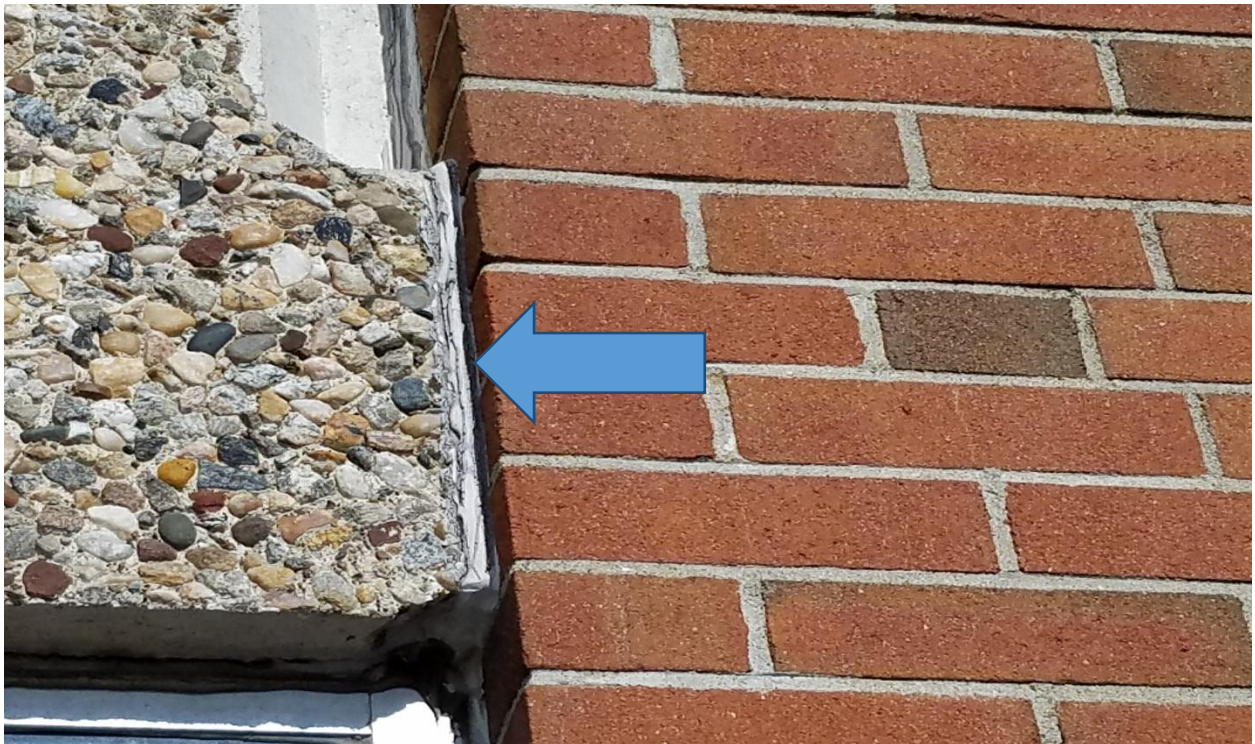
Typical joint between precast and brick needing to be re-sealed

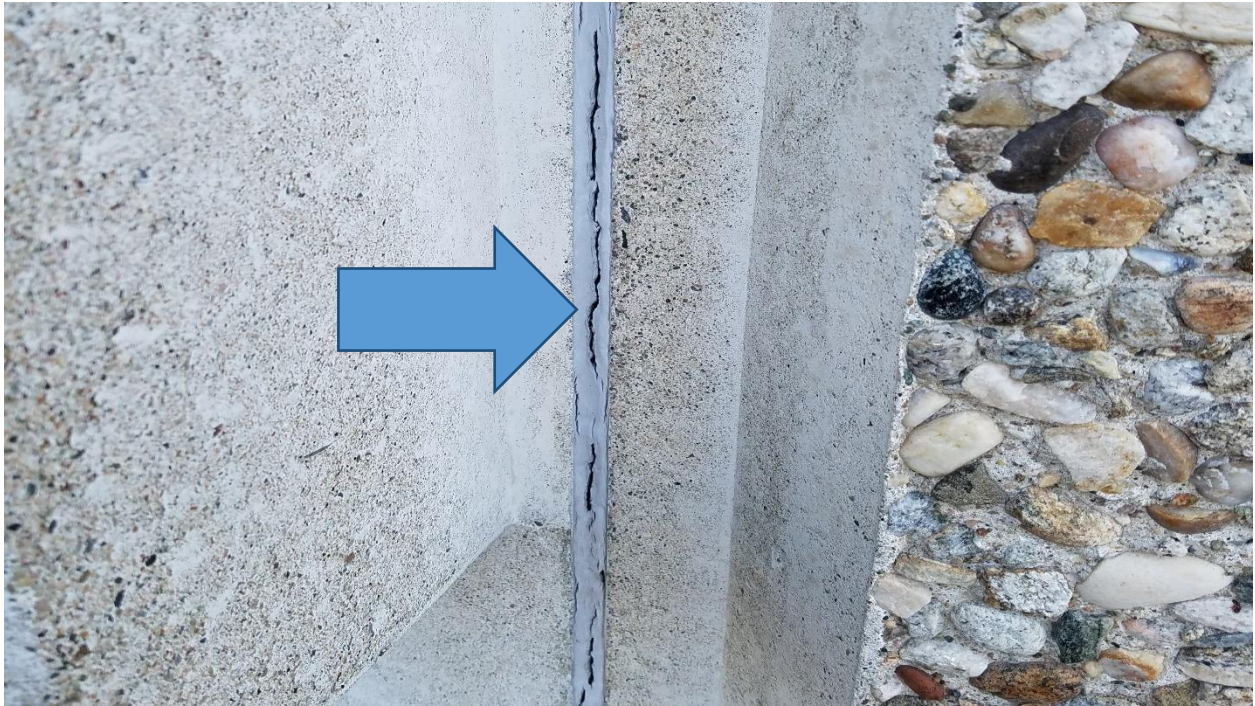
Typical joint between precast members needing to be resealed

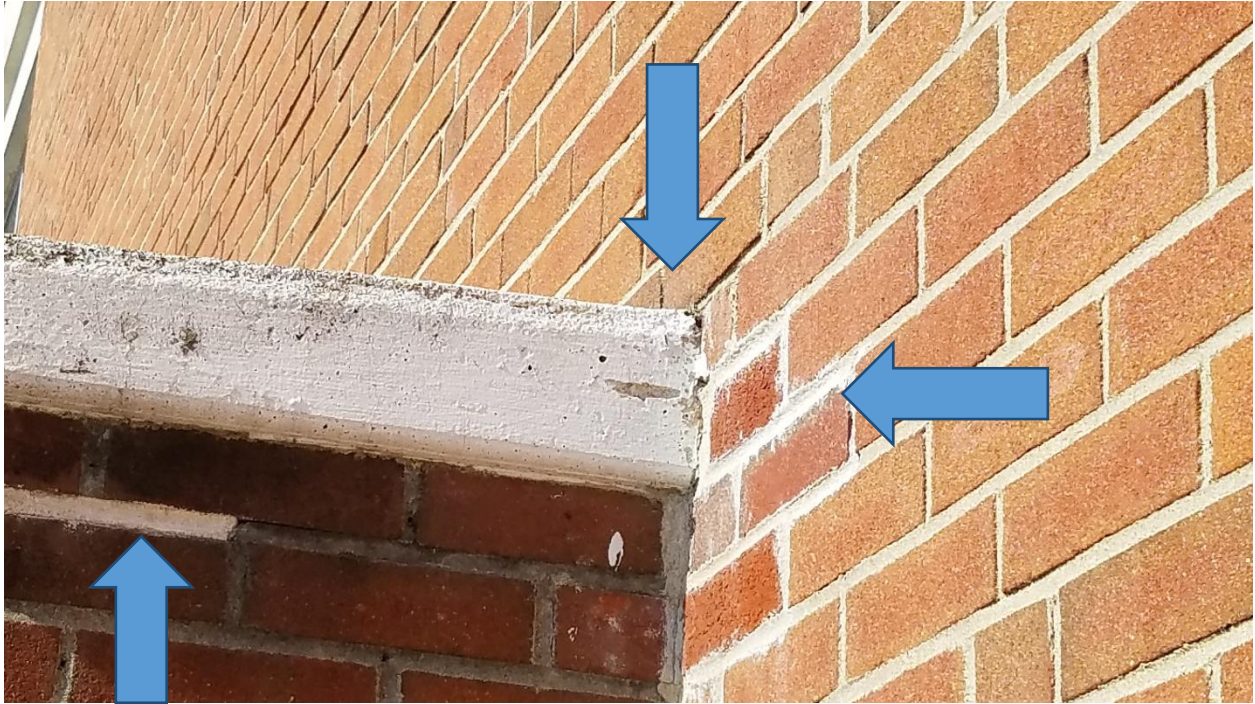
Sloped concrete entry cap with no protective membrane and no flashing to vertical brick surface – also signs of brick deterioration and previous repairs

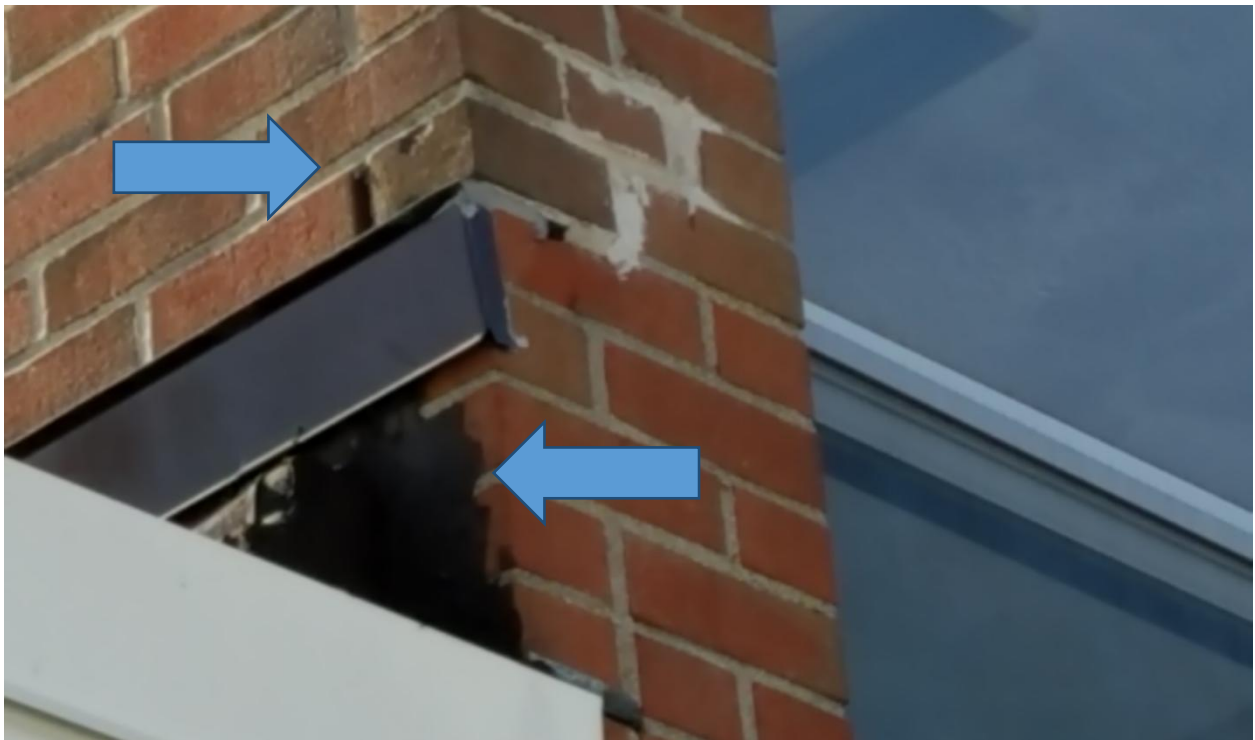
Poor roof flashing transition and open brick joints needing repair (north elevation)

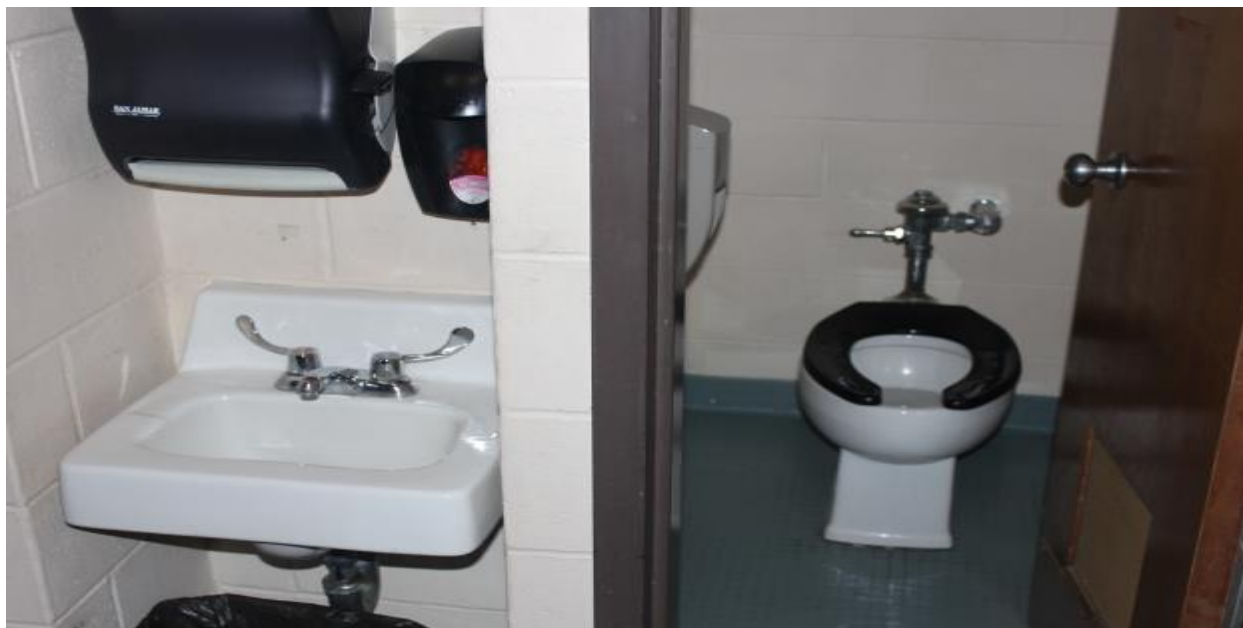
Current undersized bathrooms at classrooms. Non ADA compliant and operationally extremely small.

Perform a full ADA compliance evaluation in conjunction with a full use and needs assessment to determine future course of action with this building. \$20,000

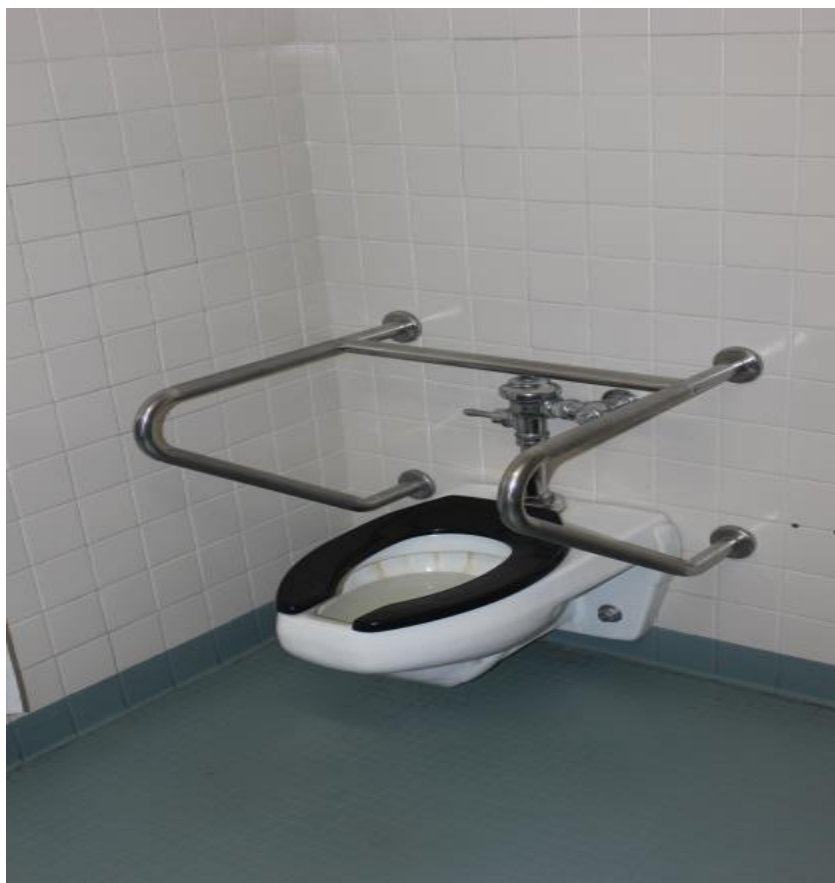
Gang bathroom retrofit for ADA compliance. Removed an adjoining toilet and installed handrail bars

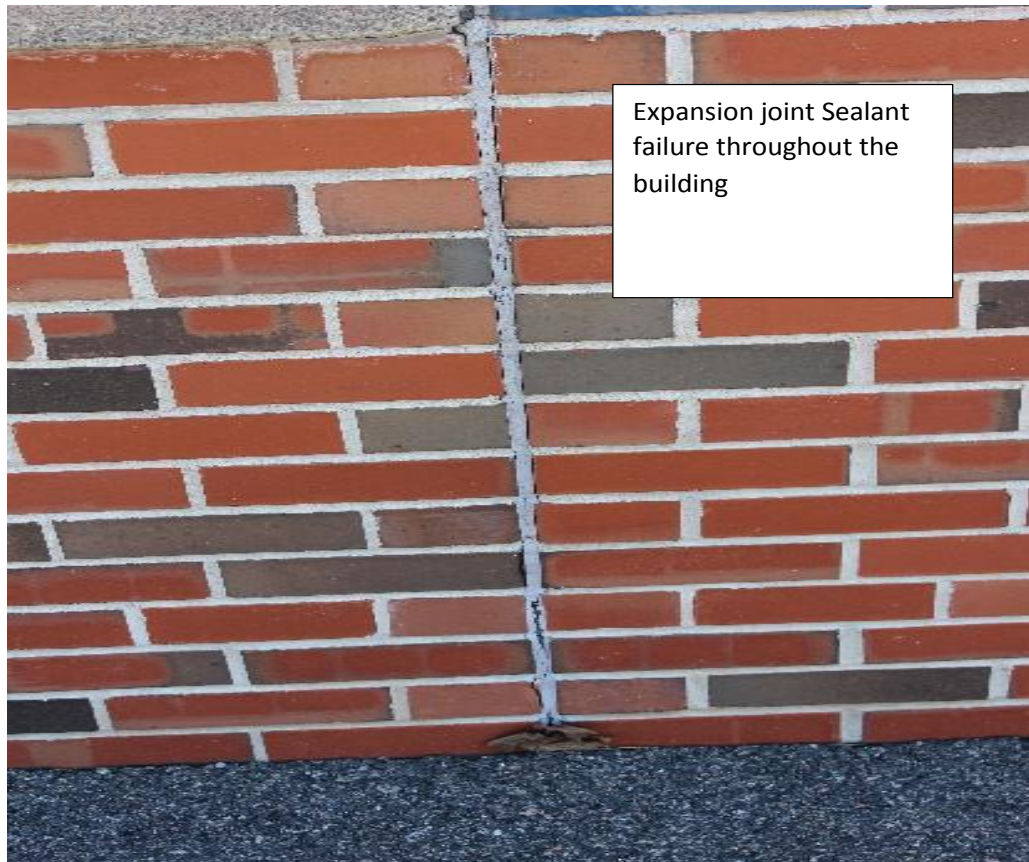
Expansion joint Sealant failure throughout the building

Weatherization, sealing, and caulking of the entire structure required to prevent air infiltration as an energy savings measure, and stop rusting conditions.

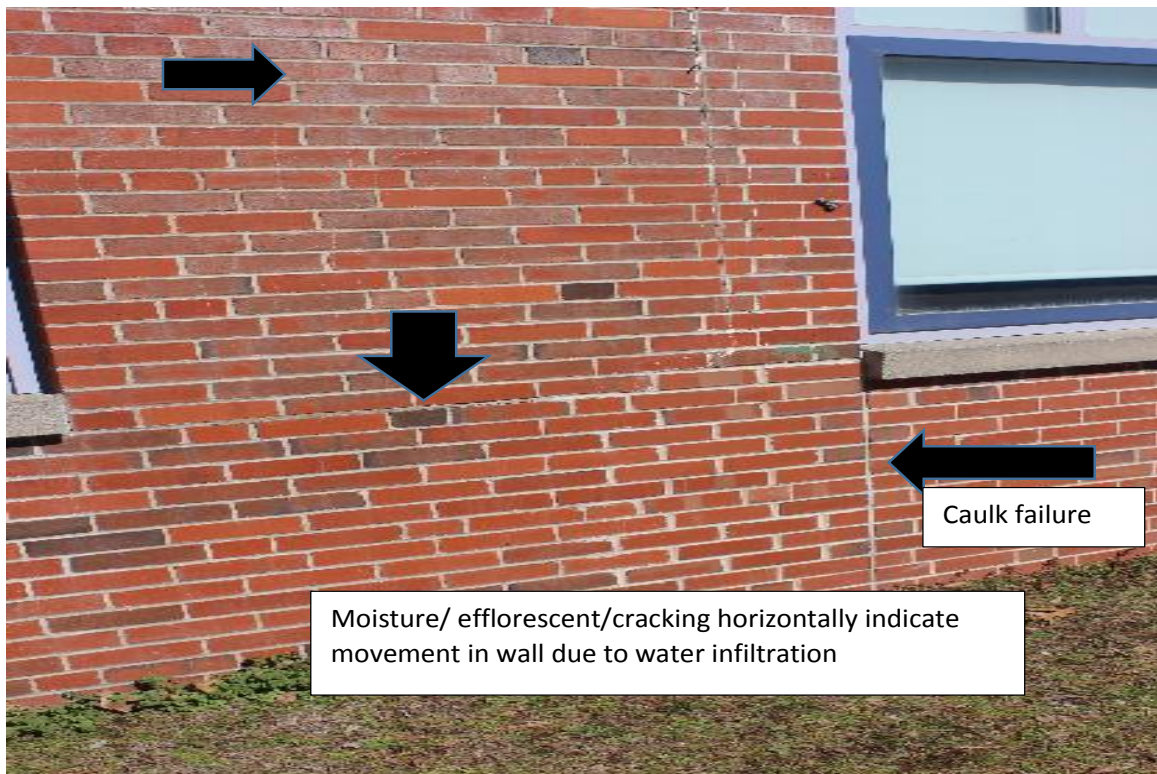
Caulk failure

Moisture/ efflorescent/cracking horizontally indicate movement in wall due to water infiltration

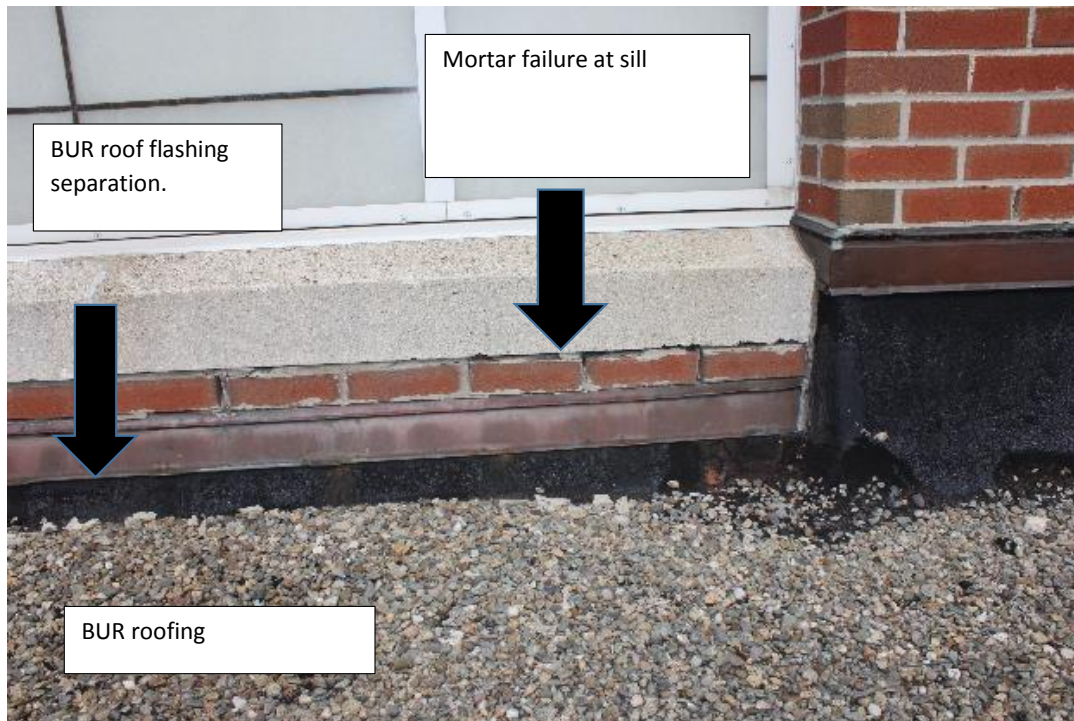
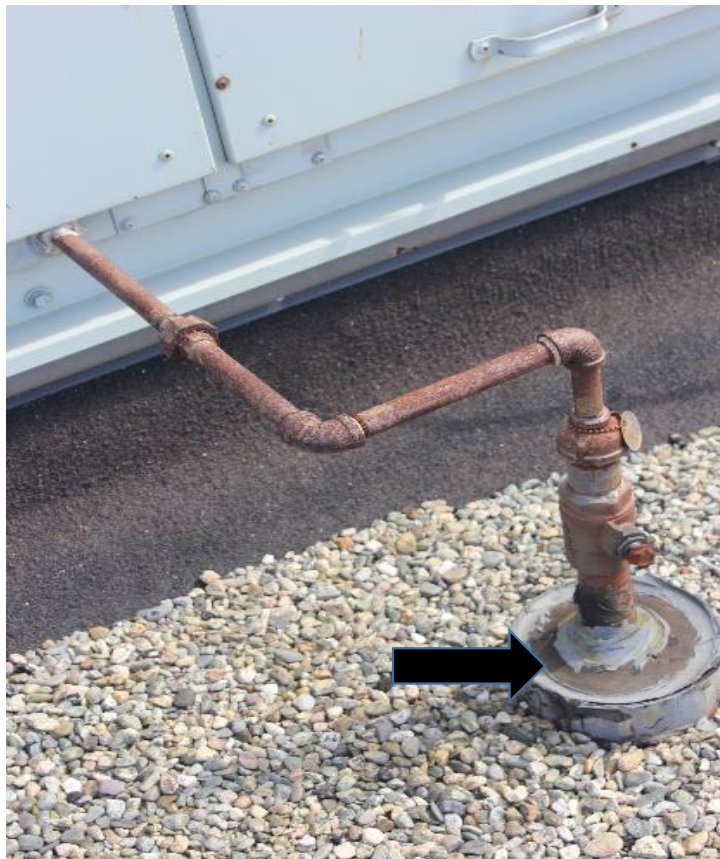
BUR flashing at HVAC and poor pitch pocket

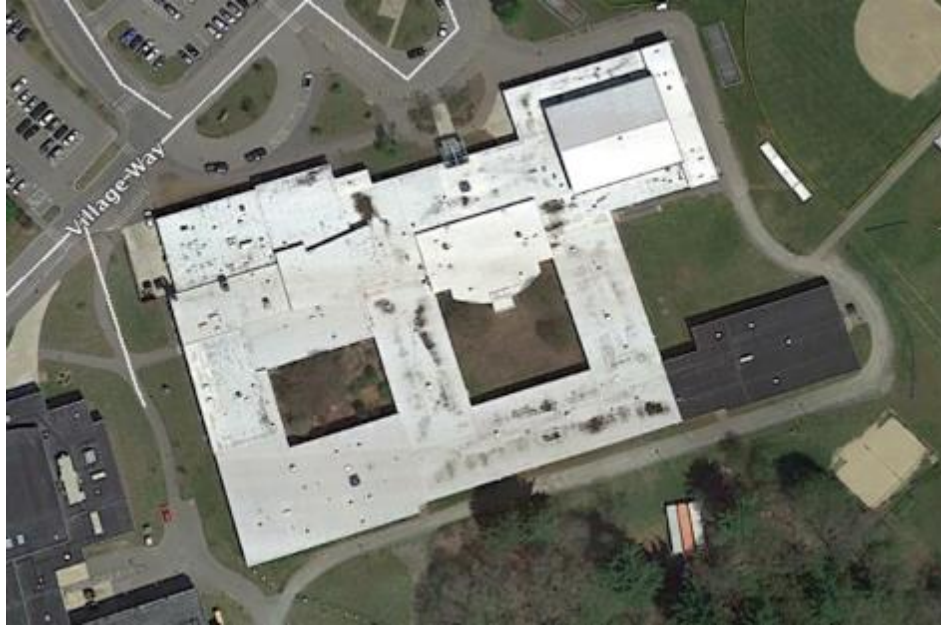
Photo 1

Aerial view of the Blake Middle School.

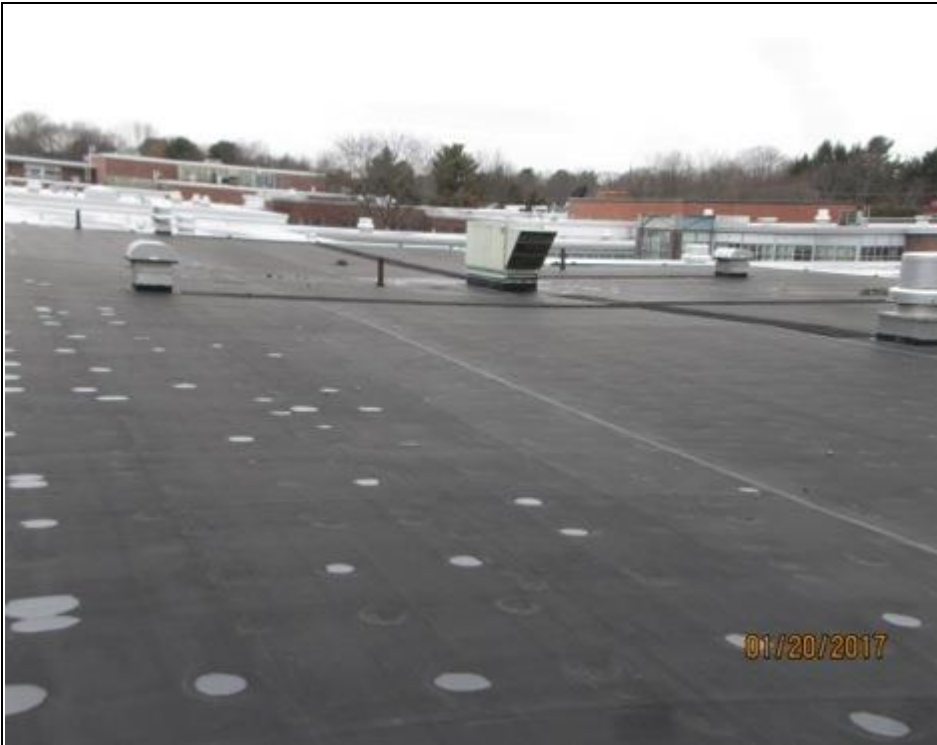
Photo 3

EPDM roof area.

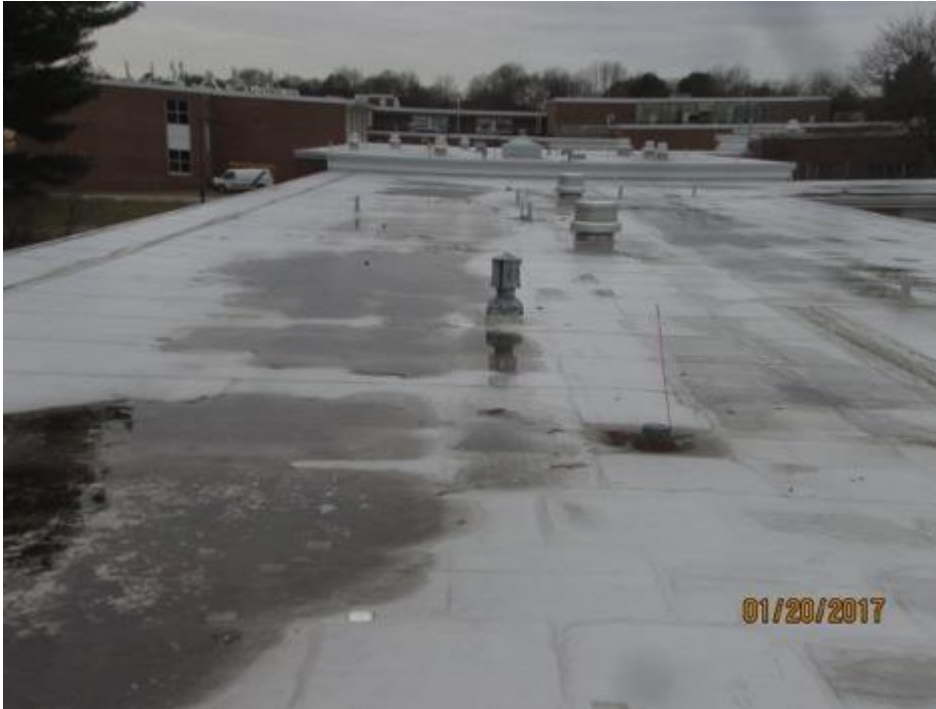
Photo 5

The condition of the PVC roofs is poor to failed. Despite the use of tapered insulation and extended drain sumps, ponded water is evident on most areas except the sloped gymnasium roof. The PVC membrane is brittle and is cracked at many areas including joints in perimeter edge metal assemblies, at corners of curbs and at ridges at insulation joints. Underlying wet rigid board roof insulation is expected to exist in many locations. There are numerous repairs evident. There is debris that is clogging roof drain strainers and collecting in corners.

PVC roof with tapered insulation still ponds water.

- Remove and replace all PVC roofing and underlying insulation. Tapered insulation will be required at most areas.
- Remove and replace all roof drains. Snake all roof drain lines.

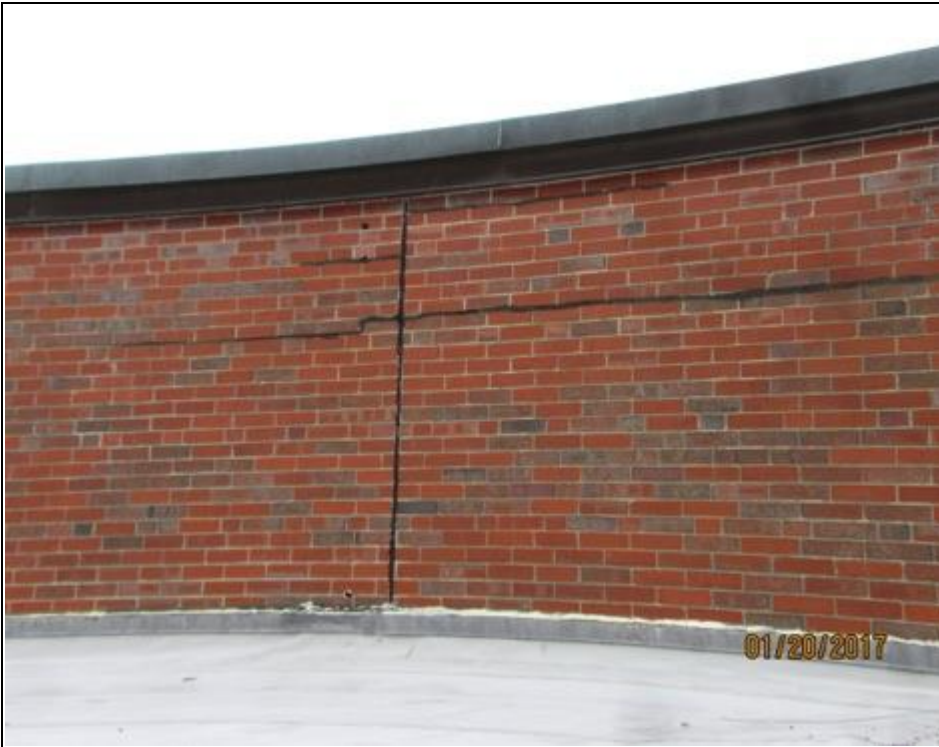
Photo 7

There are current leaks. Leaks are reported to occur adjacent to the original Auditorium. The south Auditorium brick masonry wall is extensively cracked and has failed sealant and mortar joints. The roof below this wall is tied to the wall using a reglet counterflashing detail that cannot intercept any moisture traveling within the masonry wall (not a throughwall flashing). Sealant applied to the reglet flashing is failed. This wall should be covered 100% with a watertight covering (sheet metal cladding or roof membrane) tied into the roof below. Leaks are also reported to occur along the west Auditorium wall and we believe the sources of these leaks are the low wall flashing heights and deteriorated smoke release vents located within the brick masonry wall. The south gutter serving the sloped gymnasium roof is leaking in several locations and we believe the cause of these leaks is failed seams.

South wall of the Auditorium is deteriorated allowing water to bypass the reglet counterflashing below.

- Application of sealants to defective mortar joints in the south auditorium wall.
- Replacement of failed sealants related to reglet counterflashing.
- Application of sealant to splits in PVC flashing at roof edges and at curbs.
- Welding of PVC patches at splits in the gymnasium gutter.
- Reconfigure and re-flash the gas pipe penetration at the EPDM roof.

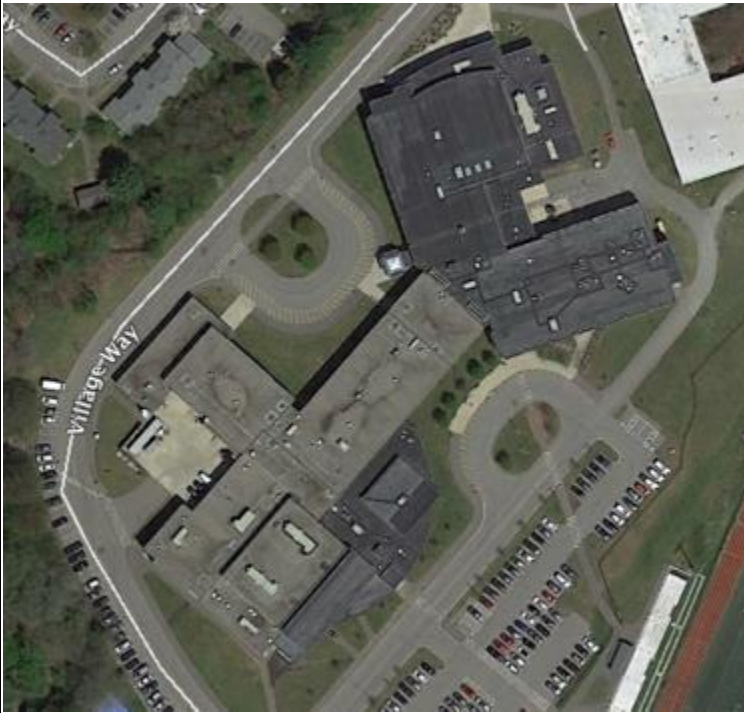
Photo 9

Aerial view.

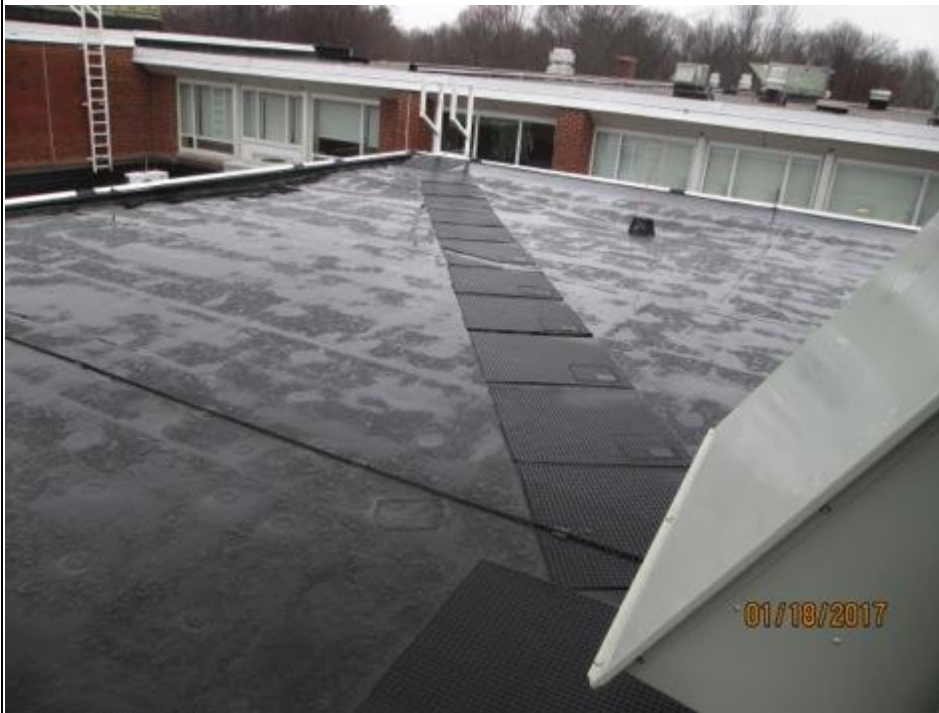
Photo 11

General view of a typical EPDM roof.

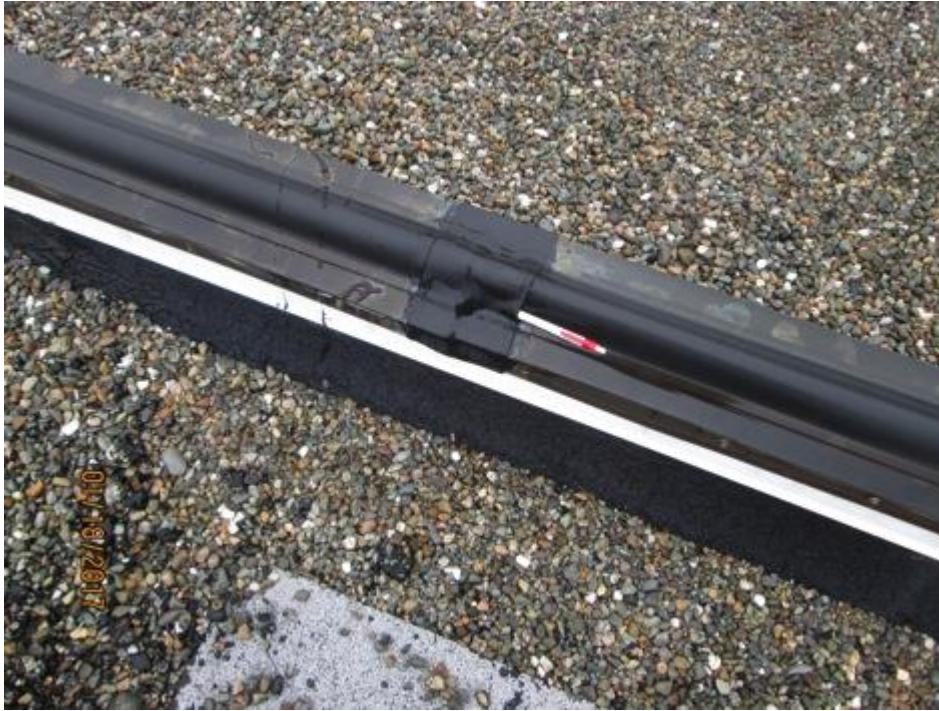
Photo 13

Seams in the expansion joints are failing.

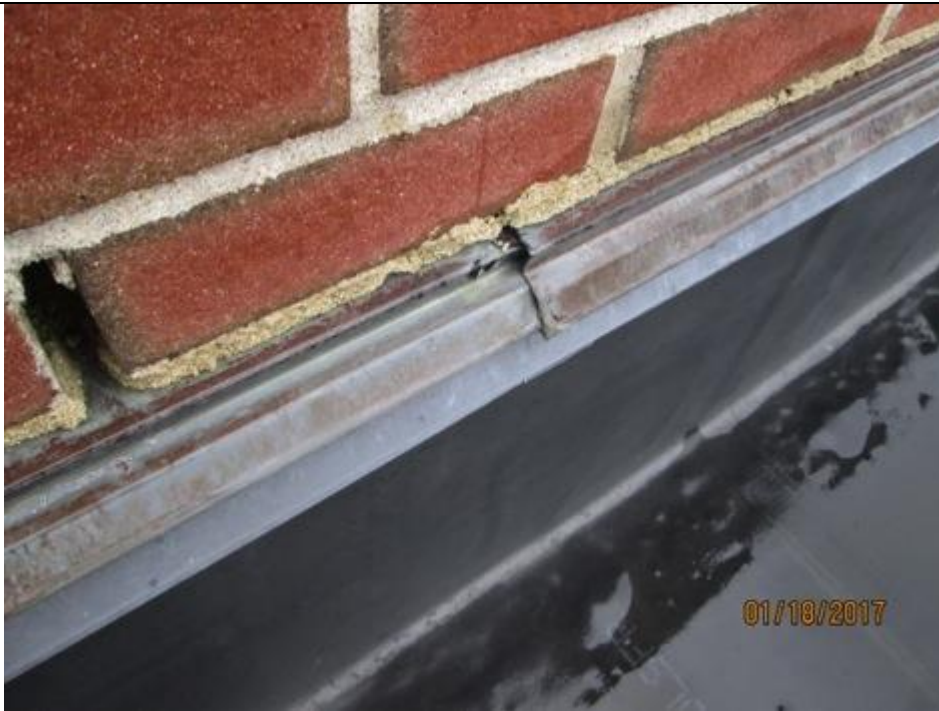
Photo 15

Throughwall flashing in the curved wall above the auditorium do not appear to be sealed.
