TOWN OF MEDFIELD

Municipal Facilities

Evaluation and Capital Plan

October 6, 2017

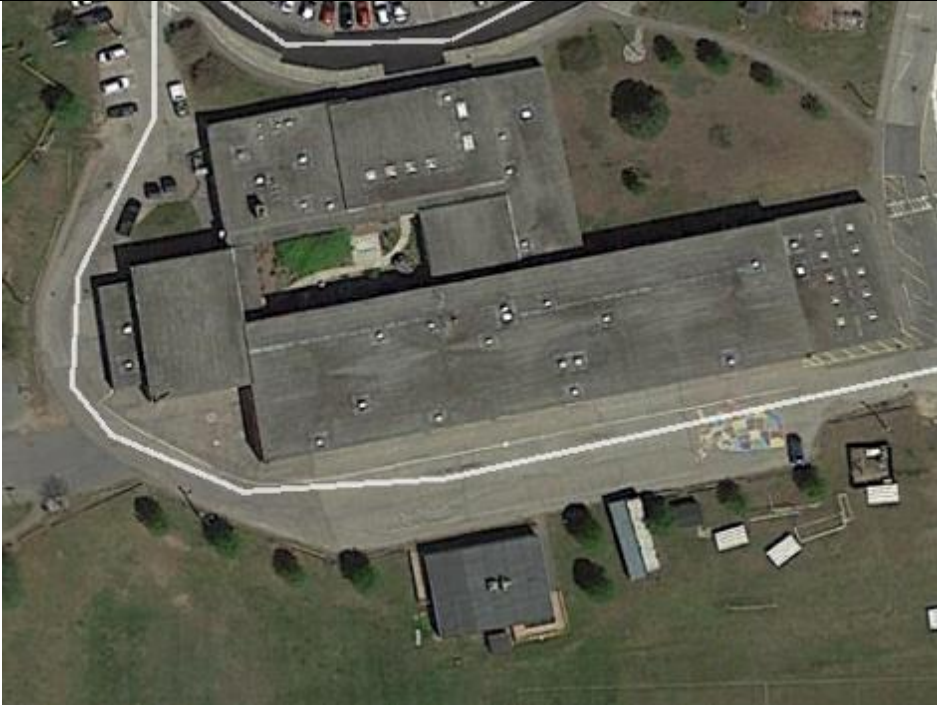
Photo 17

Aerial view.

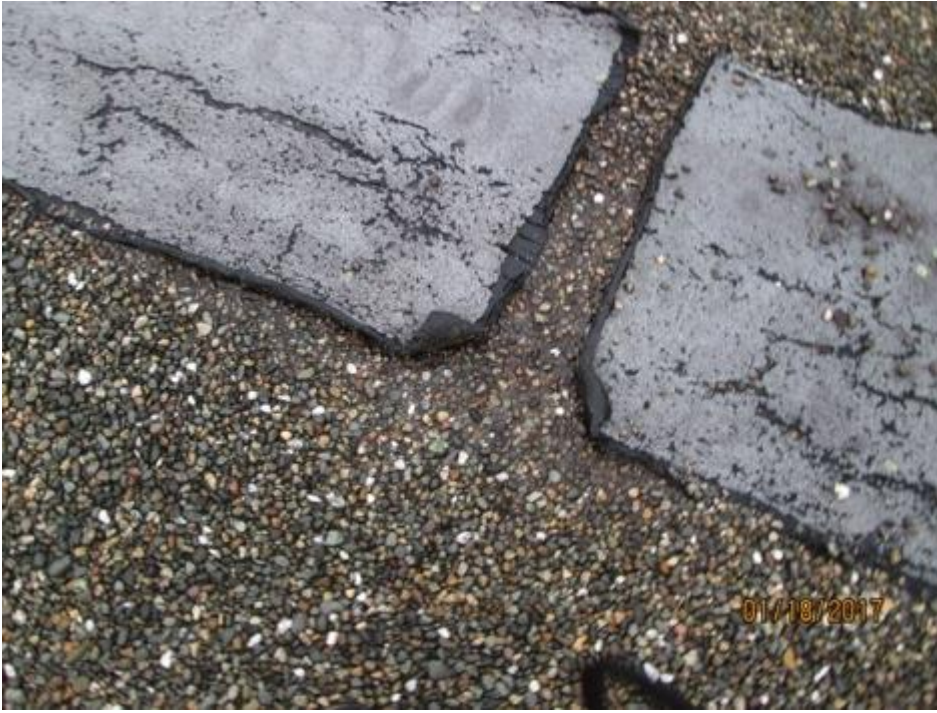
Photo 19

Curling walkway pads.

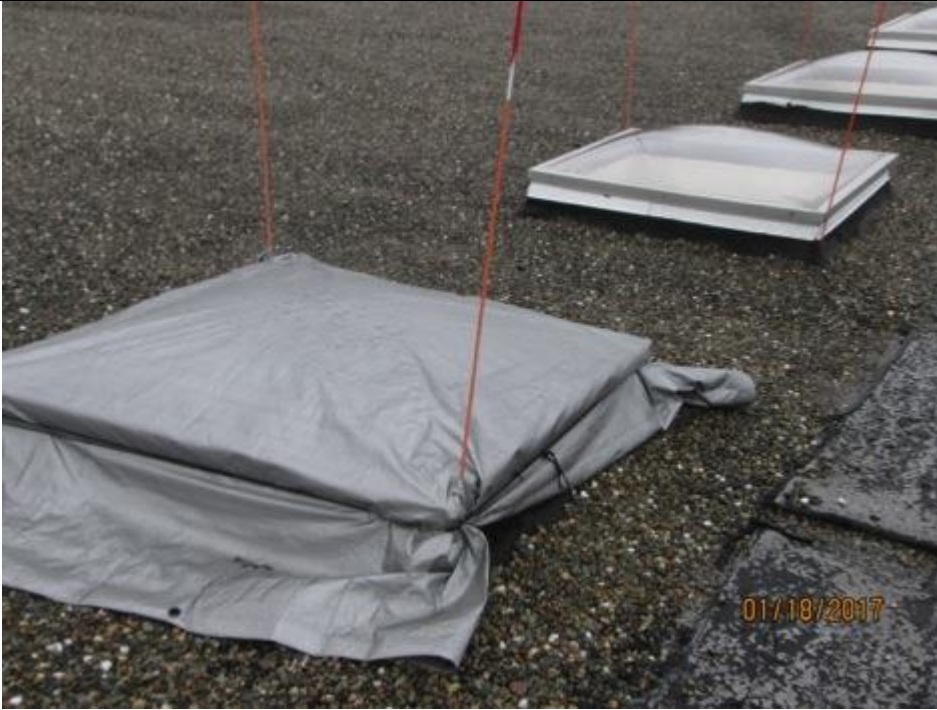
Photo 23

Damaged/
deteriorated
skylight domes.

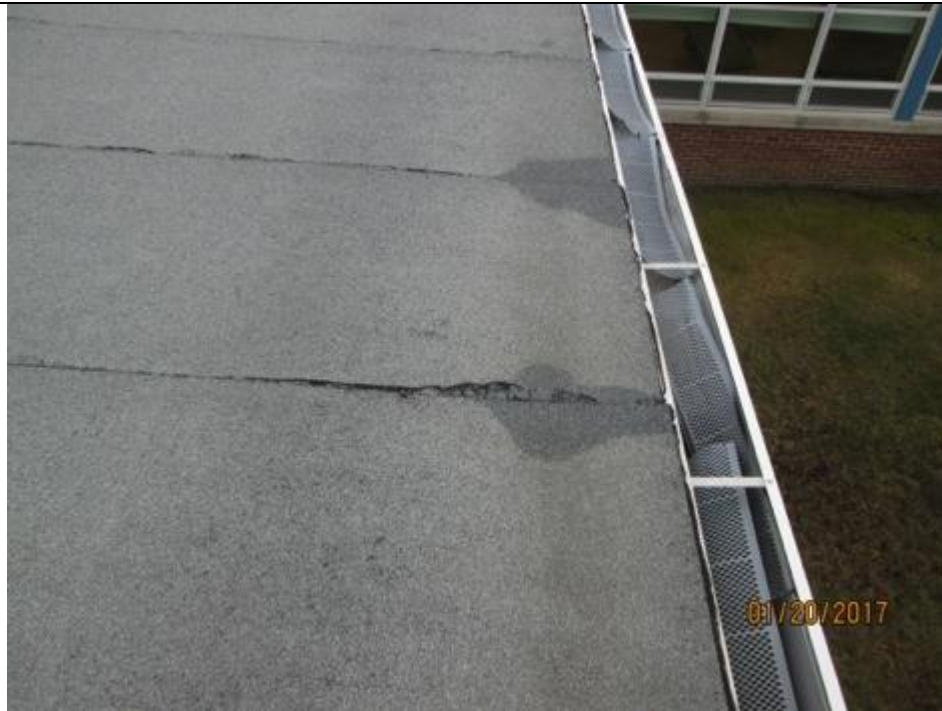
Photo 29

Poorly pitched roof edges allow ponded water and possible leaks.

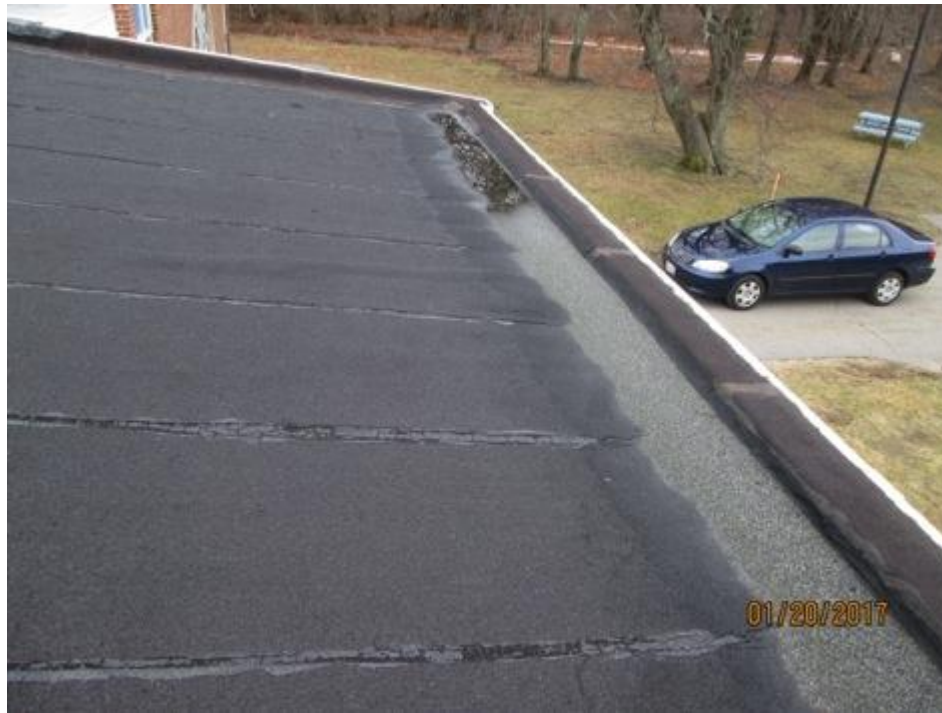
Photo 30

Poorly pitched roof edges at the older Mod Bit roofs allows ponded water and possible leaks.

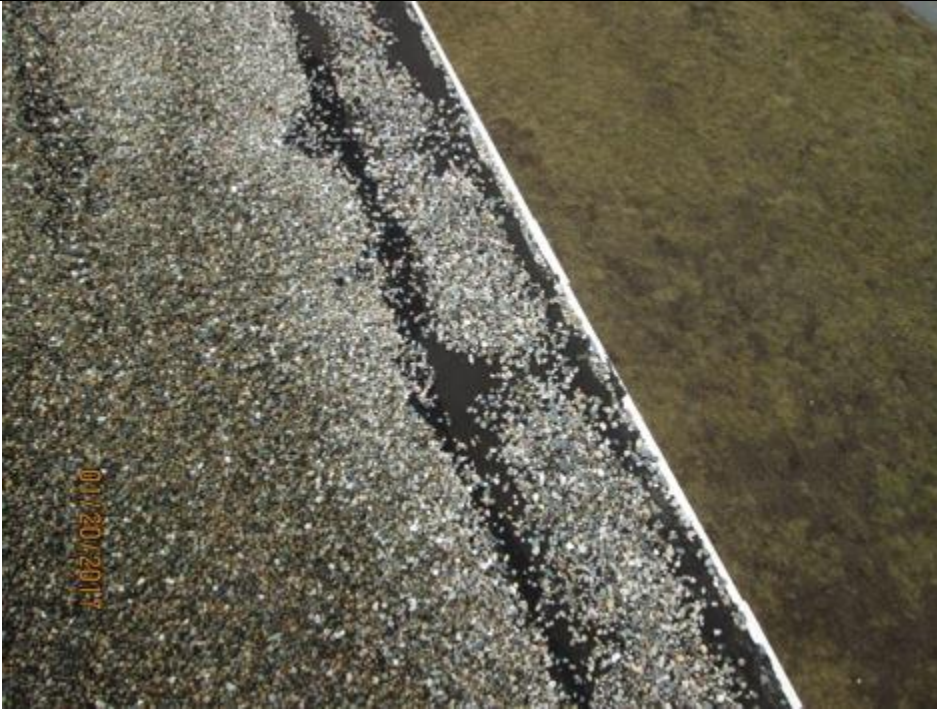
Photo 31

BUR flashing
edges are worn.

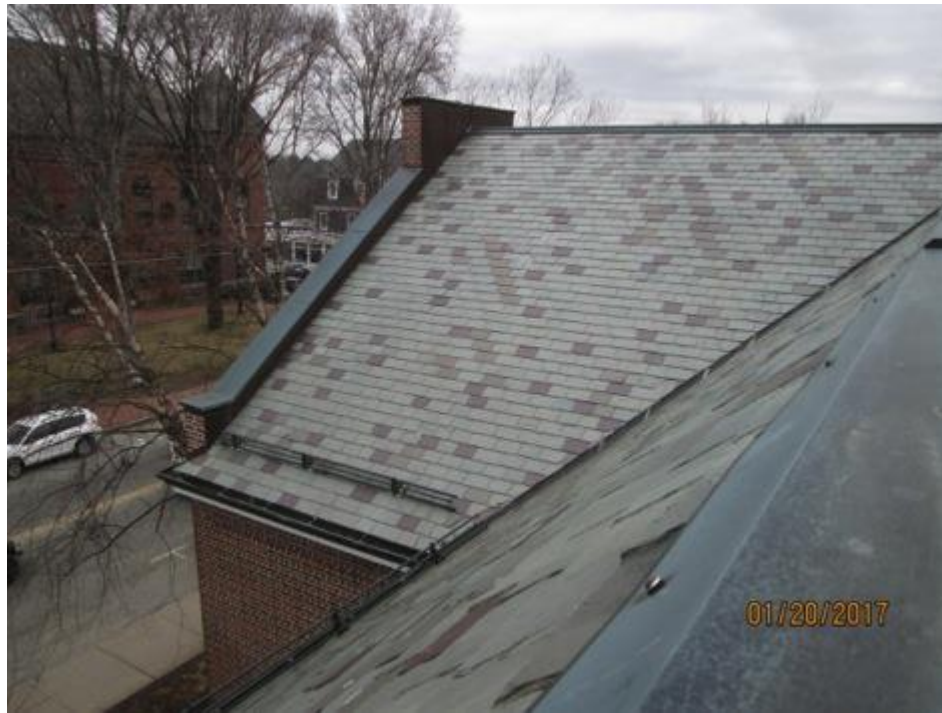
Photo 34

Typical view of a
slate roof surface.
Note the broken
slate.

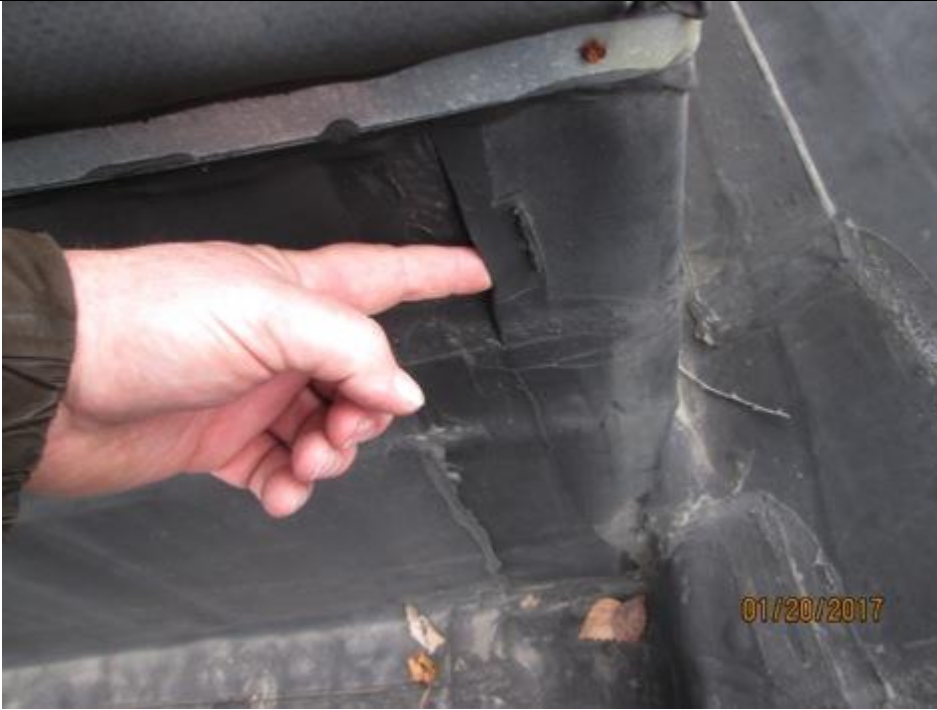
Photo 37

Failing EPDM
seam.

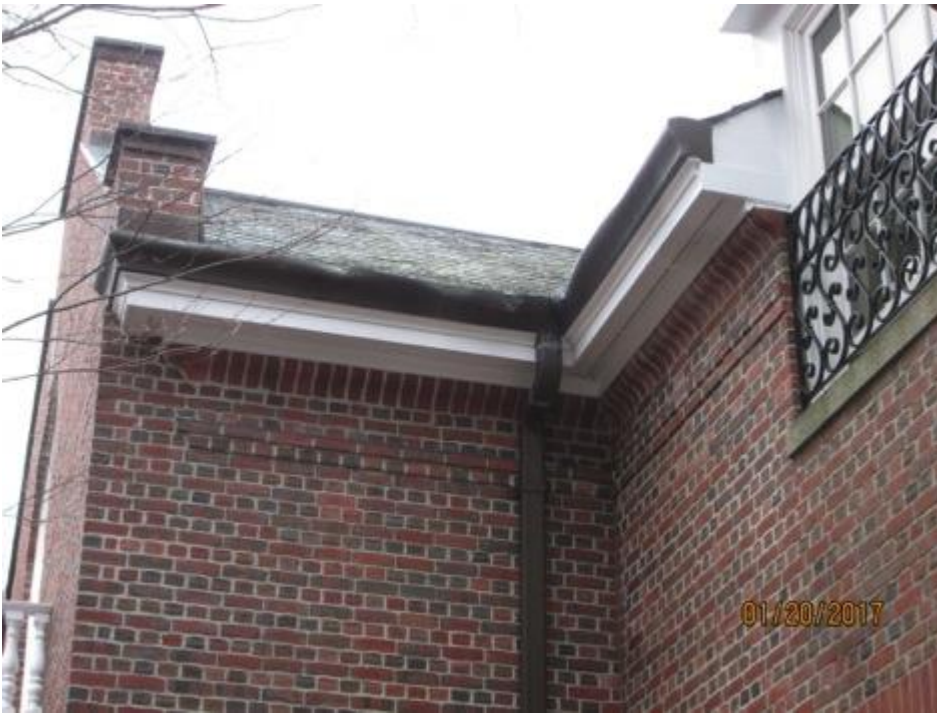
Photo 38

Damaged gutter.

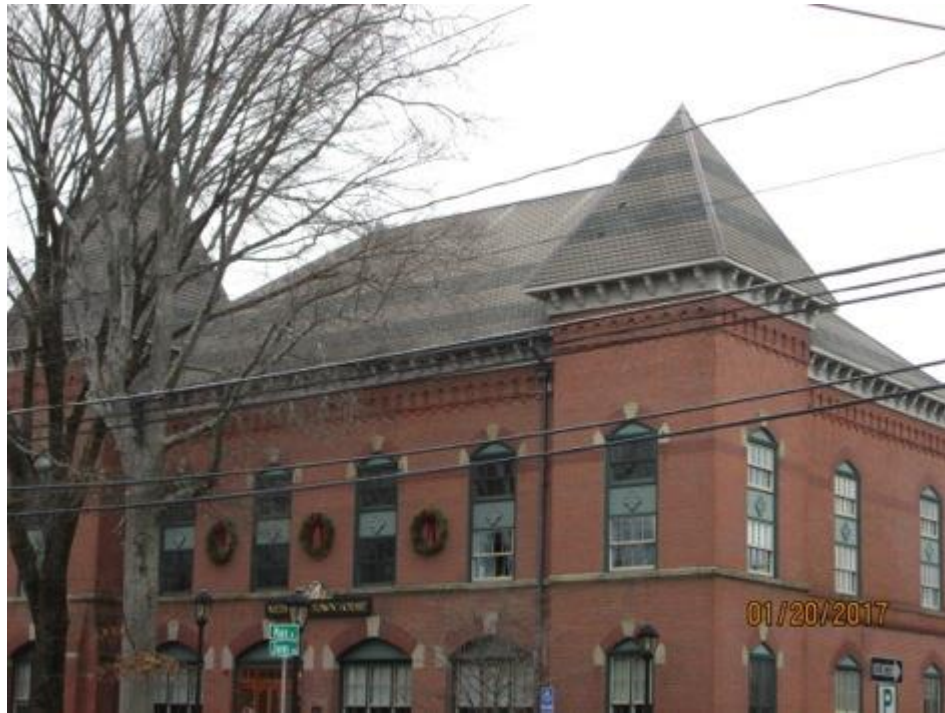
Photo 40

Typical view –
dark spots on roof
are missing
shingle tabs.

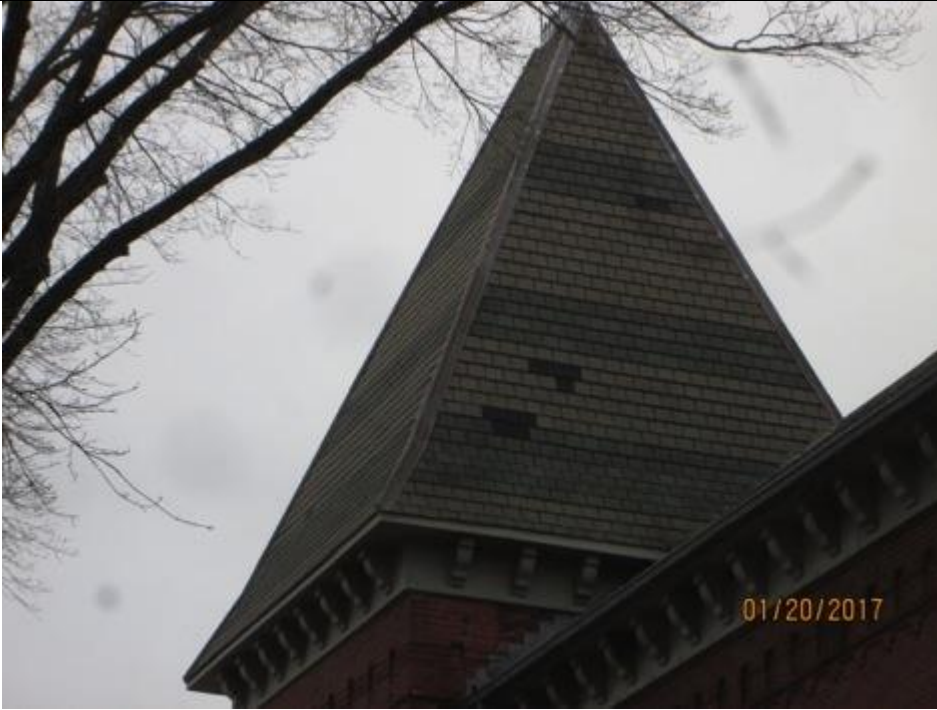
Photo 41

Typical view – dark spots on roof are missing shingle tabs.

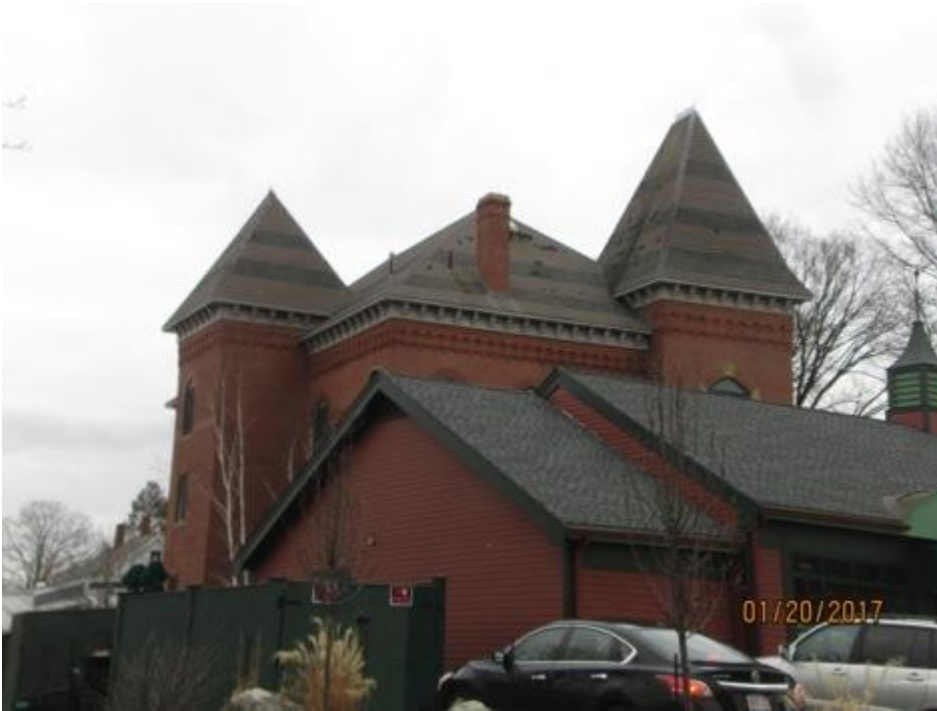
Photo 42

Typical view – dark spots on roof are missing shingle tabs.

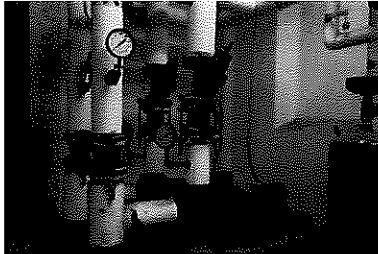
The two-way valves that control heated water flow to heating zones are starting to show signs of increased failure rate.

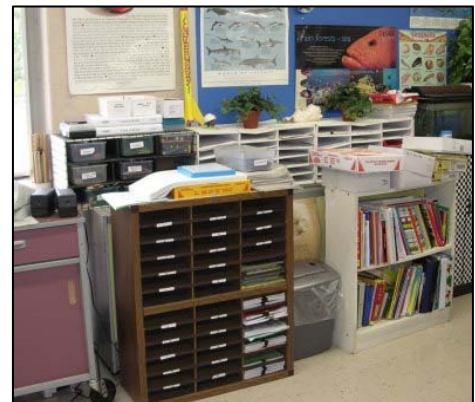
Heating and ventilation is provided to the space by unit ventilators. Supply air leaves the top of the cabinet, and return air enters through front of the cabinet near the floor. The unit ventilators will run more efficiently and more effectively if the air flow is unrestricted. During the site visit, multiple unit ventilators were observed with blocked airflow, including one classroom that has a child with allergies. A sample classroom is shown on the right, with the unit ventilator located behind and under bookshelves and storage units. Teachers should be educated on the importance of maintaining unrestricted air flow from the unit ventilators. The principal has reportedly sent an email encouraging teachers to remove papers from unit ventilators, but further action appears to be necessary. Energy consumption and cost savings from this recommendation are difficult to quantify, so specific values are not included in this report. There is no cost for implementation, so it is recommended regardless of the dollar value of the savings.

► **Action Steps:** *Work with maintenance staff and teachers to remove materials from unit ventilators.*

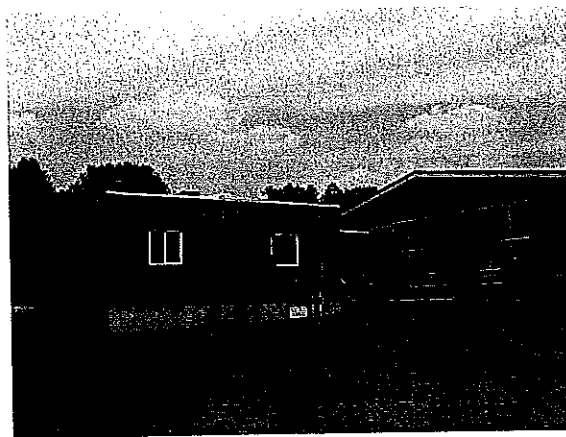
The third portion of this facility is identified as "portable" classrooms. They would be more accurately described as modular. There are two classrooms and two toilets.

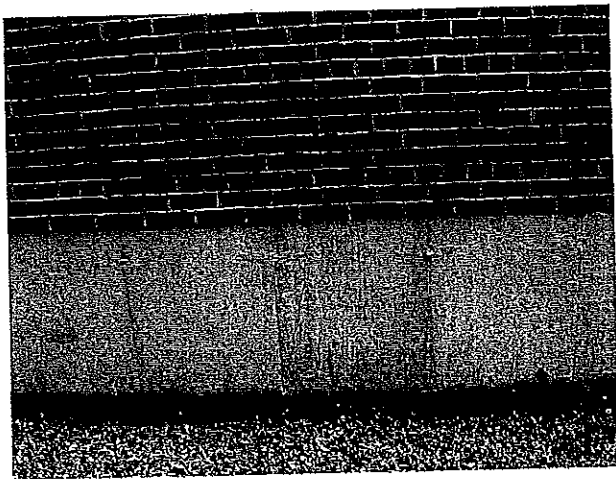
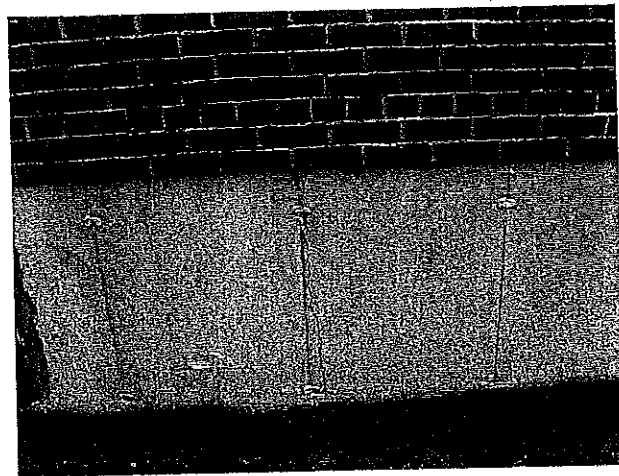
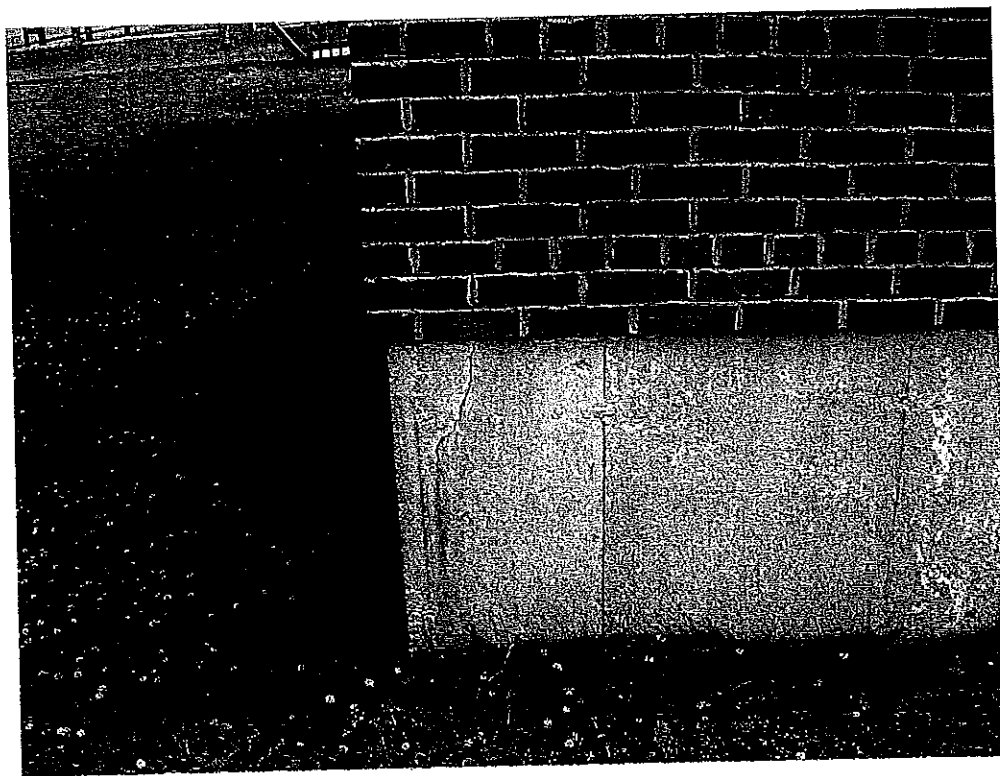
These units sit on cast in place foundation and have a flat roof structure. There are signs of cracking in the foundation.

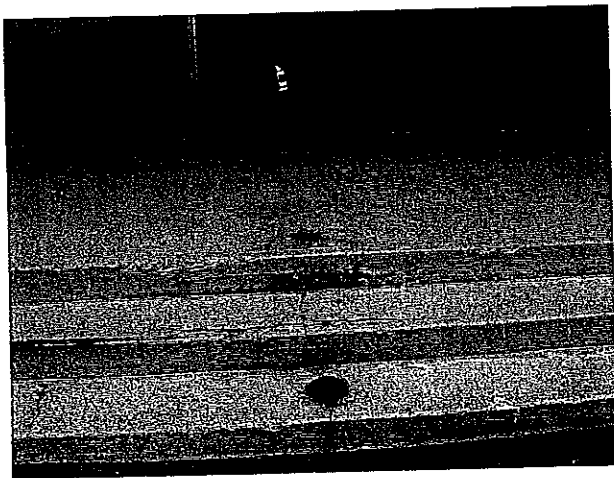
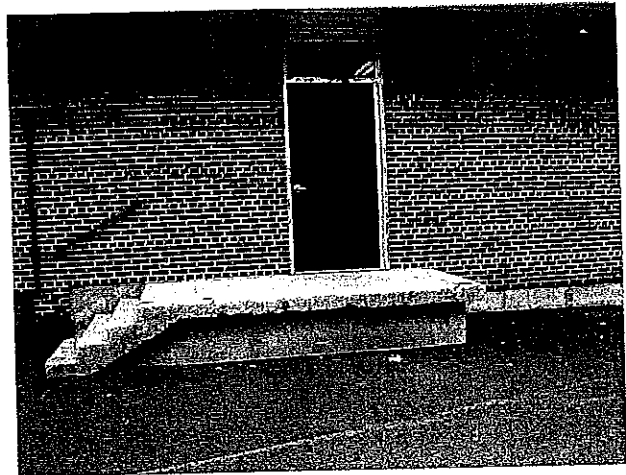
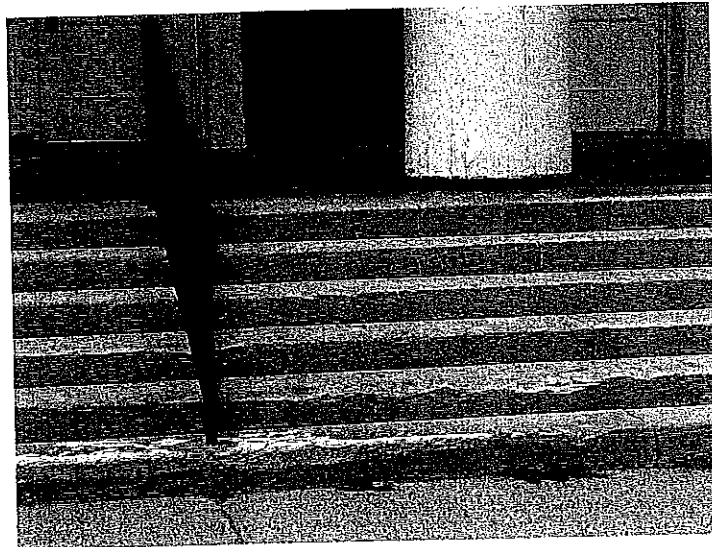
The long steps to the entrance of the 1962 building are cast in place concrete and show extensive cracking. The railing has been removed. A handicapped ramp has been installed with railings.

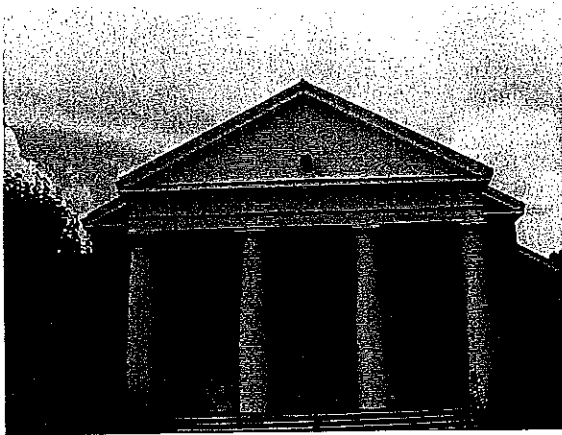
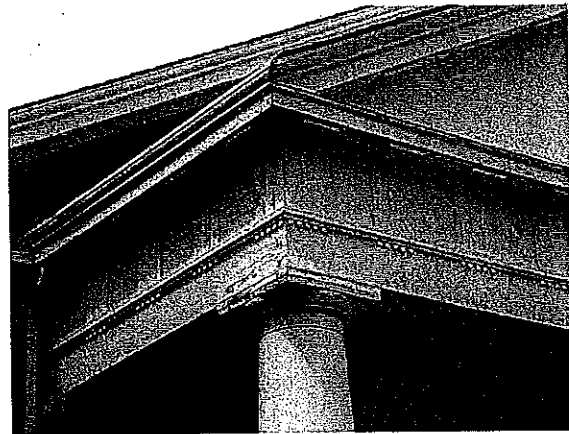
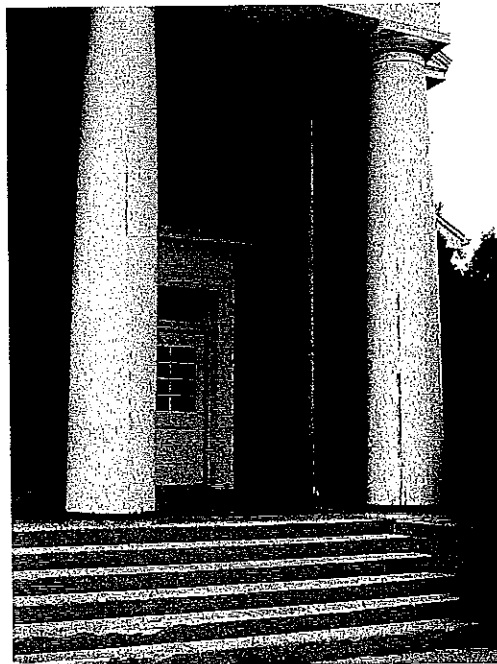
The exterior entrance to the Dale Street gym shows extensive deterioration. This is true of the fascia and soffits as well as the columns. Action is required to prevent further damage. That action is scheduled for this summer and work had started during the course of this report. A detailed inspection should be included as part of that remediation to determine the extent of restoration needed. It may be prudent to replace the original wood columns with fiberglass and reconstruct the fascias, freeze boards and soffits with newer more weather resistant materials.

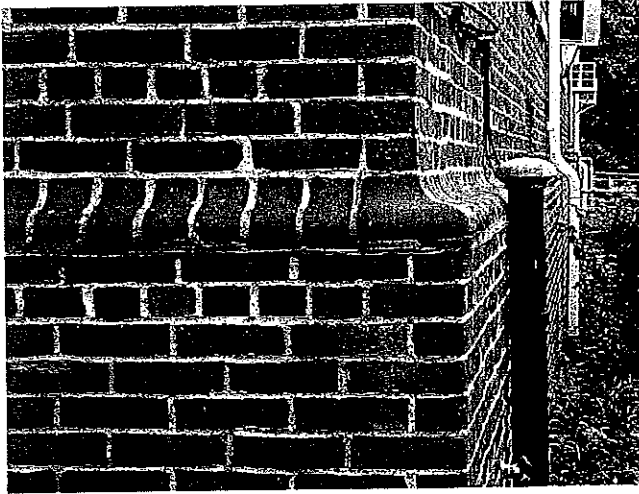
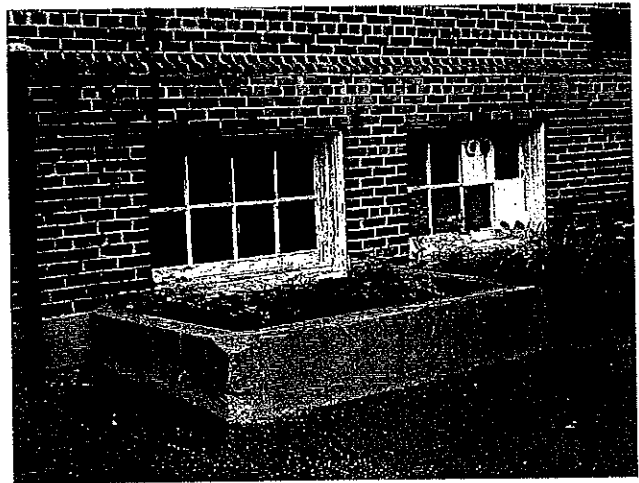
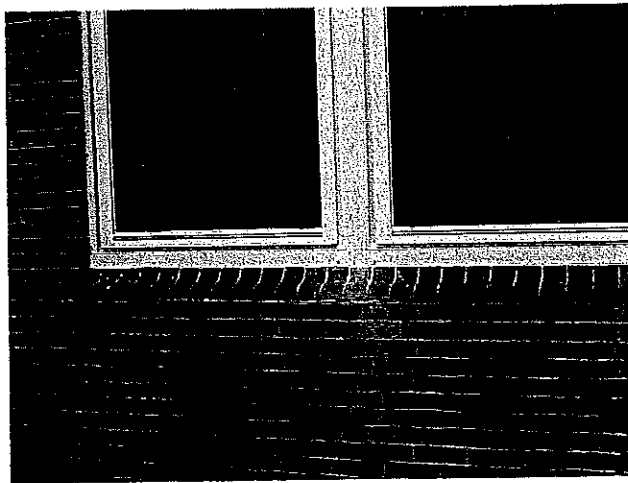
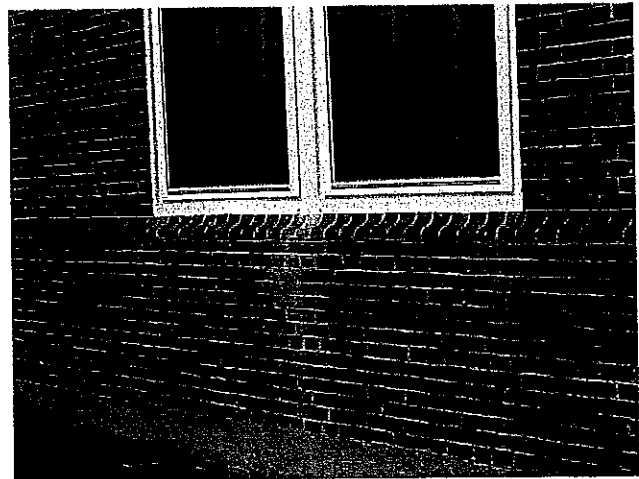
The exterior walls of three sections are brick veneer. The brick on the 1962 and 1996 buildings is in good condition. The brick work on the 1941 building is in good condition for its age however, there are signs of deterioration.

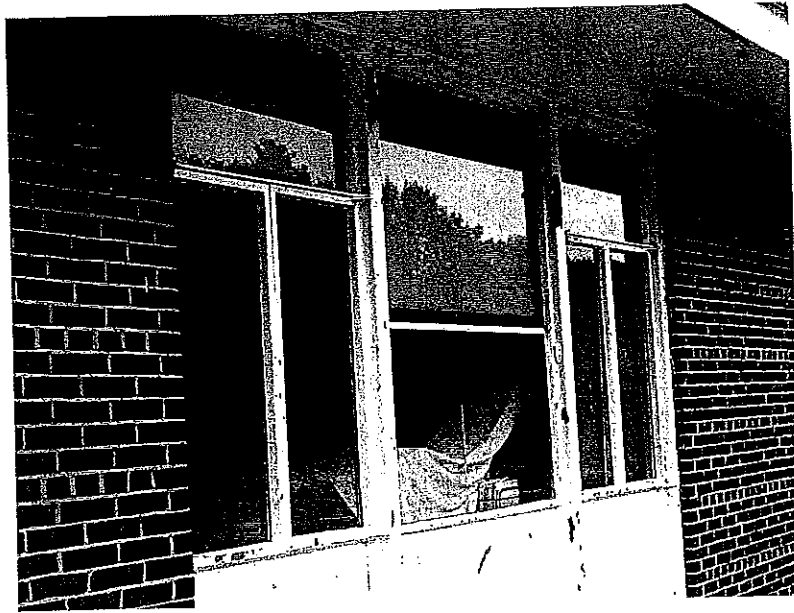
The window wall system in the 1962 building is galvanized hollow metal. As shown in the attached photos, the units are deteriorating and need to be scraped and painted before they are rusted beyond repair. The Library gable end window wall system was replaced three years ago.

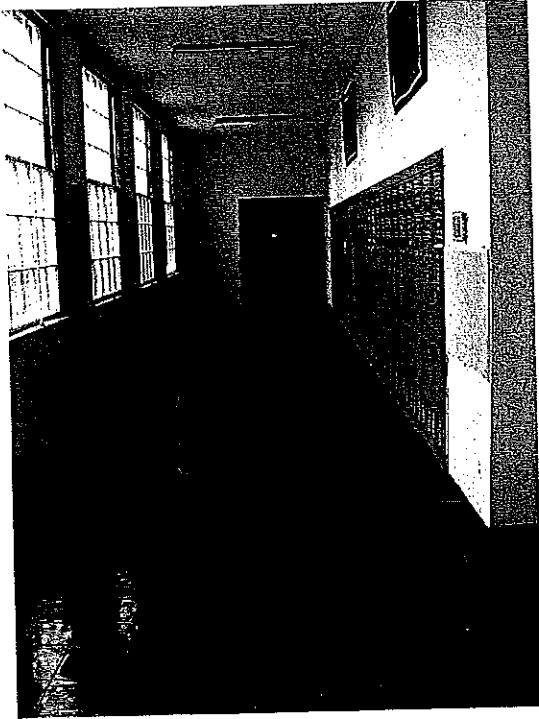
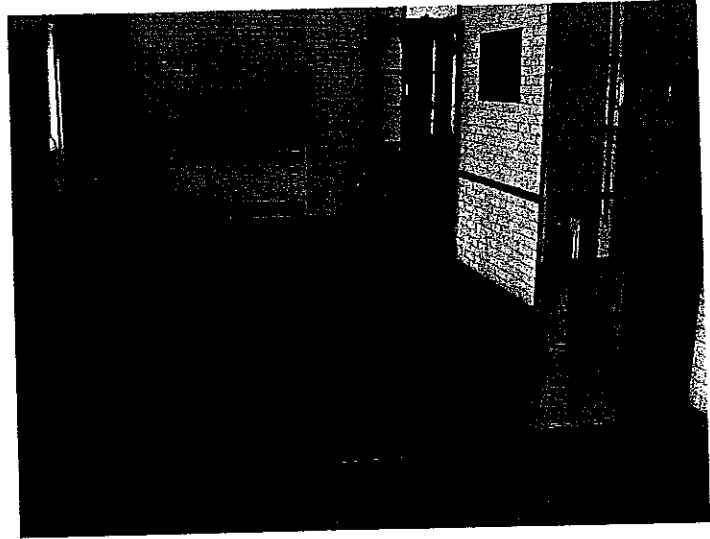
Floor coverings are typically VCT (Vinyl Composition Tile) and VAT (Vinyl Asbestos Tile). It is in good condition in the '62 building and the 96 building. Floor covering in the '41 building is typically VAT and in poor condition. It should be noted however, that none appears to be in a friable condition.

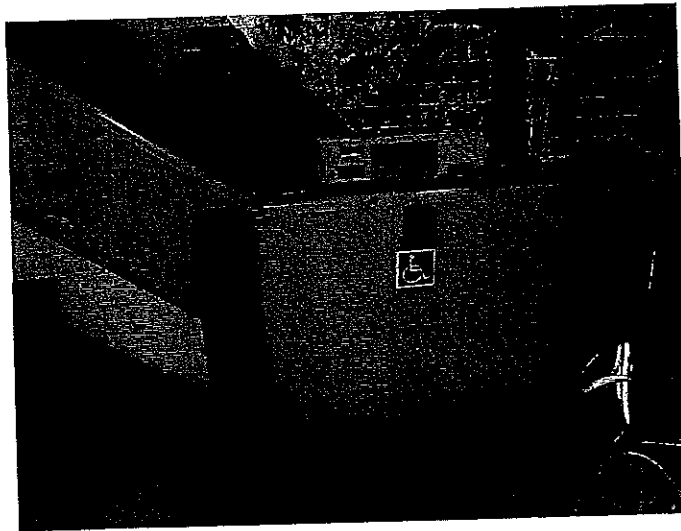
There are two chair lifts in the facility. The first allows travel from the Adam's Street entrance to the first floor of classrooms in the 41 building. There is no handicapped accessibility to the second floor classrooms. The second lift is in the auditorium/gym. It allows access to the gym floor but does not allow access to the stage. There is a pending application to the Architectural Access Board for a variance to install a portable lift to remedy this condition

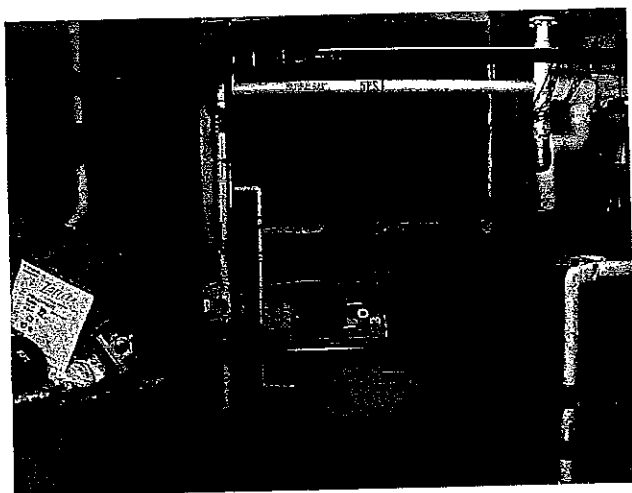
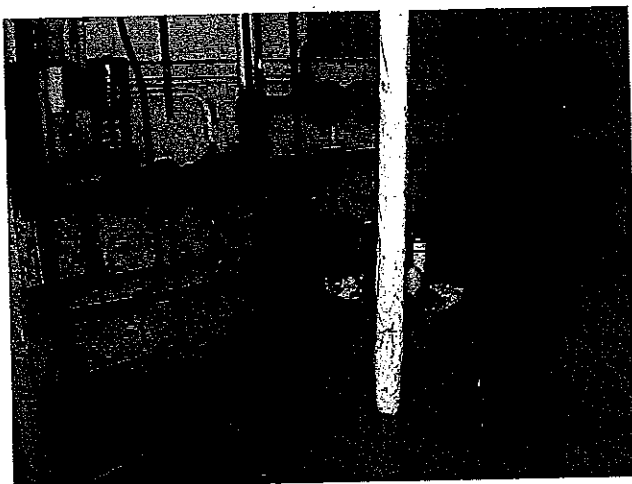
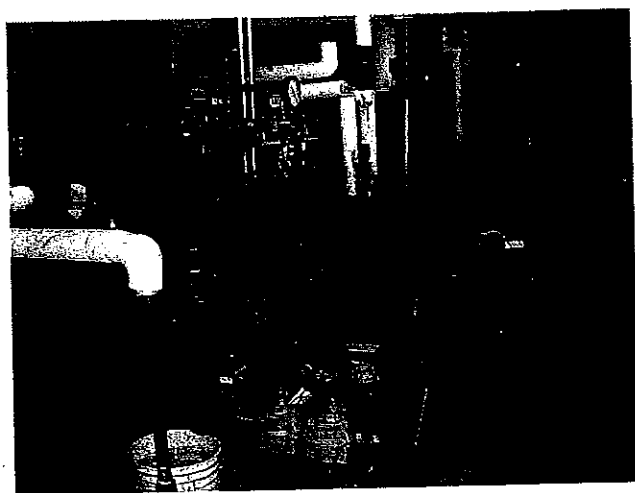
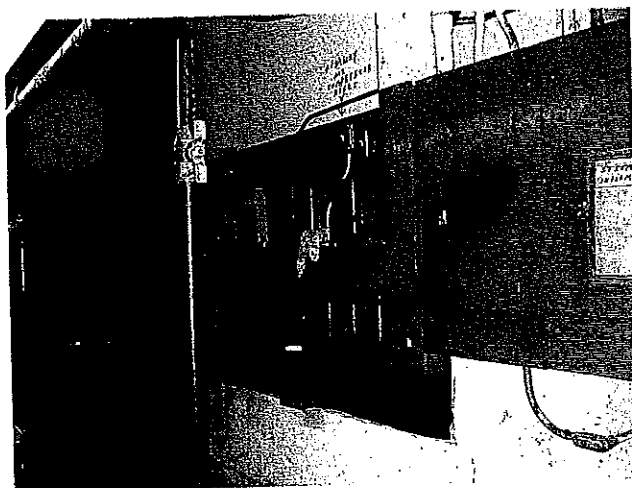
The condition of the unit vents in the 1962 building is in better condition than the equipment in the 1941 building. The 1996 building is stand alone and operates from two gas fired roof top units.

The heating system, in particular the temperature control system, has reached its operable limit. The pneumatic controls are antiquated. The original exhaust system does not operate in a manner that allows balancing of fresh air for each room. This steam system should be replaced but the cost will be driven by the process. It is recommended that this be undertaken during a total building renovation process. There are steps that can in the interim to reduce energy costs and provide for a consistent and reliable environment. Replacement of the pneumatic controls with a digital localized controller is

recommended. An investment of \$75,000 to \$100,000 in controls work would generate a very short payback in energy savings. A renovation would include conversion from steam to hot water and replacement of piping and incorporation of isolation valves. Isolation valves are not present.

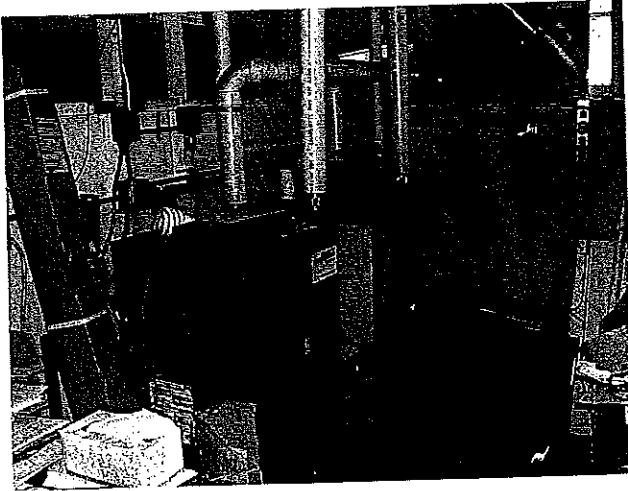
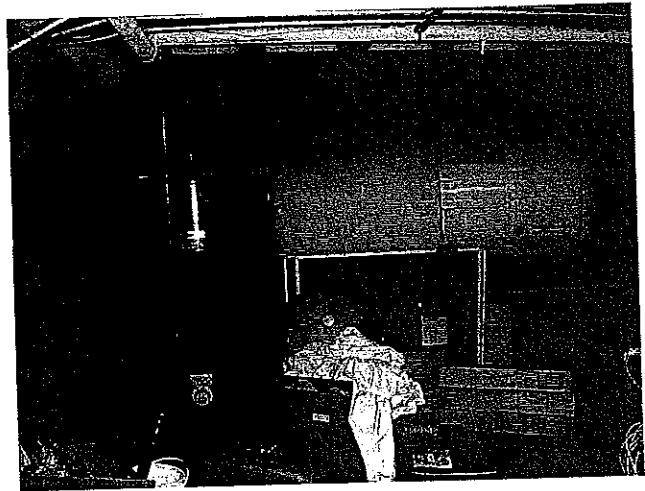
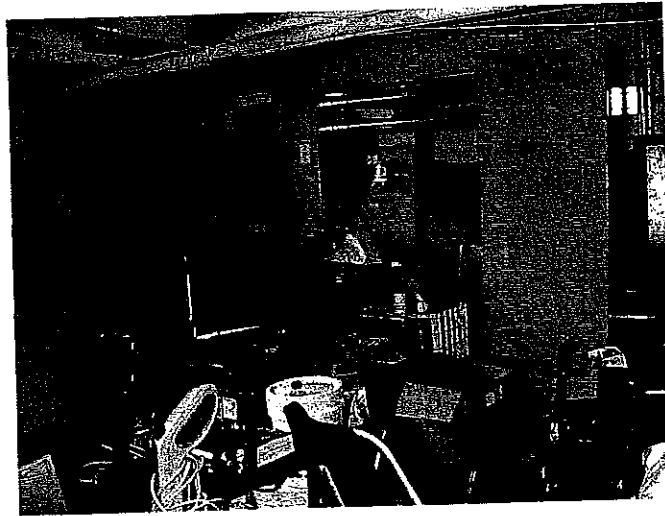
Domestic hot water is generated by three gas fire hot water heaters. Two units supply hot water to the toilets rooms. One of these is temporarily out of service. The third unit provides hot water to the dishwasher. All utilize the original storage tank designed as a steam transfer system from the boilers. There are gang toilets and staff toilets throughout the facility. The second floor of the '41 building has "point of use" heaters mounted under the sinks. The original gymnasium has locker rooms associated with it that include gang showers. These showers are no longer in use.

The domestic hot water system is functioning on half its capacity with one heater. The second unit is scheduled for repair this summer. Use of the original steam transfer hot water tank is inefficient. That tank could be replaced now or during the time of renovation.

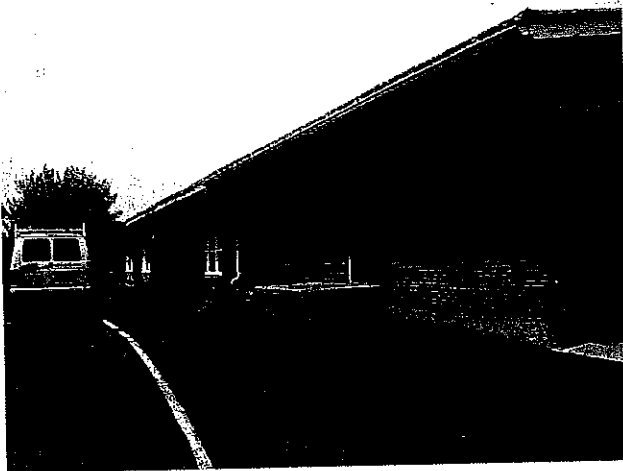
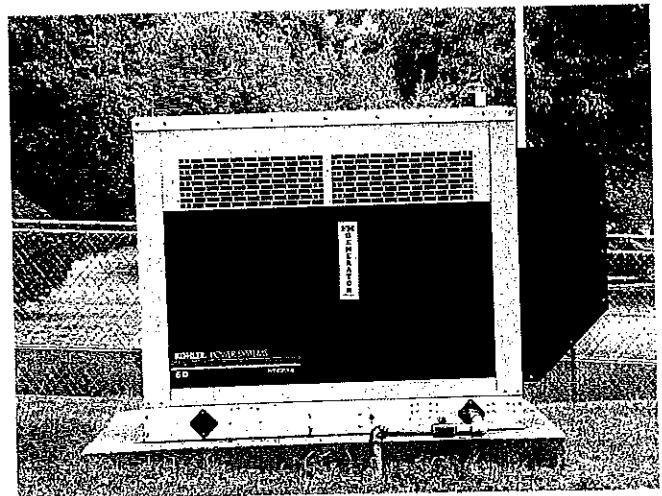
The power and light for the 1962 building are distributed from the main switch gear in the 1941 building. That switch gear has been replaced but it has no spare capacity. The power and lighting distribution system is obsolete. The generator operates the refrigerator, freezer and minimal other circuitry. The emergency lighting is battery pack. A new transformer has been placed outside the kitchen loading dock. This services the 1941 and the 1962 buildings.

The electrical power, lighting and fire alarm systems are operating at capacity and have passed their expected life cycle. They are in need of replacement.

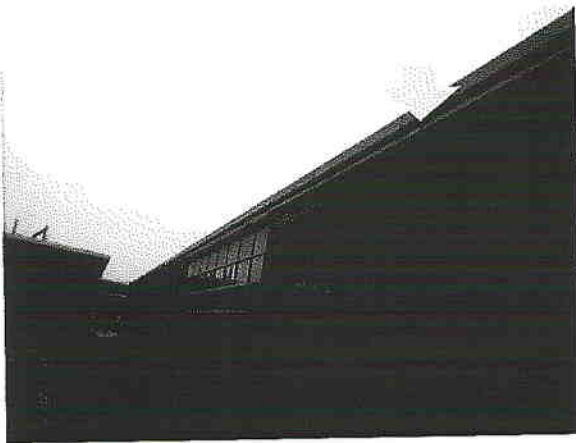
Roof-Wall Intersection Air Sealing – the exterior flashing and finishes at the roof-wall intersection are not constructed to stop air leakage.

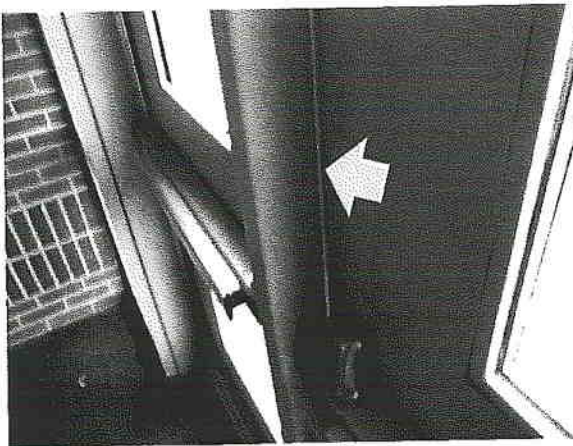
Door Weather Stripping – clear daylight around the door shows a direct pathway for unwanted air leakage.

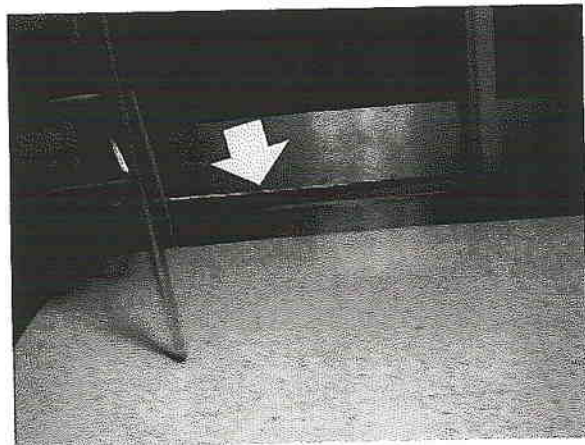
Door Weather Stripping – clear daylight around the door shows a direct pathway for unwanted air leakage.

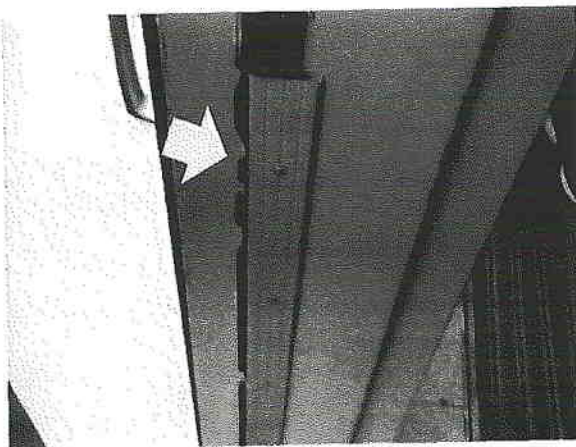
Door Weather Stripping – the gasket material has deteriorated. There is no compression seal at the perimeter of the door and as a result the door is allowing infiltration/ exfiltration.

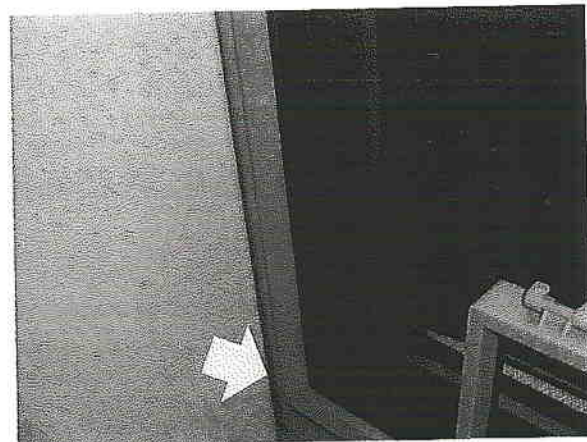
Window Casing Sealing – the joints at the perimeter of the window system are not properly sealed.

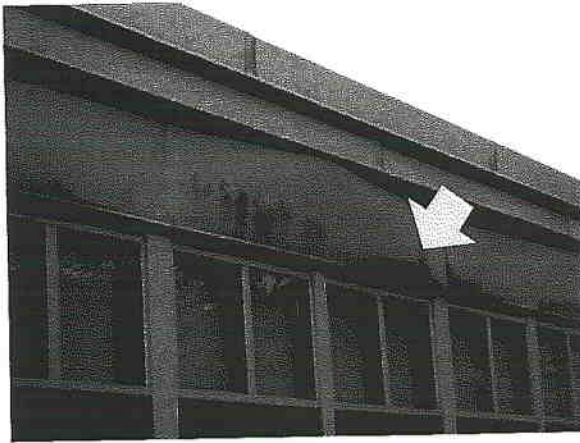
Window Buck Frame Sealing – the exterior panels above the window systems in the 100s are failing; the panel was likely the wrong material, but air exfiltration at the joint shown at the right is likely contributing to deterioration.

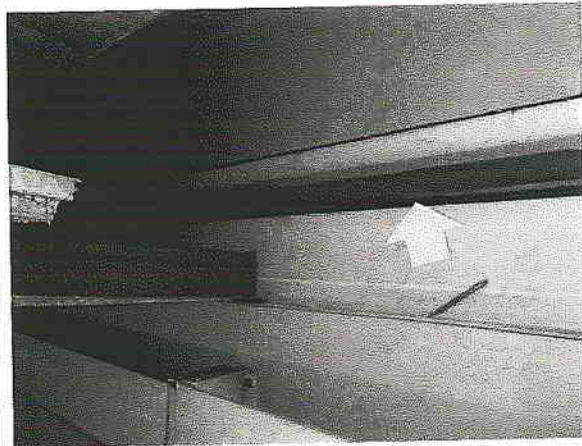
Window Buck Frame Sealing – the rough opening gap at the window between the wall and the window frame was not sealed above the drop ceiling in the 100s; this gap is allowing air leakage around the window system.

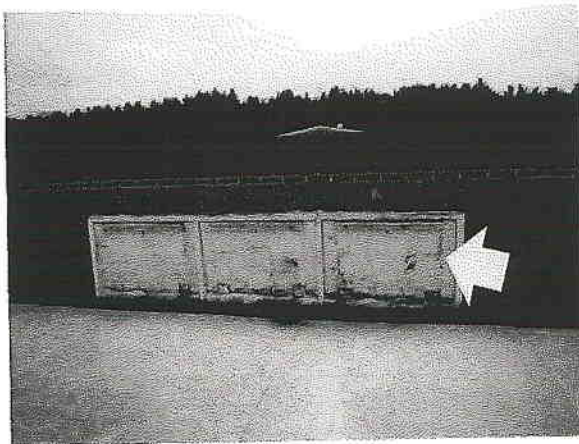
Custom Window Weatherization – the opaque operable “windows” in the auditorium tilt-out; this is not a good design for controlling rain water. Daylight is clear at the perimeter of the windows, which is a pathway for unwanted air leakage.

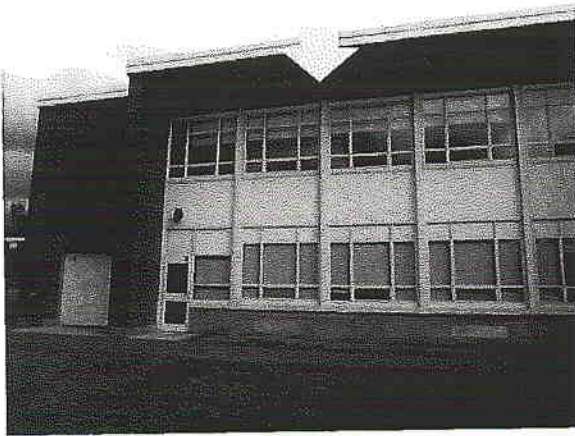
Roof-Wall Intersection Air Sealing – there are exterior vent plugs in place; this construction directs outdoor air at the weak seal (see top right picture) at the roof-wall intersection, leading to excessive infiltration/ exfiltration.

- Drape a protective sheet over furnishings and the wall below the drop ceiling.
- Remove ceiling tiles as necessary to access the roof-wall intersection.
- Install an approximately 4 inch – 6 inch wide and 2 inch deep bead of high-density spray polyurethane foam at the air leakage pathway.
- Replace the drop ceiling tiles and clean the area.

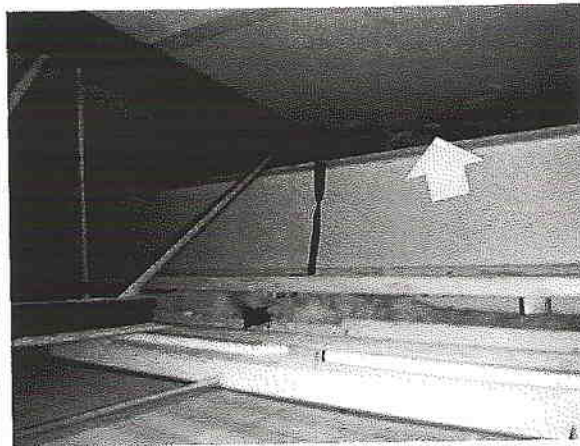
Roof-Wall Intersection Air Sealing – black discoloration of the fiberglass batt is a clear indicator of unwanted air leakage; fiberglass “filters” out dirt and debris as air pass through the material.

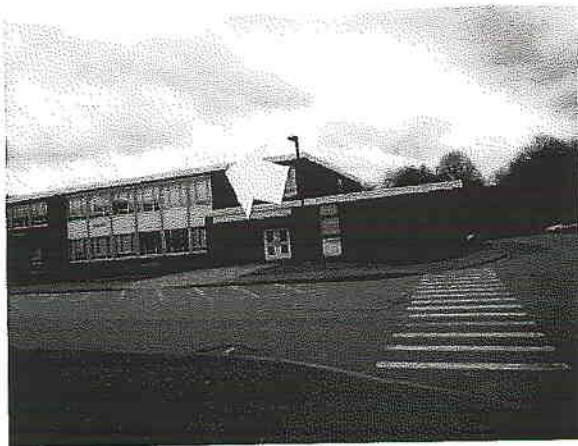
Roof-Wall Intersection Air Sealing – the exterior flashing and finishes at the roof-wall intersection are not constructed to stop air leakage.
