TOWN OF MEDFIELD

Municipal Facilities

Evaluation and Capital Plan

October 6, 2017

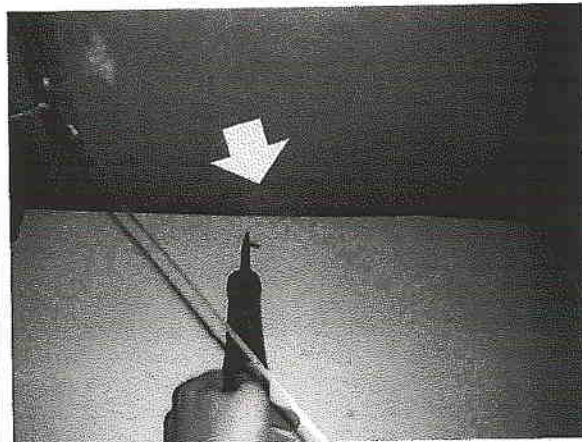
Roof-Wall Intersection Air Sealing – air exfiltration shown by smoke tracer testing at the roof-wall intersection.

- Drape a protective sheet over furnishings and the wall below the drop ceiling.
- Remove ceiling tiles as necessary to access the roof-wall intersection.
- Install an approximately 4 inch – 6 inch wide and 2 inch deep bead of high-density spray polyurethane foam at the air leakage pathway.
- Replace the drop ceiling tiles and clean the area.

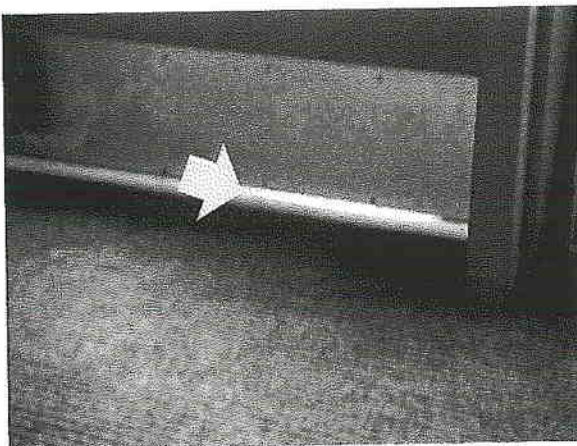
Door Weather Stripping – clear daylight around the door shows a direct pathway for unwanted air leakage.

- Ensure door operates and closes appropriately. Notify prime contractor and/or client when doors are damaged.
- Install heavy duty weather stripping with aluminum carrier at door sides and top jamb. Install for 40% - 60% weather strip compression. Caulk behind weather strip carrier for air-tight seal.
- Cut aluminum carrier weather strip at locks, swing arms or any other hardware where necessary.
- Install door bottom sweep with aluminum carrier.
- For double doors install astragal at center meeting.
- Note: weather stripping materials are selected from the options included below to best fit the existing conditions of the door system.

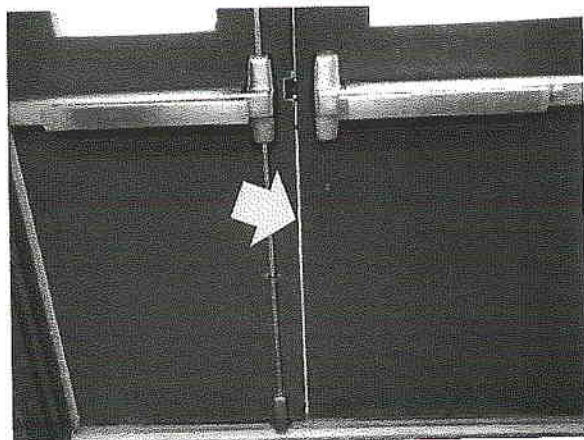
Door Weather Stripping – clear daylight around the door shows a direct pathway for unwanted air leakage.

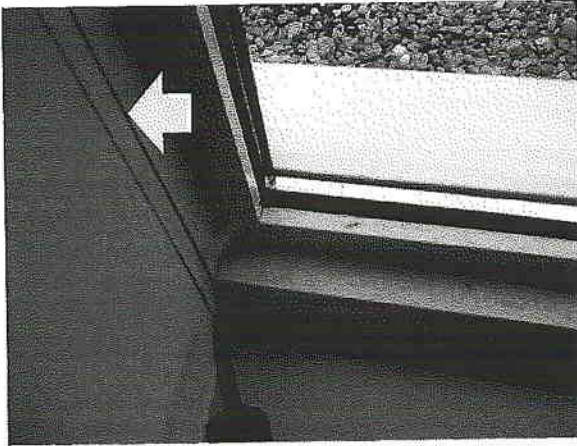
Window Casing Sealing – the perimeter of the interior casing was not sealed properly. The gaps allow air leakage at the rough opening (the gap between window and wall); interior smoke tracer testing leaked outside.

- Notify the prime contractor if the window assembly is damaged.
- Caulk the non-operational components of the jamb, casing or trim that have been identified as pathways for air leakage. Install backer rod as required at large gaps.

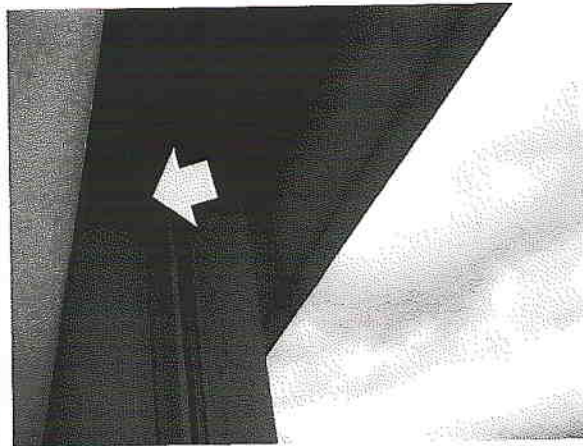
Window Casing Sealing – the joints at the perimeter of the window system are not properly sealed and are allowing unwanted air leakage around the window system.

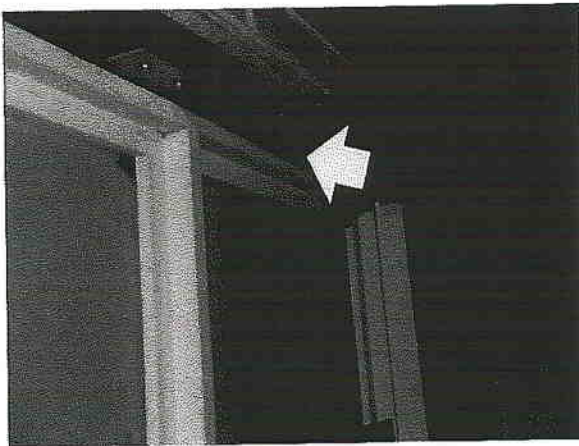
Window Buck Frame Sealing – the rough opening gap at the window between the wall and the window frame was not sealed above the drop ceiling; this gap is allowing air leakage around the window system.

- Notify the prime contractor if the window assembly is damaged.
- Seal the joints at the buck frame/ rough opening that have been identified as pathways for air leakage.

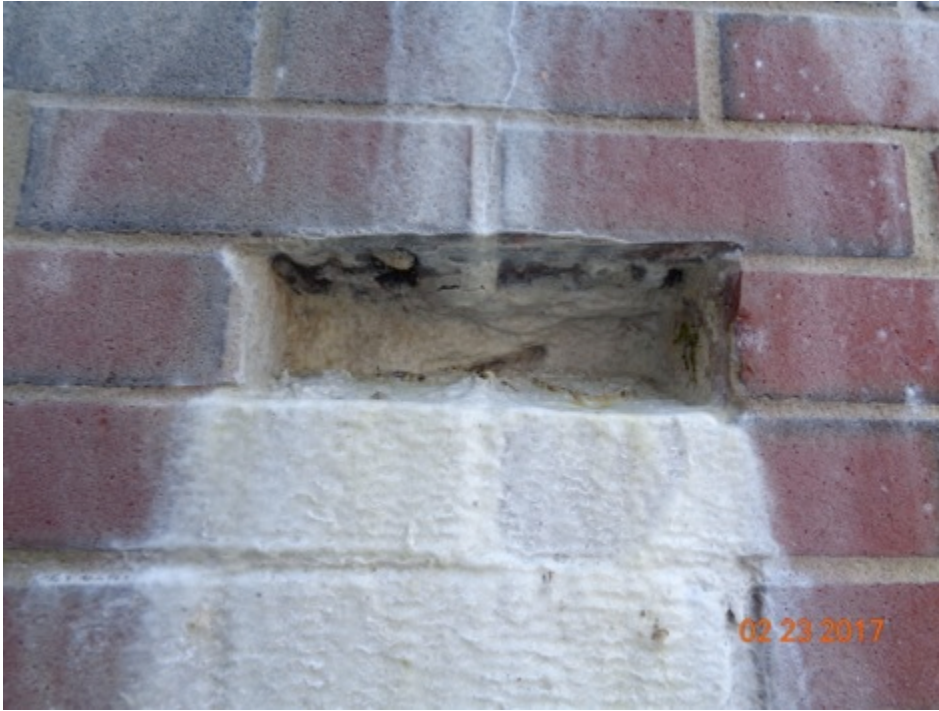
Photo 5

Severe efflorescence at the northwest canopy column. One brick was previously removed some time ago resulting in extraordinary efflorescence.

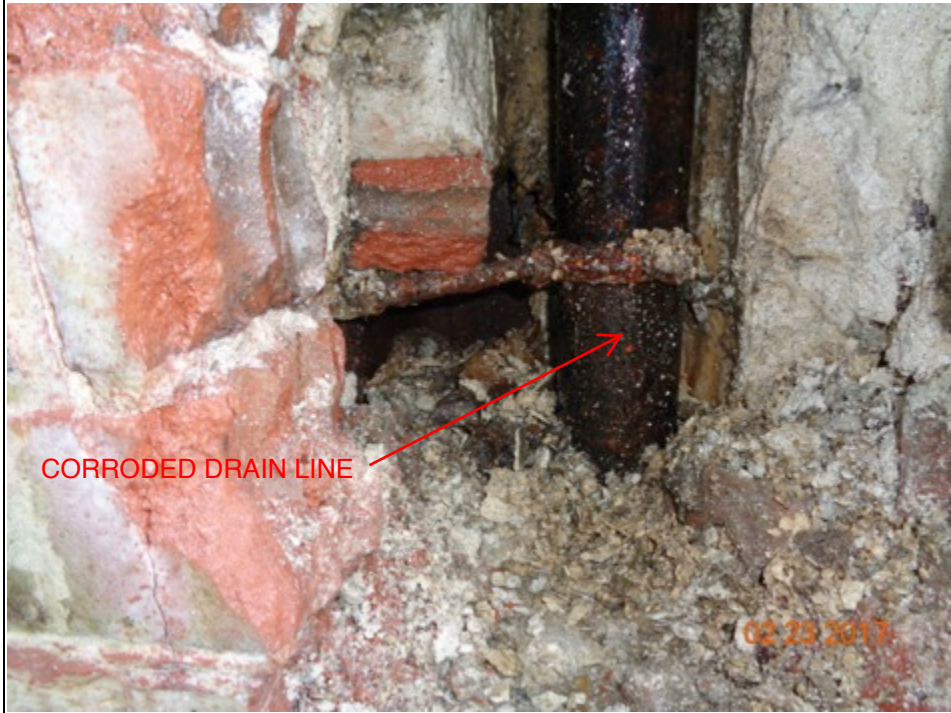
<p>CORRODED DRAIN LINE</p> <p>02.23.2017</p>	<p>Photo 7</p> <p>Medfield High School Bus Canopy</p> <p>Test cut at bottom of northeast canopy column, east side revealed saturated masonry, deteriorated pipe insulation and corroded steel pipe.</p>

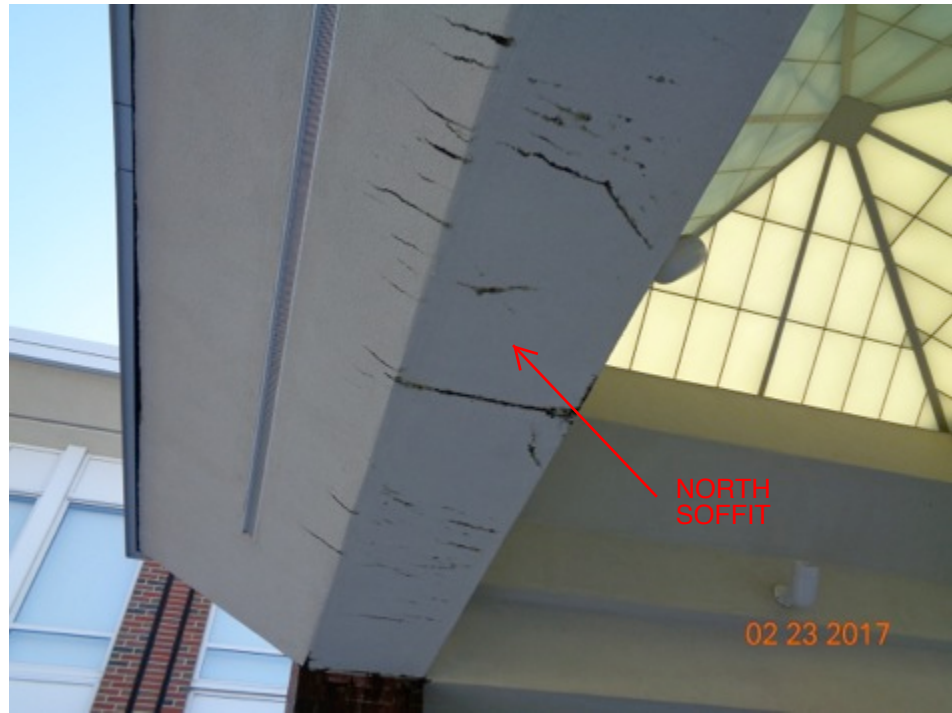
<p>NORTH SOFFIT</p> <p>02.23.2017</p>	<p>Photo 8</p> <p>Medfield High School Bus Canopy</p> <p>Cracked stucco covered soffit is actively leaking due to snowmelt.</p>

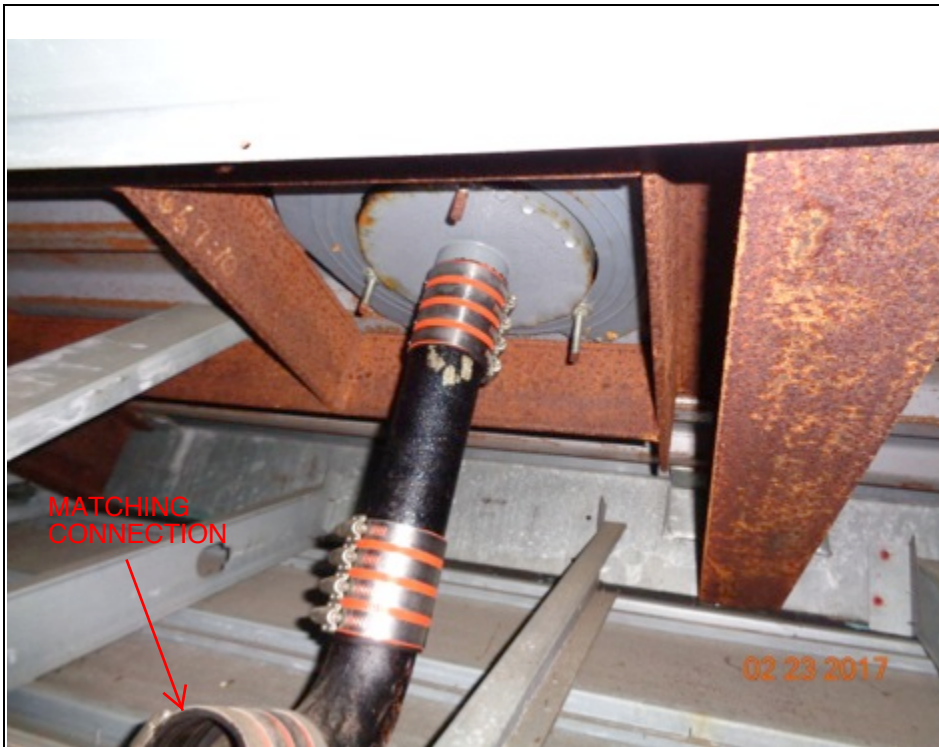
Photo 9

North canopy drain bowl is not connected. Note that the steel components appeared sound.

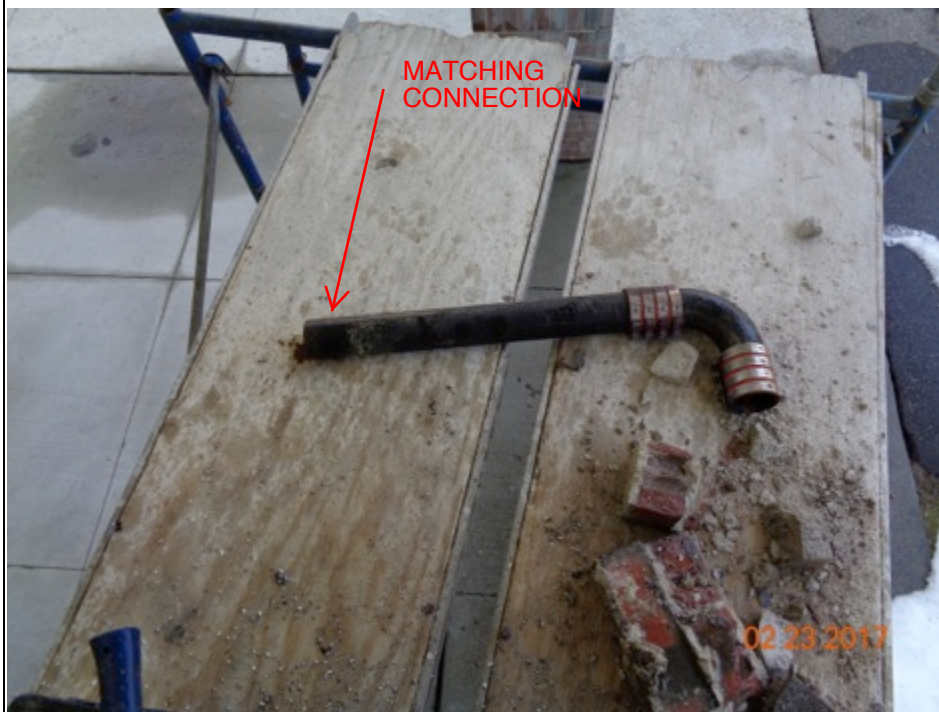
Photo 10

Missing piping found on top of soffit. Pipe was reinstalled using existing hardware.

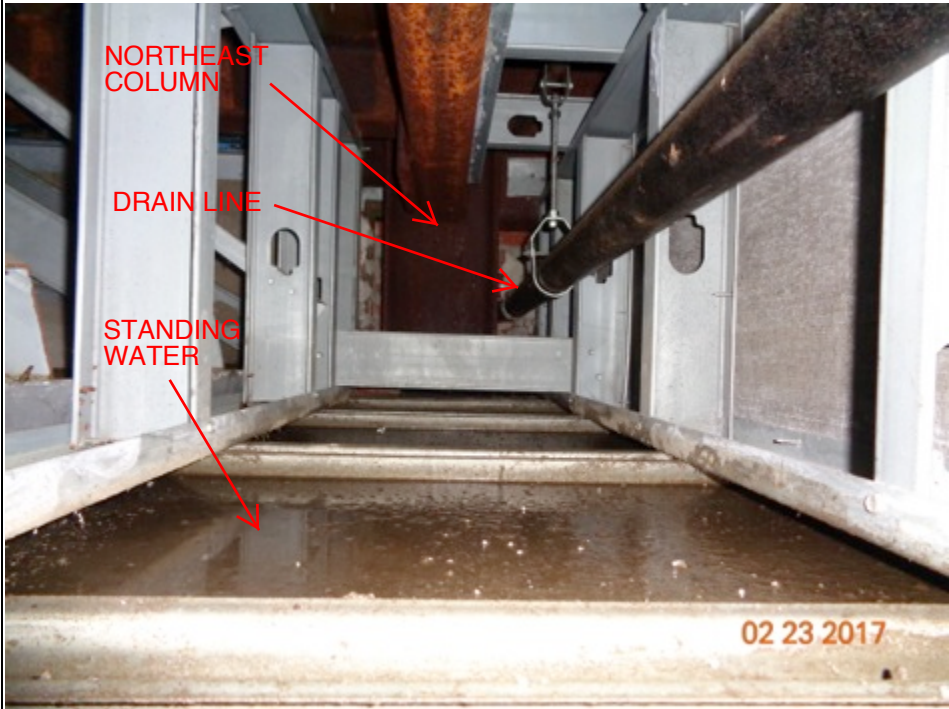
Two openings were made into the north canopy soffit. We observed that the top surface of the soffit had standing water and that the surface was slightly higher than the top of the masonry encased column. The soffit was draining through cracks in the soffit and was also draining into the top of the masonry encased column. A +/- 3' section of roof drain leader pipe was found to be disconnected from the drain line and was resting on the top surface of the soffit. Ace Restoration Co reinstalled this drain line. (Although not a leak related issue, the stucco covered soffit is poorly sealed to sheet metal roof edge treatments.)

<p>NORTHEAST COLUMN</p> <p>DRAIN LINE</p> <p>STANDING WATER</p> <p>02 23 2017</p>	<p>Photo 11</p> <p>Medfield High School Bus Canopy</p> <p>Interior of north bus canopy soffit. Drain line runs to the east side of the northeast column shown and then turns down into the underground drain line. Note the standing water on the top surface of the soffit.</p>

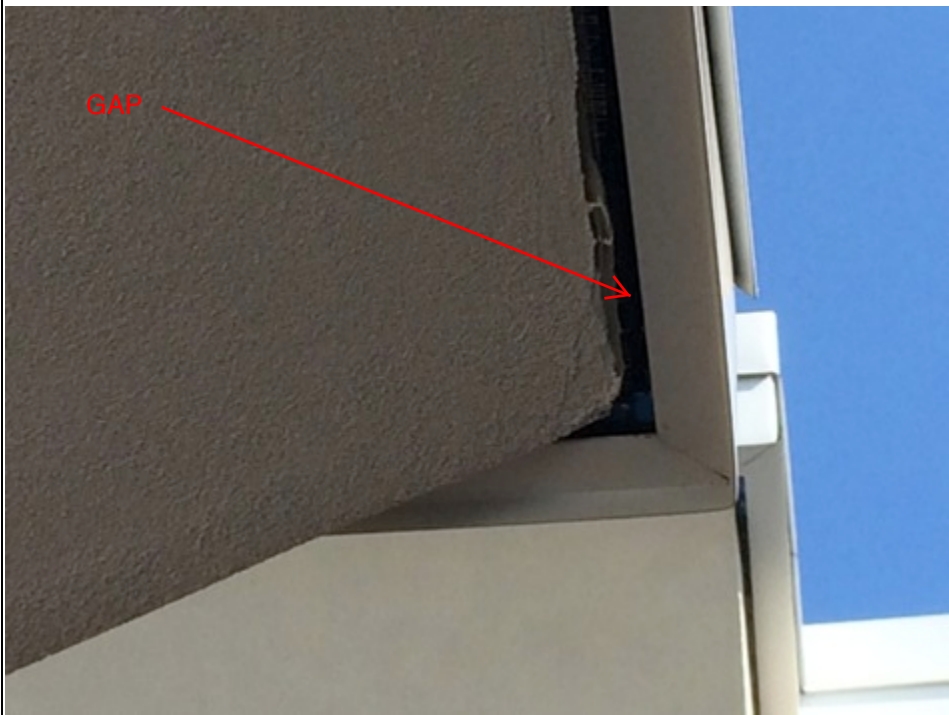
<p>GAP</p>	<p>Photo 12</p> <p>Medfield High School Bus Canopy</p> <p>Many areas of soffit are poorly sealed to the sheet metal roof edge.</p>

- Remove all soffits necessary to access the canopy drain lines.
- Remove the brick masonry and mortar fillers exposing all 4 steel columns.
- Inspect the drain lines and repair/replaced as required. Utilize drain line video services to inspect the inside of all pipes. Install electric heat trace tapes.
- Inspect the steel columns and repair/paint as required.
- Replace the brick veneer surrounding the steel columns. Allow a cavity between the brick and steel column/drain lines.
- Replace the removed soffits with a removable sheet metal soffit system. Seal the soffits to the sheet metal roof edge treatments.

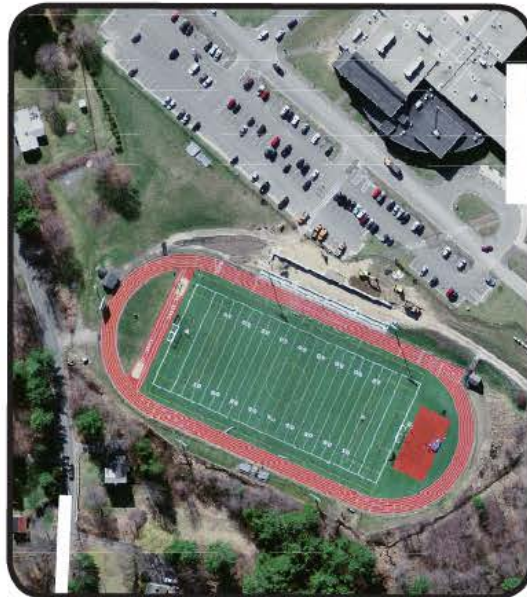
FIELD A: HIGH SCHOOL MULTI-USE SYNTHETIC FIELD AND TRACK

- TURF IS STARTING TO DEGRADE WHICH WILL DECREASE THE SAFE PLAY ON THE FIELD
- TRACK IS READY FOR AN OVERSPRAY
- THERE ARE CURRENTLY ISSUES WITH THE BASE BELOW THE TURF
- THERE ARE DRAINAGE ISSUES IN THE FIELD
- GRASS IN THE FIELD IS NOT A GREAT DESIGN CHOICE
- THE FACILITY NEEDS ADA PARKING
- ATHLETIC FIELD LIGHTING IS IN WORKING CONDITION BUT, NEEDS TO BE UPDATED
- THE CONCESSION STAND SHOULD BE UPGRADED TO MODERN CODES
- STORAGE ON THE SITE SHOULD BE ORGANIZED
- BASIC AMMENITIES WOULDHELP TO IMPROVE THE FACILITY

THE FIELD NEEDS TO BE REPLACED AS THE TURF IS BREAKING DOWN AND THE CONDITION OF THE SURFACE WILL BECOME UNSAFE.

The synthetic track has clear base issues at the long-jump triple-jump areas. It is highly recommended that the "D-Zone Areas" are built to include synthetic track surfacing which will also assist in the function of the areas when running track meets. The track has been over-sprayed once to date. The track has reached an age in which it should be sprayed again. This should occur during this process. It should be noted that a track can only be sprayed a minimum of three times which should make the track functional for an additional five to six years.

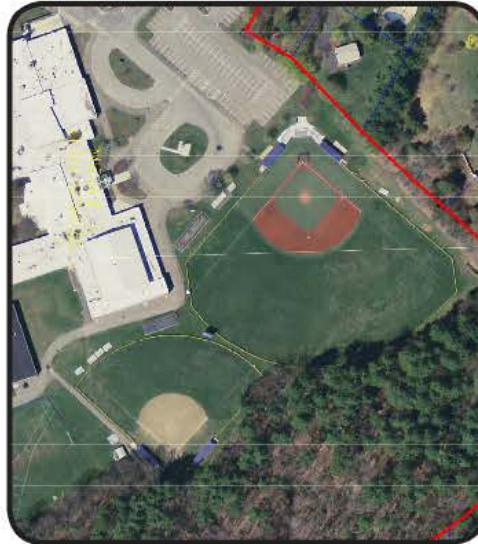
FIELD B: MIDDLE SCHOOL BASEBALL/SOFTBALL

- THE FIELD IS GENERALLY IN GOOD CONDITION
- IT IS RECOMMENDED TO ADD 8' CHAIN LINK AT BOTH THE SOFTBALL AND BASEBALL DUGOUT
- FIELD WILL NEED TO BE REPLACED IN THE NEXT 5 TO 7 YEARS
- ATHLETIC FIELD LIGHTING WOULD EXTEND THE USE OF THE FIELD BUT, LOCATION NEAR NEIGHBORS MAY NOT BE APPROPRIATE
- THE TOWN SHOULD INVESTIGATE THE EXPANSION OF TURF DURING THE NEXT REPLACEMENT
-
- THE EDGE OF THE SYNTHETIC TURF FIELD AND GRASS SHOULD BE ADDRESSED ANNUALLY
-
- THERE ARE SOME GRADING ISSUES WITH THE INFIELD OF THE SOFTBALL FIELD THAT SHOULD BE ADDRESSED

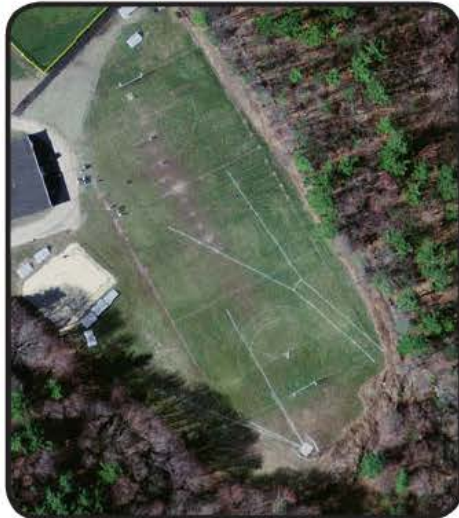
FIELD C:
MIDDLE SCHOOL PRACTICE FIELD

- THE FIELD IS IN THE WORST CONDITION OF ALL THE FIELDS
- THE FIELD IS UNDERSIZED FOR ANY SPORT EXCEPT FOR FOOTBALL
- TRACK THROWING EVENTS OCCUR IN THIS AREA
- THERE ARE WETLANDS AND A STREAM ON THE OUT SKIRTS OF THE FIELD
- THE FIELD IS SURROUNDED BY FOREST AND SECLUDED FROM NEIGHBORS

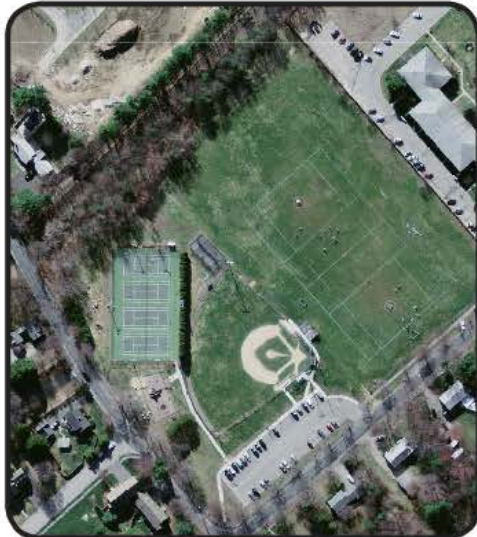
FIELD D: METACOMET PARK FIELDS

- THE FIELD IS SURROUNDED BY RESIDENTIAL NEIGHBORS TO THE NORTH, EAST AND WEST.
- THE FIELD IS LARGE AND IN GOOD CONDITION.
- PARKING IS LIMITED AND THERE ARE SIGNS OF PARKING ON THE STREET.
- DRAINAGE FLOWS TO THE SOUTHWEST
- THE FIELD IS ORIENTED MORE EAST/WEST THAN THE PREFERRED NORTH/SOUTH
- THE FIELD COULD USE ADA ACCESS IMPROVEMENTS

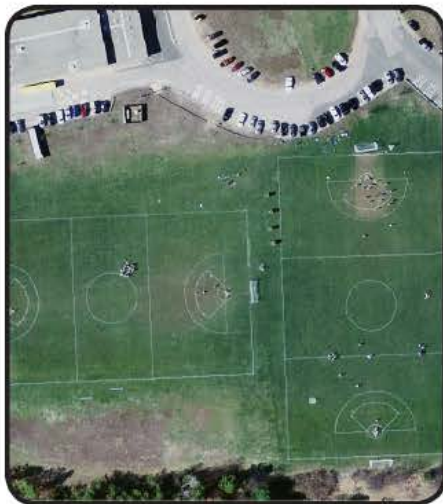
FIELD E:
RALPH WHEELOCK SCHOOL MUTLI-USE FIELDS

- THE FIELDS ARE HEAVILY USED
- ONE OF THE FIELDS IS NOT ORIENTED THE PREFERRED NORTH/SOUTH DIRECTION
- PARKING IS AN ISSUE, PARKING IS ON THE GRASS
- DRAINAGE FLOWS TO A SWALE TO THE EAST
- THE FIELD COULD USE ADA ACCESS IMPROVEMENTS
- THE FIELDS ARE SURROUNDED BY FOREST TO THE SOUTH AND EAST

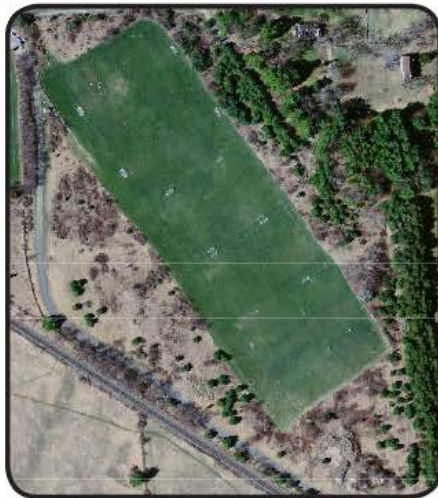
FIELD F:
SOCCER COMPLEX AT RALPH WHEELLOCK

- PARKING IS LIMITED TO THE FACILITY
- THE FIELDS COULD USE ADA ACCESS IMPROVEMENTS
- FIELDS ARE GENERALLY IN GOOD CONDITION WITH IRRIGATION
- FIELDS ARE SURROUNDED BY FOREST AND WOODED AREAS
- FIELDS ARE HEAVILY USED
