# **TOWN OF MEDFIELD**

## **Municipal Facilities**

### **Evaluation and Capital Plan**

October 6, 2017

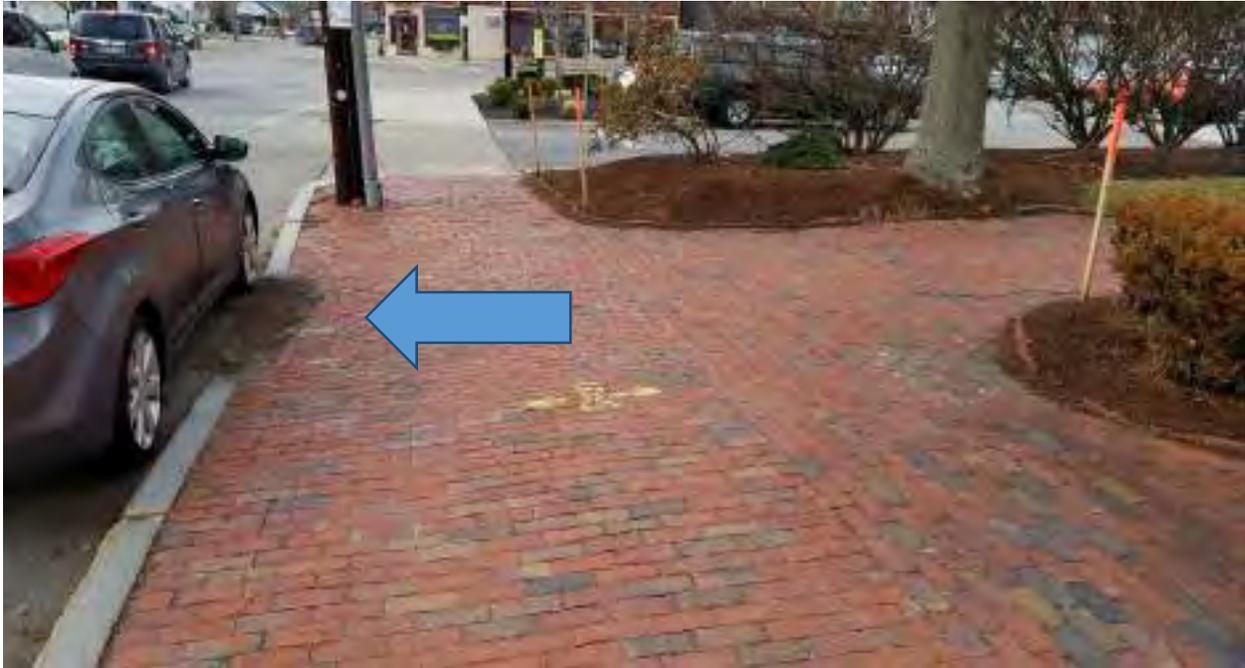
SHOWING MAIN STREET CURB CUT WITH NO DESIGNATION FOR ACCESSIBLE PARKING

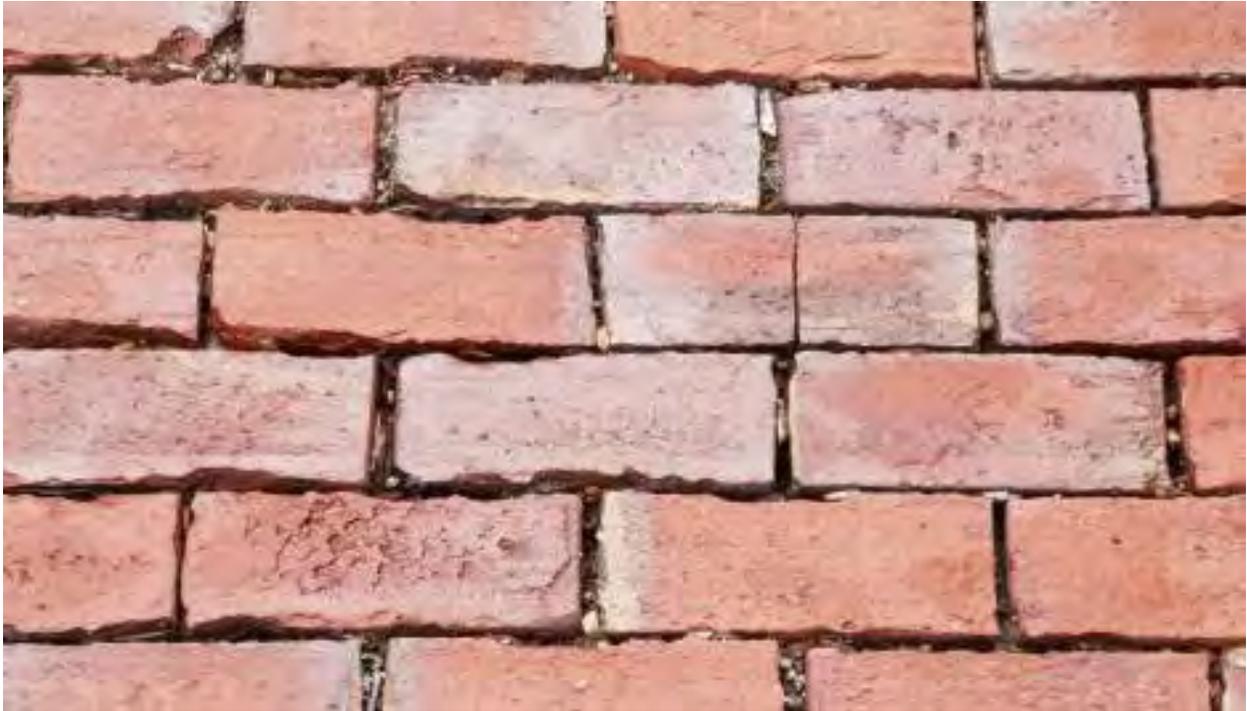
TYPICAL OPEN JOINTS OF BRICK WALKWAYS NEEDING SAND INFILL

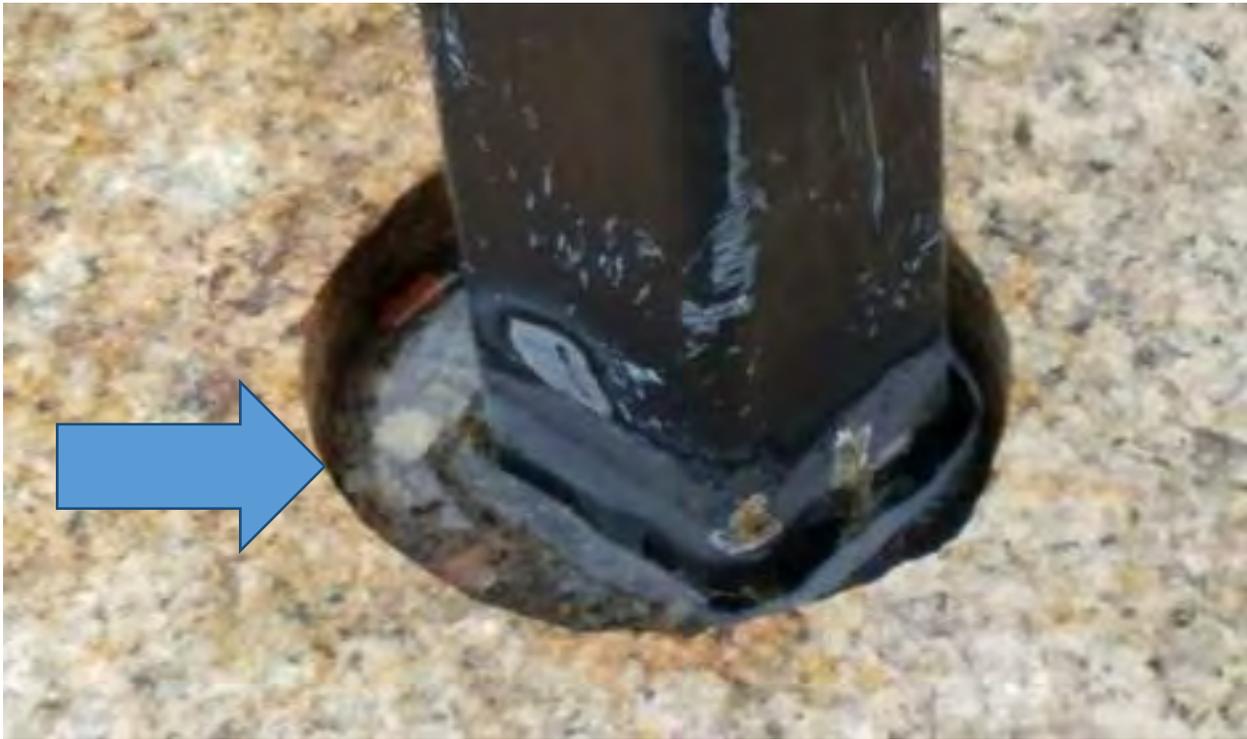
GAPS AROUND GUARDRAIL POSTS COLLECTING WATER & ICE

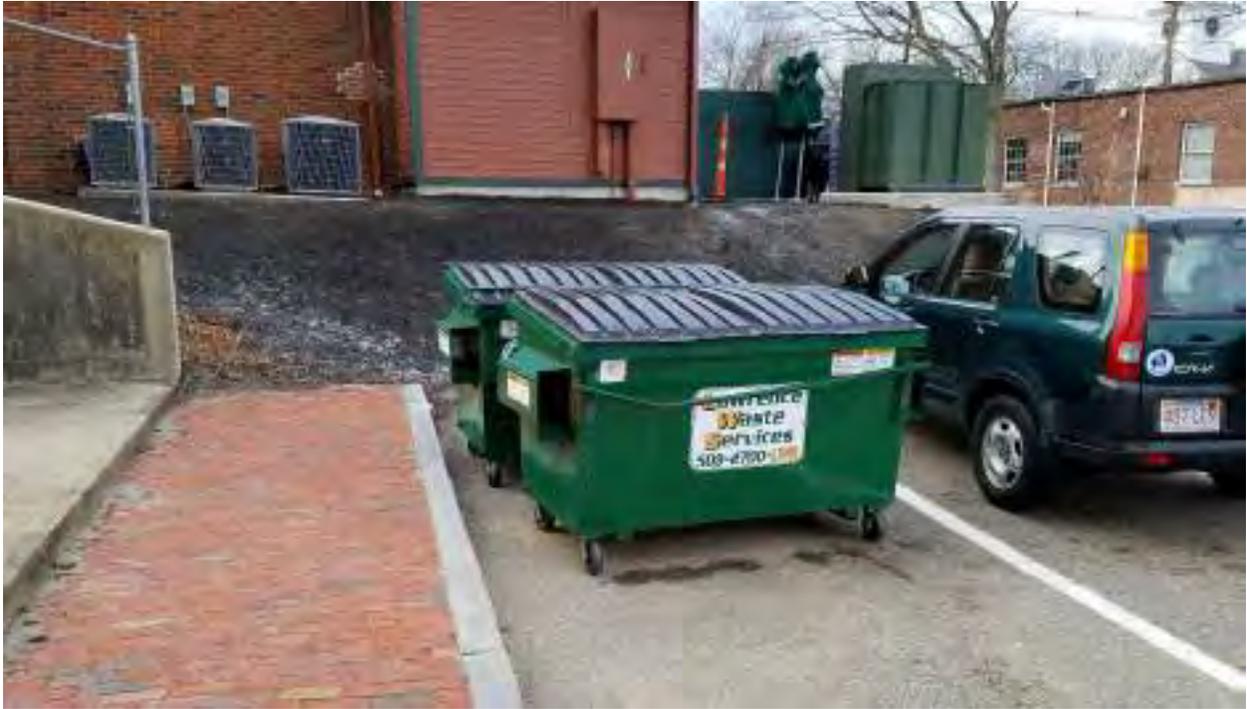
SHOWING UN-ENCLOSED DUMPSTERS NEAR CONCRETE GENERATOR PAD AT REAR

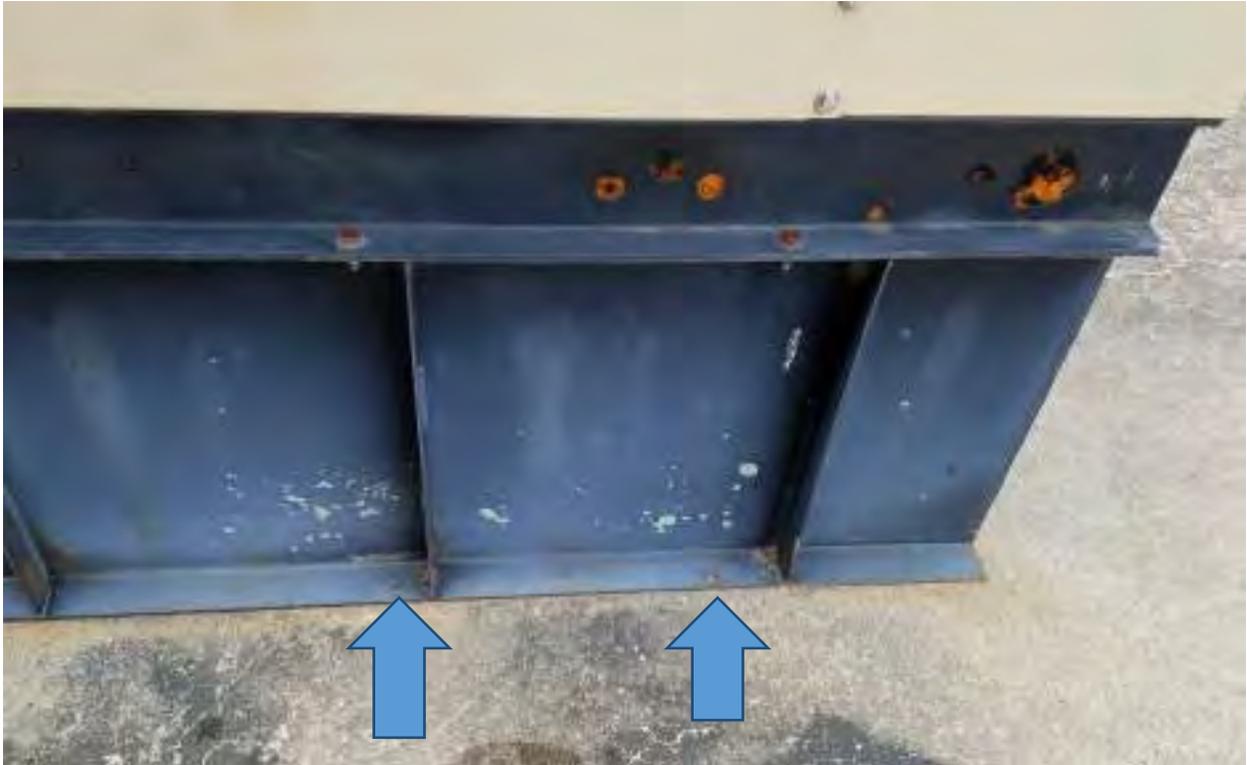
GENERATOR UNSECURED TO CONCRETE PAD

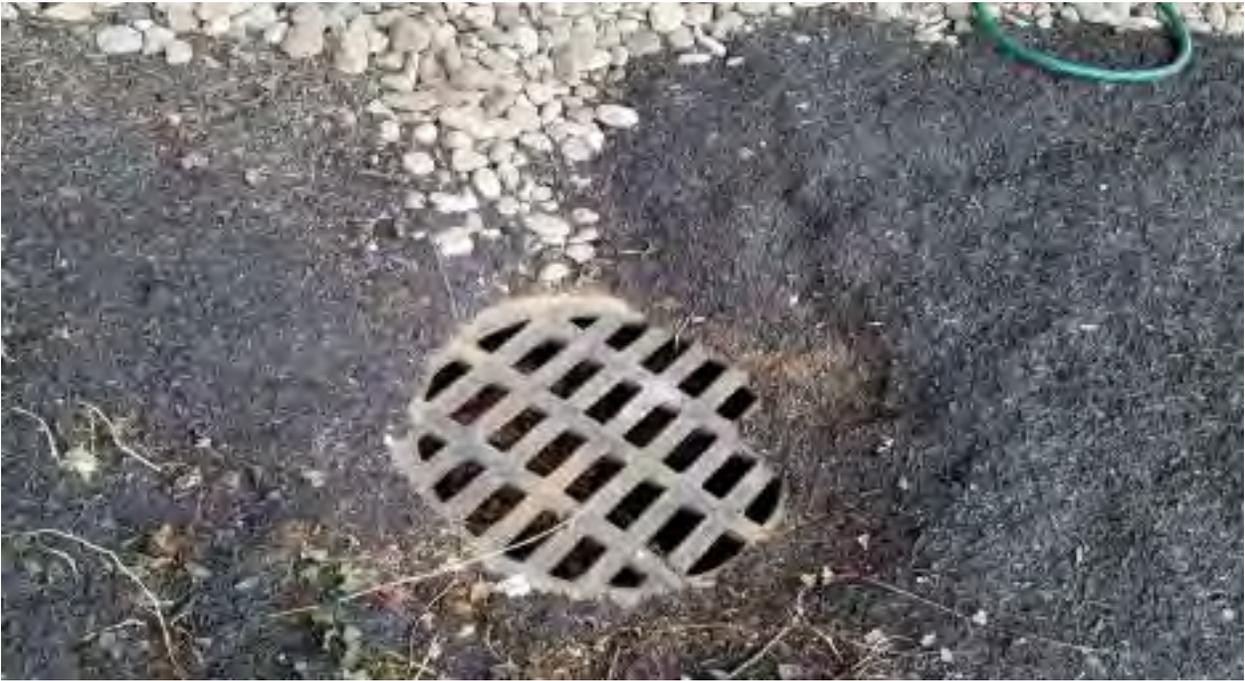
AREA DRAIN AT REAR LANDSCAPING AREA SHOWING MULCH WASHING INTO SUMP

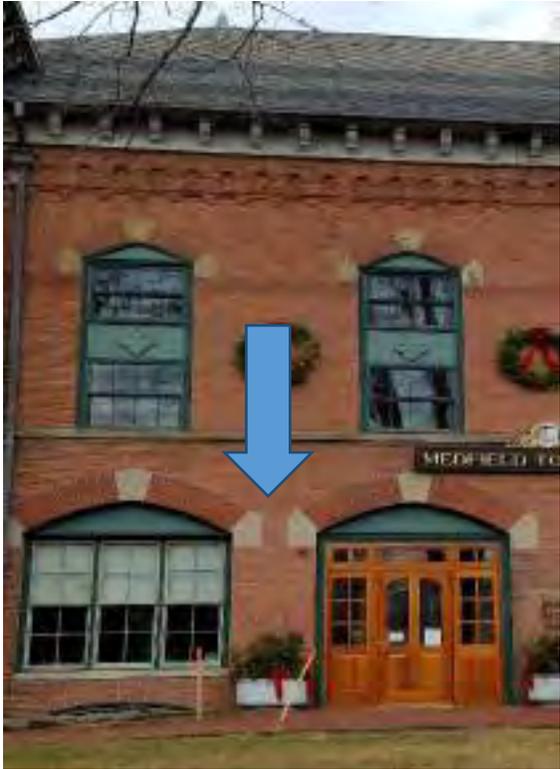
EXAMPLES OF POSSIBLE NEW BRICK, LIMESTONE & GRANITE WORK BASED ON COLOR and CONDITION

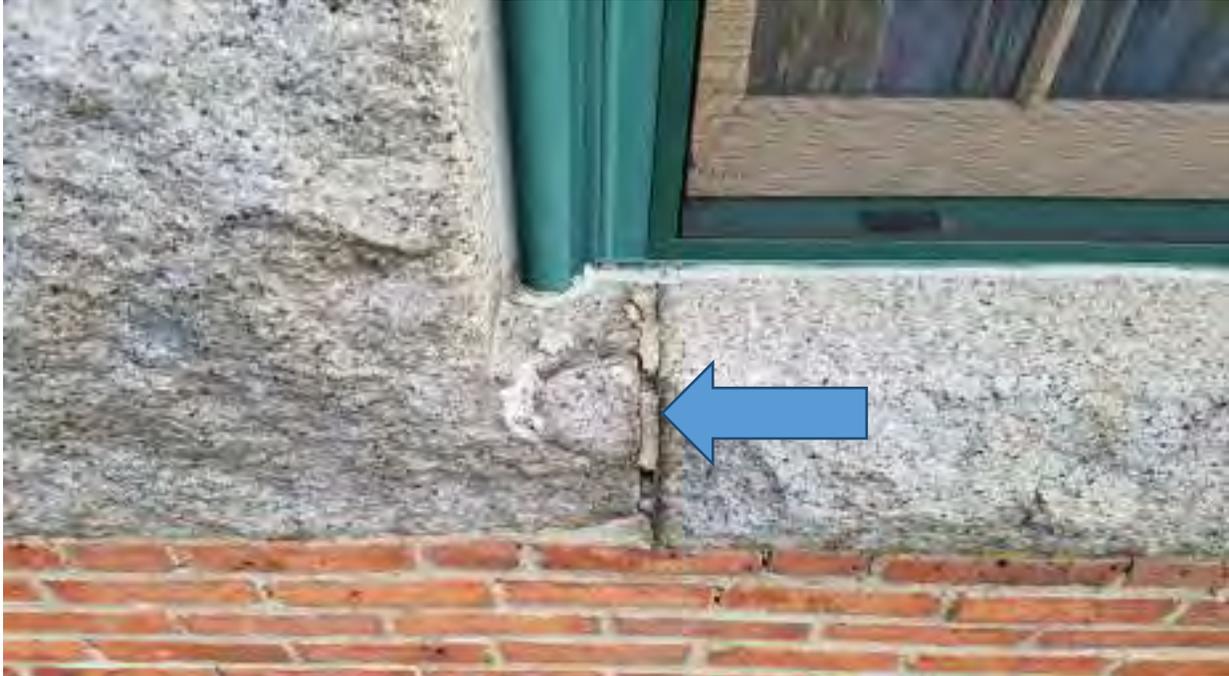
SHOWING REPOINTING NEEDED AT GRANITE SILLS

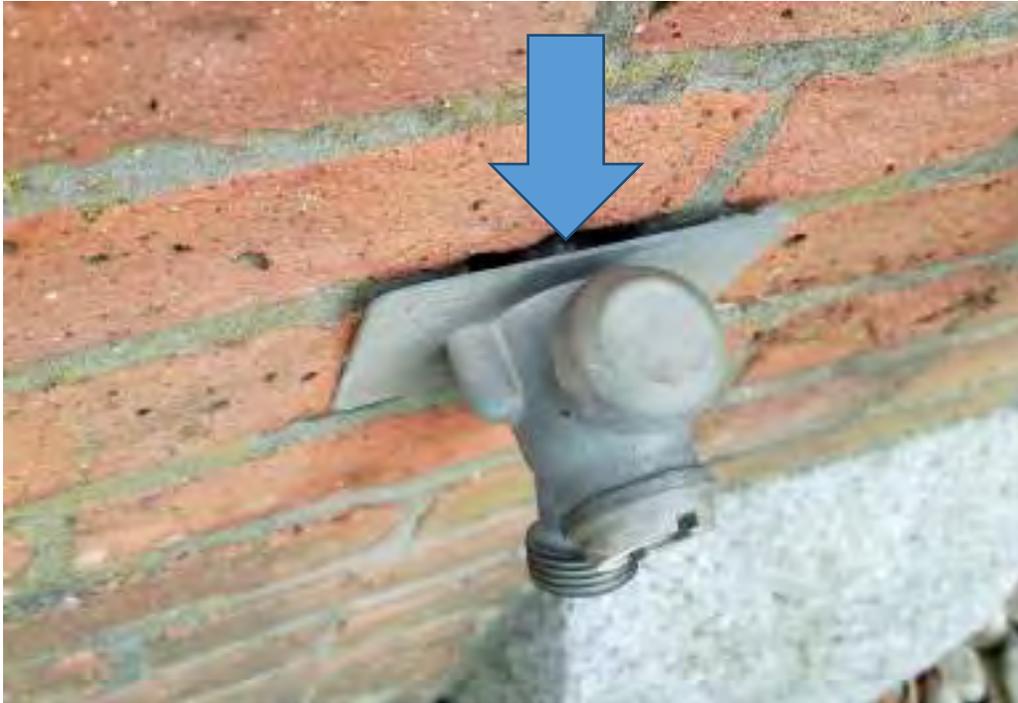
GAPS AROUND EXTERIOR HOSE BIBS NEEDING SEALANTS

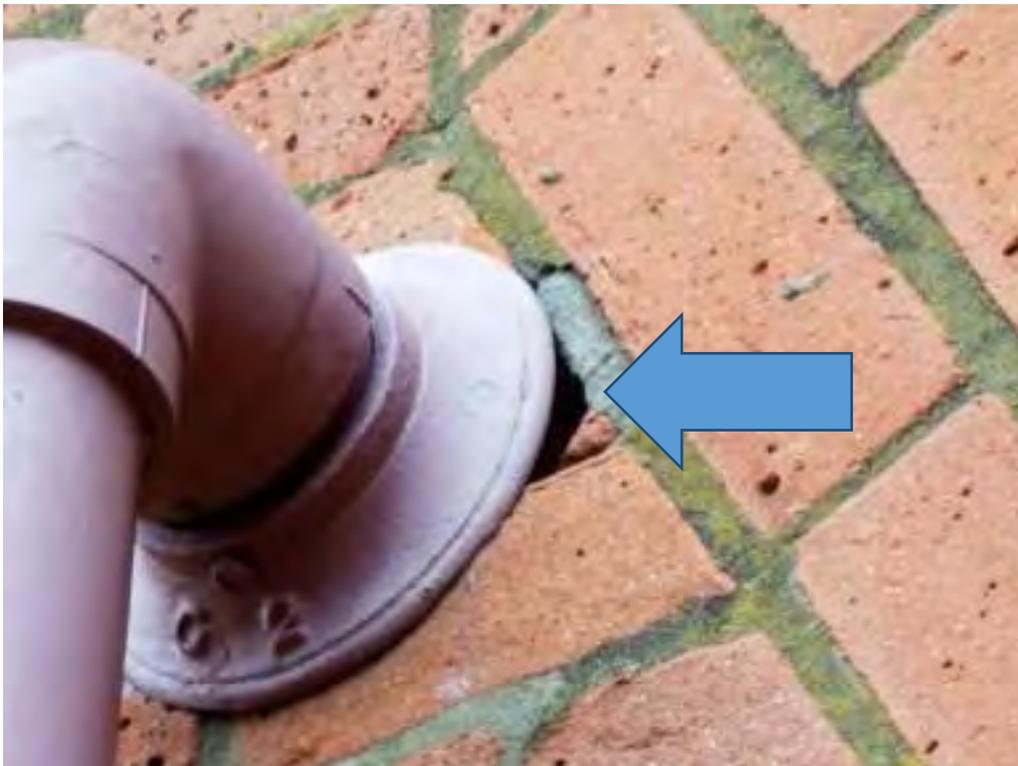
GAPS AROUND SPRINKLER DRAIN NEEDING SEALANTS

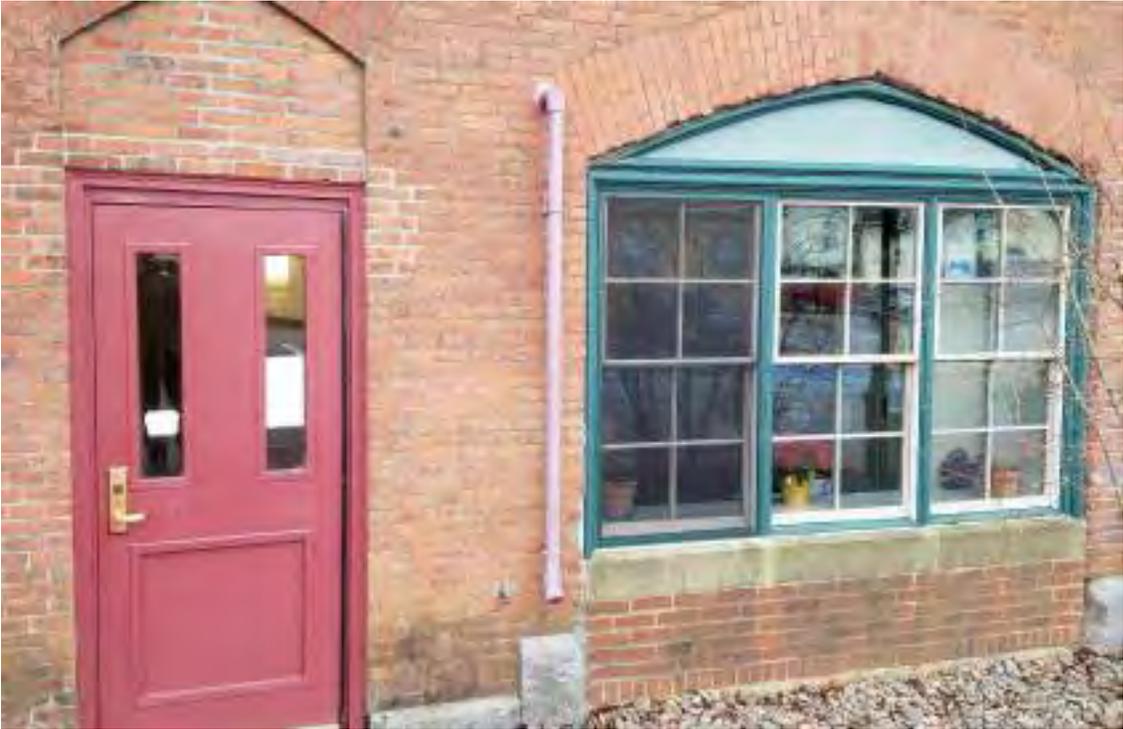
TYPICAL METAL DOORS and WINDOW UNIT (Note missing screens here & elsewhere)

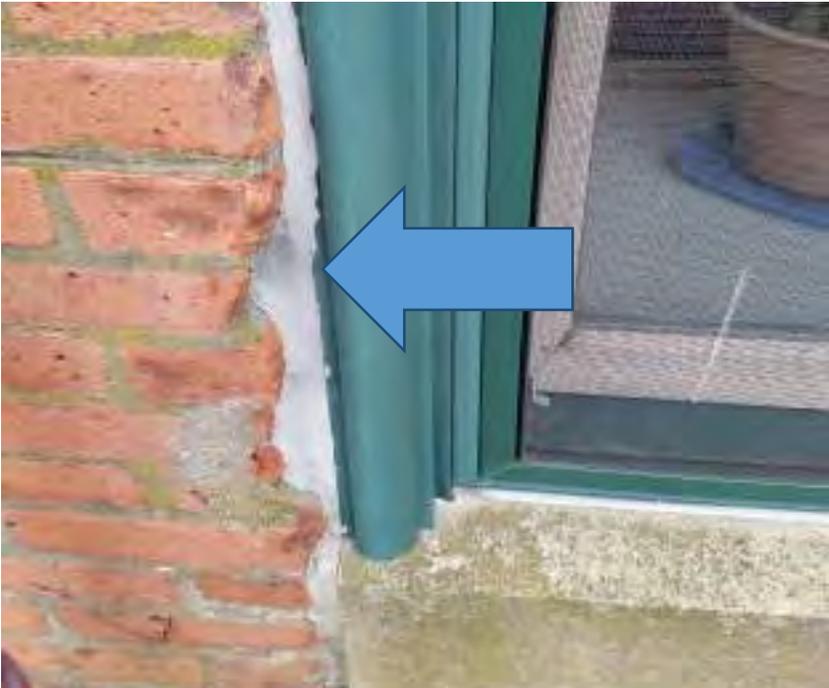
TYPICAL WINDOW UNIT SHOWING PERIMETER CAULKING

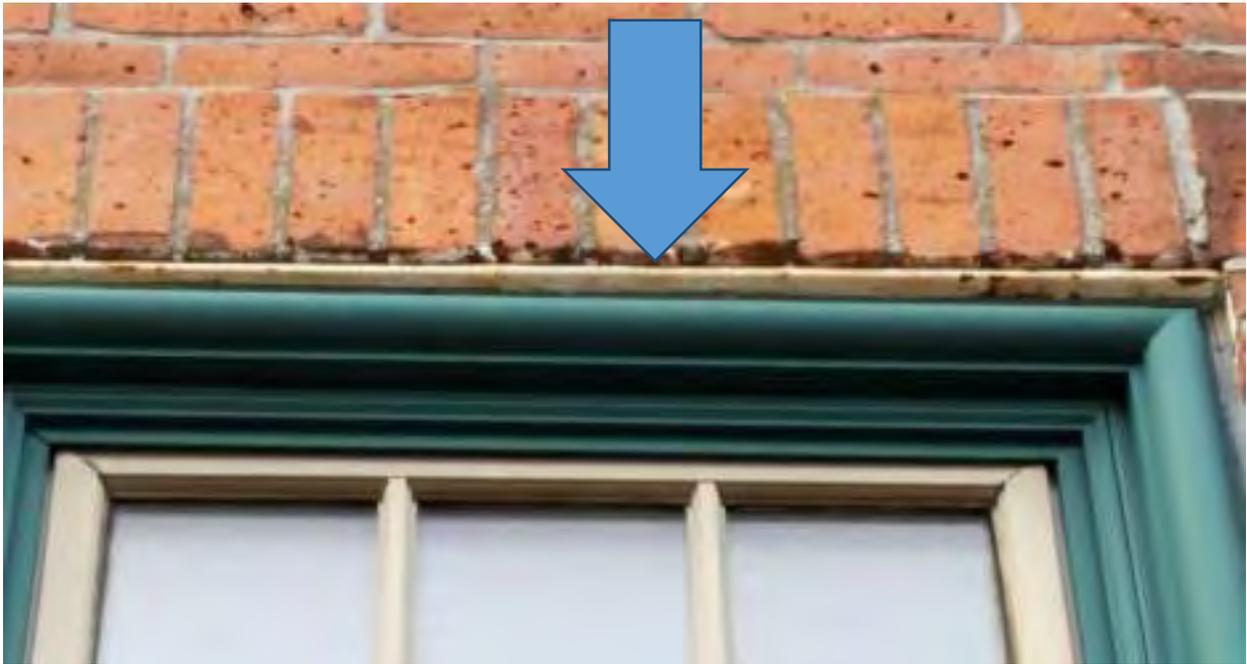
TYPICAL STEEL LINTEL NEEDING SCRAPE & PAINT

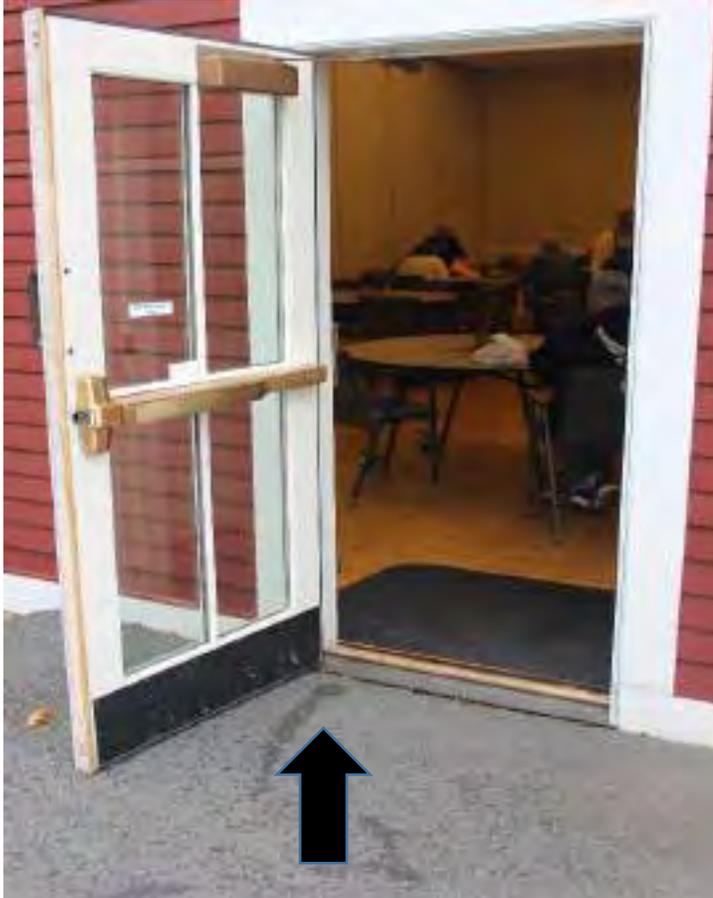
Poor drainage has led to frost heaving and door failure to open. All locations

At the rear patio, has the similar problem as the front entry at the immediate door location that must be addressed. The remainder of the pad may be too costly to address. \$7,000

An exterior envelope engineer should be consulted to develop a solution to prevent this potential rot condition. \$3,000

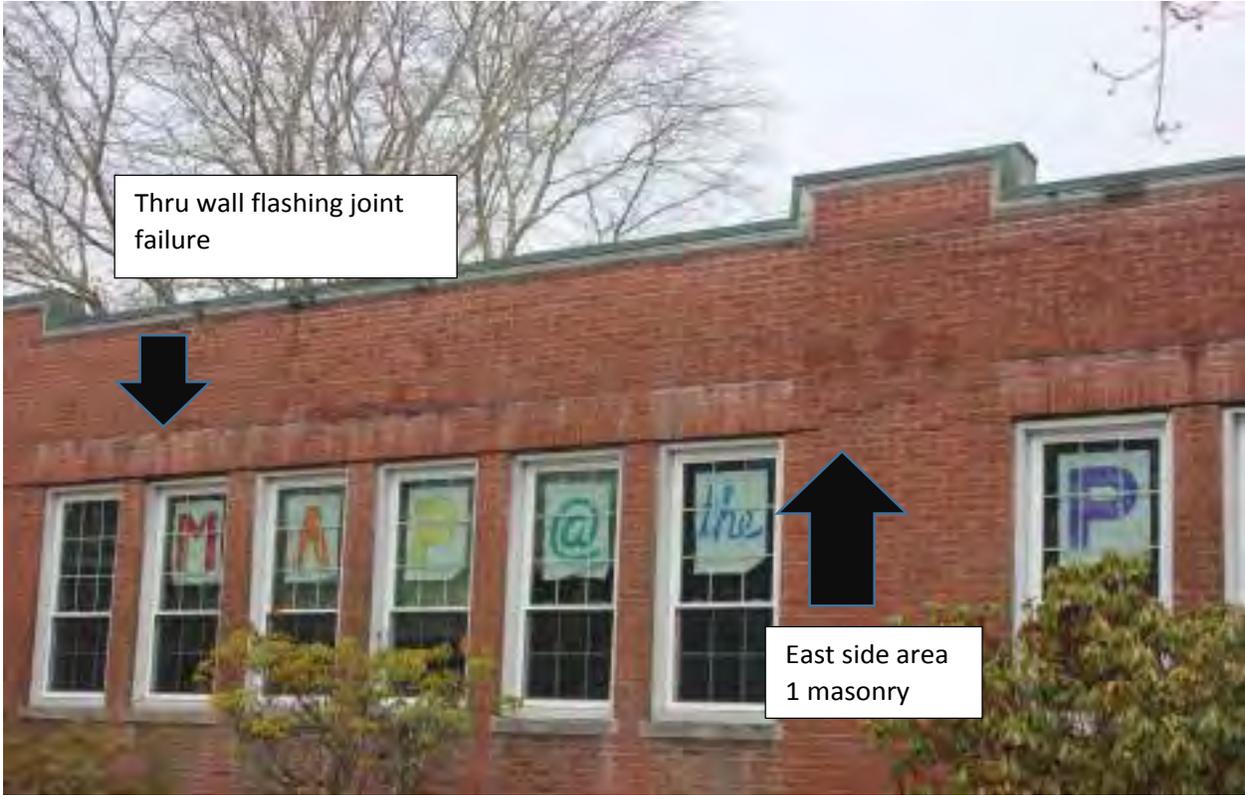
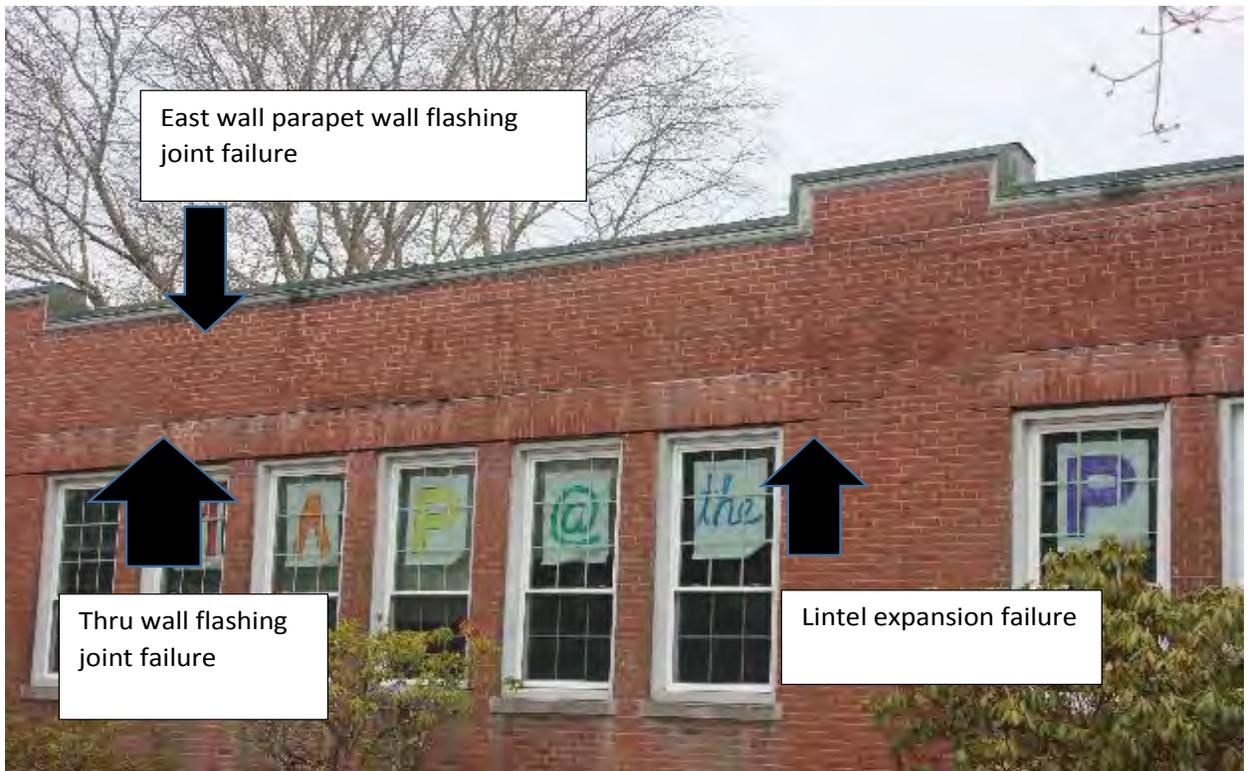
Based on the overall appearance and observed general condition of the building, the exterior walls appear to be in poor condition. On the east side of the building, large horizontal cracking is occurring along the window lintel line and where the wall transitions from structural bearing to the parapet wall. At all other lintel locations, the lintels have “rusted” to a point where the steel has “swelled” and these forces have broken the mortar joints and caused stress cracking. In many instances, the joint at the thru wall flashing, which indicates the location where the parapet wall begins has lateral cracking at this joint. This cracking appears to transmit well into the masonry assembly.

Structural/exterior envelope engineering review. The structure has such significant problems in the masonry wall at the parapet and lintel locations, and engineer review is needed immediately. See 3.2 Super structure

Masonry, flashing, repointing and structural repair as determined by the engineering review. See 3.2 Super structure

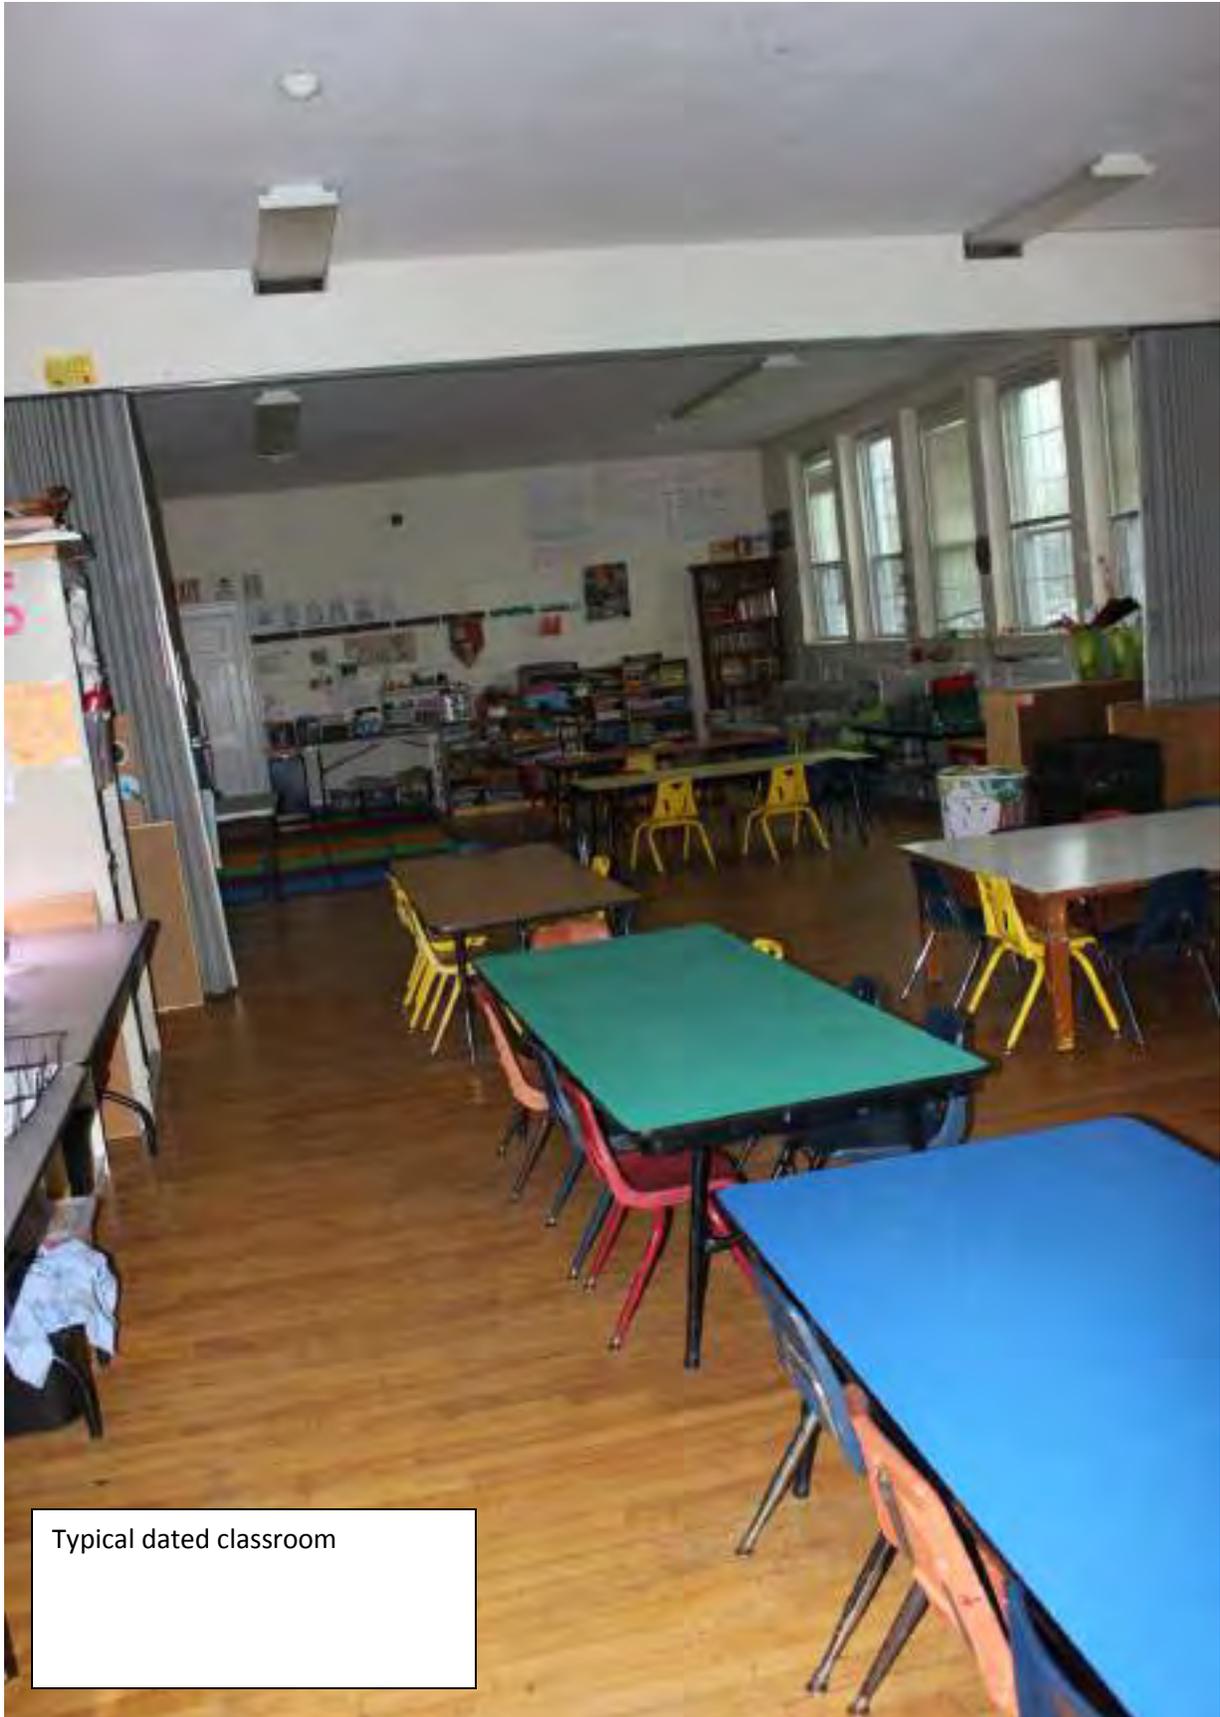
Typical dated classroom

Replacement reserves should be considered for upgrades to address all worn and dated materials as part of an interior restoration and upgrade. \$300,000

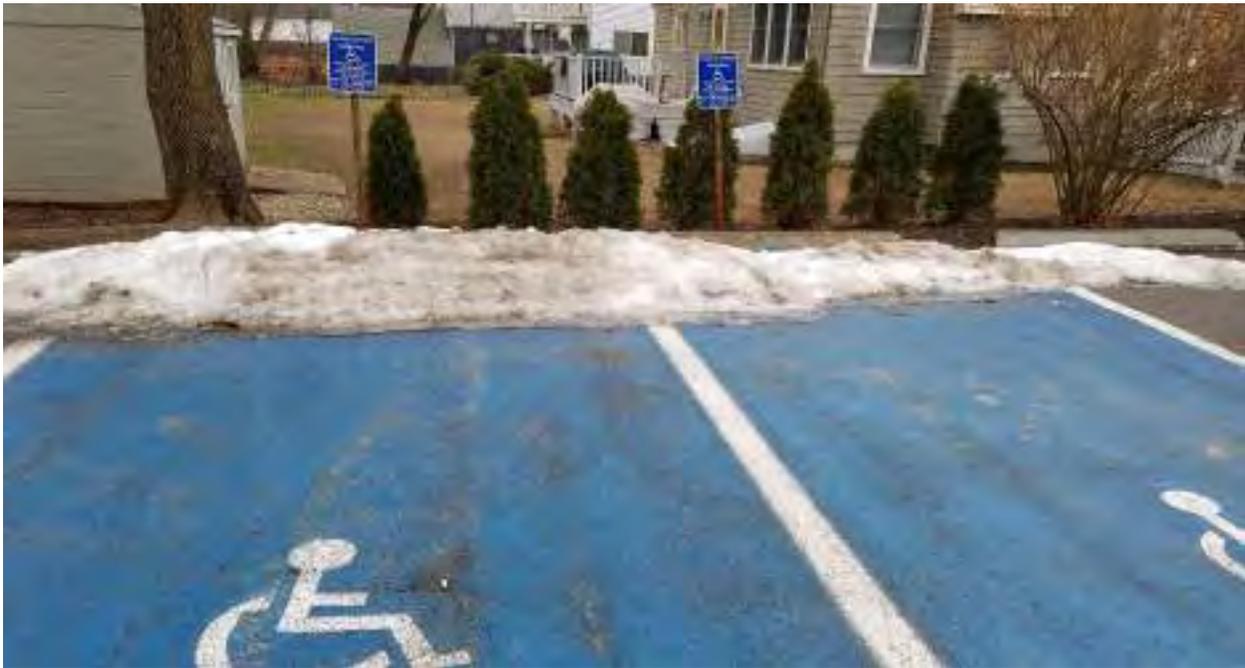
SHOWING HANDICAP PARKING SPACES & NON-COMPLIANT SIGNS

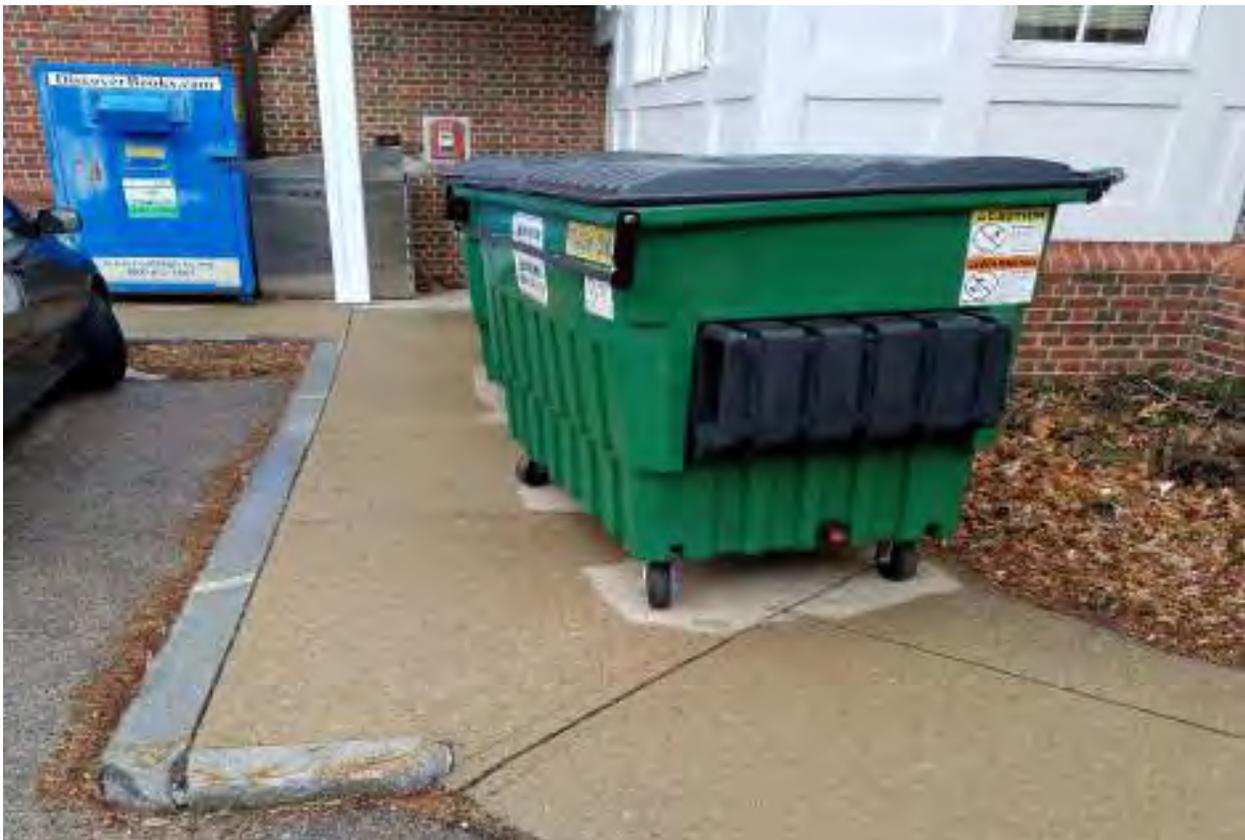
DUMPSTERS BLOCKING PATH OF TRAVEL AND BOOK DEPOSITORY BLOCKING KNOX BOX (ARROW)

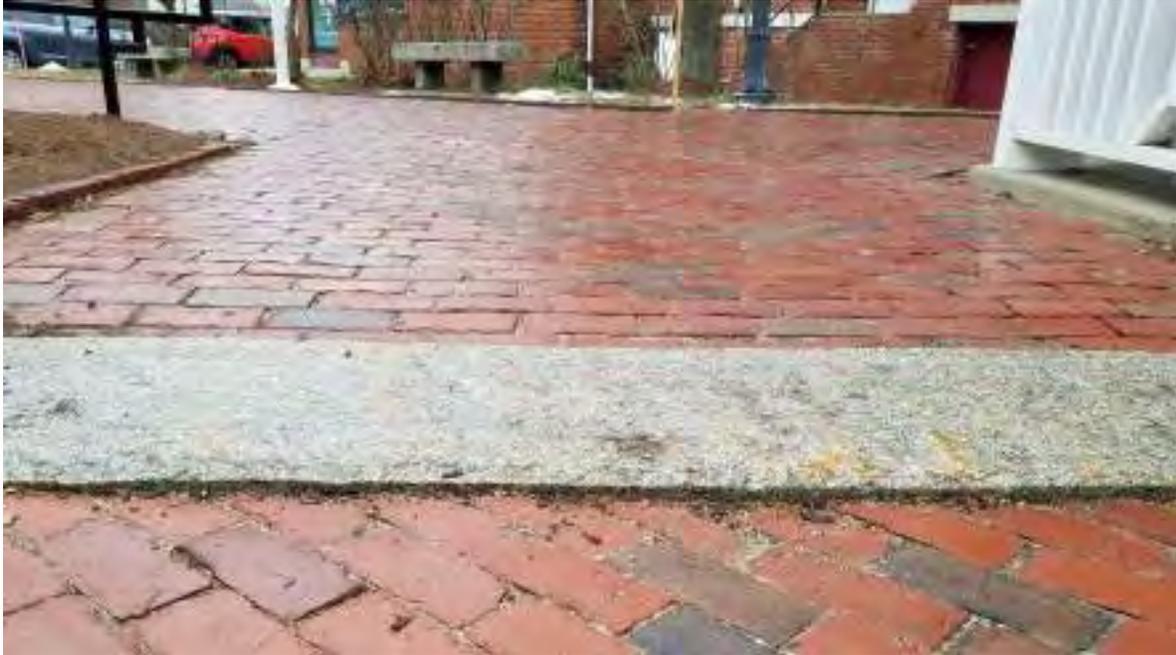
GRANITE ACCENT STRIP LIFTED CAUSING HAZARD ALONG ACCESSIBLE ROUTE

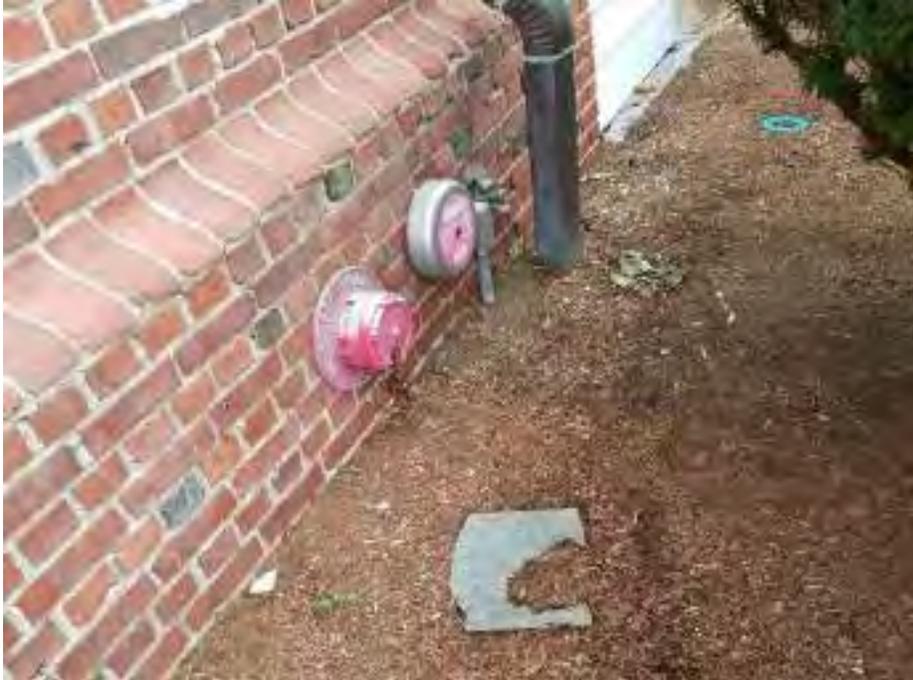
SHOWING DEMINISHED ACCESS TO FIRE DEPARTMENT CONNECTION (WEST)  
(NOTE FALLEN ROOF SLATE IN FOREGROUND)

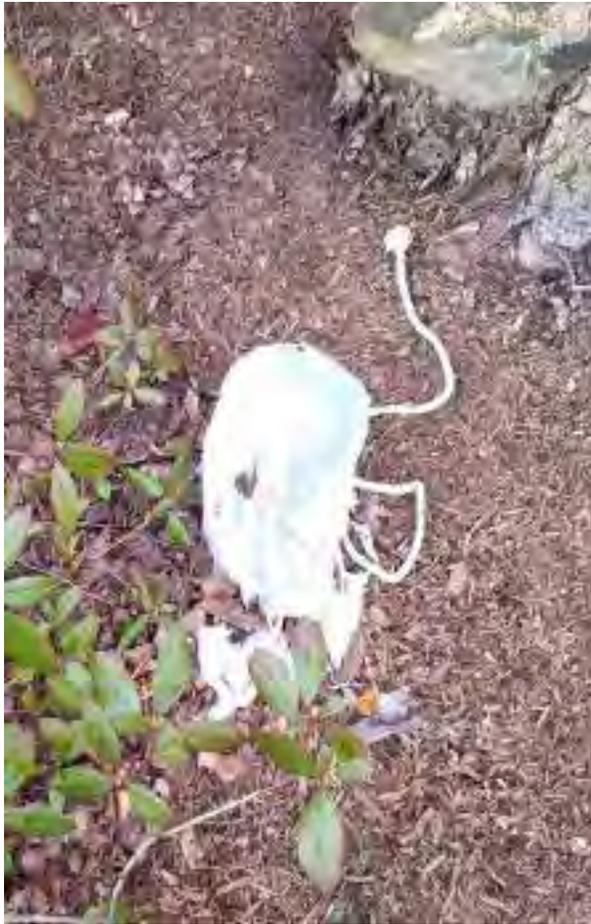
LANDSCAPING LIGHT NOT FUNCTIONING

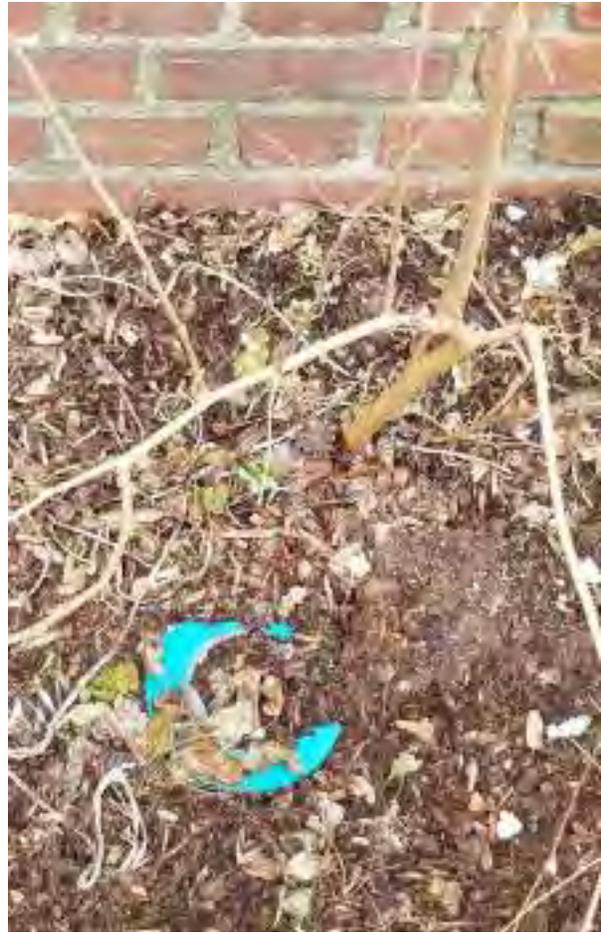
LANDSCAPING LIGHT NOT FUNCTIONING

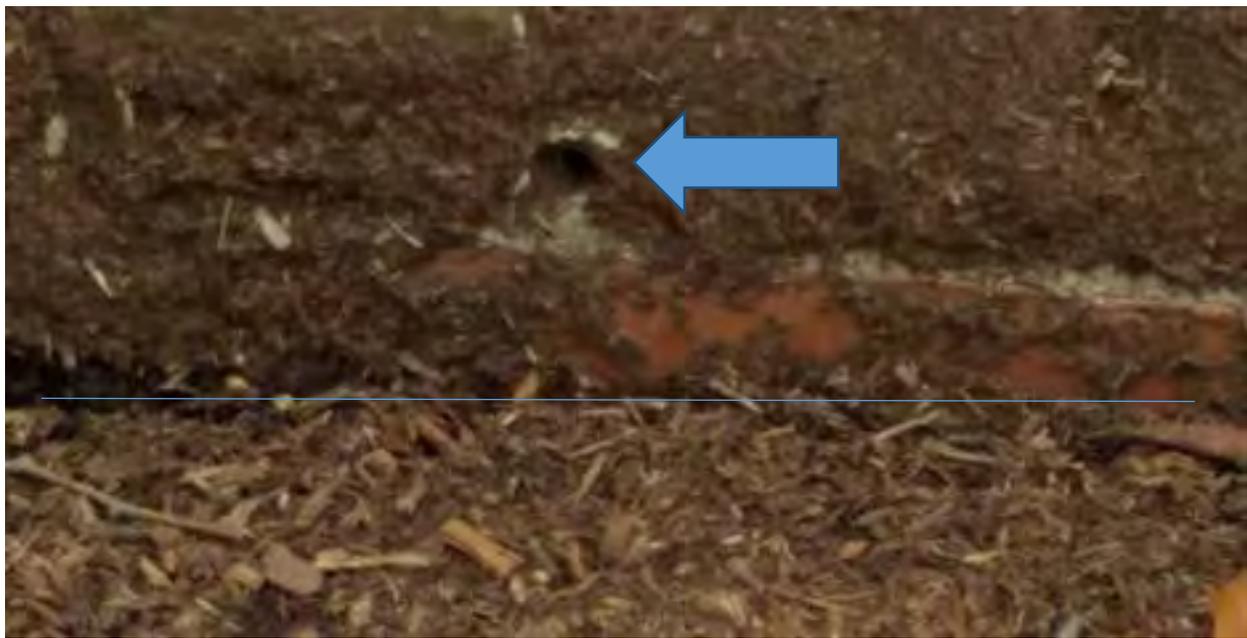
SHOWING TYPICAL CLOGGED WEEP HOLES DUE TO MULCH

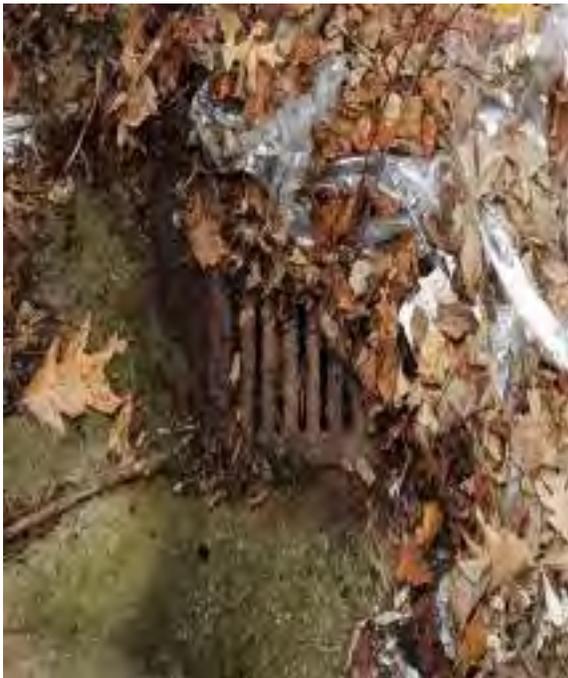
CLOGGED DRAIN IN EXTERIOR STAIRWELL

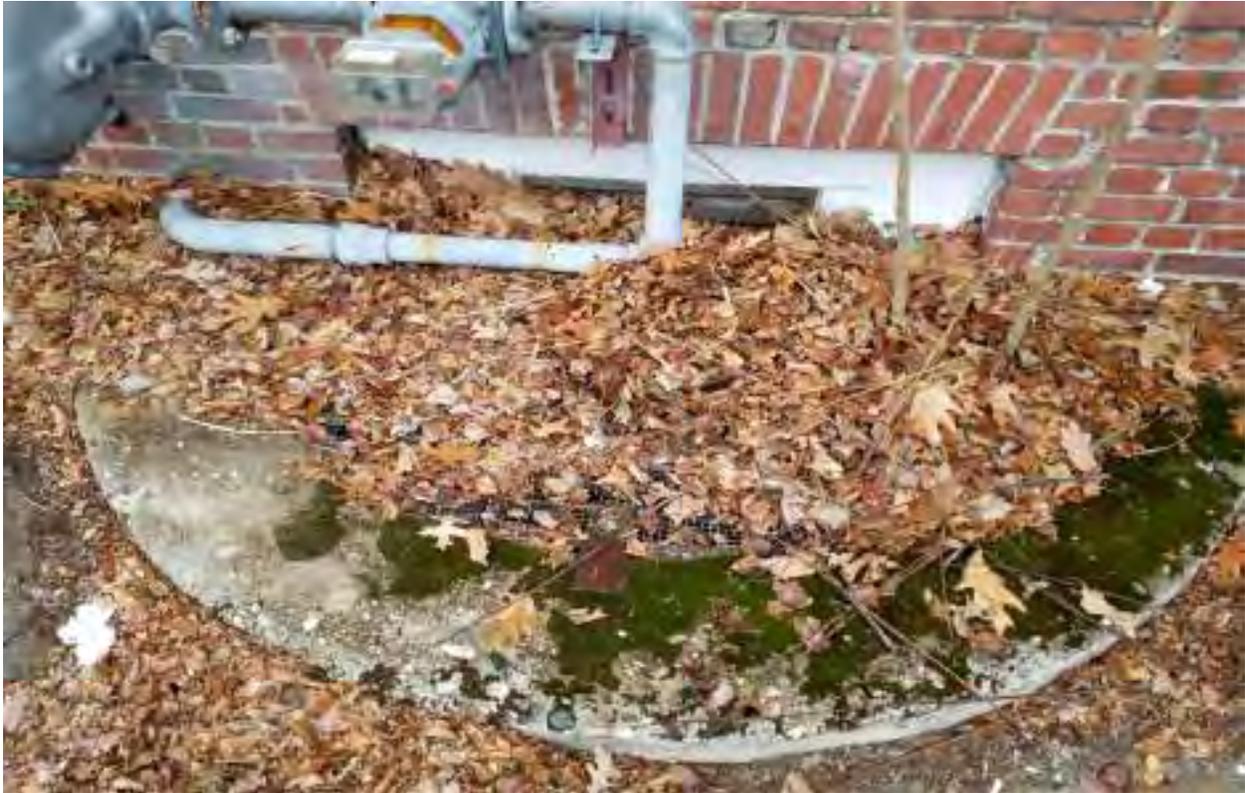
SHOWING AREA WELL DEBRIS BLOCKING MECHANICAL LOUVERS ( REAR )

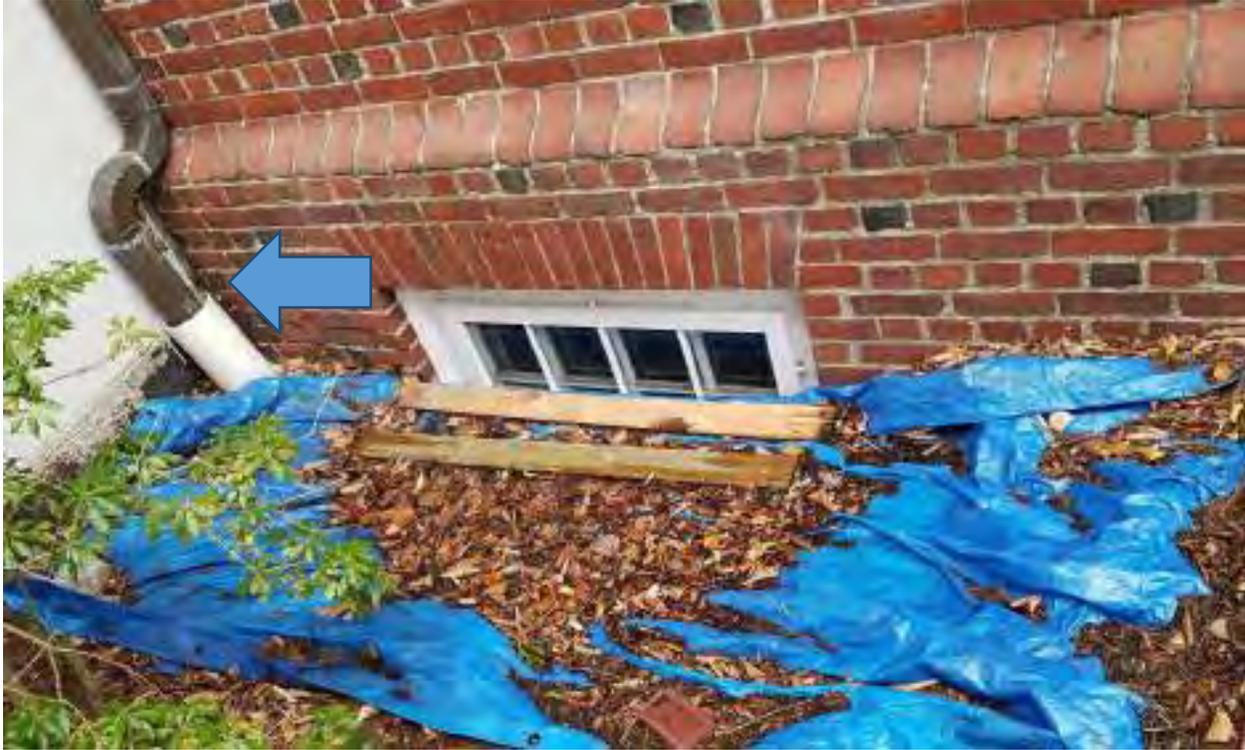
AREA WELL WITH TEMPORARY FIX and NOTE OPEN DOWNSPOUT JOINT (ARROW)
