# **TOWN OF MEDFIELD**

## **Municipal Facilities**

### **Evaluation and Capital Plan**

October 6, 2017

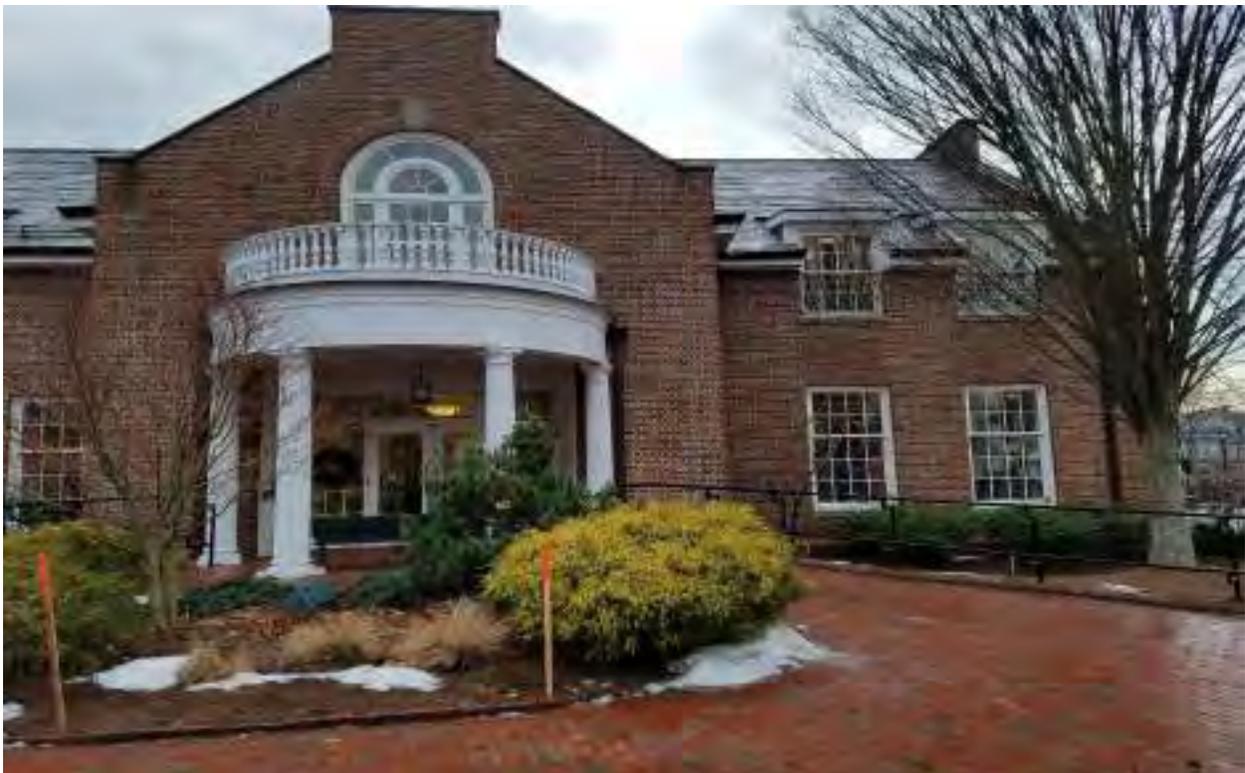
EASTERLY FACING ELEVATION SHOWING MAIN ACCESSIBLE ENTRANCE OF NEW ADDITION  
NOTE ACCESSIBLE RAILS ARE ON ONLY ONE SIDE OF RAMP

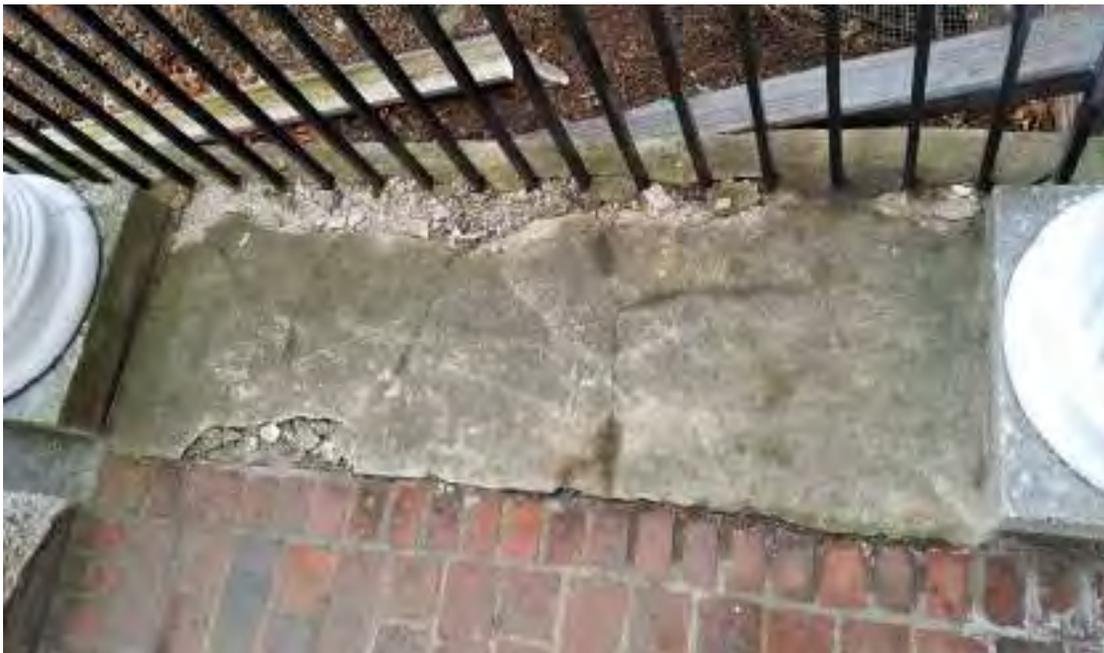
DETERIORATED EDGES OF ORIGINAL ENTRY PLATFORM (NORTH ELEVATION)

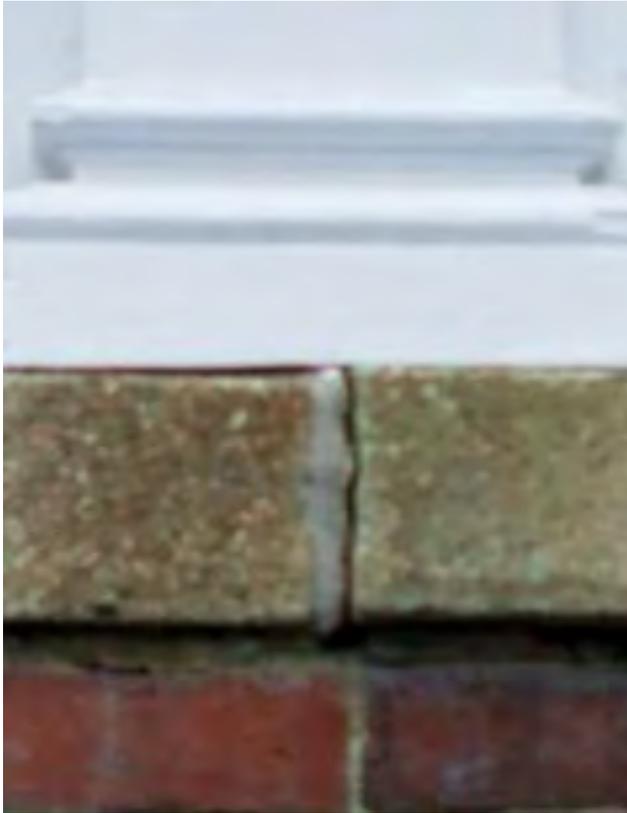
OPEN SILL JOINT TO BE REPOINTED and  
SEALANT ADDED TO WINDOW SILL ABOVE

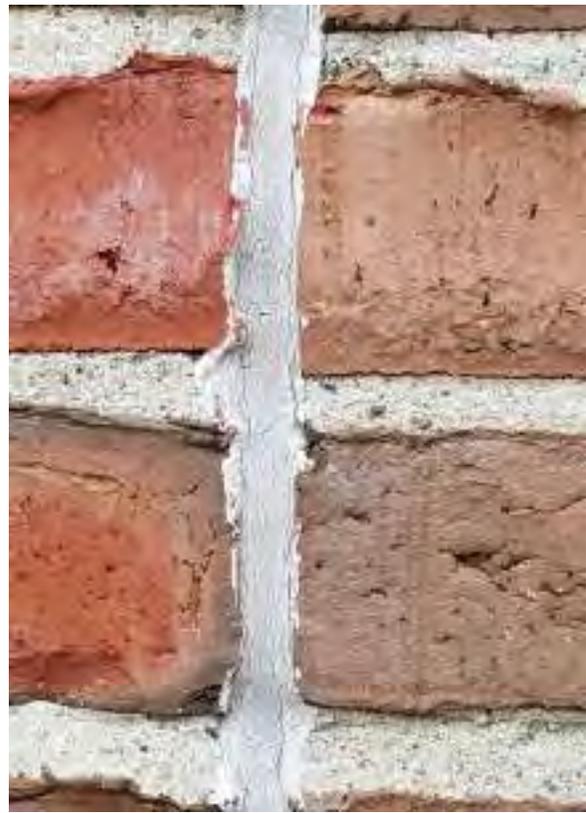
MASONRY CONTROL JOINT TO BE REDONE

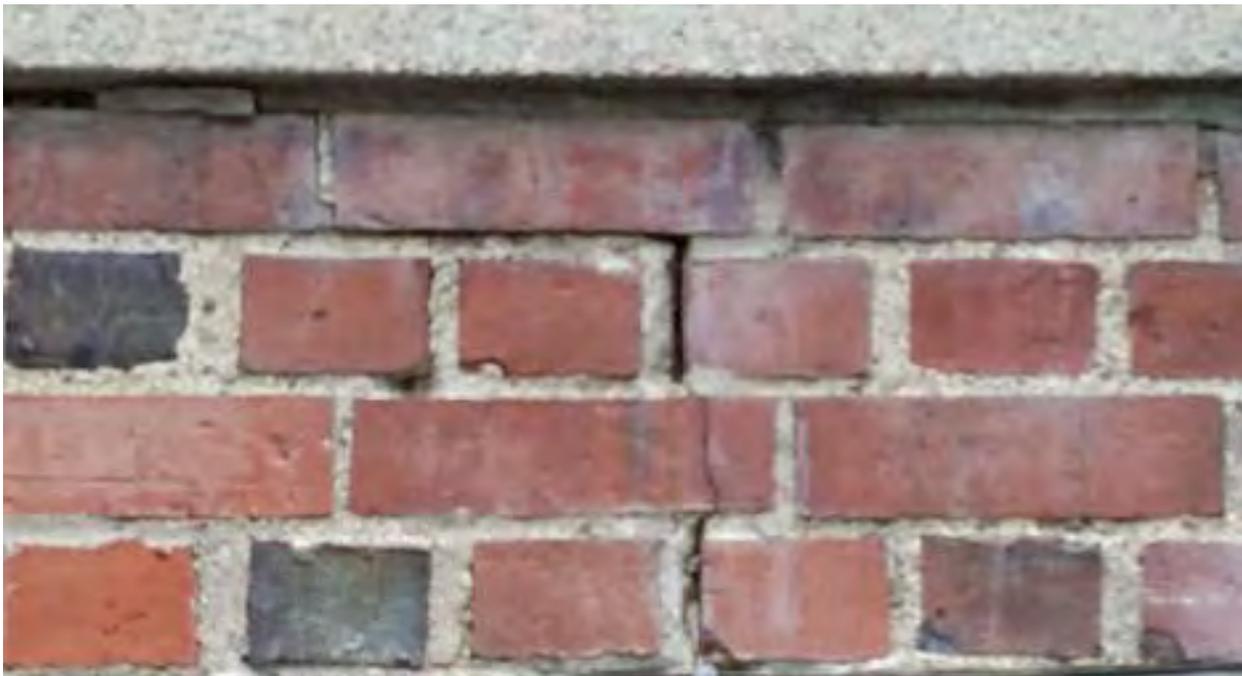
OPEN BRICK JOINTS TO BE REPOINTED (REAR ELEVATION)

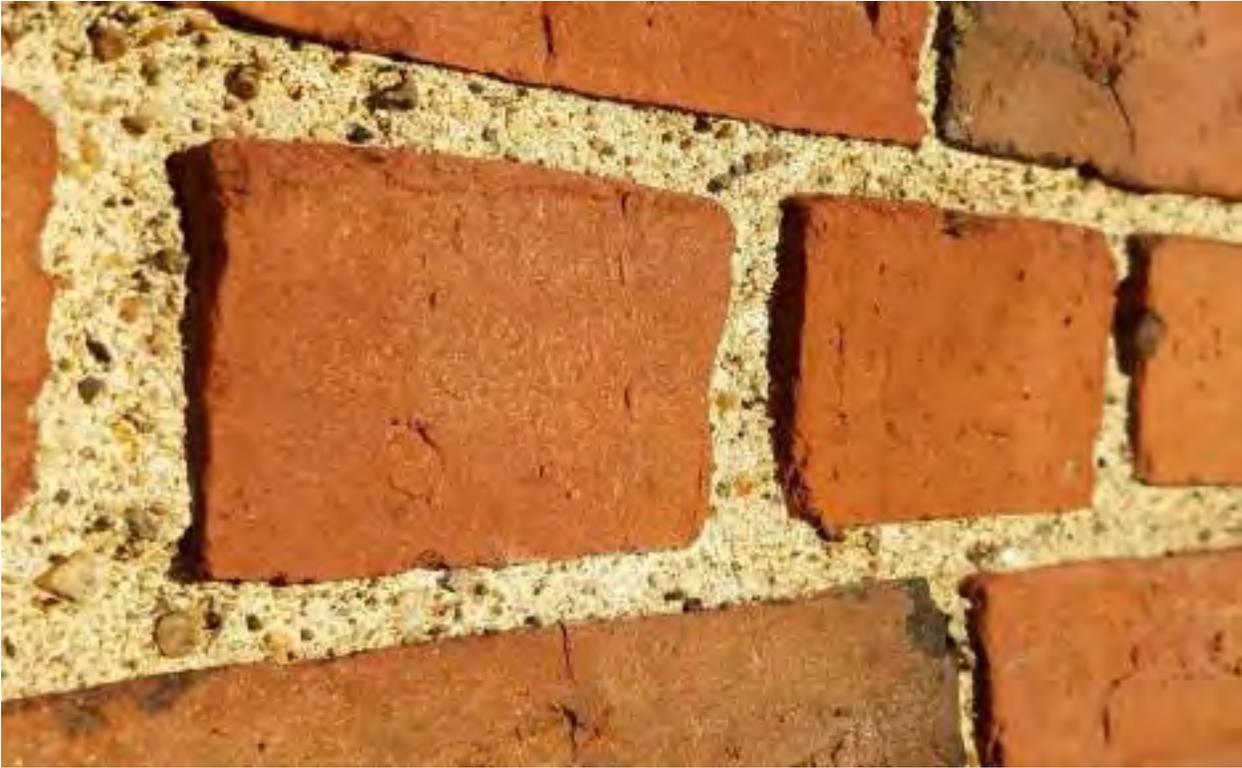
CLOSE-UP OF ORIGINAL MORTAR JOINTS SHOWING COURSE TEXTURE and WIDE SPREAD EFFLORESCENCE

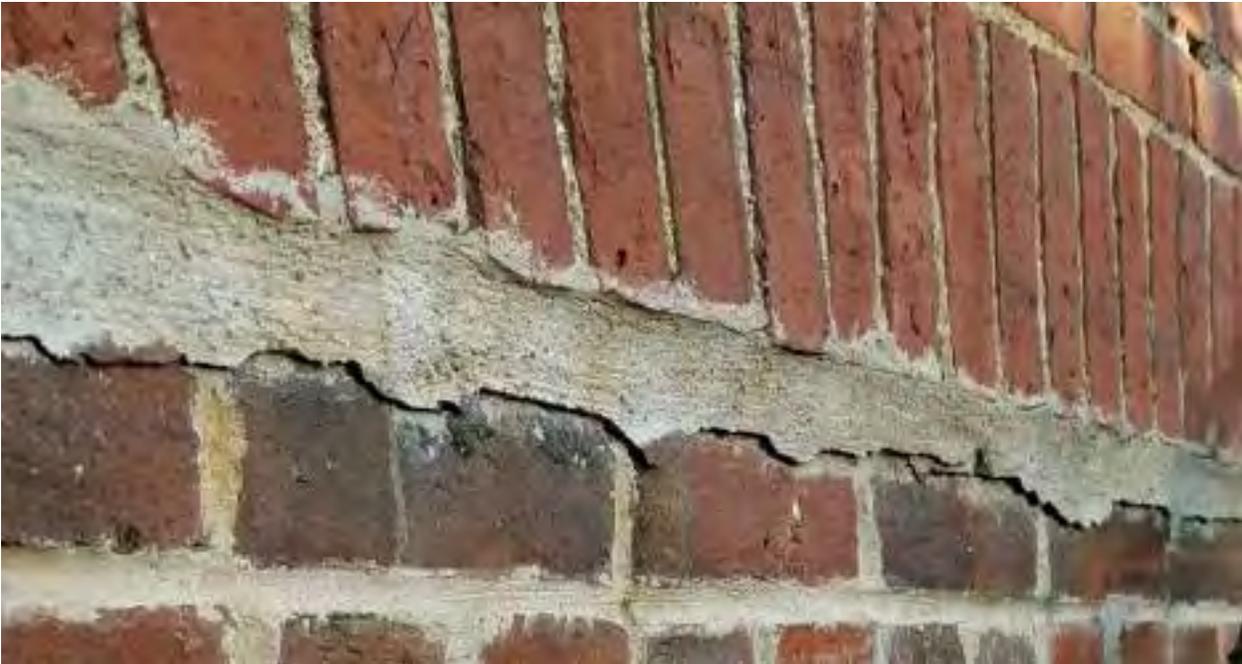
POORLY EXECUTED REPOINTING (WEST ELEVATION)

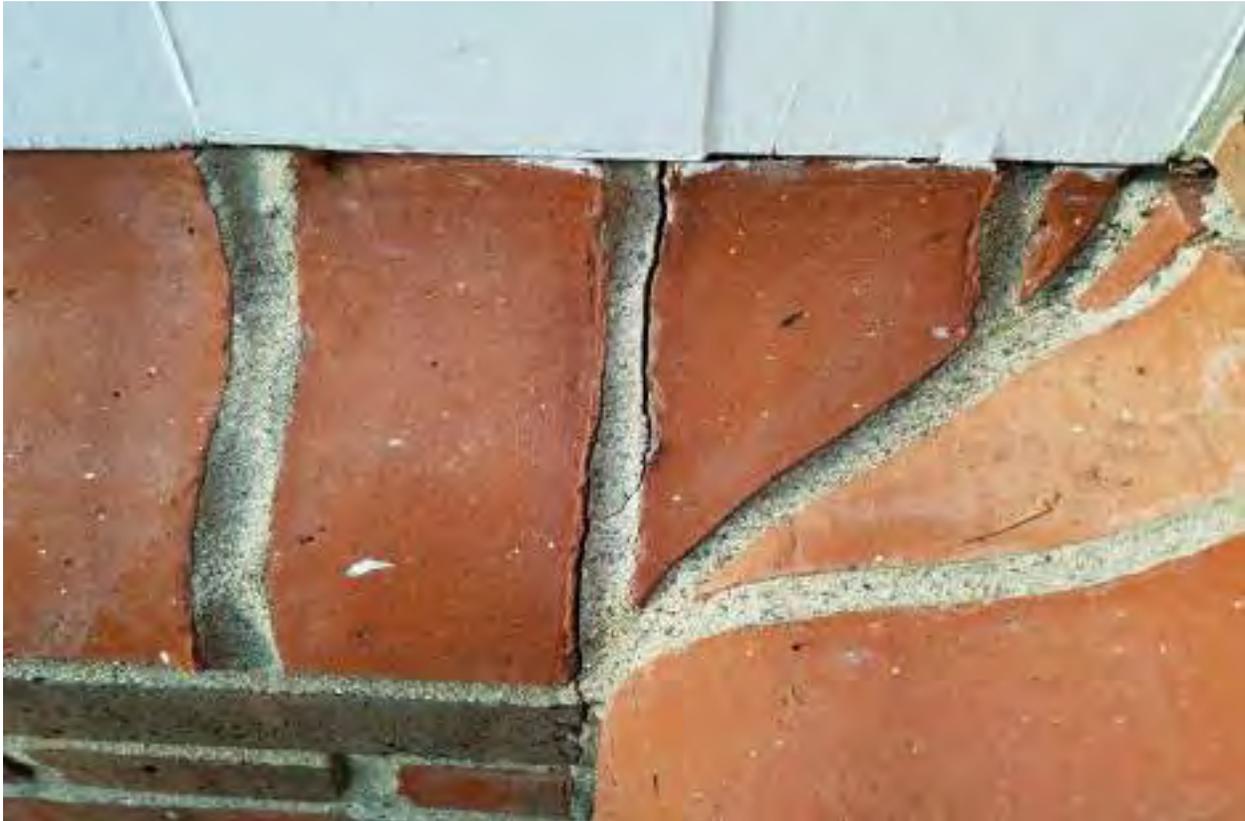
TYPICAL OPEN JOINTS IN WATER TABLE BRICK JOINTS NEEDING REPOINTING

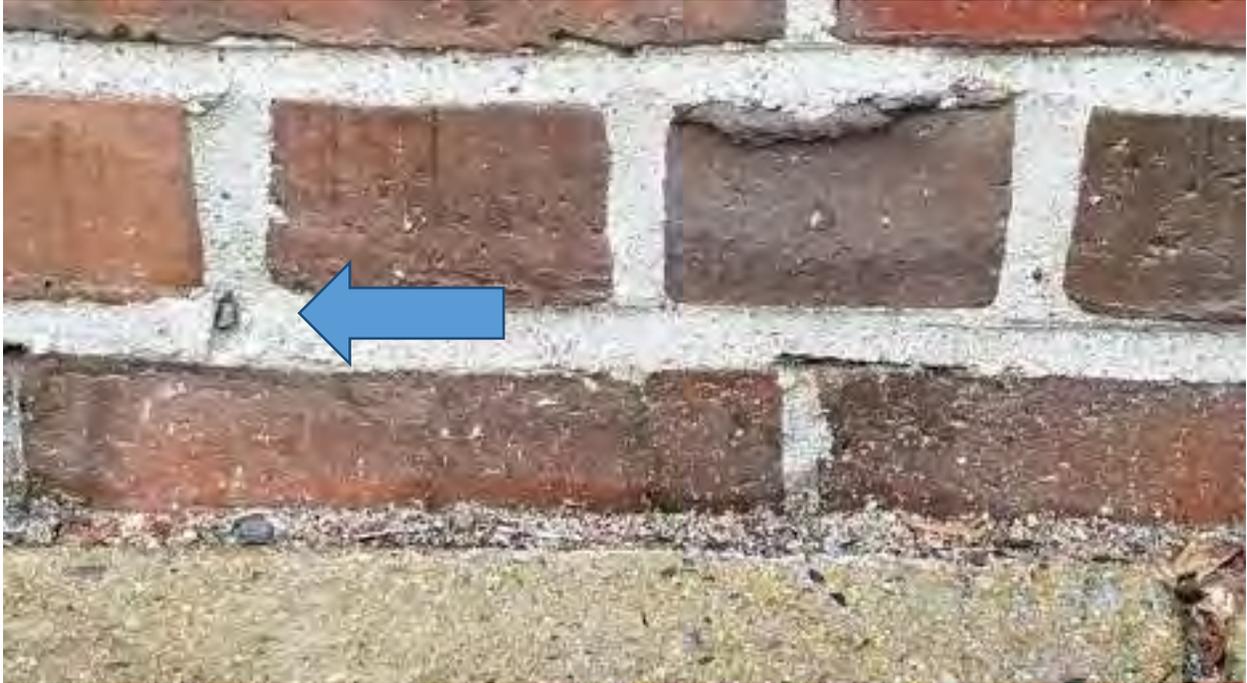
WEEP HOLES BLOCKED (REAR) ALONG SIDEWALK

TYPICAL WEEP HOLES BLOCKED BY MULCH BEDS

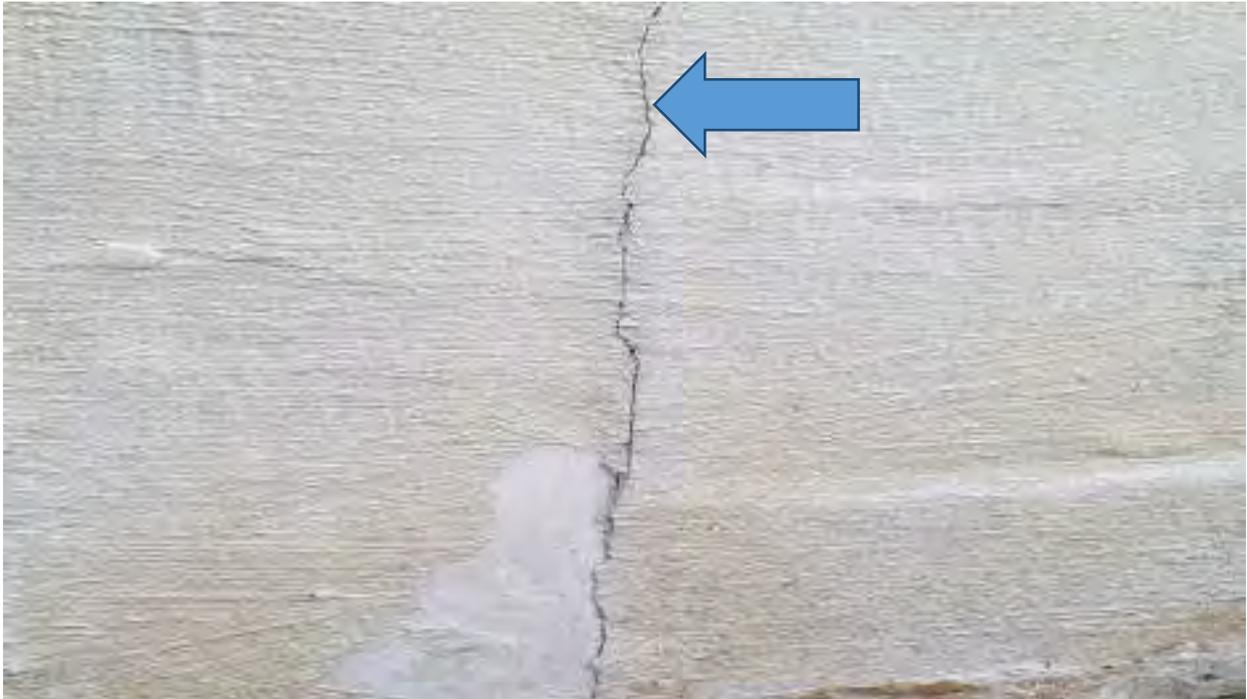
STUCCO PARGING IN EXTERIOR STAIRWELL NEEDING REPAIR and CONTROL JOINT

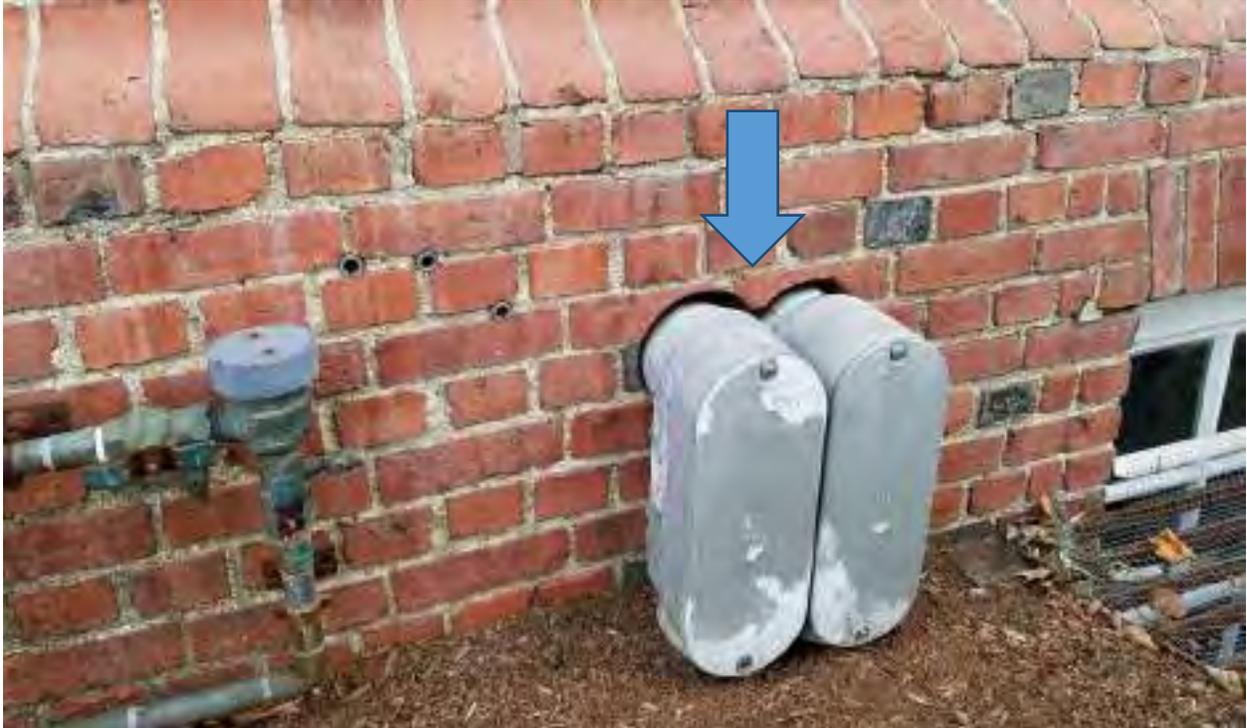
PROVIDE SEALANTS AROUND ELECTRICAL SERVICE PENETRATIONS (WEST)

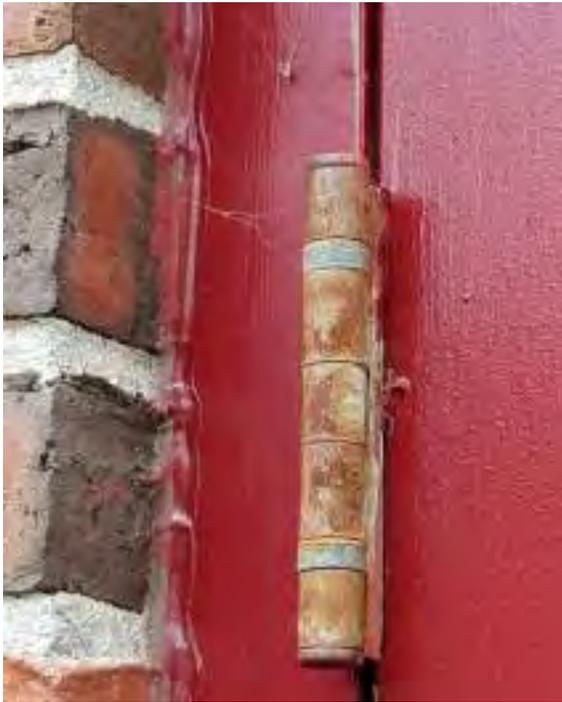
RUSTED DOOR HINGES (SOUTH ELEVATION)

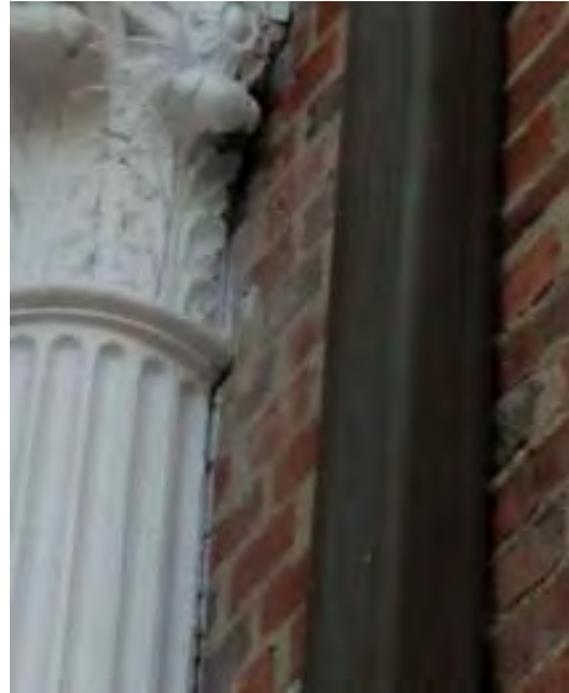
ORIGINAL FRONT COLUMN NEEDING SEALANT

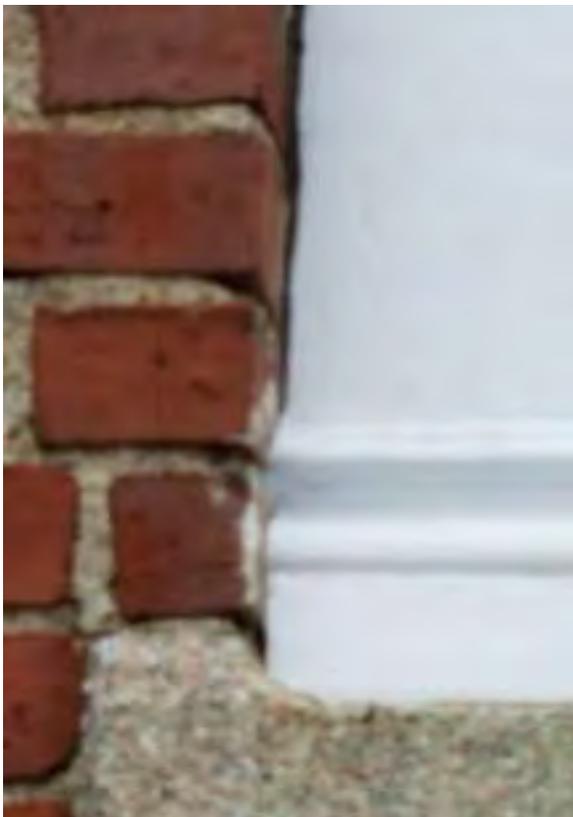
WOOD WINDOW TRIM NEEDING SEALANT

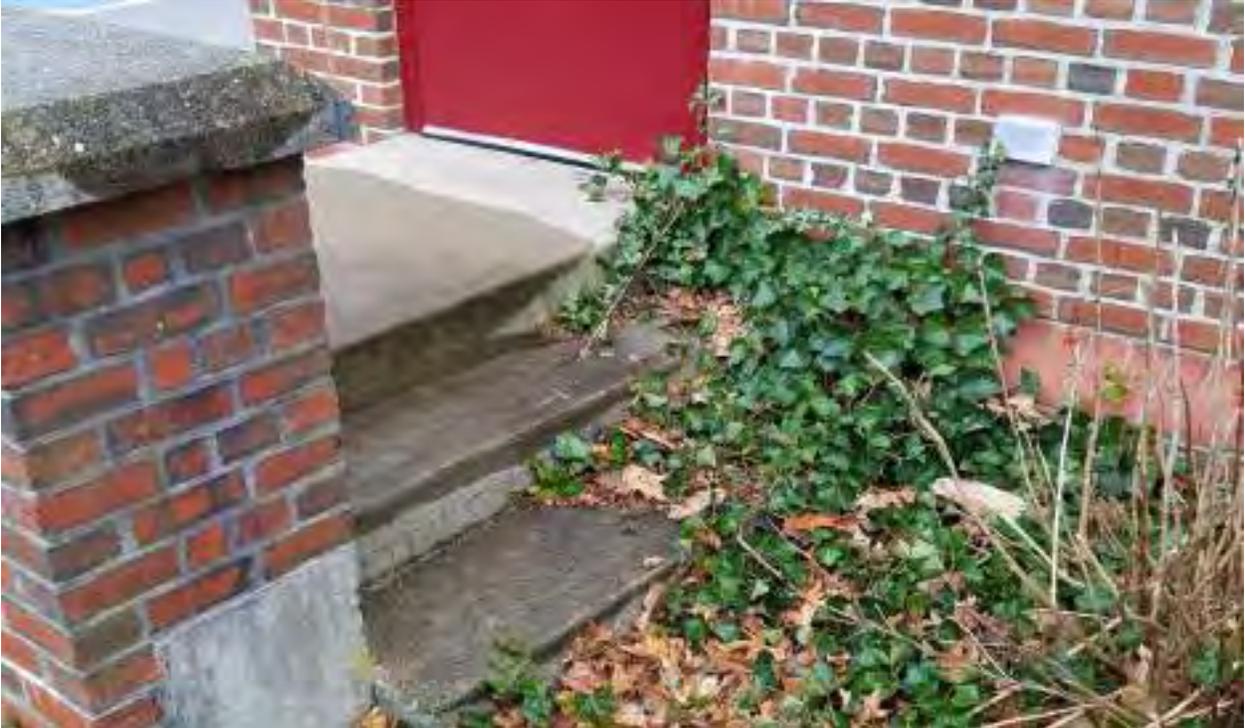
3-RISER STEPS WITH NO HANDRAILS and OVERGROWN WITH VEGETATION (EAST ELEVATION)

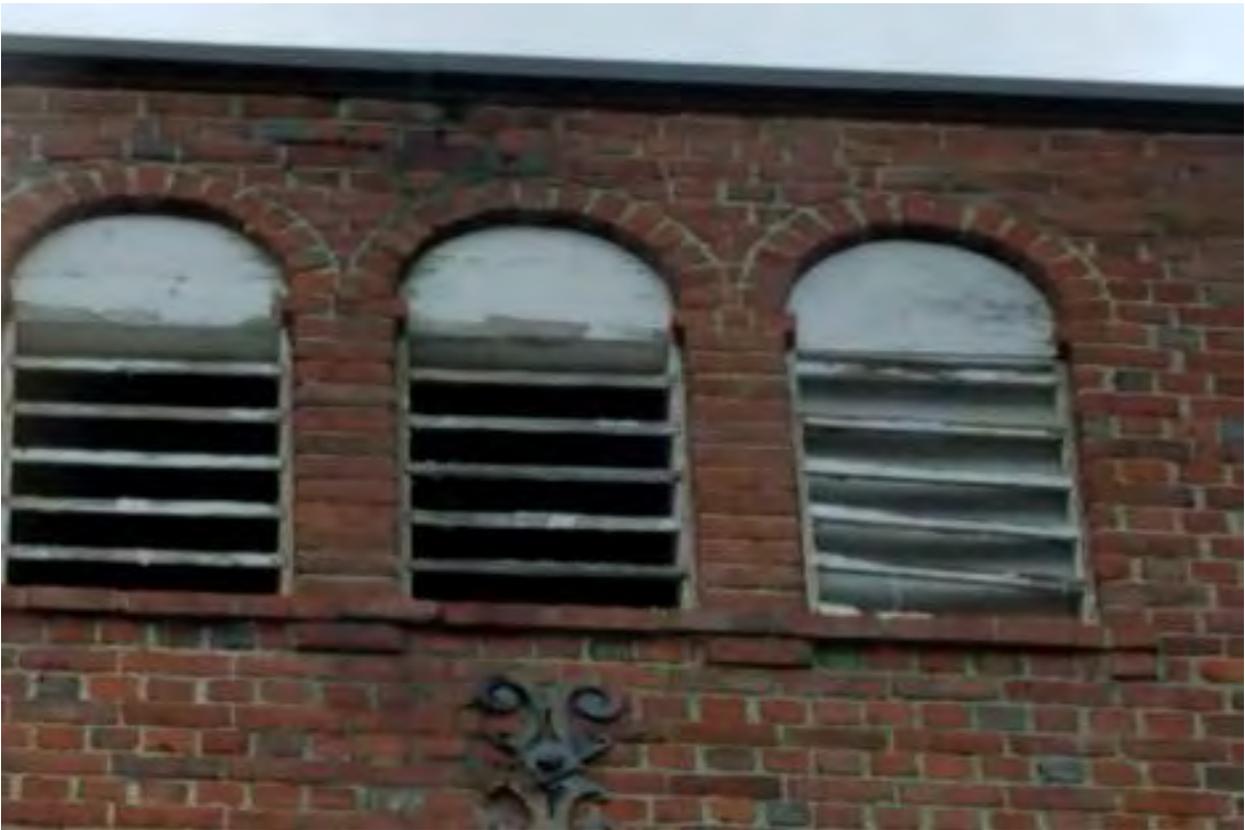
LOUVERS AND CAST IRON BRACKETS NEEDING PAINTING (REAR ELEVATION)

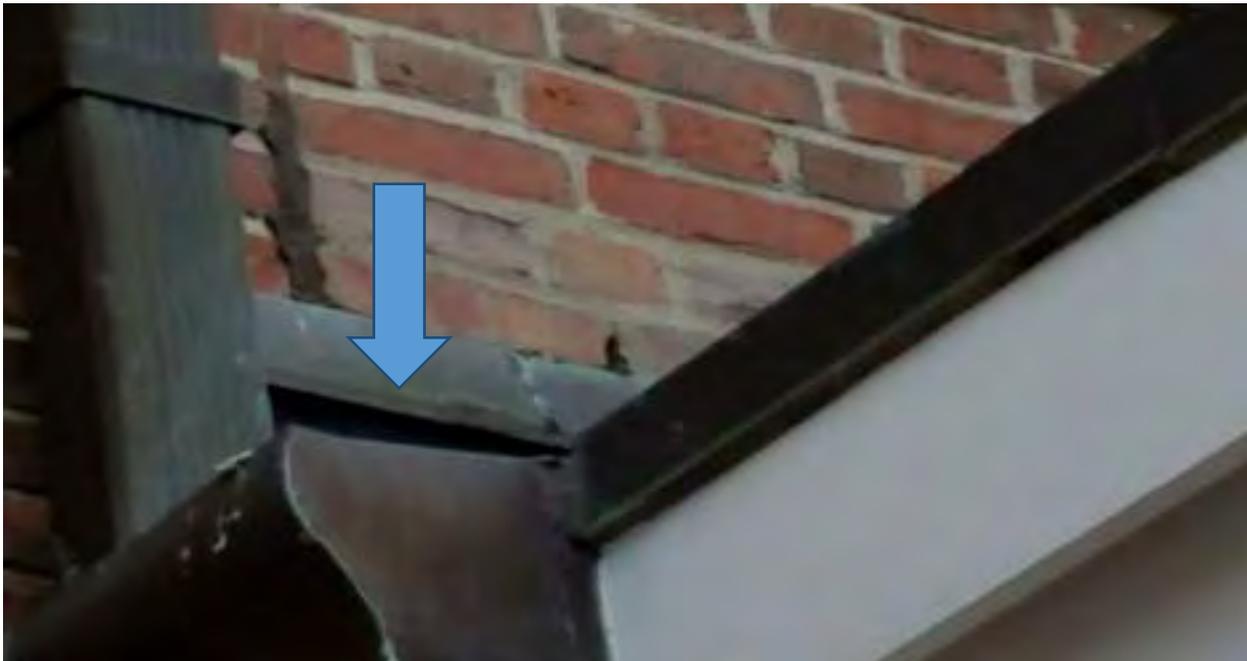
UPLIFTED COUNTER FLASHING (ARROW) ON REAR ELEVATION

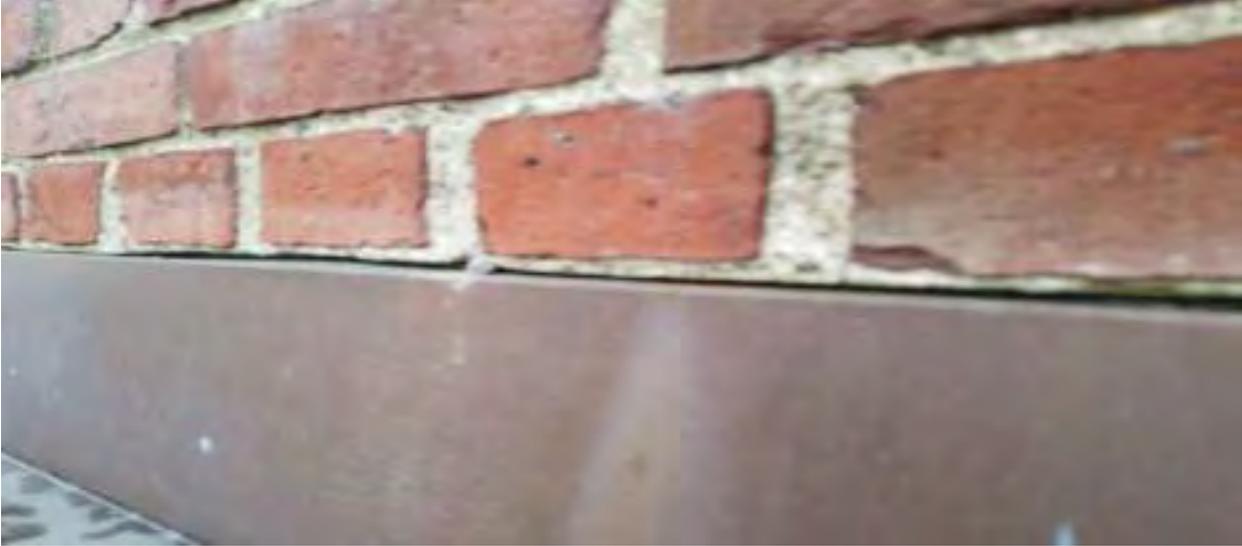
OPEN FLASHING JOINT AT REAR ELEVATION ABOVE STANDING SEAM ROOF

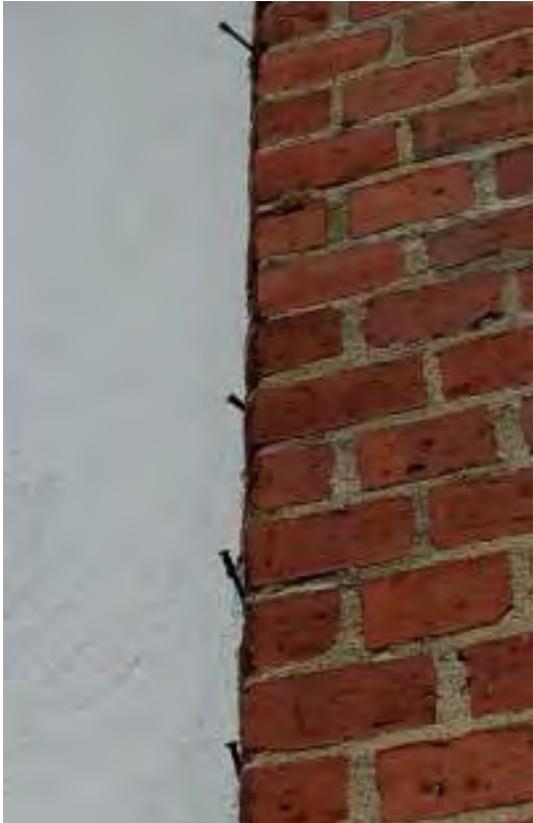
RUSTY OLD FASTENERS TO BE REMOVE

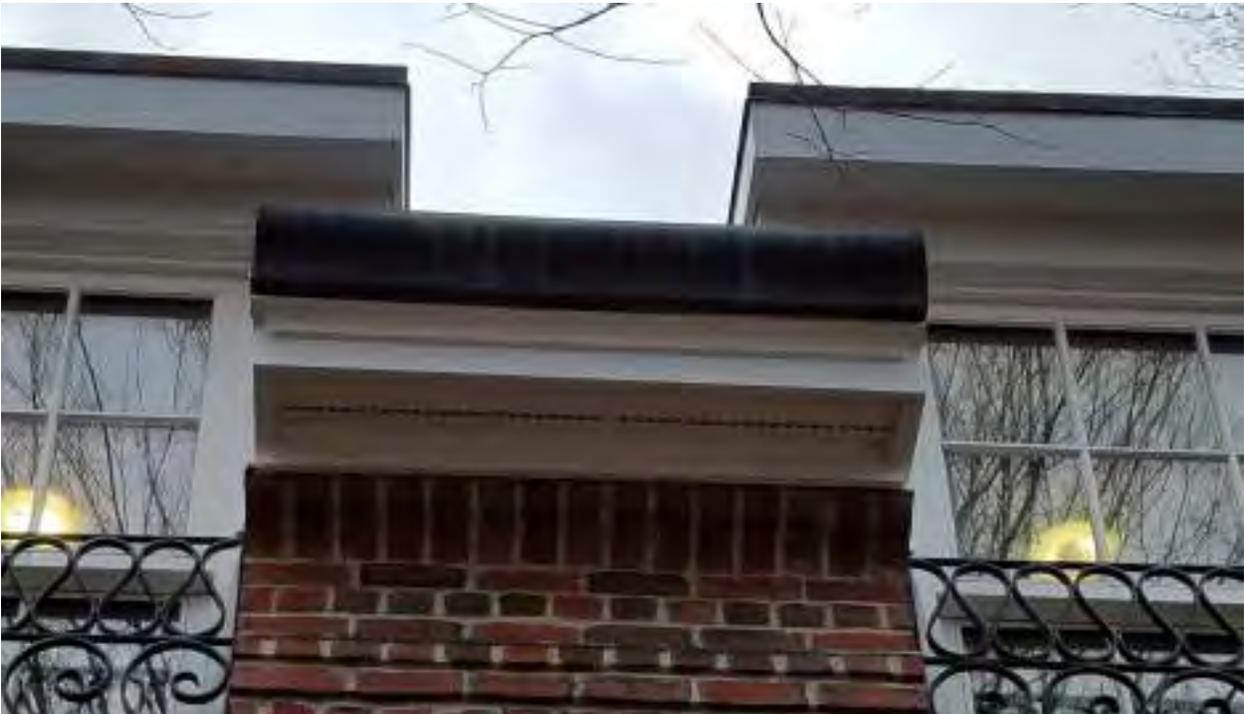
GUTTER WITH NO APPARENT DOWNSPOUT (EAST ELEVATION)

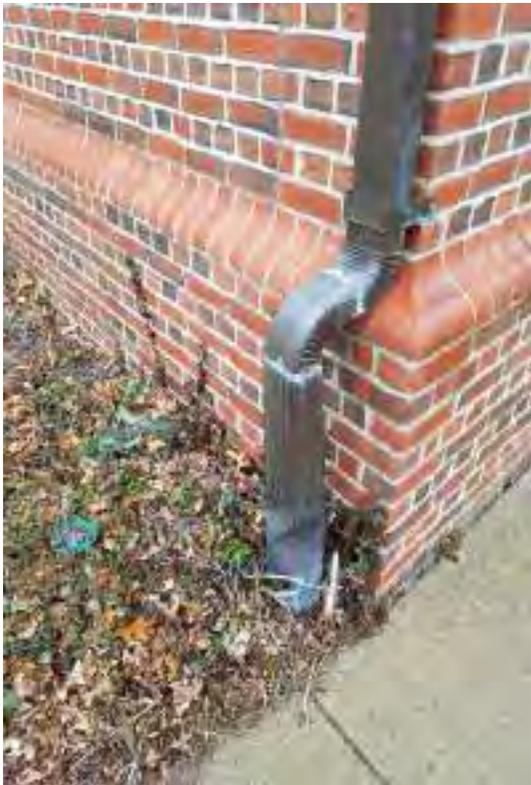
DAMAGED DOWNSPOUT

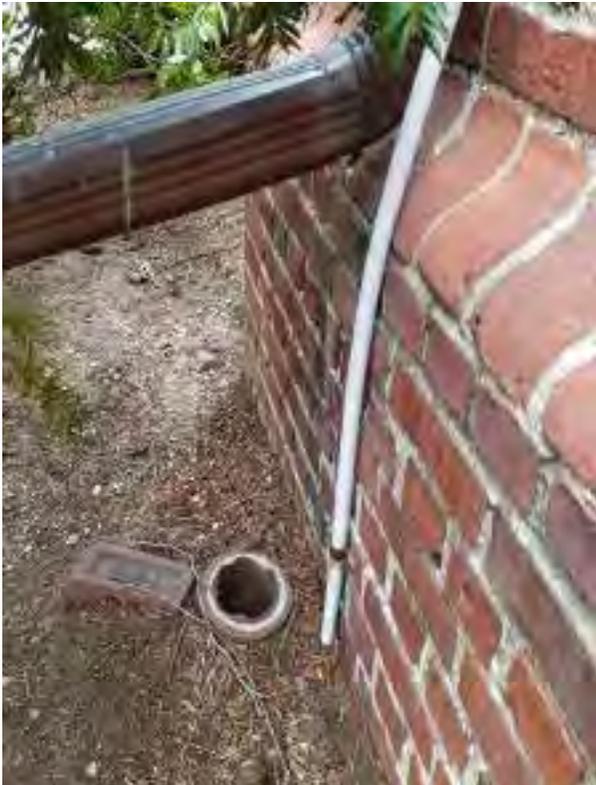
UNCONNECTED DOWNSPOUT

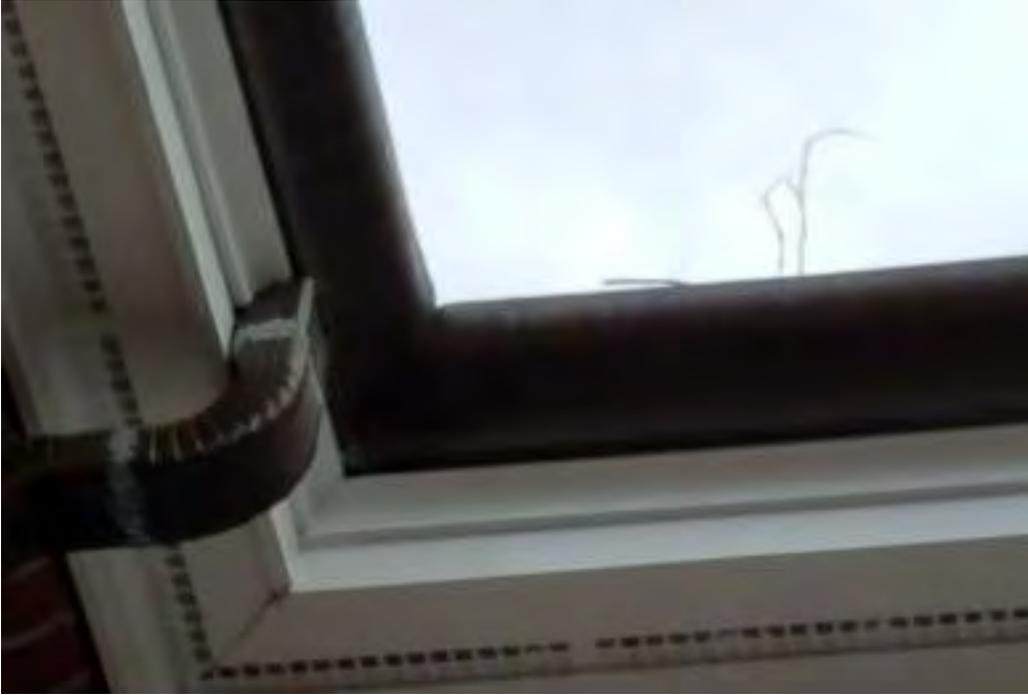
VEGETATION IN GUTTERS

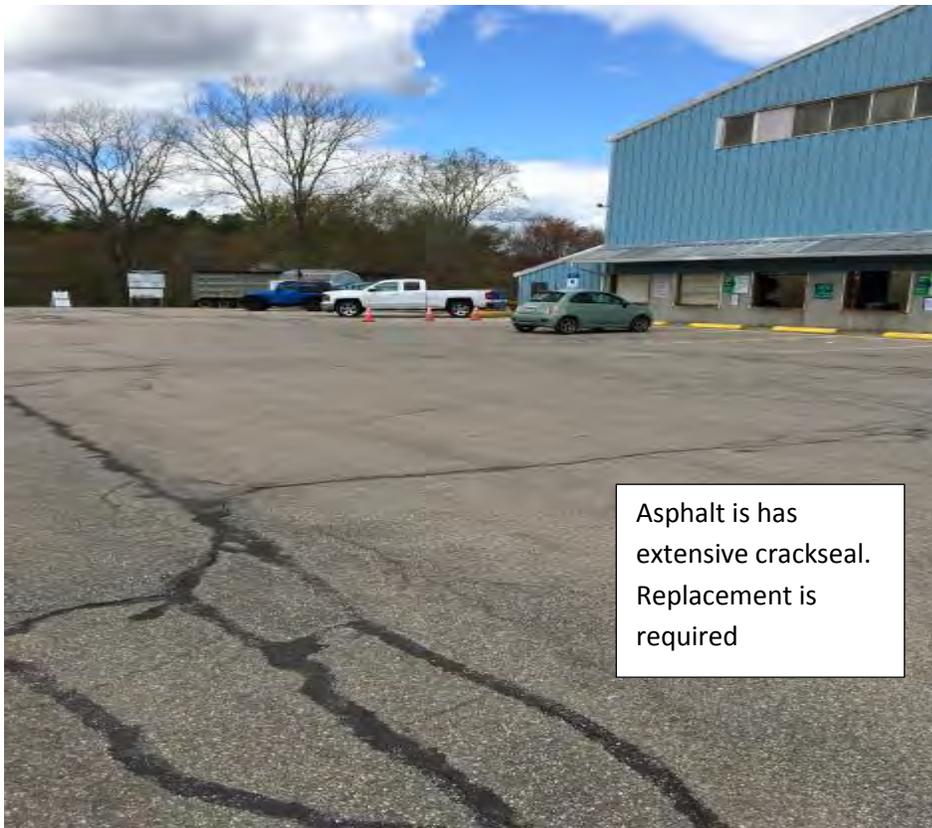
Asphalt is has  
extensive crackseal.  
Replacement is  
required

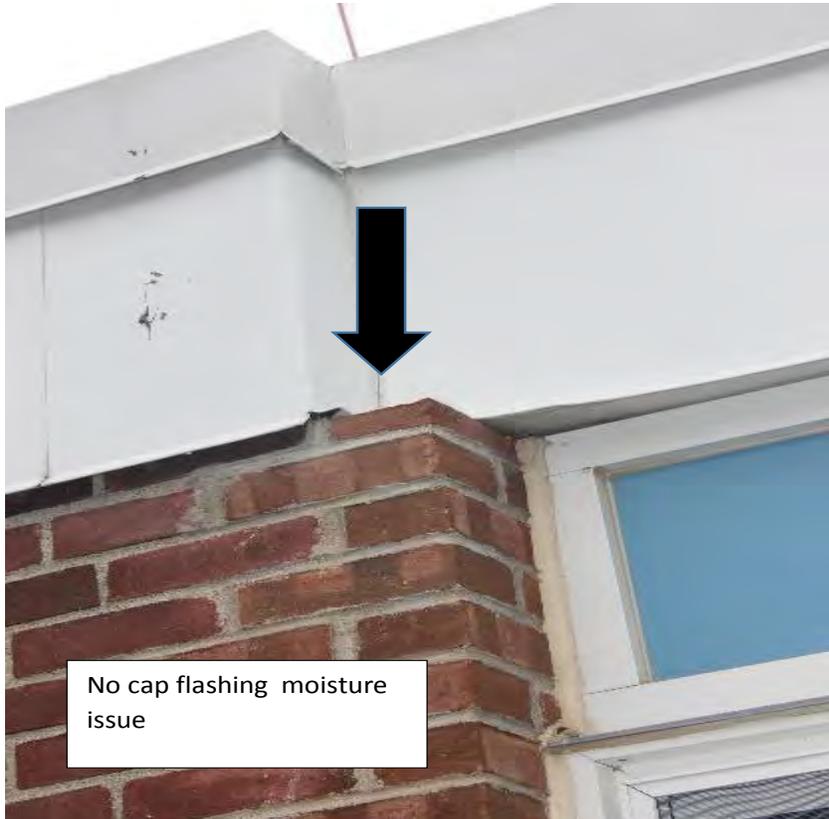
No cap flashing moisture issue

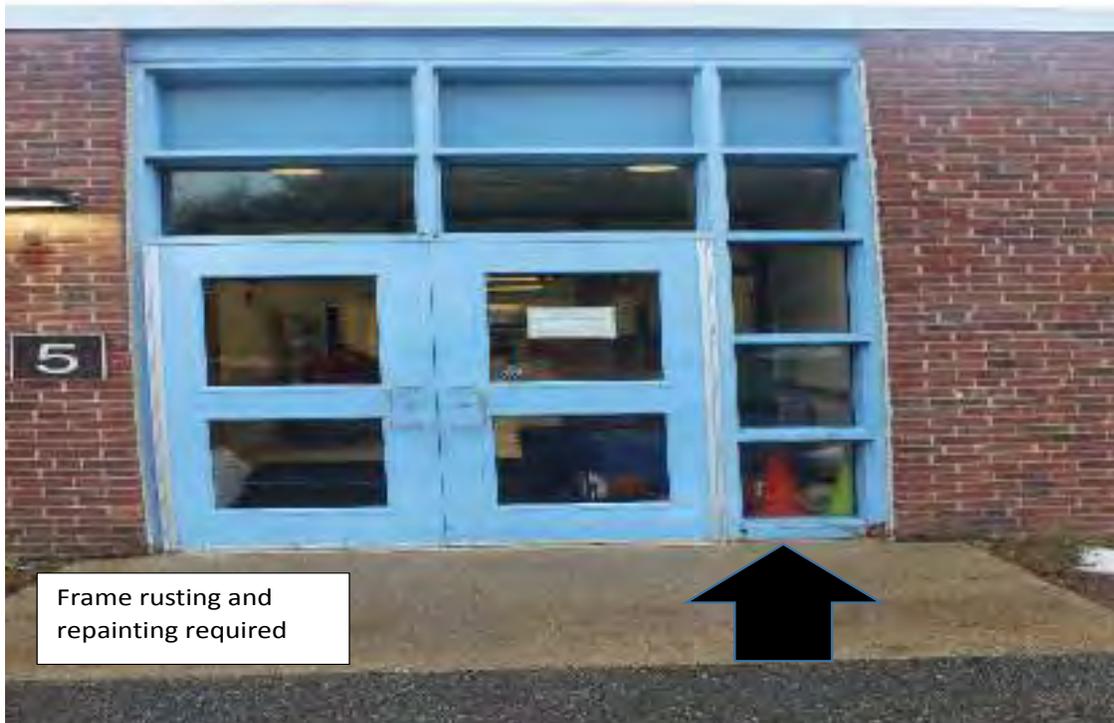
Frame rusting and repainting required

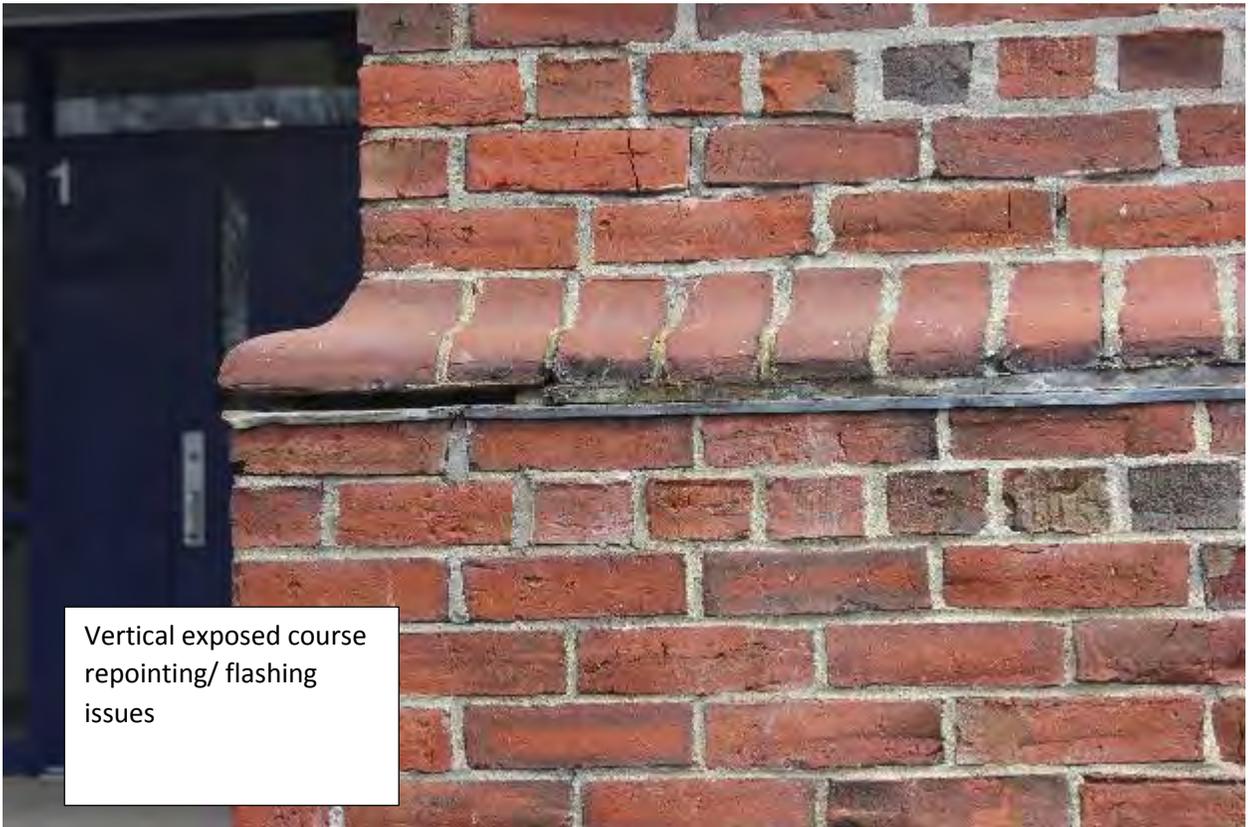
Vertical exposed course  
repointing/ flashing  
issues

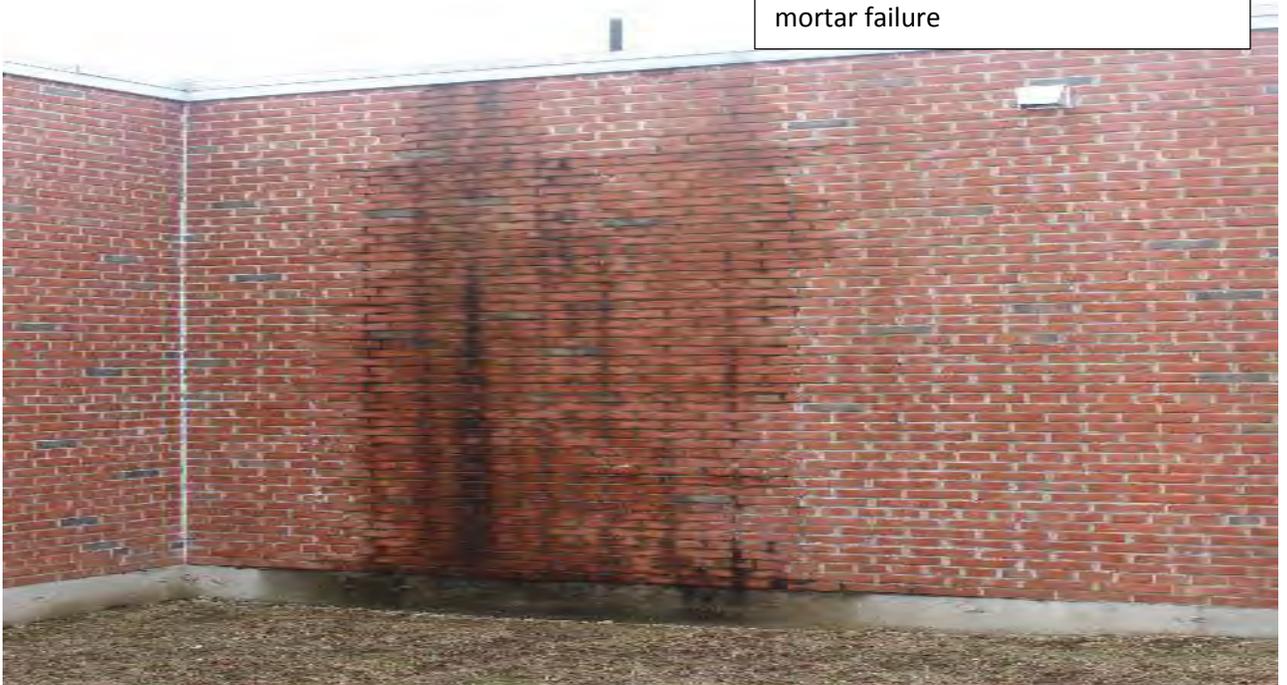
Gutter has deflected due to snow. Leaks in gutter allow water to wash down brick creating excessive moisture

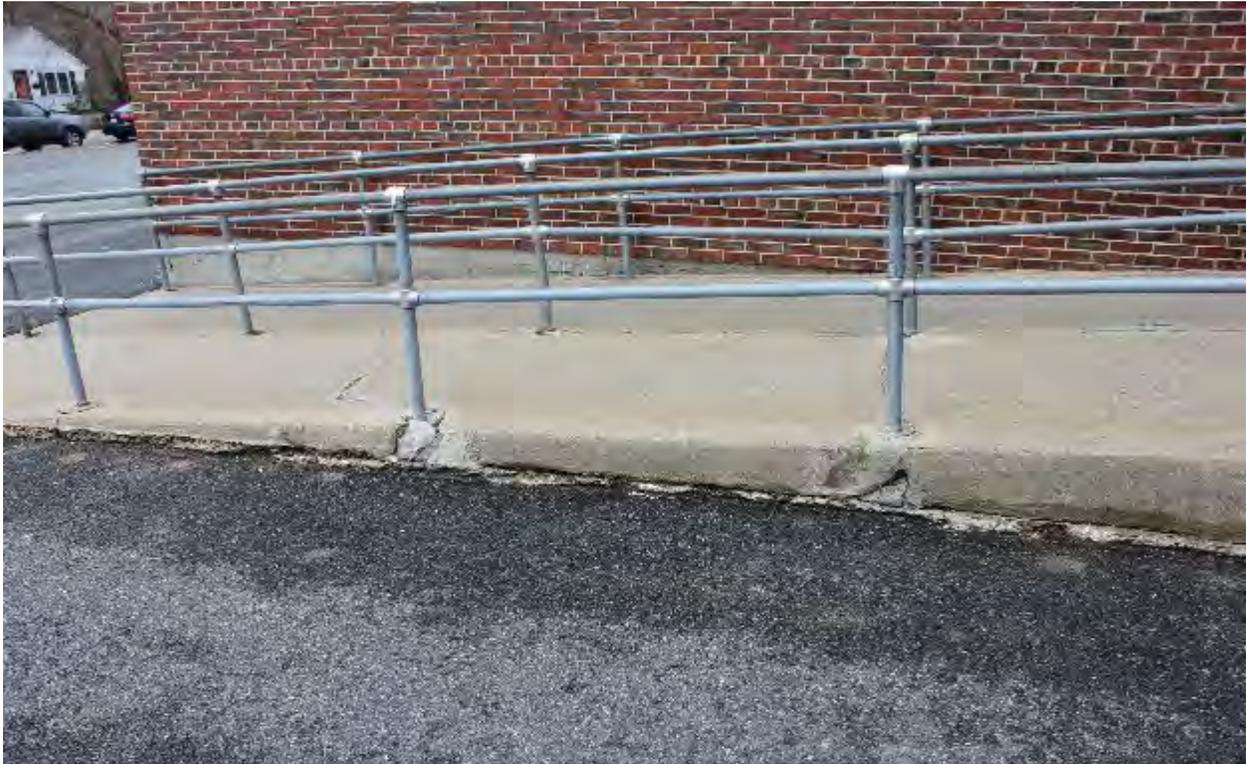
Non-Compliant Handicap ramp and rail system

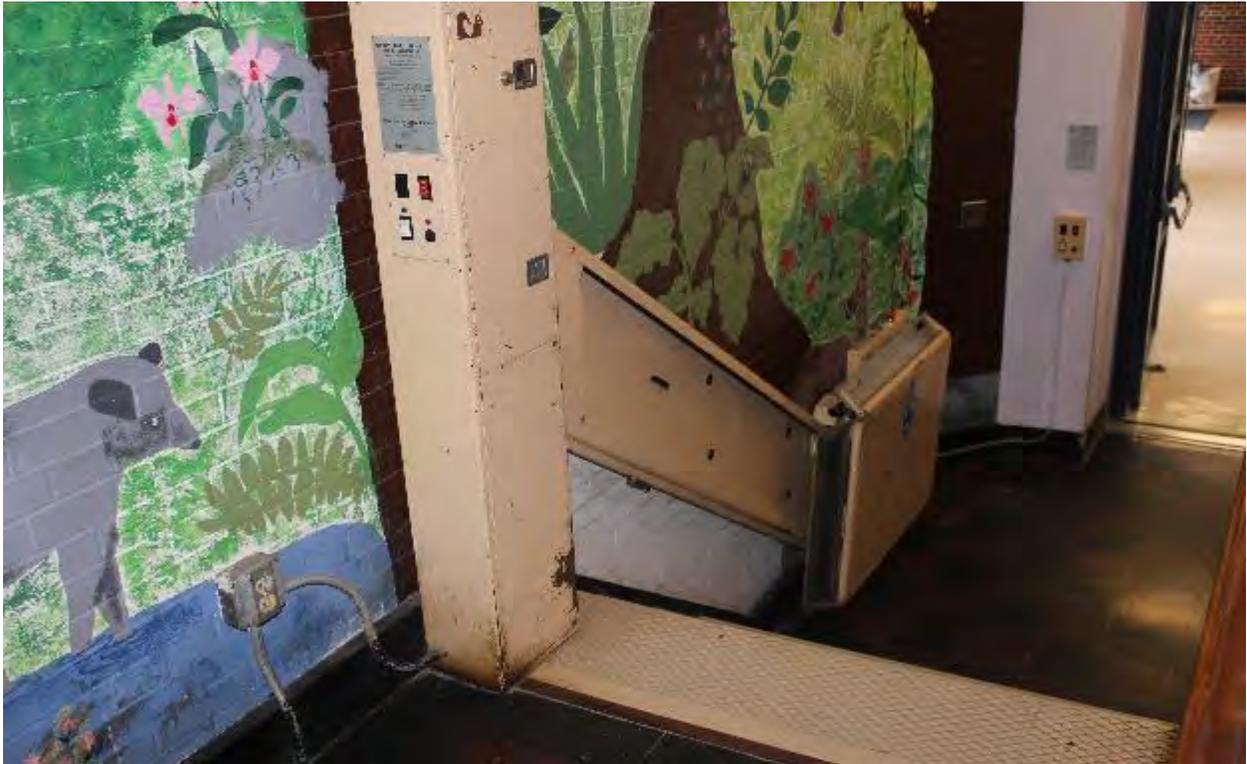
Handicap accessible lift in stair (No longer allowed by code) Note no elevator to second floor.
