# **TOWN OF MEDFIELD**

## **Municipal Facilities**

### **Evaluation and Capital Plan**

October 6, 2017

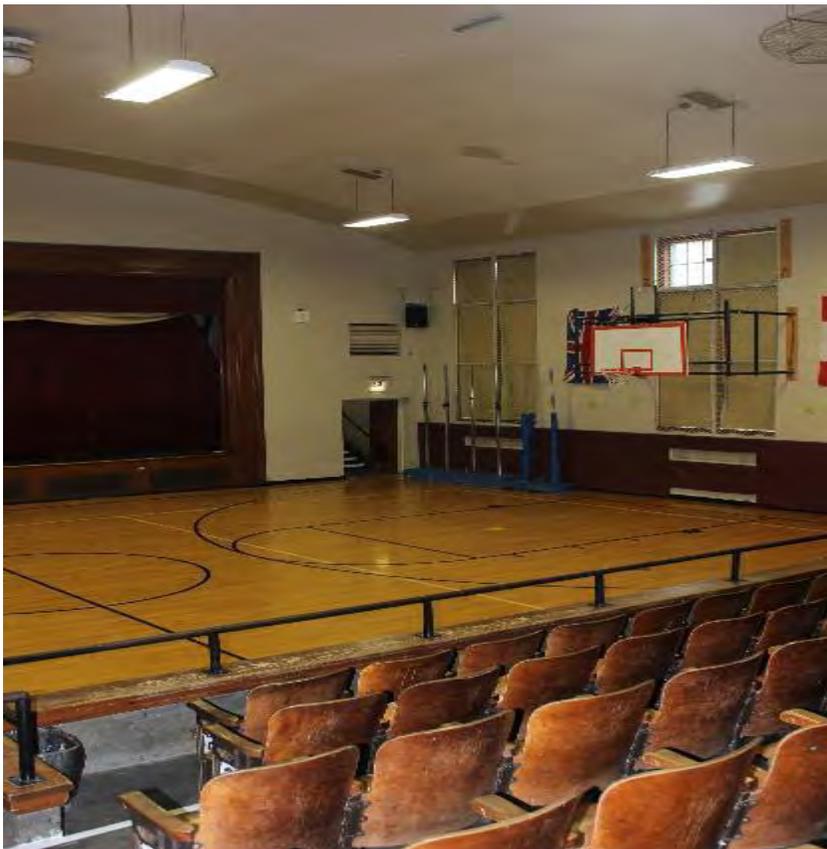
Dated interior fixtures

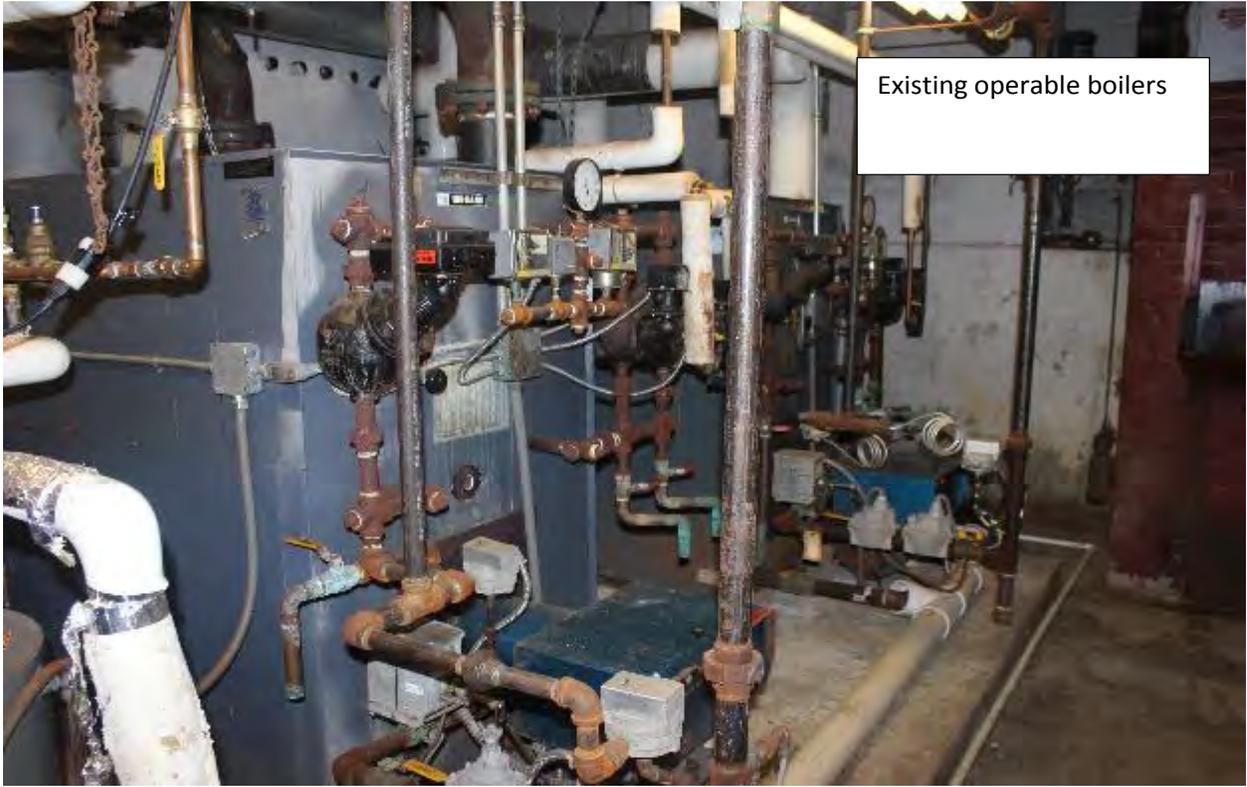
Existing operable boilers

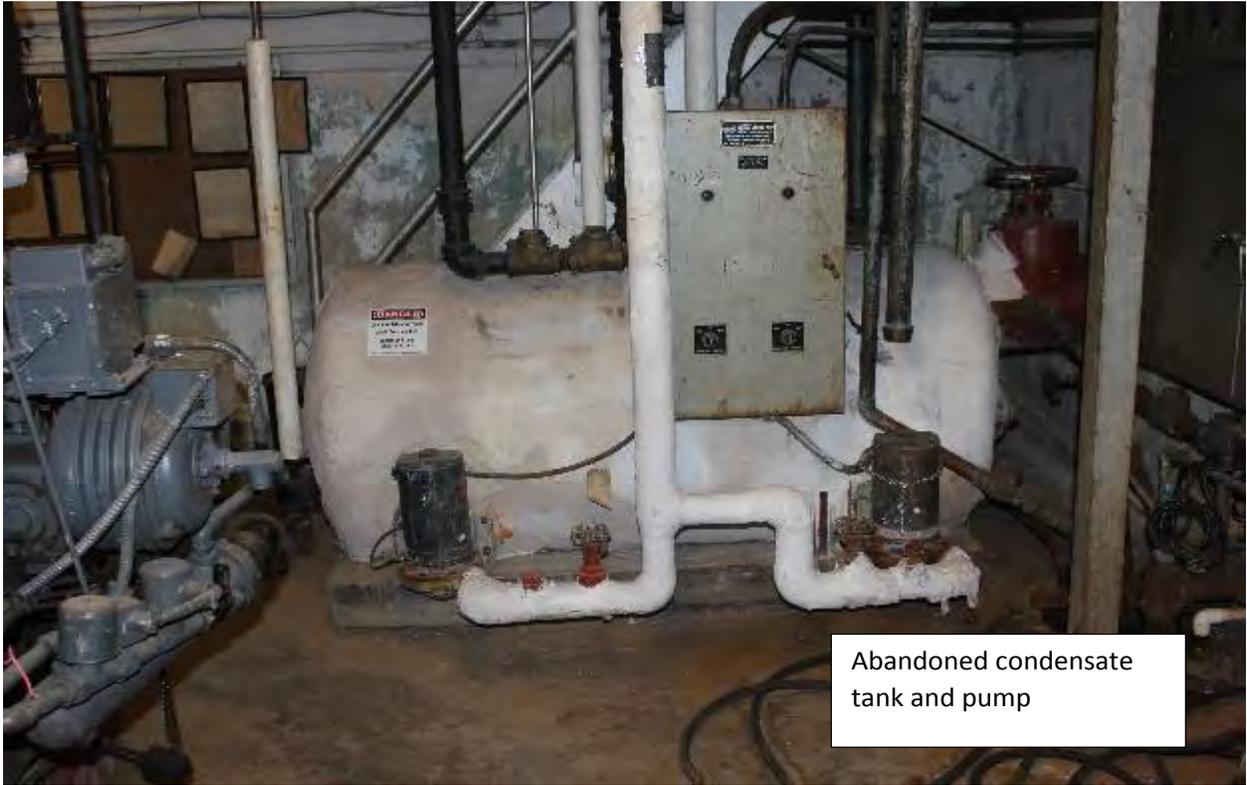
Abandoned condensate tank and pump

Removal and proper capping of all decommissioned piping is required to avoid component failure during middle of heating season on non-operational piping. Table 1

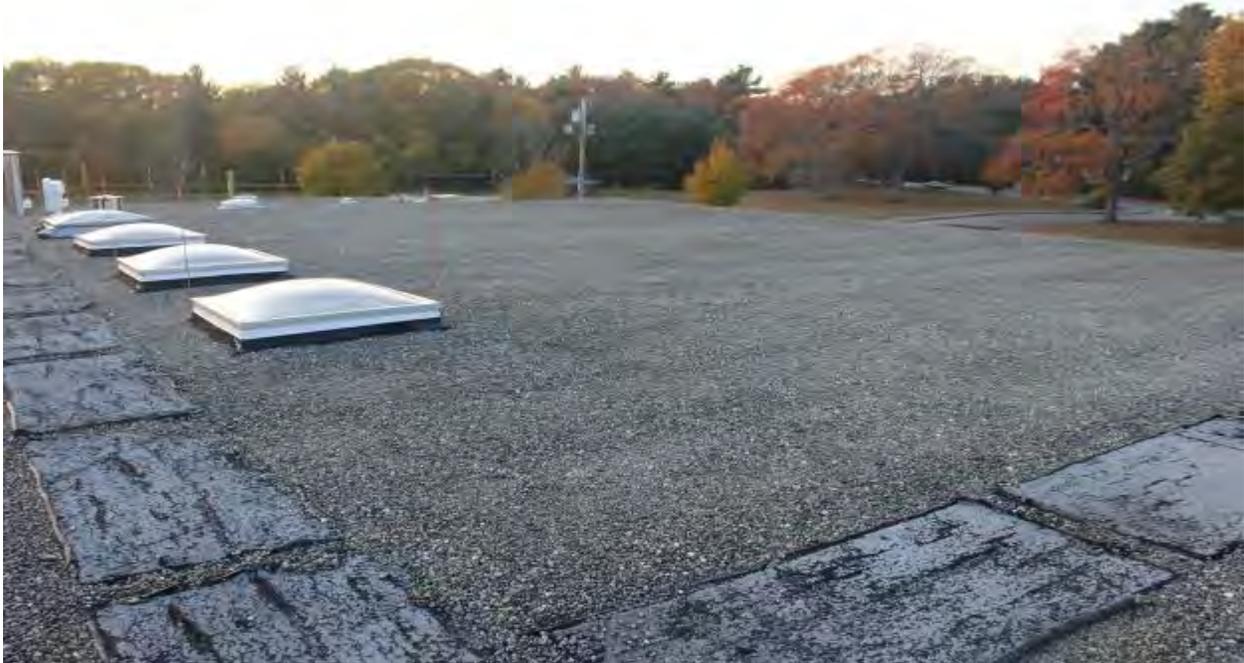
BUR roof Thinning stone ballast, walk pad failing, curb flashing is separating from vertical rise.

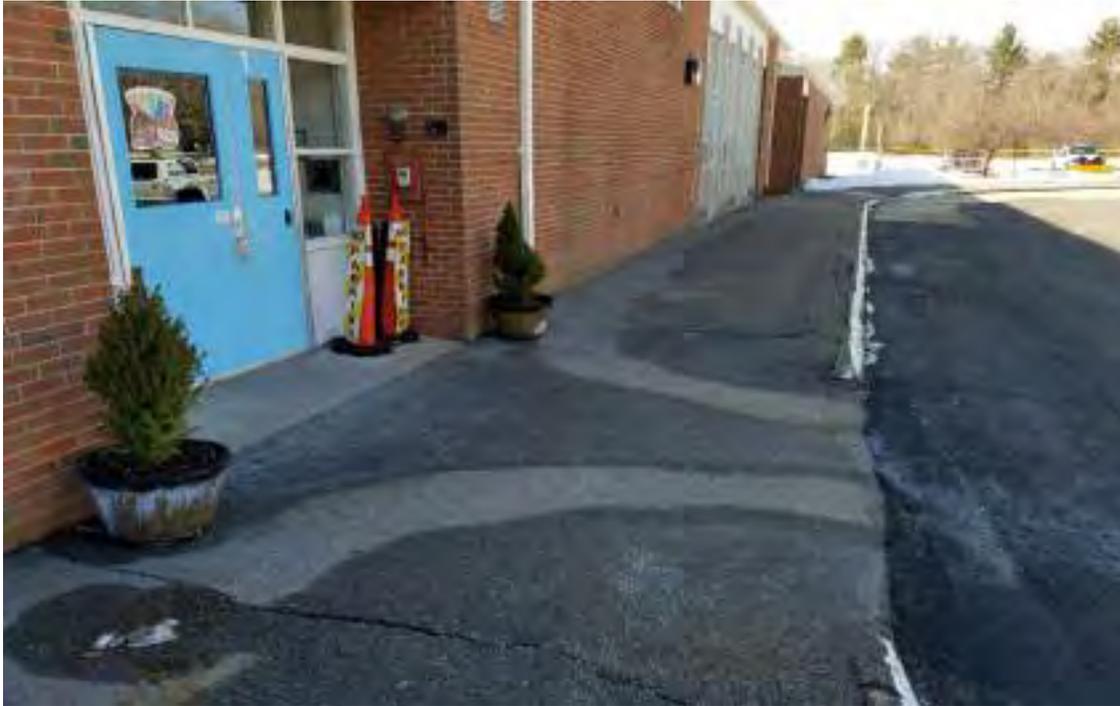
Main Entrance with no 5' level landing and non-compliant slopes. Continuation of egress path into driveway should have cross walk markings

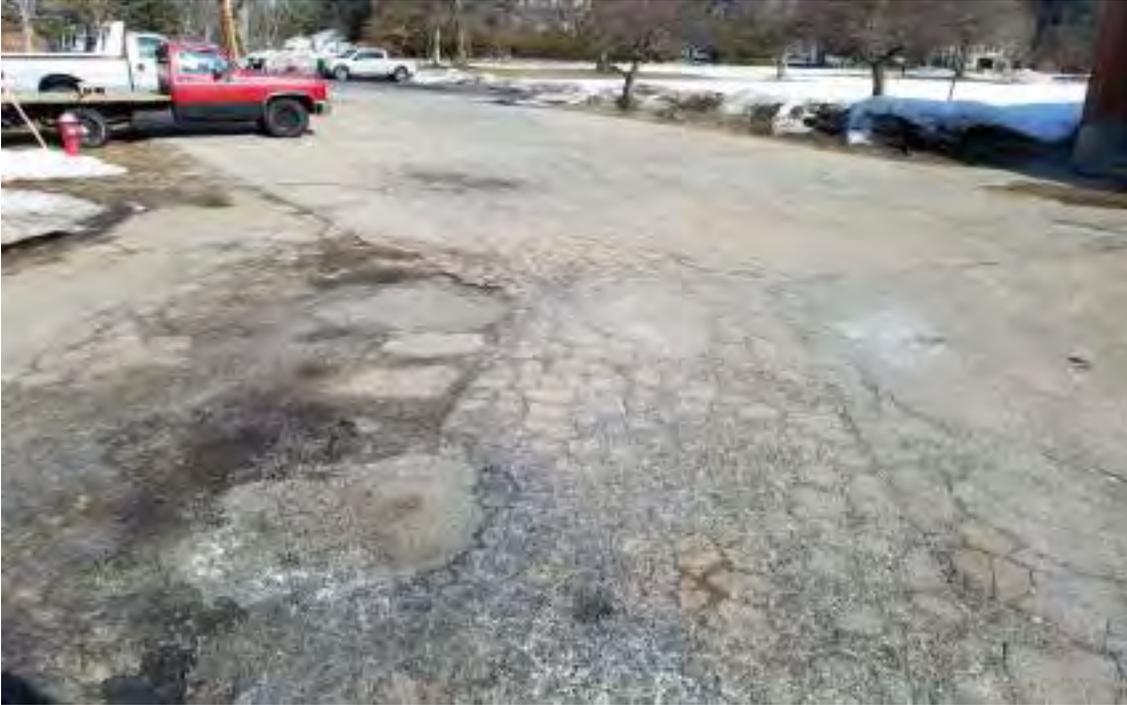
Showing poor condition of paving on west side and routine parking on lawn areas

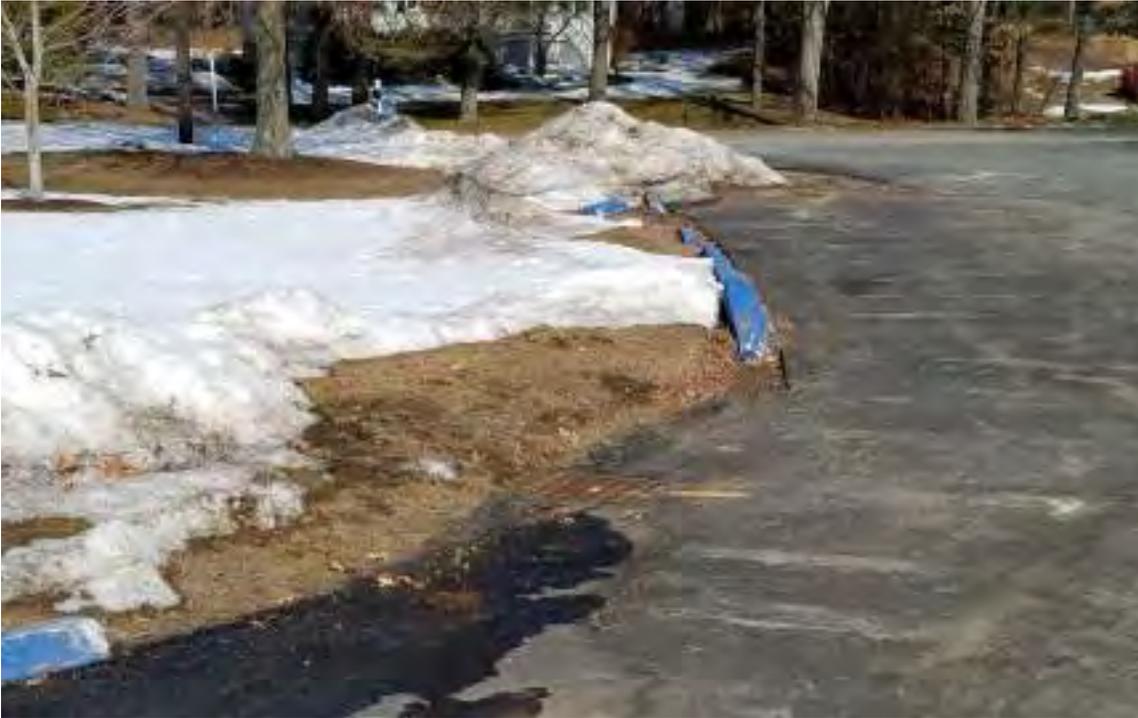
Showing front driveway / parking area with dislodged curb stops and lack of pavement markings

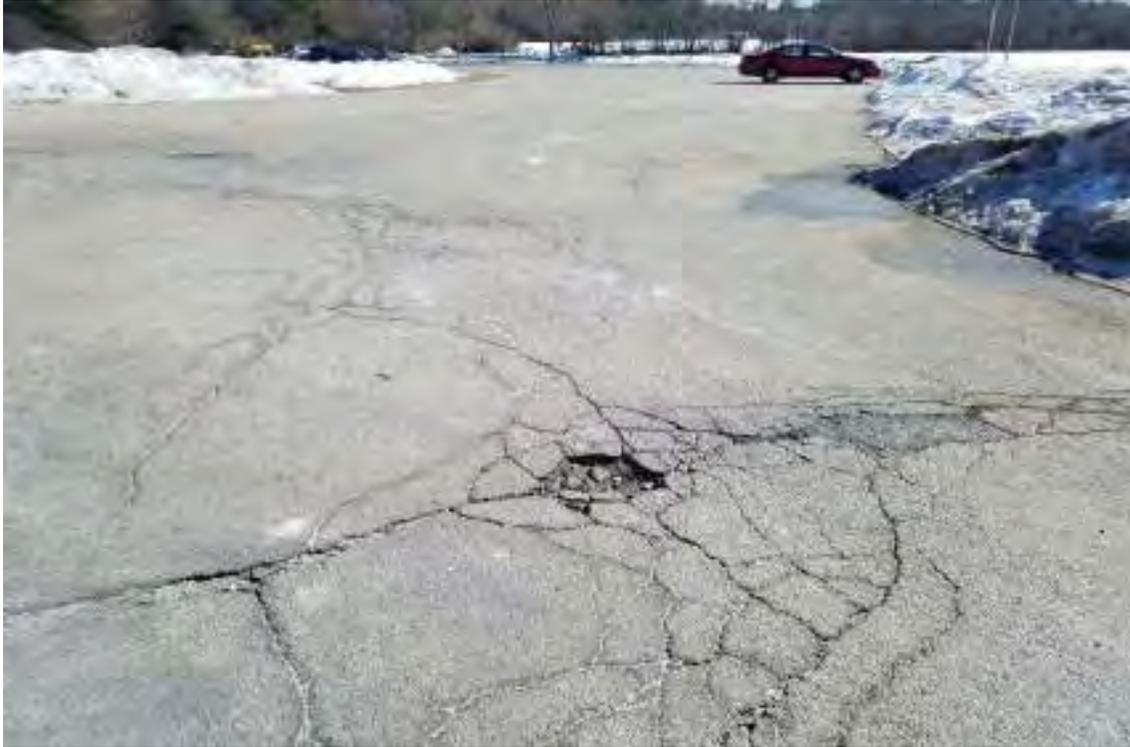
Showing deteriorated pavement and pothole at rear driveway area

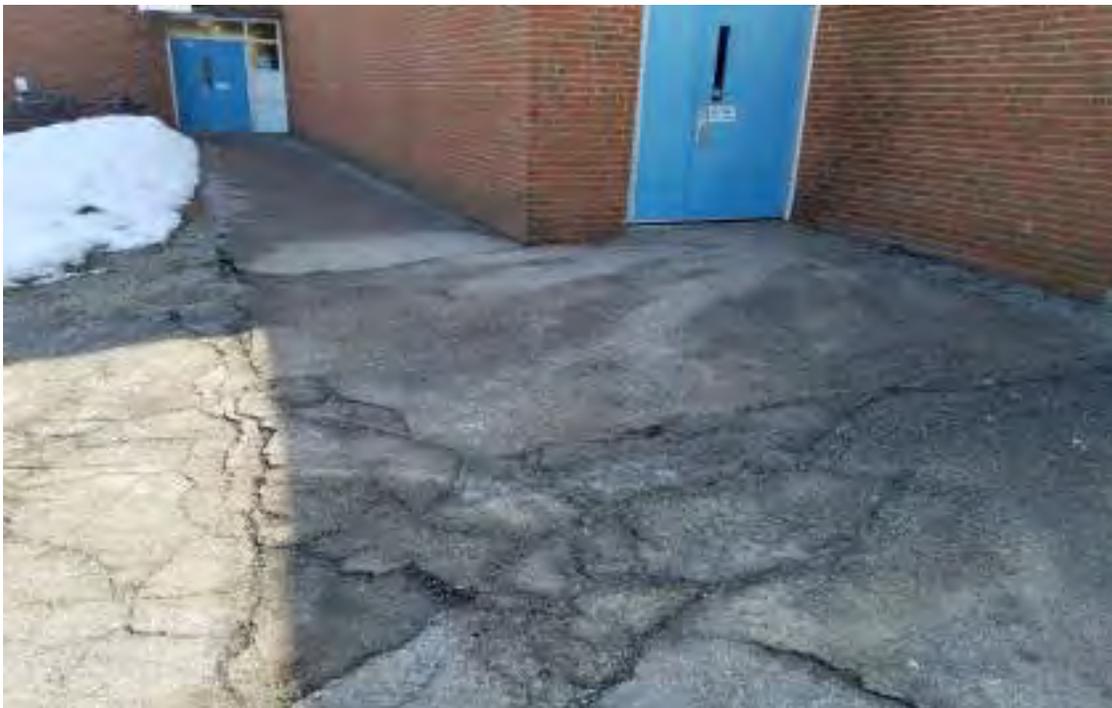
Deteriorated paving at egress path from exits

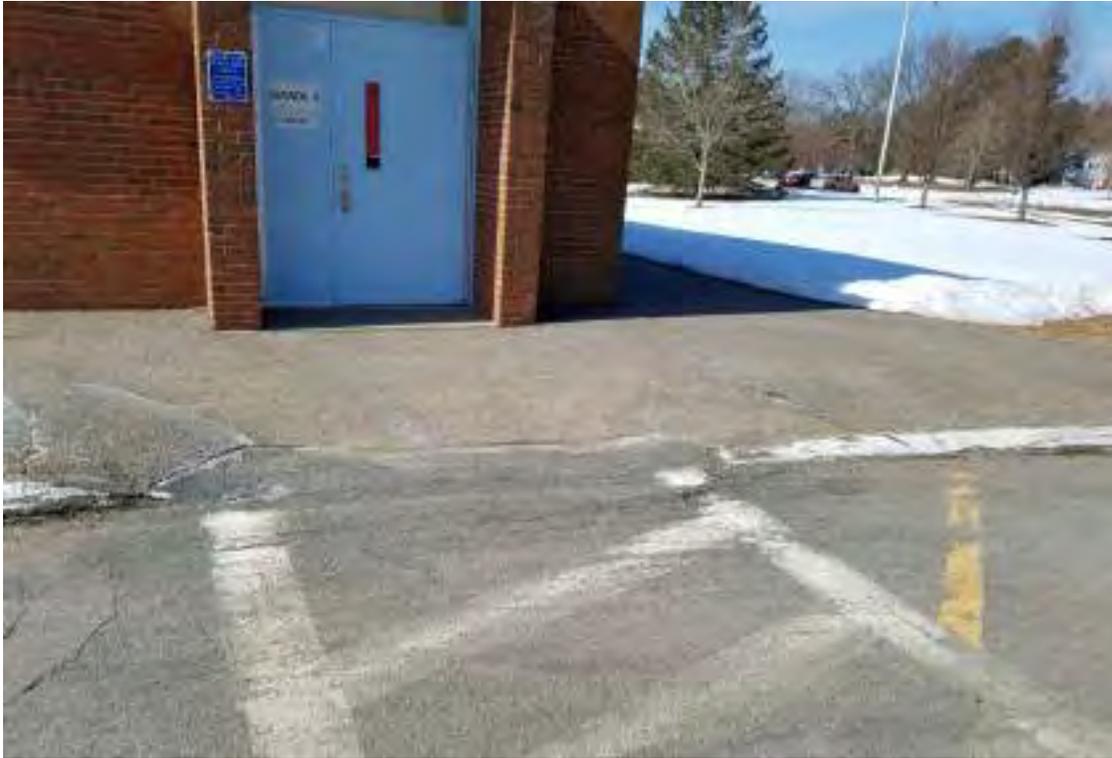
Poorly constructed curb cut and worn pavement markings

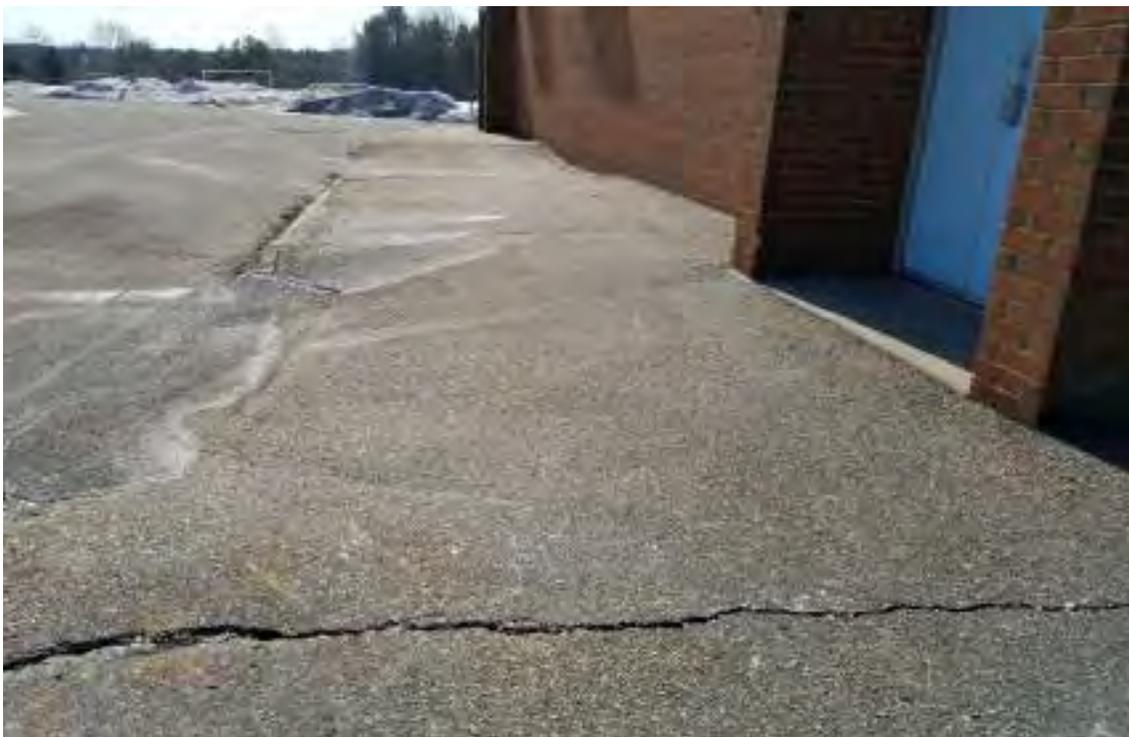
Egress door lacking 5' level landing before slope to curb cut, and deteriorated paved walkway

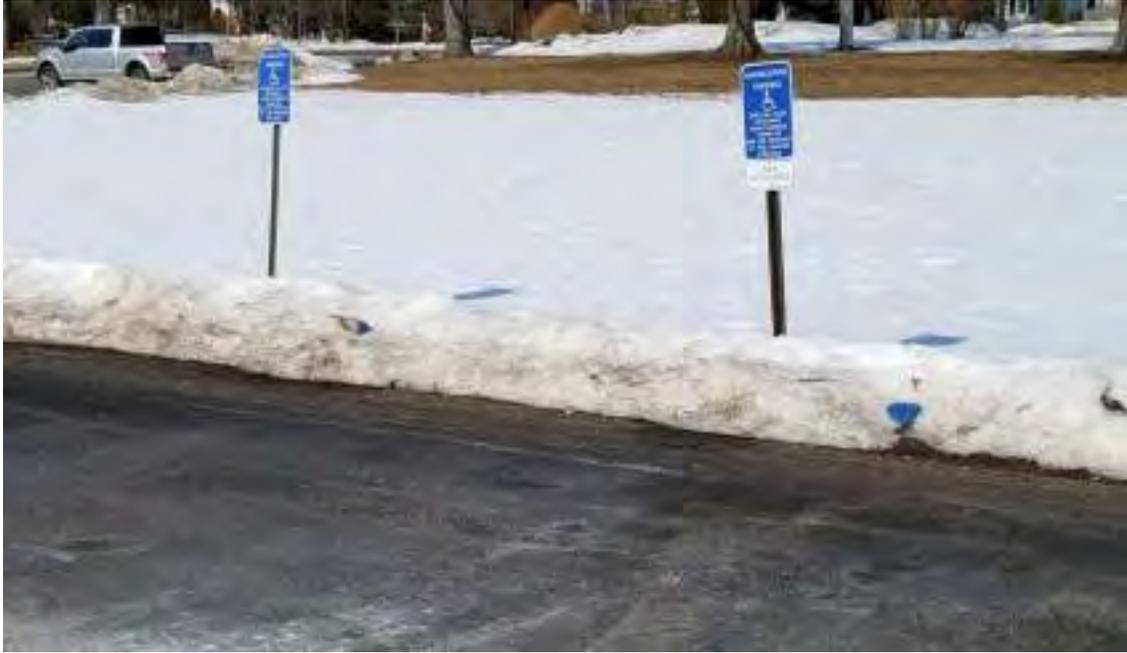
Accessible parking spaces lacking pavement markings & non-compliant sign height

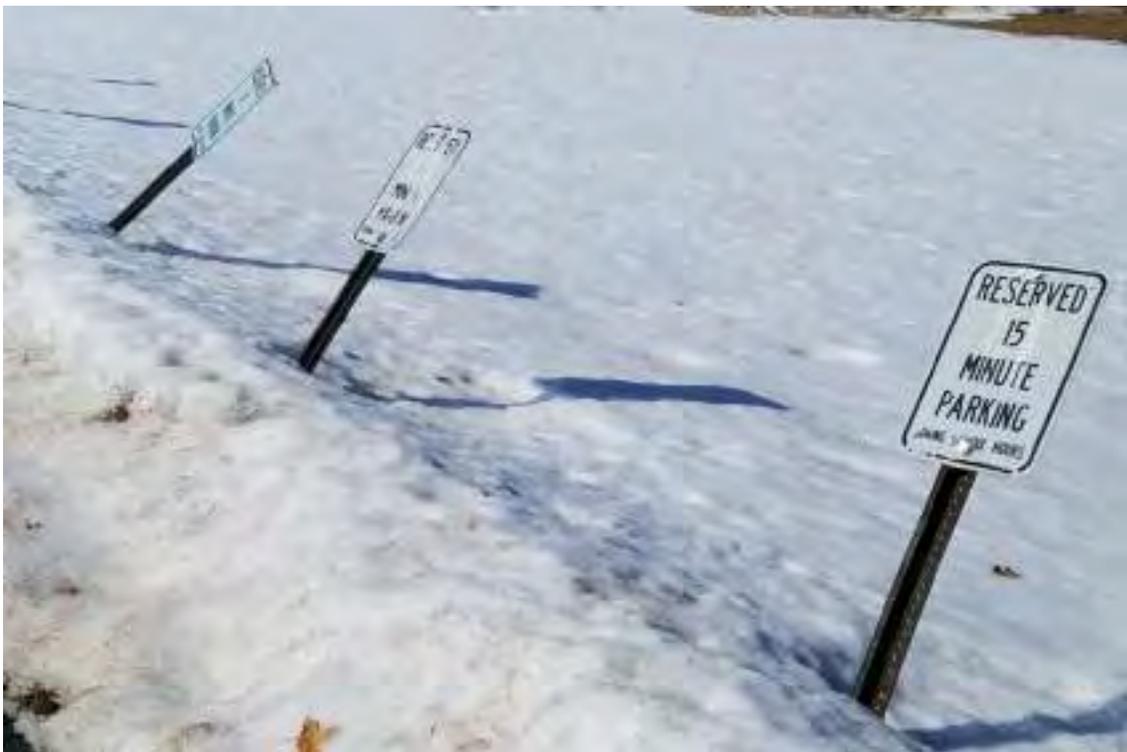
Signage needing repairs

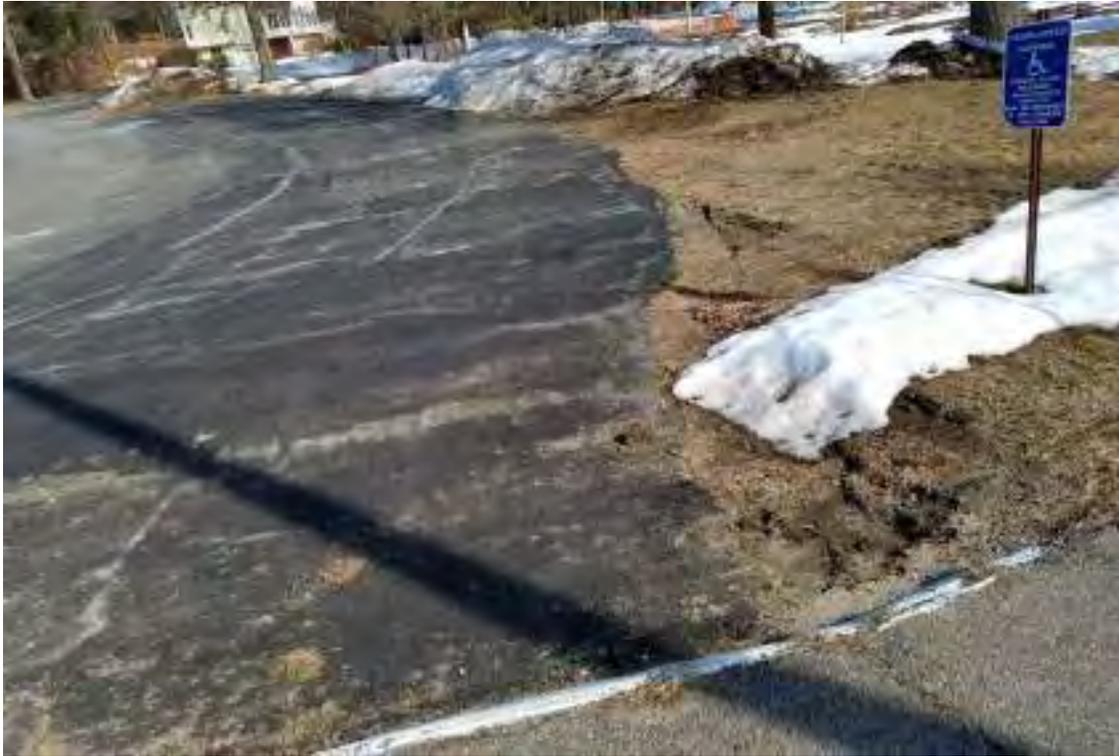
Showing lack of pavement markings and excessive slope at accessible parking space

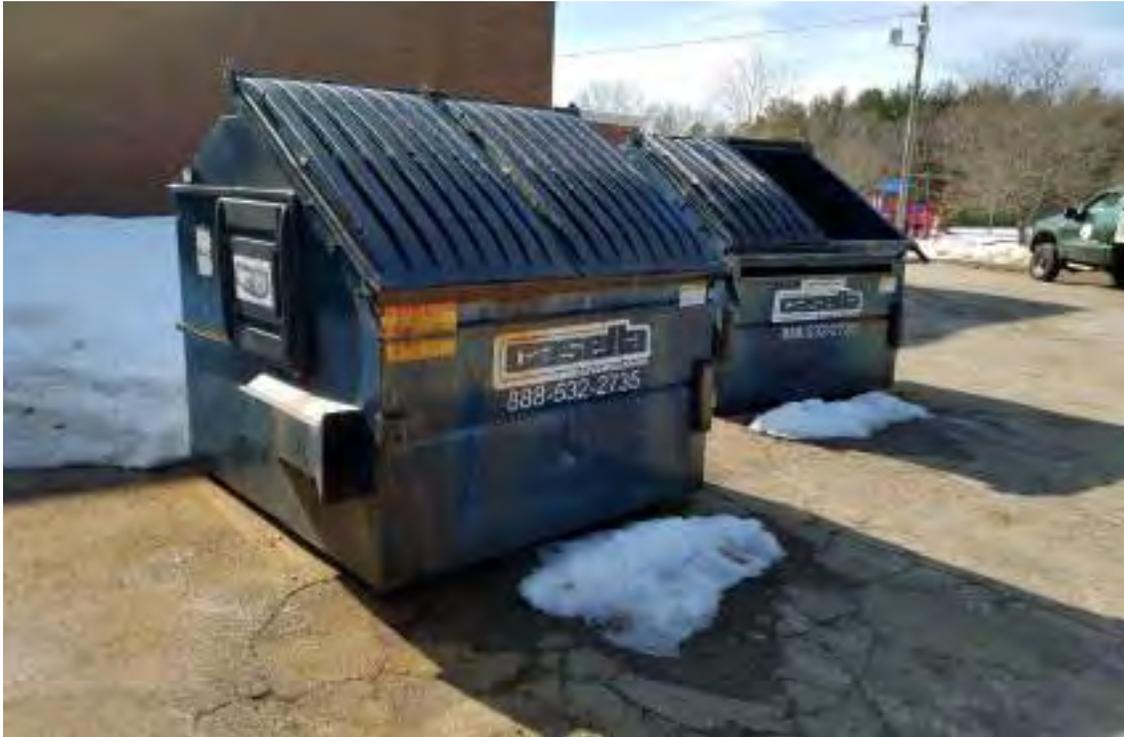
Showing unenclosed dumpsters in visually prominent location

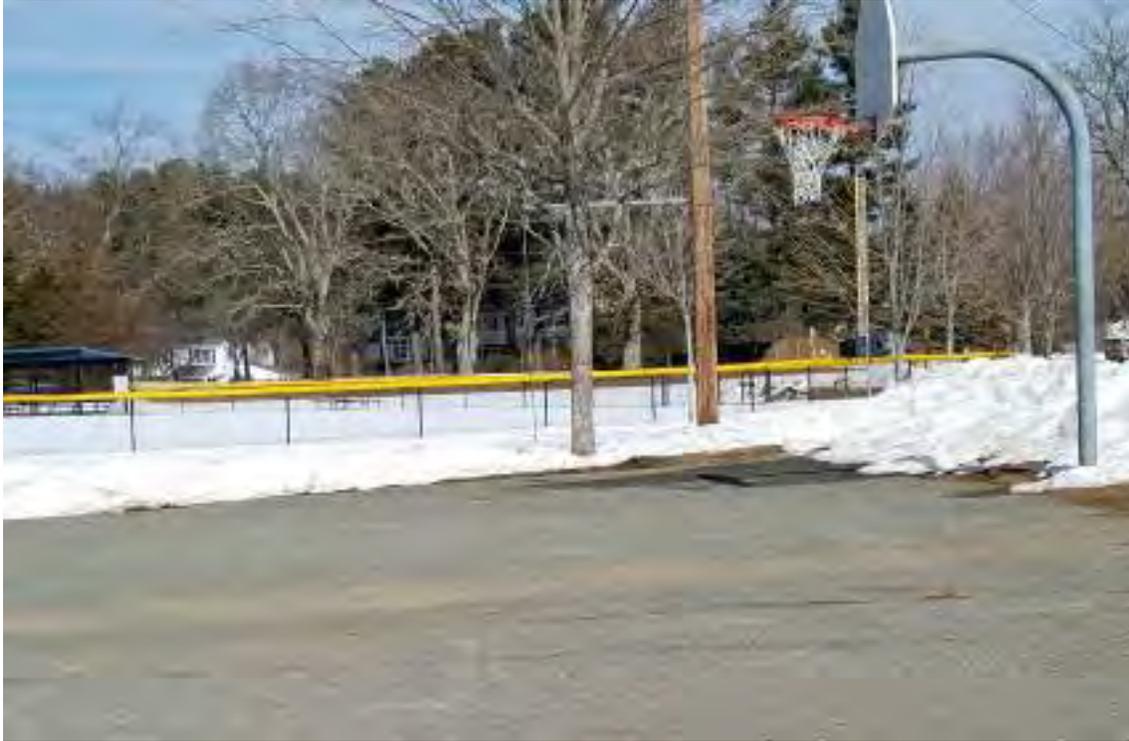
Showing excessive slope in basketball play area

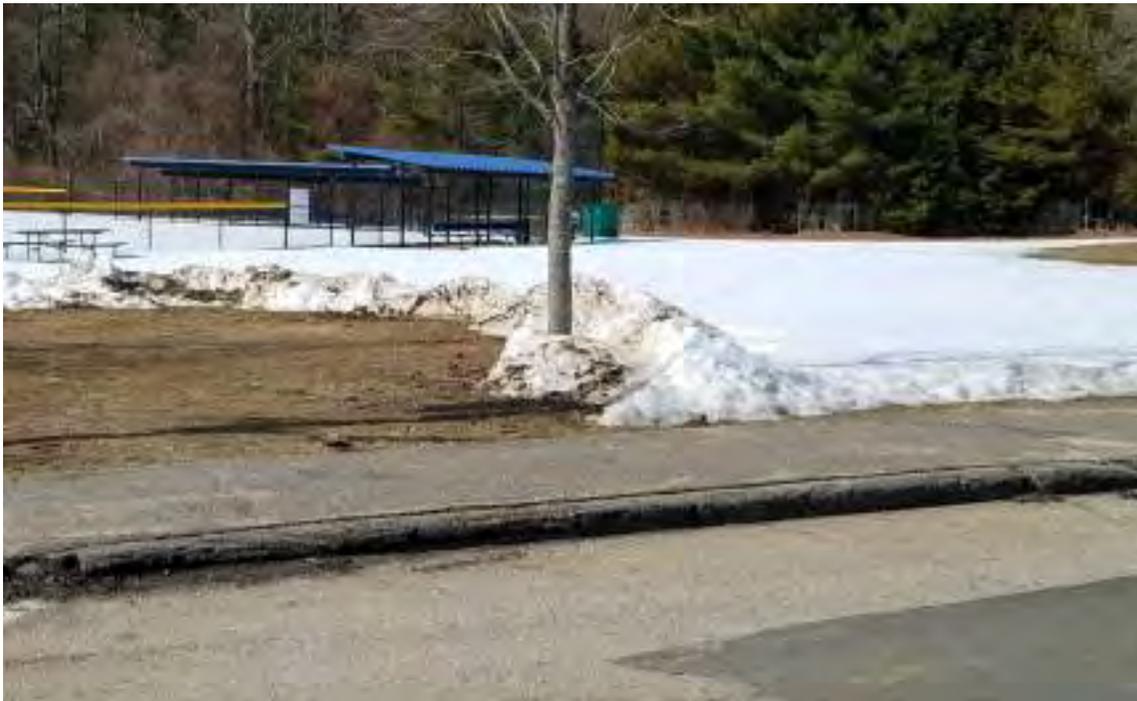
Showing lack of accessible route to ballfield from parking and lawn area used for parking

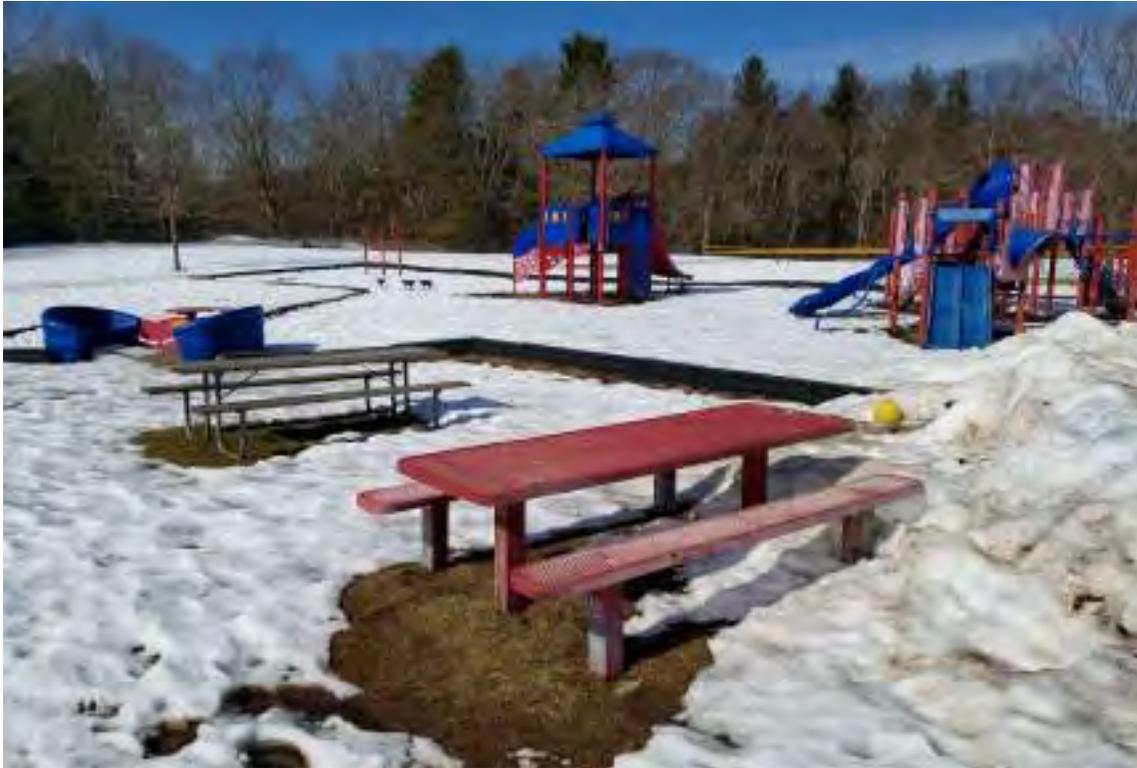
Showing non-accessible picnic area and berm obstacle around play area beyond

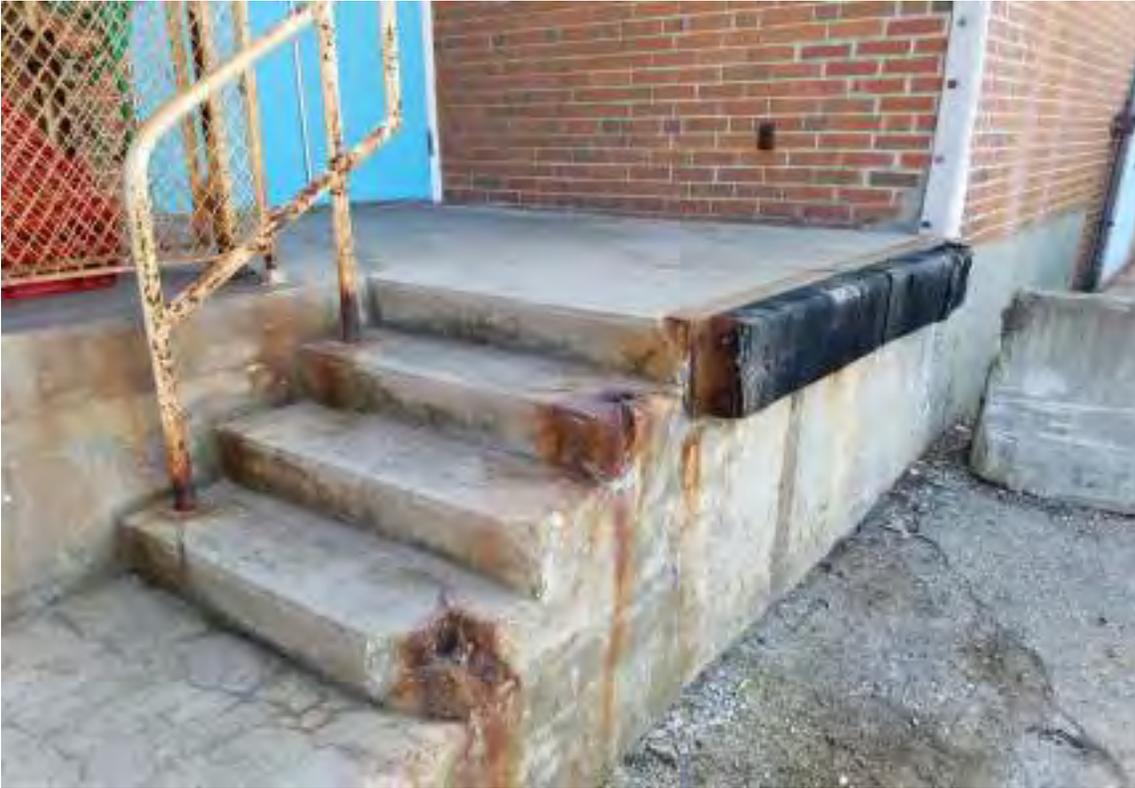
Showing deteriorated concrete steps, lack of handrail and areas needing paint

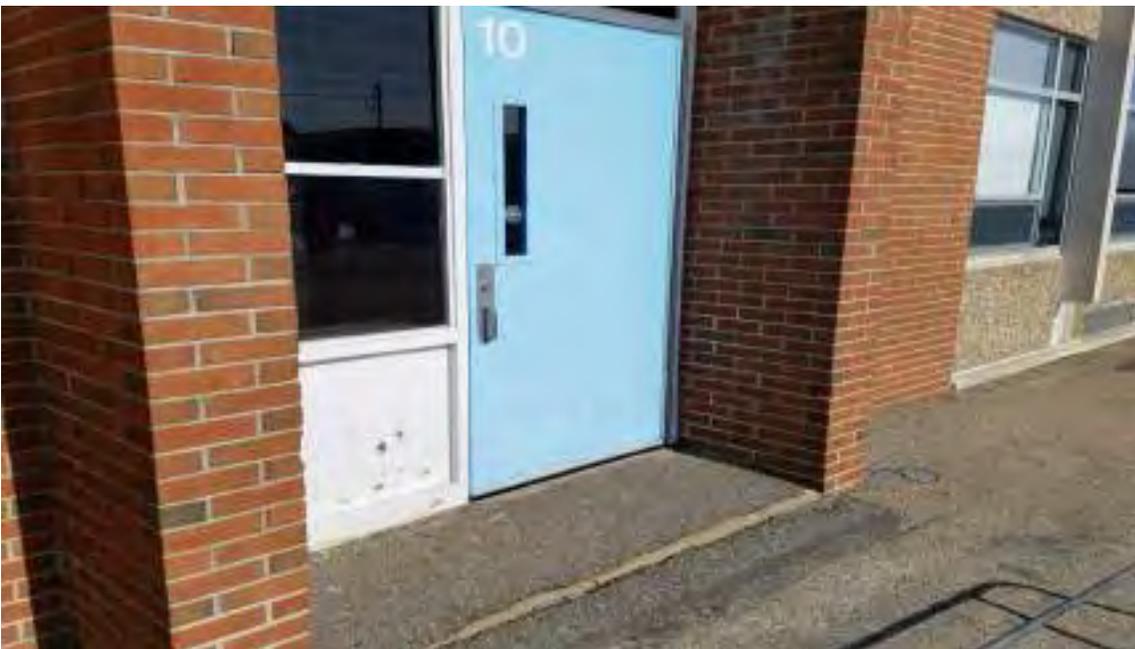
Showing lack of 5' level landing at egress door and HM frames needing paint

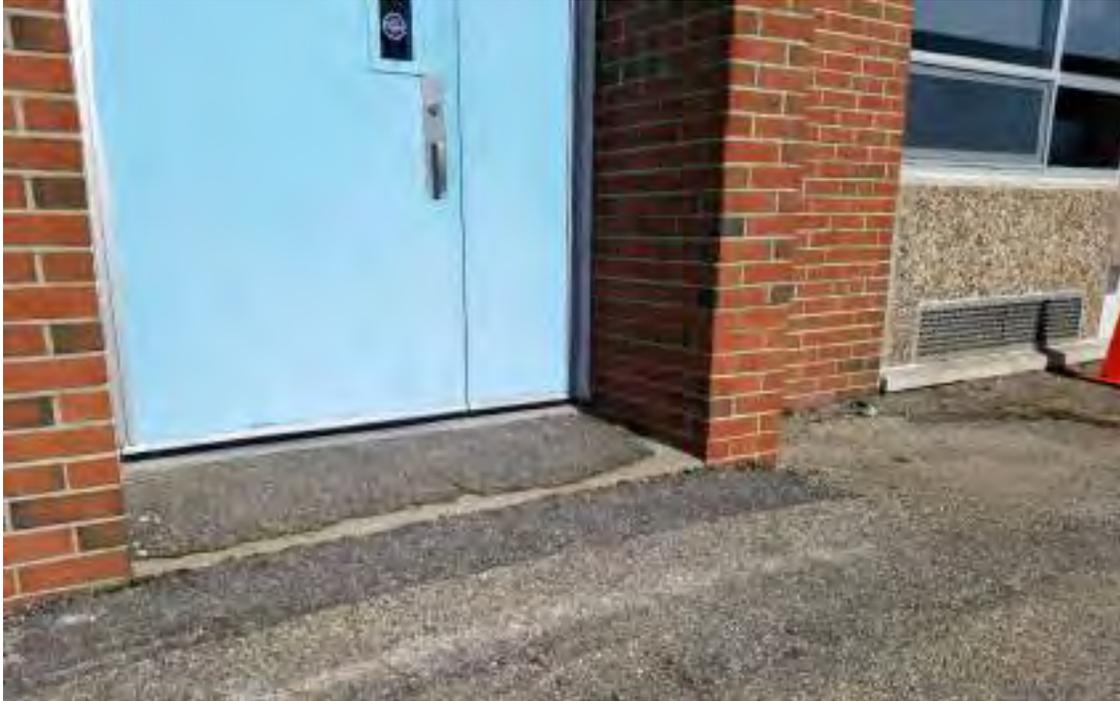
Another example of no 5' level landing at egress doors, currently poorly patched with bituminous

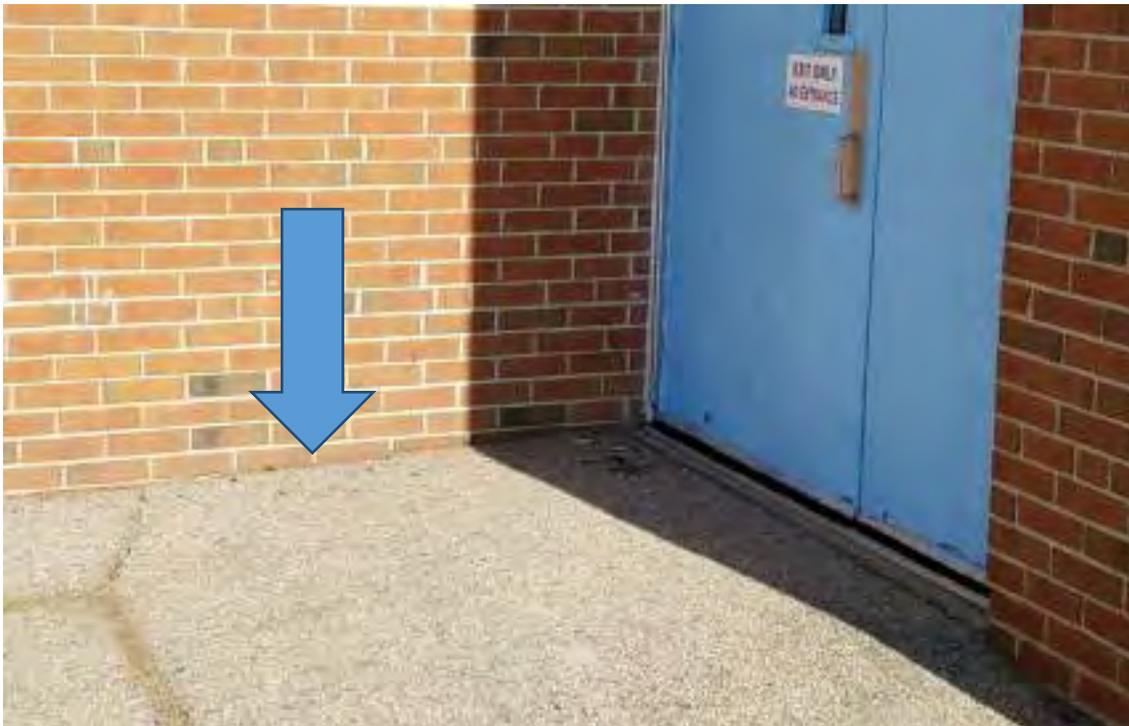
Another example of no 5' level landing at egress door

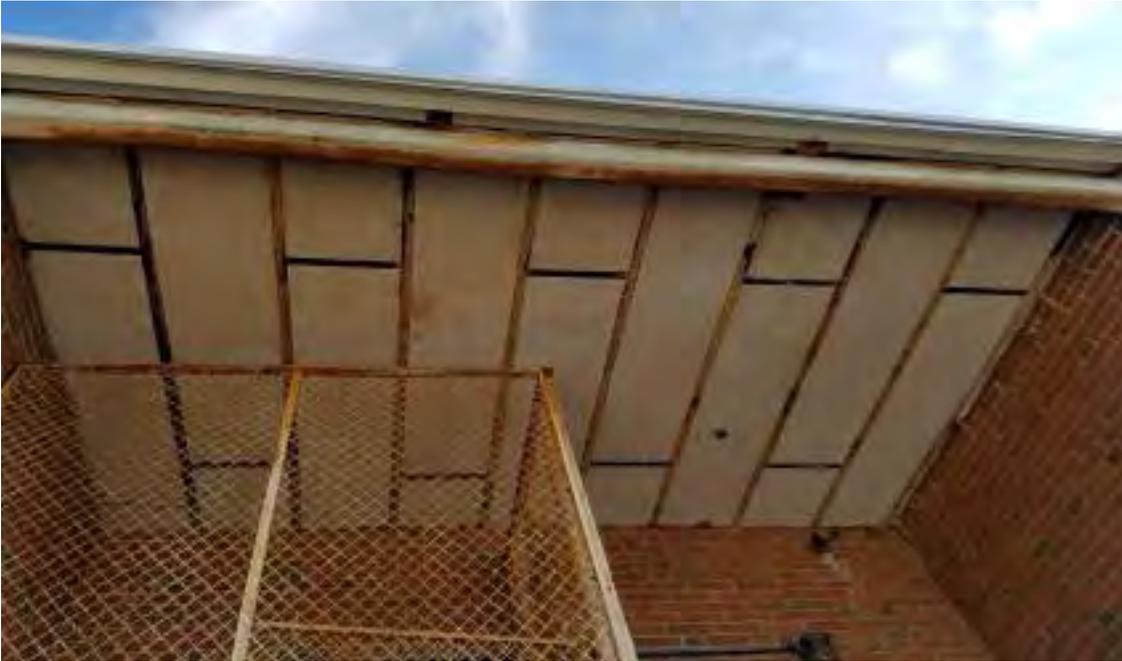
Rusted metal components at covered truck dock ( West )

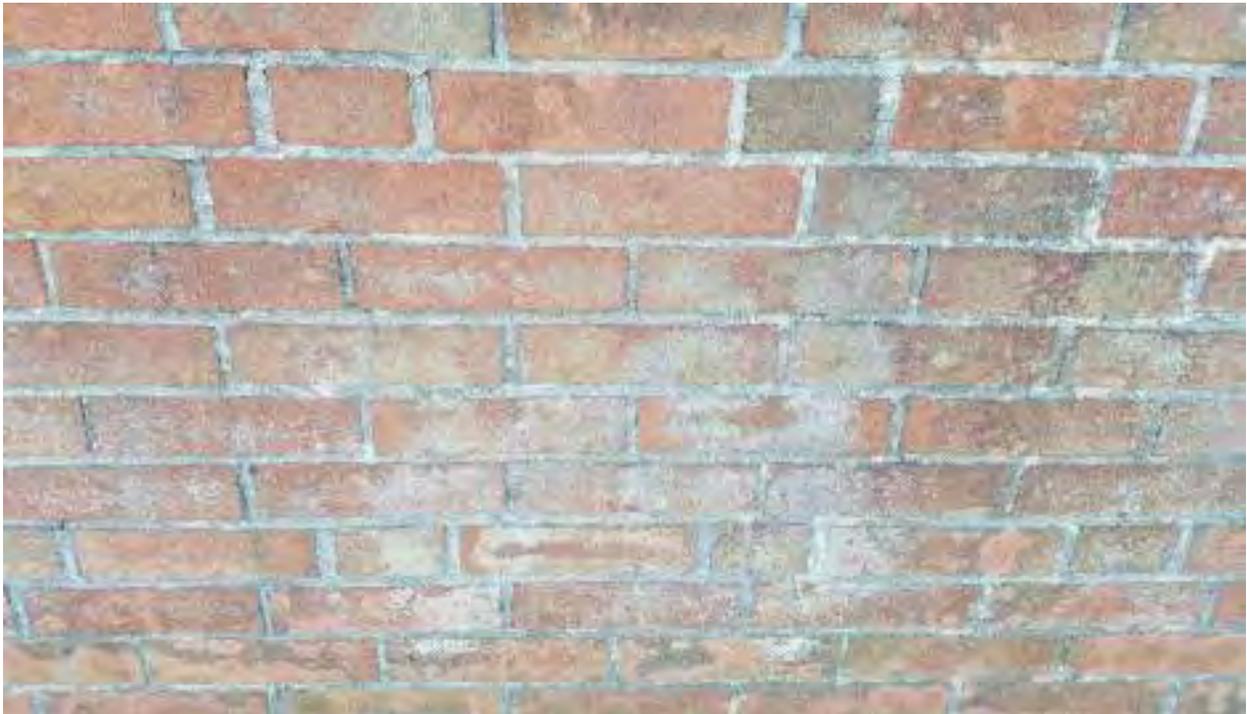
Example of brick veneer exterior surface condition needing cleaning & sealing

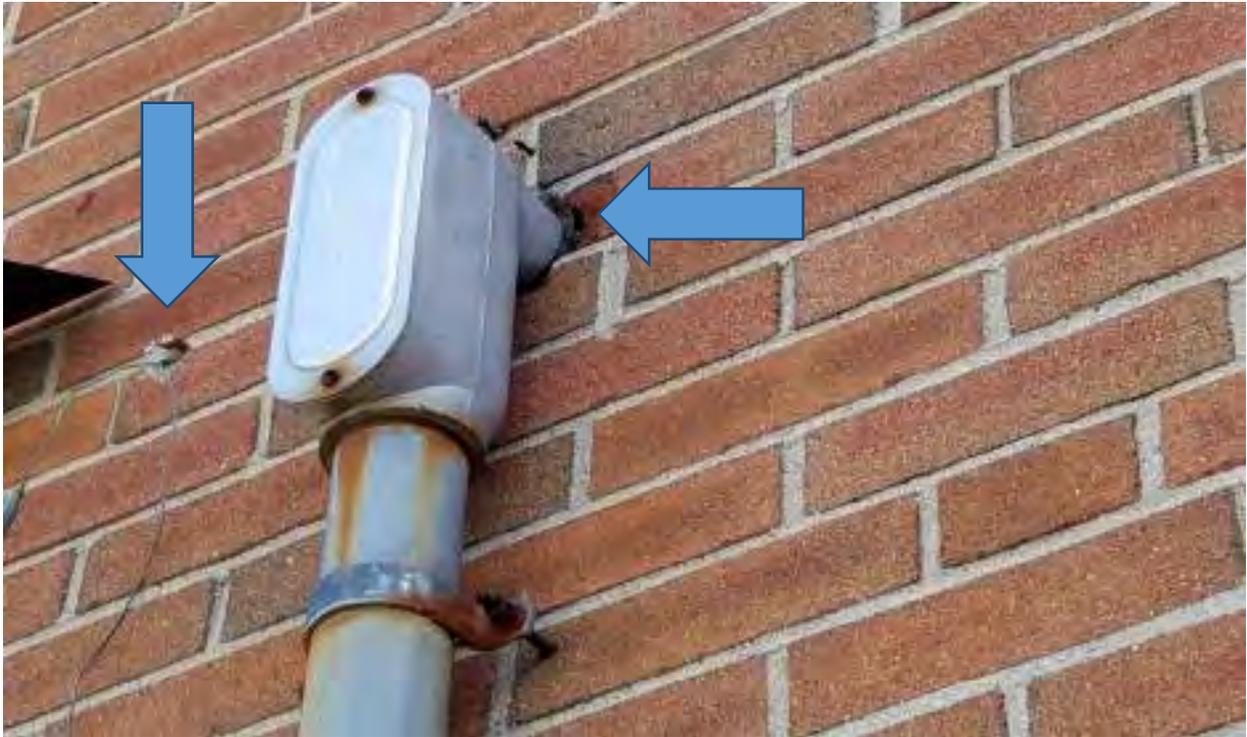
Example of brick penetrations needing sealant ( west elevation )

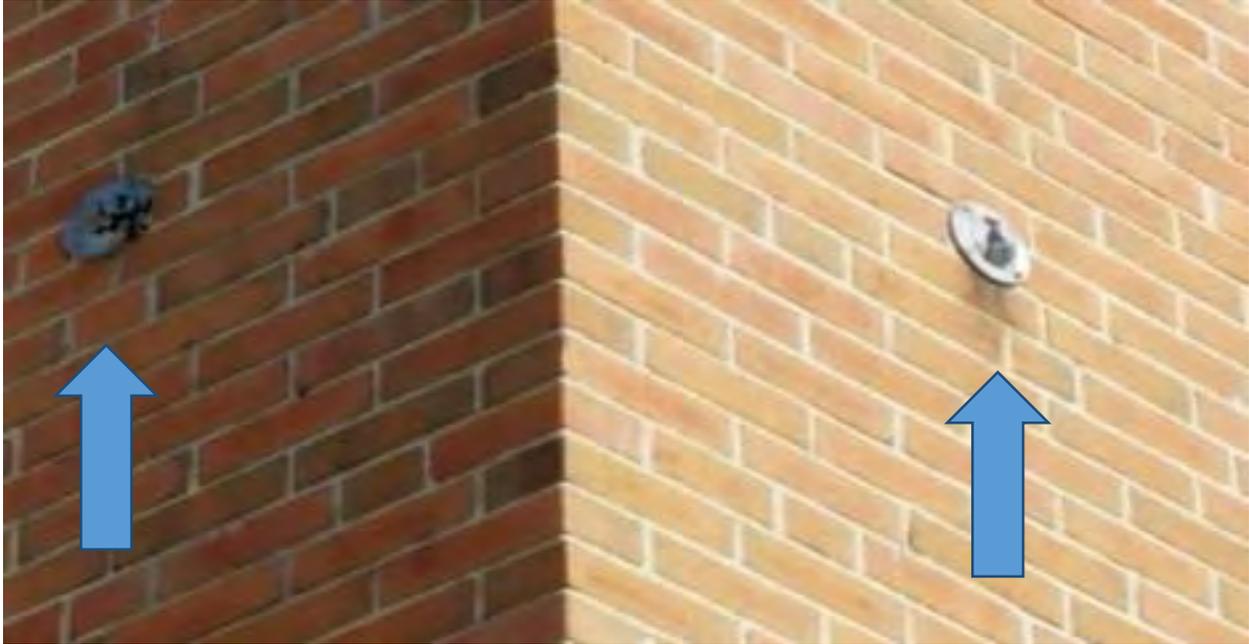
Example of abandoned exterior fixtures that should be capped or removed and infilled with brick

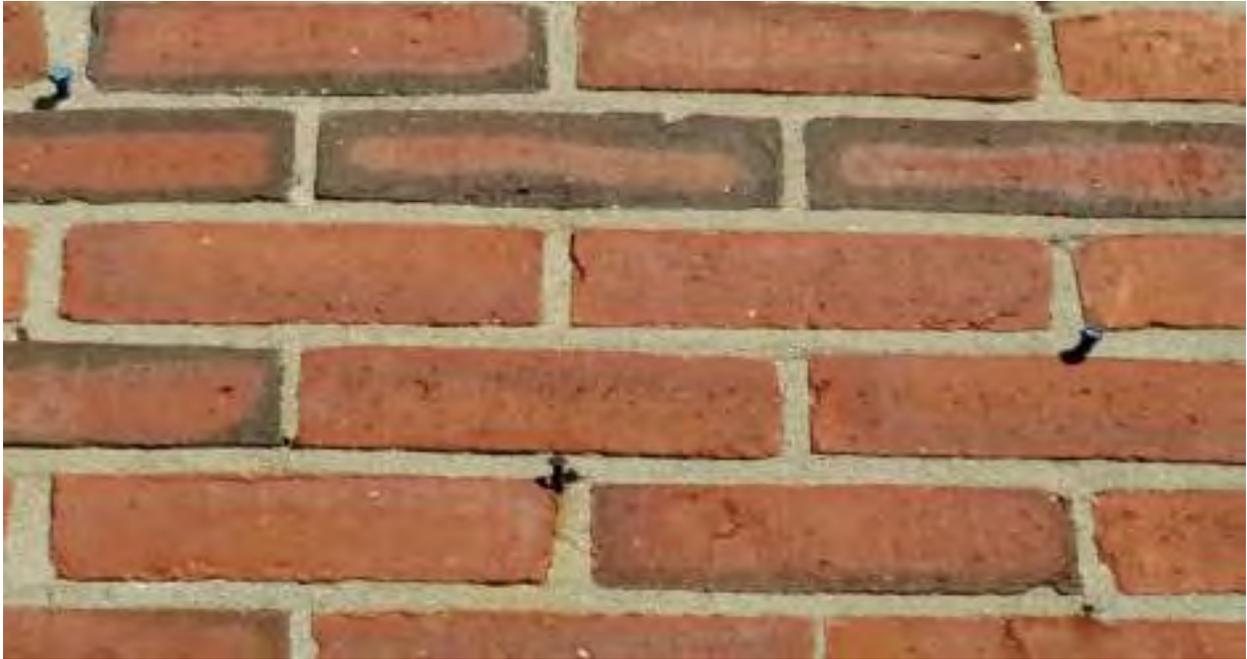
Example of old fasteners that should be removed and patched with mortar or caulking
