# **TOWN OF MEDFIELD**

## **Municipal Facilities**

### **Evaluation and Capital Plan**

October 6, 2017

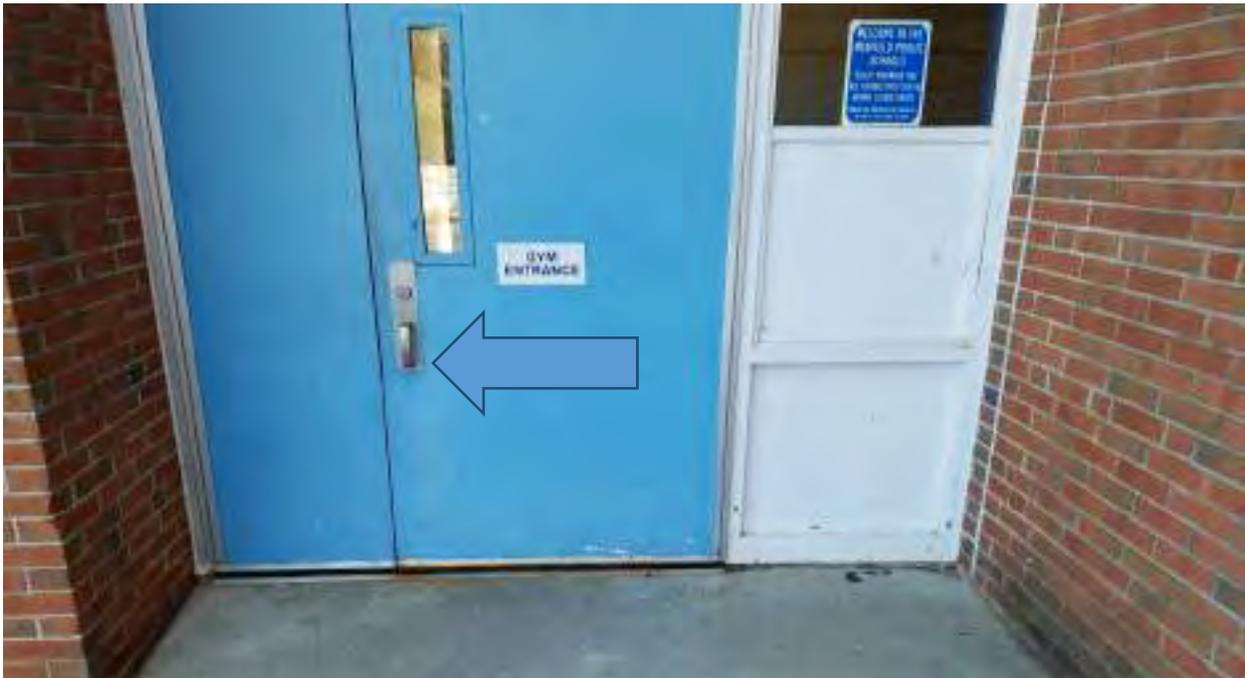
Another example of accessible entrance needing compliant latching hardware

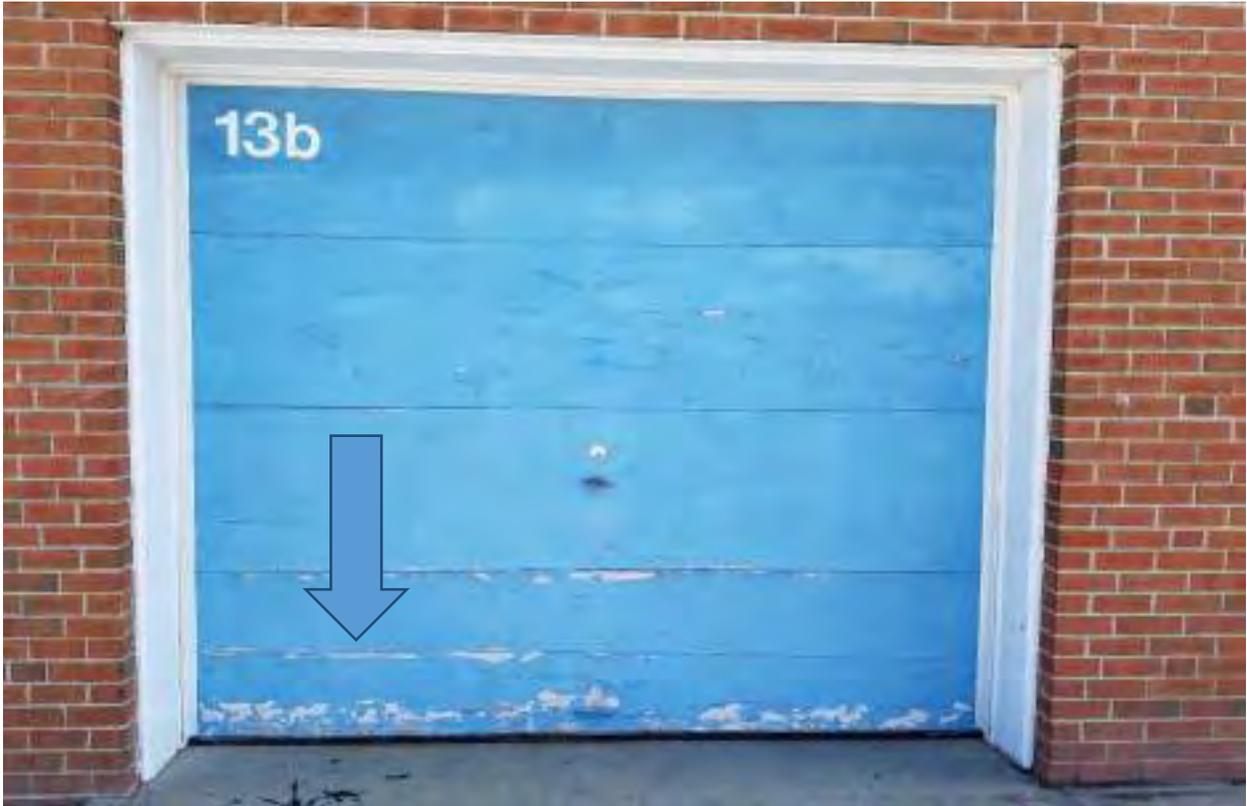
Showing delaminated veneer on garage doors

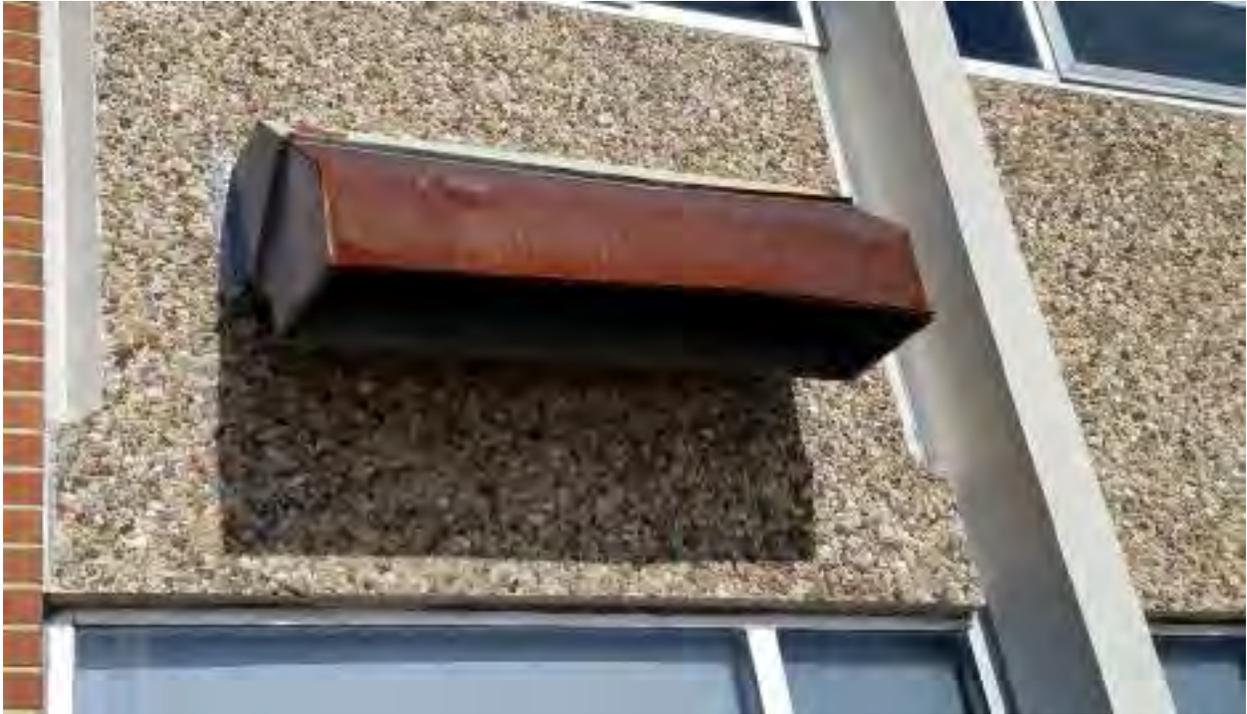
Typical rusted condition of second floor UV louver hood needing replacement

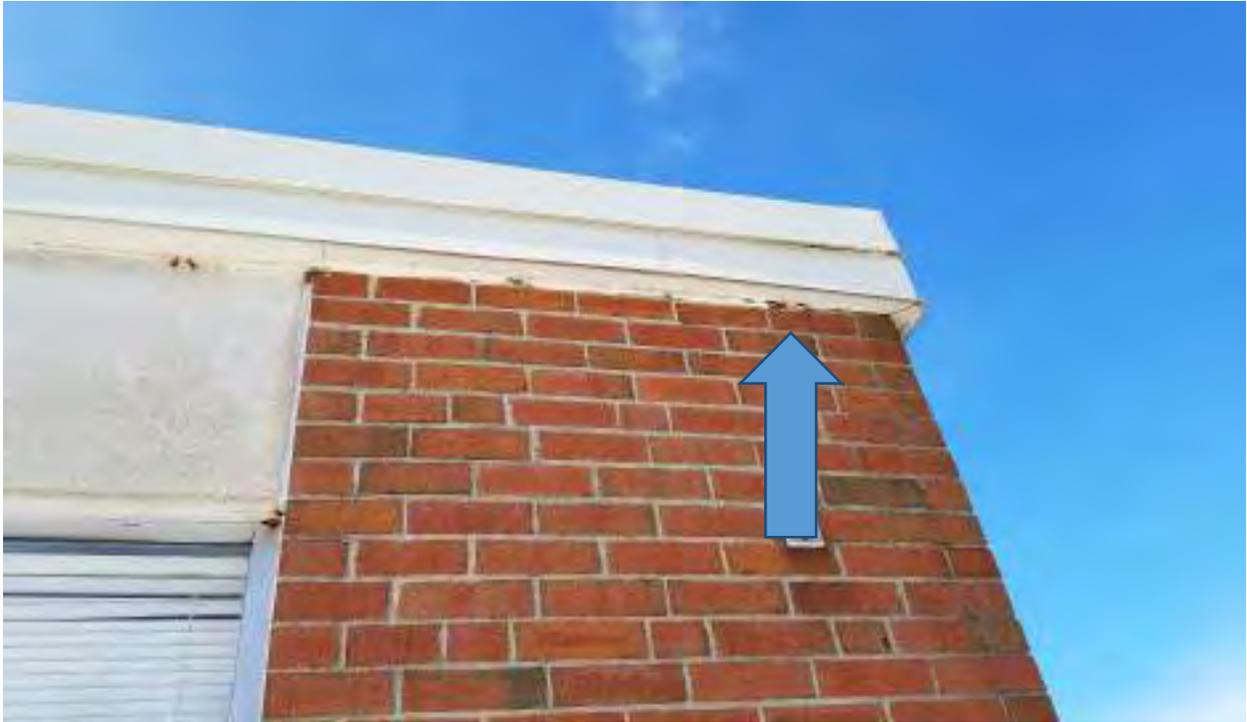
Typical horizontal joint needing to be resealed

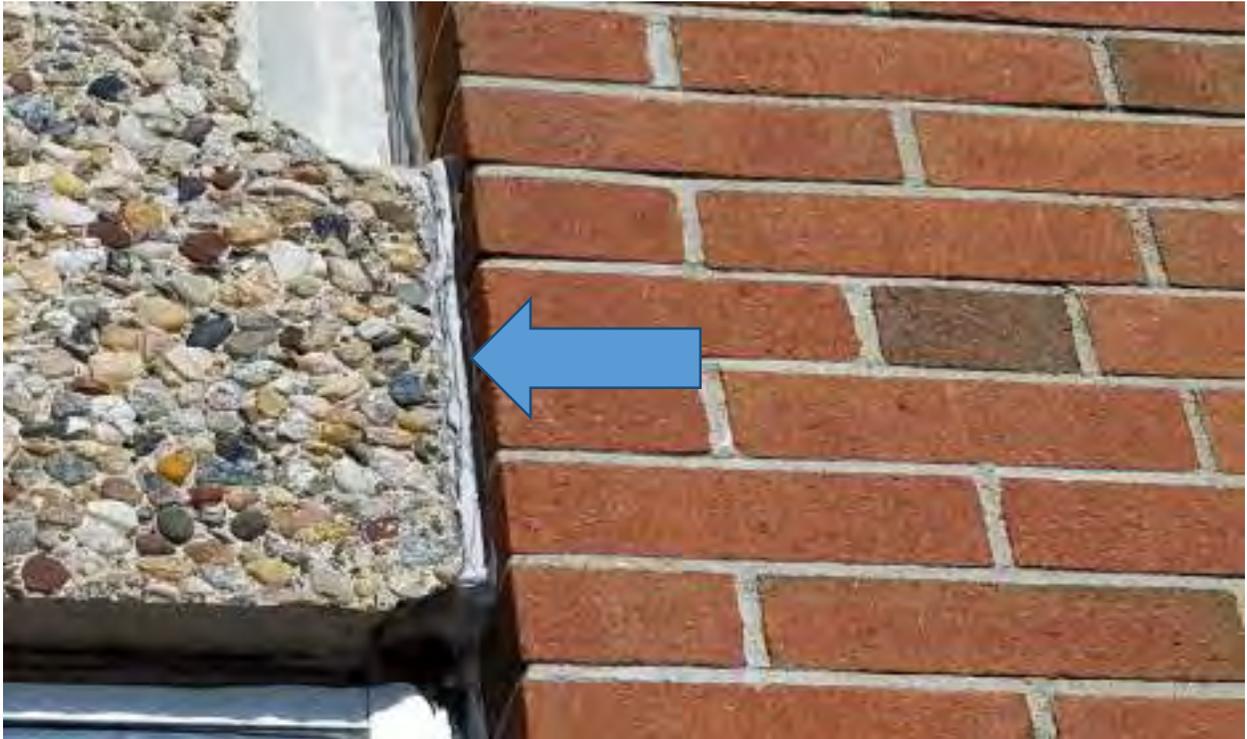
Typical joint between precast and brick needing to be re-sealed

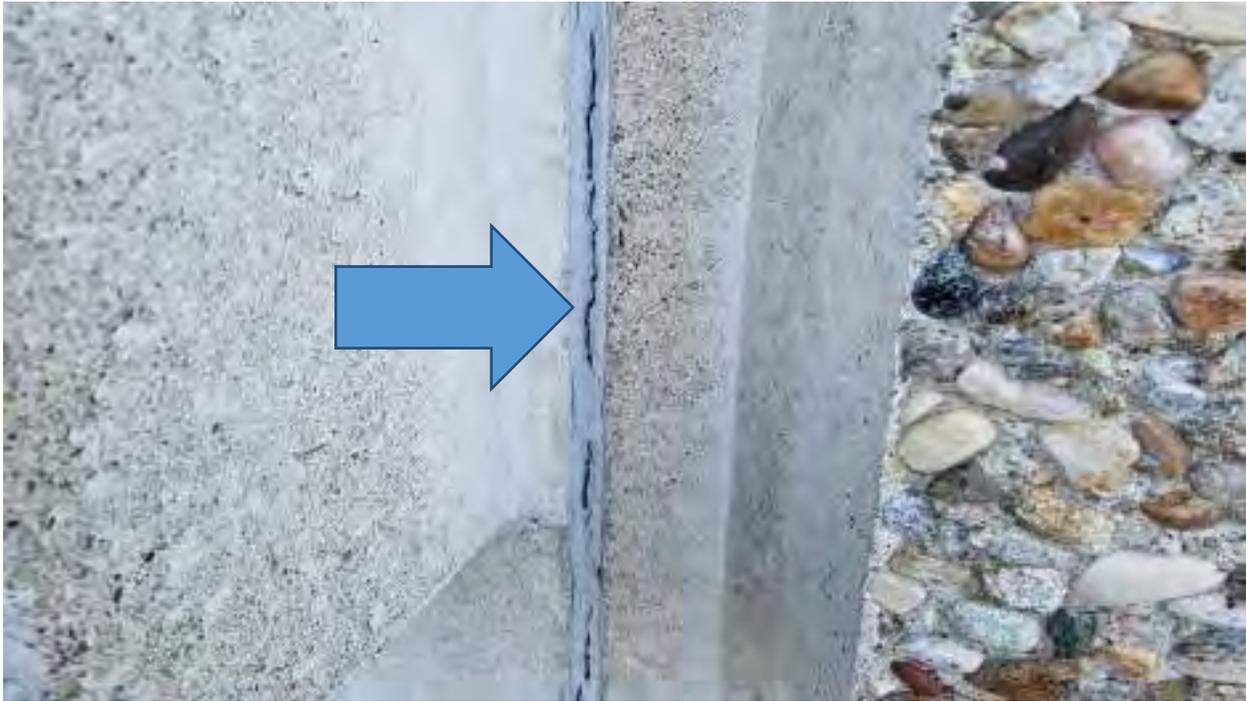
Typical joint between precast members needing to be resealed

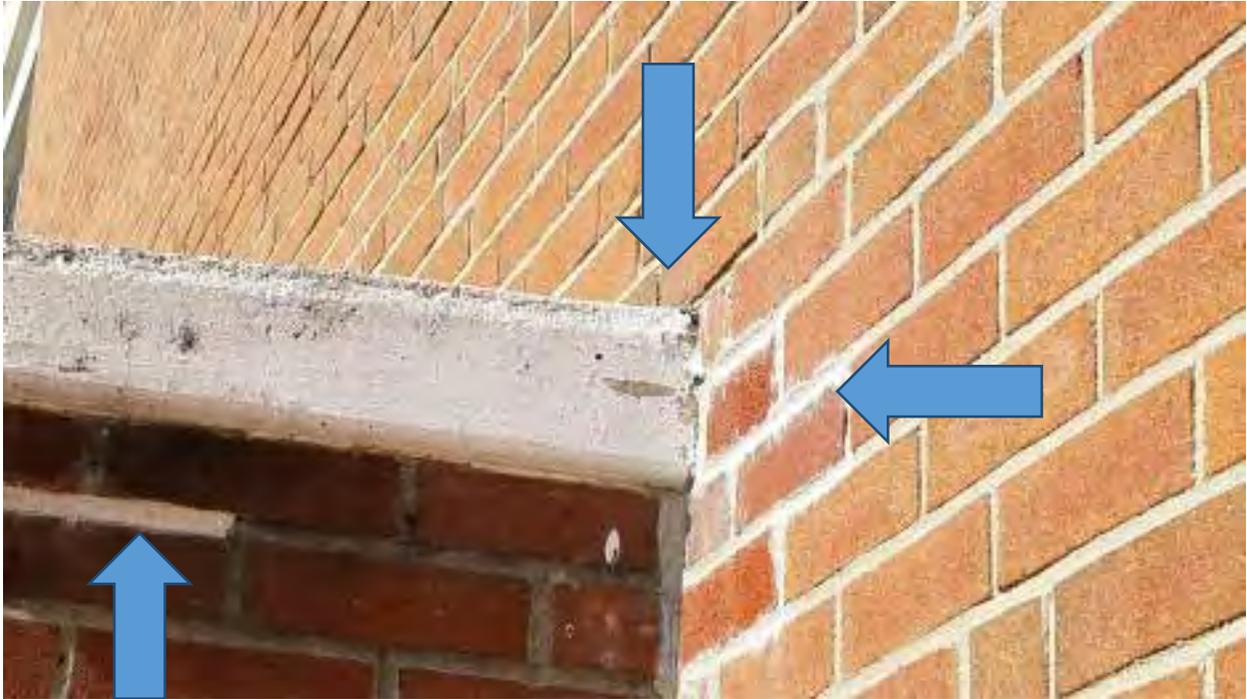
Sloped concrete entry cap with no protective membrane and no flashing to vertical brick surface – also signs of brick deterioration and previous repairs

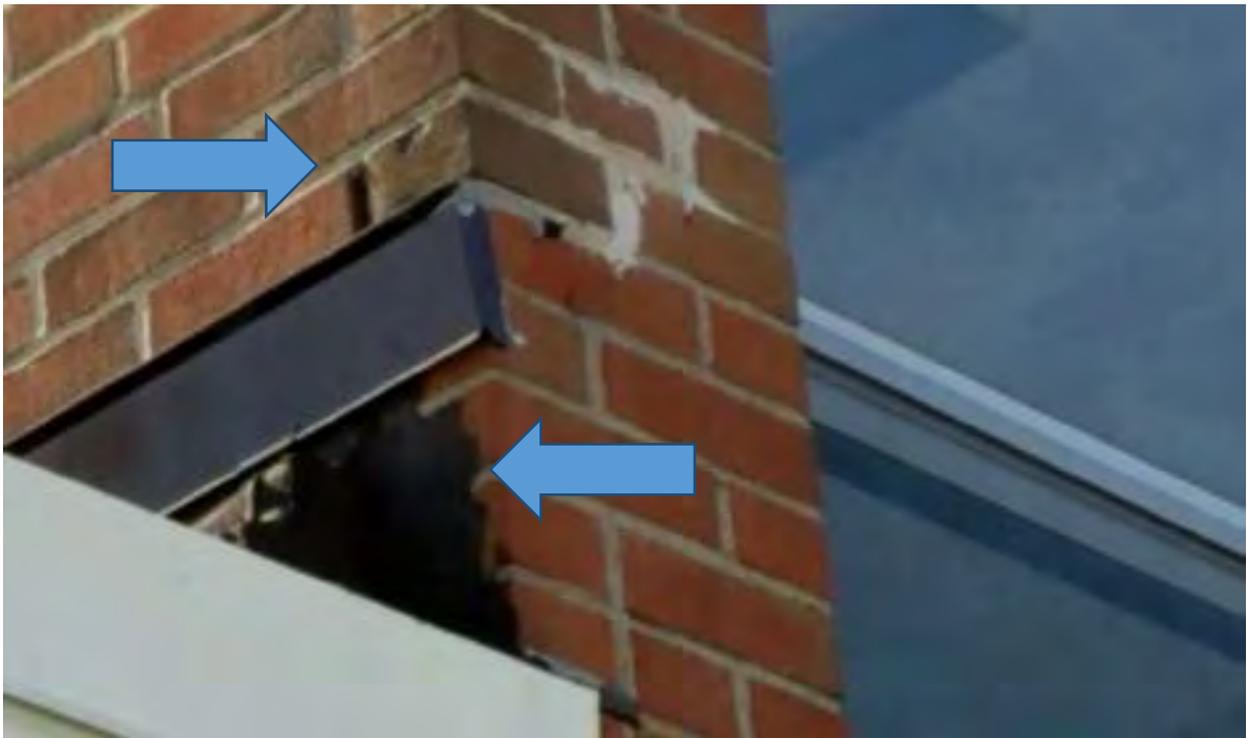
Poor roof flashing transition and open brick joints needing repair ( north elevation )

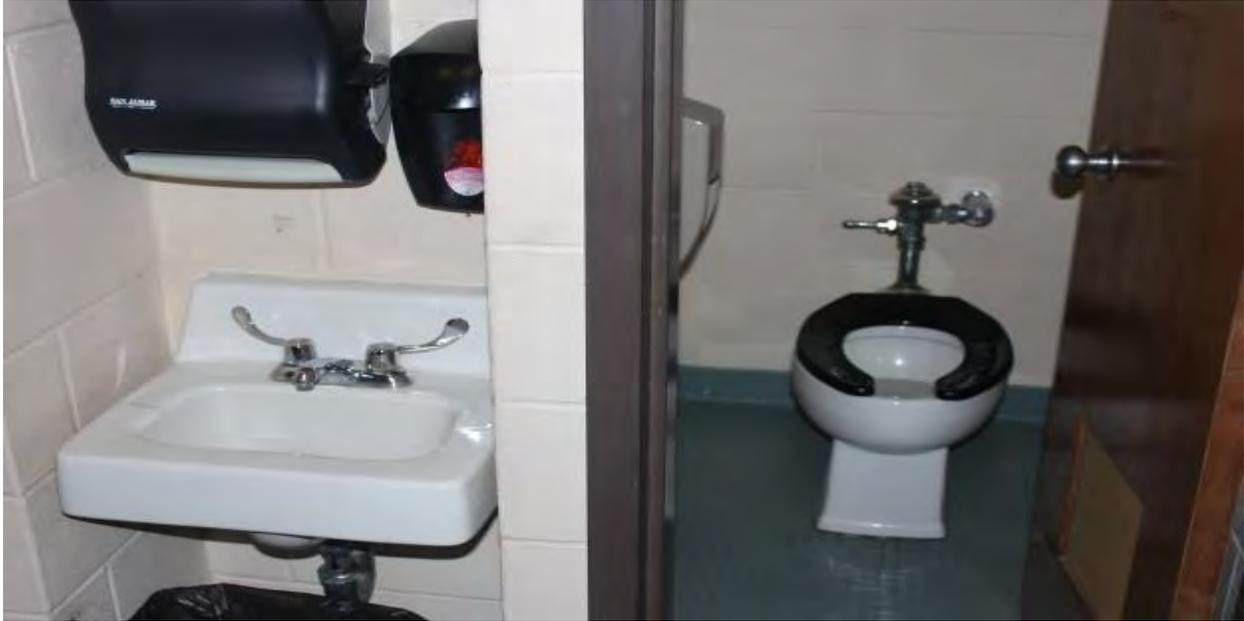
Current undersized bathrooms at classrooms. Non ADA compliant and operationally extremely small.

Perform a full ADA compliance evaluation in conjunction with a full use and needs assessment to determine future course of action with this building. \$20,000

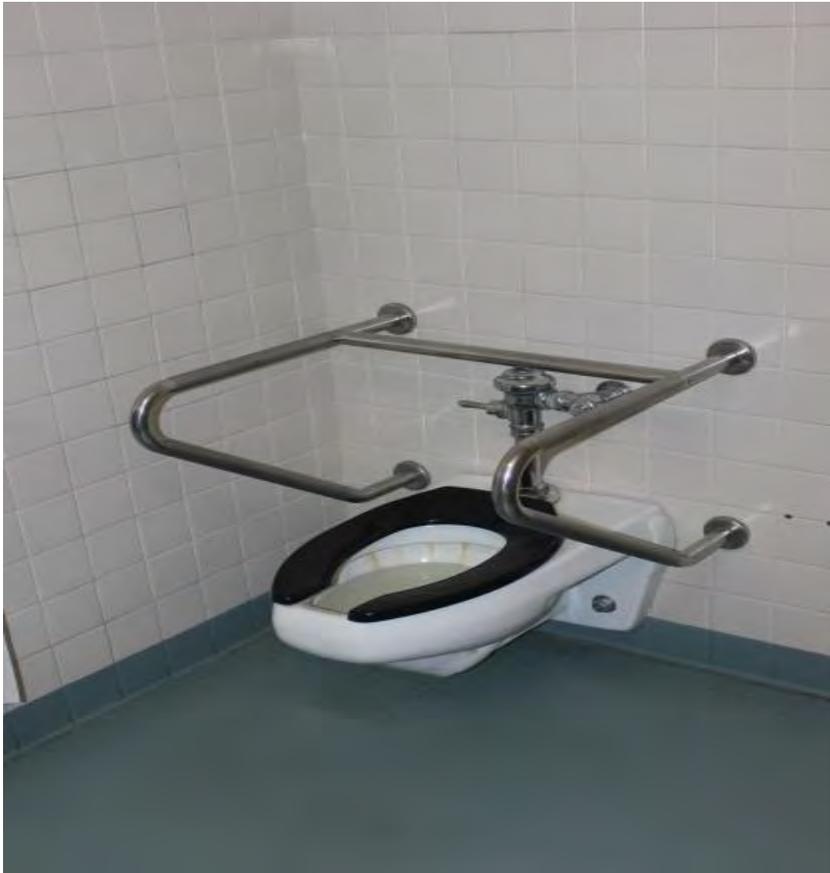
Gang bathroom retrofit for ADA compliance. Removed an adjoining toilet and installed handrail bars

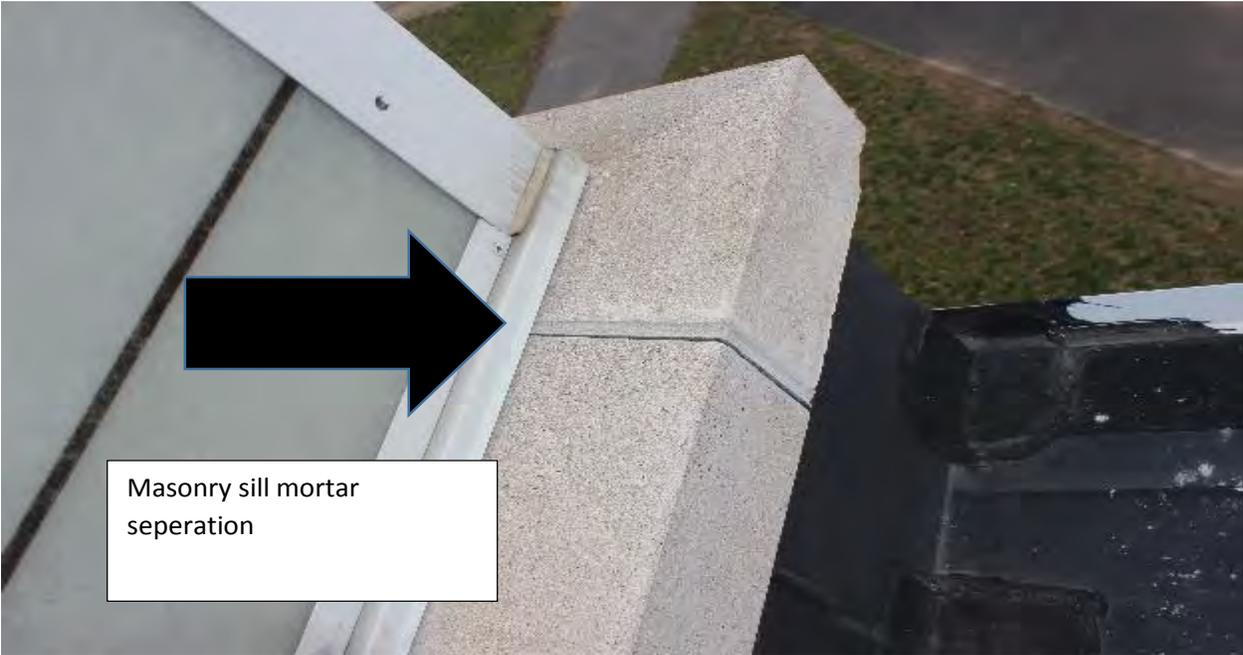
Masonry sill mortar separation

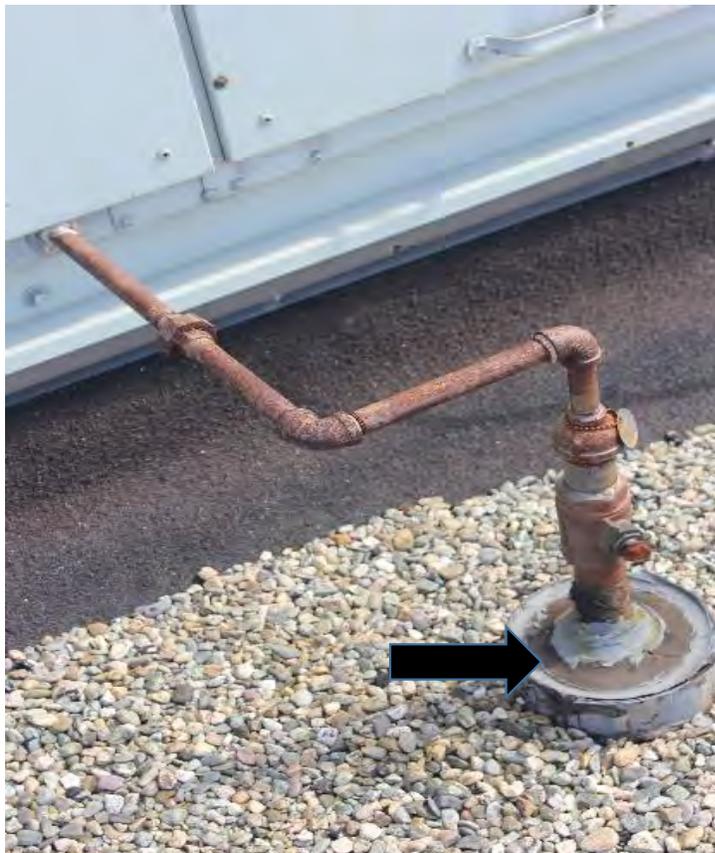
BUR flashing at HVAC and poor pitch pocket

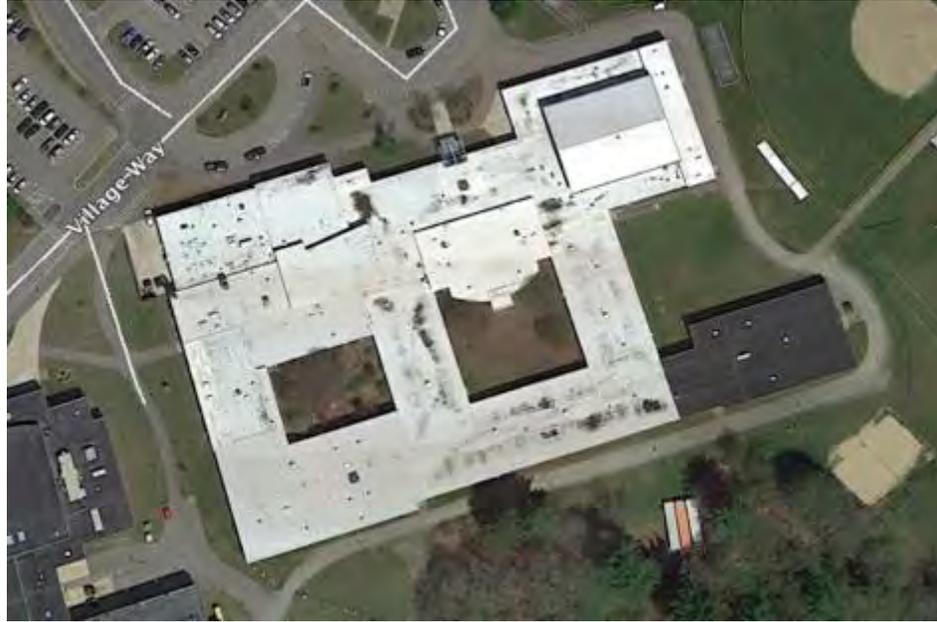
**Photo 1**

Aerial view of the Blake Middle School.

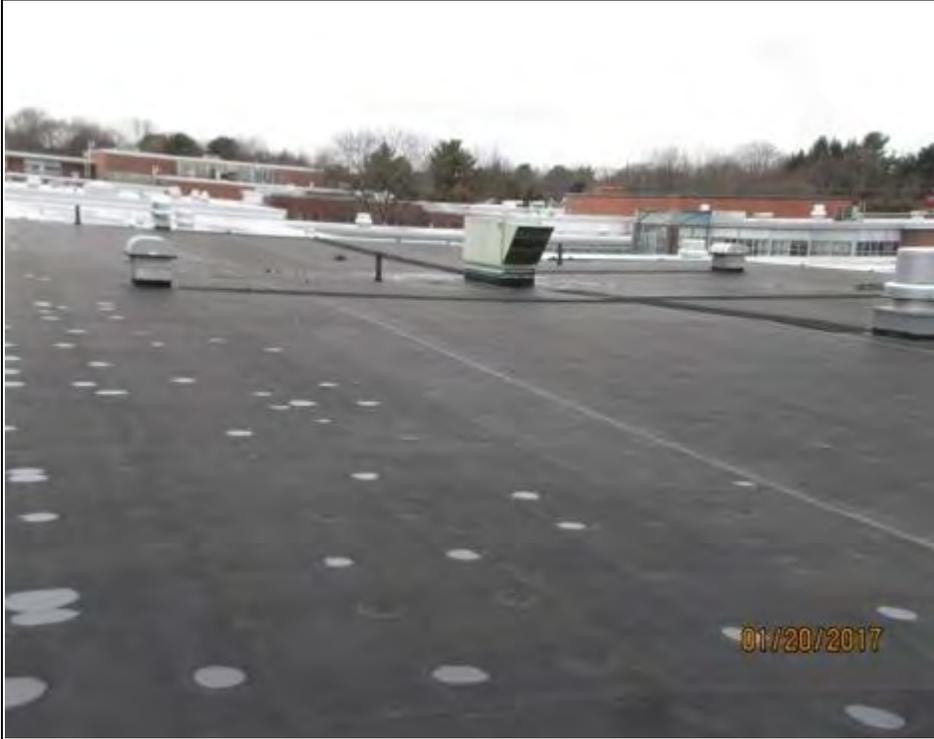
**Photo 3**

EPDM roof area.

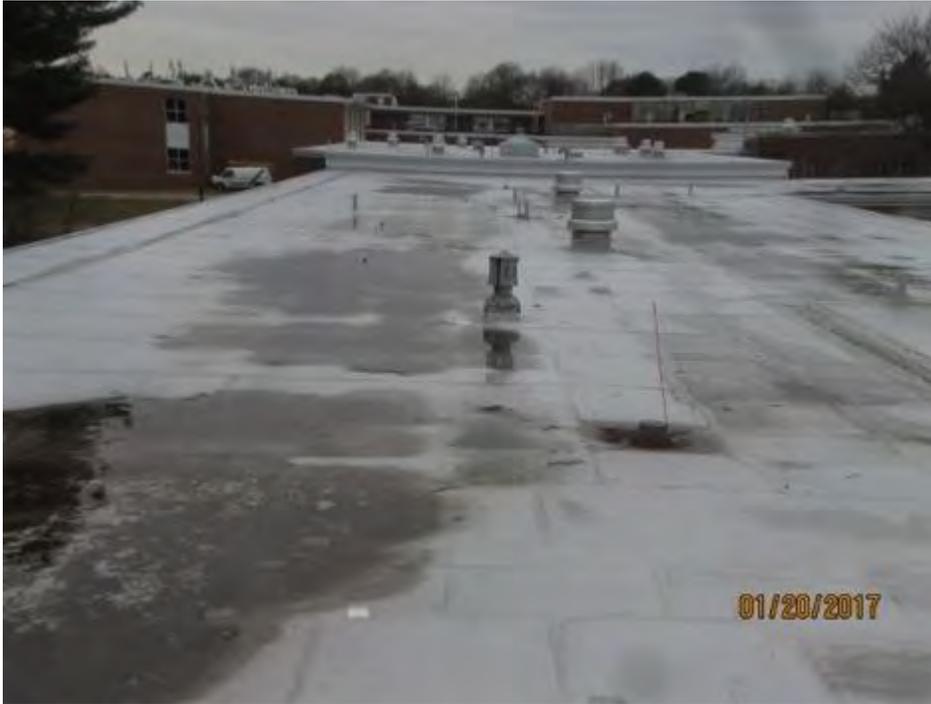
**Photo 5**

PVC roof with tapered insulation still ponds water.

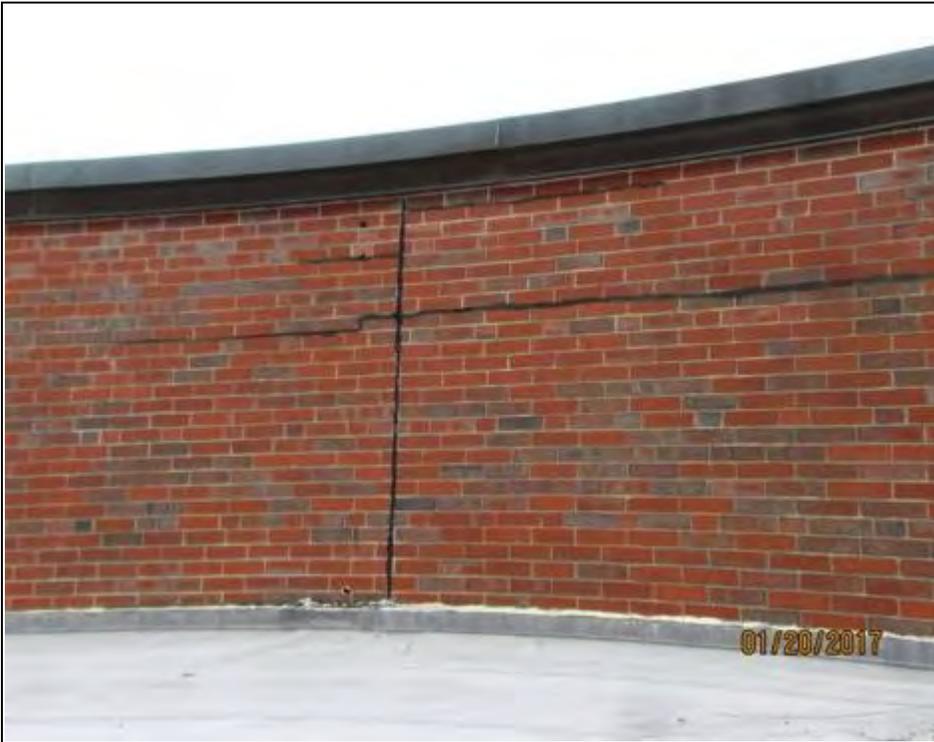
**Photo 7**

South wall of the Auditorium is deteriorated allowing water to bypass the reglet counterflashing below.

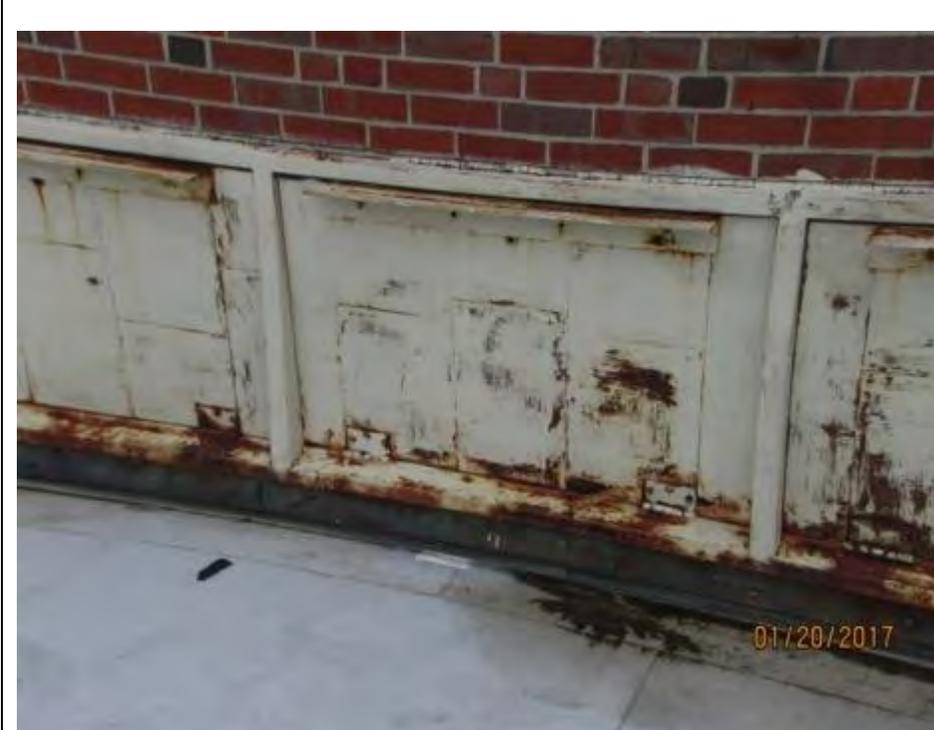
**Photo 8**

West Auditorium wall has very low flashing heights and deteriorated smoke vent doors.

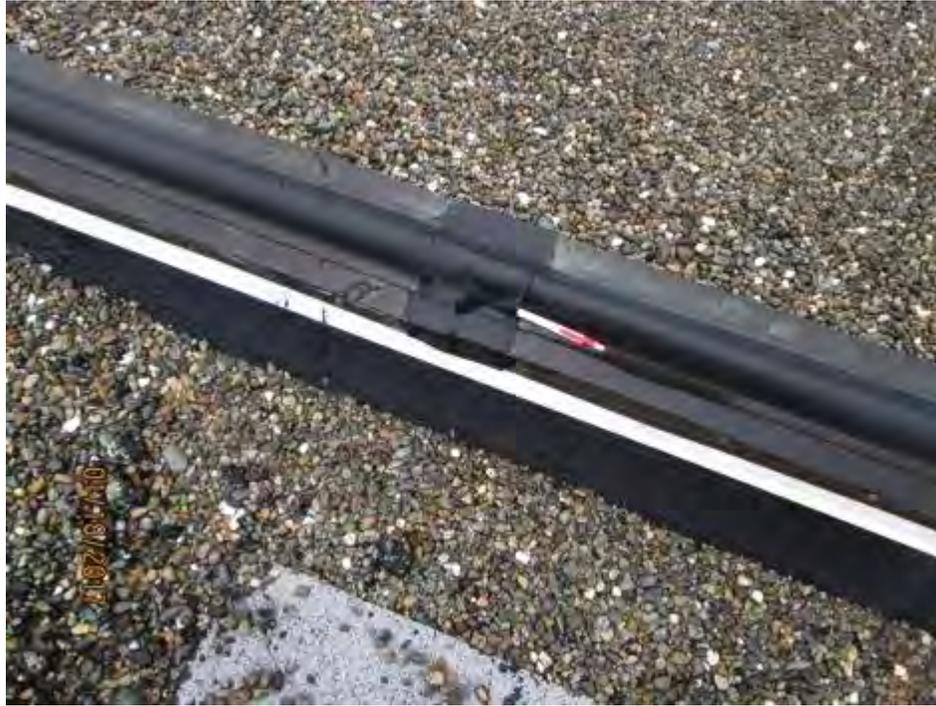
**Photo 13**

Seams in the expansion joints are failing.

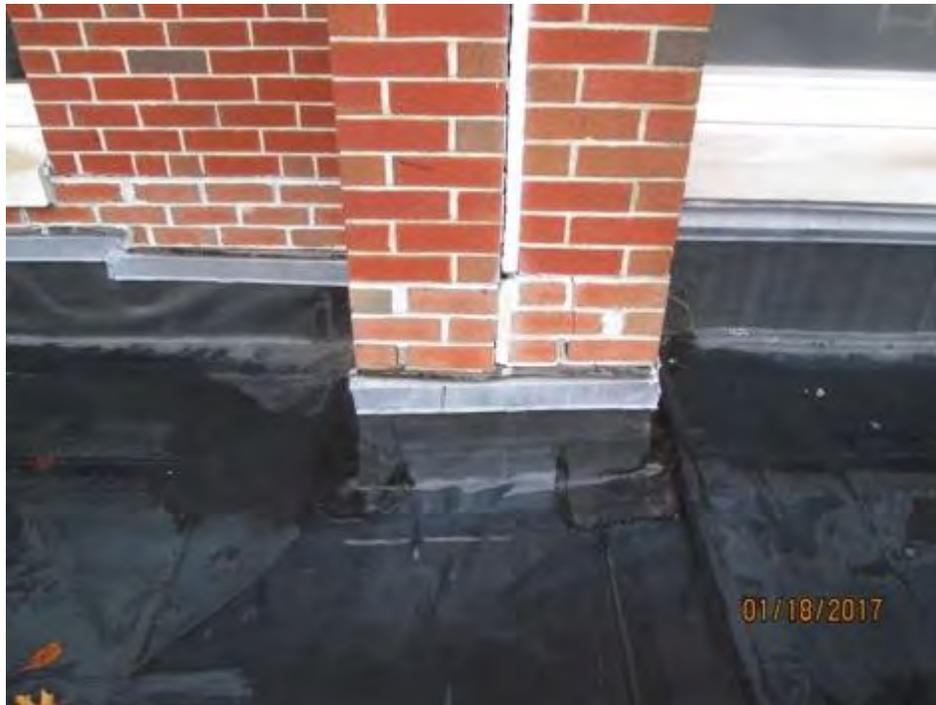
**Photo 14**

Brick masonry is disrupted and sealant joints are failed in certain locations.

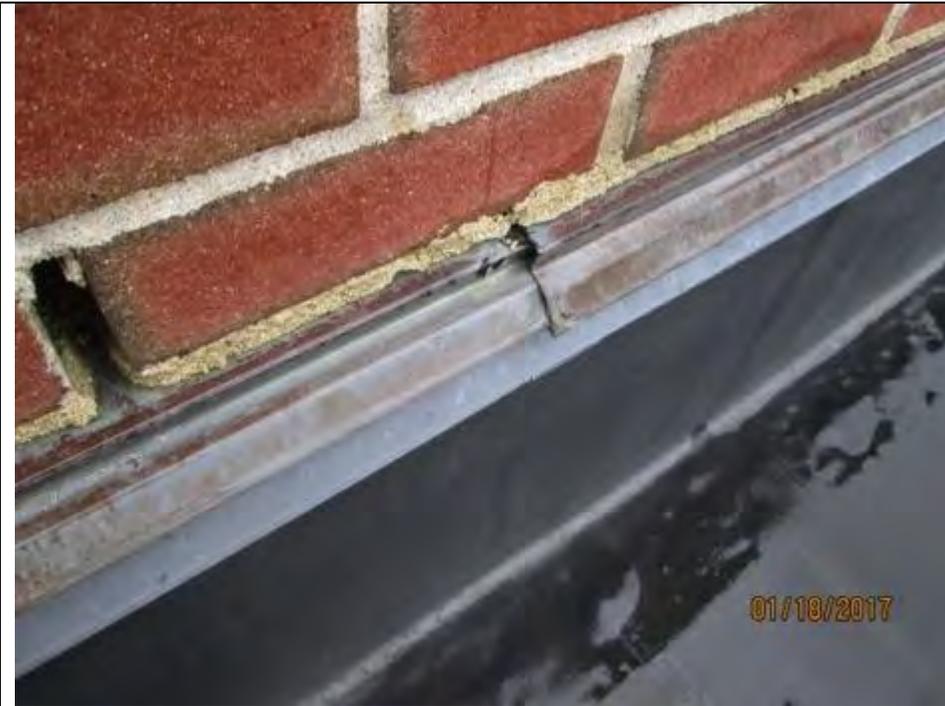
**Photo 15**

Throughwall flashing in the curved wall above the auditorium do not appear to be sealed.

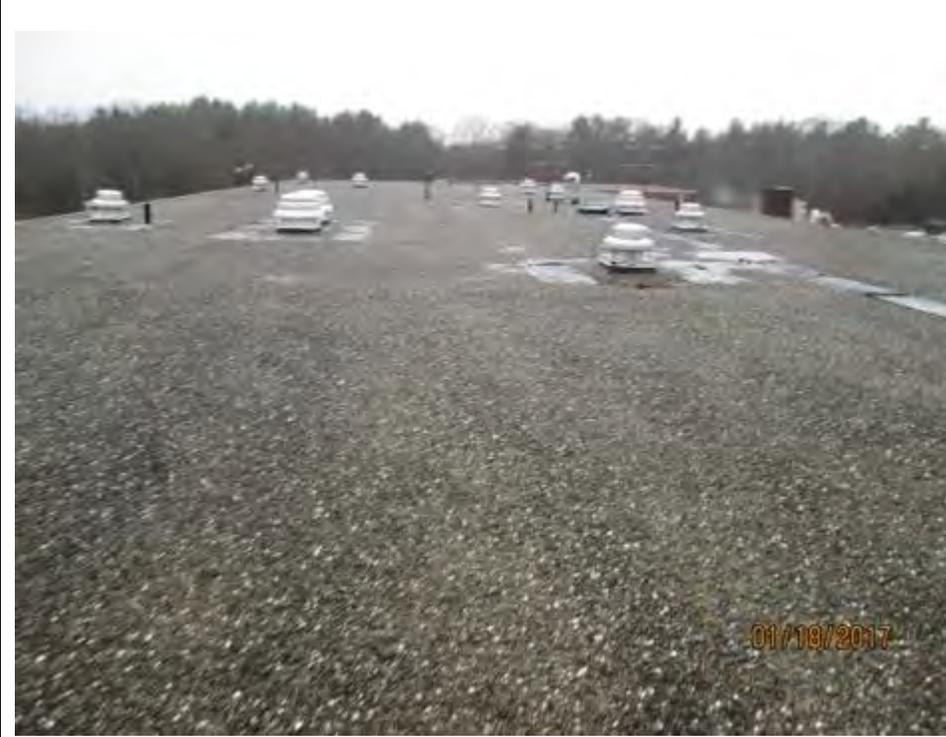
**Photo 18**  
**Ralph Wheelock School**  
Typical view of the bituminous built-up roof system.

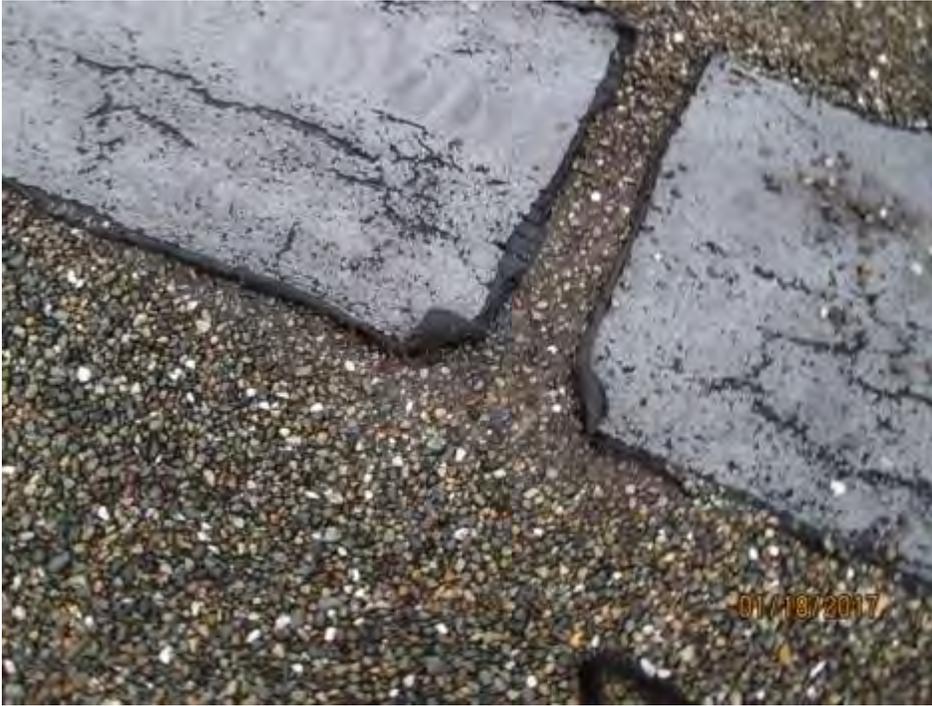
**Photo 19**

Curling walkway pads.

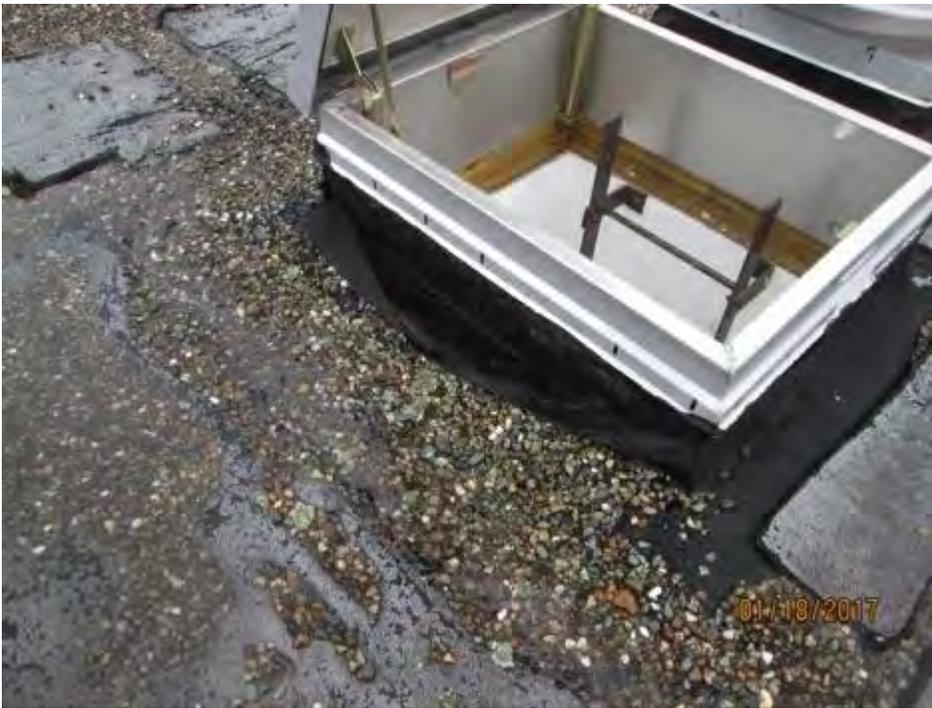
**Photo 20**

Failed base flashings.

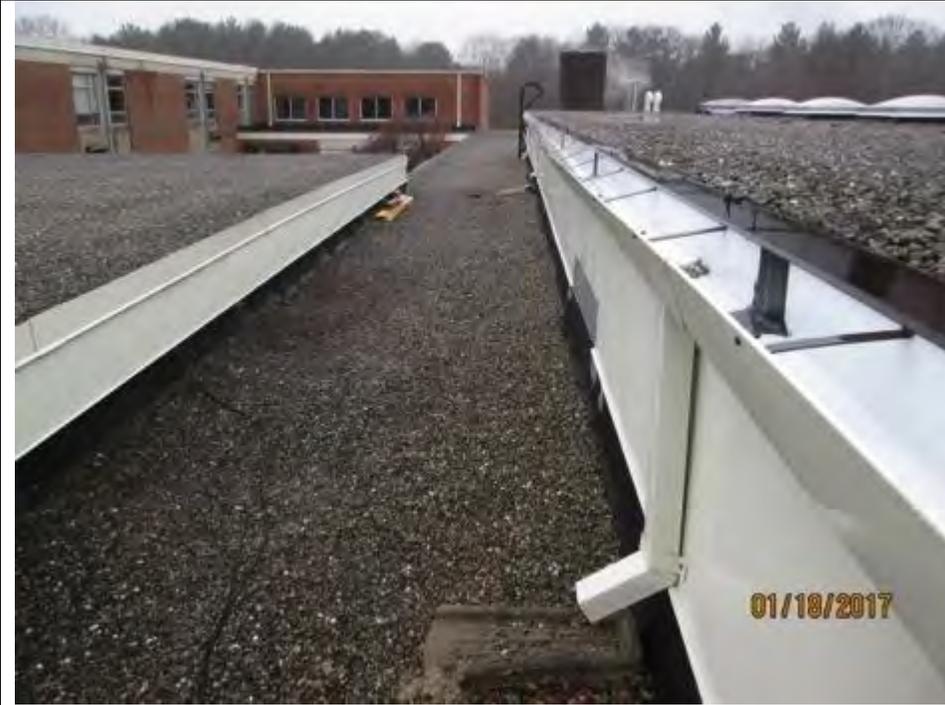
**Photo 21**  
**Ralph Wheelock School**  
Damaged gutter.

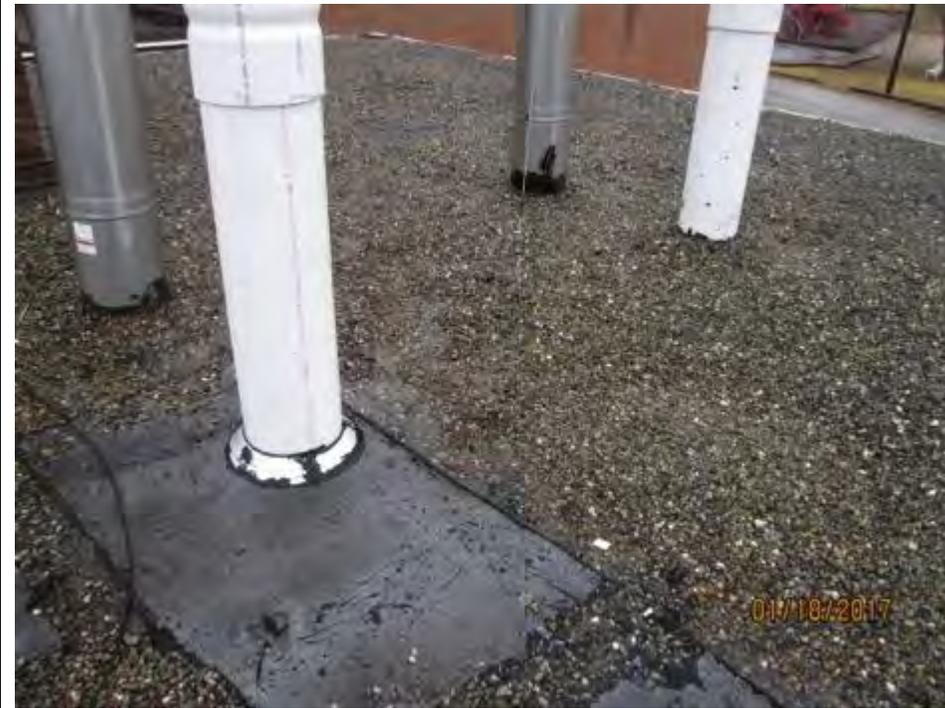
**Photo 22**  
**Ralph Wheelock School**  
Poorly flashed boiler flues (white PVC pipes).

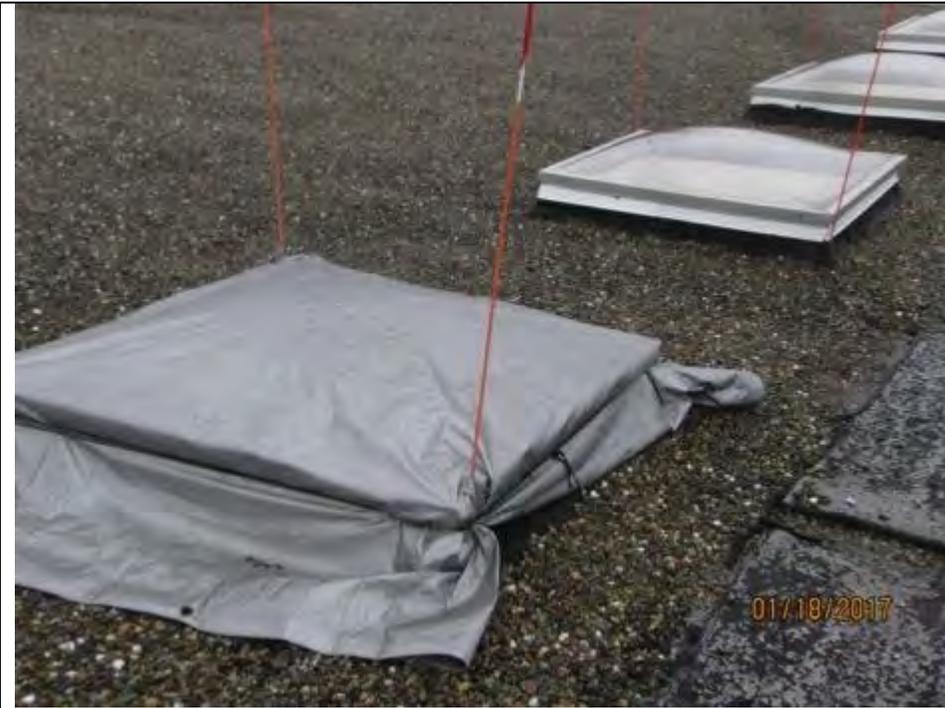
**Photo 23**

Damaged/  
deteriorated  
skylight domes.

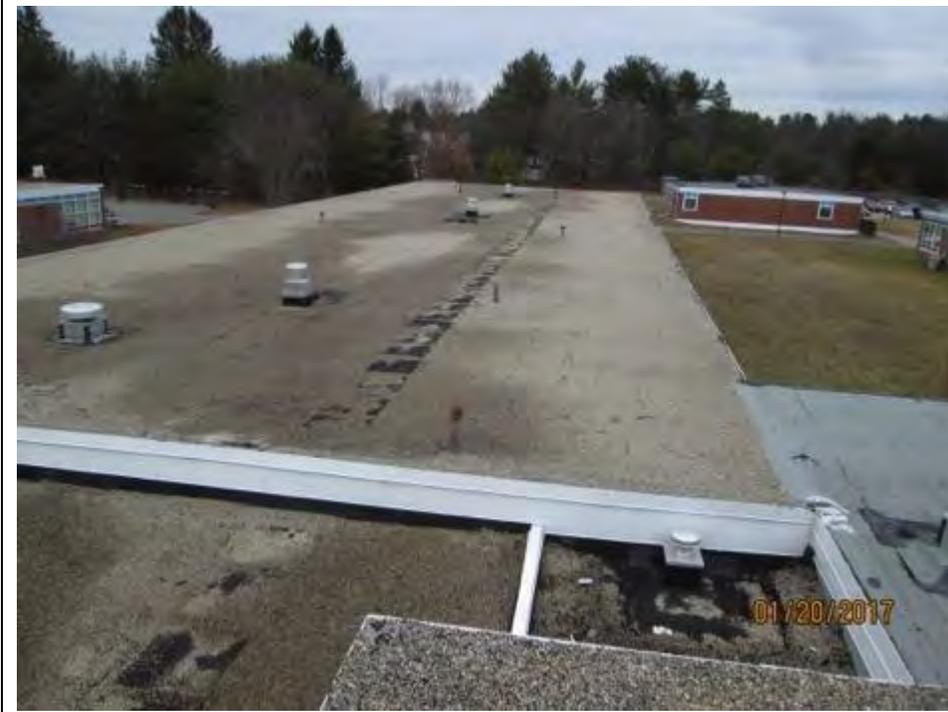
The BUR roof system covers approximately 32,700 square feet and appears to be over 20 years old. The condition of the BUR roofs is poor. Built-up flashings at metal roof edges are separating from the sheet metal and seams are failing at curbed penetrations. Walkway pads are curling. Slope to drain is minimal at best. Two pitch pockets have failed sealer. Ponding water exists at many areas near roof edges and the ponding appears to coincide with leak locations. This roof is near the end of its service life. Complete removal and replacement is recommended.

**Photo 26**  
**Memorial School**  
Typical built-up  
roof system.

- Promptly remove and replace all BURGS and Mod Bit roofing and underlying insulation. Tapered insulation will be required at some areas.
- Remove and replace all roof drains. Snake all roof drain lines.

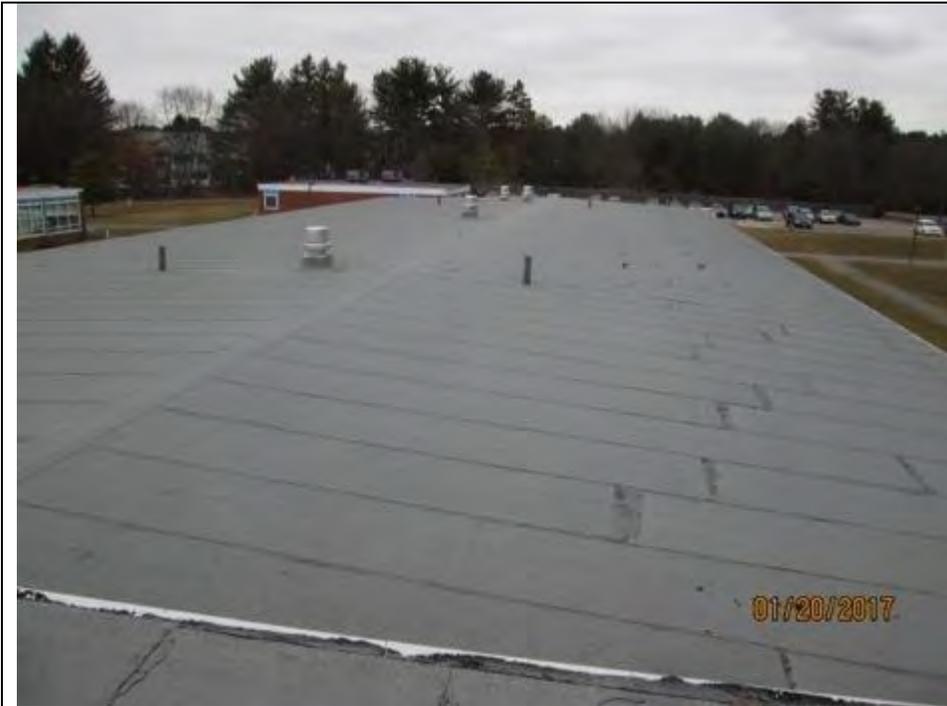
**Photo 27**

The Mod Bit roofing system (with white cap sheet) covers approximately 23,300 square feet and appears to be approximately 15 years old. The roof covering is adhered to flat rigid board insulation applied to roof decks are nearly flat or slope at approximately 3" per foot to gutters. The condition of this roof is fair to poor; much of the lower roof edges negatively slope. Tie-ins to other roof systems are cracked and split open. The resulting ponded water also coincides with reports of leakage into the building. Extensive patching of the roof edges may perform well for a very short term but proper repair should include reconstruction of the roof edges to promote positive drainage. This roof is near the end of its service life. Complete removal and replacement is recommended.

Typical newer  
Mod Bit roof  
system.

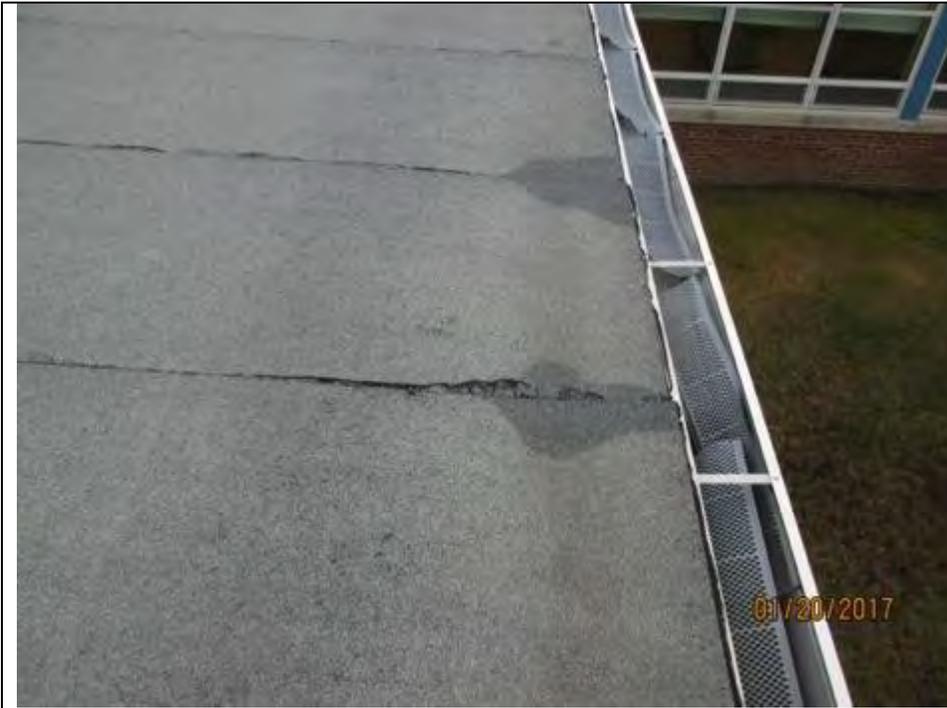
**Photo 29**

Poorly pitched roof edges allow ponded water and possible leaks.
