# **TOWN OF MEDFIELD**

## **Municipal Facilities**

### **Evaluation and Capital Plan**

October 6, 2017

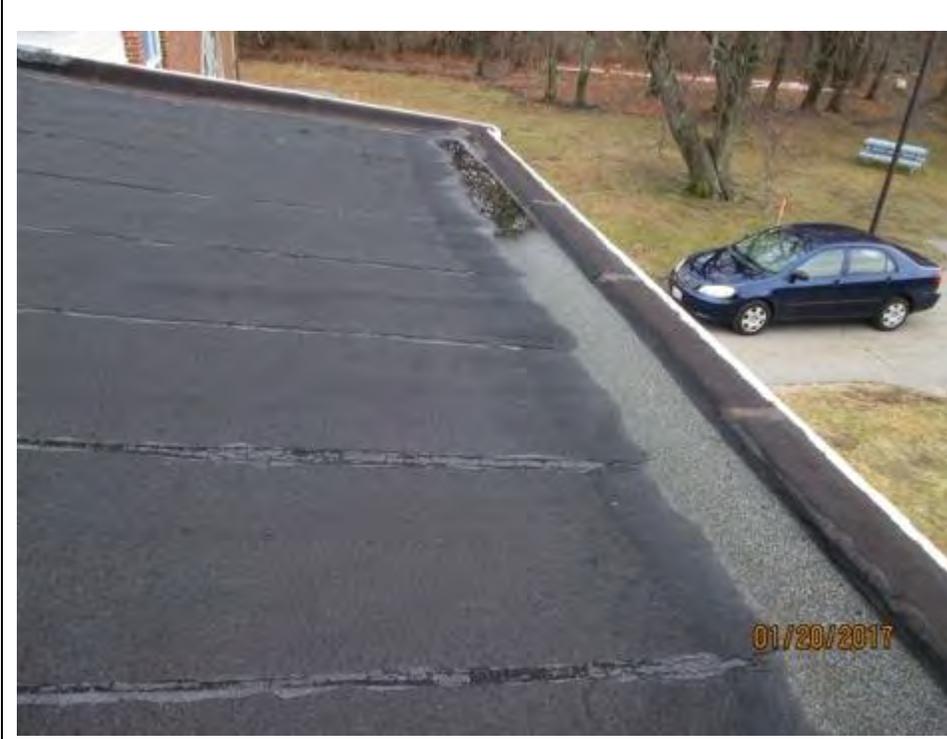
**Photo 30**

The Mod Bit roofing systems (with black cap sheet) covers approximately 4,800 square feet and appear to be greater than 20 years old. These roofs slope to roof drains at approximately 3" per foot. The condition of these roofs is failed. Much of the lower roof edges negatively slope. The resulting ponded water also coincides with reports of leakage into the building. This roof is near the end of its service life. Complete removal and replacement is recommended.

Poorly pitched roof edges at the older Mod Bit roofs allows ponded water and possible leaks.

- Promptly remove and replace all BURGS and Mod Bit roofing and underlying insulation. Tapered insulation will be required at some areas.
- Remove and replace all roof drains. Snake all roof drain lines.

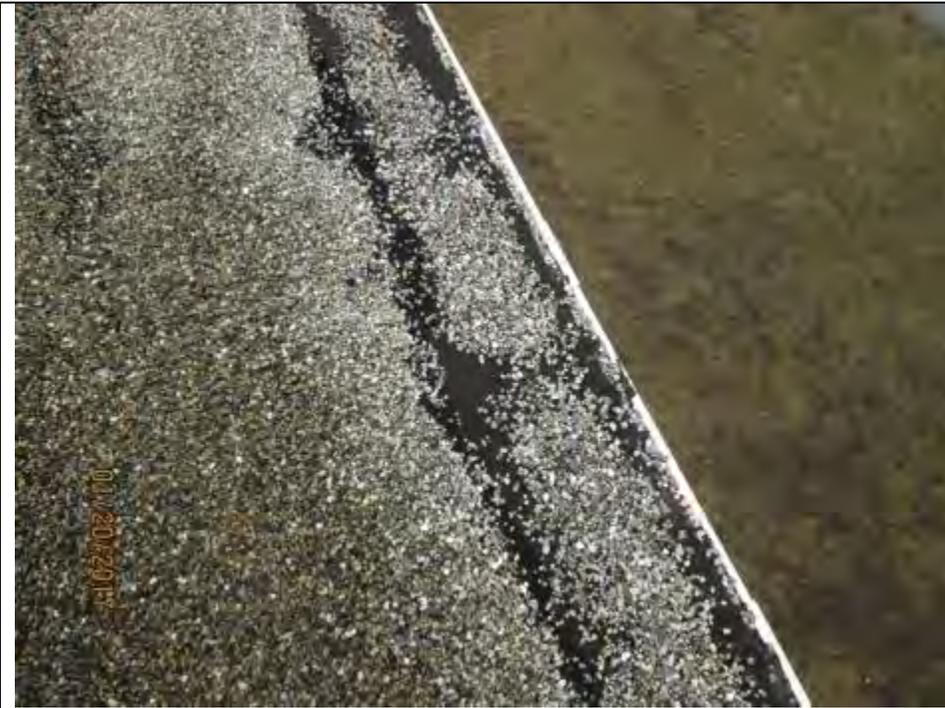
**Photo 31**

BUR flashing edges are worn.

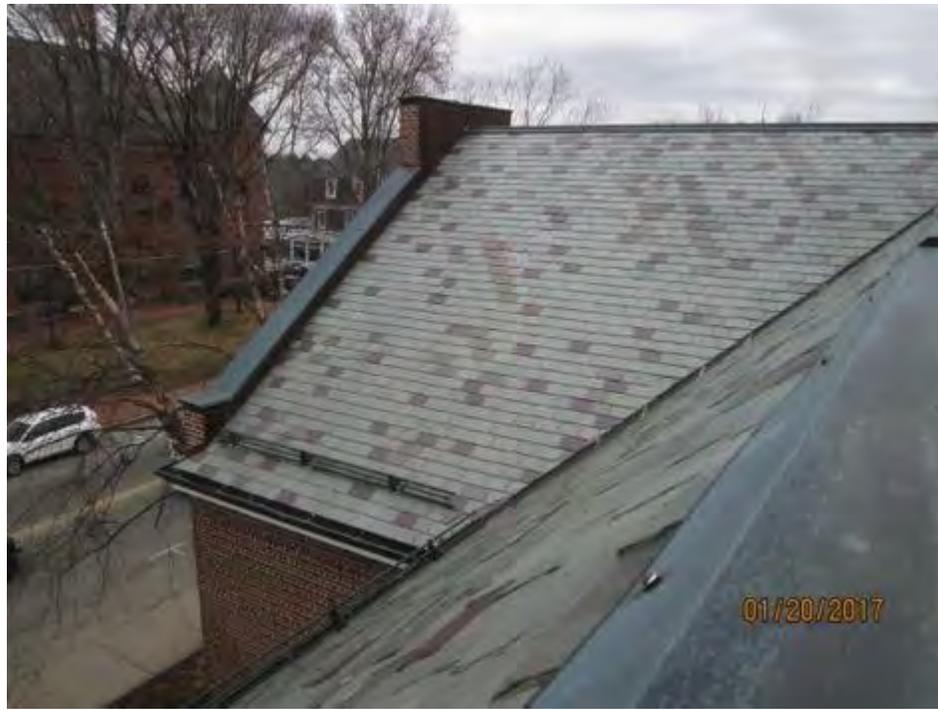
The natural slate roof system covers approximately 9,200 square feet and appears to be 19 years old. The slate roofing is applied to wood roof decks that slope at 12" per foot. The condition of the slate roofing is fair to good. There are approximately 40 slates that are missing or broken. Four areas of copper ridge cap have become loose. There is approximately 30 linear feet of gutter that appears to have been damaged by snow slide. We understand Titan Roofing will be performing the needed repairs soon.

**Photo 34**  
**Medfield Library**  
Typical view of a  
slate roof surface.  
Note the broken  
slate.

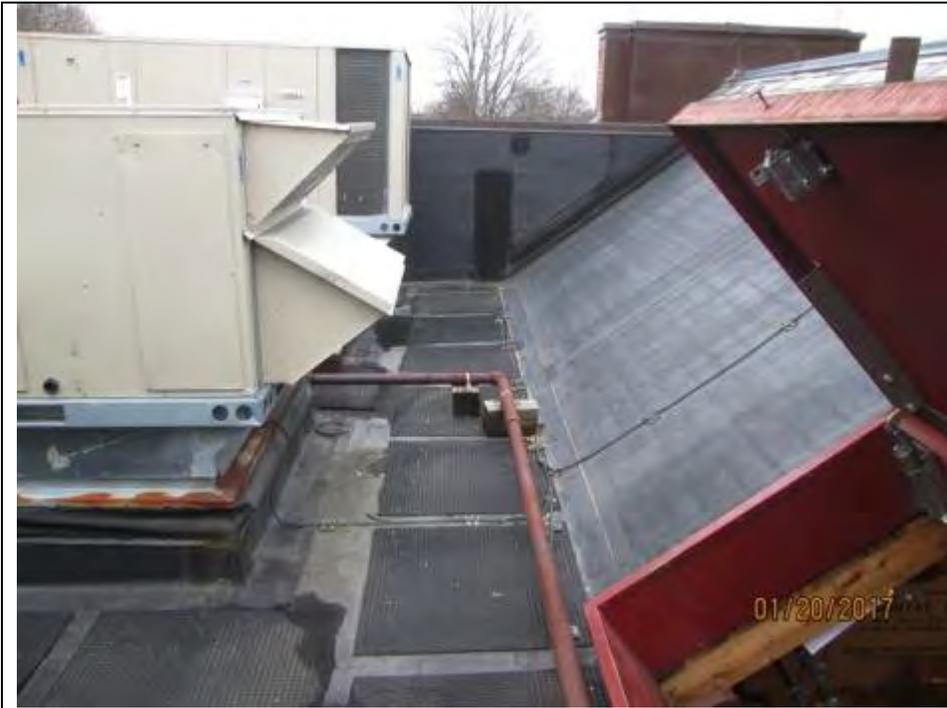
**Photo 35**

The adhered EPDM roof system covers approximately 1,300 square feet and is reported to be 17 years old. The EPDM roof covering is adhered to rigid board roof insulation at the center of the complex and at dormers built into the slate roof slopes. The center roof is heavily congested with HVAC equipment. There is a build-up of debris. The condition of the roofs at dormers is fair. The condition of the EPDM roof in the center of the complex is poor. Extensive repairs have been performed and we expect future abuse by tradesmen when servicing the HVAC equipment. We found many small punctures and tears in the EPDM roof membrane where the EPDM roof is applied to sloped roof decks below the slate roofing.

Typical view of center EPDM roof system.

- Promptly remove and replace the EPDM roofing and underlying insulation. Tapered insulation will be required.
- Snake all roof drain lines.

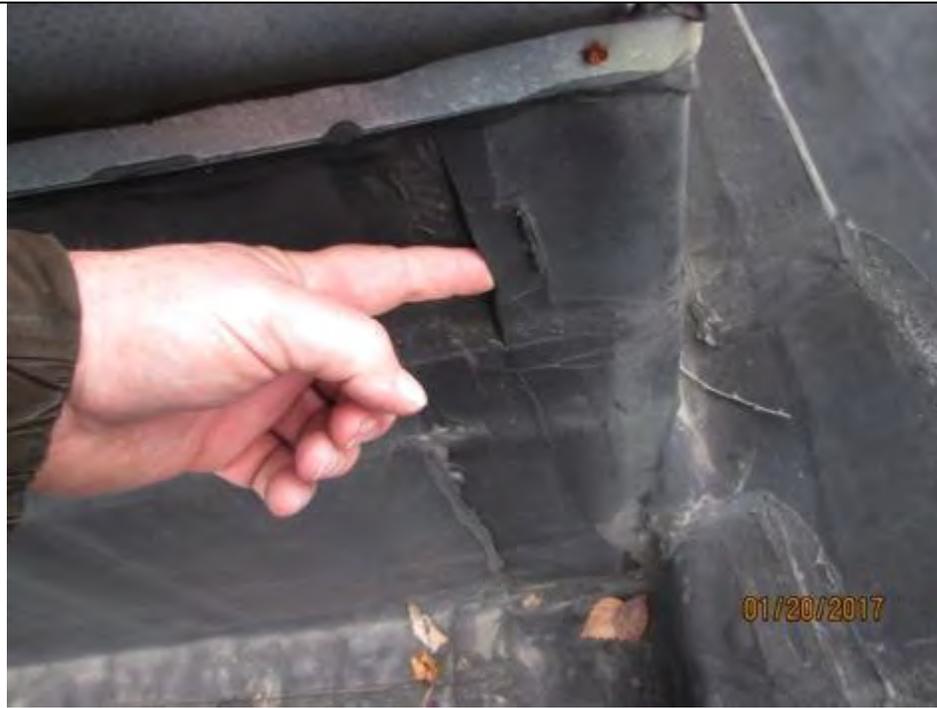
**Photo 37**  
**Medfield Library**  
Failing EPDM  
seam.

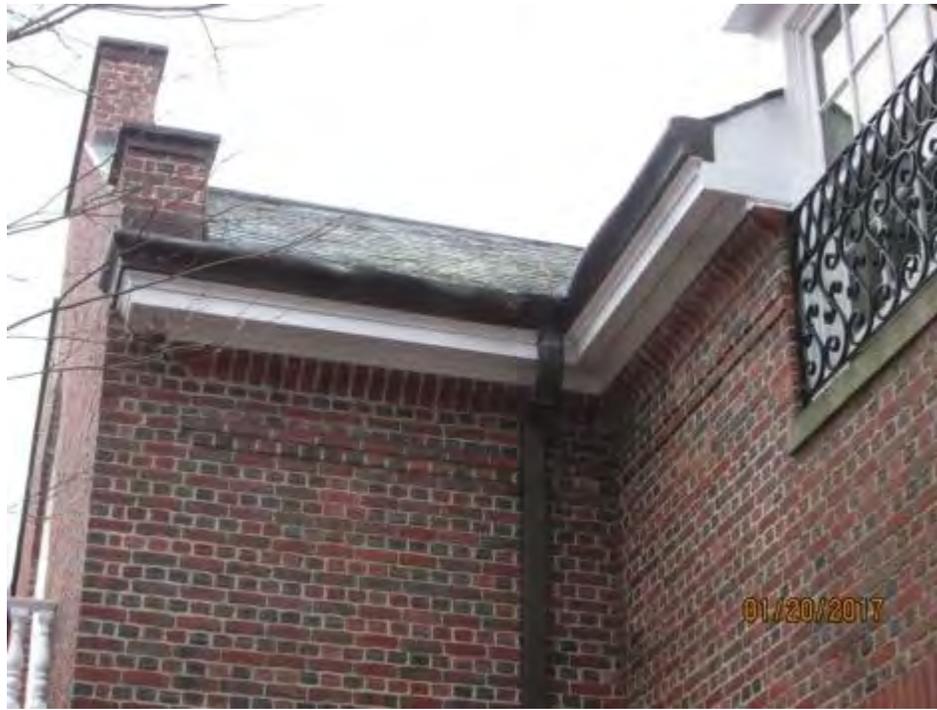
**Photo 38**  
**Medfield Library**  
Damaged gutter.

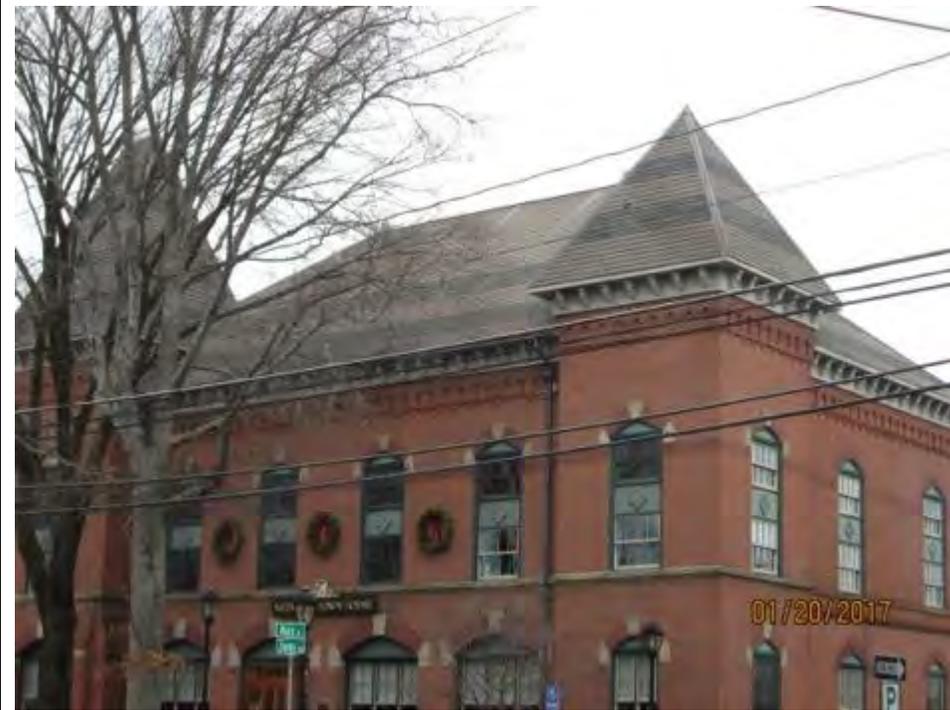
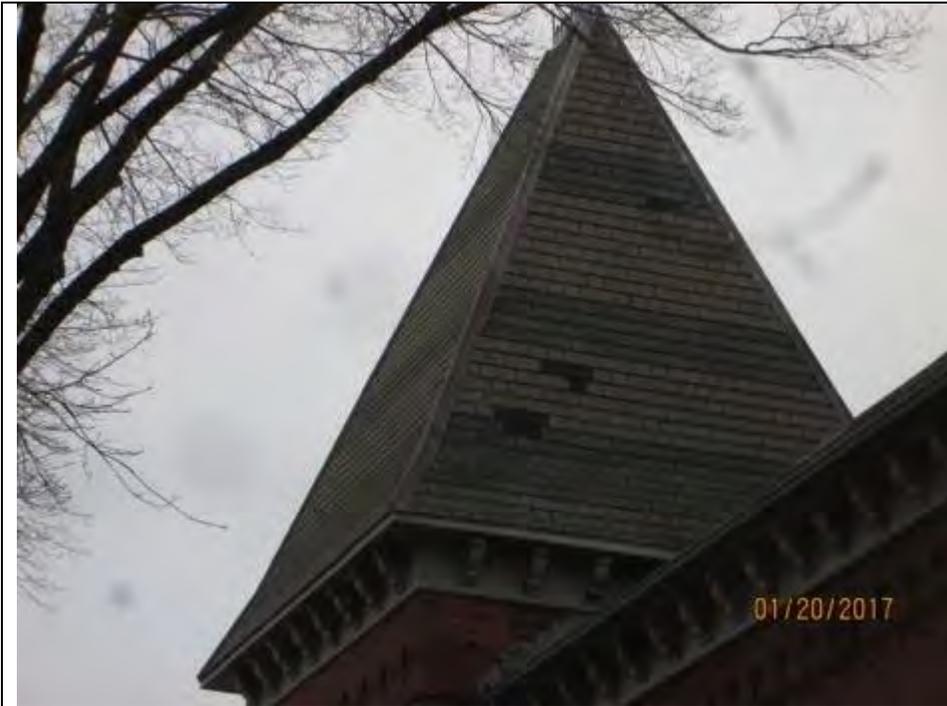
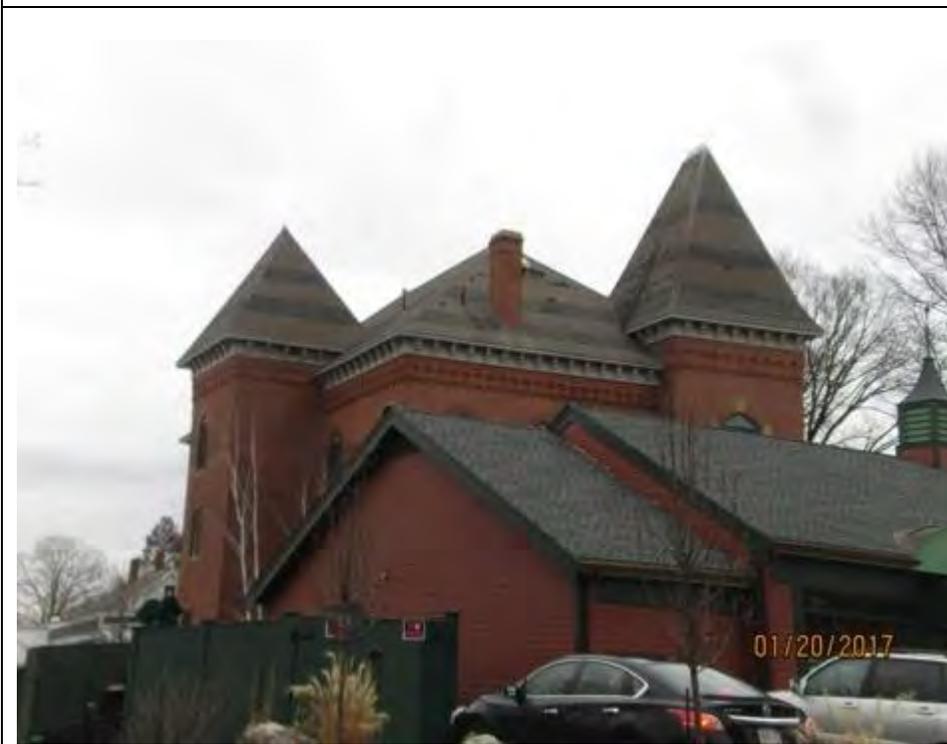
The condition of the shingle roof is fair. Approximately 70 shingle tabs are missing. The missing shingles may be due to poor installation, poor wind seal adhesive or the lack of hand sealing the tabs (often a requirement when working on very steep slopes). These deficiencies may exist throughout the project. Depending upon the extent of warranty provided with the installation, the cost of repair may be covered. We recommend that the Owner review the project files to determine if a warranty exists and the extent of coverage.

Typical view – dark spots on roof are missing shingle tabs.

- Replace all missing shingle tabs.

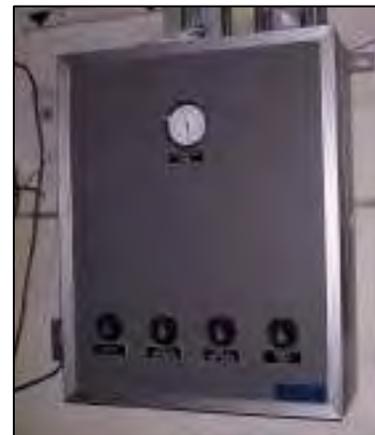
- Check the outdoor air dampers on the unit ventilators and air handling units to determine if they are functioning properly. One air handling unit appeared to have the pneumatic controls disconnected.

- Change HVAC filters. The facility reportedly has a schedule for replacing filters, but the air handling units appeared to be overdue.
- Replace the programmable thermostats for the modular classrooms with a more advanced model that can control temperatures on weekends and fan use on nights and weekends.

► **Action Steps:** *Work with in-house staff or a mechanical contractor to adjust controls.*

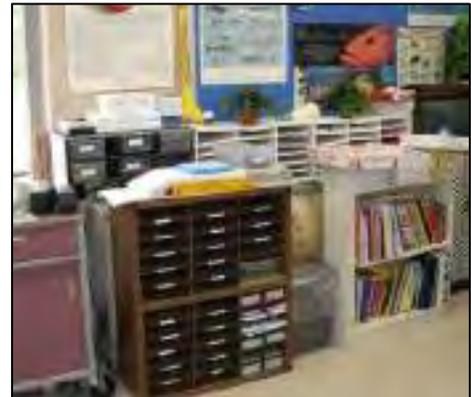
Heating and ventilation is provided to the space by unit ventilators. Supply air leaves the top of the cabinet, and return air enters through front of the cabinet near the floor. The unit ventilators will run more efficiently and more effectively if the air flow is unrestricted. During the site visit, multiple unit ventilators were observed with blocked airflow, including one classroom that has a child with allergies. A sample classroom is shown on the right, with the unit ventilator located behind and under bookshelves and storage units. Teachers should be educated on the importance of maintaining unrestricted air flow from the unit ventilators. The principal has reportedly sent an email encouraging teachers to remove papers from unit ventilators, but further action appears to be necessary. Energy consumption and cost savings from this recommendation are difficult to quantify, so specific values are not included in this report. There is no cost for implementation, so it is recommended regardless of the dollar value of the savings.

► **Action Steps:** *Work with maintenance staff and teachers to remove materials from unit ventilators.*

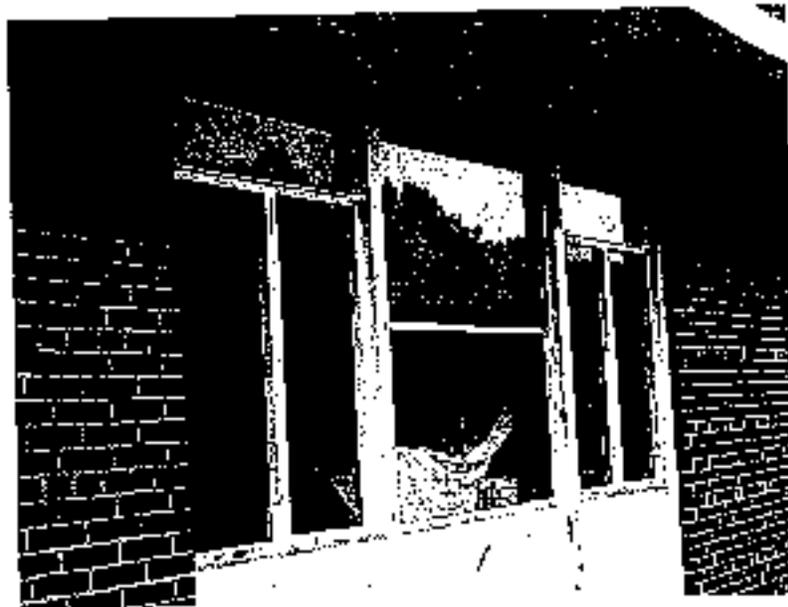
The window wall system in the 1962 building is galvanized hollow metal. As shown in the attached photos, the units are deteriorating and need to be scraped and painted before they are rusted beyond repair. The library gable end window wall system was replaced three years ago.

The Exterior doors and frames as well as the window wall system in the 1962 building are in need of cleaning and painting. If this is not addressed soon, permanent damage will occur. This is particularly true of the gym entrance facade.

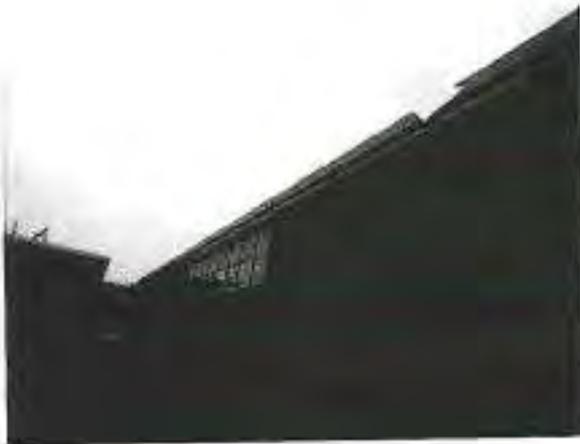
Roof-Wall Intersection Air Sealing – the exterior flashing and finishes at the roof-wall intersection are not constructed to stop air leakage.

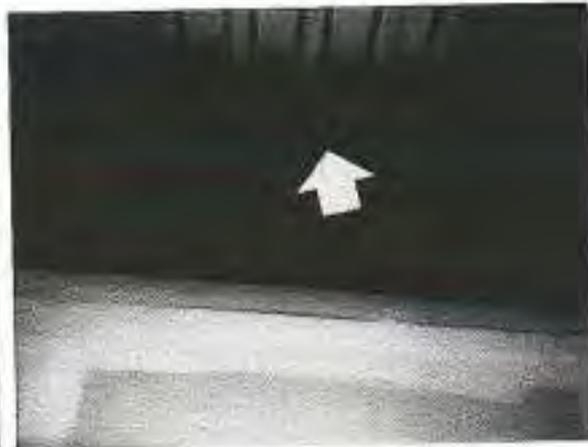
Roof-Wall Intersection Air Sealing – gaps between the roof deck and wall flashing are pathways for unwanted infiltration/exfiltration.

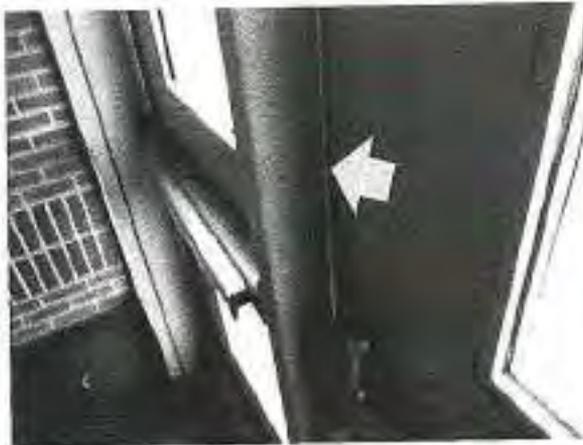
Door Weather Stripping – clear daylight around the door shows a direct pathway for unwanted air leakage.

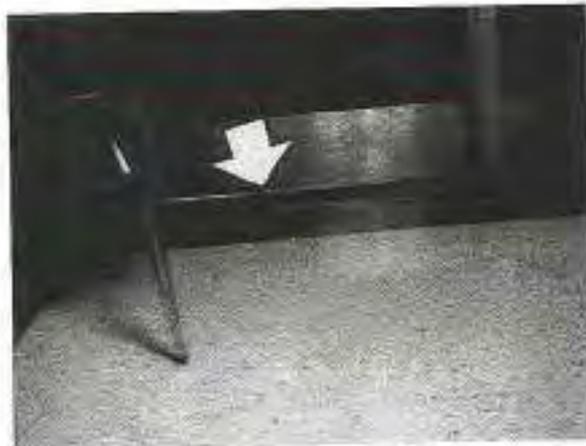
Door Weather Stripping -- clear daylight around the door shows a direct pathway for unwanted air leakage.

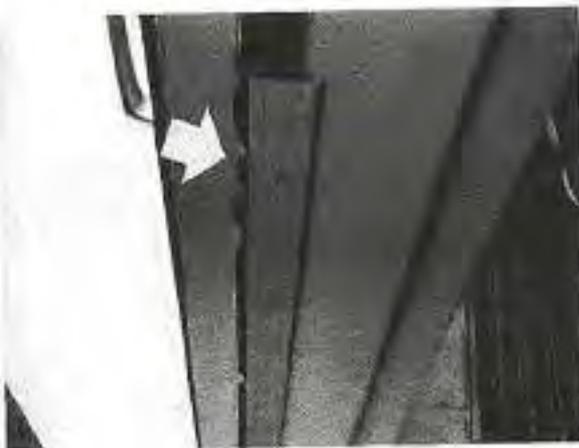
Door Weather Stripping – the gasket material has deteriorated. There is no compression seal at the perimeter of the door and as a result the door is allowing infiltration/exfiltration.

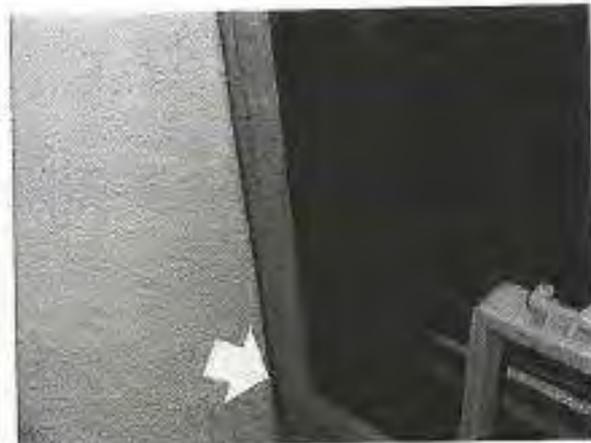
Window Casing Sealing – the joints at the perimeter of the window system are not properly sealed.

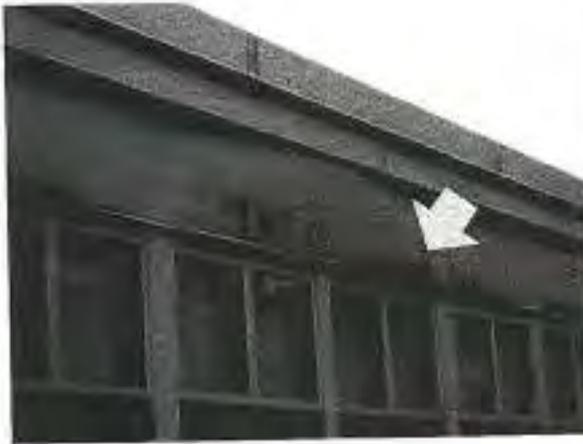
**Window Back Frame Sealing** - the exterior panels above the window systems in the 100s are failing; the panel was likely the wrong material, but air exfiltration at the joint, shown at the right is likely contributing to deterioration.

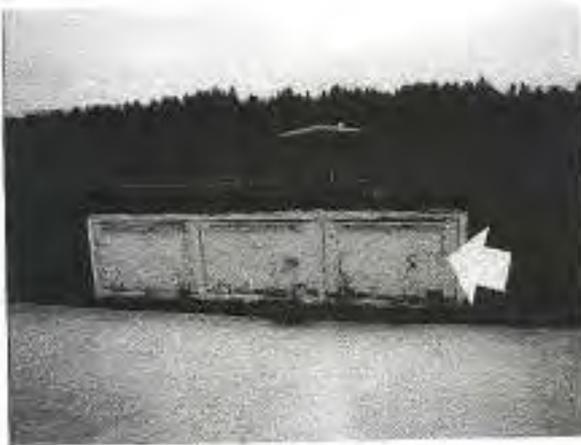
**Custom Window Weatherization** - the opaque operable "windows" in the auditorium tilt-out; this is not a good design for controlling rain water. Daylight is clear at the perimeter of the windows, which is a pathway for unwanted air leakage.

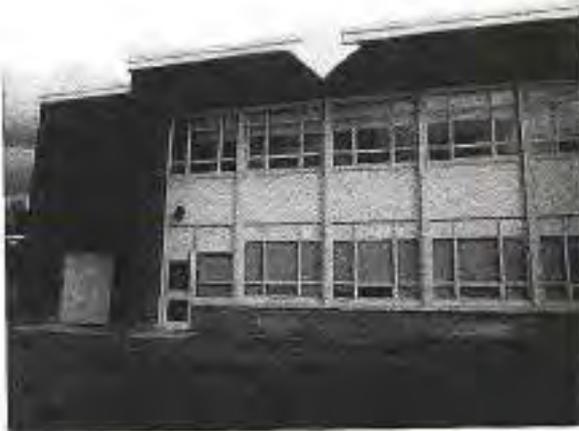
Roof-Wall Intersection Air Sealing - there are exterior vent plugs in place; this construction directs outdoor air at the weak seal (see top right picture) at the roof-wall intersection, leading to excessive infiltration/exfiltration.

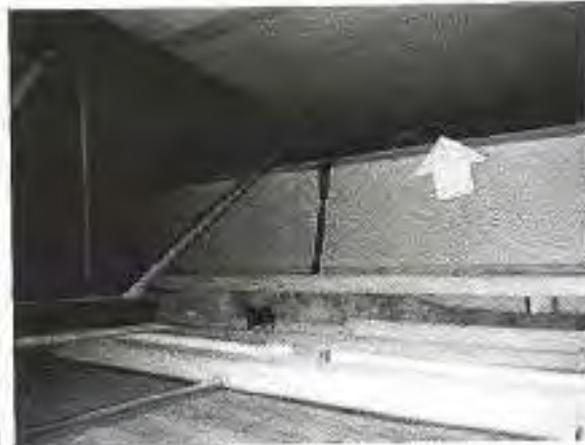
Roof-Wall Intersection Air Sealing - black discoloration of the fiberglass batt is a clear indicator of unwanted air leakage; fiberglass "filters" out dirt and debris as air pass through the material.

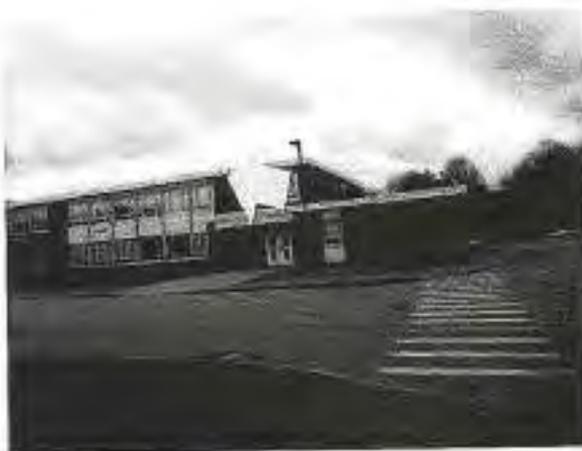
Roof-Wall Intersection Air Sealing - the exterior finishing and finishes at the roof-wall intersection are not constructed to stop air leakage.

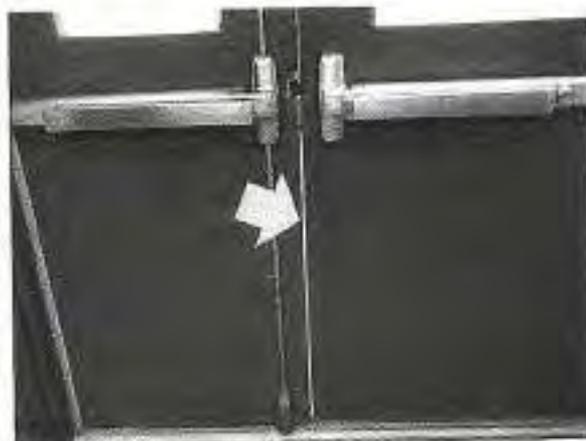
Door Weather Striping - clear daylight around the door shows a direct pathway for unwanted air leakage.

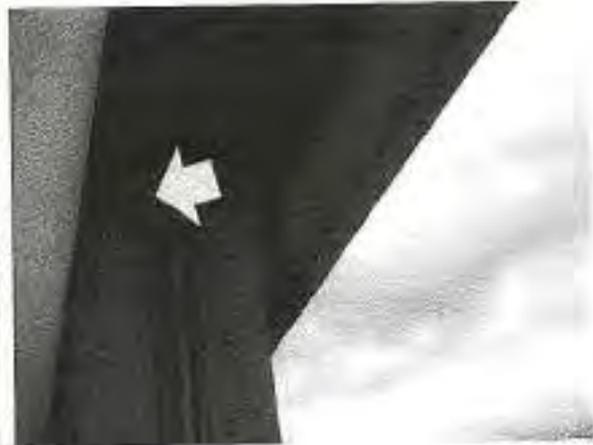
**Window Casing Sealing** – the joints at the perimeter of the window system are not properly sealed and are allowing unwanted air leakage around the window system.

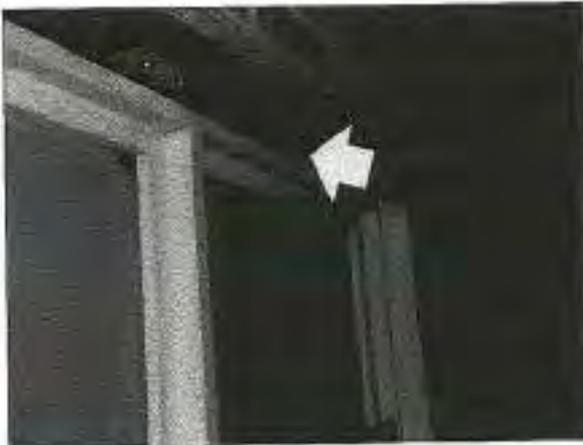
**Window Back Frame Sealing** – the rough opening gap at the window between the wall and the window frame was not sealed above the drop ceiling; this gap is allowing air leakage around the window system.

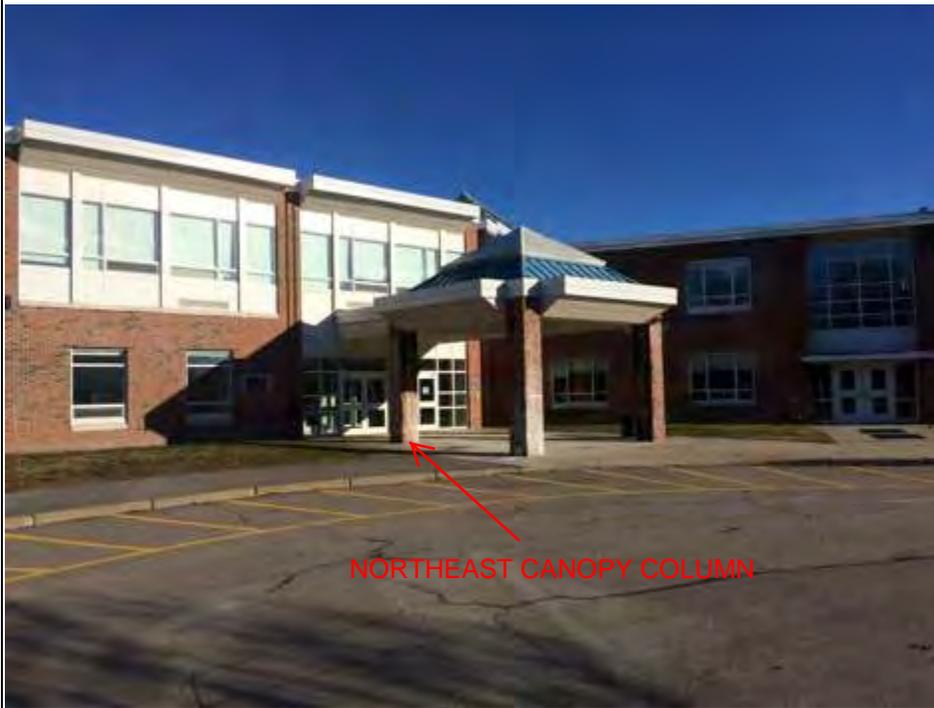
**Photo 3**

NORTHEAST CANOPY COLUMN

North and west sides of canopy.

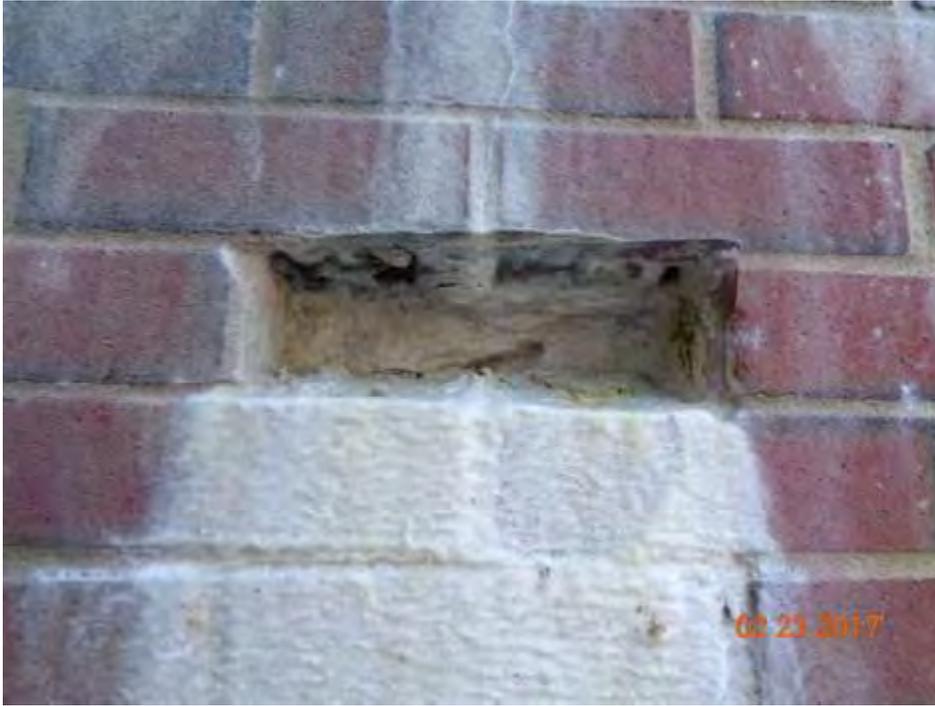
**Photo 5**

Severe efflorescence at the northwest canopy column. One brick was previously removed some time ago resulting in extraordinary efflorescence.

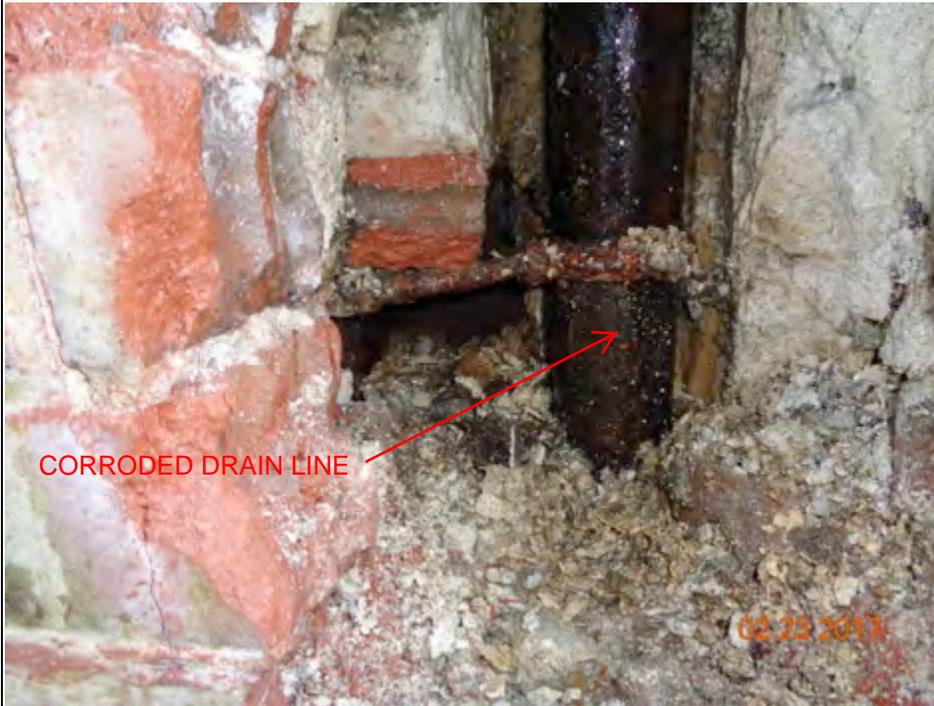
**Photo 7**

Test cut at bottom of northeast canopy column, east side revealed saturated masonry, deteriorated pipe insulation and corroded steel pipe.

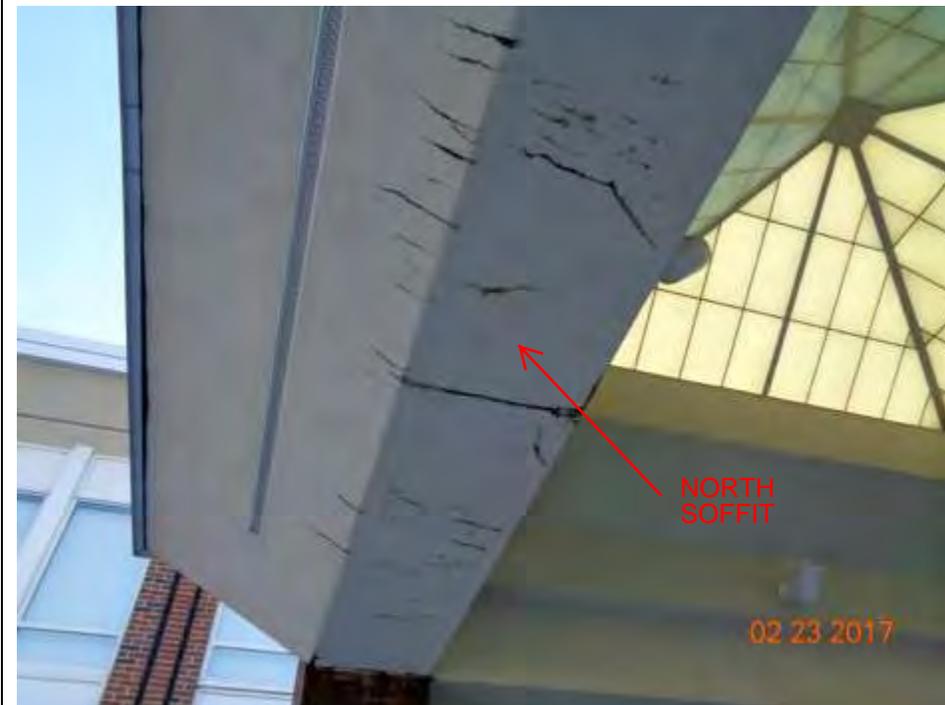
**Photo 8**

Cracked stucco covered soffit is actively leaking due to snowmelt.

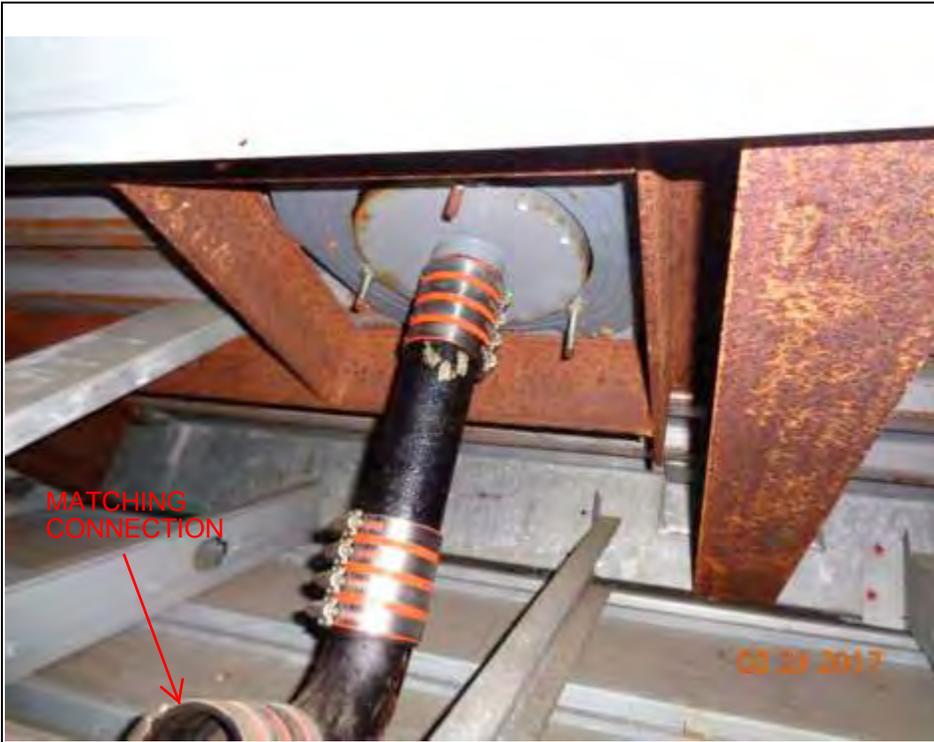
**Photo 9**

North canopy drain bowl is not connected. Note that the steel components appeared sound.

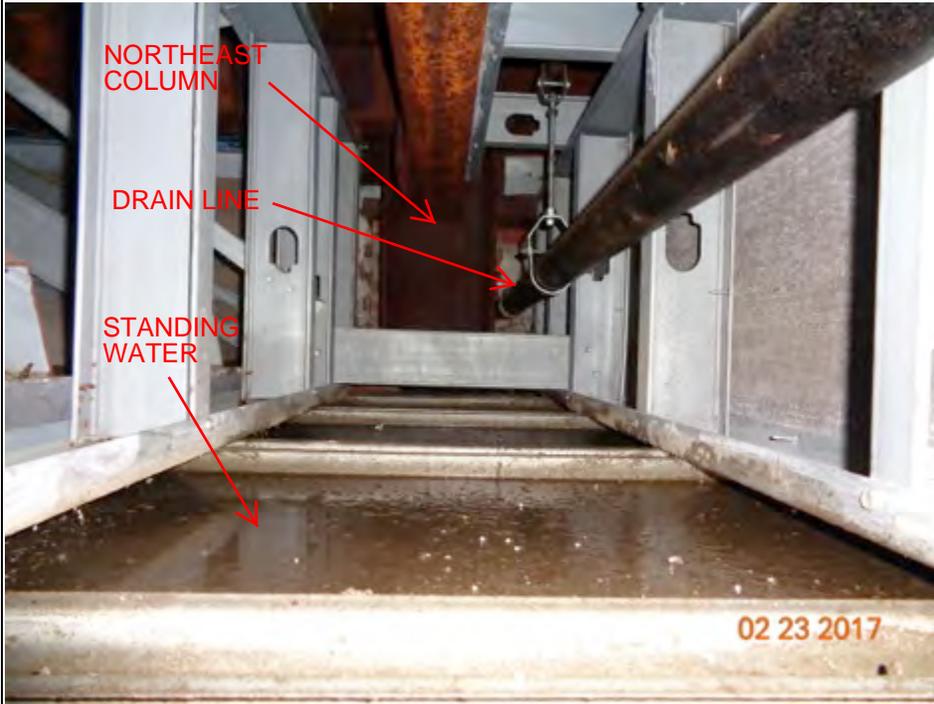
**Photo 11**

Interior of north bus canopy soffit. Drain line runs to the east side of the northeast column shown and then turns down into the underground drain line. Note the standing water on the top surface of the soffit.

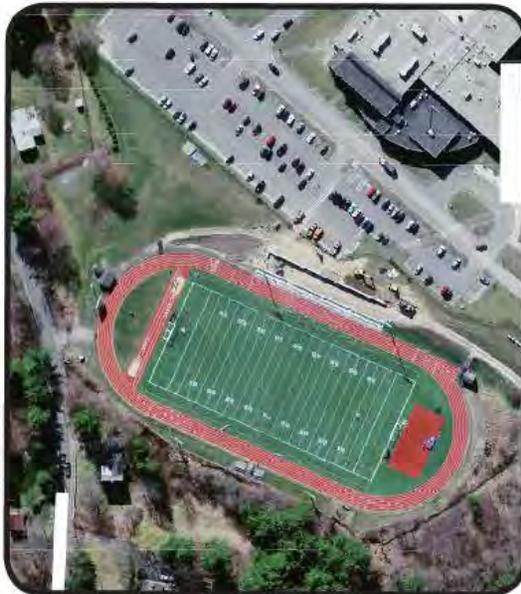
## FIELD A: HIGH SCHOOL MULTI-USE SYNTHETIC FIELD AND TRACK

- TURF IS STARTING TO DEGRADE WHICH WILL DECREASE THE SAFE PLAY ON THE FIELD
- TRACK IS READY FOR AN OVERSPRAY
- THERE ARE CURRENTLY ISSUES WITH THE BASE BELOW THE TURF
- THERE ARE DRAINAGE ISSUES IN THE FIELD
- GRASS IN THE FIELD IS NOT A GREAT DESIGN CHOICE
- THE FACILITY NEEDS ADA PARKING
- ATHLETIC FIELD LIGHTING IS IN WORKING CONDITION BUT, NEEDS TO BE UPDATED
- THE CONCESSION STAND SHOULD BE UPGRADED TO MODERN CODES
- STORAGE ON THE SITE SHOULD BE ORGANIZED
- BASIC AMMENITIES WOULDHELP TO IMPROVE THE FACILITY

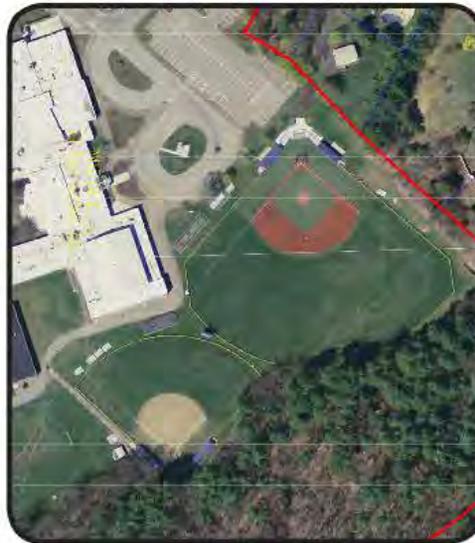
FIELD B:  
MIDDLE SCHOOL BASEBALL/SOFTBALL

- THE FIELD IS GENERALLY IN GOOD CONDITION
- IT IS RECOMMENDED TO ADD 8' CHAIN LINK AT BOTH THE SOFTBALL AND BASEBALL DUGOUT
- FIELD WILL NEED TO BE REPLACED IN THE NEXT 5 TO 7 YEARS
- ATHLETIC FIELD LIGHTING WOULD EXTEND THE USE OF THE FIELD BUT, LOCATION NEAR NEIGHBORS MAY NOT BE APPROPRIATE
- THE TOWN SHOULD INVESTIGATE THE EXPANSION OF TURF DURING THE NEXT REPLACEMENT
- 
- THE EDGE OF THE SYNTHETIC TURF FIELD AND GRASS SHOULD BE ADDRESSED ANNUALLY
- 
- THERE ARE SOME GRADING ISSUES WITH THE INFIELD OF THE SOFTBALL FIELD THAT SHOULD BE ADDRESSED

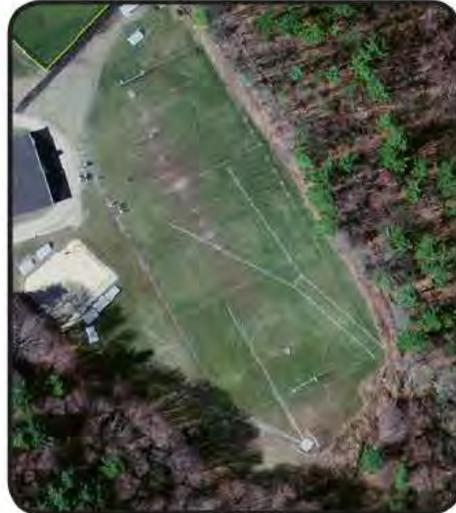
FIELD C:  
MIDDLE SCHOOL PRACTICE FIELD

- THE FIELD IS IN THE WORST CONDITION OF ALL THE FIELDS
- THE FIELD IS UNDERSIZED FOR ANY SPORT EXCEPT FOR FOOTBALL
- TRACK THROWING EVENTS OCCUR IN THIS AREA
- THERE ARE WETLANDS AND A STREAM ON THE OUT SKIRTS OF THE FIELD
- THE FIELD IS SURROUNDED BY FOREST AND SECLUDED FROM NEIGHBORS

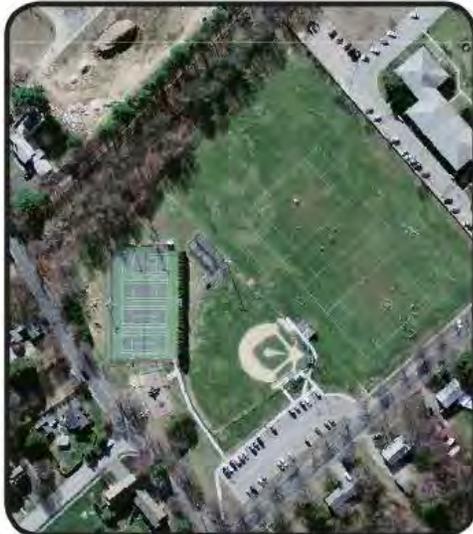
## FIELD D: METACOMET PARK FIELDS

- THE FIELD IS SURROUNDED BY RESIDENTIAL NEIGHBORS TO THE NORTH, EAST AND WEST.
- THE FIELD IS LARGE AND IN GOOD CONDITION.
- PARKING IS LIMITED AND THERE ARE SIGNS OF PARKING ON THE STREET.
- DRAINAGE FLOWS TO THE SOUTHWEST
- THE FIELD IS ORIENTED MORE EAST/WEST THAN THE PREFERRED NORTH/SOUTH
- THE FIELD COULD USE ADA ACCESS IMPROVEMENTS

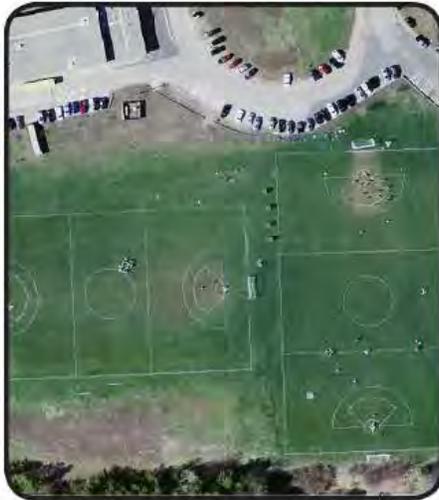
FIELD E:  
RALPH WHEELOCK SCHOOL MUTLI-USE FIELDS

- THE FIELDS ARE HEAVILY USED
- ONE OF THE FIELDS IS NOT ORIENTED THE PREFERRED NORTH/SOUTH DIRECTION
- PARKING IS AN ISSUE, PARKING IS ON THE GRASS
- DRAINAGE FLOWS TO A SWALE TO THE EAST
- THE FIELD COULD USE ADA ACCESS IMPROVEMENTS
- THE FIELDS ARE SURROUNDED BY FOREST TO THE SOUTH AND EAST

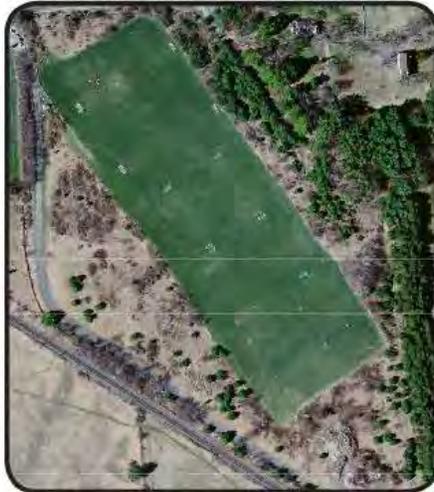
FIELD F:  
SOCCER COMPLEX AT RALPH WHEELock

- PARKING IS LIMITED TO THE FACILITY
- THE FIELDS COULD USE ADA ACCESS IMPROVEMENTS
- FIELDS ARE GENERALLY IN GOOD CONDITION WITH IRRIGATION
- FIELDS ARE SURROUNDED BY FOREST AND WOODED AREAS
- FIELDS ARE HEAVILY USED

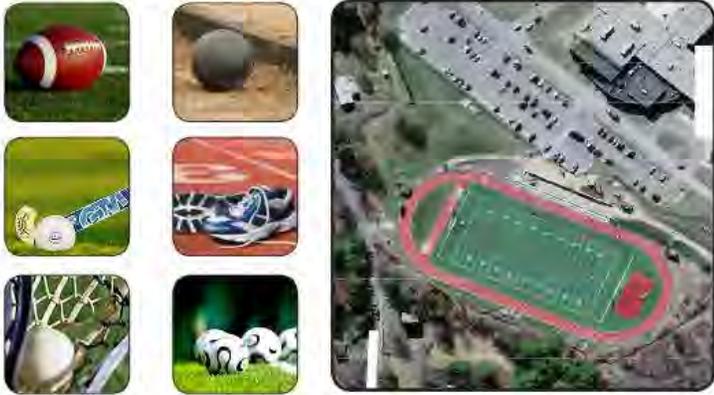
**FIELD A:  
HIGH SCHOOL MULTI-USE SYNTHETIC FIELD AND TRACK**

The synthetic track has clear base issues at the long-jump triple-jump areas. It is highly recommended that the "D-Zone Areas" are built to include synthetic track surfacing which will also assist in the function of the areas when running track meets. The track has been over-sprayed once to date. The track has reached an age in which it should be sprayed again. This should occur during this process. It should be noted that a track can only be sprayed a minimum of three times which should make the track functional for an additional five to six years.

Due to the high level of use of fields in the Town of Medfield and the current condition of the existing field at the High School it is recommended that the existing synthetic turf field with upgraded drainage system and synthetic track be replaced. The synthetic turf fibers are starting to deteriorate, a condition common found in a field with this amount of use and age of the product. The ability of the field to maintain infill in a stable condition will continue to be reduced in turn reducing the overall safety of the field to the athletes. Concerns over rising Gmax will continue to be an issue in the field. Currently there are multiple areas that flood on the field. This is an indication of a failing base/drainage system. It is recommended that a new drainage system replace the existing to alleviate flooding, additionally it is recommended that a trench and slot drain are added to the perimeter of the track to assist with drainage.
